**EFFECTIVE ROAD PAVEMENT REHABILITATION FOR
LOCAL GOVERNMENT ROADS WITHIN THE
SUNSHINE COAST REGION**

A dissertation submitted by
Thomas Sanders

Bachelor of Engineering (Civil)

Submitted: October, 2014

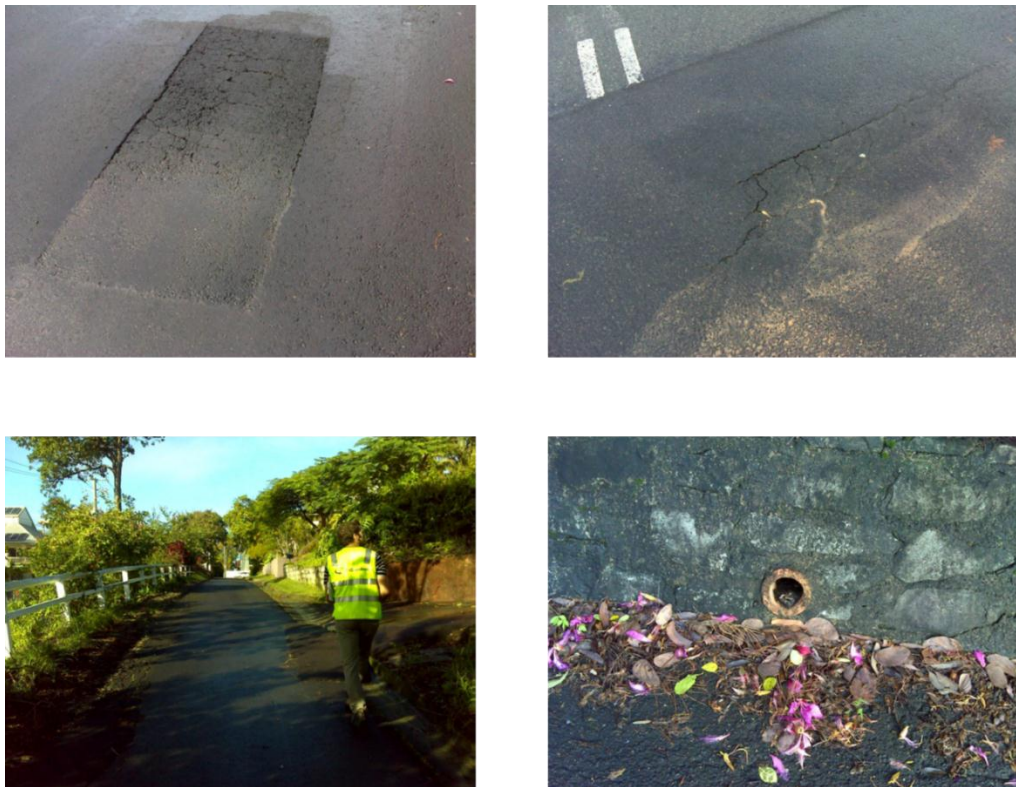
Figure 27: Mary St, Alexandra Headland - Site Photographs

In 2012 Mary St, Alexandra Headland was prioritised as a pavement rehabilitation for the 2012/2013 financial year. A visual inspection was undertaken by Council officers on 29 June 2012 following a period of heavy rain. The inspection revealed that the pavement demonstrated signs of significant structural damage including rutting and crocodile cracking. The pavement had been extensively patched with significant crocodile cracking in patches, indicating that the repairs were not successful. Photos below in Figure 27 shows typical pavement distress prior to pavement rehabilitation.

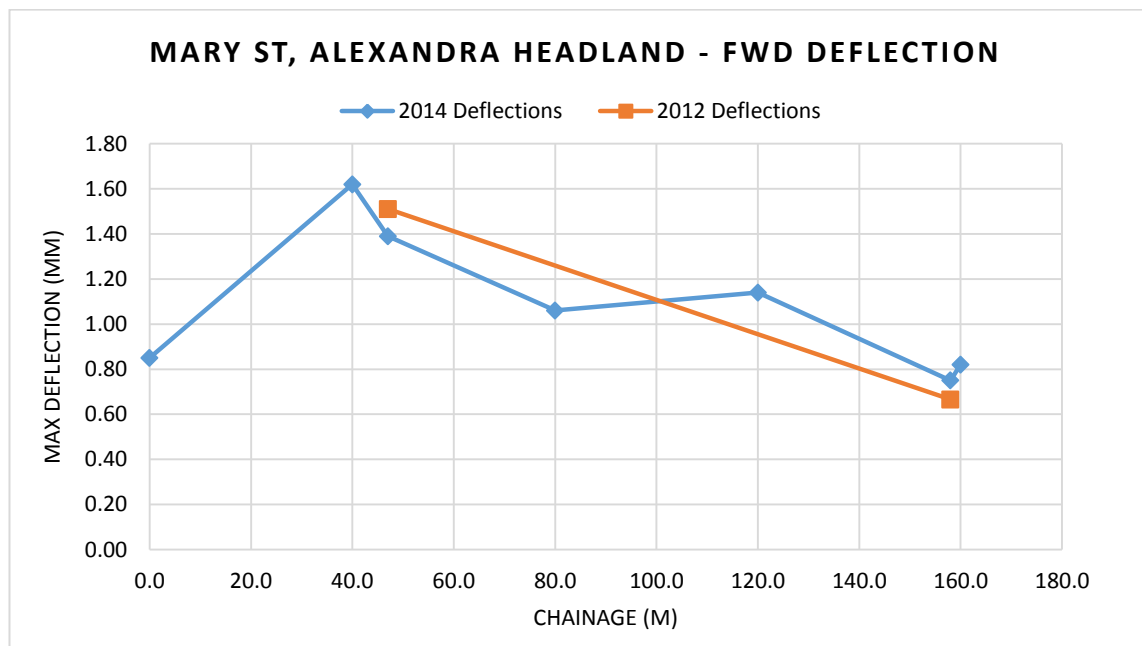
Figure 29: Mary St, Alexandra Headland - 2012 and 2014 Maximum Deflection Results

Austrroads (2009) suggest that very high local deflections (more than 1.5mm) may indicate weak subgrade conditions. Considering significant subsoil drainage works undertaken as part of the pavement rehabilitation and site inspections prior to and post construction suggest groundwater may be a contributing to the subgrade performance.
