University of Southern Queensland

**Pacific Highway Glenugie: Case Study of the Use of Heavy Duty
Granular Pavement in Northern NSW**

Bachelor of Engineering (Honours)

Submitted: October, 2016

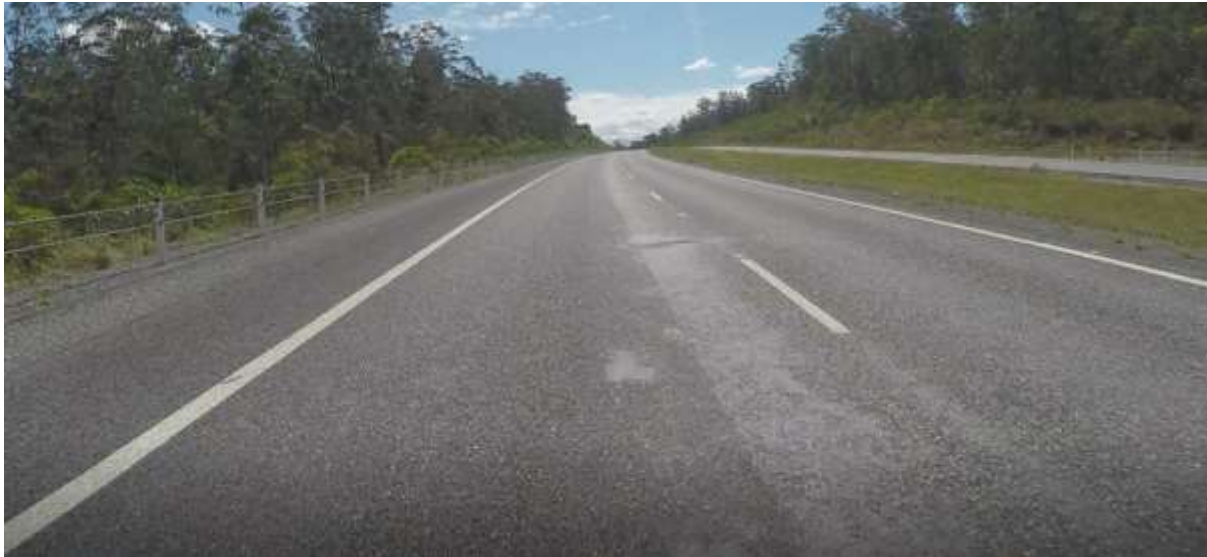
Figure 4.4: Image from the video used for the defect mapping, heavy patch can be seen of the left side of the image.

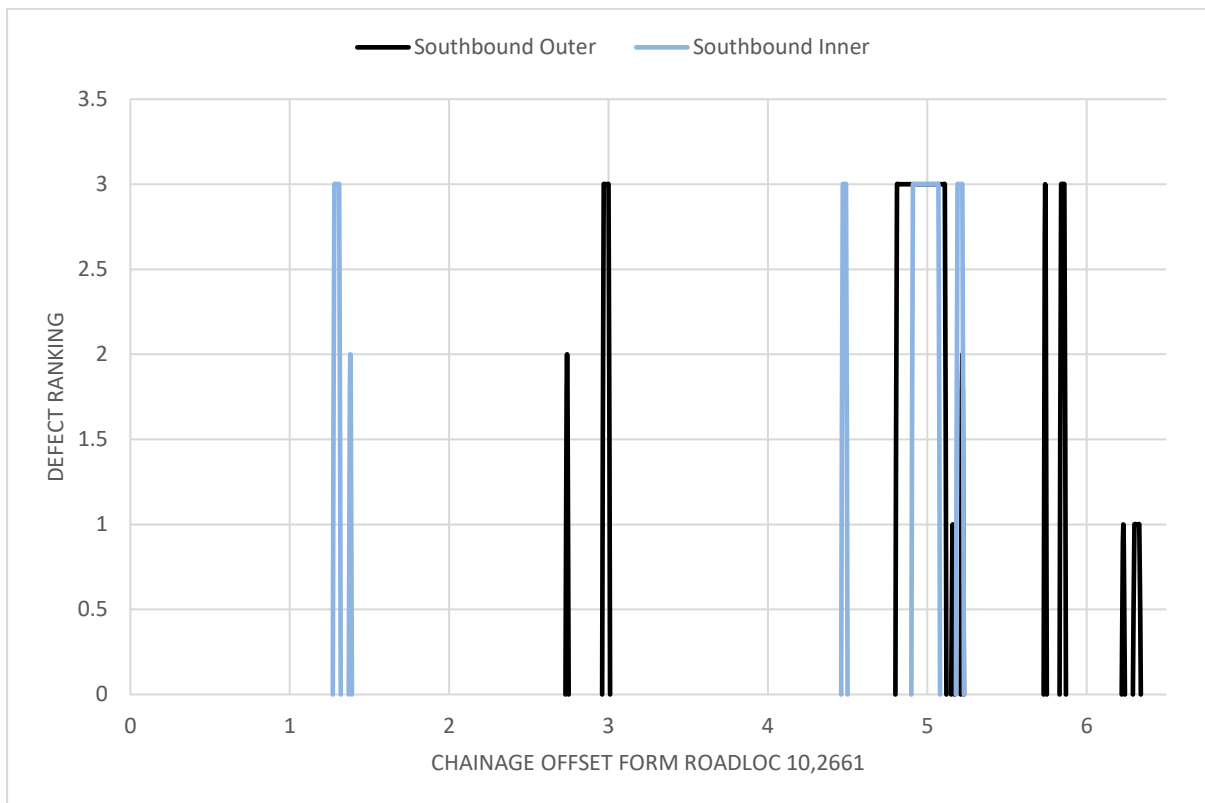
Figure 5.1: Defect mapping of the south bound lanes.

The result from the southbound defect mapping can be seen in the figure below. The ranking for the defect is on the y axis and has been determined by the ranking system outline in the methodology section of the report. Along the x axis is the chainage relative to Road Loc position. The mapping shows that a considerable number of defects were identified along the southbound lanes.

Around the 5km mark, two large failures have been identified in the mapping in both the outer and inner lane. The failure in the outer lane is the longer of the two and is 300m in length, running from chainage 4.81 to 5.11. The failure in the inner lane runs from chainage 4.91 to 5.08 and is 170m in length. Furthermore, the defect mapping of the southbound lanes showed that 4.5% of the inner lane and 7.2% of the outer lane were affected by structural pavement defects. These are both higher than the average of 4.0% calculated for the 4 lanes combined. This indicates higher levels of structural defects in southbound lanes when compared the northbound. This can also be seen by comparing the southbound figure above with the northbound figure below.

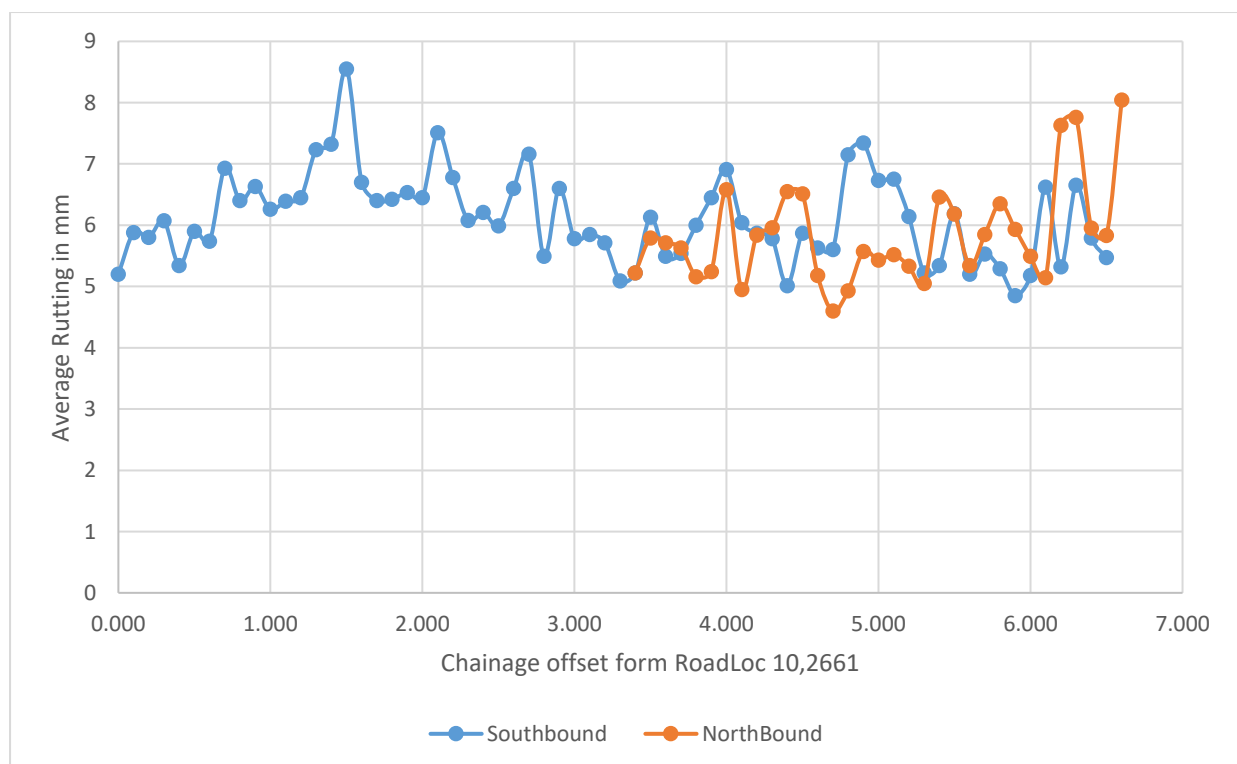
Figure 5.3: Average Rutting in mm graphed against the chainage of the pavement examined

The graph of the rutting data for the north and southbound lanes is shown below. The graphs show that the rutting ranges from 4.5mm to 9mm across the length of pavement examined. The rutting of the pavement is not consistent with peaks and troughs occurring along the section of pavement. In the southbound lane, two large peaks occur at the chainage 1.5km mark and around the 5km mark. In the northbound, the most notable peak in the data occurs at the 6.2km mark. It is clear from the data that rutting has occurred along the length of the pavement examined with higher depth of rutting in some areas.

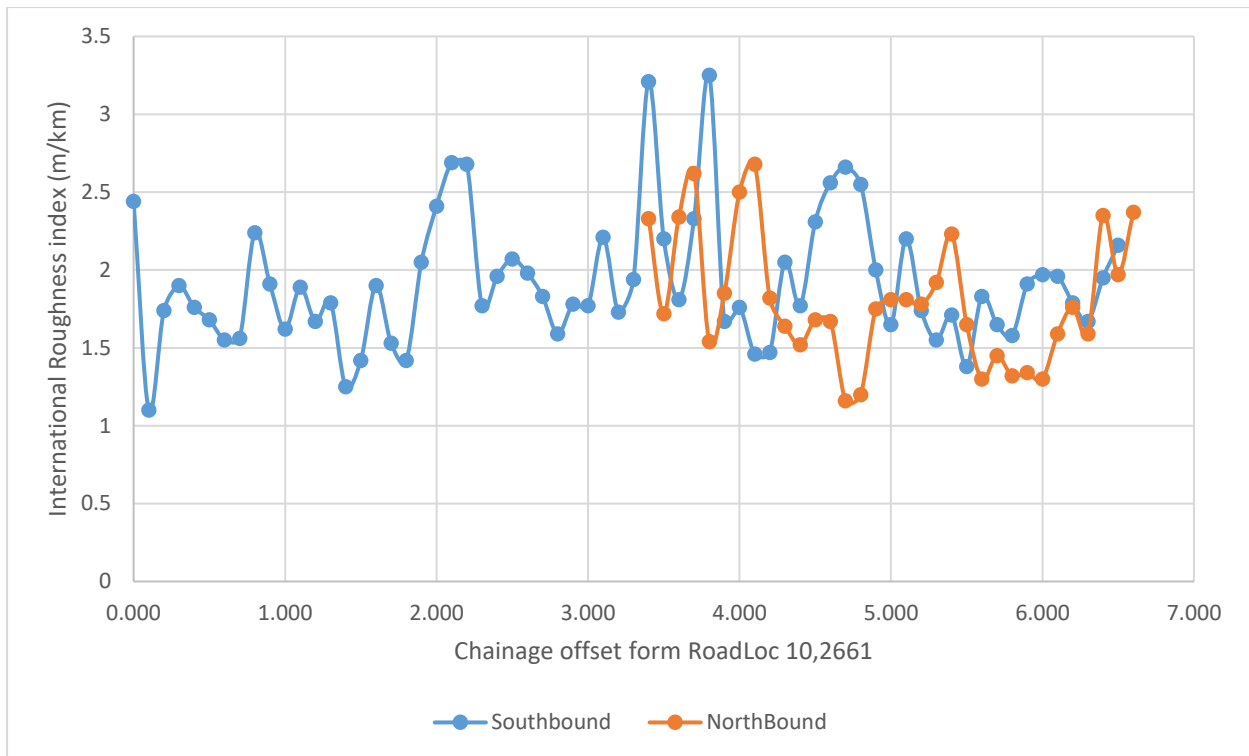
Figure 5.4 : Average international roughness index in m/km graphed against the chainage of the pavement examined.

Below is a graph of the roughness data for the north and southbound lanes. The graphs show that the IRI ranges from 1m/km to 3.5m/km across the length of pavement examined. The roughness data for the section of pavement examined varies with several peaks and troughs. The data indicates there is some roughness along the section of the pavement. When looking at the figure, it is important to keep in mind that some roughness is expected and no road has a perfectly flat surface.

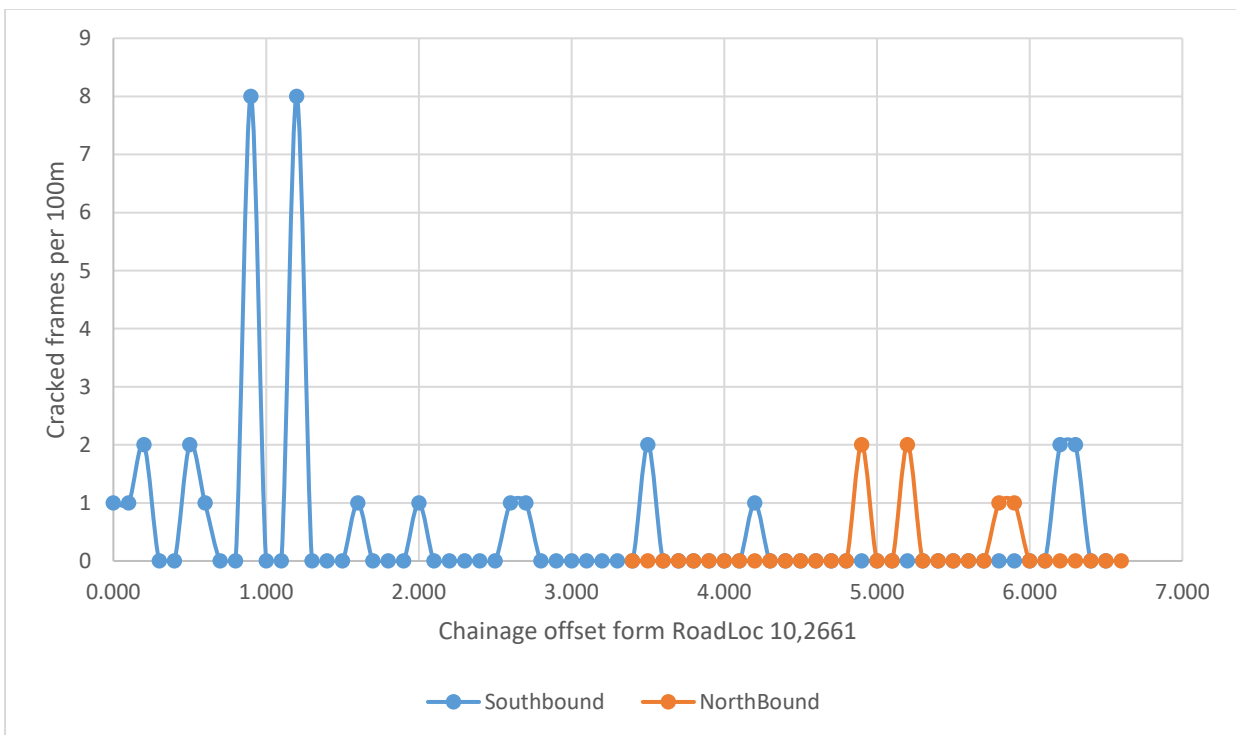
Figure 5.5: Average cracking in cracked frames per 100m graphed against the chainage of the pavement examined.

Below is a graph of the cracking data for the north and southbound lanes. The graphs show that the cracking ranges from 0 to 8 cracked frames per 100m across the length of pavement examined with a lot of sections showing 0 cracked frames. Two peaks in the cracking can be seen around the 1km chainage in the southbound lane. The data indicates that there is little cracking along the section of the pavement.

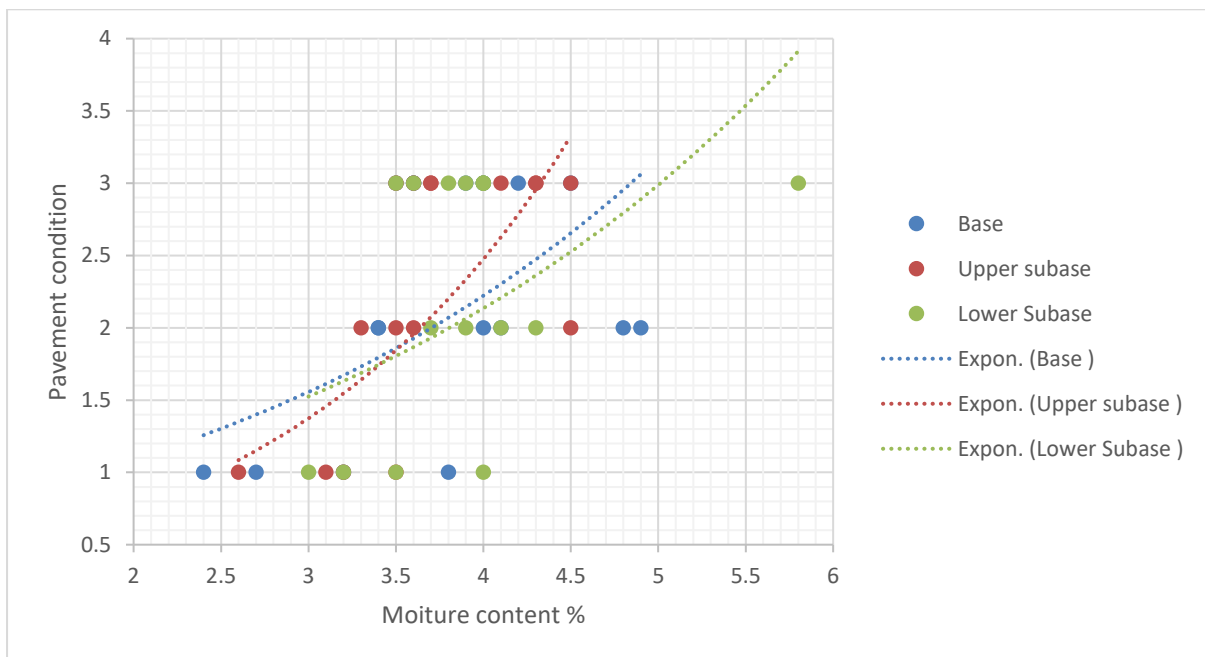
Figure 5.9: Shows pavement condition vs moisture content for the base, lower base and sub-base with linear lines of best fit.

The condition of the pavement as recorded in the test pit logs has been graphed against the moisture content of the sample for the base, lower and sub-base material to examine if a relationship exists between them and the moisture content. The condition of the pavement has been given a number value 1, 2 or 3 based on the condition of the pavement at the time of sampling being good, fair or poor.

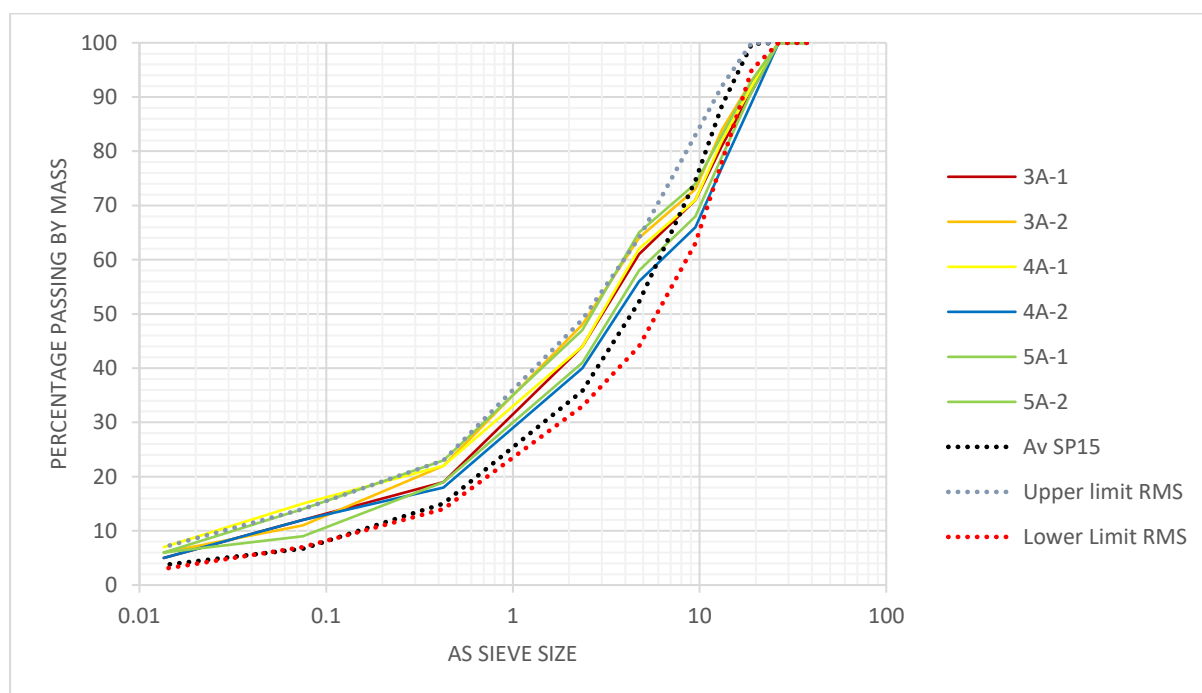
Figure 5.10: Particle size distribution results from the base material for the 3 test pits sampled

Particle size grading were carried out on 18 samples of DGB20 material, sample 3A-1, 3A-2, 3B-1, 3B-2, 3C-1, 3C-2, 4A-1, 4A-2, 4B-1, 4B-2, 4C-1, 4C-2, 5A-1, 5A-2, 5B-1, 5B-2, 5C-1, and 5C-2. The results show the percentage of material tested passing through the sieves by mass. The particle size distribution results for the samples mentioned above can be found below figures. Also included in the figure is the average grading result for the gravel stock pile that corresponds to the area sampled along with the upper and lower limits which are stipulated by RMS 3051 materials standard.

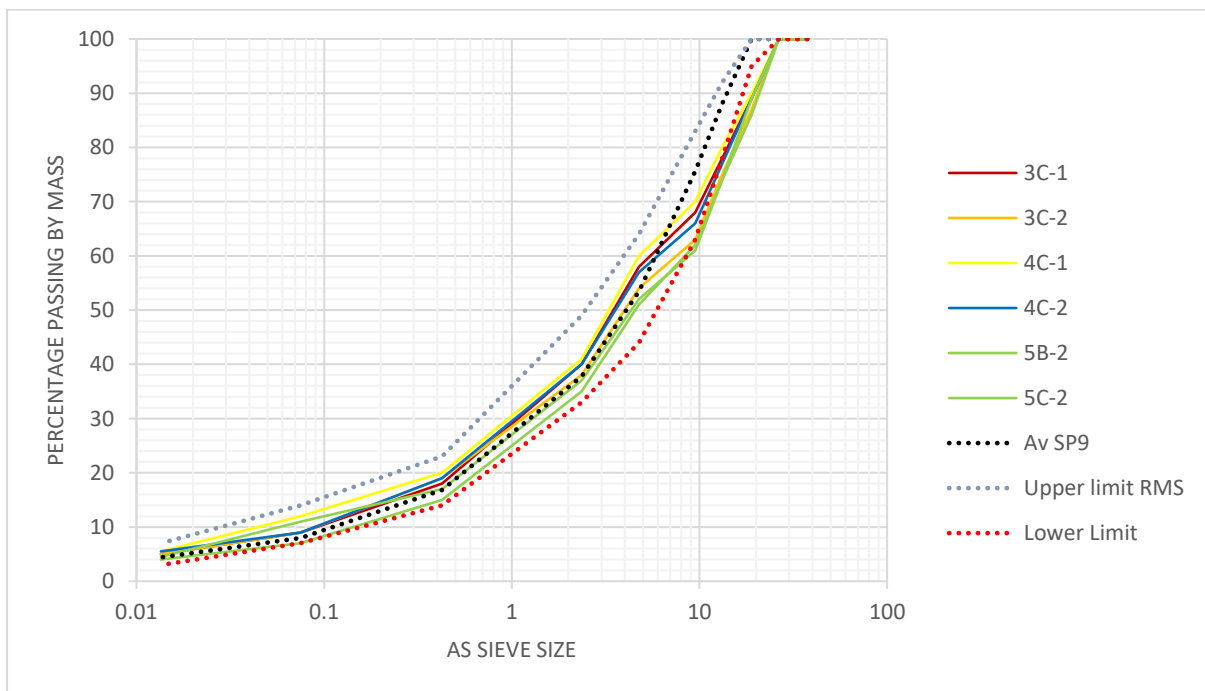
Figure 5.12: Particle size distribution results from the lower sub-base material for the 3 test pits sampled

average of the 5 five particle size distribution test carried out on the stock during construction is represented as a black dotted line along with the upper and lower RMS limits which are the red and blue dotted lines. Examining the results of the samples tested, it can be seen that most of the samples have broken down considerably since testing was carried out on the stock pile. From around the 8mm size and below, all samples showed increase in the amount of the finer material when compared to the stock pile tests average. Similar to the base material the results for the upper sub-base show that above the 8mm particle size the grading curve shows that less material is passing through the sieves. This is an unusual result and suggests the material above 8mm is generally larger in size then when the stock pile was sampled in construction of the Glenugie project.

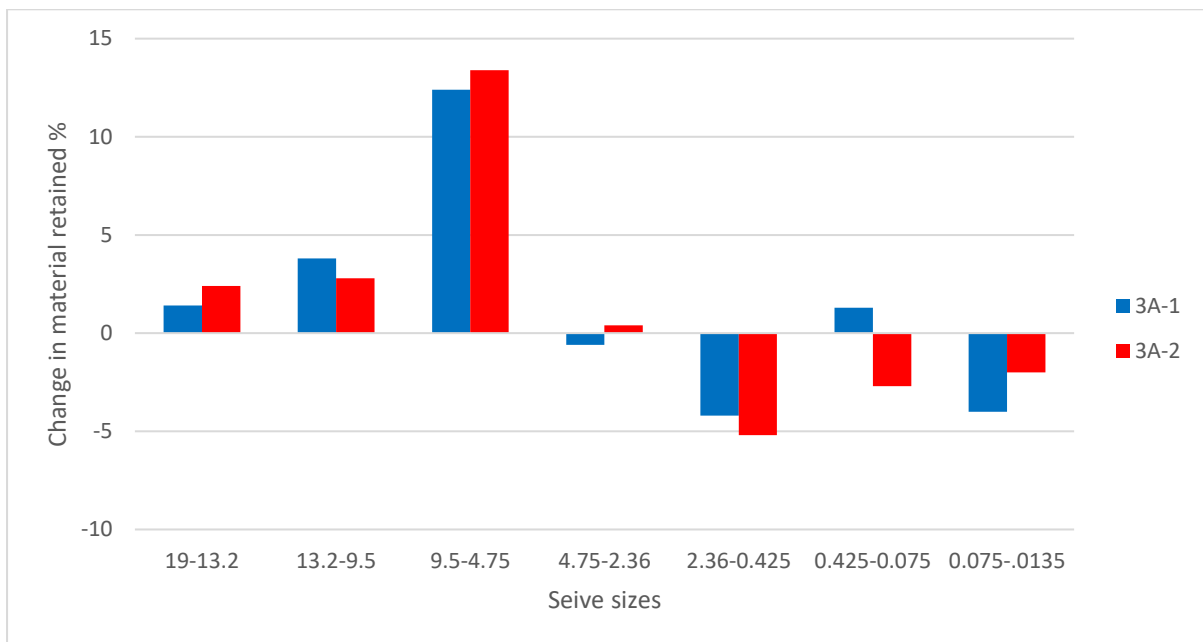
Figure 5.13: Change in material retain on the sieves for the base material at test pit 3

The change in mass retained on the sieve between the stock pile testing and the test carried out for this project are graphed below for samples from the shoulder and the outer wheel path. This section of analysis looks to examining if more material breakdown occurred in the sample from the outer wheel path when compared to the shoulder. This will help to determine if traffic loading has played a role in the in the beak down of the pavement material.

The figure above shows the result for both the shoulder material and material from the outer wheel path for the base layer at test pit 3. It can be seen that similar levels of break down are occurring in both samples, if anything the martial from the shoulder may have broken down more. This would suggest that it is unlikely that traffic loading is the cause of the break down base on these samples.

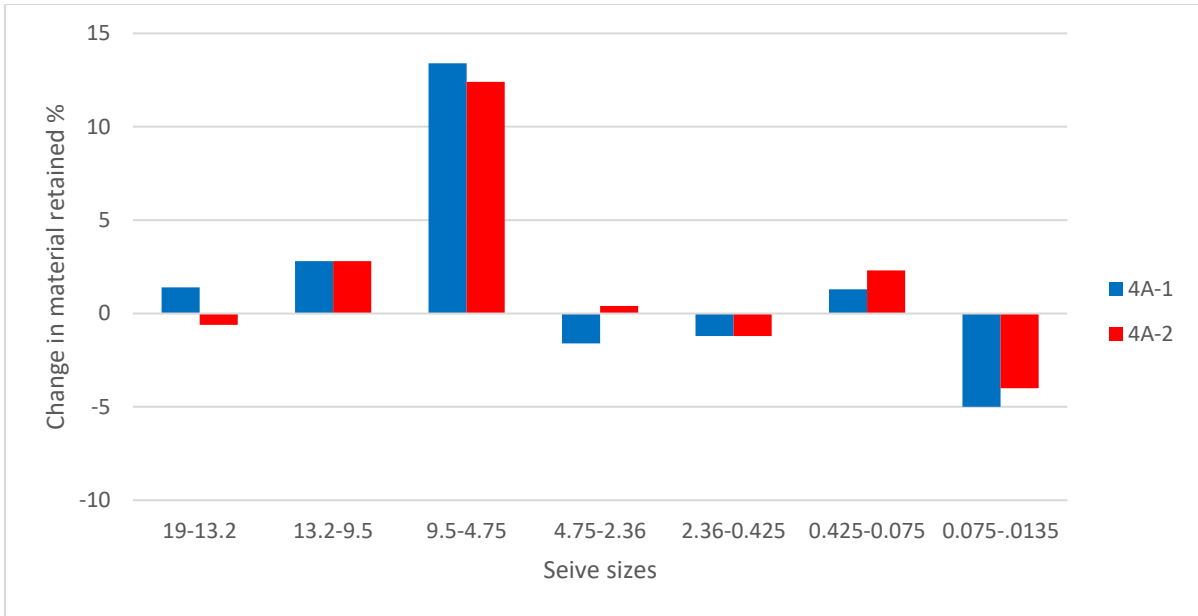
Figure 5.14: Change in material retain on the sieves for the base material at test pit 4

The figure above shows the results for both the shoulder material and material from the outer wheel path for the base layer at test pit 3. It can be seen that similar levels of break down are occurring in both samples. This would suggest that it is unlikely that traffic loading is the cause of the break down base on these samples.

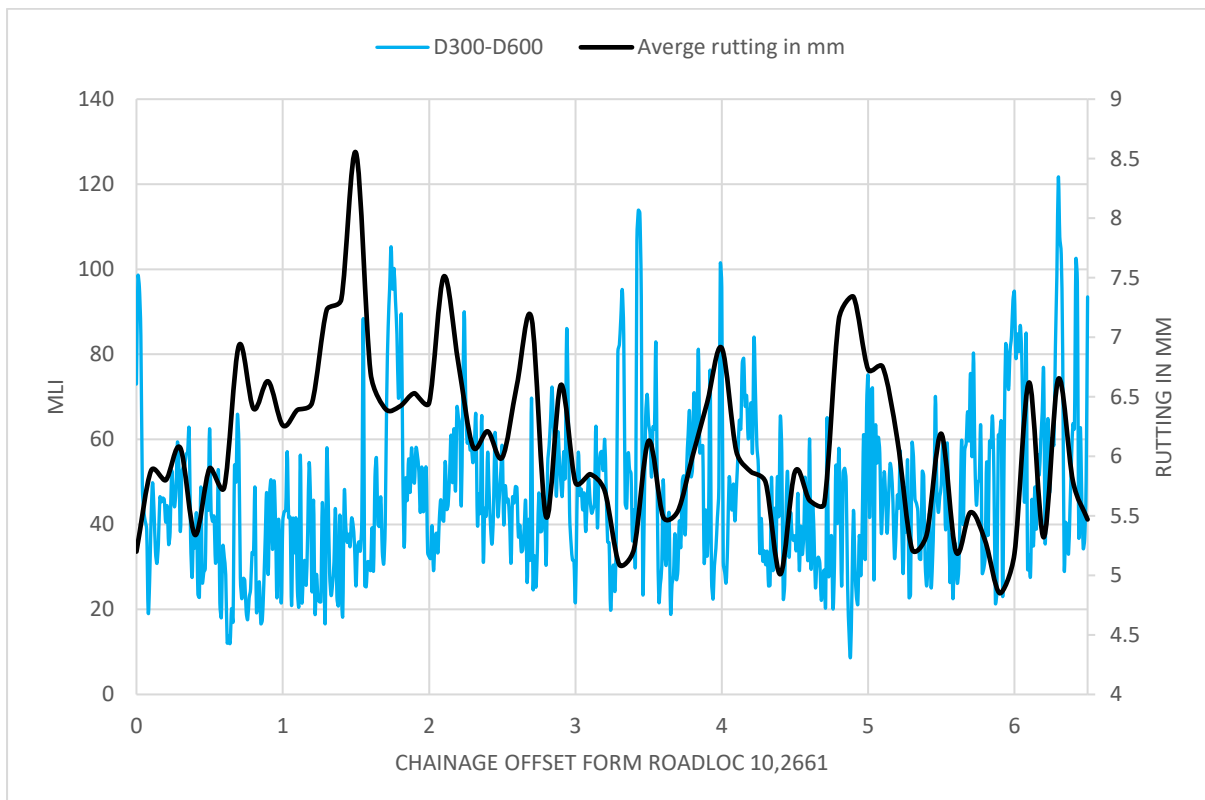
Figure 5.16: Middle Layer Index value vs rutting data

In the figures below the values for Middle Layer Index and Lower Layer Index area graphed with the rutting data collected in the earlier stages of the study. By analysing these factors together the study will be able to identify if weaknesses or abnormally in the lower formation layers have played a role in the development of the failure or rutting in the pavement. Due to time and resource restriction this section of analysis is only going to focus on the outer southbound lane as it has the most failures to be compared with the Middle Layer Index and Lower Layer Index values. The southbound defect mapping showed major defects at approximately chainages 3, 4.8 to 5.2 and at 5.7. The index values surrounding these areas will also be examined to aim to identify if the underlying structure in these areas has some sort of weakness.

In the figure above it can be seen that the Middle Layer Index has no correlation with the rutting value. The two values act independently of each other with no pattern. At chainage 3, 4.8 to 5.2 and at 5.7 again no evidence of the weak or soft underlining material can be identified from the Middle Layer Index. The Middle Layer Index show that structural condition of the earthworks upper zone is unlikely to have been a cause of the high rutting and failure found in the southbound pavement. This is indicated by the lack of correlation between the Middle Layer Index, the rutting data and failures in the pavement.
