Safety of electrical equipment in water-based amusement
rides from an engineering perspective

Kendra Gurrin

ENG4111 and 4112 Research Project

Bachelor of Engineering (Honours) (Power Engineering)

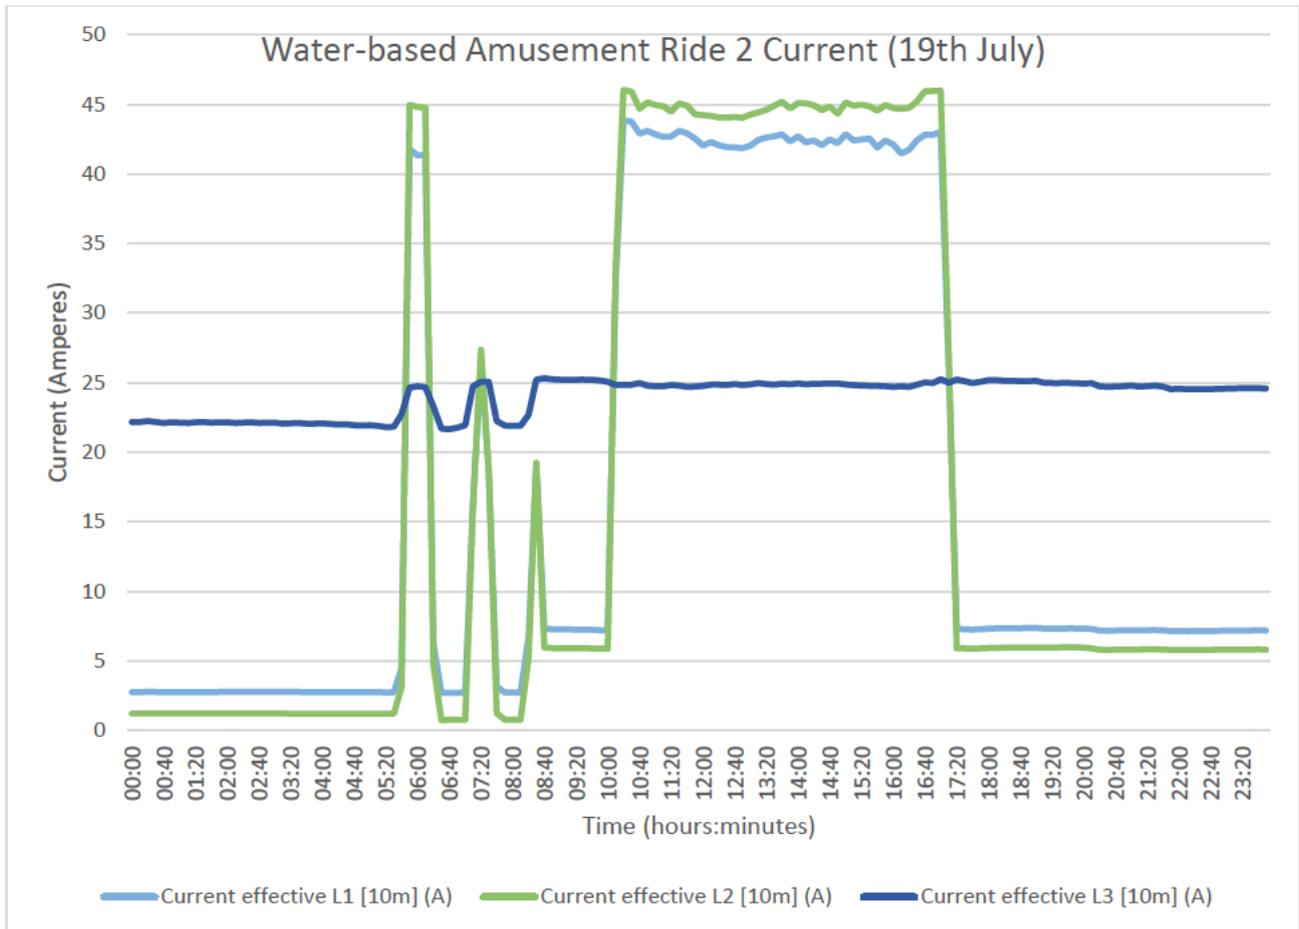
Figure 5.1 Water-based Amusement Ride 2 three-phase current on the 19th of July 2023

The graph indicates that the L3 current for the water-based Amusement Ride 2 is on overnight at 22 A, while the other two phases have a current of less than 5 A. The current for all three phases should be zero, as the amusement ride is on standby. During the testing of Amusement Ride 3, there was an additional challenge: the main isolator handle broke apart when it was time to re-energise the amusement ride, leaving the ride power unable to be restored. The graph in Figure 5.2 is from the day of testing for Amusement Ride 3. The failure happened after business hours, so a new handle was purchased the following day. It would have been impossible for the current to have been on when indicated in the graph.

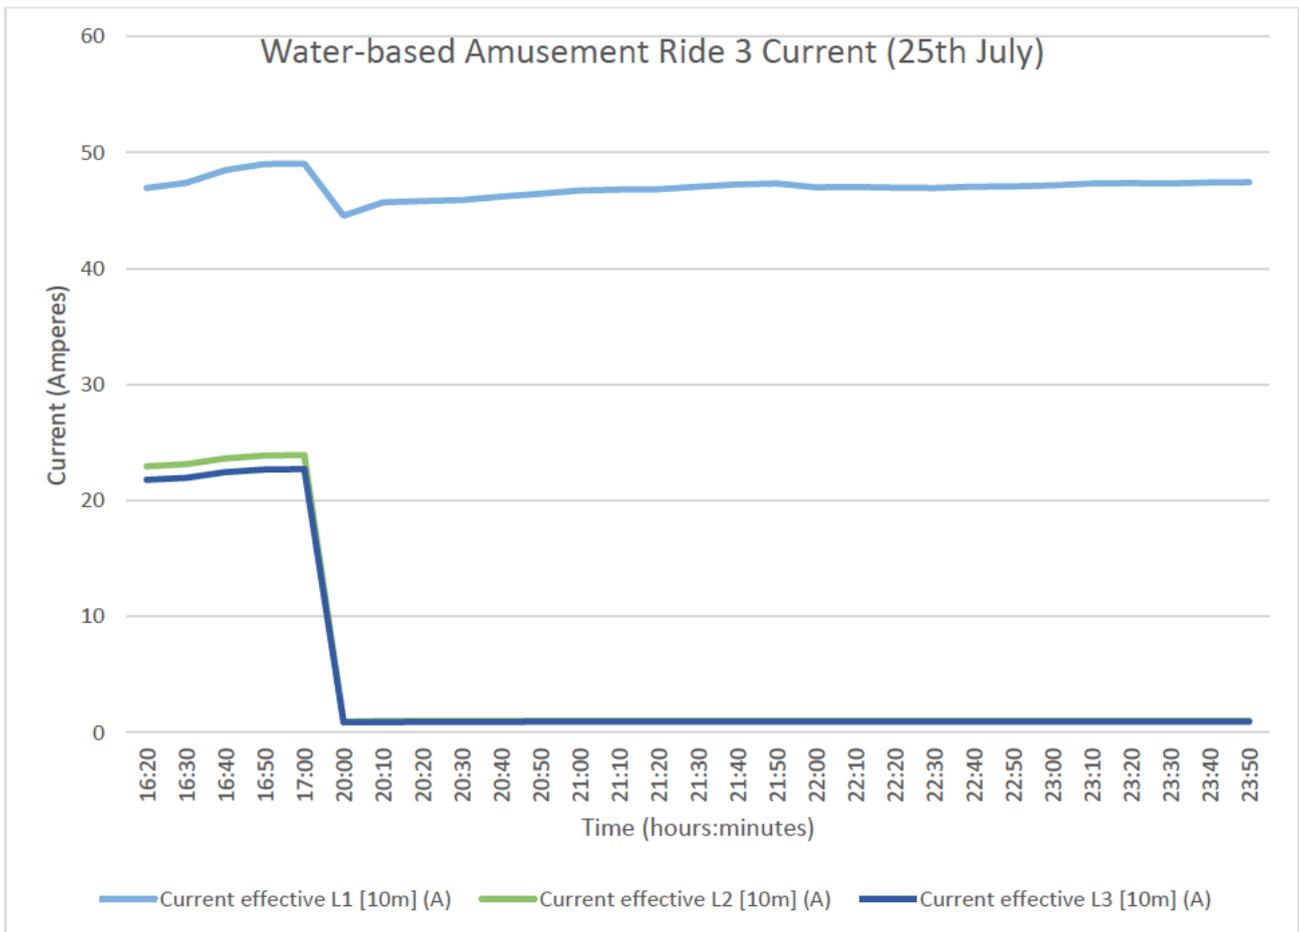
Figure 5.2 Water-based Amusement Ride 3 three-phase current on the 25th of July 2023

The Janitza and Fluke, power quality analysers were connected to a known supply and compared to confirm the hypothesis. The power quality analyser measures the power for two hours; the Rogowski coil then moves to the following input to identify the issue. Figure 5.3 shows that the L1 current is 1 A below L2 and L3. The Fluke power quality analyser measured approximately 0.8 A more than the Janitza L2 and L3 measurements. The current transformers were measuring lower when connected to the L1 input.

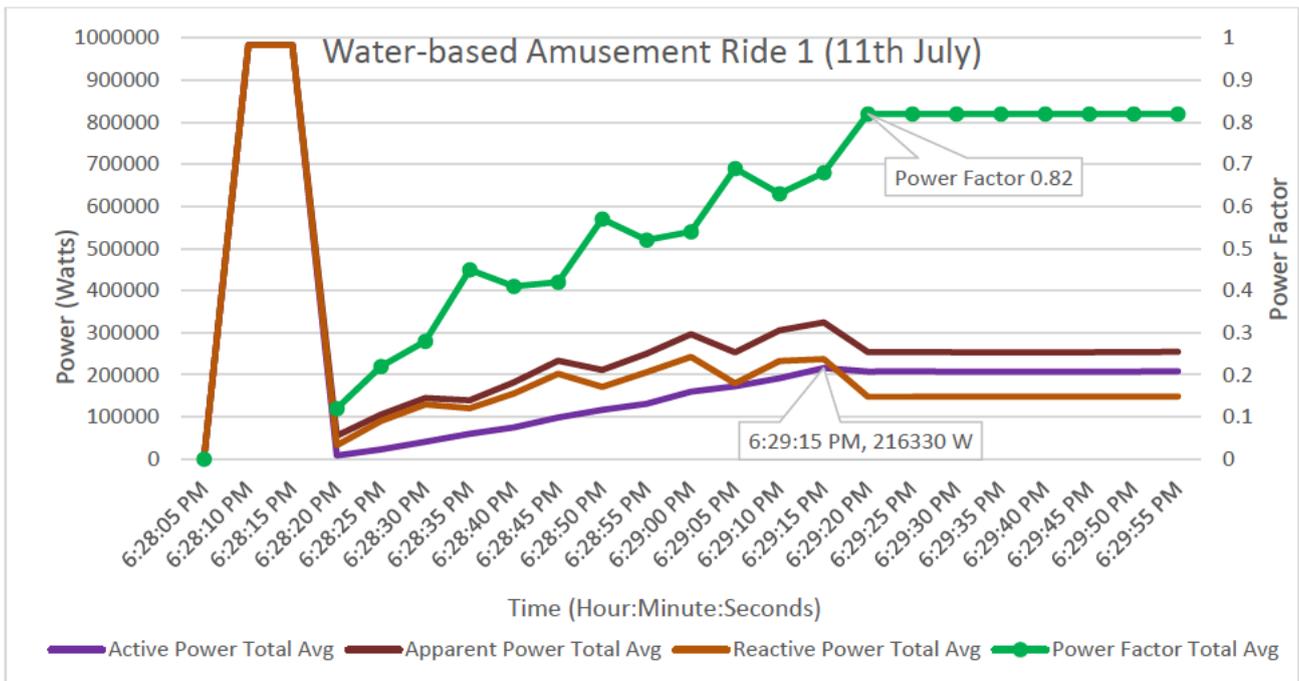
Figure 5.5 Water-based Amusement Ride 1 three-phase power and power factor

The results show a low power factor when the reactive power is highest during the start. The power factor then increases to 0.82 when the reactive power is lowest. During starting, the considerable reactive power reduces after 10 seconds and stabilises after 1 minute and 10 seconds. Reactive power is the consequence of the voltage and current not being in phase. The results were further analysed to obtain the current readings during the startup of the ride.

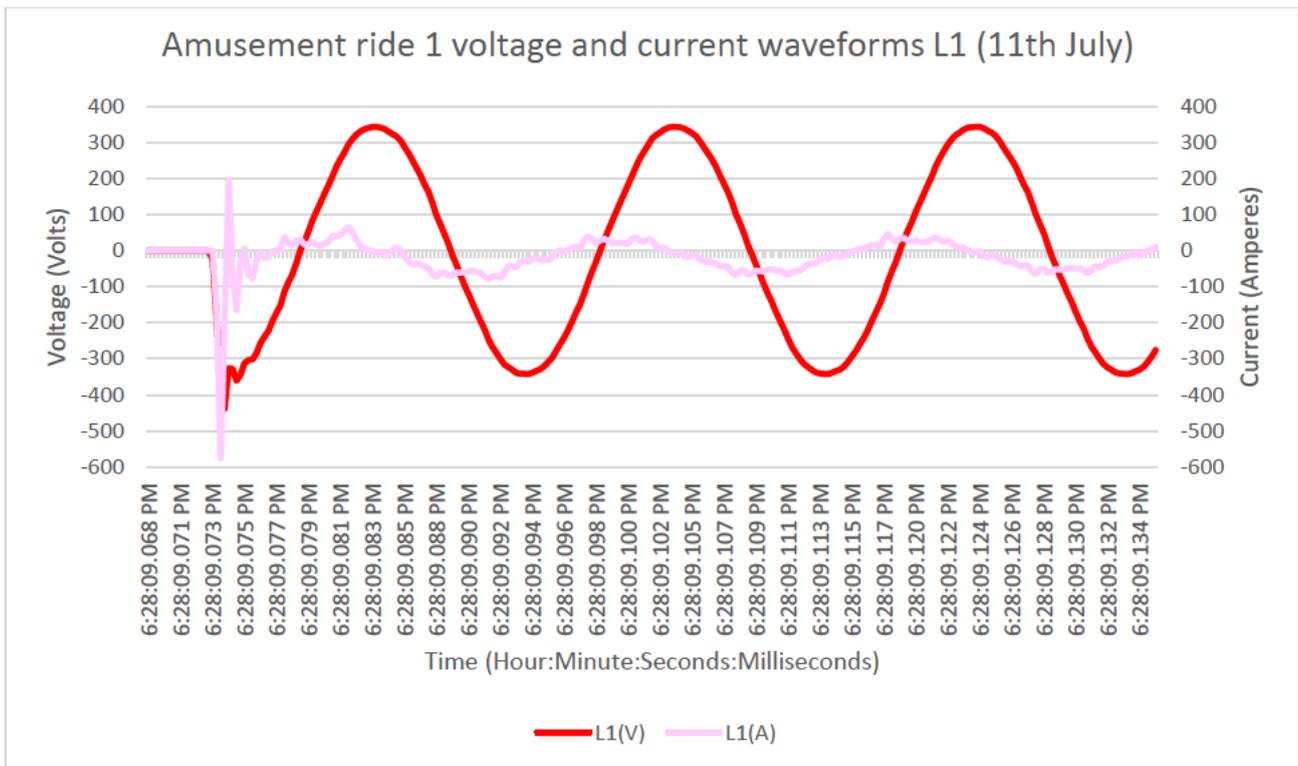
Figure 5.6 Water-based Amusement Ride 1 L1 voltage and current waveforms

The current results were inconsistent across the ride's three phases, with the largest phase being L1. The current recorded was 6277 A; this current did not change the magnitude of the two readings. The inconsistent results indicate that the power quality analyser measurements are incorrect. Further analysis of the voltage and current waveforms show transients. Figure 5.6 illustrates the L1 transient on the 11th of July. Oscillatory transients happen when there is a sudden change in the steady-state condition during the switching of inductive or capacitive loads. The load resists the change, resulting in an oscillatory transient. In this case, the transient occurs during the startup of the ride. The transients were present at startup during the power quality monitoring. The current leads the voltage, leading current occurs in circuits with capacitive loads.

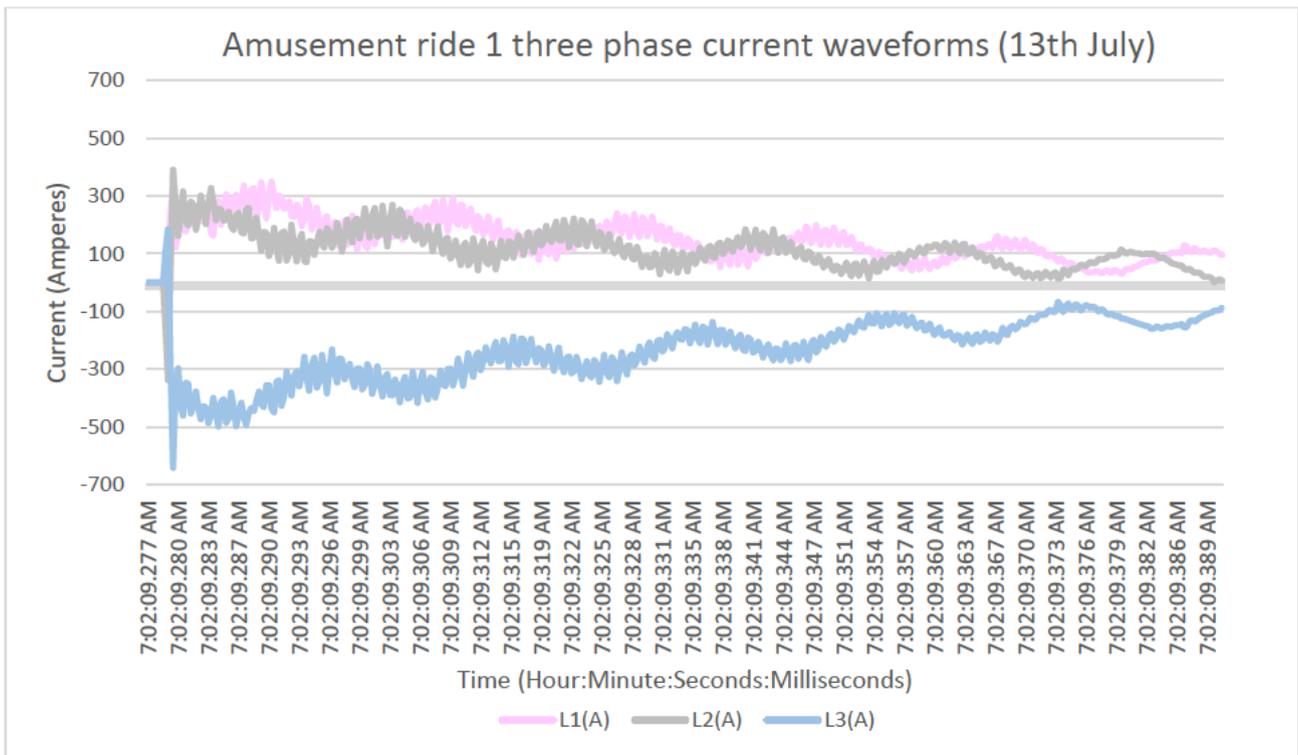
Figure 5.8 Water-based Amusement Ride 1 three-phase current waveforms

The oscillatory current transient is shown in Figure 5.8. The design has considered capacitor switching with the installation of line filters to dampen the oscillatory transient. The transients last 200 milliseconds or 0.2 of a second. In addition, the three-phase current waveforms are displaced from the zero point. Displacement from the zero point is typical where there is DC present in an alternating current power system, and the phenomenon is labelled DC offset. The presence of transients during startup is not a critical event. However, the presence of a DC offset is unexpected.

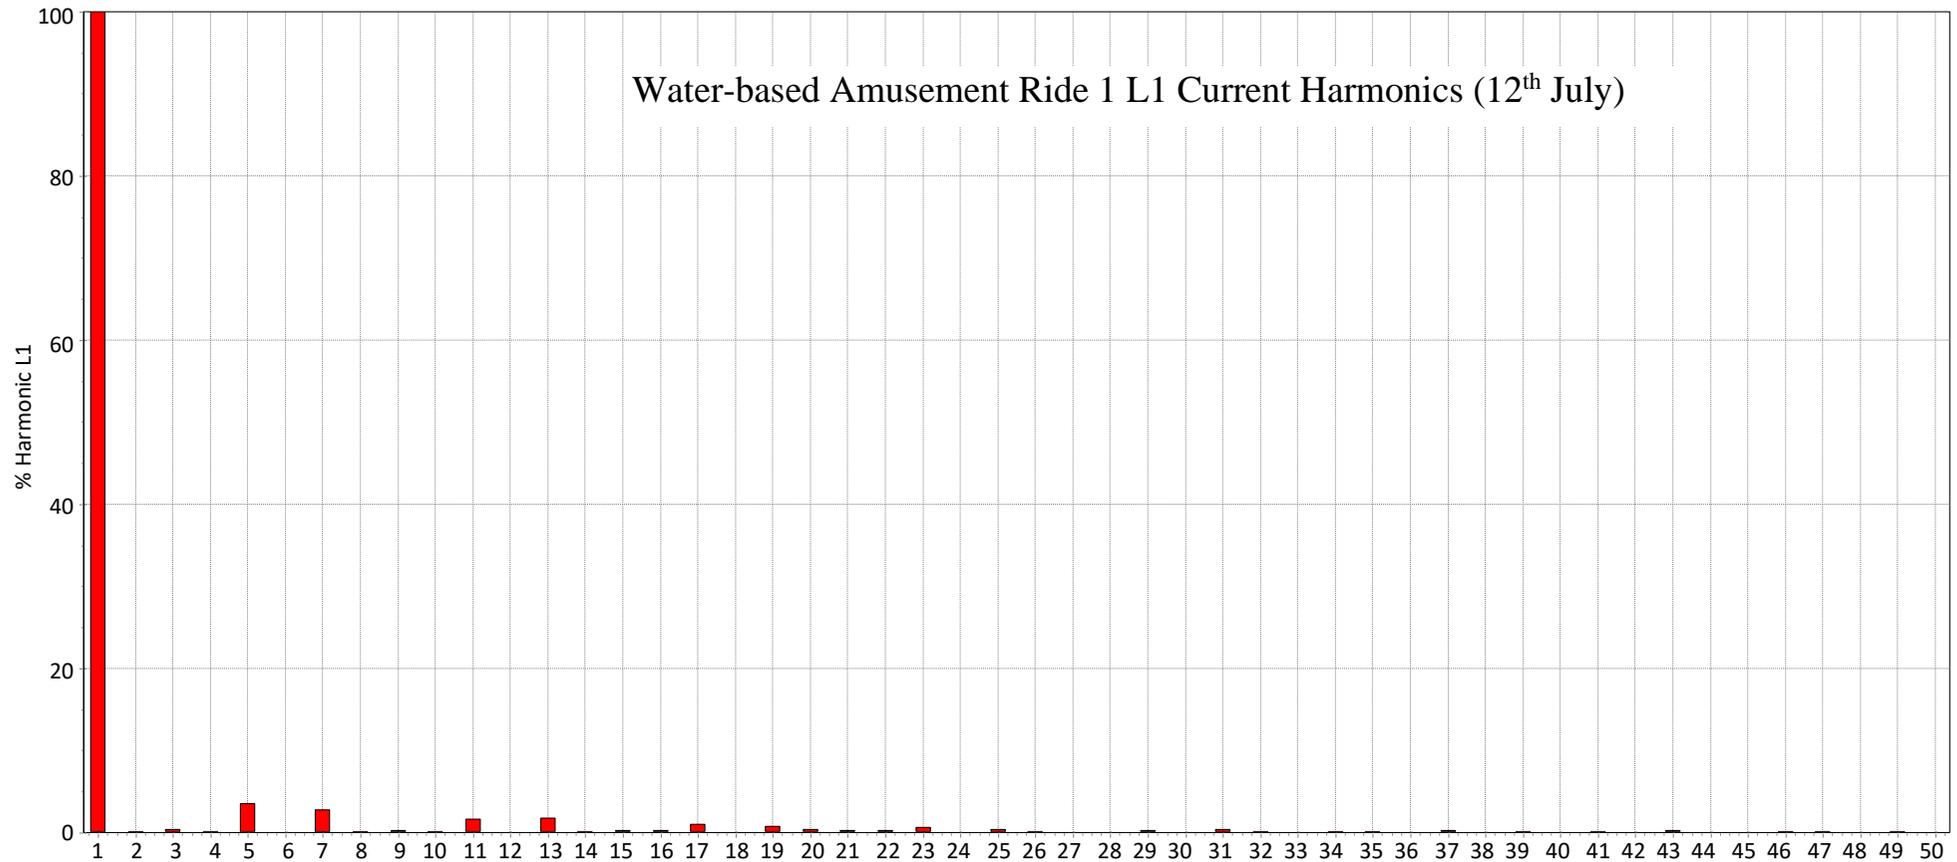
Figure 5.10 Water-based Amusement Ride 1 L1 current harmonics on the 12th of July

the system. The time window for the current harmonics was reduced to ensure only harmonics during steady-state operation were exported. The results are illustrated in Figure 5.10, which shows a substantial decrease in the current harmonics.

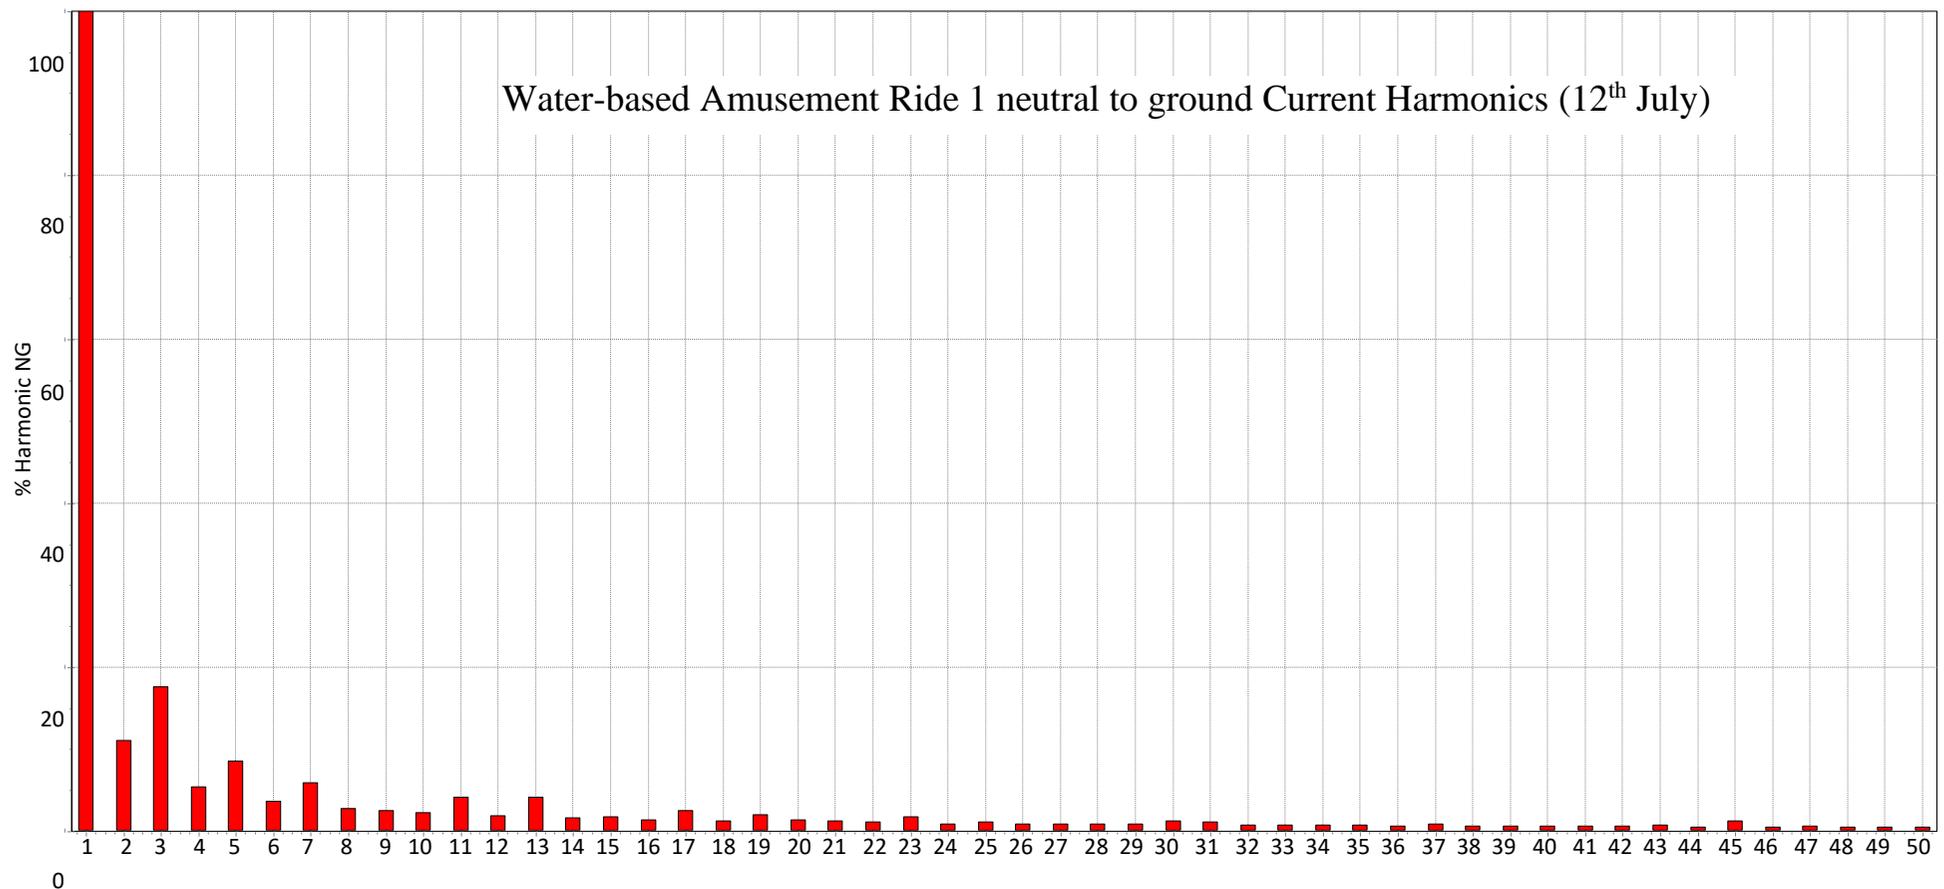
Figure 5.11 Water-based Amusement Ride 1 neutral to ground current harmonics on the 12th of July

IEC 61000.3.12. AS/NZS IEC 61000.3.12 is intended for equipment above 16 A and equal to or less than 75 A. This standard was chosen for the analysis as the smallest drive has a current rating of 19 A. Standards Australia (2023a) applies to equipment connected to the public supply system. As discussed in section 5.3, VRTP owns the supply system; thus, the requirements do not apply. Figure 3.4 in section 3.1.1 shows the current emission limits for balanced three-phase equipment with the fifth harmonic range from 10.7% to 40%, depending on the short-circuit ratio of the equipment. The seventh harmonic is less, ranging from 7.2% to 25%. Nevertheless, the harmonic currents are well below the identified limit. In addition, the results from the neutral current harmonics were reviewed. The neutral-to-ground current harmonics are of a greater magnitude.

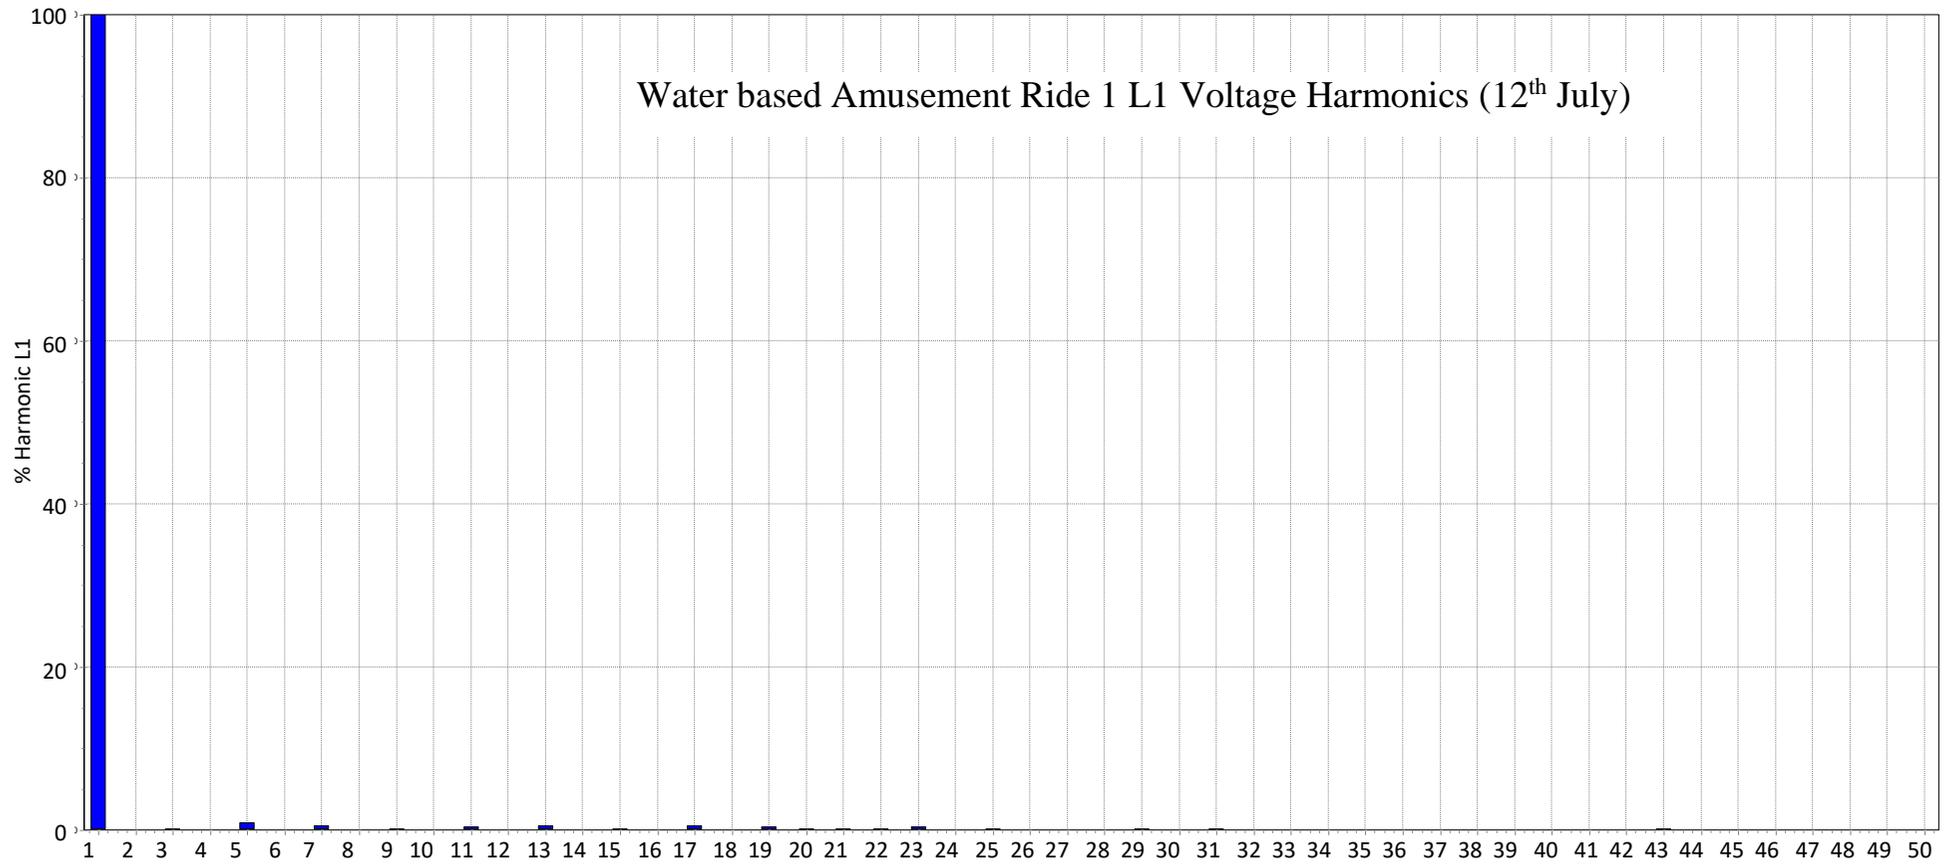
Figure 5.12 Water-based Amusement Ride 1 L1 voltage harmonics on the 12th of July

Figure 5.12 depicts the voltage harmonics. The research in Section 3.1.1 discusses the standard for harmonic voltages in industrial plants: AS/NZS 61000.2.4. Standards Australia (2009) states that the maximum fifth harmonic voltage is 8% within the plant. The largest harmonic voltage is the fifth harmonic at 0.93%, with a THD for the 12th of July of 1.56%; this is below the limit. Additionally, Standards Australia (2019) states that the harmonic distortion limit for electrical machines is 12% from the 2nd to the 30th harmonic. The fifth harmonic voltage is well below both identified levels.

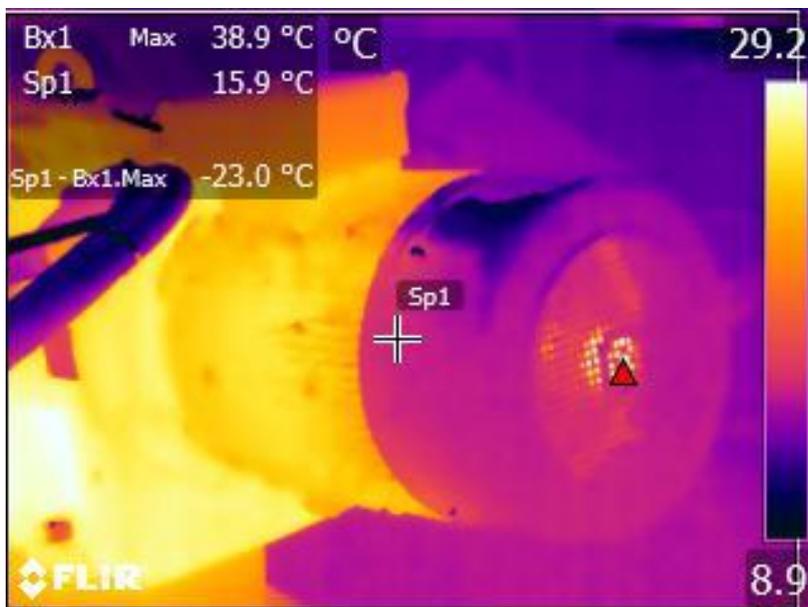
Figure 5.17 Water-based Amusement Ride 1 thermal image of motor

ride. Where the motors for the amusement rides were not located in the water, the thermal images indicated uniform heat distribution. The uniform heat distribution is illustrated in Figure 5.17, which shows a thermal image from The water-based Amusement Ride 1. The thermal image shows consistent colouring on the body of the motor, with the fan casing being lower in temperature. The hottest part of the motor is the fan-bearing at the end of the fan casing. The motor thermal images were consistent with the results of the previous amusement ride condition monitoring studies (Shen et al. 2014; Shen et al. 2022). The heat was consistent with normal operation due to the consistent colouring. However, the previous study reported by Shen et al. (2022) does not include the higher temperature at the fan-bearing. Ongoing monitoring would enable trends to be observed and indicate if the fan-bearing temperature was abnormal. Two noteworthy images from The water-based Amusement Ride 1 illustrate temperature rise in components.

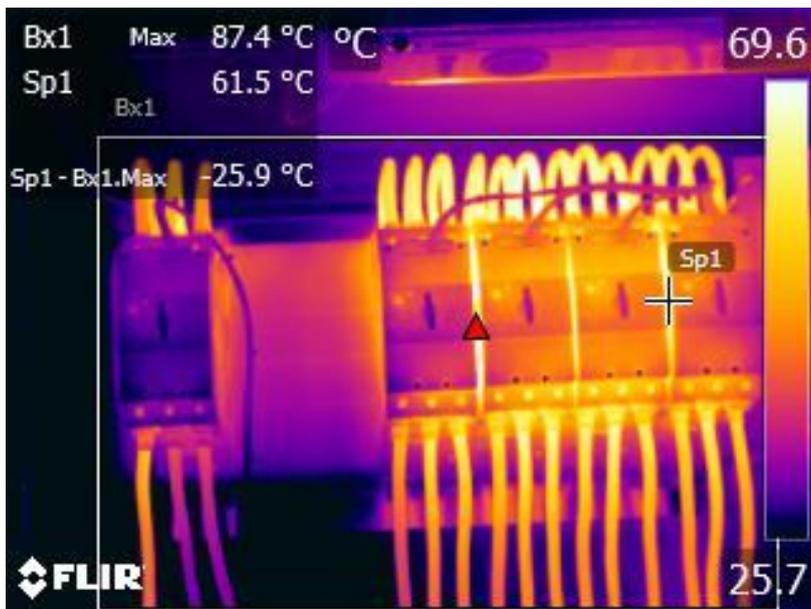
Figure 5.18 Water-based Amusement Ride 1 thermal image of motor circuit breakers

Figure 5.18 identifies heat rise between moulded case circuit breakers Q03 and Q04, denoted with the red triangle. The black cross signifies the comparison temperature between Q05 and Q06, of 61.5 °C. The temperature indicated between the Q03 and Q04 circuit breakers is 87.4 °C, with a difference of 25.9 °C. The temperature difference in a thermal imaging study was much lower at 12 °C (Shen et al. 2022). However, the thermal images do not demonstrate the fault characteristics shown in the infrared study on contactors (Yu et al. 2019). Contactors are simpler in construction than circuit breakers, and the thermal images during fault conditions may differ from the reference images. However, due to the ride being operational, it was deemed that thermal images do not illustrate a fault. The ride was running at full load when the thermal image was taken. The manufacturer information for the moulded case circuit breakers states that the maximum operating temperature is 155 °C (Siemens AG 2001a). Thus, the circuit breaker is working within the manufacturer's limits. The equipment's current carrying capacity and ambient temperature were also considered.

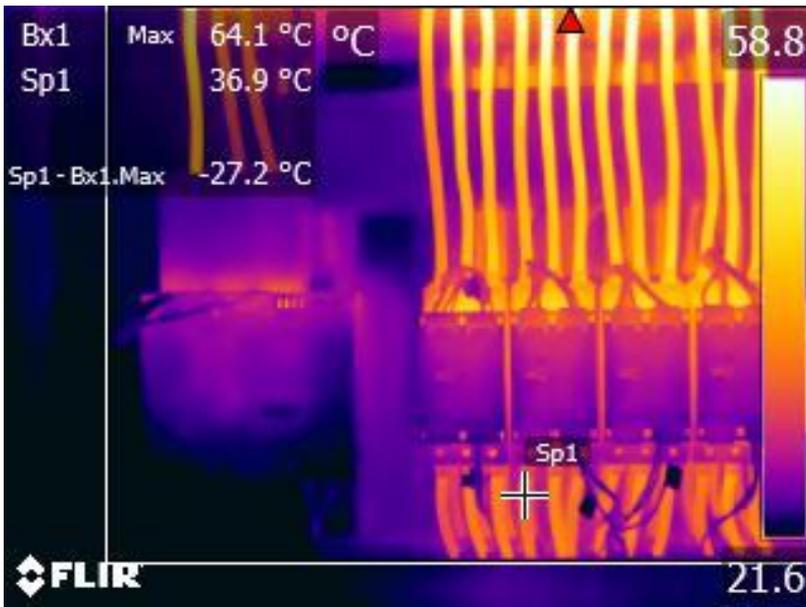
Figure 5.19 Water-based Amusement Ride 1 thermal image of conductors

A temperature rise of 27.2 °C between the conductors is shown in Figure 5.19. The thermal image was taken directly below the circuit breakers discussed above. The expected temperature was calculated to assess the expected temperature rise of the conductors. The expected value includes assumptions and theory from AS/NZS 3000 and AS/NZS 3008.1.1.

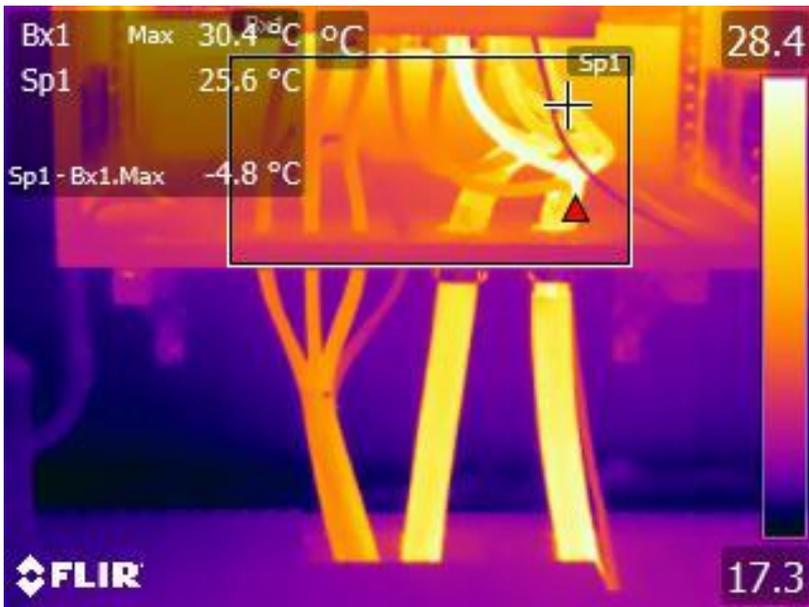
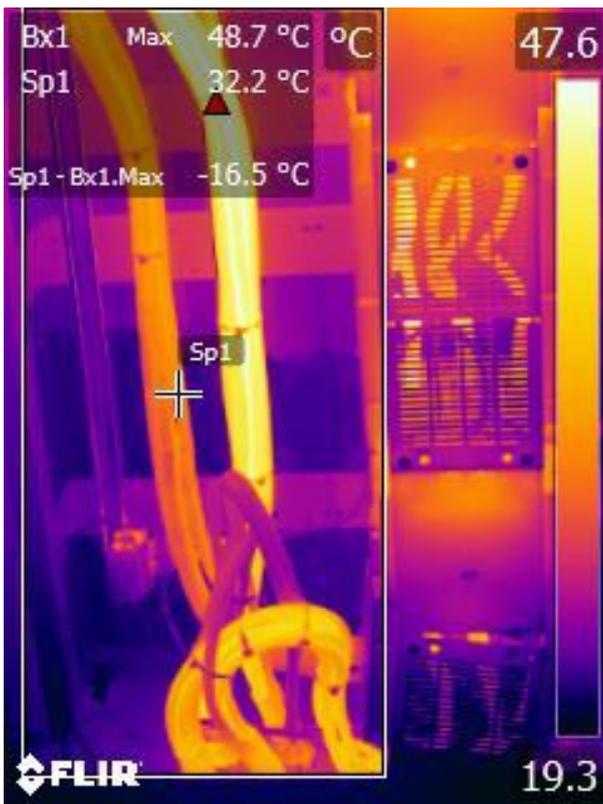
A thermal image from The water-based Amusement Ride 3 (Figure 5.20) illustrates a three-phase supply where the red phase was 4.8 °C above the other two. The red triangle highlights the temperature increase. The upstream installation of the cables was reviewed to see if the temperature increased in the red phase of the cables. Figure 5.21 illustrates the upstream connections; however, the trefoil conductor installation meant the thermal camera could not distinguish between the conductors' phase temperatures. The conductors upstream are on the right side of Figure 5.21. The results were not definitive.

Figure 5.20 Water-based Amusement Ride 3 thermal image of pump 1 at the VSD

Figure 5.21 Water-based Amusement Ride 3 thermal image of pump 1 at the MCC
