**Locating Low Voltage Underground Power Cable Faults Using
Infrared Technology**

A dissertation submitted by
Gregory Mansell

in fulfillment of the requirements of
ENG4111 and ENG4112 Research Project

Bachelor of Engineering (Honours), Power Engineering

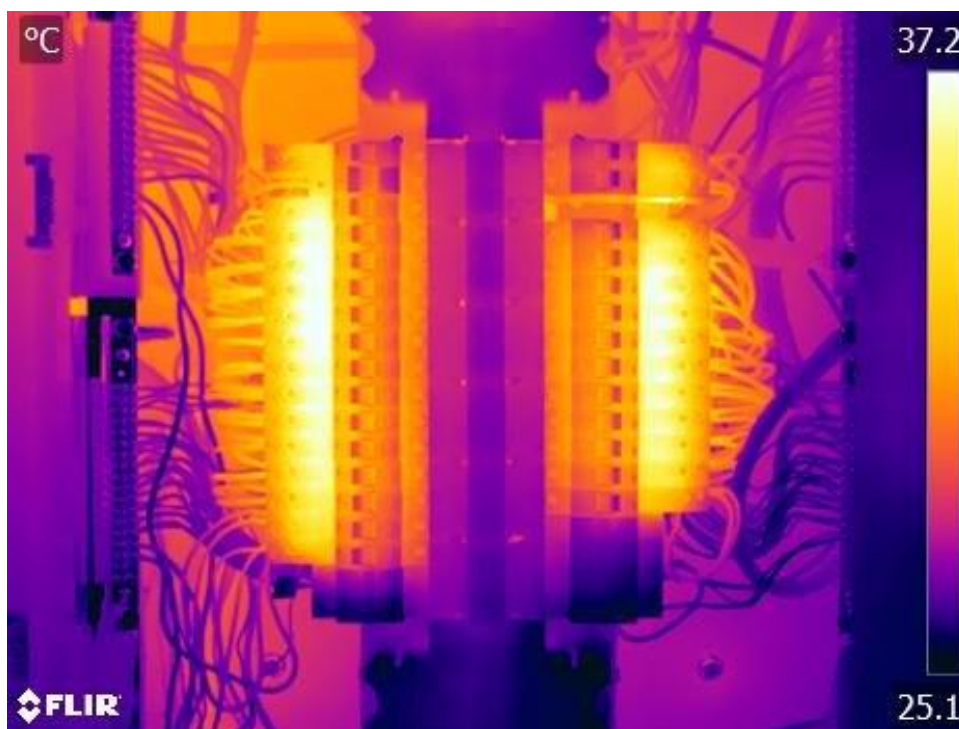
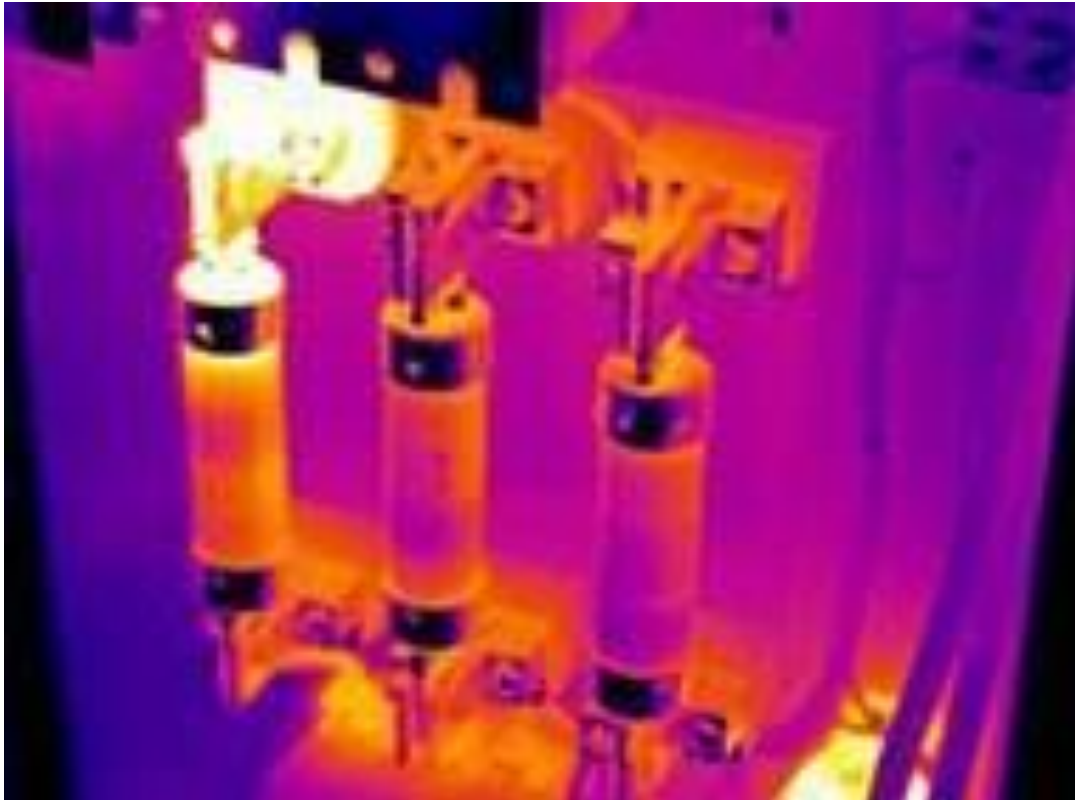
Figure 15 and 16 above show two switchboards that have issues that has the potential to lead to failures. Figure 15 shows a board that could be overloaded. This board would need to have the currents checked on each of the subcircuits to determine the load and the rating of each breaker. Figure 16 shows a high resistance connection on the top of the A phase fuse. This additional heat generated will be using more power from the supply and has the ability to cause an electrical fire if it is not picked up in time (Revolution Electrical, 2023).

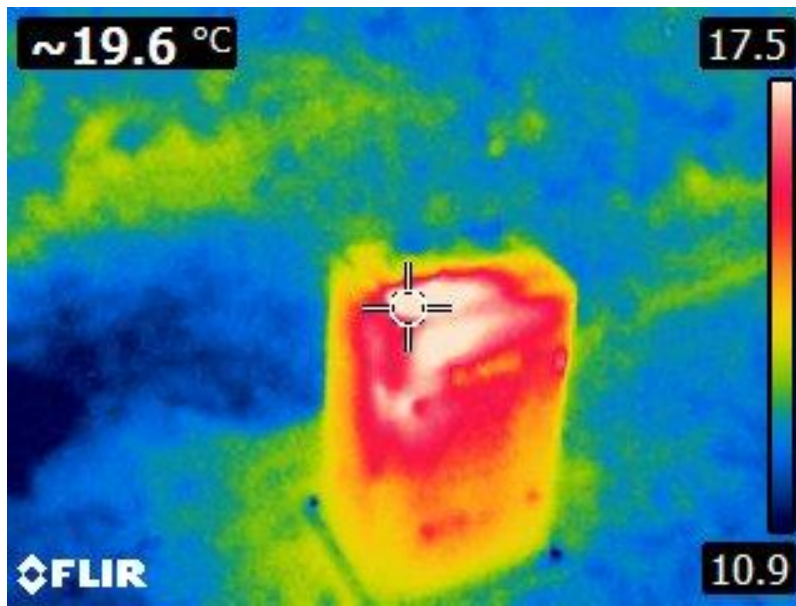
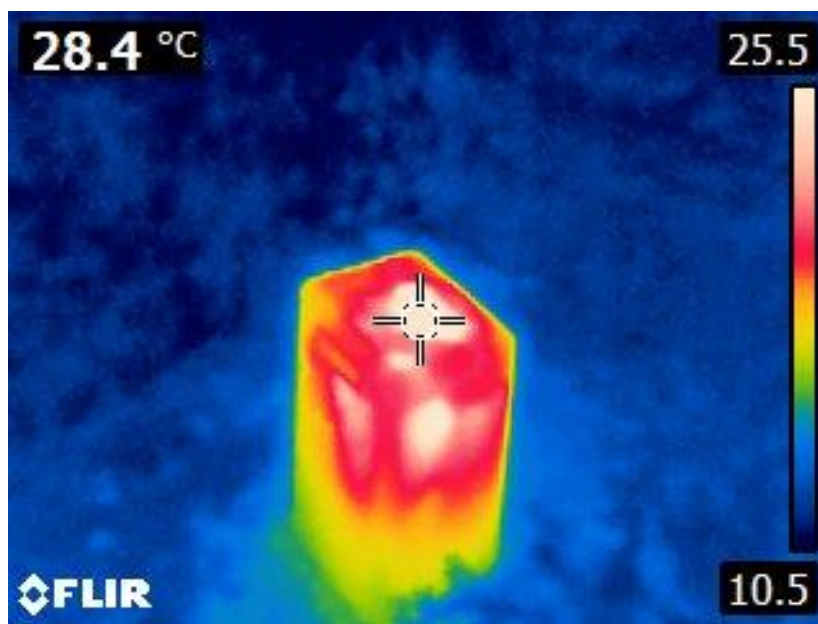
Figures 17 and 18 above show how the thermal imaging camera can detect a hot spot on the pillar. These will be recorded and a follow up will be performed to check the internal connections and correct any defects within the pillar.

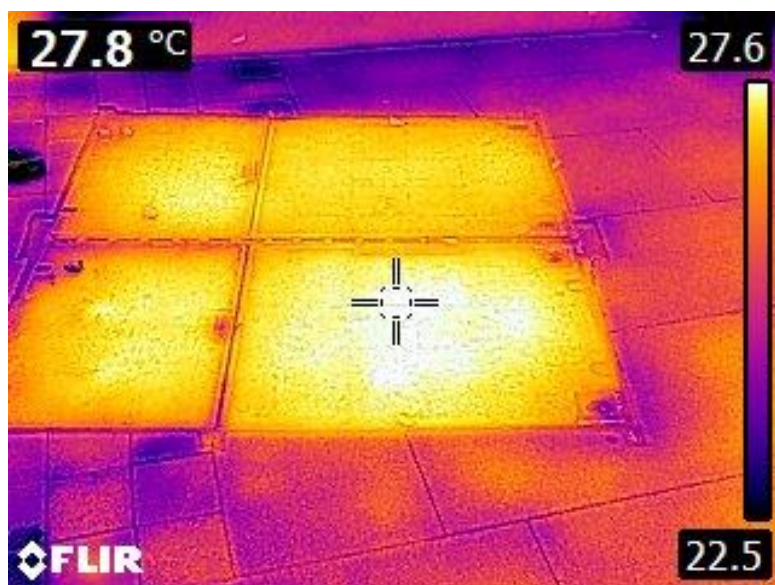
Figure 21 Thermal Image of Site 1

Site 1 is located in a pit and duct arrangement and the survey was conducted on a sunny day with an ambient temperature of 19°C. In this case the fault was found in a pit. It was still in service and current was passing through the PVC insulation to ground. This current path caused burning of the PVC and generated enough heat within the pit to cause the lid to become hotter than the surrounding tiles above ground.

Figure 21 shows the hot spot generated on the pit lid caused by the fault within the pit. The heat has radiated from the cable into the free air. This temperature difference had then conducted through the concrete pit lid and can be detected by the infrared camera.

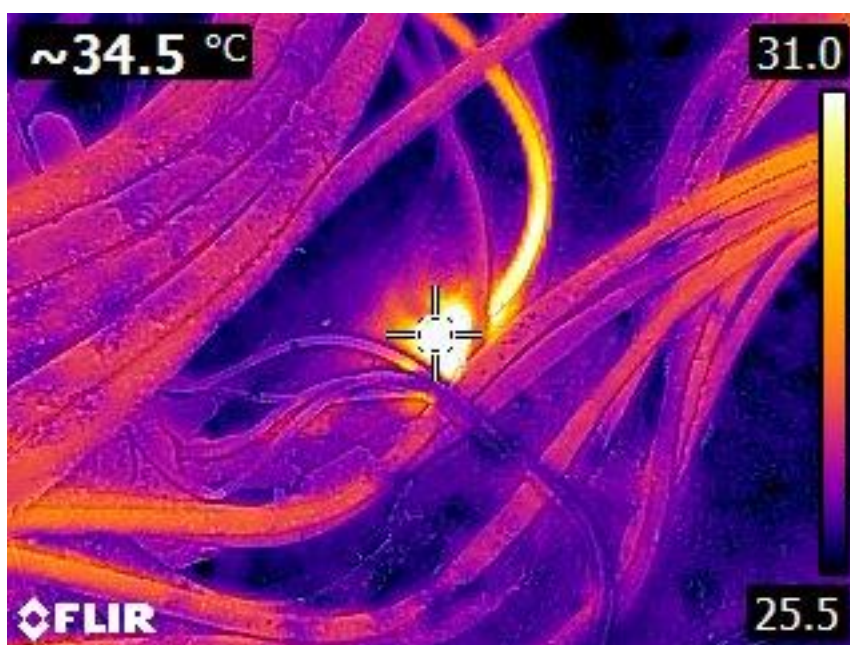
Figure 22 Thermal Image of the Fault at Site 1

The temperature inside the pit is much higher than detected on the pit lid. The fault is still heating the air and is fairly low at 34.5°C. This type of fault would be burning for a while without the 400A HRC fuse operating. Figure 22 shows the infrared image of the fault and the heat conducting up the cable and radiating into nearby cables.

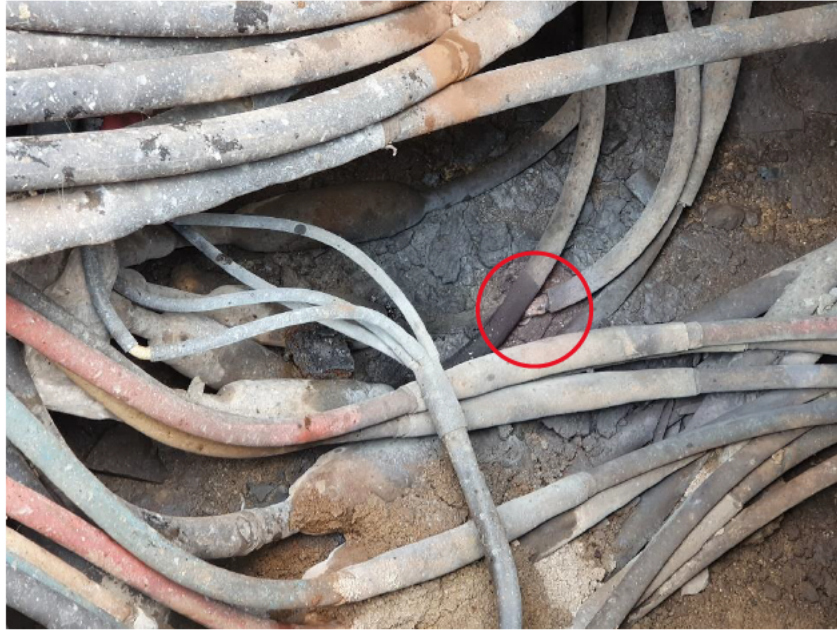
Figure 23 Photograph of Fault Within Pit for Site 1

The red circle in Figure 23 shows the location of the fault. This photograph shows the missing PVC insulation where the fault current has been burning the insulation away. The infrared camera works well in these situations since the hot air within the pit has been trapped and can easily transfer through the pit lid via heat conduction.

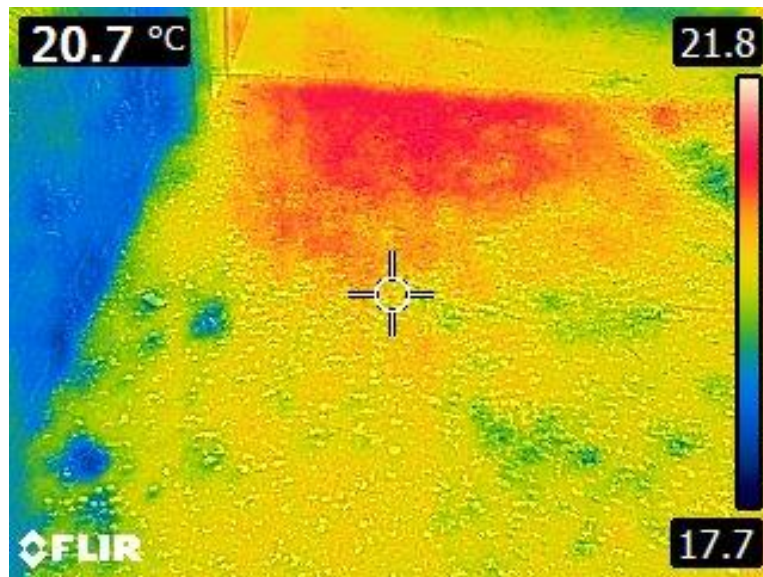
Figure 24 Site 4 Thermal Survey Image

The fault detected at site 4 was located on the mouth of a duct line underneath the driveway to a residence. At the time of the survey, the cable was still in service and heat was still being generated by the fault current. Figure 24 below shows the thermal image of the fault location. The heat from the fault was radiating out the end of the duct line creating the hotspot shown.

In this image there is no thermal radiation given off from the driveway. This would be due to the thicker slab and reinforcing bars laid into the driveway compared to the relatively thin bitumen foot path. The footpath will be able to conduct the heat enabling this location and emphasising the difference in thermal properties between the two materials.

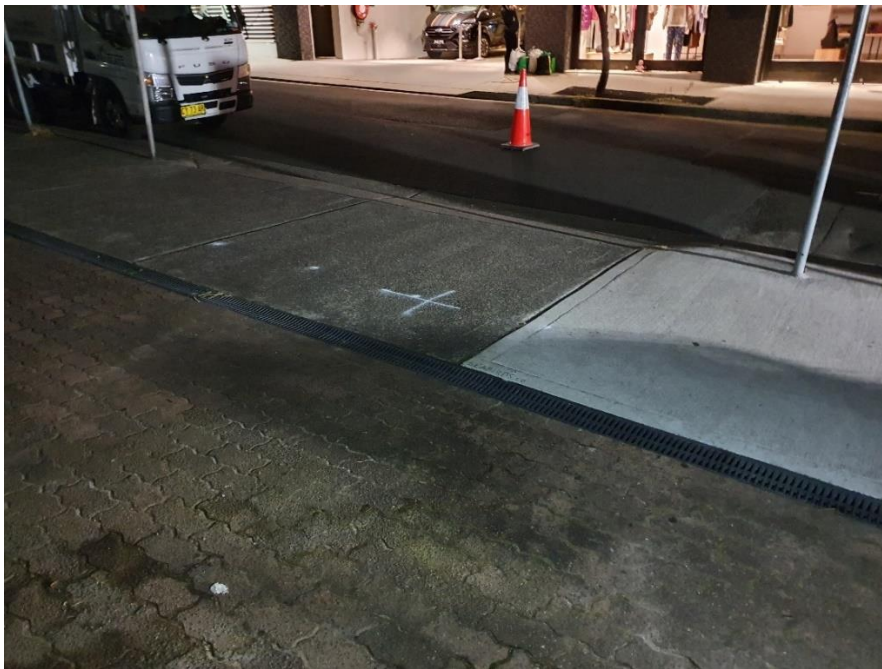
Figure 25 Site 5 Fault location

The fault at site 5 was located after initial investigations determined the fault was located in a different section of cable. This meant the fault had been re-energised and had been able to continue to generate heat at the fault location. The fault was located on the service tee to a customer's premises, which only affected one property. Supply was still available at all the network points and at all the remaining properties.

This fault was pinpointed on the property boundary between the concrete footpath and the customer's tiled area. It had been raining during the day but the ground had started to dry up. Having the ground wet would have made a successful thermal survey nearly impossible since the water would have removed any heat from the ground.

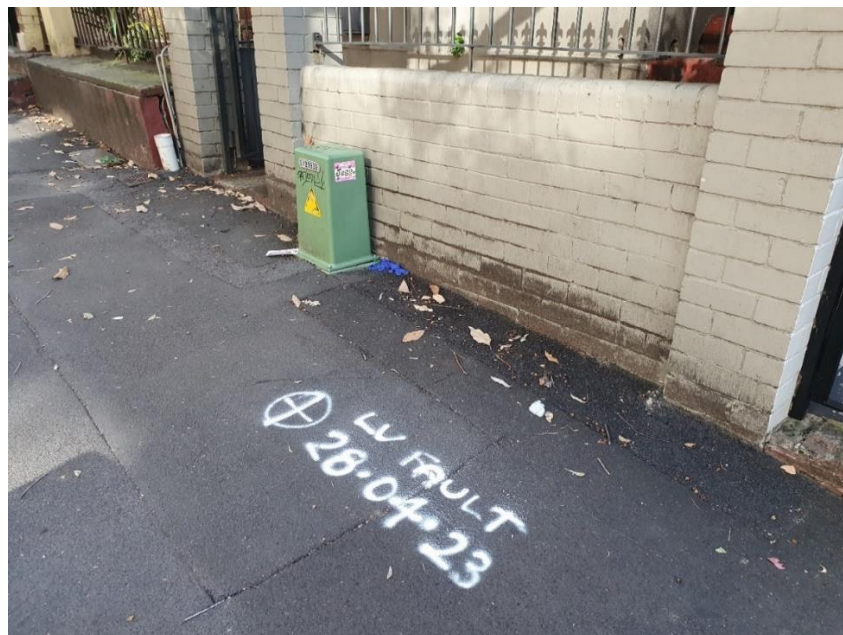
Figure 27 Photograph of Fault Located Adjacent to Low Voltage Pillar

Figure 27 below shows the fault location site identified through an arc reflection method and pinpointed using the audio frequency equipment. The thermal image shown in Figure 28, shows a hot spot under the scar in the bitumen footpath. This type of scar is indicative of a previous fault repair, and in this situation a joint is located at the end of the scar.

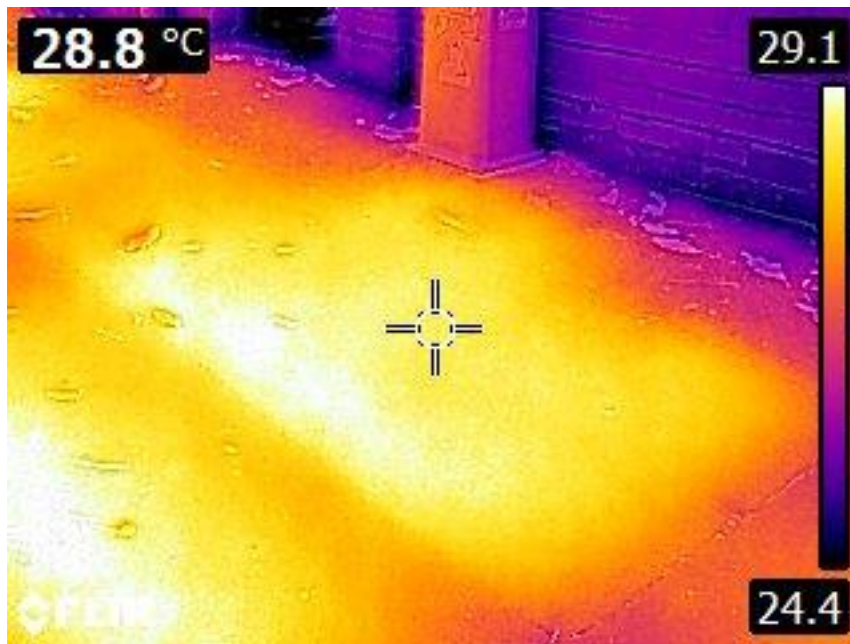
Figure 28 Infrared Image of Fault Location

This survey was completed on a sunny day, however the fault was in the shade. This made the survey harder to detect since there was reflected infrared radiation detected on the left side of the image in Figure 28. To determine the extent of the reflected infrared radiation, this survey was performed from multiple angles to ensure the fault was correctly identified.

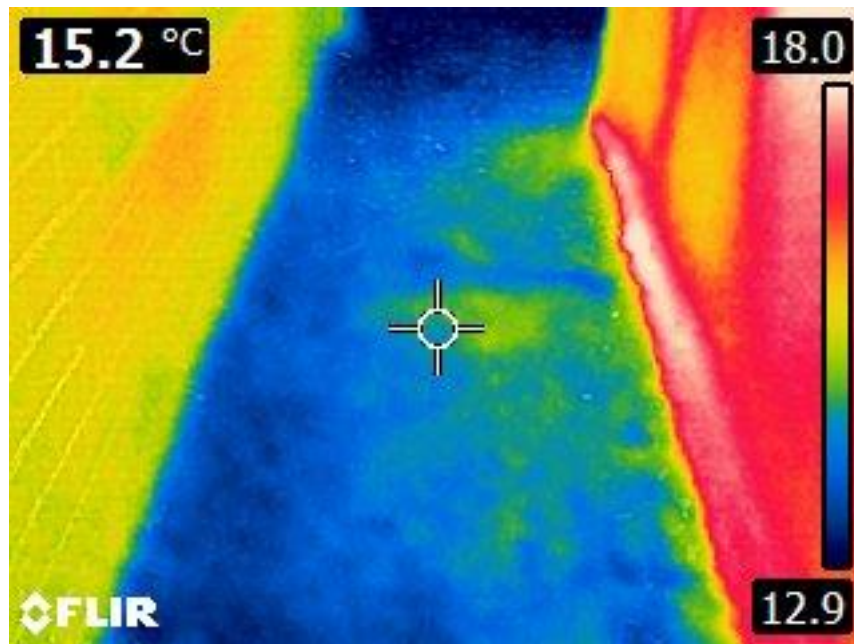
Figure 30 Infrared Image of Site 13

S1231 is located against an east facing brick wall that was exposed to the sunlight during the day, as seen in Figure 31. The low voltage cables have been installed between the substation and the wall. Figure 30 shows the infrared image of the area. The fault can be seen between the wall and the substation in the dull yellow area. This does not stand out as much as the other successful sites due to the radiated infrared radiation from the substation and the wall. A survey was also completed on the adjacent substation in a similar location that also showed no signs of heat between the wall and the substation, ruling out any form of reflection in this situation, also shown in Figure 30 below.
