University Of Southern Queensland
Faculty of Engineering & Surveying

Investigation into the Performance of First Flush
Systems for Diesel Engine Based Pollution on Roof
Runoff

ENG4112 Research Project

Submitted: October 2008

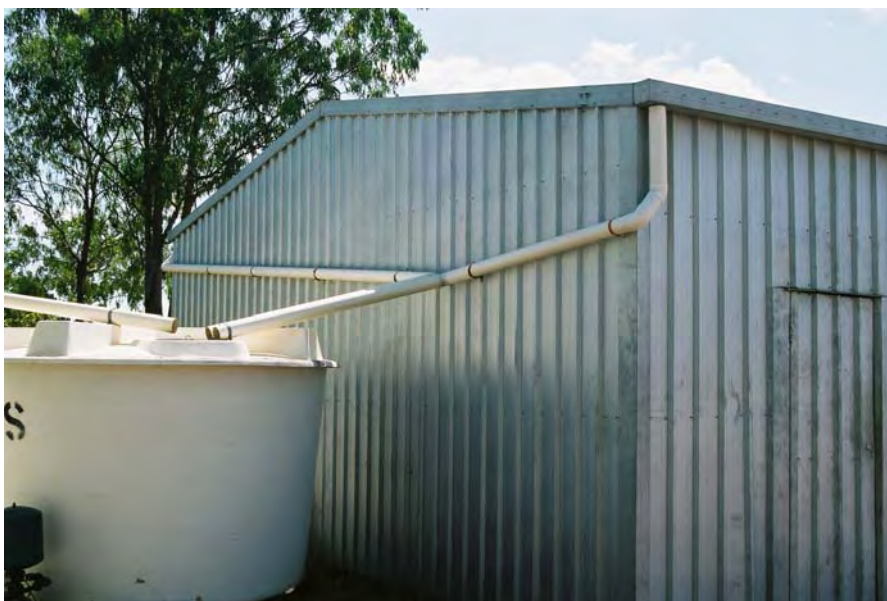
Figure 3.3 Aurukun Power Station – Line store and tank

The samples were taken from the tank collecting water from the accommodation block and line store roofs which are approximately 45m South East of the exhaust outlets. As noted in the weather observations in Appendix G, the prevailing wind direction is quite irregular. The roof had a visible chalky build up of contaminants prior to sampling.

The closest weather station is in Weipa, some 75km away. The area is believed to have similar weather patterns. The nearer weather station in Mapoon was damaged prior to the study. Three first flush devices had to be installed due to the layout of the downpipes as shown in Figure 3.3. The site has Zinalume roof sheeting and Zinalume gutters. The collecting roof is 144m² with a 15 degree pitch.

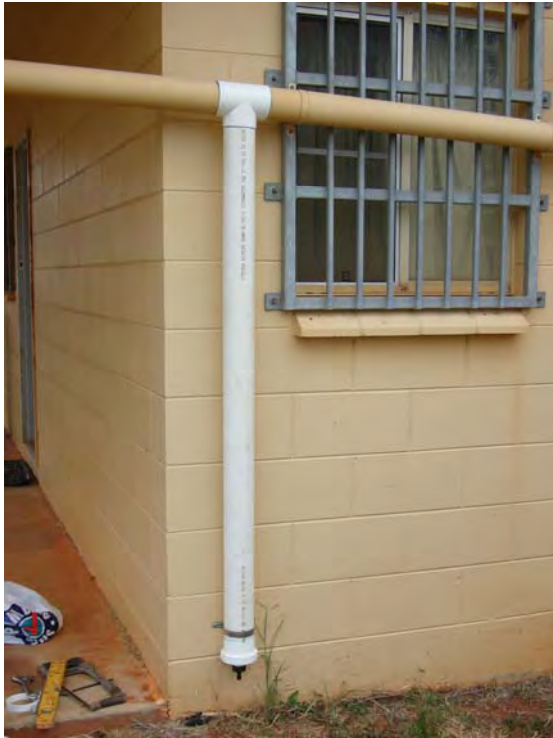
Figure 4.2 First Flush Device - Eastern

Figures 4.2 and 4.3 show installed first flush devices at the Lockhart River site. Two devices were installed at this site. The length of the first flush system is approximately 1600mm on the windward roof side and 2100mm on the leeward roof side. Ideally the larger system would be installed on the windward side, however this was not the case as the downpipe levels did not suit.

All rainwater goods were cleaned at the time of installing the first flush device. The tank was desludged using a vacuum siphon and funnel and the majority of water remained in the tank. The roof, gutters and downpipe were cleaned as best as possible to remove contaminants.
