**ATTERBERG LIMITS AND THEIR  
RELATIONSHIP TO LONGITUDINAL CRACKING  
IN GRANULAR PAVEMENTS**

**Courses ENG4111 and 4112 Research Project**

**Bachelor of Engineering (Civil)**

Submitted: October, 2010

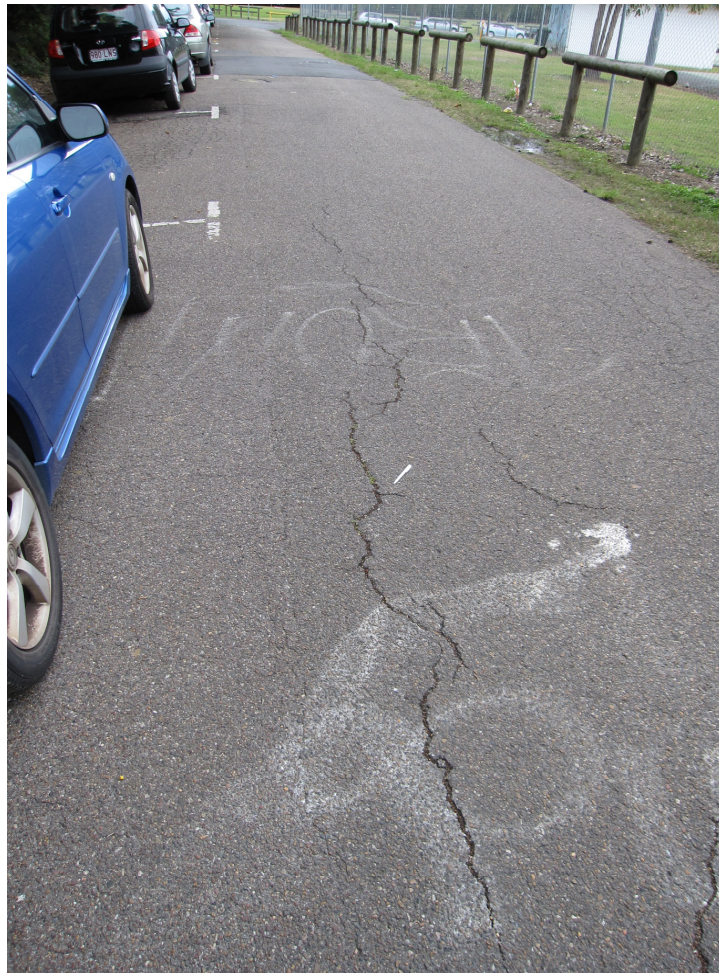
Figure 1.1 shows a typical example of non-load related longitudinal cracking of an unbound granular pavement with thin bituminous surfacing.

**Figure 1.1** – Longitudinal cracking due to expansive subgrade

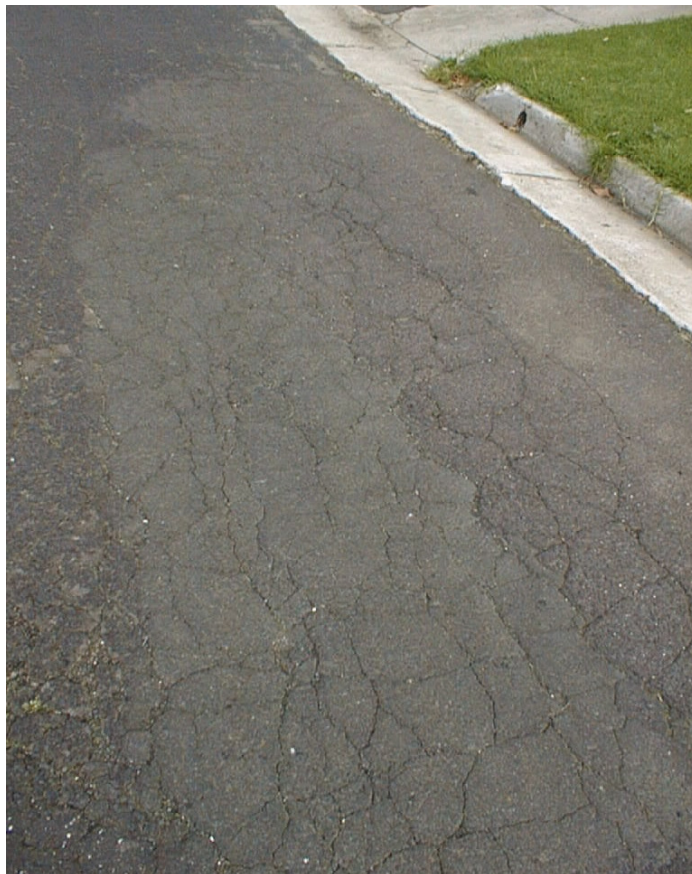
Oxidation of the asphalt binder causing brittleness is another cause of crocodile cracking. Figure 3.11 shows a typical example of crocodile cracking subsequent to movement of the supporting pavement.

**Figure 3.11** – Crocodile cracking photo

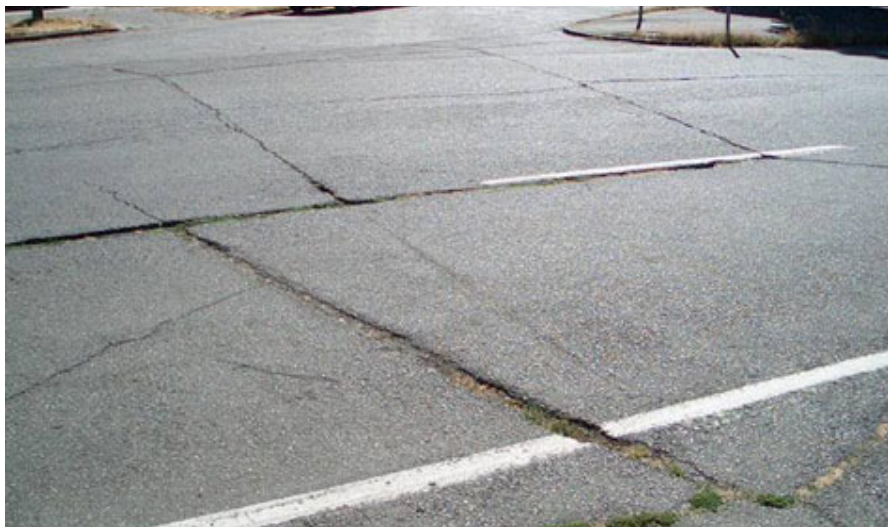
**Figure 3.13** – Block cracking photo

Block cracking can occur in rigid and flexible pavements. In pavements with cemented or stabilised layers, the inevitable shrinkage cracking can reflect upward through to the asphalt layer.

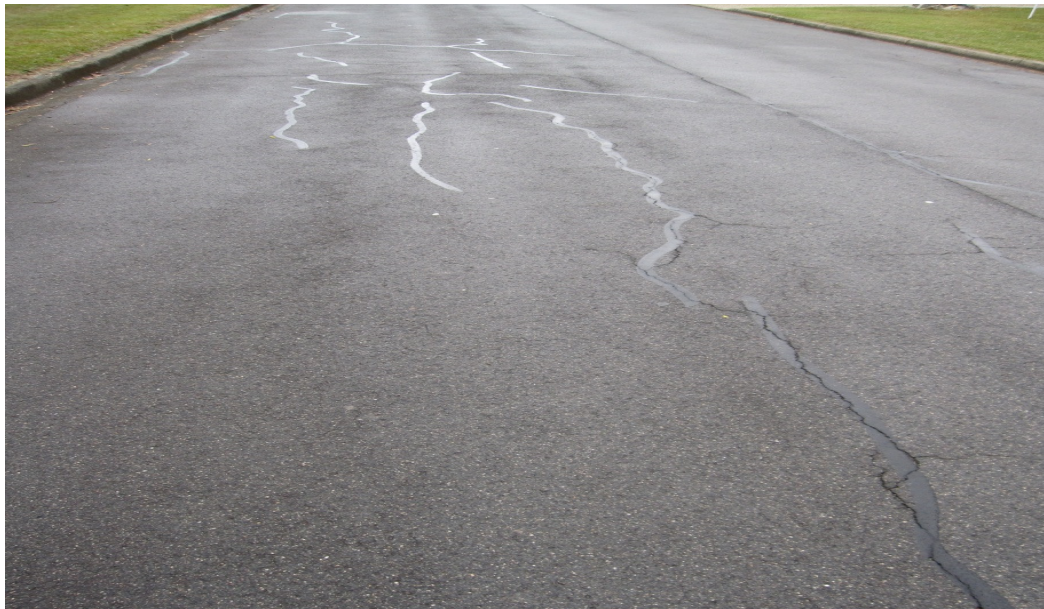
**Figure 3.14** – Longitudinal cracking photo

Longitudinal or linear cracking occurs primarily parallel to the axis of the road. The Southern Downs Regional Council Road Assessment Manual notes that there is likely to be little if any interconnection between individual cracks.

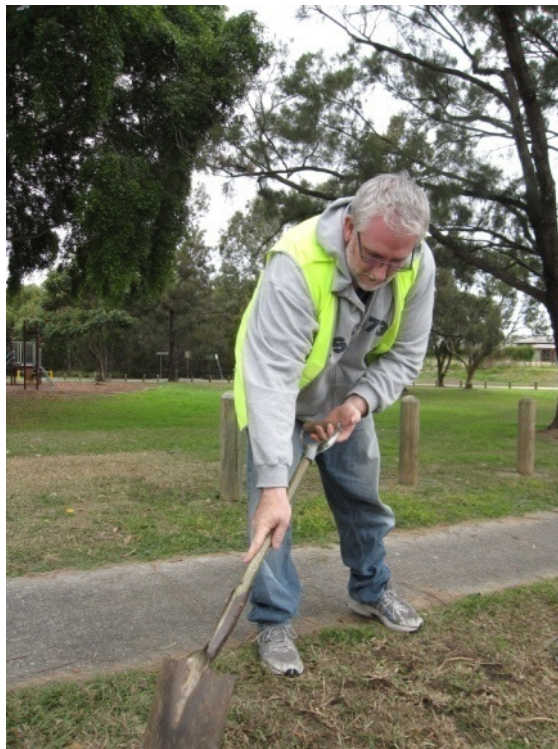
Subgrade samples were obtained by first removing turf and topsoil with a shovel (Figure 4.2) and then drilling a disturbed core sample with a hand auger. The sample depth for all locations was between 300mm and 600mm. Test samples of approximately 3kg were collected and care was exercised when drilling and collecting to ensure that the subgrade sample was not contaminated with topsoil. The disturbed samples were collected in plastic bags. Location labels were fixed to the bags and the samples delivered to the soils laboratory.

**Figure 4.2** – Topsoil and turf removal with shovel

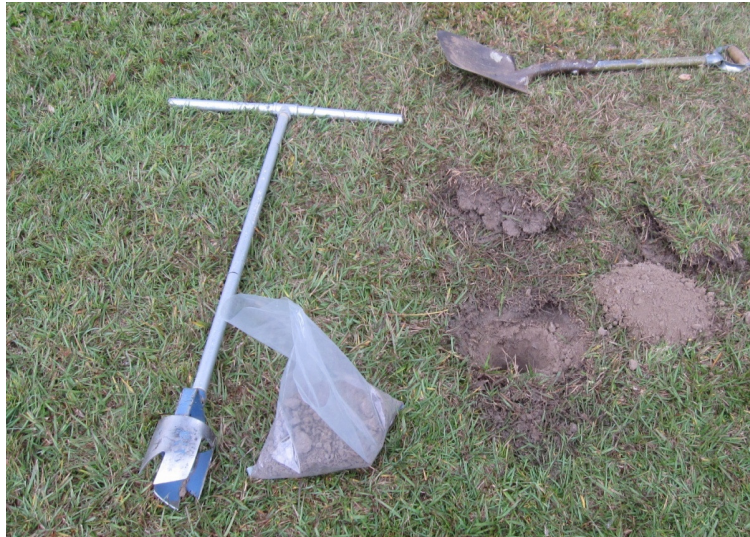
Figure 4.3 shows the tools used for collecting samples and Figure 4.4 is a photo of the samples prepared for testing in the laboratory.

**Figure 4.3** – Tools used for sample collection

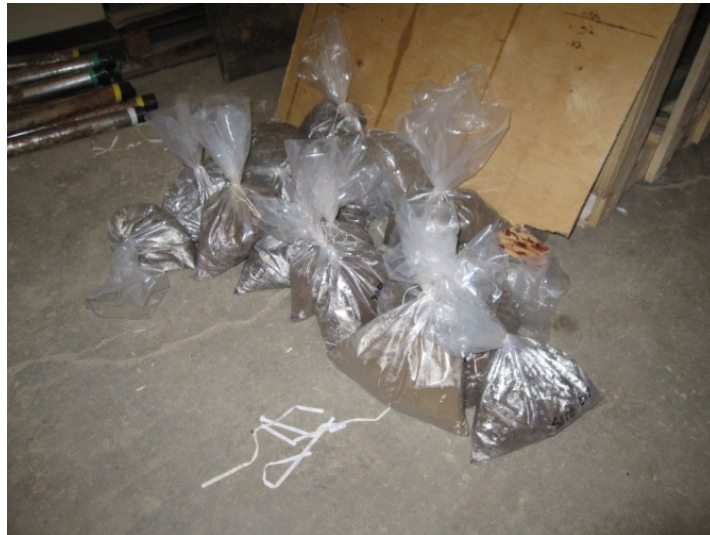
**Figure 4.4** – Samples bagged and sealed prior to laboratory testing

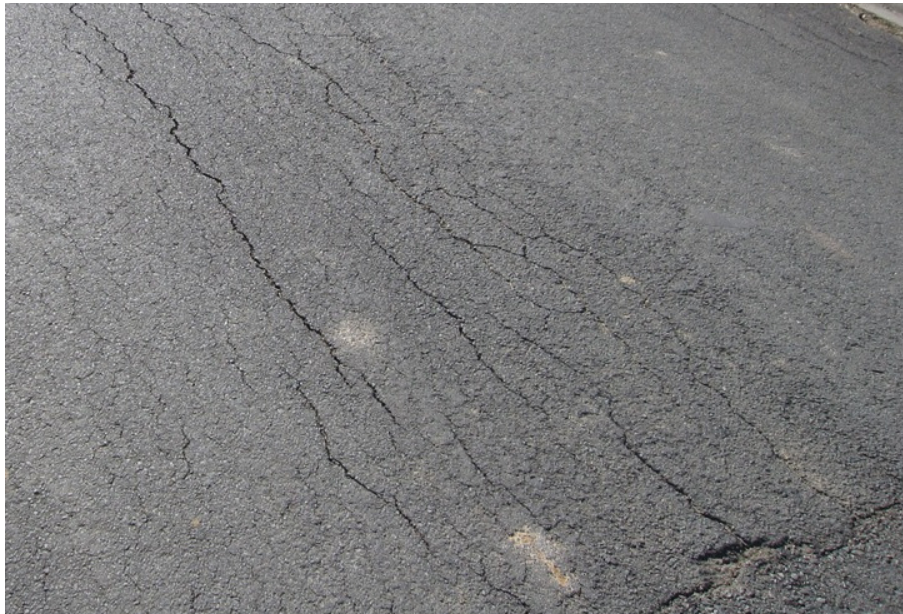
**Figure 6.1** – Photo of Site 018 showing longitudinal cracking subsequent to subgrade deformation

- Site No's 018 and 020 were omitted from the analysis set due to the observed longitudinal failure being assessed as a secondary failure mechanism. After a review of the photographic evidence, the primary failure mechanism for these sites was attributed to subgrade rutting. Figures 6.1 and 6.2 are photographic plates showing the damage observed at sites 018 and 020 respectively.

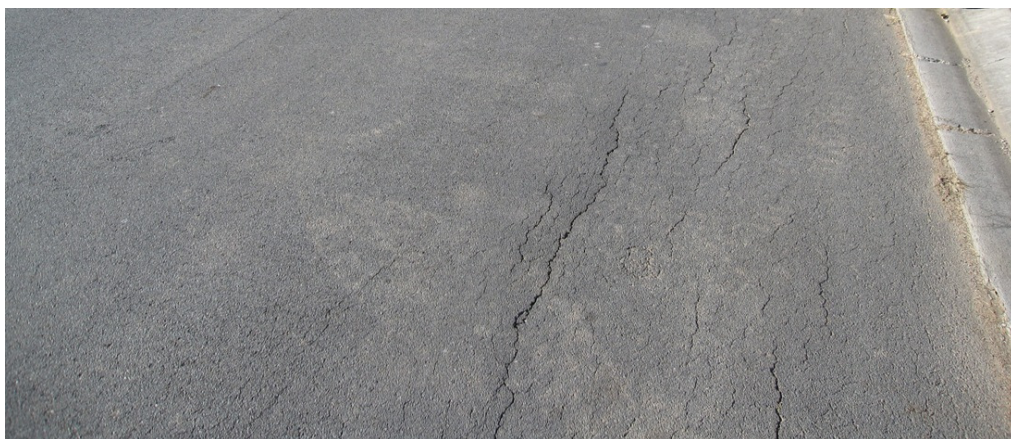
**Figure 6.2** – Photo of Site 020 showing longitudinal cracking subsequent to subgrade deformation

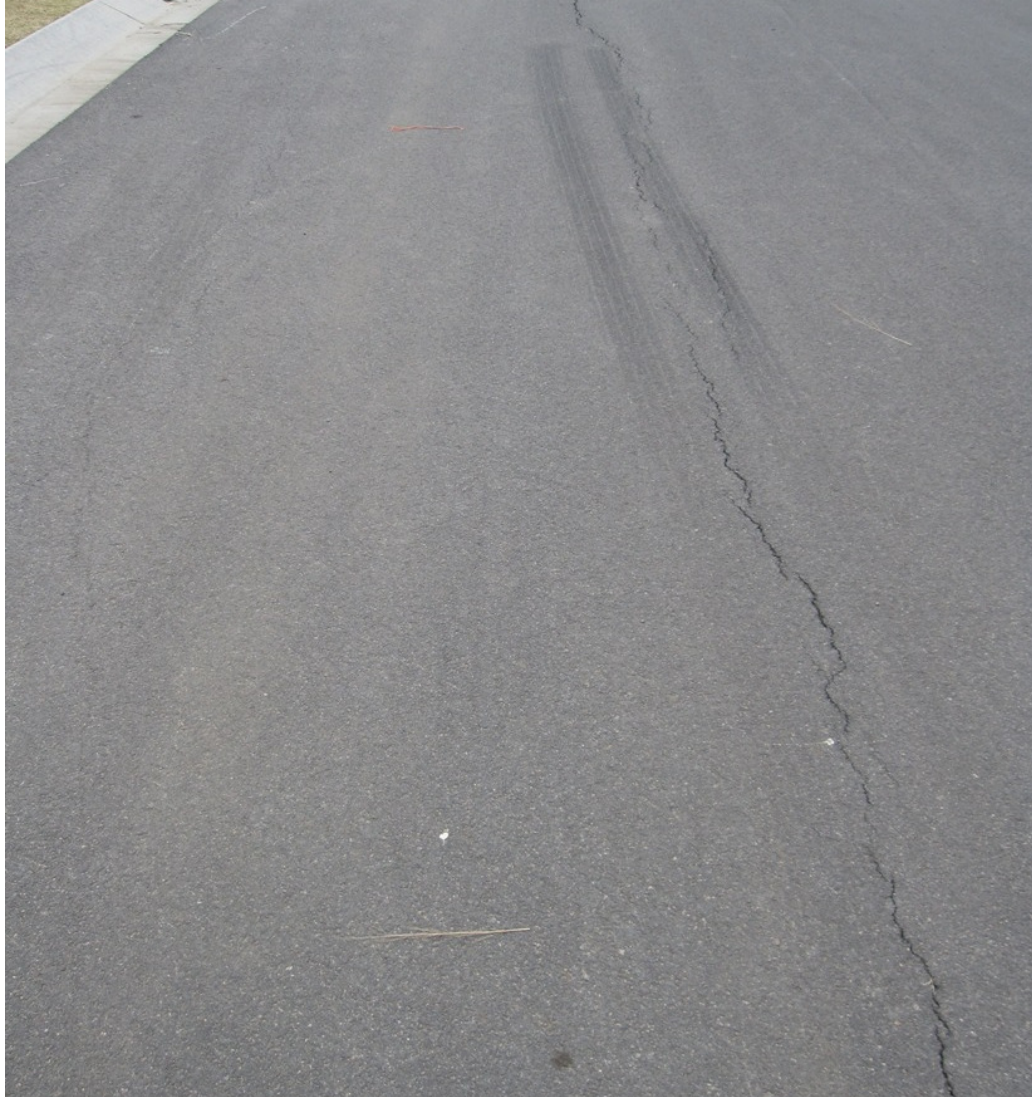
**Figure 6.3** – Photo of Site 006 as inspected

- Extent of cracking observed at Site No.006 was subsequent to a reconstruction of the Asphaltic Concrete surfacing. An amended extent of cracking, in accordance with advice and photographic evidence has been included for this site. Figure 6.3 shows a photographic plate of site 006 as inspected, the number of cracks recorded for this section of road was 2.

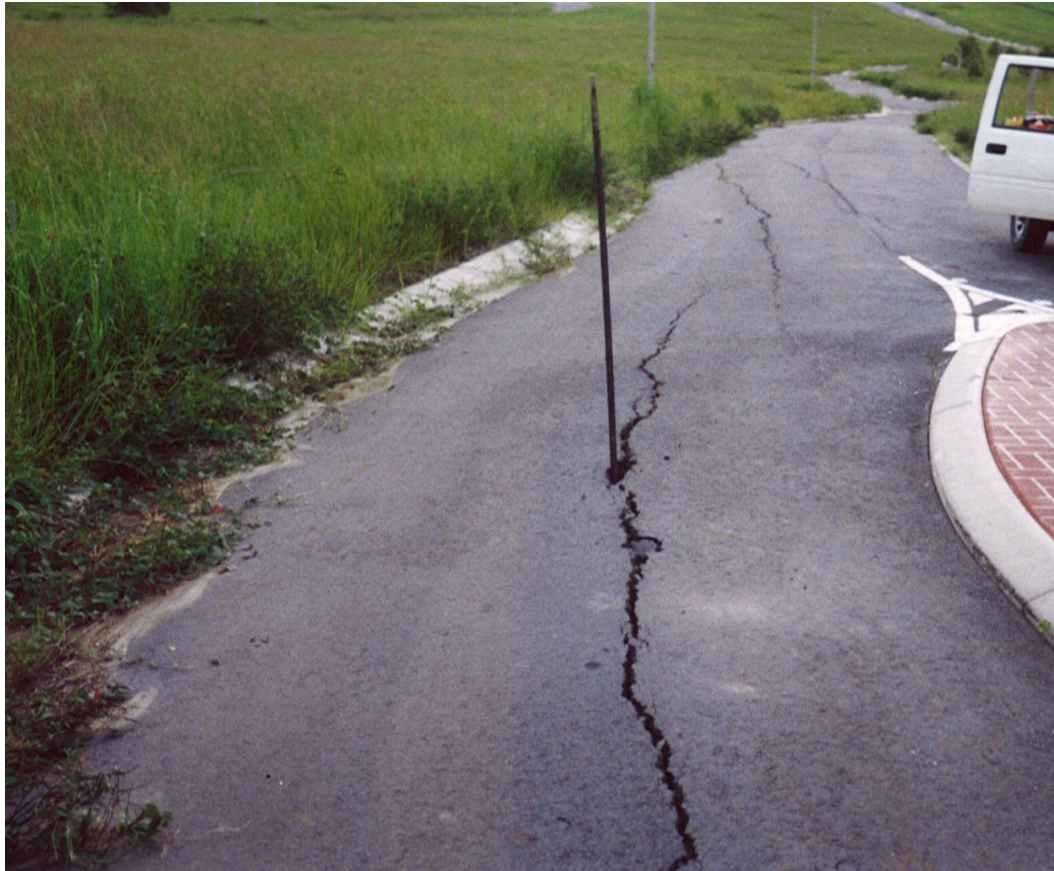
**Figure 6.4** – Photo of Site 006 prior to remediation works

by consulting engineer engaged to inspect construction of the works. The number of cracks for this section of road was revised to 4 on the basis of discussions with the consultant and the supporting photographic evidence.

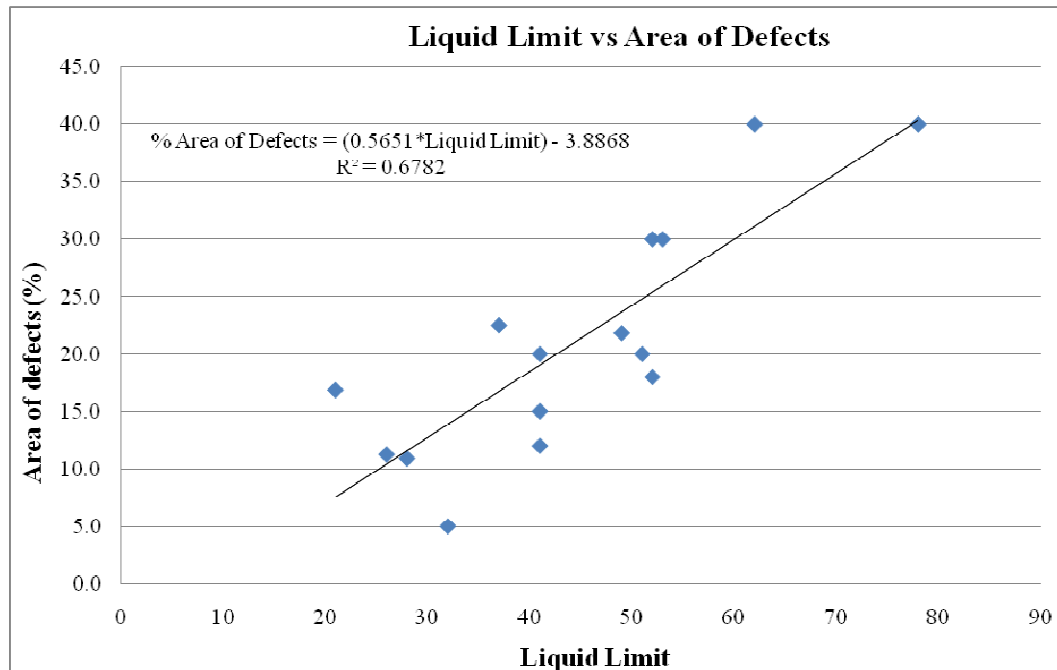
**Figure 6.5**– Relationship between area of observed pavement defects and Liquid Limit of the subgrade soil

A correlation was expected as the Liquid Limit provides a measure of how much liquid a fine grained soil can retain before exhibiting liquid behaviour.

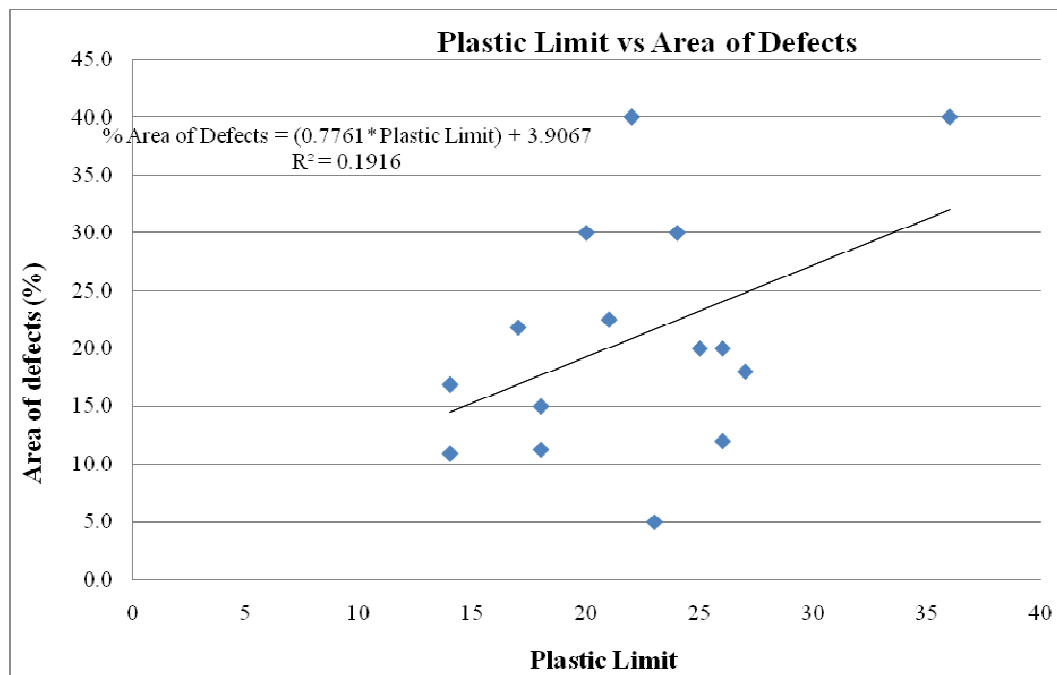
**Figure 6.6** – Relationship between area of observed pavement defects and Plastic Limit of the subgrade soil

The variation of Plastic Limit values against observed area of pavement damage (as a percentage) was also investigated. Results for 15 of the 20 sites were compared and a plot of this data is shown in Figure 6.6. The plot shows no relationship between percent pavement cracking and the Plastic Limit. Various regression models were investigated for this data and no meaningful relationship was observed.

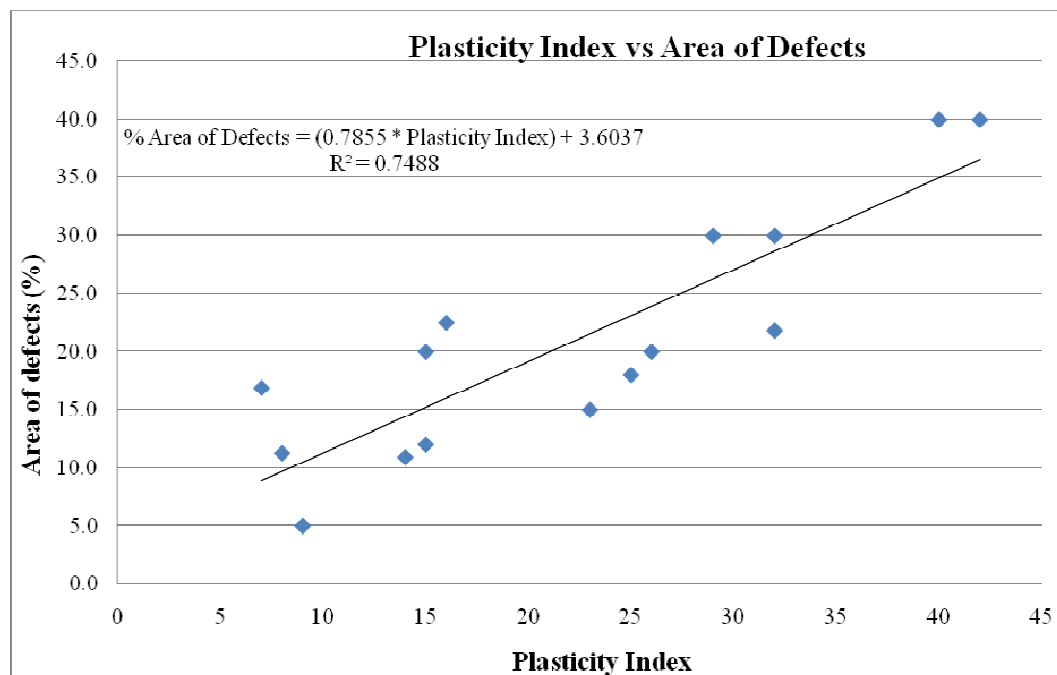
**Figure 6.7** – Relationship between area of observed pavement defects and Plasticity Index of the subgrade soil

This was expected as the Plasticity Index gives an indication of the expansive activity of a particular soil (Manosuthikij, 2008) and environmental longitudinal cracking of pavements is caused by this expansive activity.
