Options for the Replacement of Aging Bridges under Local Authority Control in Rural Areas of Queensland

Tyronne Meredith

Bachelor of Engineering (Civil)

Submitted: October 2011

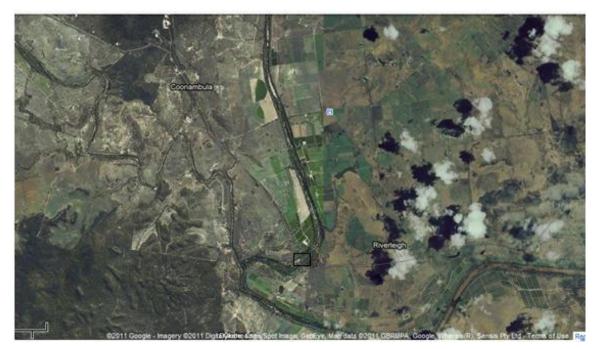
Meanders – Figure 24 shows a top view of the river system in the vicinity of the bridge.

Figure 24: Top view of the Burnett River system in the vicinity of Jack Parr Bridge. The location of the bridge is shown in the black box. The river flows from the top of the diagram to the bottom.

This aerial photograph suggests that there are no meanders in the river system upstream of the bridge location. It is suggested in the literature that meanders travel downstream. Therefore it is not expected that this will be an issue in this area.

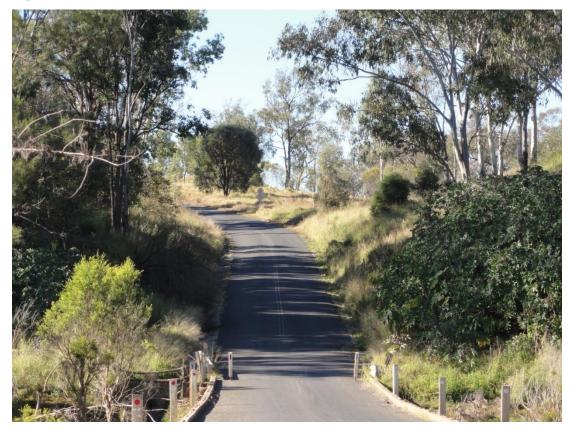
Figure 25

Safety – The only safety aspects considered in this investigation was road alignment and approach road, the safety of the bridge will be considered further in the further analysis. The current approach from Mundubbera can be seen below in figure 25. As can be seen the driver traverses a horizontal and vertical curve before coming onto a small straight section before approaching the bridge. This road has two lanes and is well signed. Therefore the driver is prepared for entering the bridge well before approaching it.

Figure 25: The approach to Jack Parr Bridge from Mundubbera

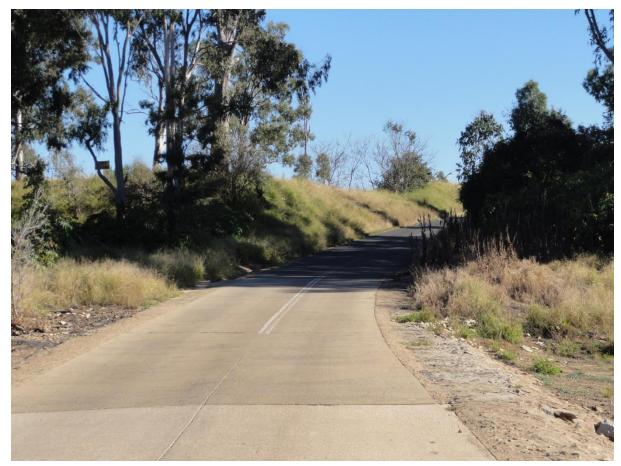
Figure 26

The current approach from Coonambula is shown below in figure 26. As can be seen this approach also involves a horizontal and vertical curve, however the vertical curve is shorter in length and has a larger radius. Although it cannot be clearly seen, there is a large straight between the approach curve and the bridge of approximately 70m which is relatively flat. This once again allows the driver sufficient time to prepare for entering the bridge.

Figure 26: The approach to Jack Parr Bridge from Coonambula

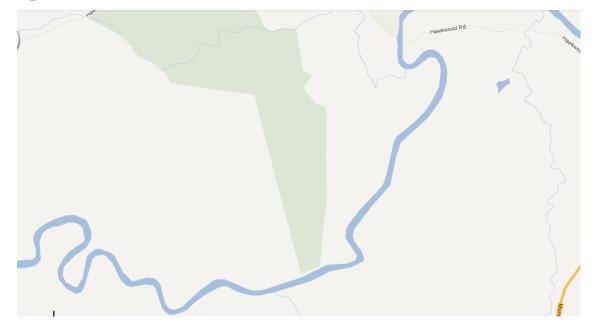
Figure 27

Meanders – An aerial view of the Auburn River in the vicinity of the bridge is shown below in figure 27.

Figure 27: The Auburn River in the vicinity of the Flagstone Bridge. The bridge can be seen in the top of the diagram where Hawkwood Road crosses the river.

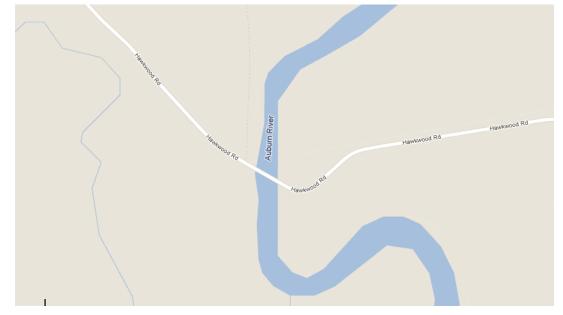
Figure 28

Safety – The current alignment of the approach road is shown in the aerial view below in figure 28.

Figure 28: Current alignment of approach road to Flagstone Bridge

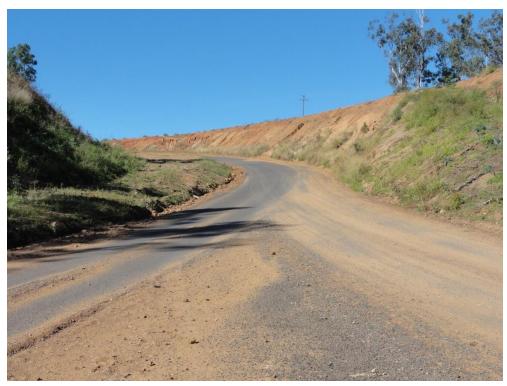
Figure 29: The approach to Flagstone Bridge from Mundubbera

Figure 29 below shows the approach to Flagstone Bridge from Mundubbera.

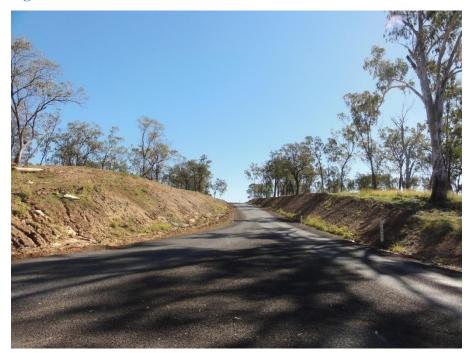
Figure 30: The approach to Flagstone Bridge from Hawkwood

Figure 30 below shows the approach road to Flagstone Bridge from Hawkwood.

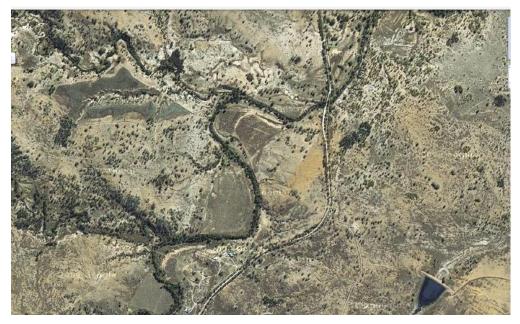
Figure 31

Figure 31: Derrabungy Creek in the vicinity of Derrabungy Bridge

This aerial photograph shows that there is significant meandering in the vicinity of Derrabungy Bridge. It is therefore suggested that there is significant potential for further meandering to occur at near the current bridge position.

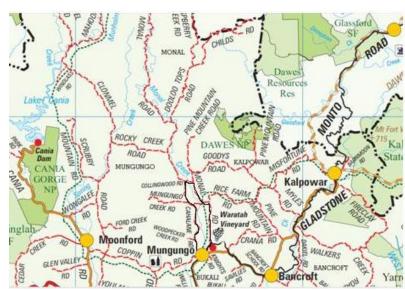
Figure 33

Figure 33: Network Two as shown by drawn area

This analysis was undertaken using two different networks. Due to the close proximity of Derrabungy, Jack Parr and Flagstones Bridges, one network was used to analyse each of these bridges. This network is bounded by the Eidsvold Theodore Road in the north, the Mundubbera Durong Road in the south, the North Burnett Regional Council boundary in the west and the Burnett Highway in the east. This area is depicted in figure 32. It should be noted that the Eidsvold Theodore Road, Mundubbera Durong Road and the Burnett Highway are all state controlled roads. A second network analysis was then undertaken on an area North of Monto known as Mungungo. The network analysed involves the loop formed by the two intersections of Monal Road and Cahalane Road. This network is shown in figure 33.

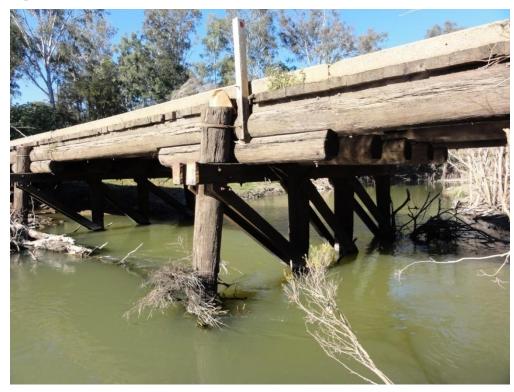
Figure 36

Jack Parr Bridge is situated 12km west of Mundubbera on Coonambula Road. The existing structure is a nine span two lane timber beam bridge which crosses the Burnett River. The existing bridge can be seen in figure 36. Coonambula Road has been classified as a Local Road of Regional Significance. It is a two lane bitumen sealed road from Mundubbera to Jack Parr Bridge and turns to a well maintained gravel formation past the bridge. The bridge services a citrus orchard, a significant amount of cattle properties and a low density rural sub division. Local anecdotal evidence suggests that the bridge is submerged on average three times a year for between 24 - 48 hours. During the December 2010 – January 2011 flood event the bridge was submerged for a considerably longer period. The bridge is the first major waterway crossing on Coonambula Road from Mundubbera.

Figure 36: Jack Parr Bridge

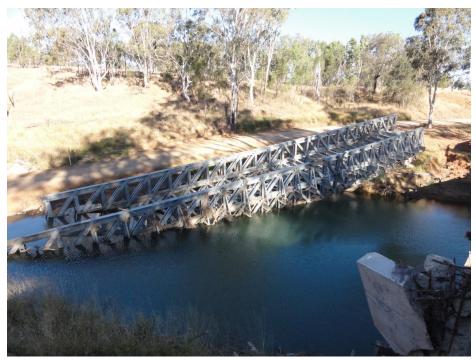
Figure 37

Derrabungy Creek Bridge is situated 35km south of Mundubbera on Beeron Road. The previous structure was a single span steel truss bridge which was destroyed in a January 2011 flood event as can be seen in figure 37. The creek is a tributary of the Boyne River which in turn is a tributary of the Burnett River. In the vicinity of the bridge Beeron Road consists of a gravel formation. The previous structure serviced approximately three permanent residences with the predominant industry in the area being beef cattle. Between the township of Mundubbera and Derrabungy Creek there is a relatively low level crossing of the Boyne River. Approximately 10km past this crossing Beeron Road crosses Beeron Creek at a low level crossing. Derrabungy Creek has been described through local anecdotal advice as being a fast rising and fast falling creek. It has been suggested that the low level structure in place prior to the steel truss bridge was only submerged on average for a total of one day every year. There is currently a single lane side track in place around the existing structure.

Figure 37: The existing steel truss bridge after being destroyed.

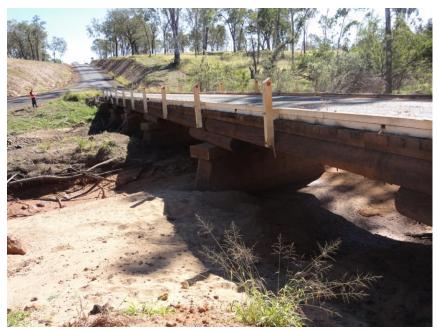
Figure 38

Flagstone Bridge is located on Hawkwood Road approximately 19km south west of Mundubbera. The existing six span bridge crosses the Auburn River just upstream of its confluence with the Burnett River. The existing one lane structure comprises a timber girder superstructure with concrete piers as a substructure. This structure can be seen in figure 38. Hawkwood Road is a Local Road of Regional Significance which was once a part of the state road system. It varies between single lane and double lane bitumen in the vicinity of Flagstone Bridge. The bridge services a relatively large cattle industry, a feedlot, a citrus orchard and an irrigated broad acre The relatively low level Boyne River Crossing mentioned cropping property. previously also forms part of the route between Mundubbera town ship and Flagstone Bridge. There is also another low level crossing of the Auburn River further along Hawkwood Road. Local anecdotal evidence suggests that Flagstone Bridge is submerged for approximately 12 days every year. It has been suggested that this flooding is through both natural flow and through back up flow from the Burnett River.

Figure 38: Flagstone Bridge
