Managing the repair of transport Infrastructure after a Natural disaster

A dissertation submitted by
Danial John Fitzgerald
0050041921

In fulfilment of the requirements of
Courses ENG4111 and ENG4112 Research Project

towards the degree of
Bachelor of Engineering (CIVIL)

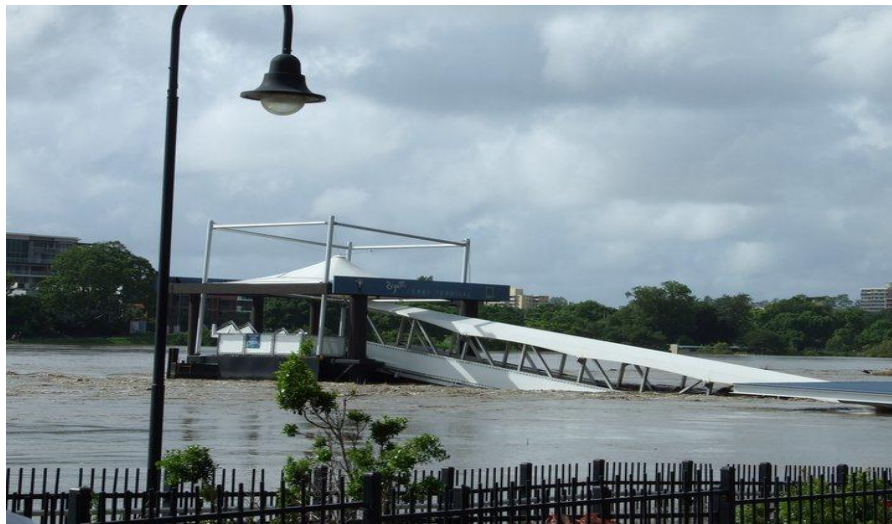
Figure 1-1 Regatta Passenger terminal during 2011 flood

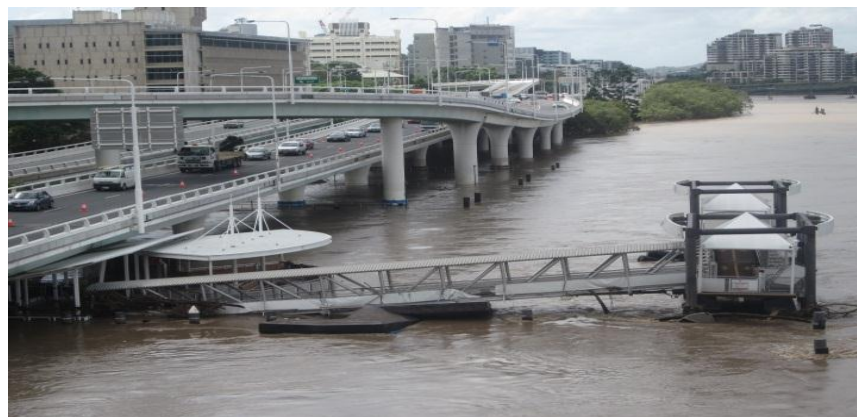
Figure 1-2 North Quay Passenger terminal during 2011 flood

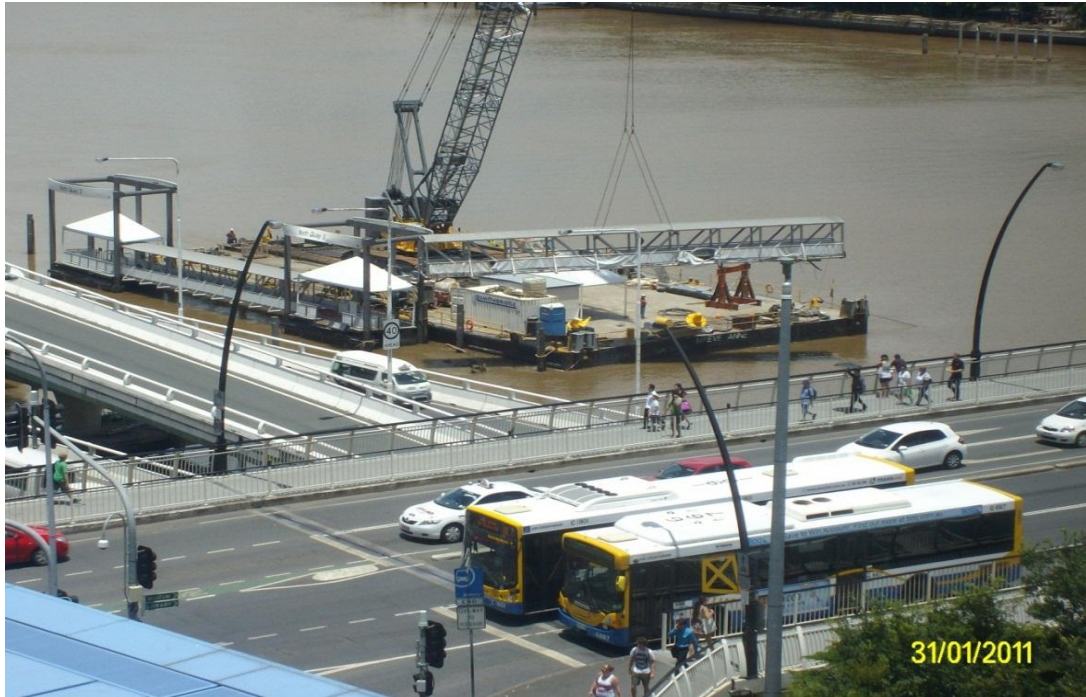
Figure 4-3 519 Tonne Crane Barge 'Maeve Anne' removing Gangway from North Quay

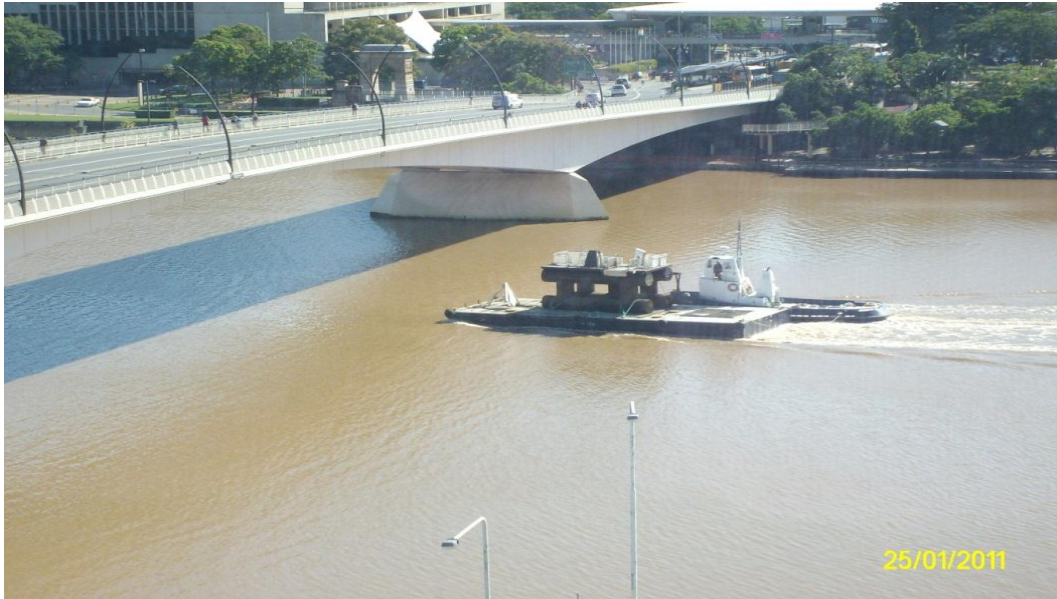
Figure 4-4 small flat top barge used for transporting salvaged materials to Fisherman's island

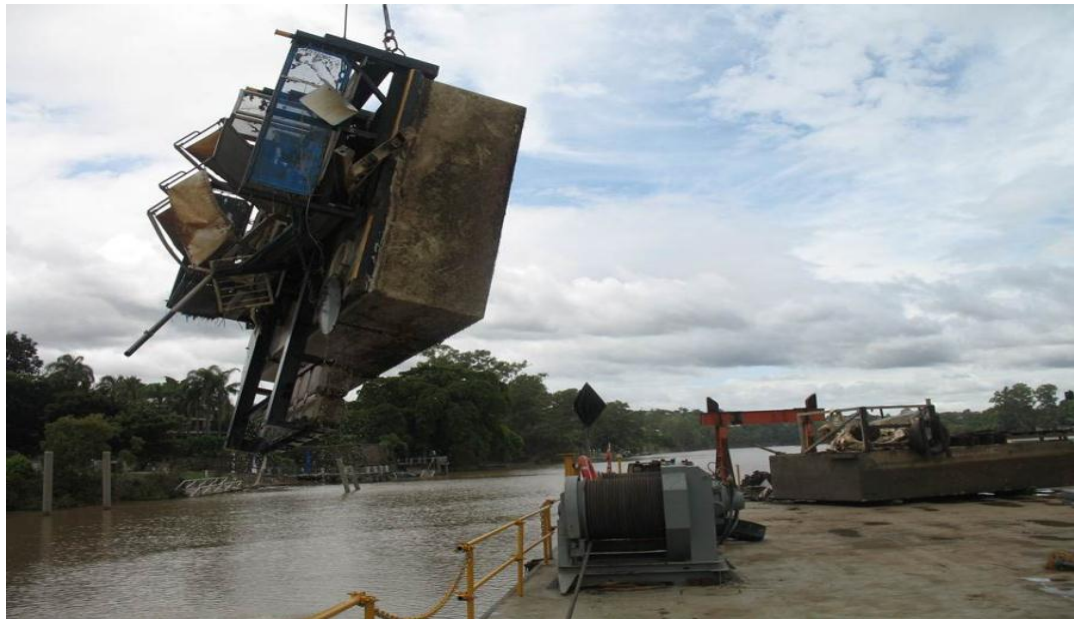
Figure 4-5 Retrieval of sunken pontoon from Brisbane river during the 2011 flood, being loaded onto the 'Maeve Anne'

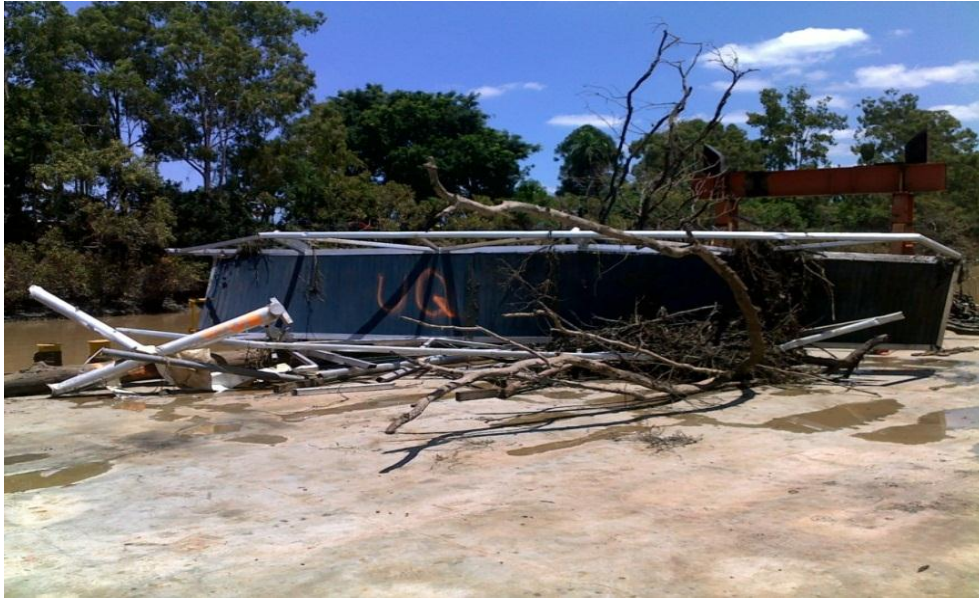
Figure 4-6 Salvaged Gangway from University Of Queensland

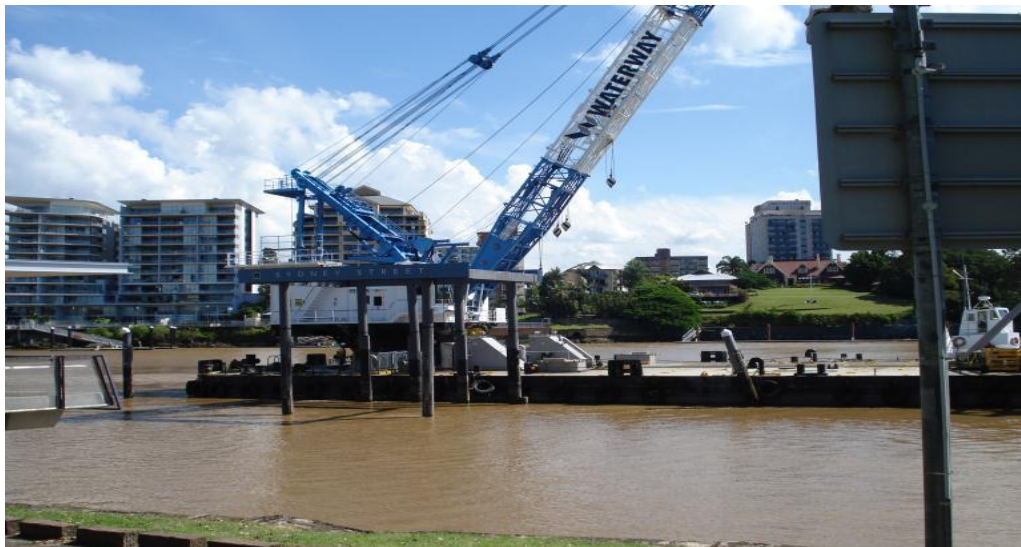
Figure 4-7 "Kochi" Crane Barge on the Brisbane River 2011

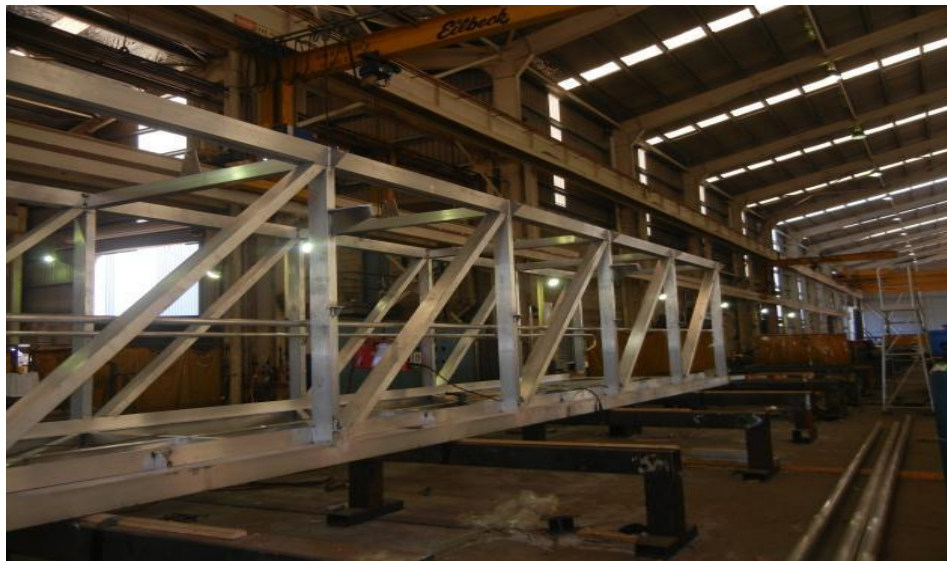
Figure 4-8 Gangway construction in Sydney workshop

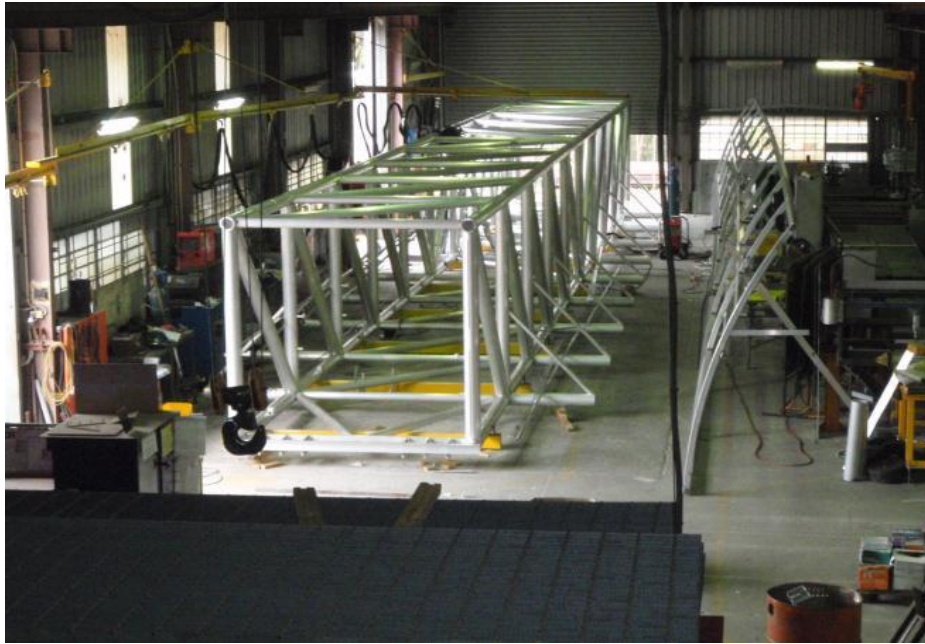
Figure 4-9 Gangway construction in Brisbane workshop

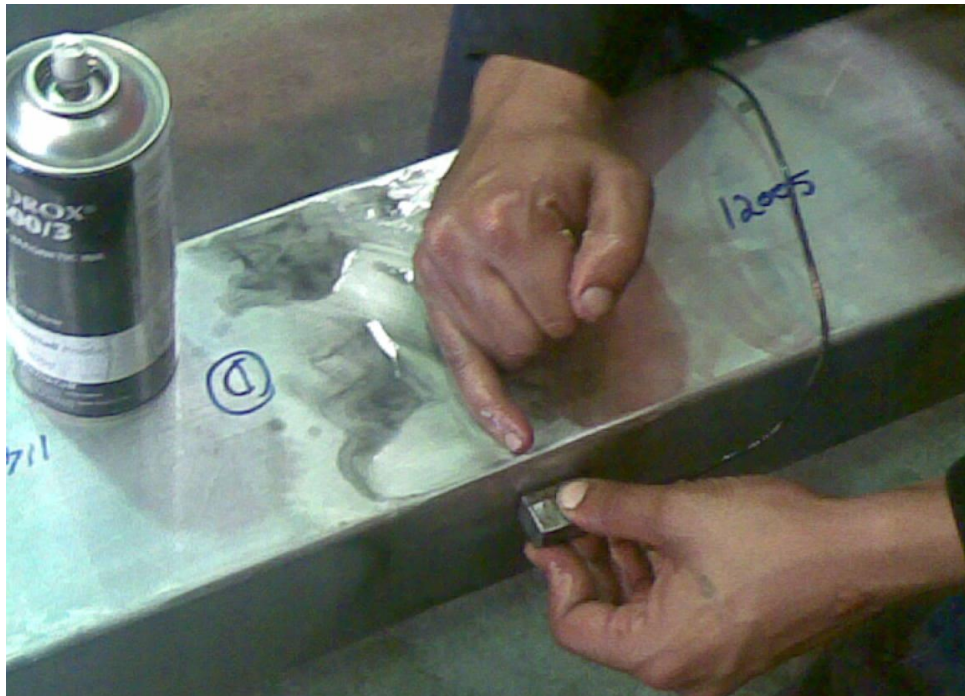
Figure 4-10 Ultrasonic testing of welds on Gangways

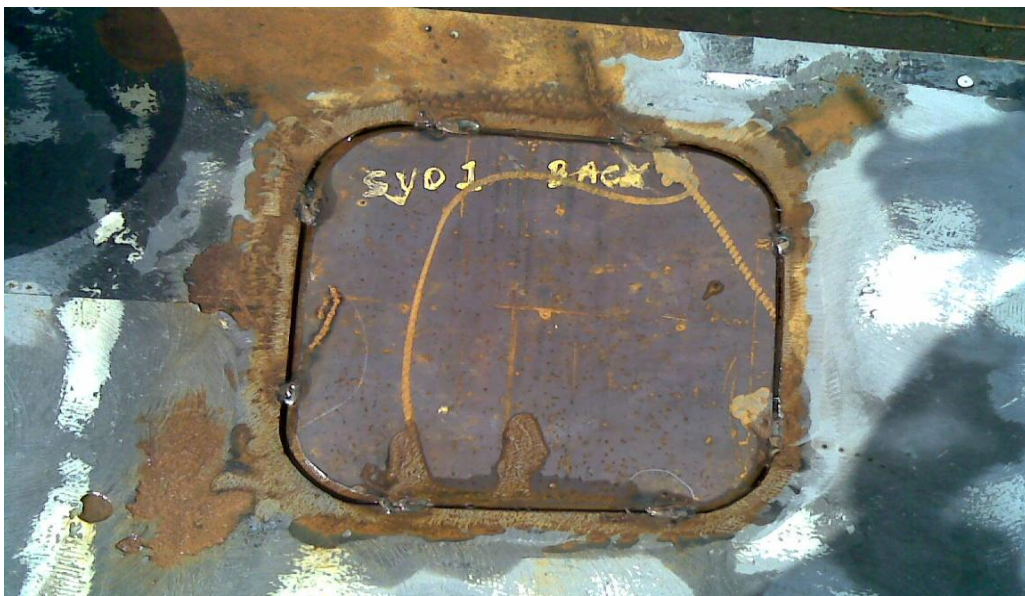
The repairs required were mainly caused by tearing around the hold down bolts for the shade structures, balustrading, damage caused by debris hitting the pontoons and overall wear and tear.

Figure 4-11 repaired section of pontoon where hold down bolts were pulled through

Once the pontoons were repaired, they were subsequently sandblasted, then pressure tested and if approved, sandblasted again and painted with Interzone 485 to 1500 microns (Colour Grey) using Forgacs own painting facilities. The main framework for the shade structures was installed on the pontoon at the Forgacs fabrication yard and then the pontoon was floated and transported to site via a tug.

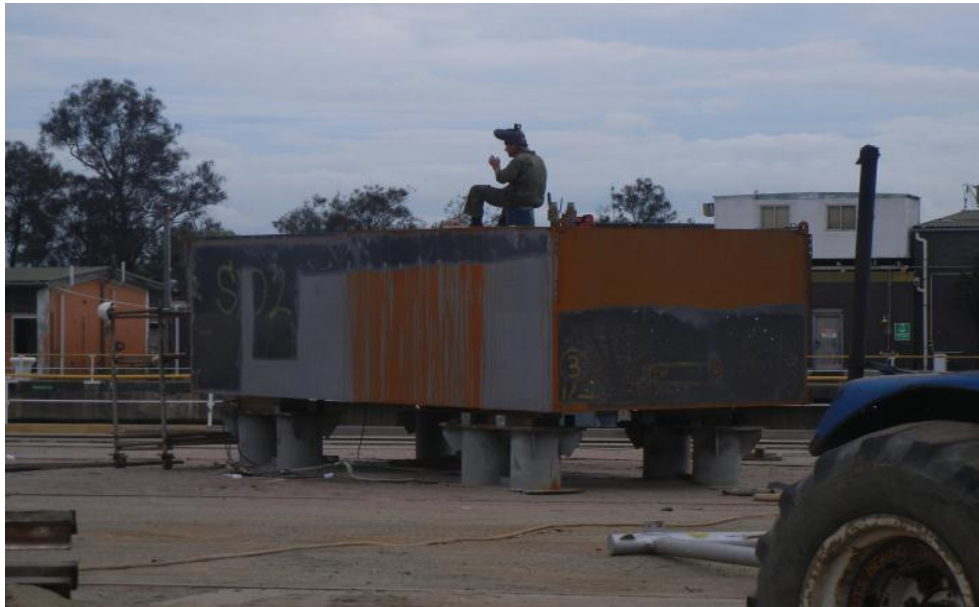
Figure 4-12 Pontoon section being repaired

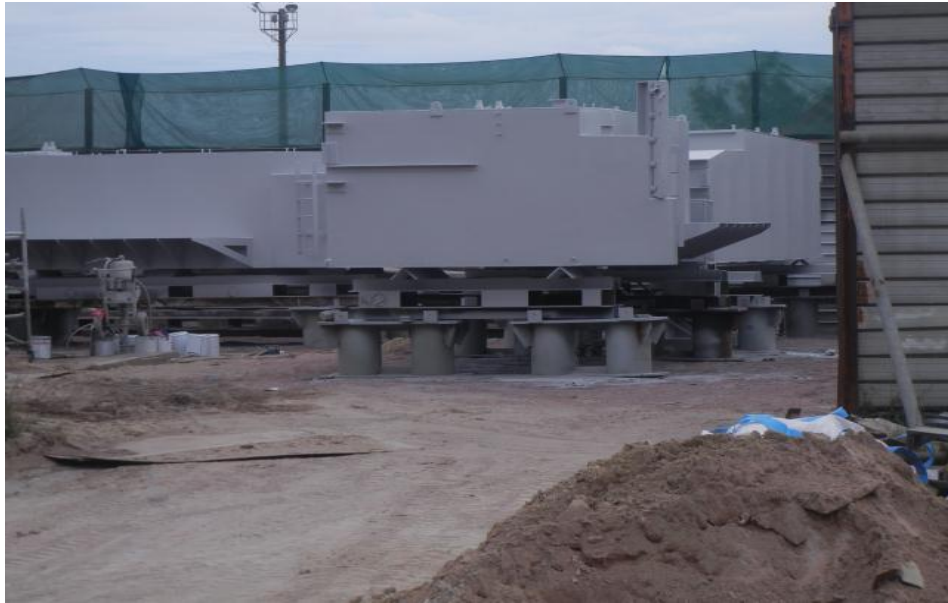
Figure 4-13 Pontoon sections being painted

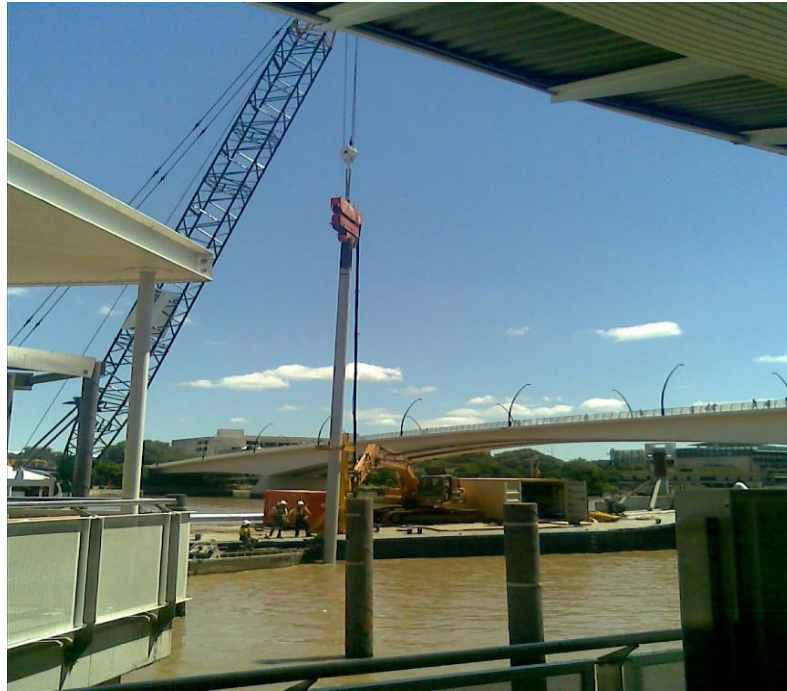
Figure 4-14 Vibrating pile into place at North Quay

To also meet the new flood height level classification some of the existing piles in certain locations had to have their heights extended. This was achieved through welding of an additional section to the existing sections, with the weld undergoing the appropriate NDT requirements.

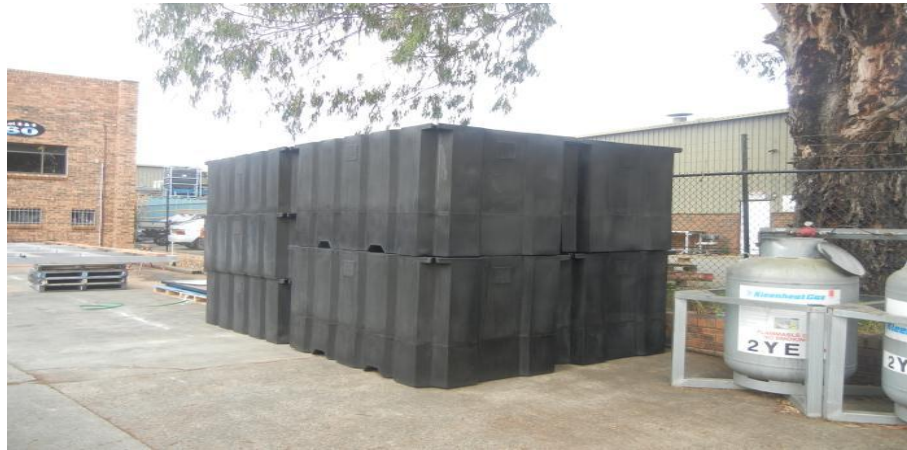
The pontoon was designed and built using a relative new design that allowed for rapid construction. The material used for the pontoon itself was MDS Marine Polyethylene floatation modules approx. 1800Ltr, F2700 foam filled with closed Cell Polyurethane. These modules were bolted together than encase by an RHS steel frame and poly fenders connected to the outside of the pontoon.

Figure 4-15 floatation modules used to construct pontoon for QUT terminal

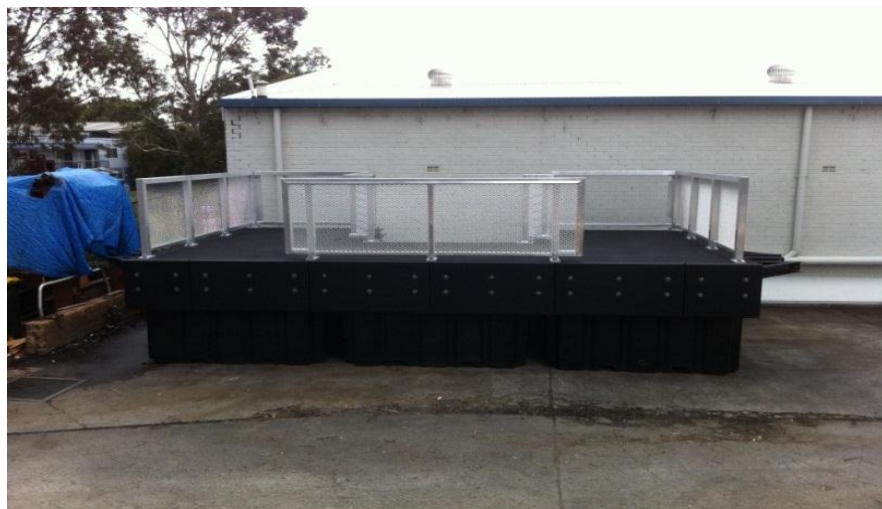
Figure 4-16 Constructed QUT pontoon

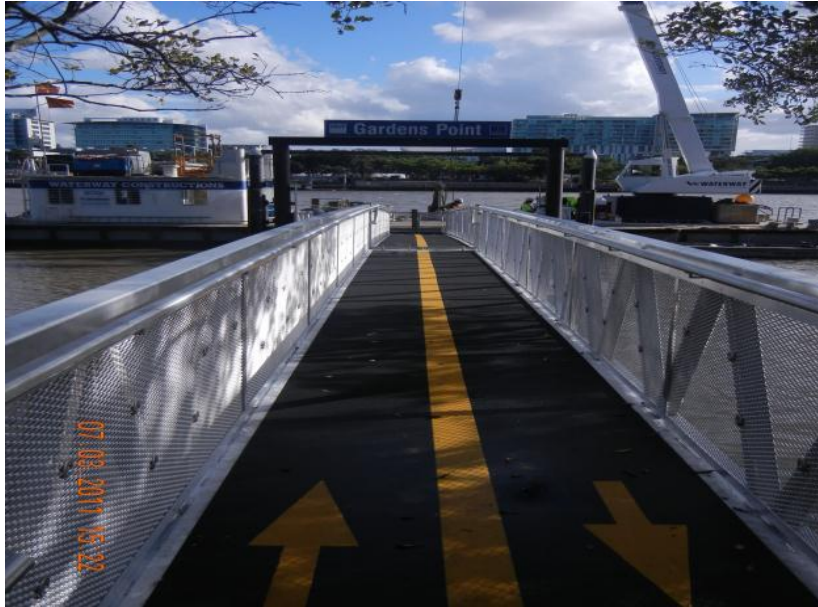
The gangways and balustrading were constructed from aluminium and had to adhere to the BCC QA documentation requirements such as ITP, weld testing and weld mapping.

Figure 4-17 QUT Gangway in position

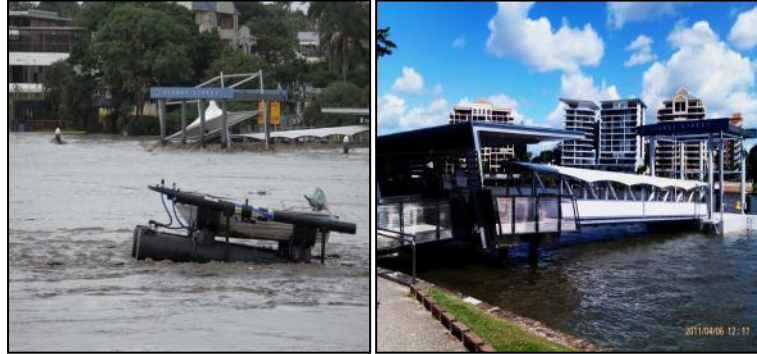
Figure 4-18 Sydney St before and after

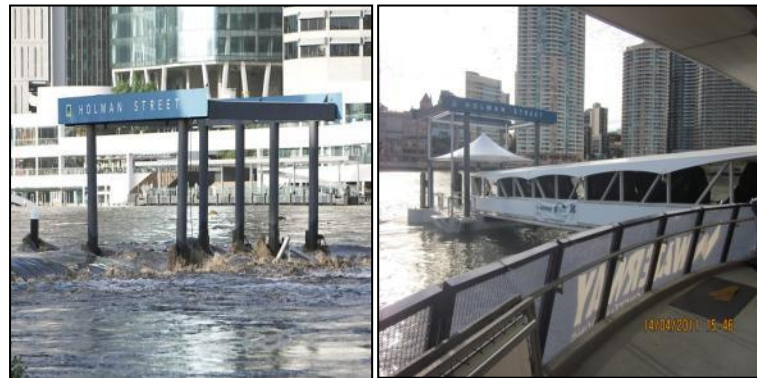
Figure 4-19 Holman St before and after

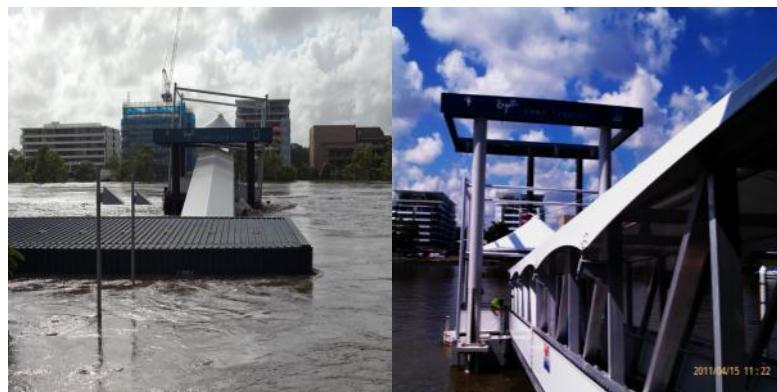
Figure 4-20 Regatta before and after
