University of Southern Queensland

**ANALYSIS OF HIGH-SPEED RURAL TRAFFIC  
CRASHES WITHIN THE SOUTH-WEST  
DISTRICT OF TOOWOOMBA REGIONAL  
COUNCIL**

**Bachelor of Engineering (Civil)**

Submitted: October 2011

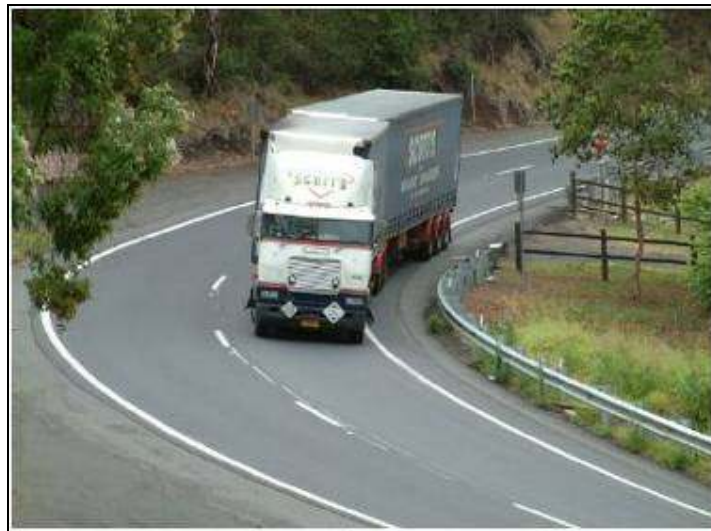
**Figure 2.7:** Heavy vehicle tracking on a horizontal curve (Ayers 2010, p. 17)

Figure 2.7 below exemplifies how large vehicles track towards the inside of a curve. The amount of curve widening depends mostly on the curve radius, with reference also made to the normal lane width, traffic composition and vehicle clearance (Austroads 2010, p. 159). At greater curve radii, Austroads provides recommended curve widening extents, however it is recommended that vehicle turning templates be utilized at smaller radii.

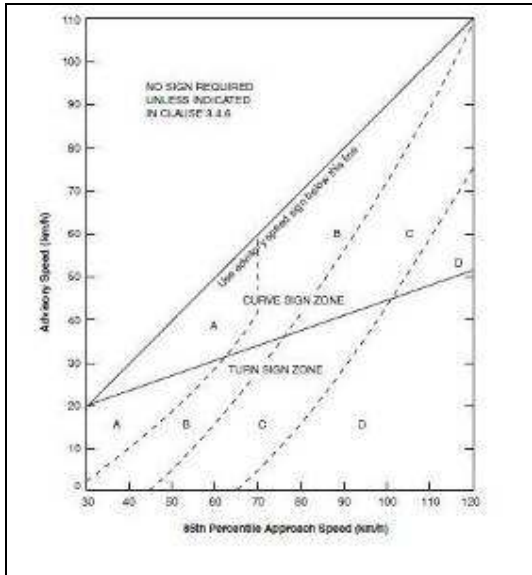
**Figure 2.12:** Signposting of substandard horizontal curves (TMR 2009, p. 43)

TMR’s MUTCD provides guidance on the treatment of substandard horizontal curves; the horizontal geometry influences drivers operating speed more so than other geometric elements. This treatment can involve warning signs with advisory speeds, chevron alignment markers (CAM), guideposts and linemarking. In determining the type and size of warning signs and CAM, MUTCD provides the following two charts,

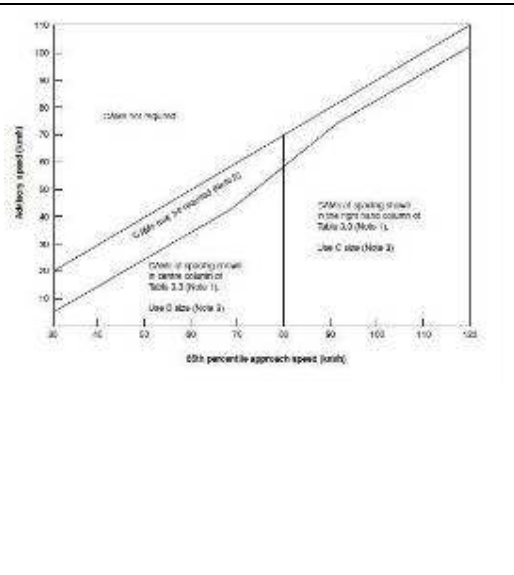
**Figure 2.13:** Guide for the use of Chevron Alignment Markers (TMR 2009, p. 44)

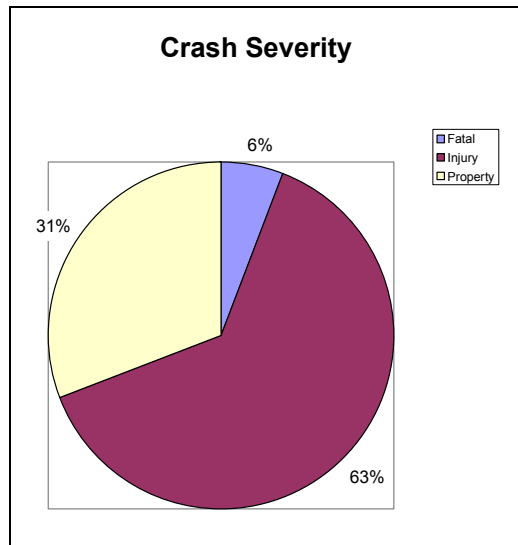
**Figure 5.1:** Crash severity

An initial comparison will be made on the crash severity of the local data, to gauge whether the trends experienced locally compare to those experienced elsewhere. For simplicity, the crash severity will be separated into fatal, injury, (including hospitalisation, other medical treatment and injured) and property damage only. Results for the local data are contained in Figure 5.1 below.

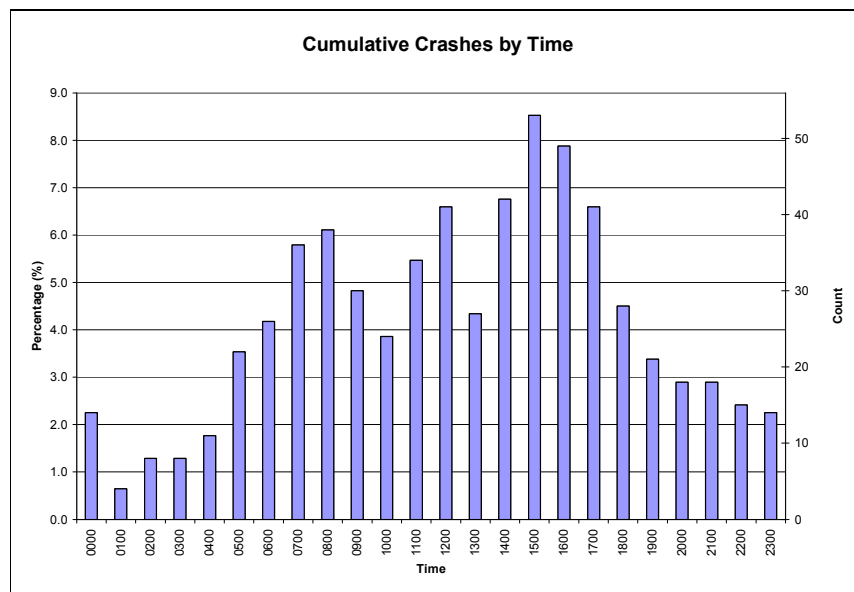
Figure 5.3: All crashes by time of day

The crash data received from TMR was separated by hour, with graphical results displayed in Figure 5.3.

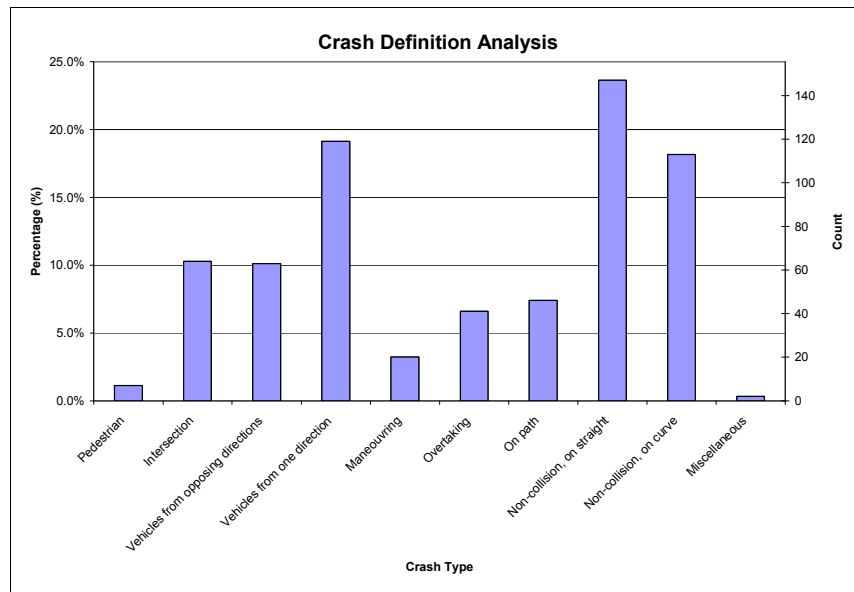
**Figure 5.9:** All crashes by DCA definitions

As stated, the crash data was separated into the various DCA crash-types. The cumulative results for this process are contained in Appendix 11.7, with Figure 5.9 below conveying the number of each crash-type for each council district.

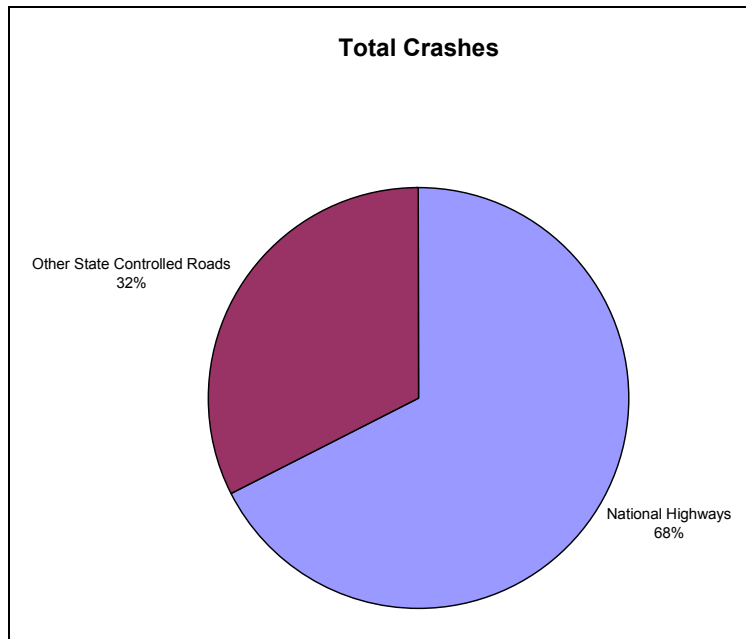
**Figure 5.12:** Total crashes split by NH and OSCR

The results shown above plausibly show that a greater number of crashes occur on the more heavily trafficked national highways. Atop the list of total crashes are the major routes of the New England Highway, Warrego Highway and Gore Highway, presumably due to their high traffic volumes and long segment lengths. Figure 5.12 below splits the total crashes by National Highway, with a clear majority of 68%, and Other State Controlled Roads.

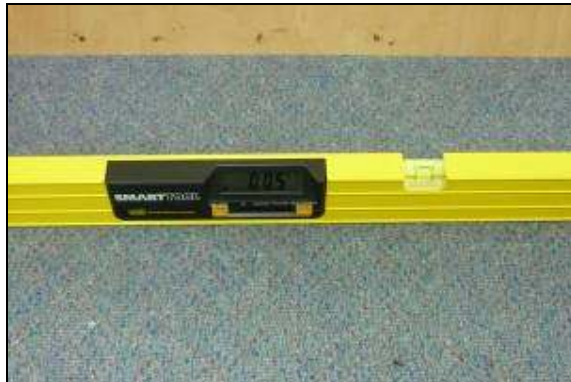
**Figure 6.2:** Digital level used in estimating road crossfall

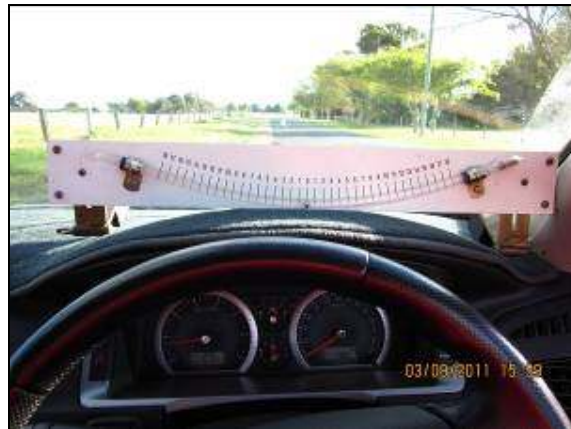
**Figure 6.4:** Ball bank indicator in survey vehicle

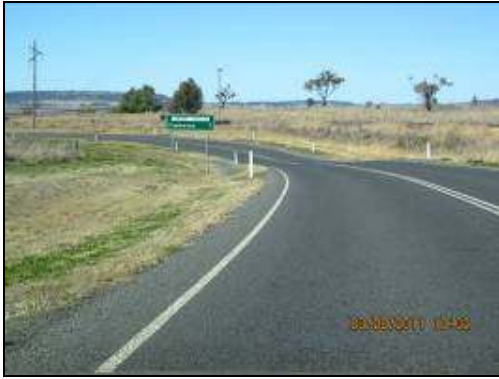
**Figure 6.17:** Crash Site 3 Toowoomba-Karara Road looking south, dip mid-corner

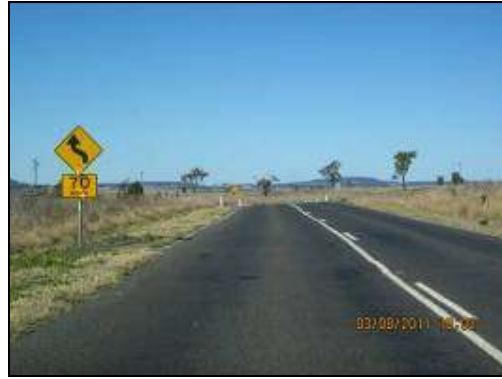
**Figure 6.18:** Crash Site 3 Toowoomba-Karara Road, crest leading into horizontal curves

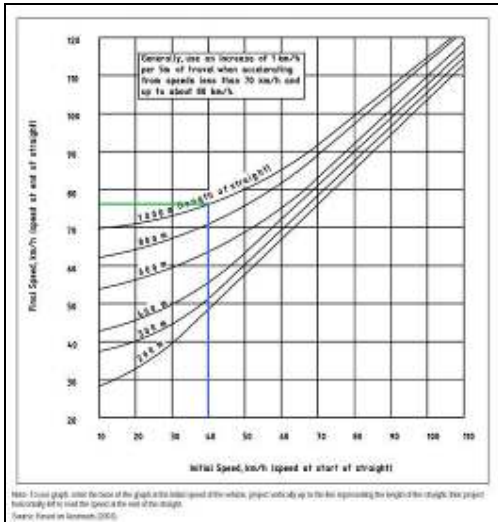
**Figure 6.20:** Northern approach speed (76 km/h)

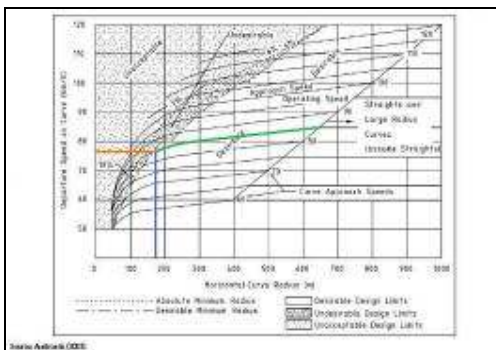
**Figure 6.26:** Curve 4 north-south departure speed (77 km/h): ACCEPTABLE
