**PROPERTY RIGHTS, CADASTRAL  
BOUNDARIES & COASTAL EROSION IN  
NEW SOUTH WALES**

**Bachelor of Spatial Science (Surveying)**

The aim of this project is to investigate the effects of coastal erosion on coastal boundaries and to determine the rights, obligations and limitations attached to that land with respect to both the private land owner and the general public.

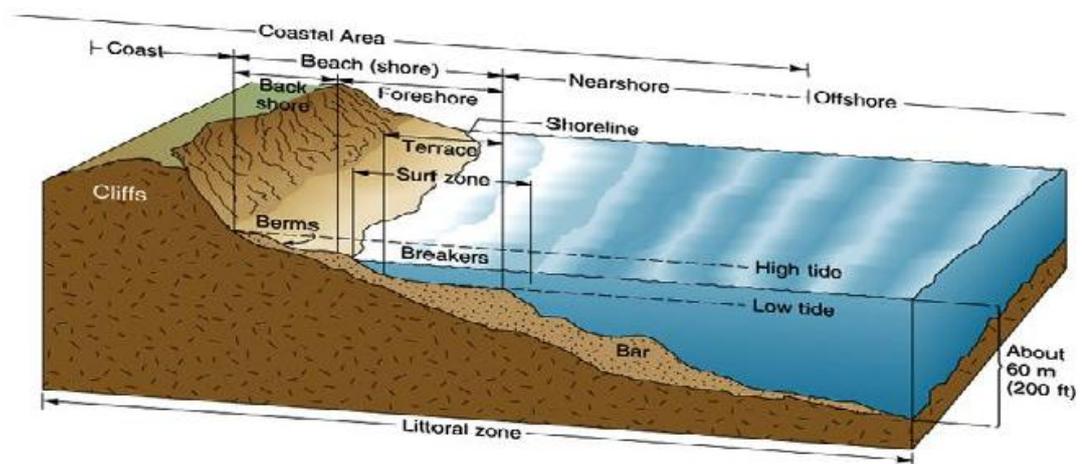
The littoral zone (*Figure 5*) is widely referred to as a section of sea or lake which is closest to the shore. The extent of the littoral zone can be measured from the mean high water mark to the areas seaward that are permanently submerged.

Figure 5 - Littoral Zone (U.S. Navy 2011)

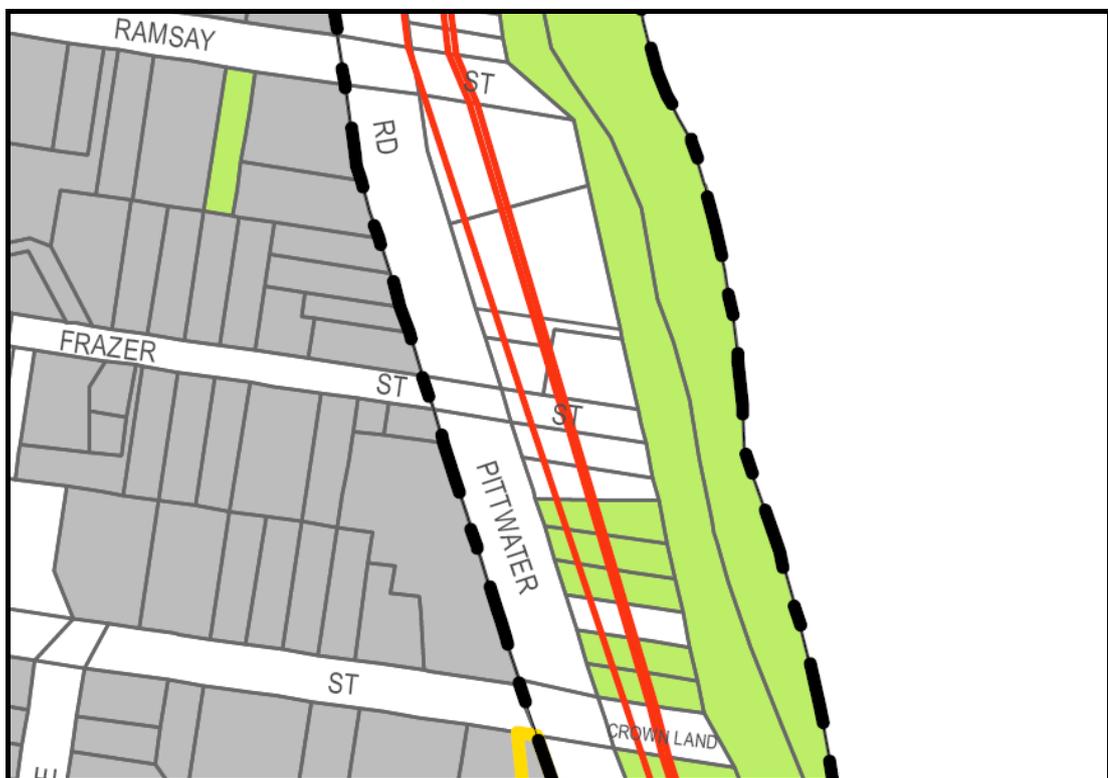
The wave impact zone is an area set out by Warringah Council along Collaroy-Narrabeen Beach with which it is referred to as a coastal hazard zone. It is a zone along the beach front that stretches from Fishermans Beach, Collaroy to Narrabeen, incorporating the entire beachfront of Collaroy-Narrabeen Beach. The zone is shown in *Figure 6* as the area to the East of the most Eastern red line, and includes most existing development along the beach front. The other two red lines shown in *Figure 6* are the Zone of Slope Adjustment line, and the Zone of Reduced Foundation Capacity line, with which new development eastward of these lines must be ‘...supported by piles to withstand loads which may be induced in the pile by slumping of the soil face’ (Warringah Local Environment Plan 2000 Schedule 13, clause 3(b)).

Figure 6 – Wave Impact Zone (Warringah Council 2011)

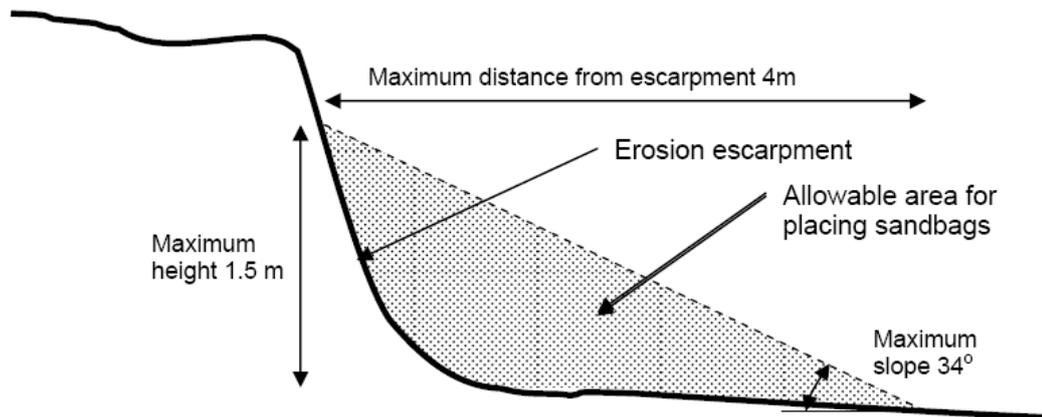
Emergency coastal works must only consist of sand or geotextile fabric bags filled with sand that has not been taken from a beach or sand dune adjacent to the beach (DECCW, 2011). They may not include materials such as rocks, concrete or construction waste. These works are to be placed against the erosion escarpment on the seaward side as per *Figure 7*.

*Figure 7* – Allowable Area for Placing Sand or Sandbags (DECCW 2011)

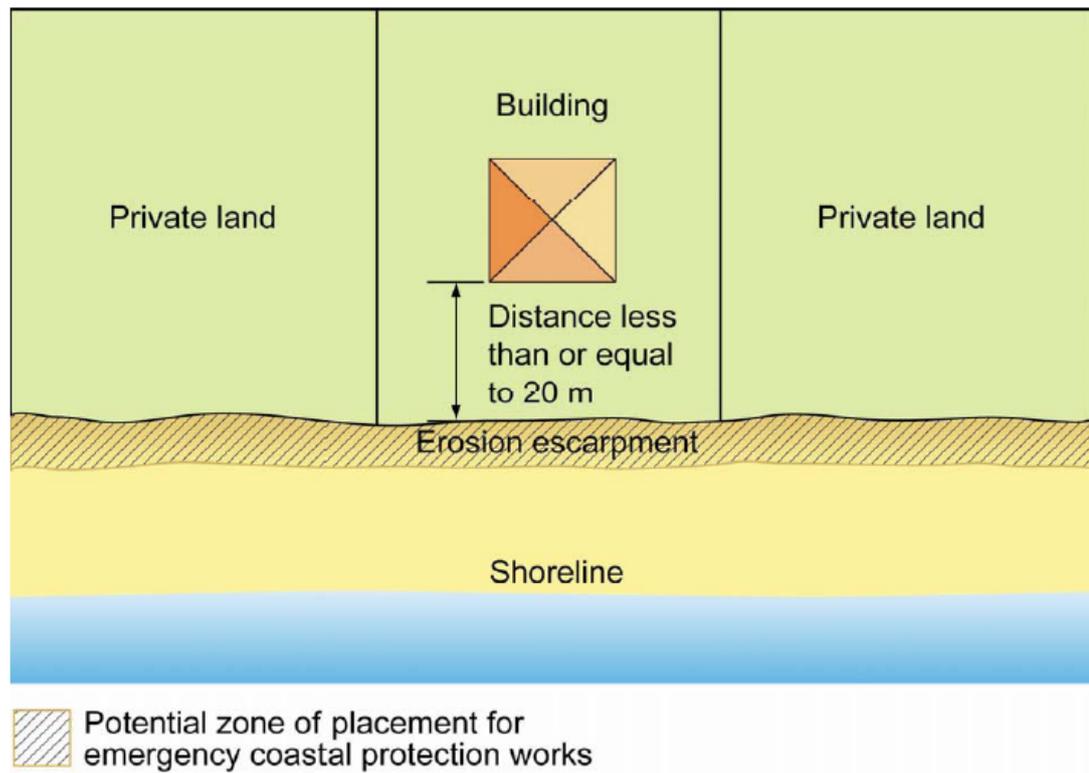
Figure 8 – Emergency Coastal Protection Works on Adjacent Private Land (DECCW 2011)

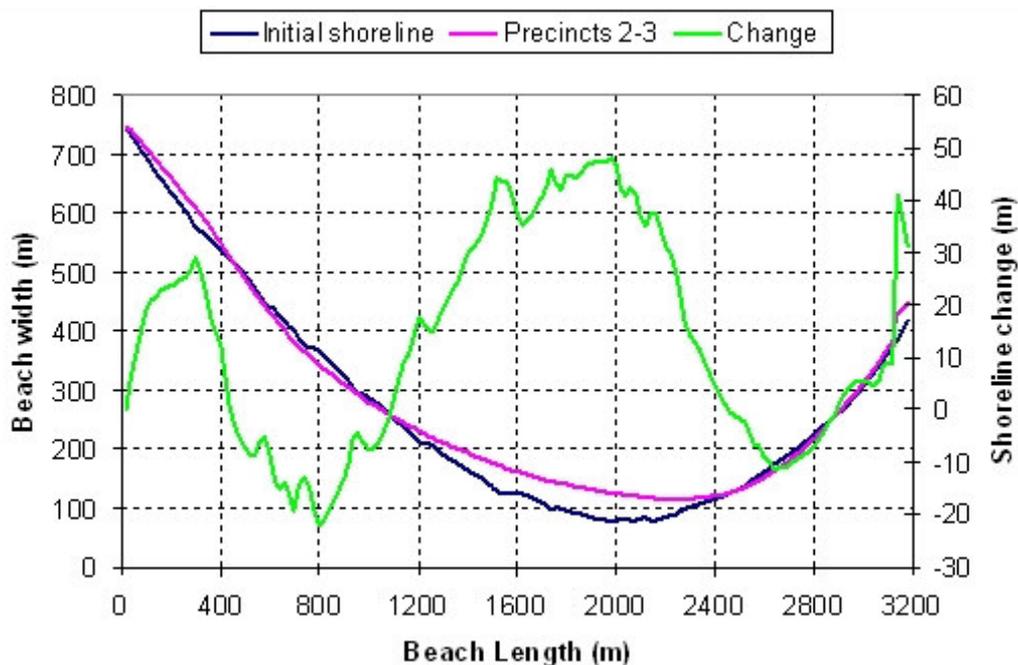
Figure 9 – Nourishment of Precincts 2-3 showing the initial and final shoreline positions and the degree of change - Collaroy Narrabeen Beach (Acworth c.2009)

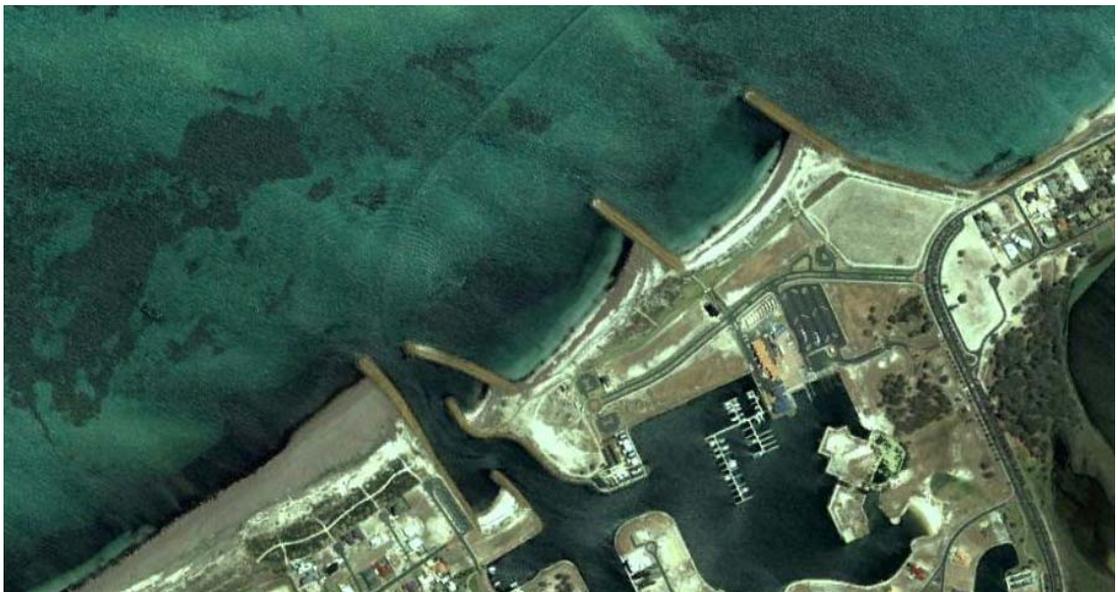
*Figure 10 – Accretion & Erosion at Port Geographe due to Groynes – 2003 (Google Earth 2011)*

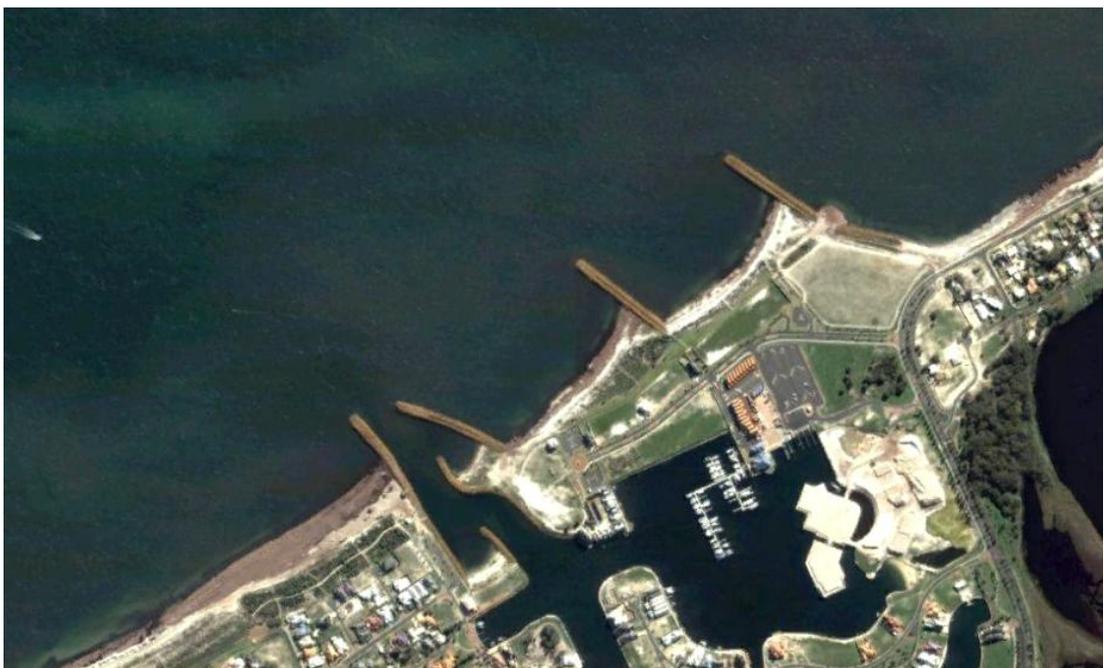
*Figure 11 – Accretion & Erosion at Port Geographe due to Groynes – 2005 (Google Earth 2011)*

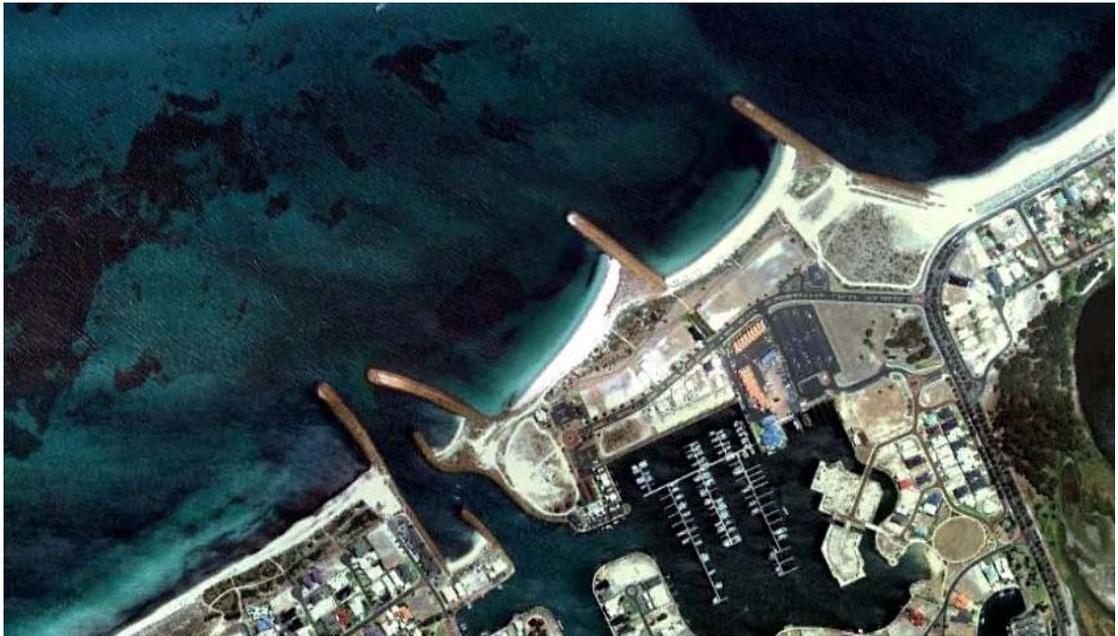
Figure 12 – Accretion & Erosion at Port Geographe due to Groynes – 2010 (Google Earth 2011)

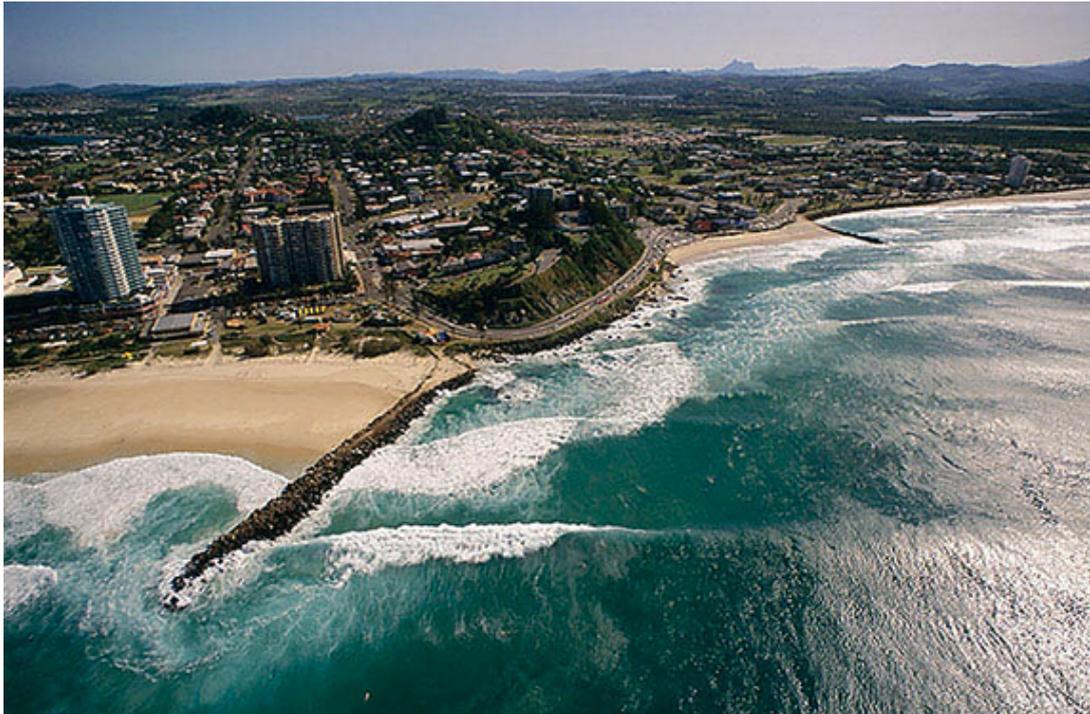
*Figure 15 – Kirra Beach - Big Groyne with Little Groyne in Background (Joli n.d.)*

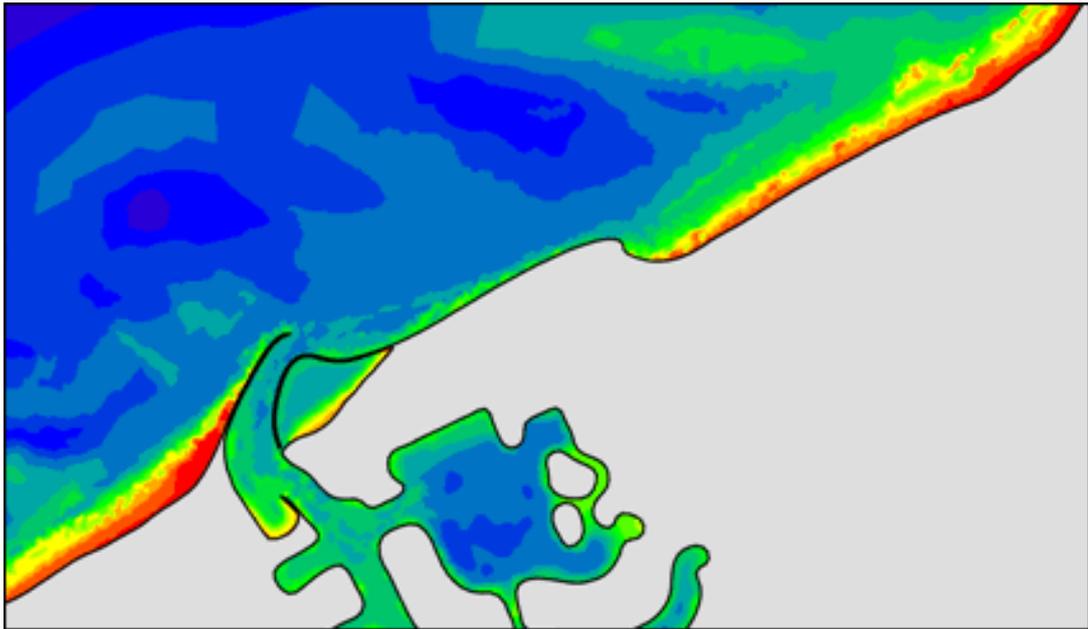
A study recently completed on the effects of the groynes at Port Geographe has conceded there is a problem with the way in which the groynes have been constructed. A new model has been developed by Professor Pattiaratchi of the Faculty of Engineering, Computing and Mathematics in the School of Environmental Systems Engineering at the University of Western Australia in which a reconfiguration of the groyne layout has been proposed to allow a more natural flow of sand and seagrass along the coastline (Pattiaratchi & Wijeratne 2011). The new model places the groyne at a parallel angle to the swell direction (*Figure 16*).

Figure 16 – Most Appropriate Re-design for Groyne at Port Geographe (Pattiaratchi & Wijeratne 2011)

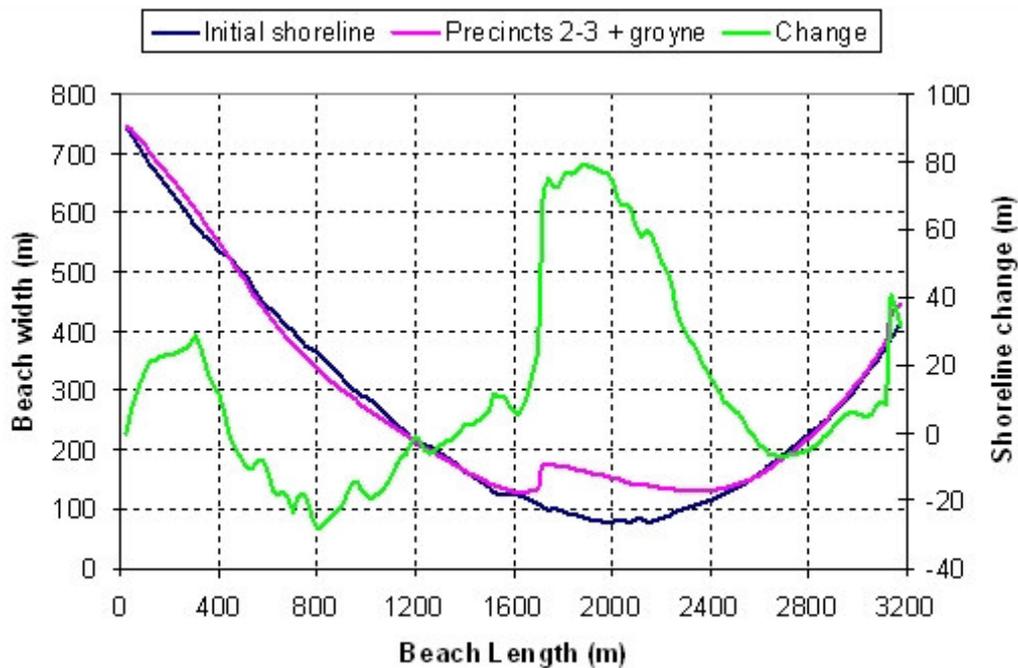
The groyne has been proposed and modelled at Devitt Street, Narrabeen, and is a design square to the beach. This may bring about an increase in beach sediment to the south of the groyne, but in contrast cause increased erosion to the north of the wall. This scenario also includes the continuation of beach nourishment (*Figure 17*).

Figure 17 - Nourishment of Precincts 2-3 with a groyne at Devitt Street, Narrabeen showing the initial and final shoreline positions and the degree of change (Acworth c. 2011)

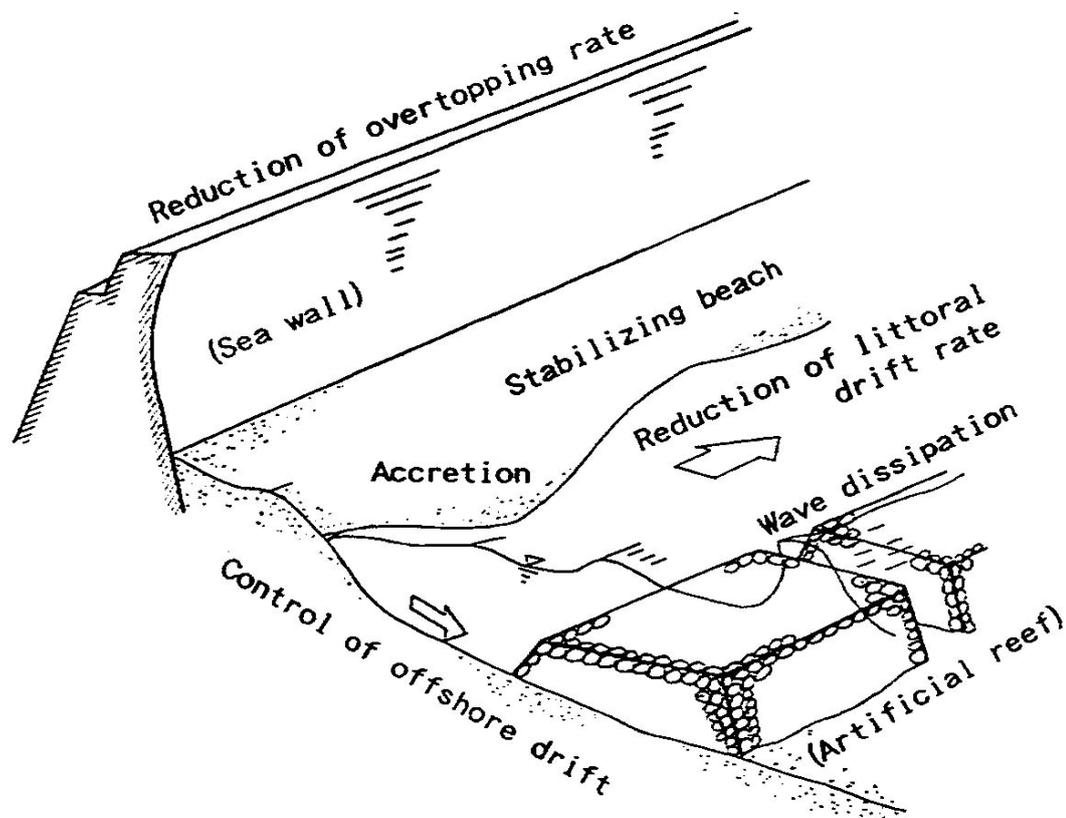
They act as a submerged breakwater, helping to reduce the wave energy in the region of the shallow water or nearshore zone (Sawaragi, Deguchi & Park 1988). Japan has seen the construction of many artificial reefs over the past decades to help control coastal erosion. The main design used is a broad-crested submerged breakwater (Figure 18), although these can be expensive to build (Sawaragi, Deguchi & Park 1988; Pilarczyk 2003).

Figure 18 – Broad-Crested Submerged Breakwater (Artificial Reef) (Pilarczyk 2003)

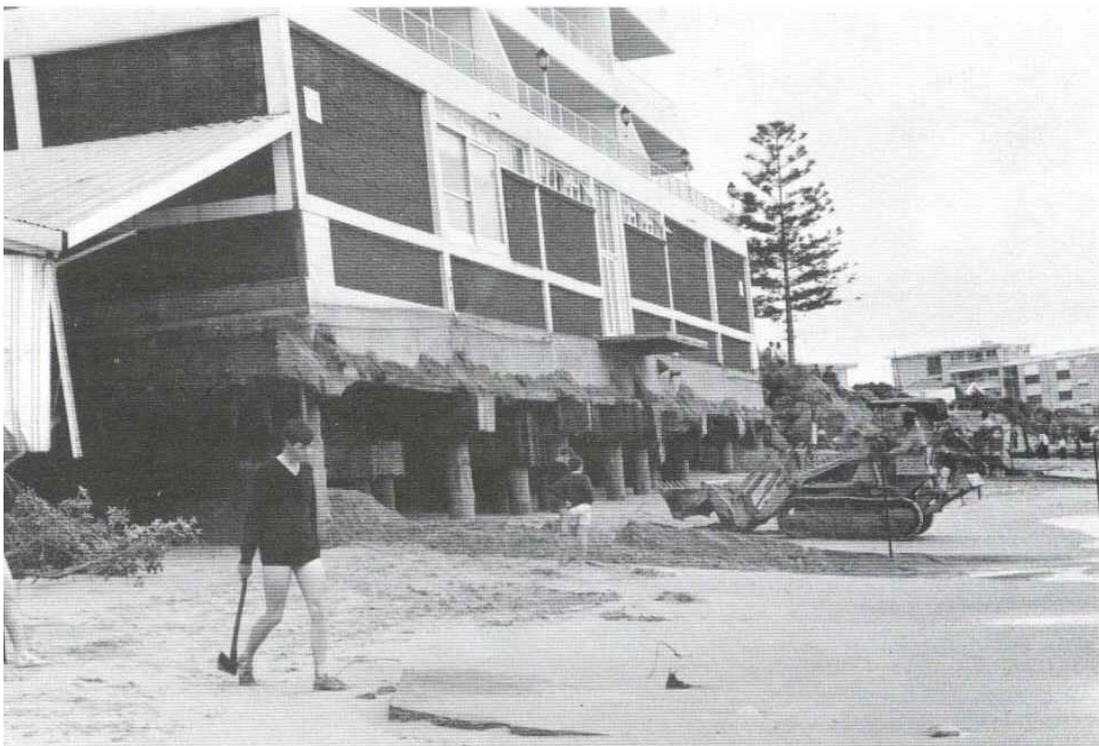
The storms of 1967 undermined the ‘Flight Deck’ apartment block, exposing its concrete foundations (*Figure 19*).

*Figure 19* – ‘Flight Decks’ exposed foundations after 1967 storm (Worley Parsons 2011)

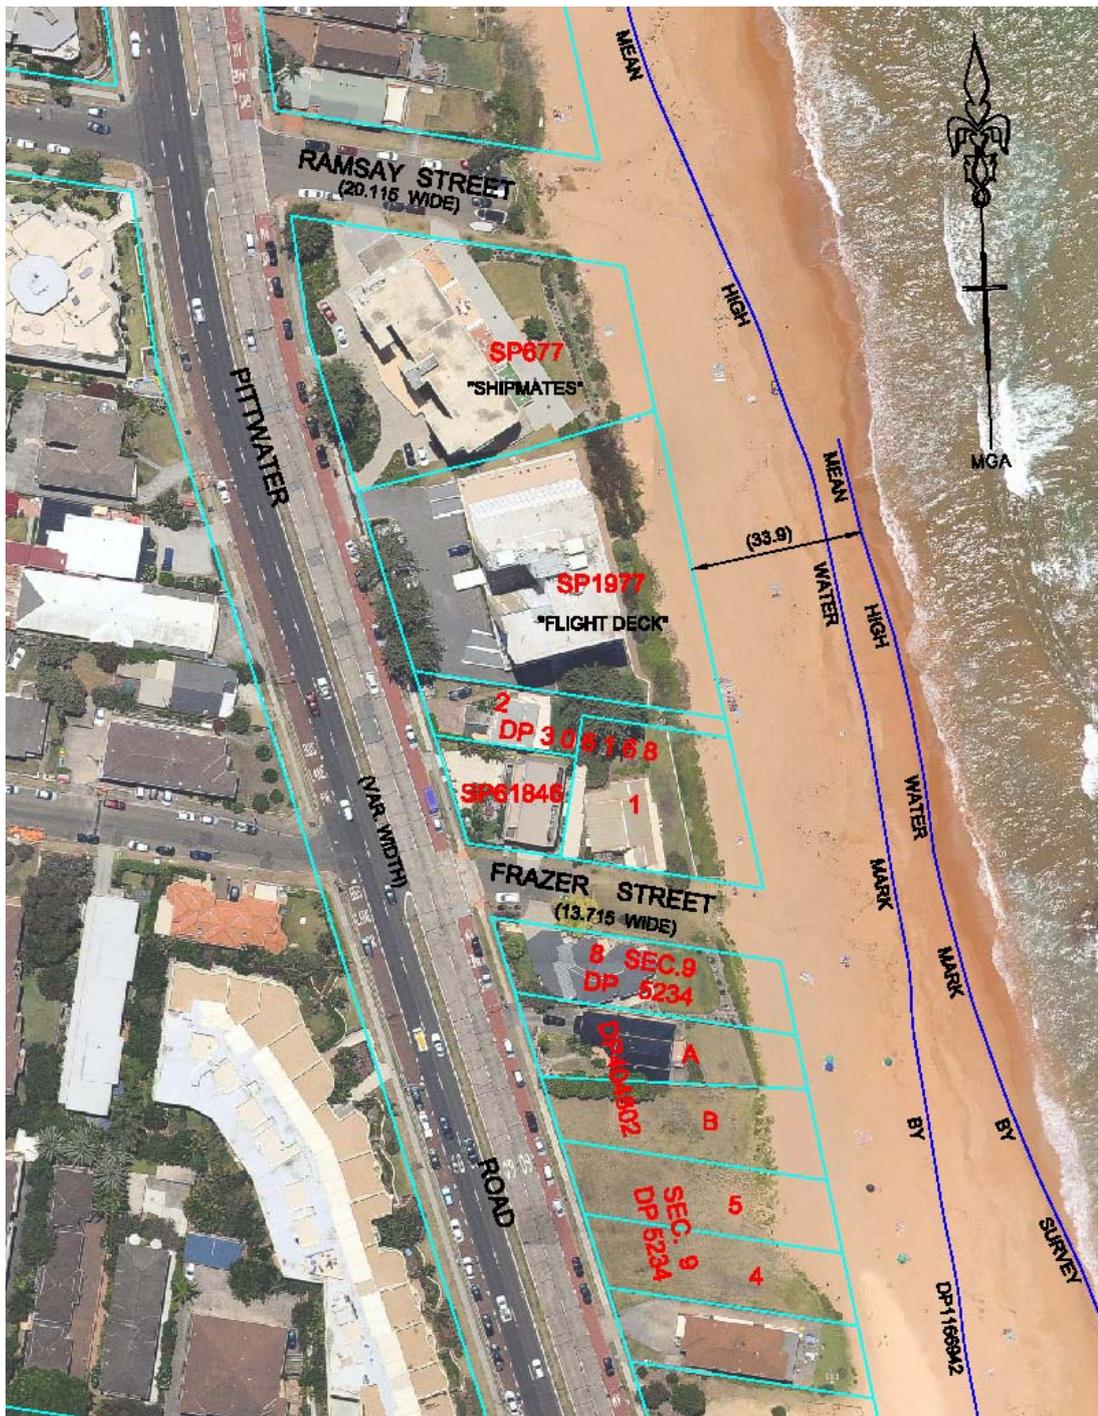
A detail survey of part of Collaroy-Narrabeen Beach front was conducted on 31<sup>st</sup> July, 2011. The survey took place between numbers 1098-1124 Pittwater Road, and 1 Frazer Street, Collaroy and included the sandy beach and location of the grassy bank that runs along the property boundaries of the beach reserve and the landward properties bounding the reserve. The purpose of the survey was originally to determine the position of the mean high water mark in comparison to the cadastral boundaries of privately owned land along the strip. In carrying out the detail survey, it became apparent that the mean high water mark was not a concern for the cadastral boundaries (*Figure 22*) as it was found to be a minimum of 33.9 metres from the fixed line boundaries at the time of survey. It was apparent from the detail survey that no major storm activity had recently occurred due to observations of the gentle gradient of the beach, hence the mean high water mark being so far away from the private cadastral boundaries. Further evidence is shown when comparing the position of the surveyed MHW line to the MHW line shown on DP1166942 (*Figure 22*). The concern was the amount of erosion that had occurred between the private land and the beach.

Figure 22 – Position of Mean High Water Mark as per survey & DP1166942 (background image – nearmap 2011)

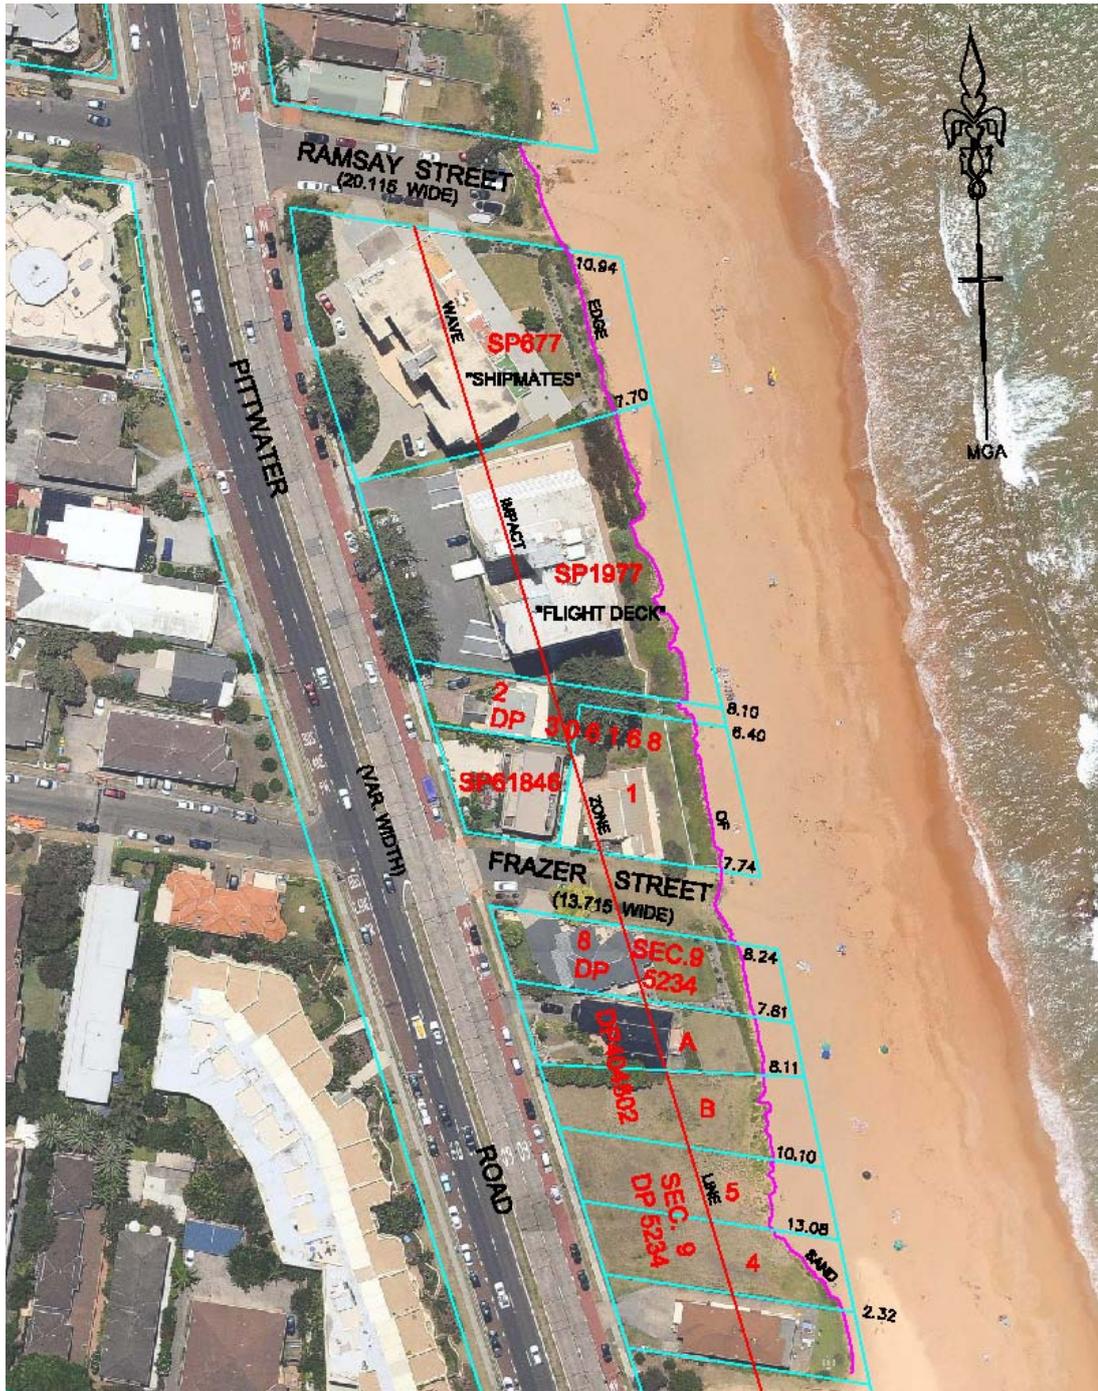
It was revealed from the detail survey that the sandy beach had encroached upon the private land by up to 10.94 metres measured along the adjacent boundary lines to the sand line (Figure 23). This poses an increasing problem of privately owned land becoming part of the sandy beach, confusing beachgoers who may trespass on private land.

Figure 23 – Position of sandy beach with offsets to cadastral boundaries (background image – nearmap 2011)

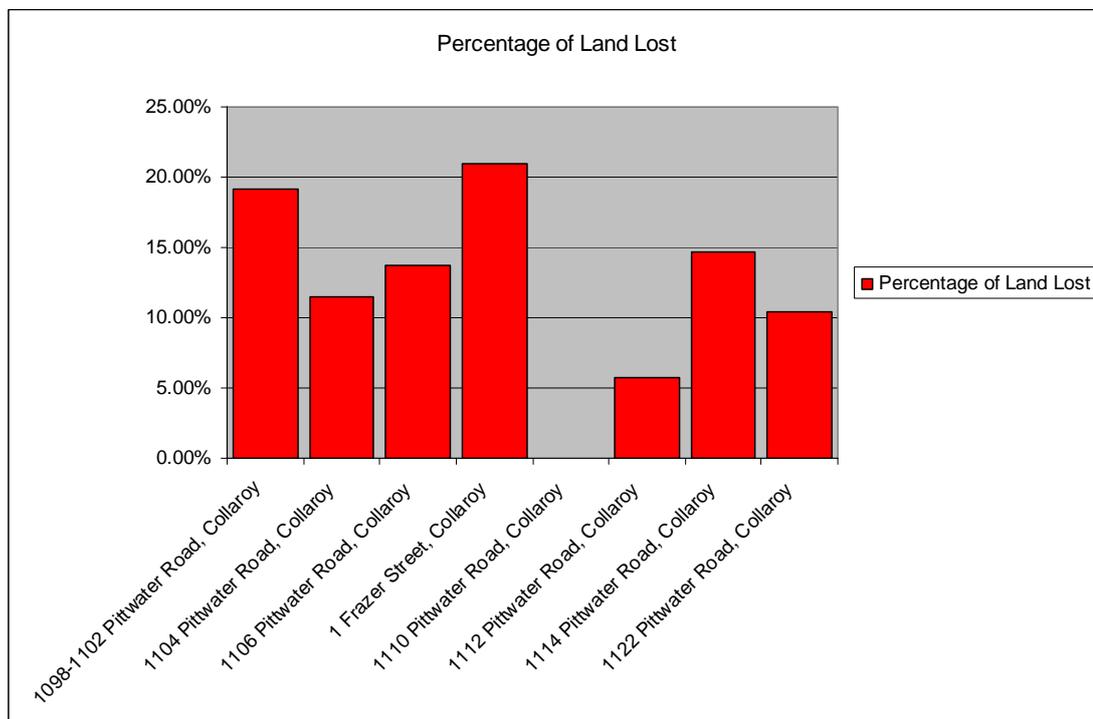
Table 3 – Percentage of Physical Land Lost

AutoCAD was used to compute the amount of physical land lost from the landward side properties to the beach caused by erosion along these fixed-line cadastral boundaries. As table 1 and graph 1 shows, up to 20.94% has been lost in the case of No.1 Frazer Street, Collaroy. This could cause some concern for beachfront land owners.

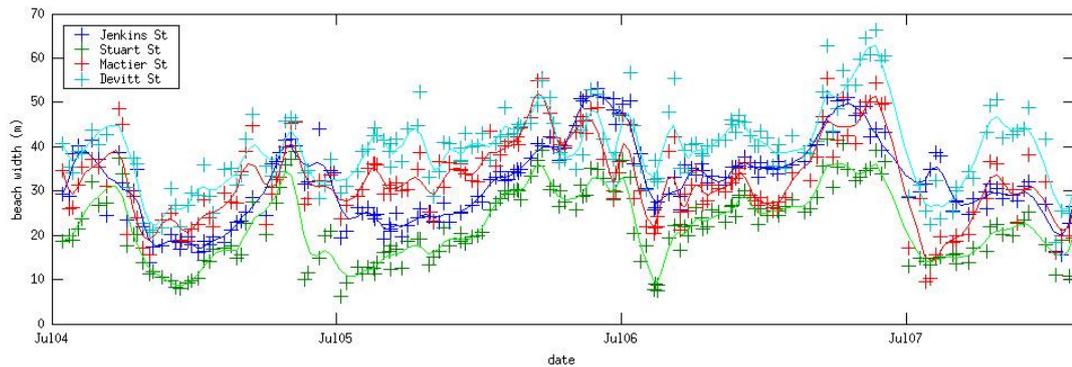
Table 4 – Fluctuations in beach width at Collaroy-Narrabeen (Water Research Laboratory – School Of Civil And Environmental Engineering 2011)

It should be noted that the beach width is not measured to the landward side cadastral boundaries of the beach reserve, but instead from water line to landward sand/vegetation line. Due to this, the actual beach width at the extreme would measure just 6 metres wide from water line to the fixed-line cadastral boundary in December 2004.

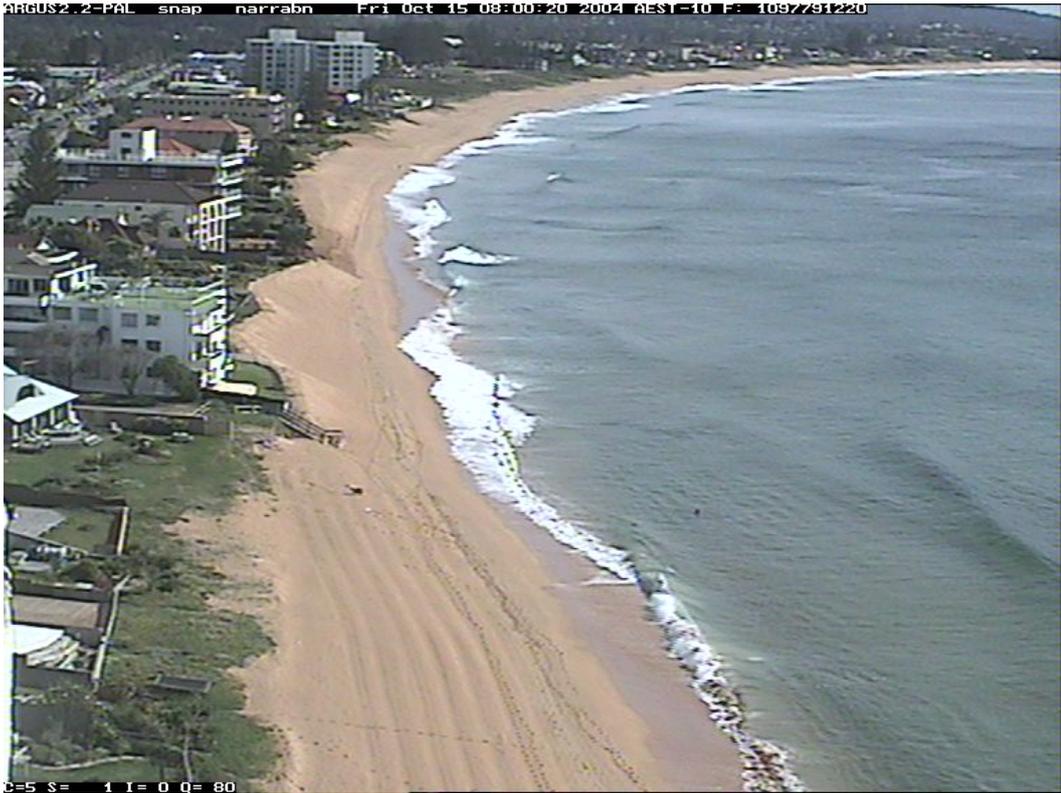
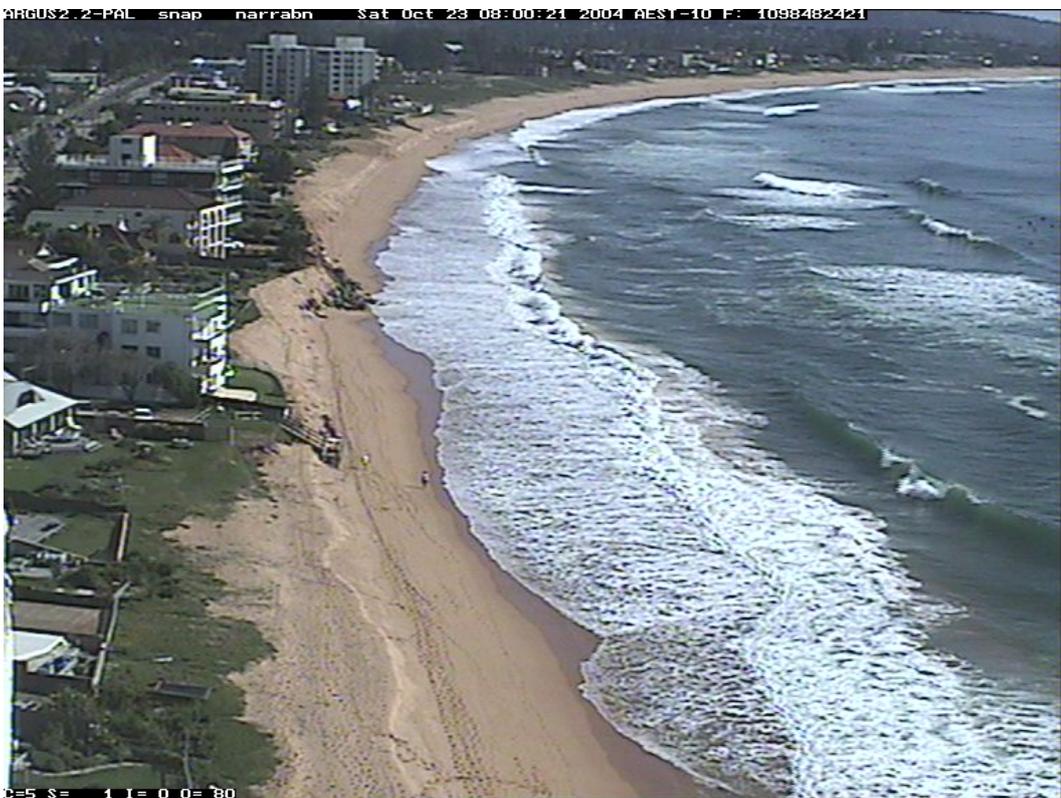
As photographic evidence from the monitoring cameras atop of ‘Flight Deck’ suggests (*Figure 24 & 25*), erosion of the beach and adjacent private land is not occurring gradually, day to day, week to week, month to month; instead it is happening almost instantaneously, during and immediately after a large storm. *Figure 24 & 25* are photos taken at the same time of day, just a week apart. As can be seen, a large storm that has occurred during the week has exposed rock protection works in front of beachfront properties. The erosion has also exposed the foundations of a set of steps used to access the beach, making them a hazard to the public’s use. These results, both measured and photographic, therefore illustrate that the primary study area within Collaroy-Narrabeen does not comply with the doctrine of accretion and erosion.

Figure 24 – Photo taken 8am, Friday 15<sup>th</sup> October, 2004 looking North (Water Research Laboratory – School Of Civil And Environmental Engineering 2011)

Figure 25 – Photo taken 8am, Saturday 23<sup>rd</sup> October, 2004 looking North (Water Research Laboratory – School Of Civil And Environmental Engineering 2011)

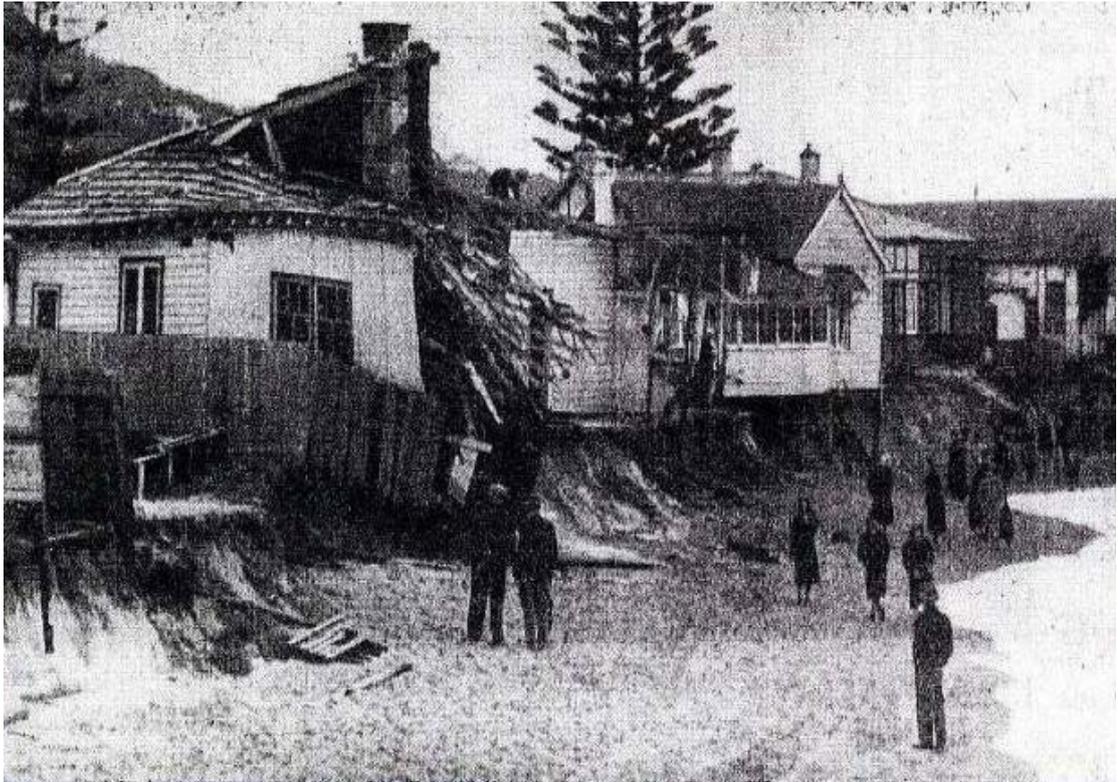
Storms in 1945 hit Collaroy-Narrabeen Beach and destroyed many properties (Worley Parsons 2011), some of those which now form the northern end of the Collaroy Beach car park (*Figure 26*). These buildings in this area were removed, and the properties resumed by council, allowing no more development on the properties.

*Figure 26 – Damage to houses, June 1945, resulting in them being demolished, with the land being resumed by council (Cameron 2010)*

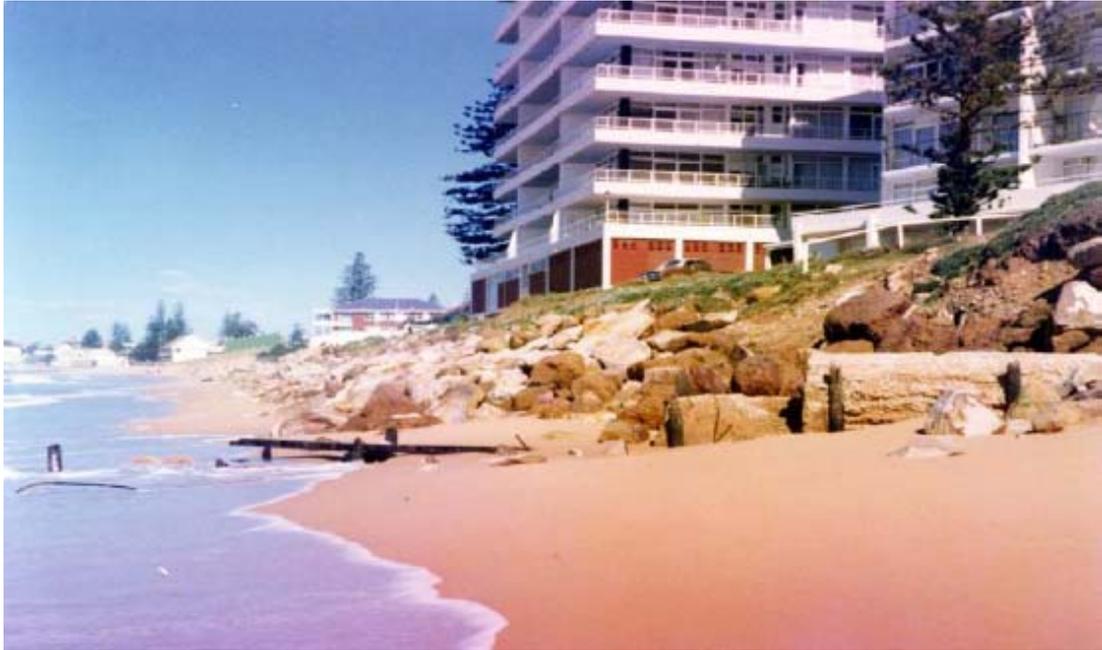
As an emergency measure large boulders and rocks were placed along the eroded beach area (*Figure 27*) after historically large storms in 1967 to help not only break up the path of wave surges, but also to stabilise the already weakened banks and sand (Worley Parsons 2011). Much like the tank traps mentioned above, these rocks are an effective way of reducing wave surges.

*Figure 27 – Emergency rock protection in front of ‘Shipmates’ & ‘Flight Deck’ c.1972 (Worley Parsons 2011)*

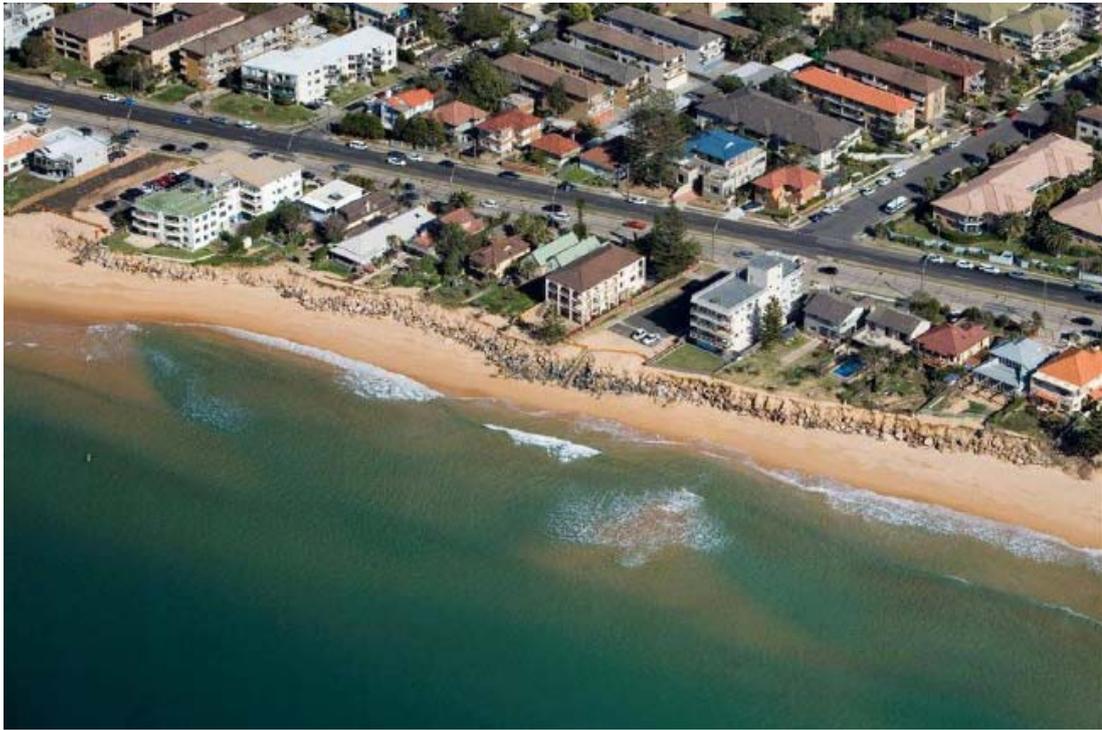
measure, but have become a long-term protection method for the beachfront properties, although do not prevent beach erosion as can be seen in *Figure 28*. This photo was taken after large storms in 2007, and as can be seen, the beach has been heavily eroded. They do, however, prevent erosion occurring past (landward from) the rock protection, therefore protecting beachfront residences and their foundations.

*Figure 28* – Exposed rock walls at Collaroy-Narrabeen Beach, 28 July 2007 (Worley Parsons 2011)

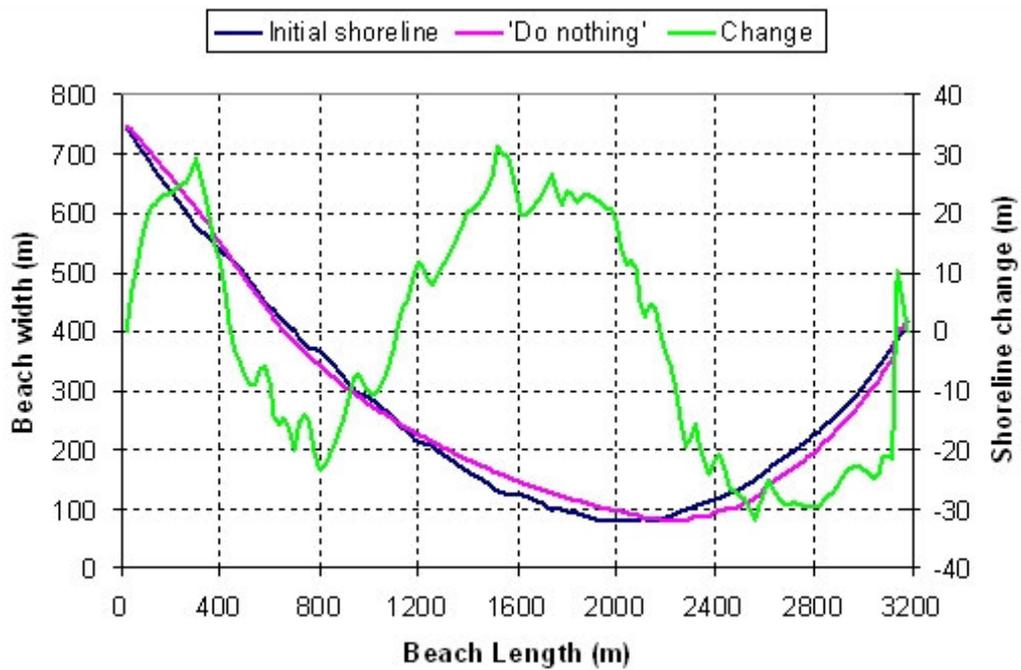
a shoreline change of -32m, and in doing so push the Mean High Water Mark Westward towards the right-line boundaries of the private properties.

Figure 29 – The ‘do nothing’ scenario showing the initial and final shoreline positions and the degree of change (Acworth c. 2011)
