Investigation of Shunt Vehicle Derailments

ENG4112 Research Project

Bachelor of Engineering (Mechanical)

24 October 2013

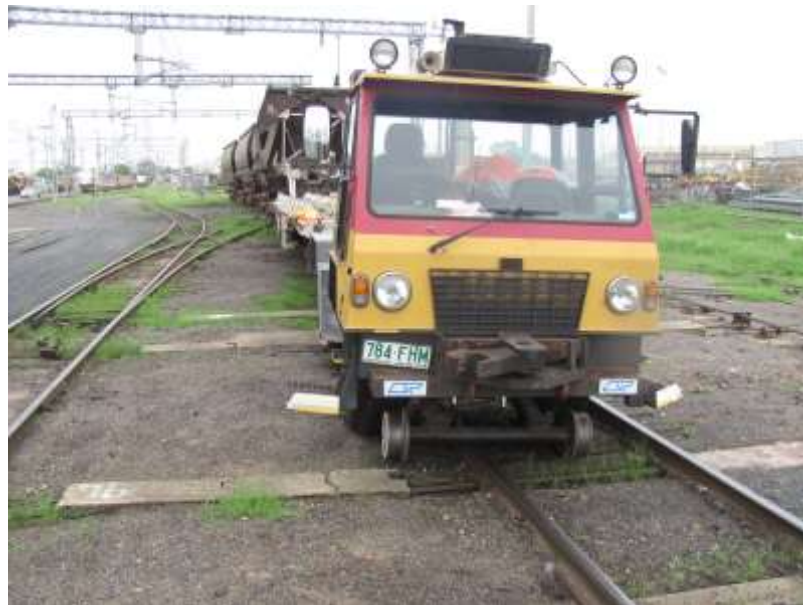
Figure 1-1: Derailment

- An incident in which one or more wheelsets run off the track

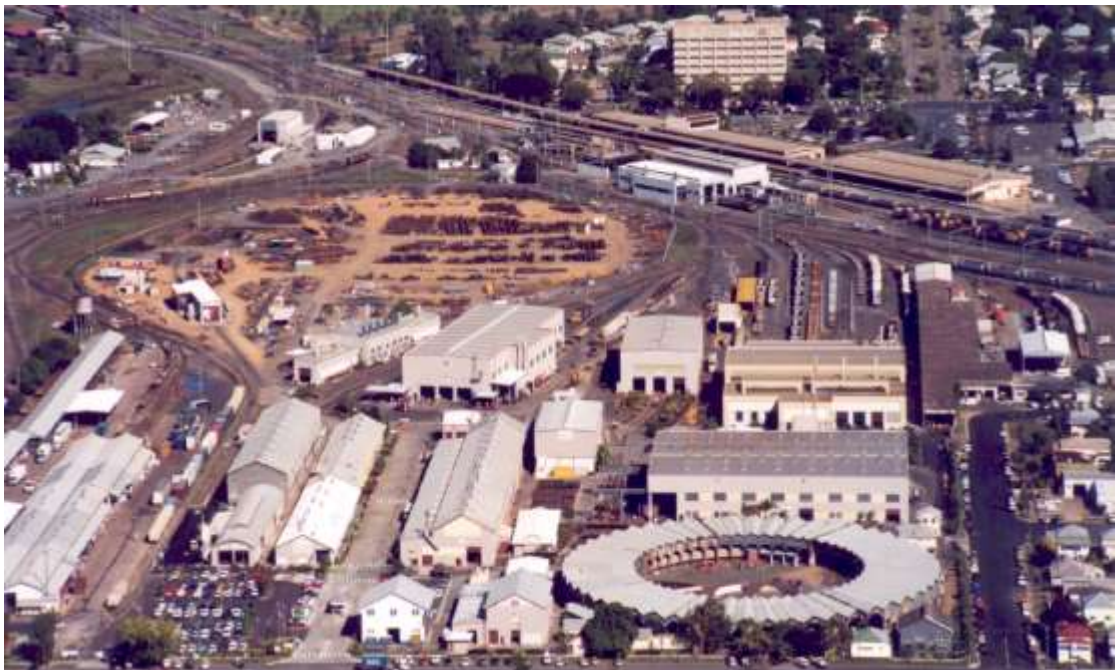
Figure 1-2: Workshop layout

The Aurizon Rockhampton Rollingstock Maintenance facility is a heavy repair workshop that is capable of carrying out repairs and modifications to locomotives, wagons and track vehicles. The workshops cover 3 hectares with the heavy lift sheds connected by rail lines as can be seen in Figure 1-2.

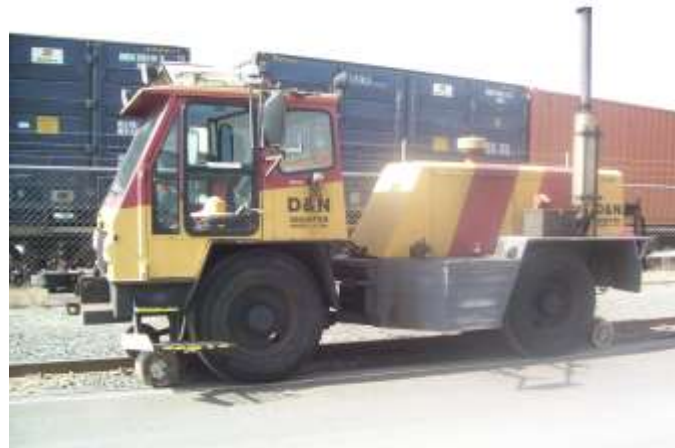
Figure 2-1: DN 300

The D & N Shunters, models DN 100 and DN 300, are a rubber tyred articulated steer purpose built tractors suitable for both on rail or off rail travel. For on track operation small diameter hi-rail wheels are lowered to engage the track and provide guidance on track whilst the rubber tyres provide vehicle support and traction. The vehicles rated shunting capacities are, 300 tonnes on rail for the Model DN-300 and 100 tonnes for the Model DN-100; subject to reductions for speed, weather conditions and grades. The D & N Shunters can be registered for on road travel and can be operated on the rail or road at speeds up to 30 kph. The DN 100 and DN 300 are illustrated below with the specifications for the two machines given in Table 2-1.

When driving on road the hi-rail wheels front and rear are lifted and held in the raised position. When on rail operation is required the machine is driven to a suitable level crossing and the machine is aligned with the rails. The front hi-rail wheels are lowered to ensure flanges are engaged between the rails. The machine is then driven forward to ensure the rear hi-rail wheels are above the rail and then they are lowered ensuring the flanges are engaged between the rails. The steering lock out is switched to lock so there is no articulation in the vehicle and the machine is ready for on rail use. During on rail operation the machine operates in four wheel drive.

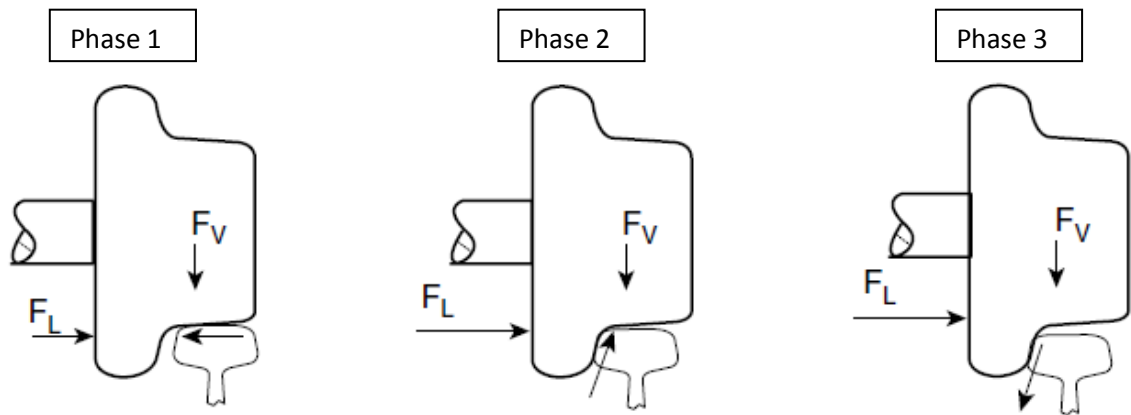
Figure 2-5: Flange climb process (Wu & Wilson 2006)

The first phase, left hand illustration, the wheel is under a lateral force and the wheel moves right initiating flange contact with the rail. A lateral creep force is produced and acts on the wheel to oppose flange climb. The second phase the flange contact angle is increased and the wheelset lateral velocity decreases. This results in the lateral creepage and creep force reversing direction due to the change of sign of the effective angle of attack; the lateral force is assisting the wheel to climb. Once the maximum contact angle has passed, the wheelset lateral velocity increases resulting in rapid lateral displacement of the wheelset. This results in the effective angle of attack approaching zero and changes sign. This leads to the lateral

creepage and creep force changing direction and the lateral creep forces now oppose the wheel climbing motion, as shown in phase 3.

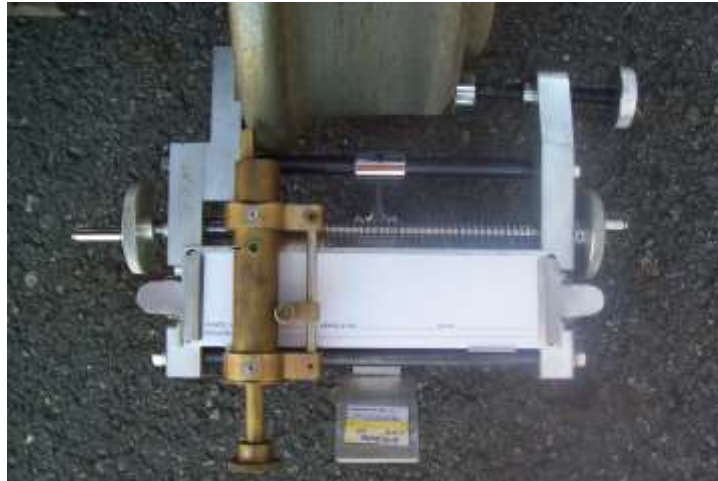
Figure 3-1: Profile recording device

The hi-rail wheels have the same profile as locomotives and wagons, the LW-3 profile, but as the hi-rail wheels have a diameter of 220mm they are far smaller in diameter than the wagon or locomotive (minimum 660mm and 1040mm respectively) wheels so they do more revolutions per unit length and therefore wear more quickly. As flange angle can contribute to flange climb the hi-rail wheel profiles were checked using a purpose built recording device at regular intervals; usually fortnightly. The wheel profile recording device is shown in Figure 3.1. The device is basically a tracing apparatus that clamps to the wheel. The device consists of a clamp assembly, a sprung loaded moveable point, a stylus in the form of a ball point pen, a recording sheet and thread to move this assembly across the wheel profile. The stylus is attached to the sprung loaded moveable point and as the point is moved across the tread the profile is recorded on the recording sheet.

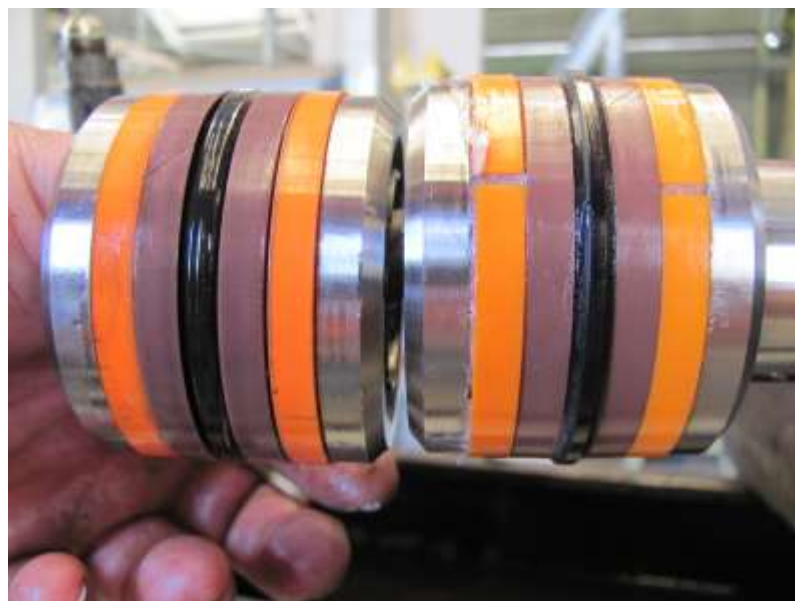
Figure 4-1: Steering ram seals

To try and establish the cause of the creep in the vehicle alignment the hydraulic steering rams were removed and dismantled. Inspection of the ram components found that the seals in one hydraulic ram were not full size. Either undersize seals had been fitted to the piston or the seals were worn and hydraulic fluid was passing the piston allowing articulation of the machine. Figure 4.1 below shows the worn seal on the left. As the steering rams operate together it is unlikely that only one ram should be affected with wear therefore it is probable the incorrect seals were initially installed on the piston. The seals were replaced in both steering rams and repeatability of the alignment was obtained. However during recent operations there is once again a drift in the alignment. The operators report that after repeatedly negotiating several curves during shunting and then when on a straight track again when the alignment function is activated there is noticeable movement in the machine as it aligns. This has not as yet been investigated but it appears the constant negotiation of curves in one direction maybe placing additional pressure on the steering rams causing hydraulic fluid to bypass the seals.

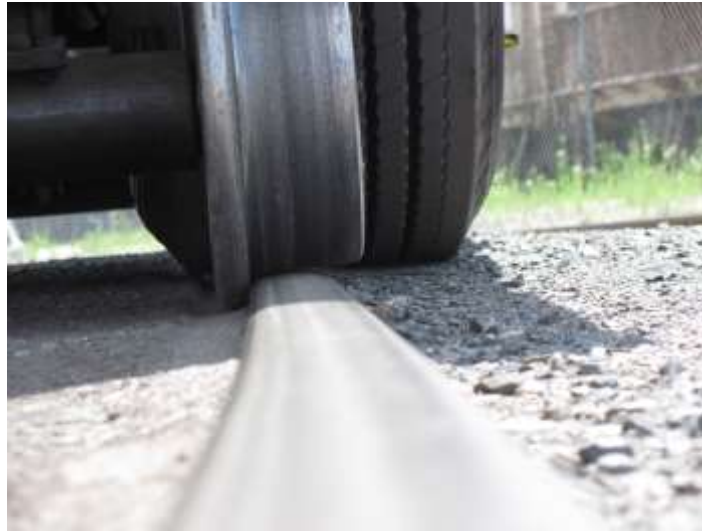
Figure 4-3: Tyre supported by roadway

In Section 2.9 NARCOA reported that grade crossings and turnouts present hazards to hi-rail vehicles due to the highway tyres riding up on the pavement, Figure 4.3, causing the lift off of the hi-rail wheels.

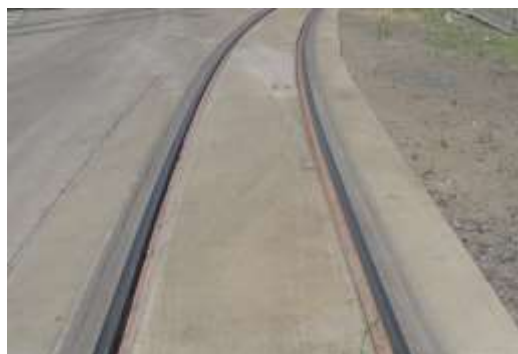
Figure 4-4: Pre- concrete cutting

A section of curved track within the workshops yard runs through a concreted roadway where the top of the rail is level with the top of the concrete. There have been numerous derailments along this section of track, the cause of which is likely to be hi-rail wheel lift off or reduced vertical force due to the highway tyres riding high. To try and counter this issue the concrete has been relieved each side of the rail so that no part of the rubber wheels touched the concrete, refer Figures 4.4 & 4.5. Since the concrete has been removed from each side of the rail there have been no further derailments in this section.

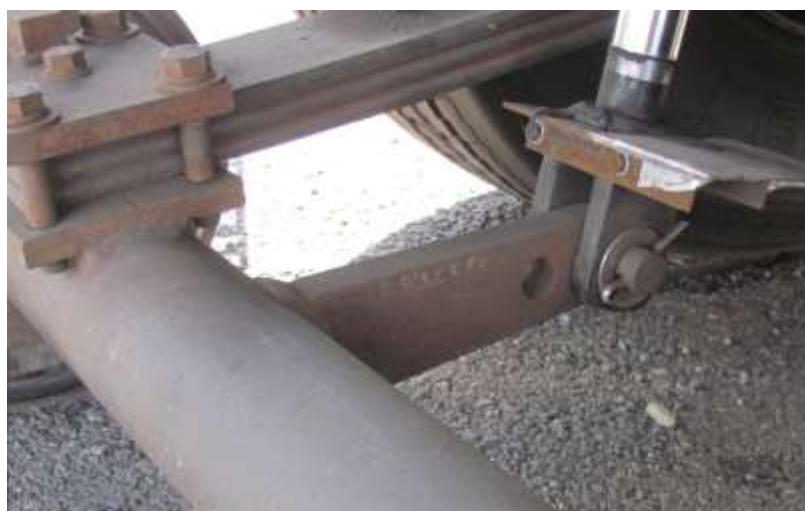
Figure 4-6: Hi-rail lift ram attachment points

The primary objective of weighing the DN 300 was to obtain the wheel weights of the hi-rail wheels on the rail. To facilitate the connection of the lift rams to the hi-rail axle there are short levers welded to the axle. These levers have two holes where connection can be made, refer Figure 4.6. Machine weights were taken for both pin positions; the weights are displayed in Table 4.1 below.

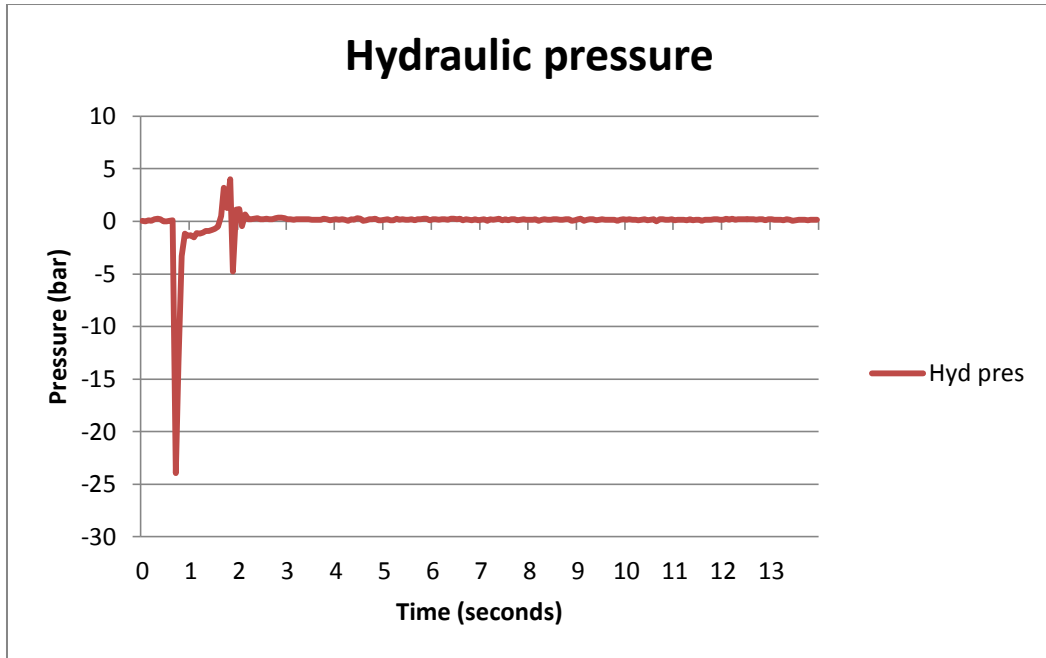
Figure 4-10: Hydraulic pressure fluctuations

The loss of pressure in the hi-rail system is most likely due to a faulty pressure reducing valve. The maintenance fitters on site that service the DN 300 advise this particular valve was replaced many years ago; the reason for replacement is unclear but based in this information it appears there may be a valve reliability issue. The present pressure reducing valve in the hydraulic system is an adjustable type with a pressure range of 14-85 bar. As the required system pressure is 33-34 bar the present valve is operating in the bottom half of the range. Parker Hydraulics valve catalogue states 'You want to choose the setting that best meets the operating range'. A pressure reducing valve with an operating range of 7-40 bar, such as the EATON PRV1-10-S-0-12/4.5 would be closer to the operating range.

To ensure the pressure loss was not caused by dirty or substandard hydraulic fluid a sample of the fluid was sent to a condition monitoring laboratory for analysis. The laboratory confirmed the hydraulic fluid was satisfactory thereby ruling out inferior hydraulic fluid being the cause of pressure loss. The laboratory report is contained in Appendix F.

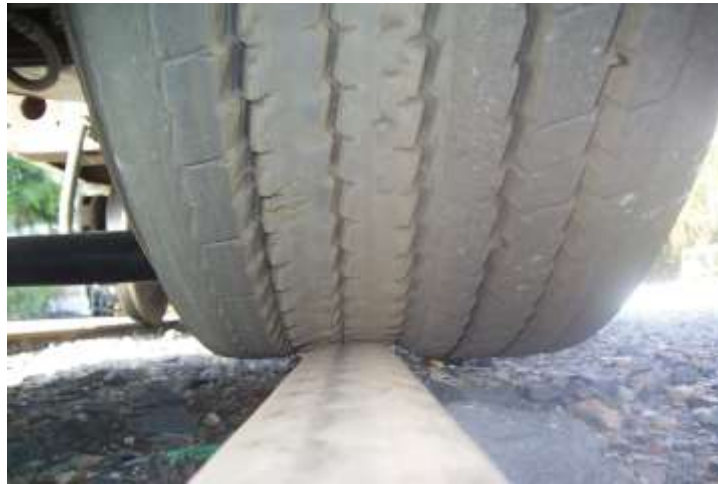
Figure 4-12: DN 300 tyre wear

become sufficiently deep the sliding across the rail becomes more difficult if at all possible. If the tyre does not slide across the rail but remains running in the groove there is an increased lateral force applied to the hi-rail wheels as the rubber tyres tend to follow the rail. This increased lateral force will be in addition to any existing lateral force and could result in the total lateral force being greater than the vertical force on the wheel.

Varley, the company who bought out the original manufacturers of the DN shunters was contacted in relation to the tyre issues and their response was to reduce the inflation pressure. The tyre pressures were reduced and the machine was trialled. The reduced tyre pressures were not successful as the tyres deform and slide off the rail head when cornering. Freighquip advised they had similar experiences with lower tyre pressures and tight radius corners. At the reduced pressures there was evidence of interference between the vehicle chassis and the side wall of the tyres. The tyre pressures were returned to maximum shop air pressure of 105 PSI; less than the maximum allowable tyre pressure but found to be a satisfactory operation pressure.

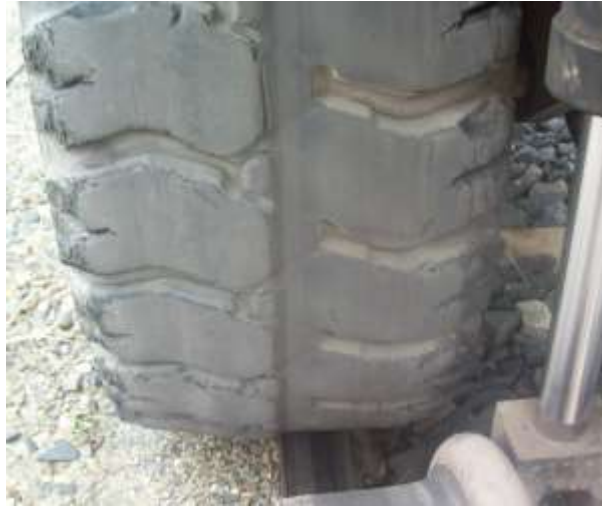
Figure 4-13: DN 100 tyre wear

It is difficult to quantify how much extra lateral load is placed on the hi-rail wheel in cornering as a result of operating with grooved tyres but the derailment issues with the DN 100 were eliminated by replacing all rubber tyres on the machine. Although DN 100 is a lighter machine and the wear on the tyres was more a raised line in the tread it highlights the fact that tread profile can be affect the lateral force on the hi-rail wheels. The DN 100 tyre wear is shown in Figure 4.13.
