University of Southern Queensland

# **Accuracy of a Machine Guided Grader**

**Bachelor of Spatial Science**

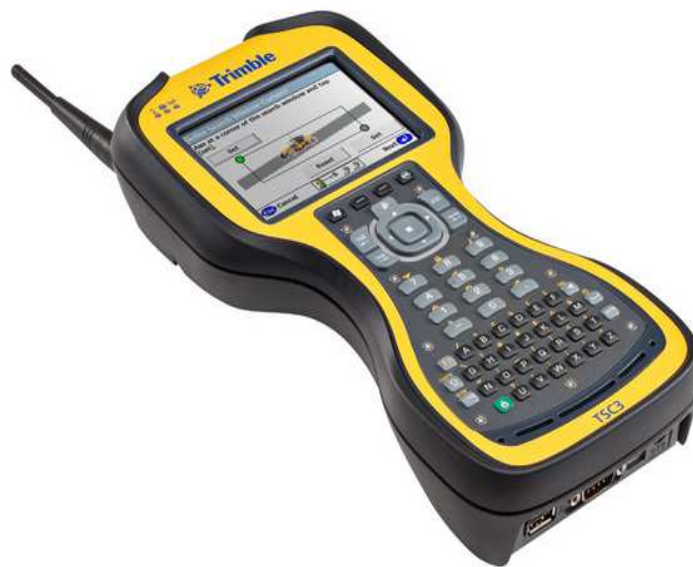
Figure 7-1 Trimble TSC3 Controller

The SCS900 software is installed on a Trimble Handheld controller called a TSC3. Trimble.com describes “the controller as a ground-breaking handheld field computing solution that streamlines the flow of everyday surveying work and the number of peripheral devices you need in the field” (Trimble, 2010b). The controller will run the software and act as a storage device for all the required survey files design and as-constructed. It is shown in the image below (Sitech).

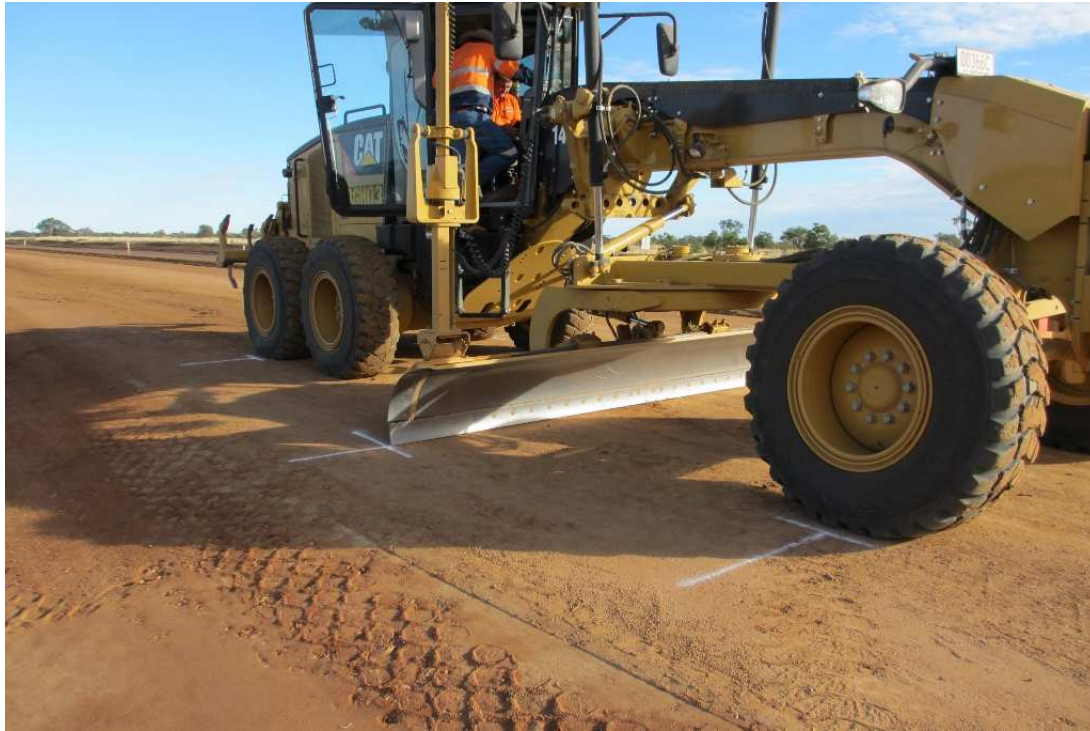
Figure 8-1 Trimble Guided Grader in Position 1 Landsborough Highway

So we positioned the grader on a relatively flat area ready to do a full mainfall, blade slope and rotation sensor calibration and followed through the above steps.

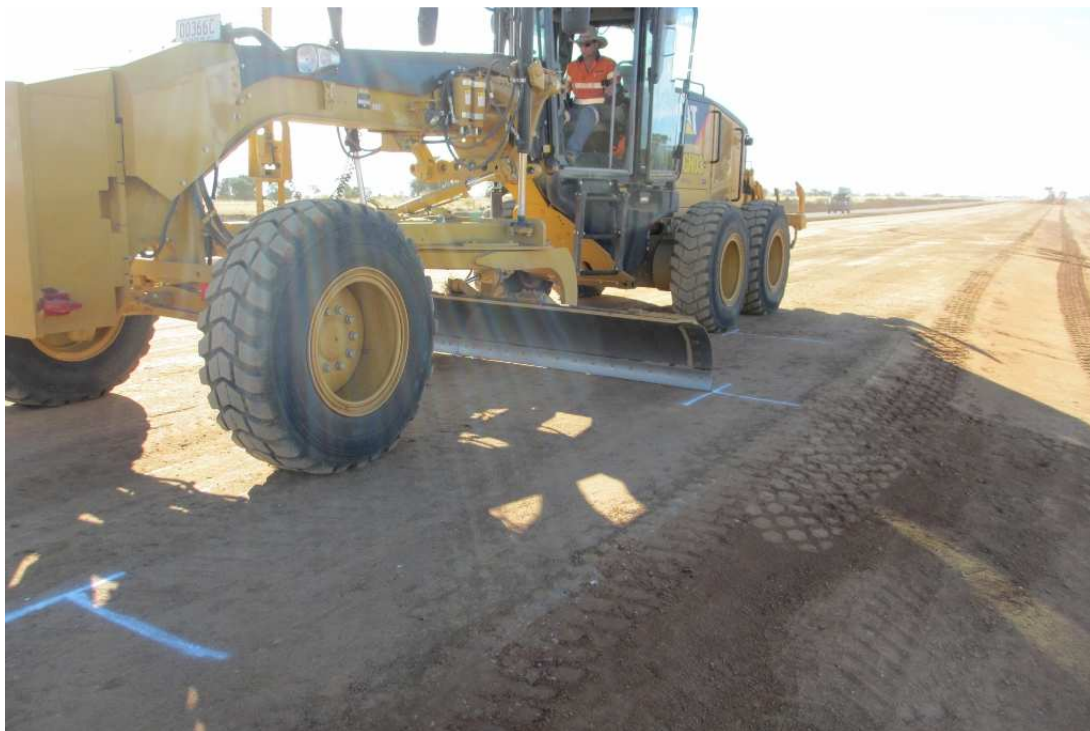
Figure 8-2 Trimble Guided Grader in Position 2 Landsborough Highway

After position one was recorded the grader was rotated 180° and moved into position 2 shown below.

After pressing continue, readings are taken calibrating the blade slope sensor. The blade is then lifted allowing the grader to move forward so that the tyre marks move onto position 3. After pressing continue in position 3 the mainfall sensor is calibrated completing the process.

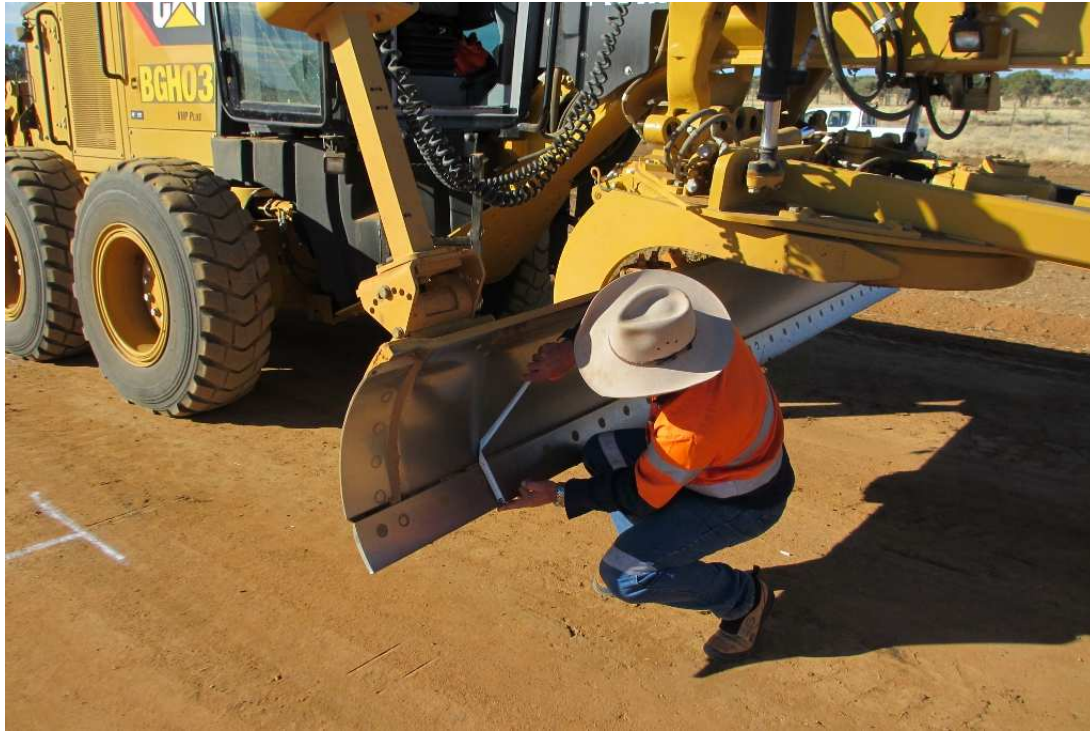
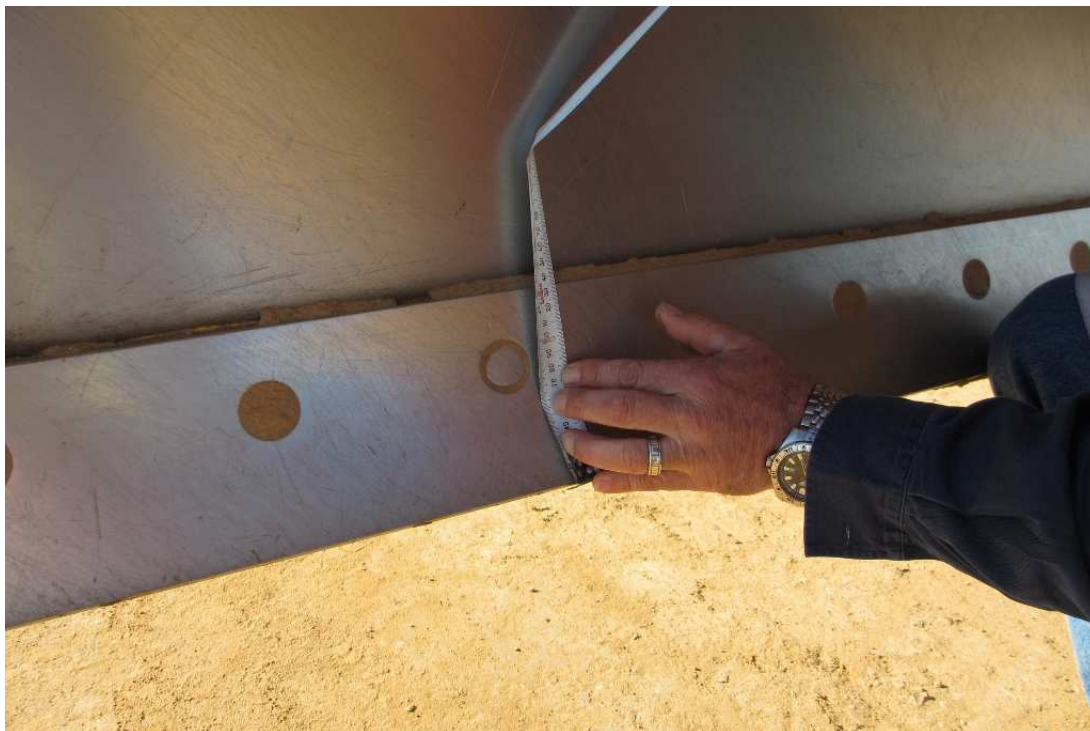
Figure 8-3 Measuring Blade Wear Landsborough Highway

The cutting blade of a grader is one of the most important parts of the machine, as it's the cutting edge of the grader that does the final trimming. Part of the grader operator's job is to maintain the cutting blades of the machine through inspecting the blade for uneven wear and replacing the blade once it is worn. In addition to this a Trimble guided grader operator needs to regular measure the blade wear. A measurement is taken from the centre of the bolt to the cutting edge of the blade. John and I carried this out prior to testing and came up with a distance of 87mm. This is shown in Figure 5.8 and 5.9.

Every morning when the operator runs through his pre start checks he needs to inspect the blade and measure the blade wear. As there are days where blade wear can be up to 20mm over the course of the day. Especially where final trimming has occurred the previous day on a very hard surface.

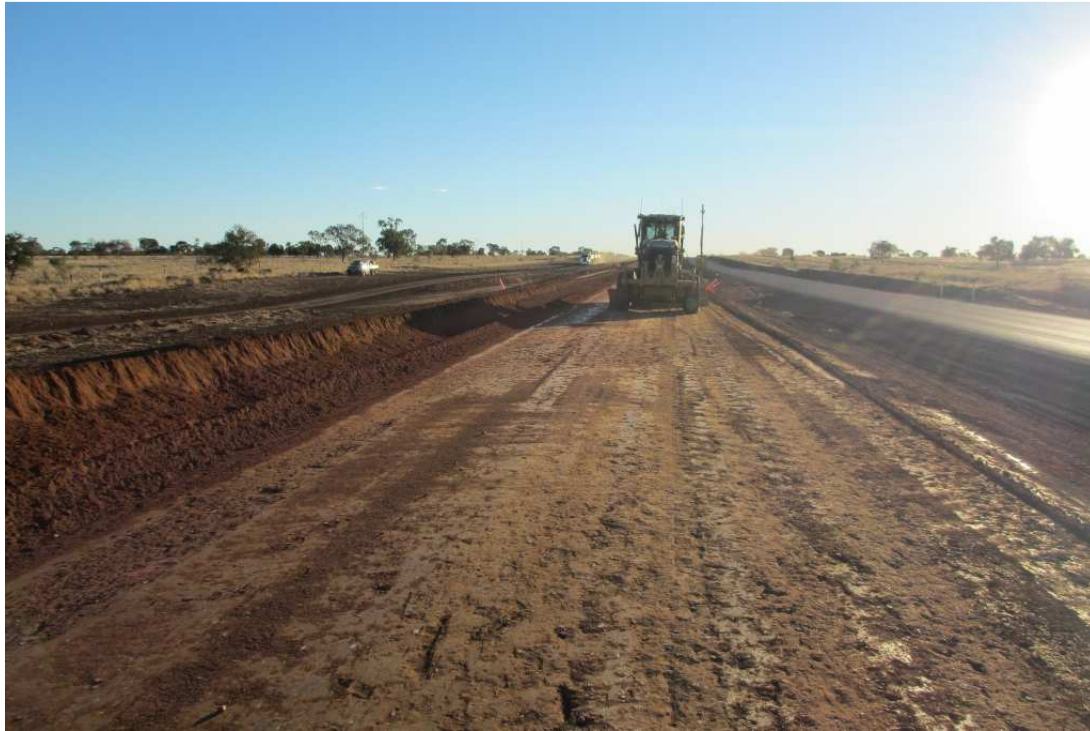
Figure 10-1 Field Test 1 Finished Surface Level

What we do know about Field Test 1 and Field Test 2 is that Field Test 1 was conducted on a stabilised road base material that is a mixture of cement and fine gravels. The product produced binds together quite well and is easily worked around with the grader to create a smooth even surface as shown in the photo below.

When Field Test 2 was conducted the product produced was more of a subgrade like material that didn't bind together as well so the opportunity for a smooth even surface was not quite as good. Unfortunately I don't have a photo showing this surface so differences can't be compared directly.

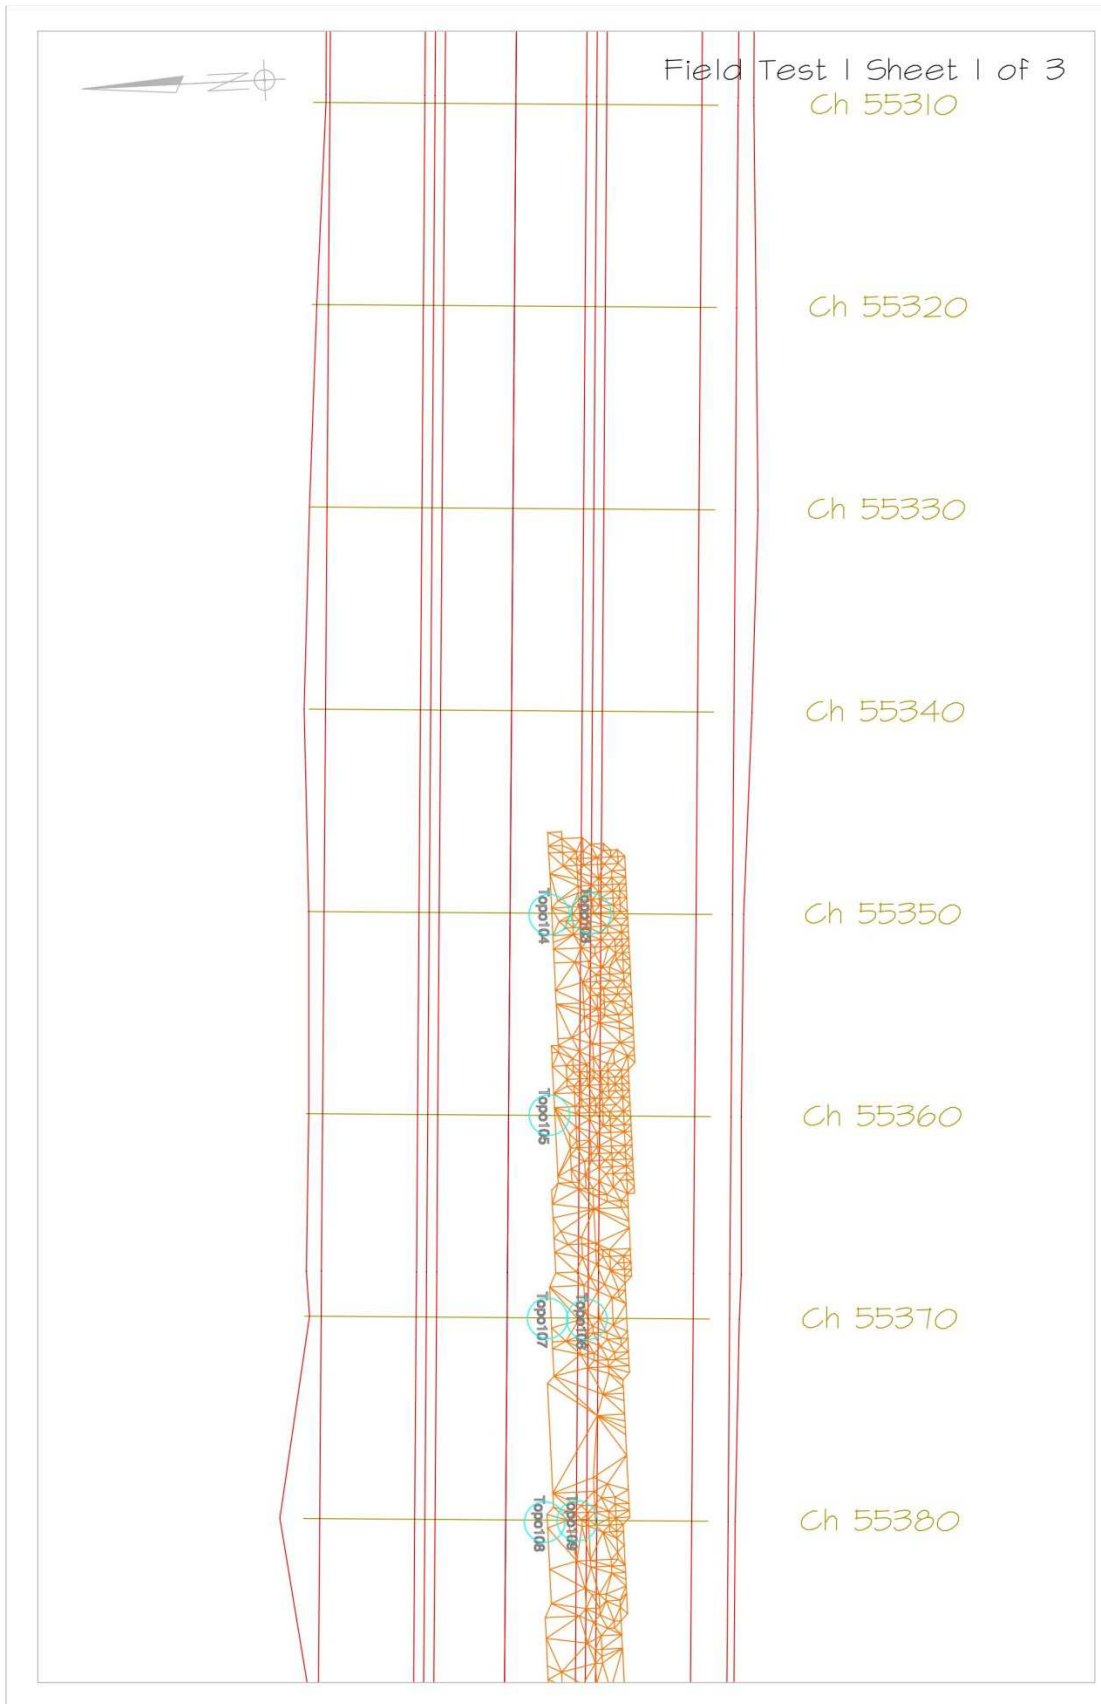
Plot showing TIN vs Surveyed Points

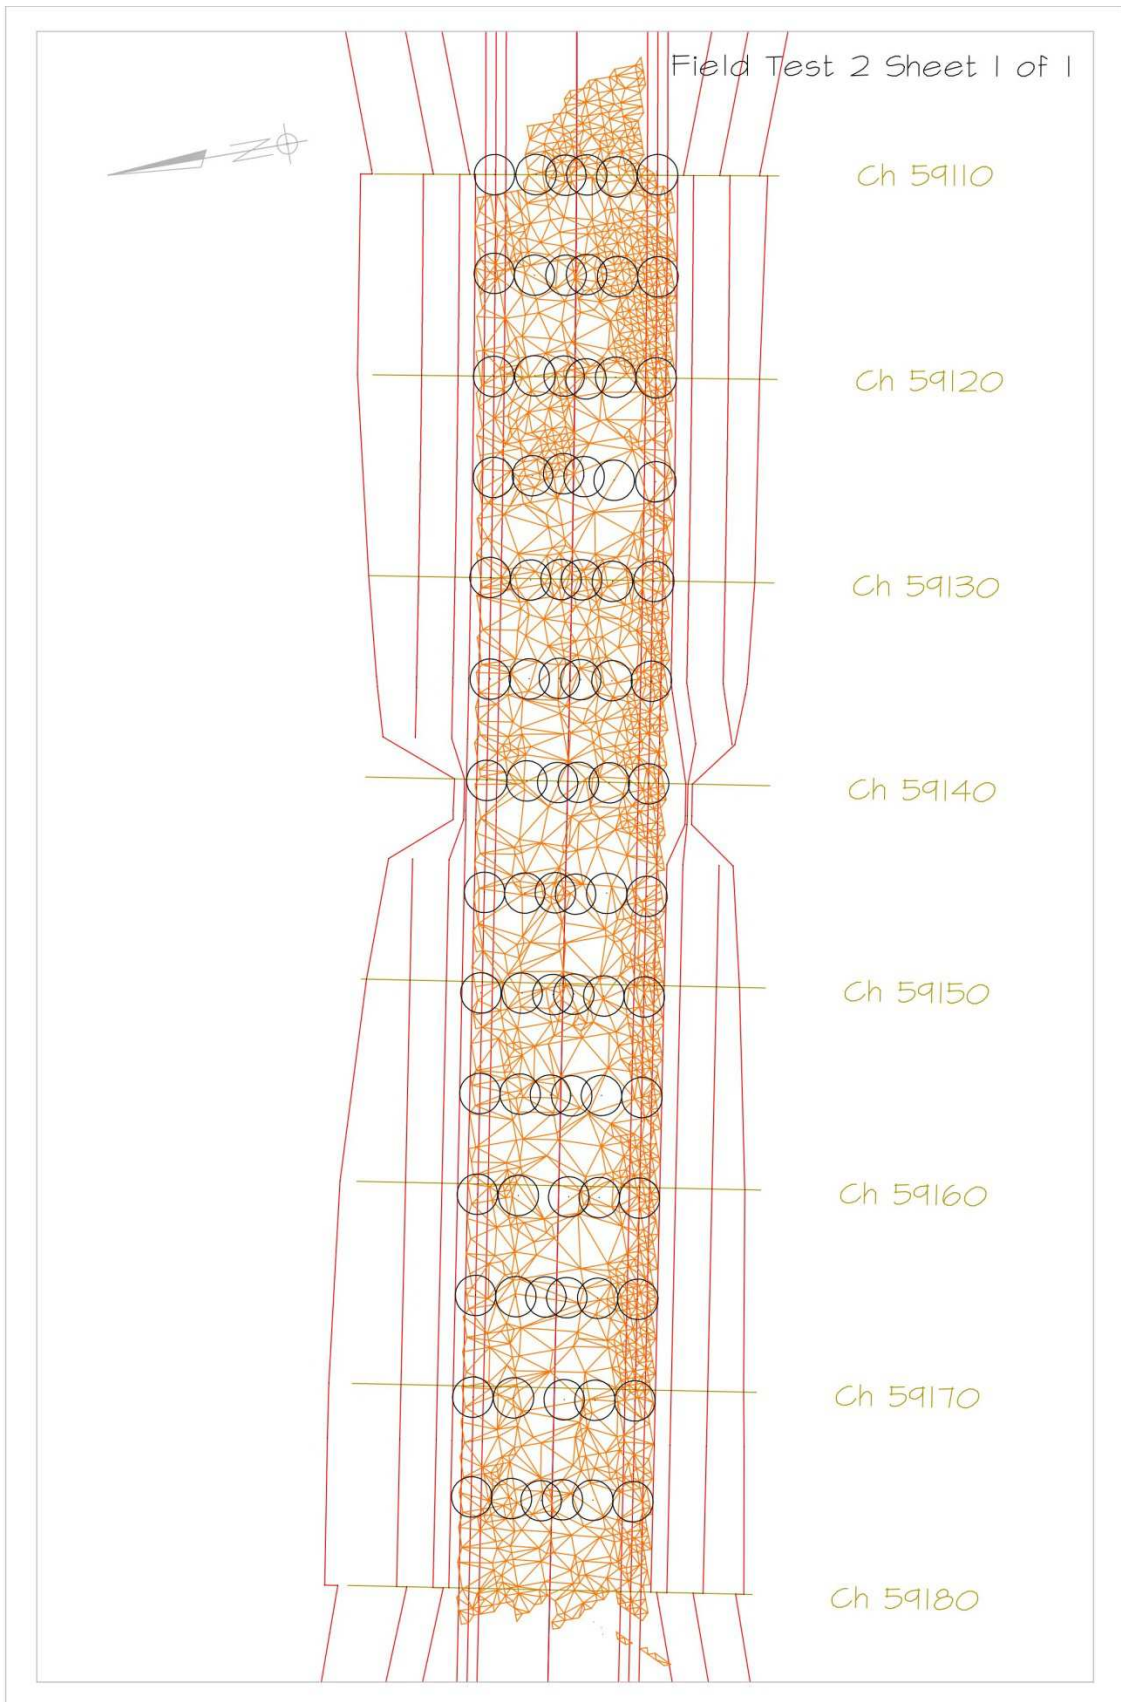
Plot showing TIN vs Surveyed Points
