University of Southern Queensland
School of Mechanical and Electrical Engineering

**USE OF FIBRE-OPTIC (FBG) SENSORS IN THE STRUCTURAL
HEALTH MONITORING OF A BATTLEFIELD HELICOPTER ROTOR
BLADE**

ENG4111 and ENG4112 Research Project

Bachelor of Engineering (Mechanical)

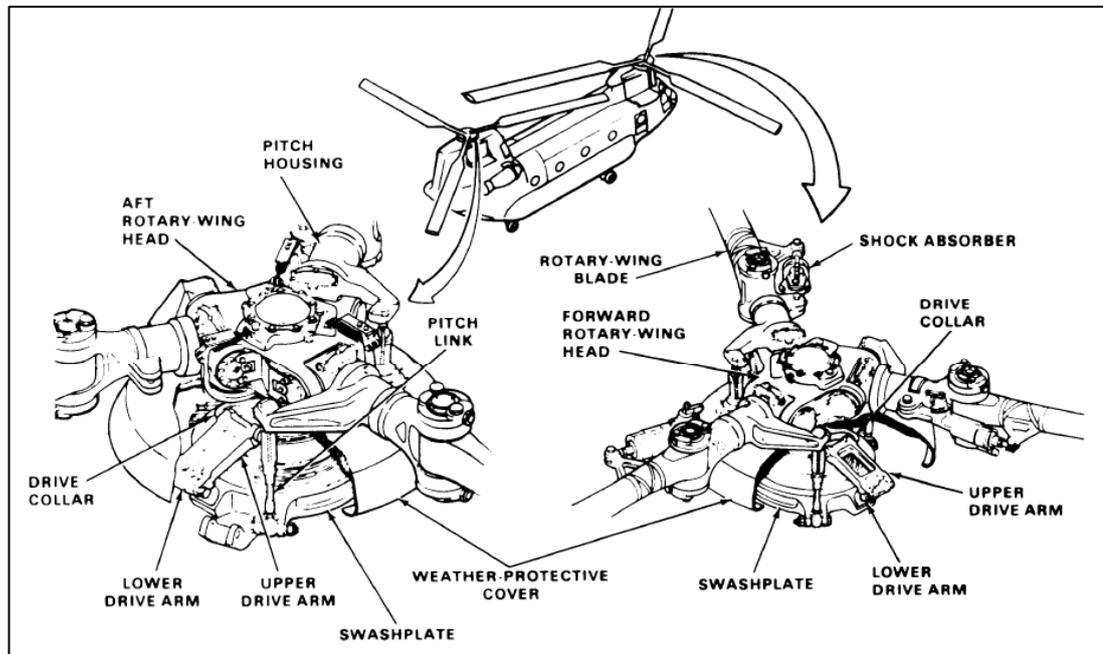
Following is a diagram depicting the CH-47 rotor head assembly. It details the blade roots ends attached to the pitch varying housing. NOTE: For brevity not all components in this figure have been discussed in the preceding text.

Figure 6. CH-47 rotor head assembly (Source: US Army 2002).

Mounted coaxially over the pitch-varying shafts are pitch-varying housings to which the lead / lag dampener is attached. This direct action shock absorber is attached to the blade and to the pitch-varying housing to control the rate of fore / aft movement of the blade. Each pitch-varying shaft is connected to the pitch-varying housing via a laminated, tie bar assembly. The high tensile strength and low torsional stiffness of the tie bar retains the blade against centrifugal force and allows the blade pitch to change about the pitch axis. Blade pitch changes are accomplished by three pitch-varying links connected from the rotating ring of the swash plate to the pitch-varying housing on each rotor blade (U.S. Army 2002).

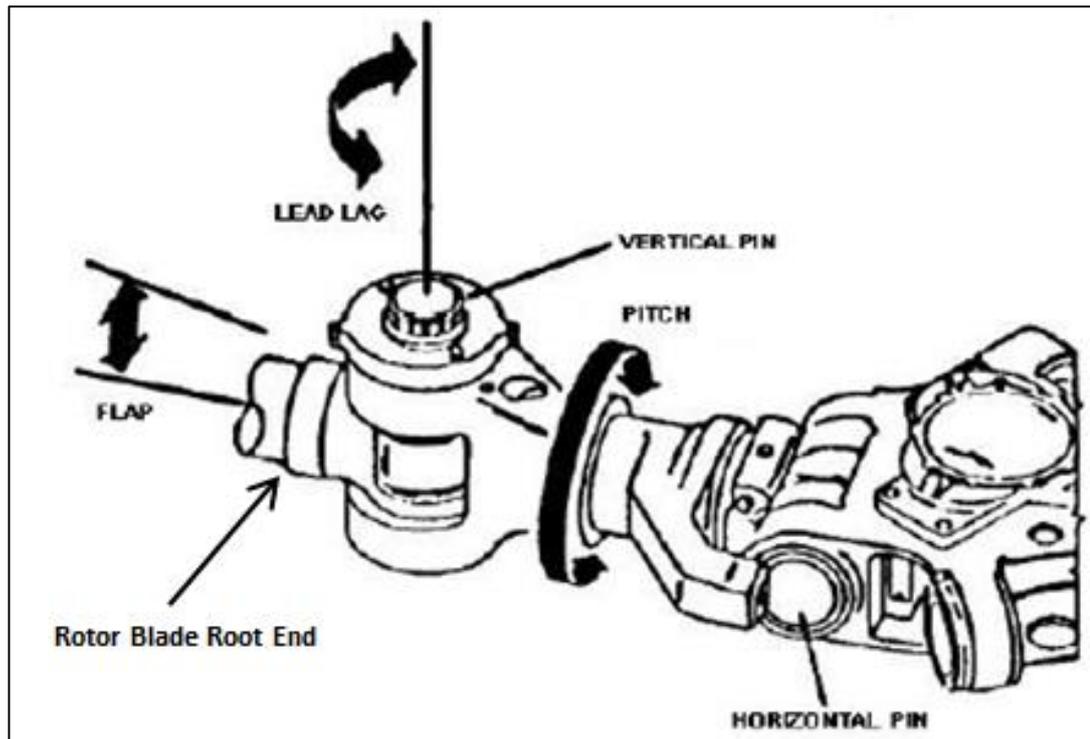
The following diagram details a forward rotor head depicting the pitch, flap and lead / lag axis. The rotor blade is attached to the rotor head at the vertical pin which also allows for the lead / lag movement.

Figure 7. Forward rotor head blade attachment (Source: US Army 2002).

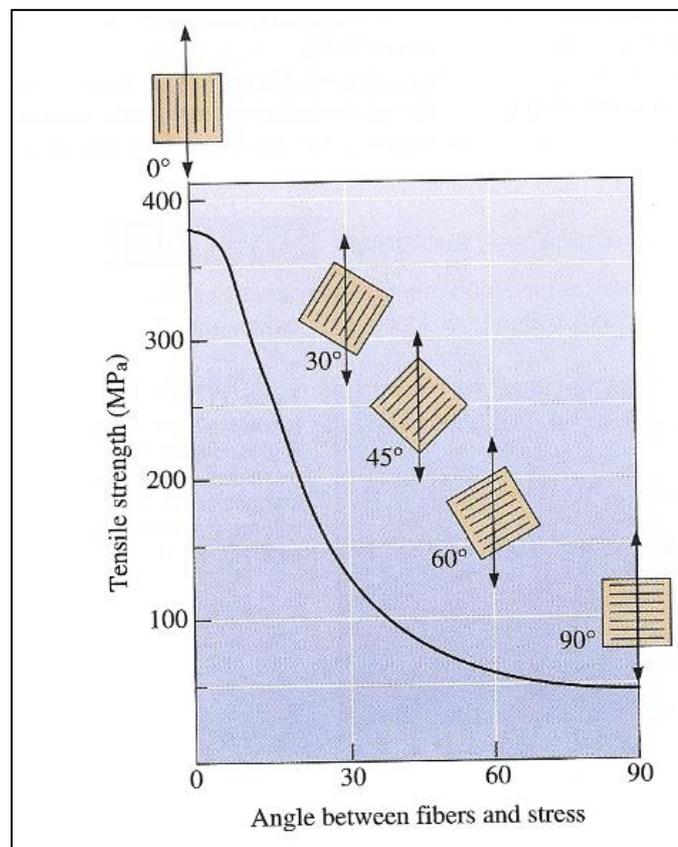
Tensile strength vs fibre orientation and stress for E-glass fibres reinforced with an epoxy matrix are presented below. It is easily seen that the maximal condition is achieved when the fibre is parallel to the load path.

Figure 18. Tensile strength vs fibre orientation and stress for E-glass fibres (Source: Askeland, P & Phule, P 2008).

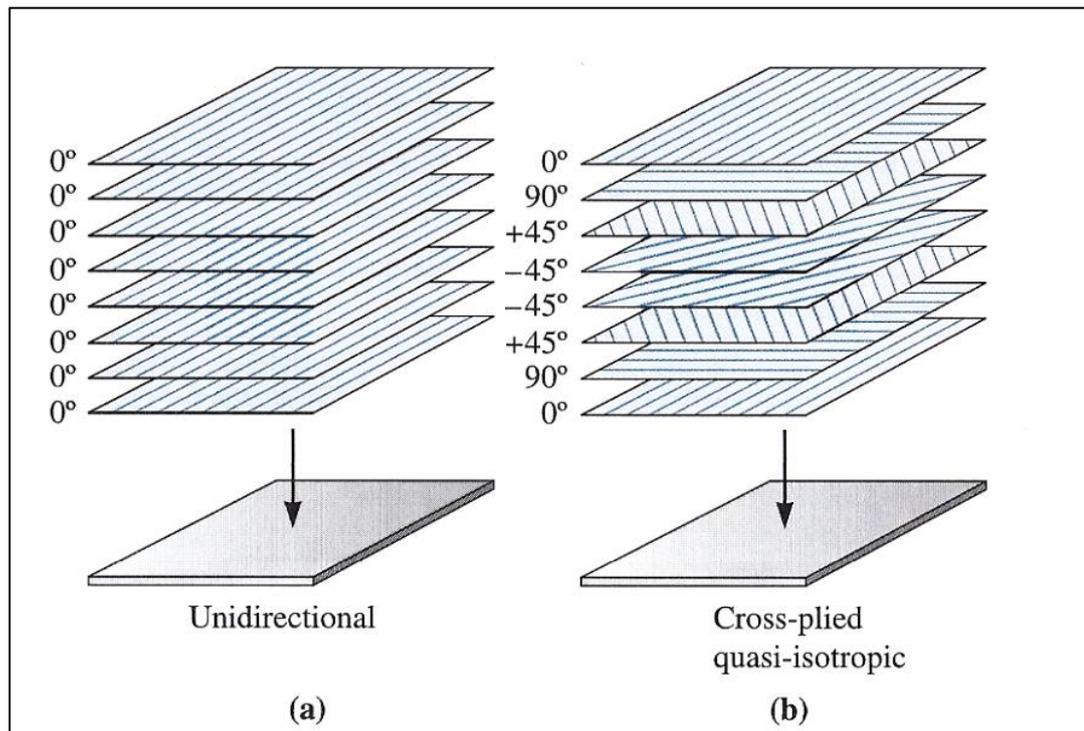
Fibre orientation of each individual layer is specified via an angle of either a positive or negative sense, from the primary fibre direction which is denoted as 0° . The following figure presents unidirectional plies (a) with aligned fibres which can be used to create multi-layered composite structures resulting in good strength in a unidirectional sense (0°). Whilst more complicated lay-ups (b) may provide strength in differing directions ($0^\circ/\pm 45^\circ/90^\circ$) depending on the fibre orientation, as in the case of the Ch47 D-spar and skin.

Figure 19. Unidirectional & multi-directional plies (Source: Askeland, P & Phule, P 2008).

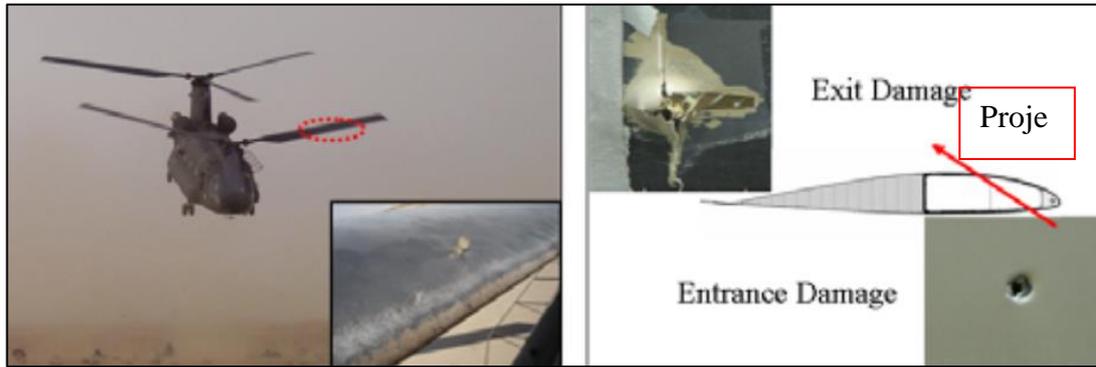
This is demonstrated by the following examples, in which it is observable that the projectile entry and exit of small arm fire may result in significantly differing damage profiles. This damage is to the D-spar of a CH-47 rotor blade, a critical area which traditionally would result in the discarding of the entire rotor blade. The differing nature of the damage between the point of entry and exit is also depicted.

Figure 21. Typical battle damage due to small arm fire (Cline C et al. 2011).

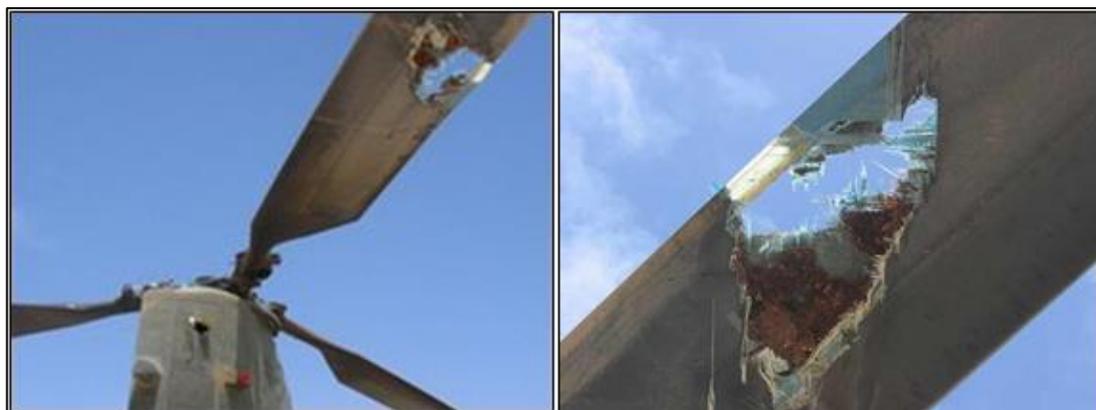
The following indicative picture is of the resultant battle damage from an RPG on a CH-47 Chinook aft rotor blade. Again, the irregular nature of the damage is easily observable and is at least in part a result of the composition of the material itself.

Figure 22. RPG damage to a CH-47 aft rotor blade.

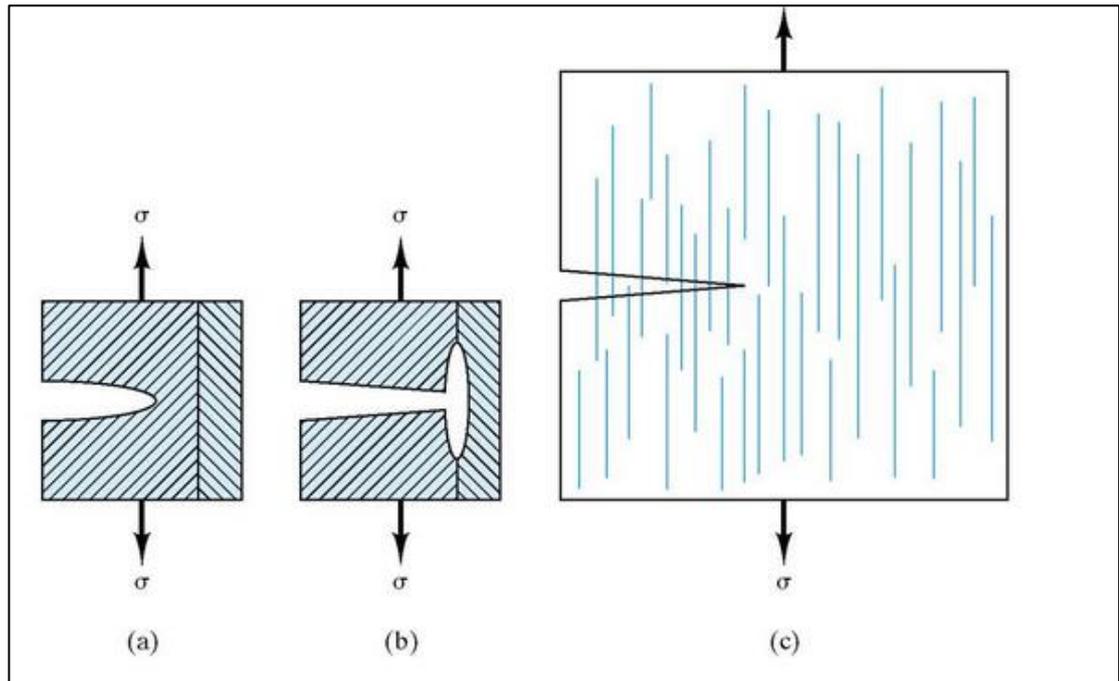
The following figure presents crack propagation through the matrix (a) evolving into a micro-delamination between the matrix and fibre (b) and eventual fibre fracture through multiply fibres (c).

Figure 23. Composite Crack propagation (Source: City college of San Francisco 2014).

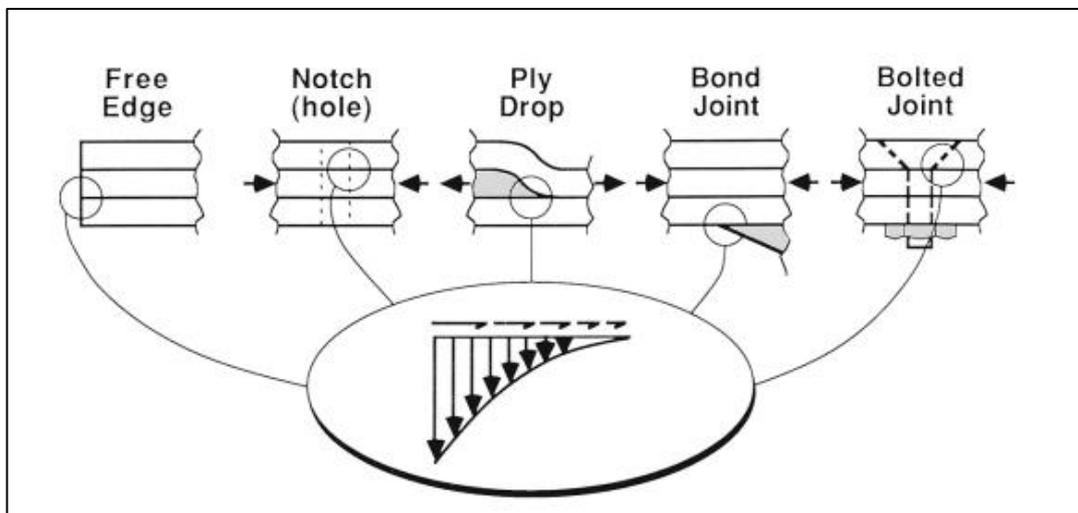
Structural elements which create interlaminar stress concentrations applicable to composite rotor blades include any irregular or rapid change in profile such as free edges, notches or mechanically fastened areas. Of particular interest to composite rotor blades are bonded joints and rapid changes in ply geometry such as drops or steps. Structural elements which create interlaminar stress concentrations applicable to composite rotor blades are detailed below.

Figure 24. Interlaminar stress concentrations (*Source: Mandell et al 2003*).

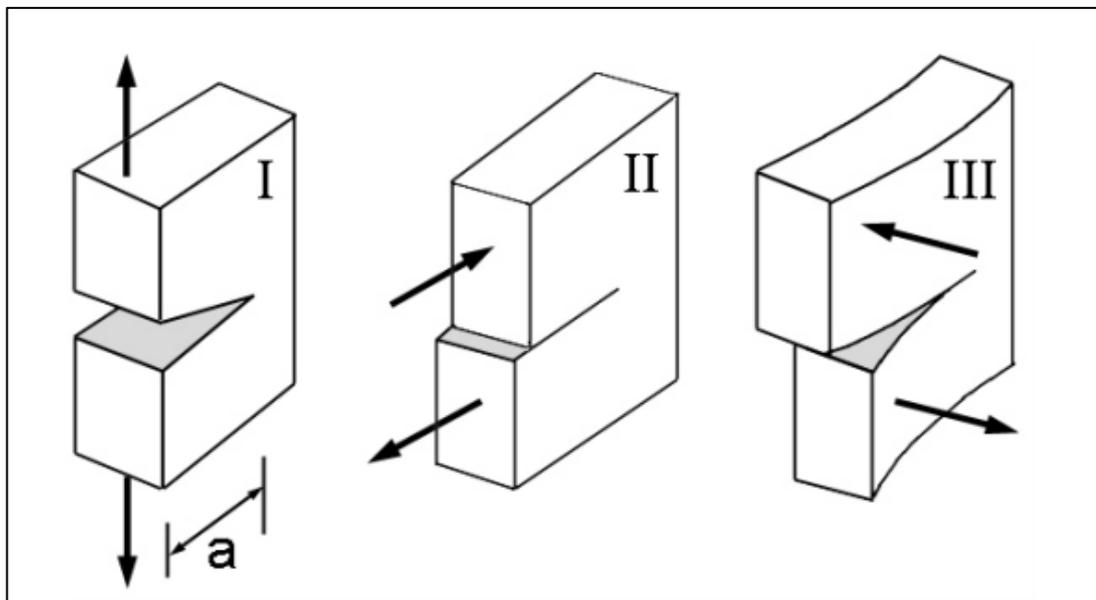
The three modes of laminate crack growth in composite structures, Mode I - opening, Mode II - sliding and Mode III – tearing are presented below. It should be noted that mixed-mode cracks are also common in many geometries.

Figure 25. Modes of laminate crack growth (Source: Mandell et al 2003).

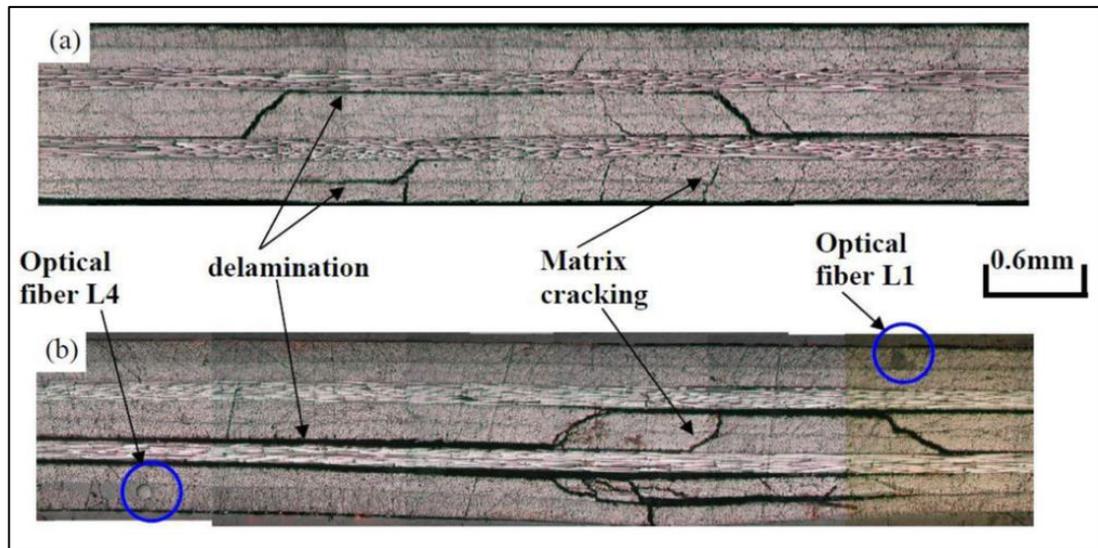
The following diagram illustrates the extent of post-impact damage to a matrix. It is an optical micrograph of a section of FRP detailing the positions of imbedded fibre sensors and the extent of post-impact damage matrix and delamination (a) immediately following impact, and (b) after 200,000 cycles have been applied.

Figure 26. Optical micrograph of impact damage (Source: Chow-Shing Shin 2014).

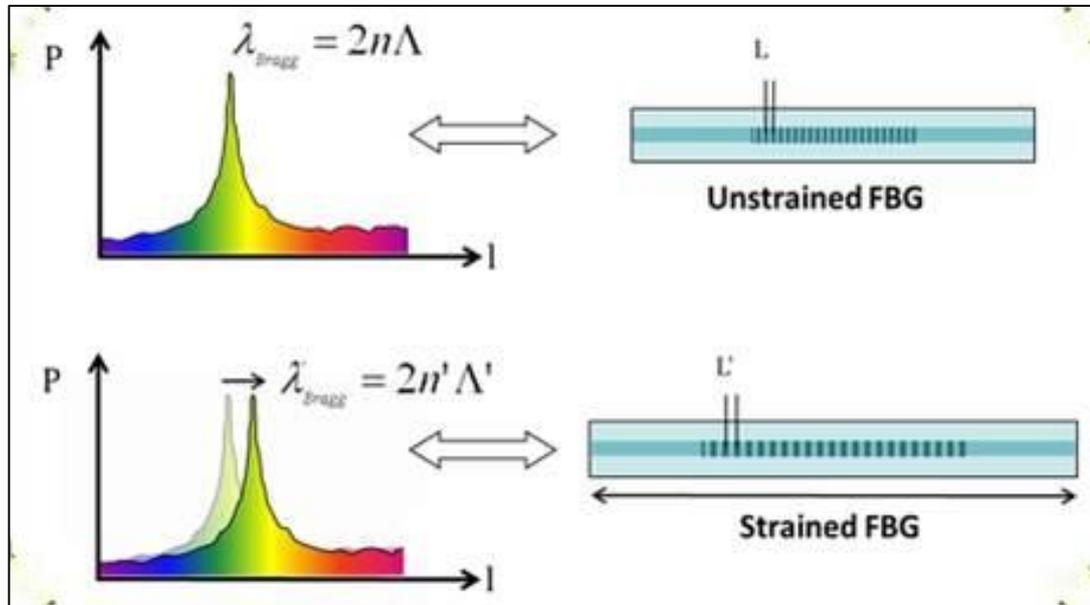
This shift in Bragg wavelength is a result of the physical deformation of the FBG and is equitable to the strain experienced by the sensor, which represents a change in reflected spectral response due to this physical deformation (lengthening or compressing) of the FBG. This is depicted in the following diagram.

Figure 31. FBG spectral response.(Wang 2005).

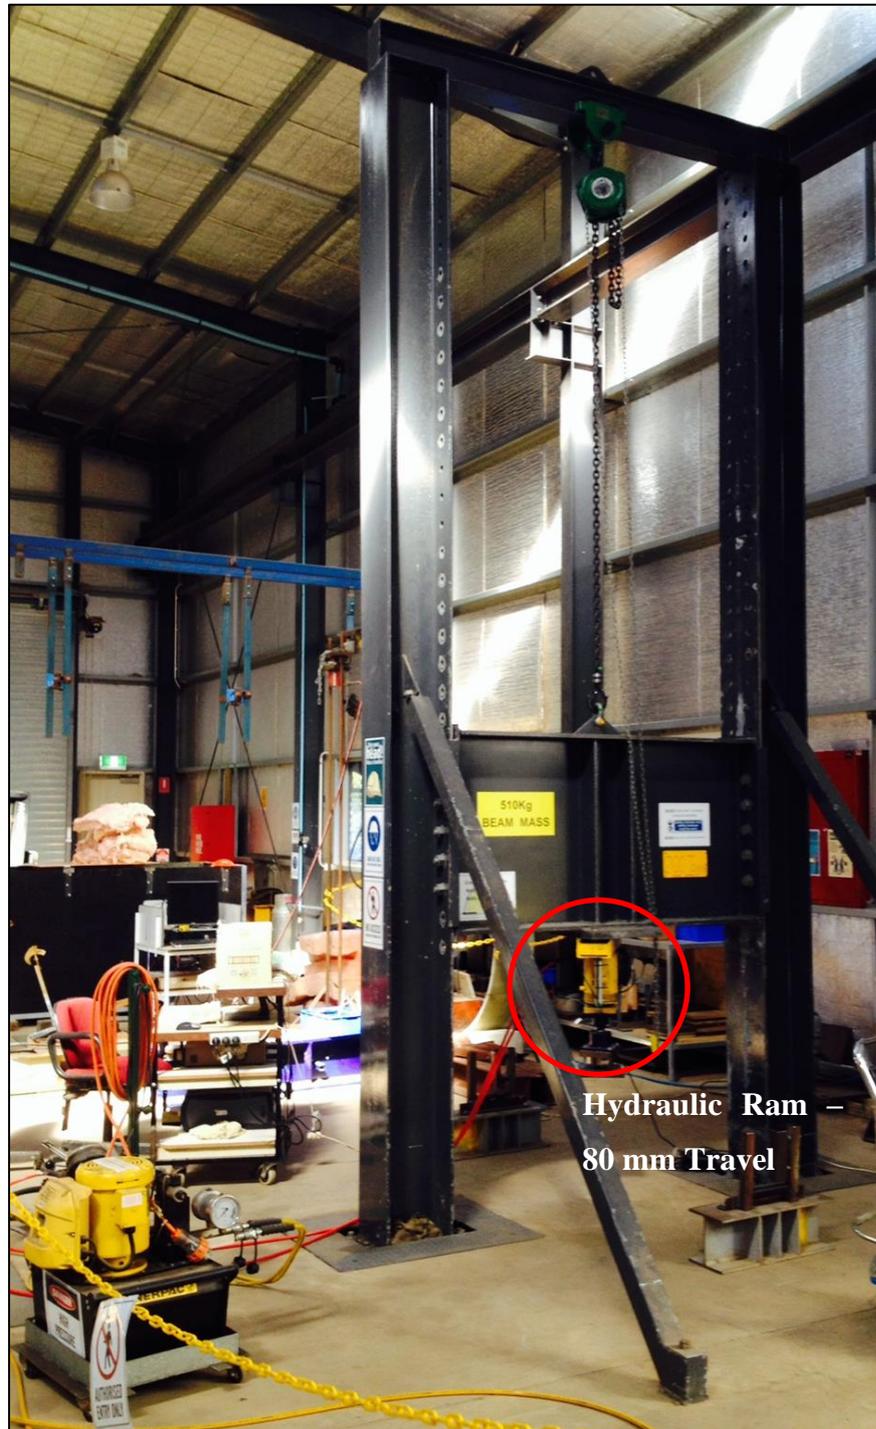
As can be seen this is a large testing press capable of applying significant downward force, as such the width and height constraints were determined as critical; however, low in risk given the physical internal dimensions of the testing press.

Figure 36. CEEFC 200 Tonne hydraulic test press (USQ CEEFC 2014).

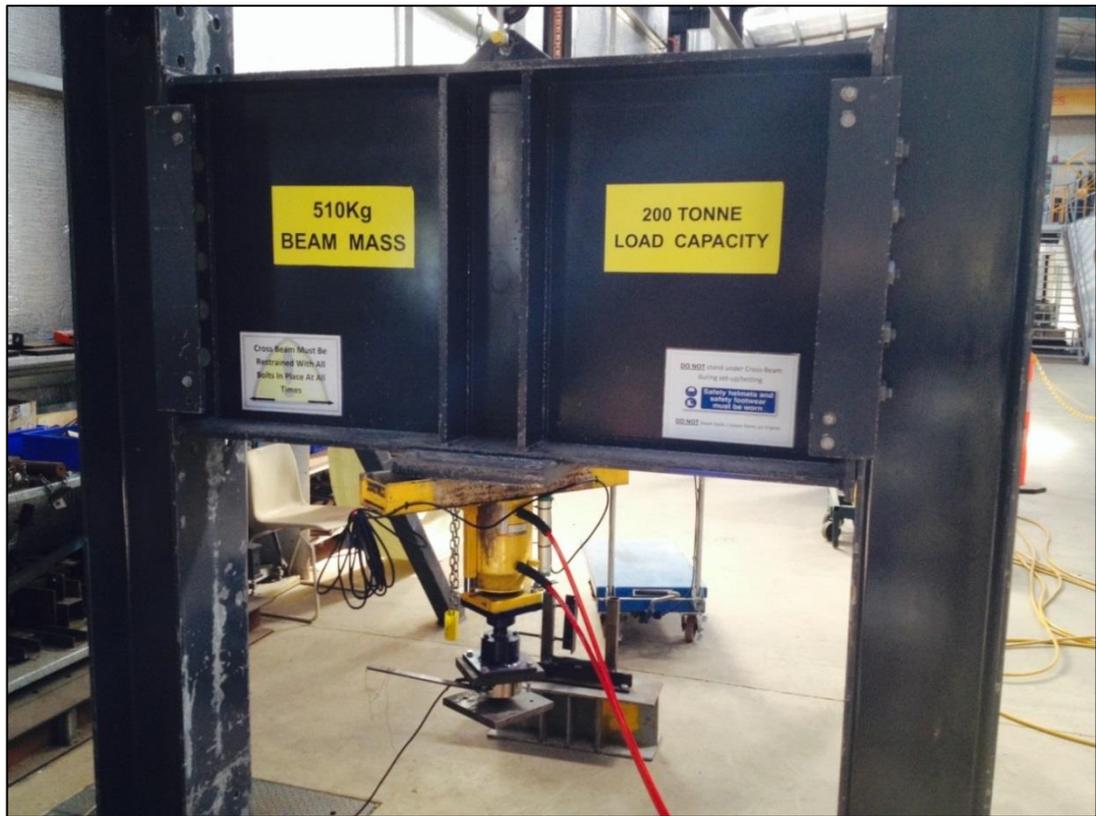
Figure 37. Hydraulic press cross beam (USQ CEEFC 2014).

It has an 80 mm travel limitation; however, bulk height adjustment may be achieved by moving the cross beam up or down as required by removing the bolts restraining the cross beam. A chain block was then used to adjust the beam height. The cross beam is depicted below.

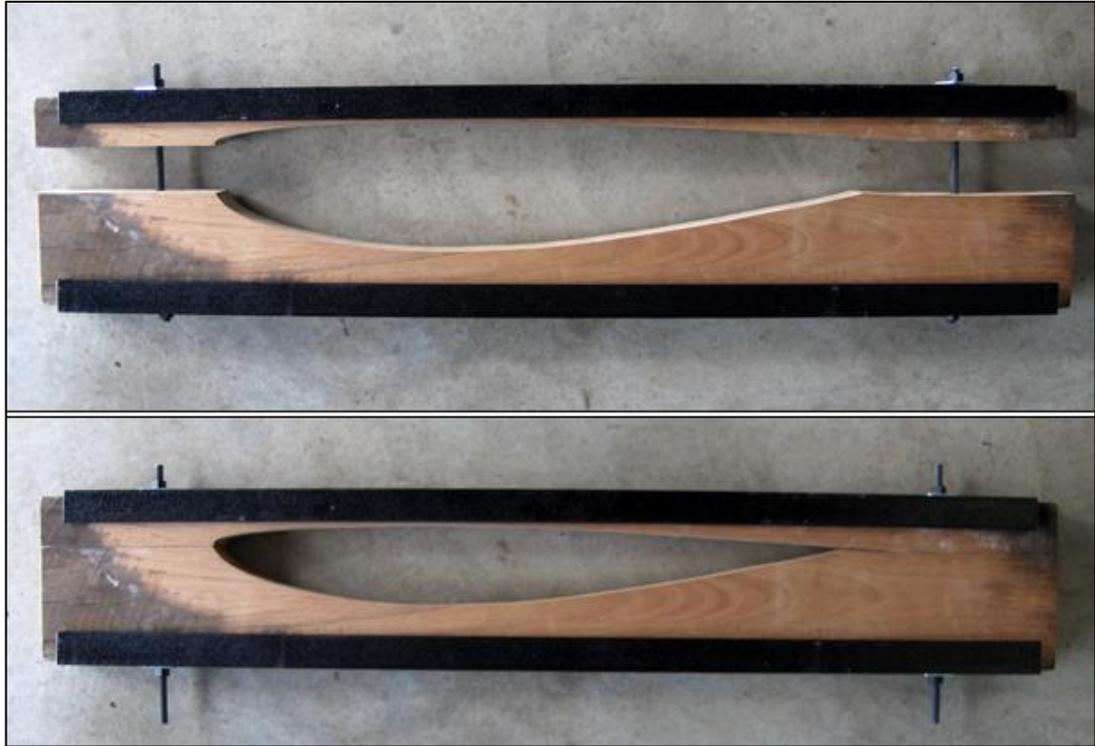
Figure 39. Root-end clamp sub-component.

The secondary function of the steel channel section is to allow for welding of the root-end clamp in a perpendicular orientation to the main support beam longitudinal axis.

The root-end clamp in both the open and closed position is depicted below.

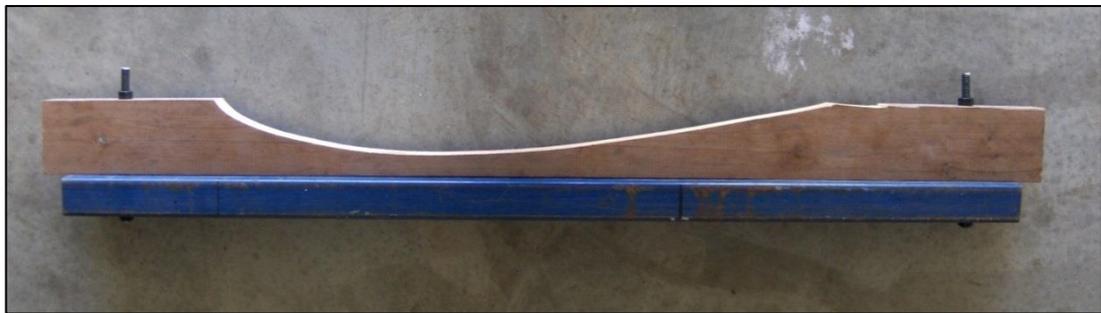
Figure 40. Lower adjustable support.

The support consists of an RHS section which supports and resists deflection of a cypress pine section profiled matched to that of the blades upper flight surface. This surface is orientated so it is facing downwards. The timber is attached to the RHS by two sections of M10 threaded rod and nuts, and 40 x 40 x 2.0 mm flat washers.

The cypress profile section, selected as it is softer than hardwood, was manufactured by accurately band-sawing the blade outer profile removing the unwanted material. This profile was then sanded with a barrel sander to obtain a smooth, consistent profile free from stress raisers or appreciable, sudden changes in form as depicted below.

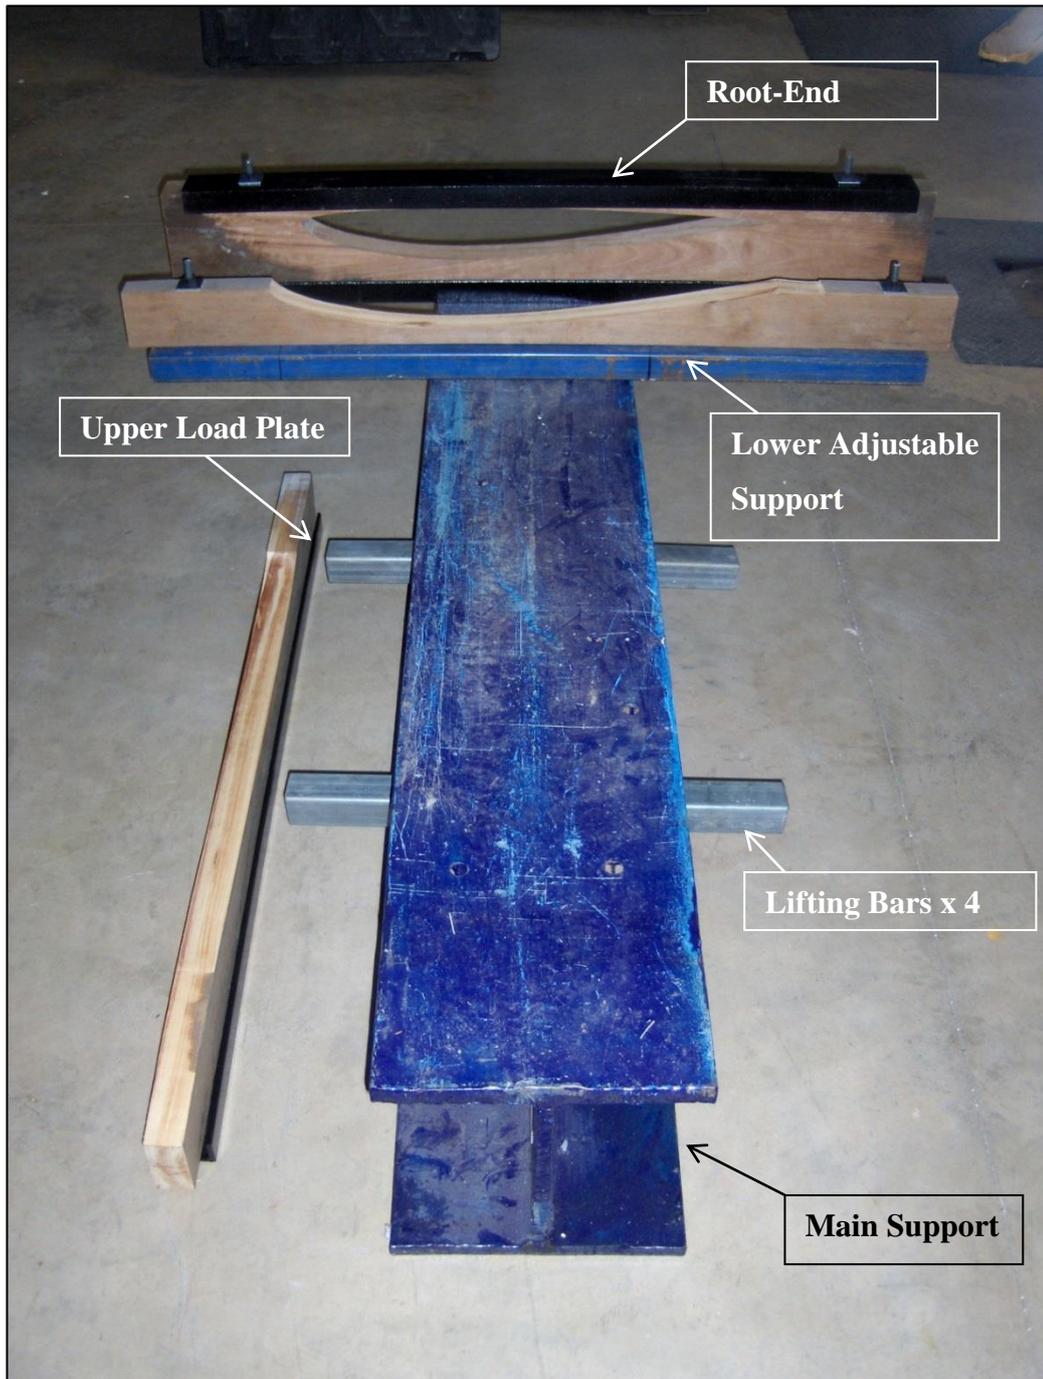
The following figure is the complete blade test fixture assembly without the blade section installed and the upper load plate lying on the floor next to the main support. The main support (blue beam) has a mass of ≈ 260 kg and is approximately 1700 mm in length. The four galvanised RHS positioned perpendicular to the universal beam section are welded in place to allow for movement of the fixture which is further discussed later.

Figure 42. Blade test fixture assembly un-welded.

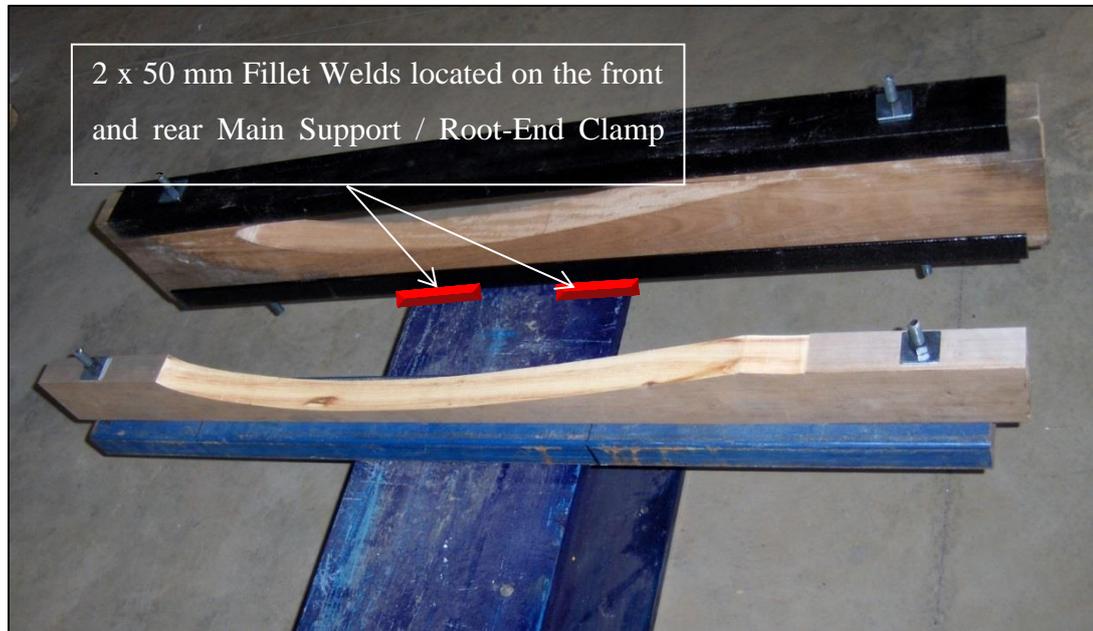
The following figure is an oblique view of the main support, lower support and root-end clamp (closed) and fillet weld locations (in red). It should be noted that the fillet welds are duplicated on the non-visible side of the root-end clamp requiring four welds in total.

Figure 43. Root-end clamp weld locations.

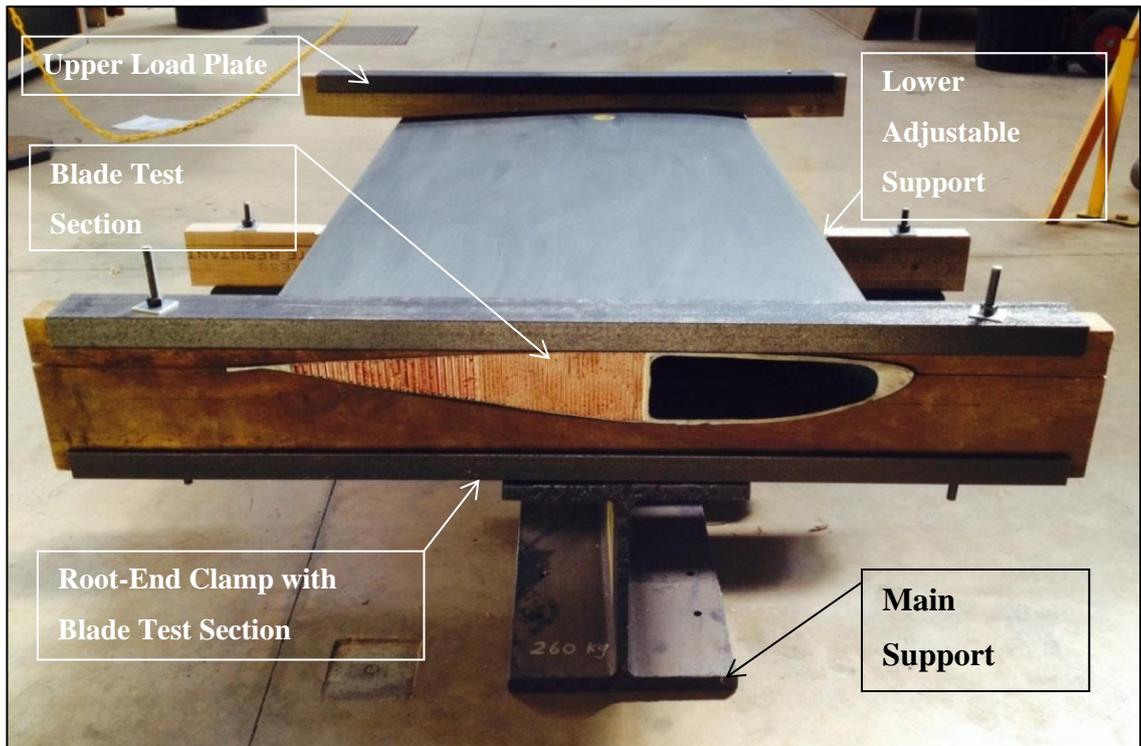
The assembled blade test fixture is viewed from the fixed end.

Figure 44. Test fixture with blade installed.

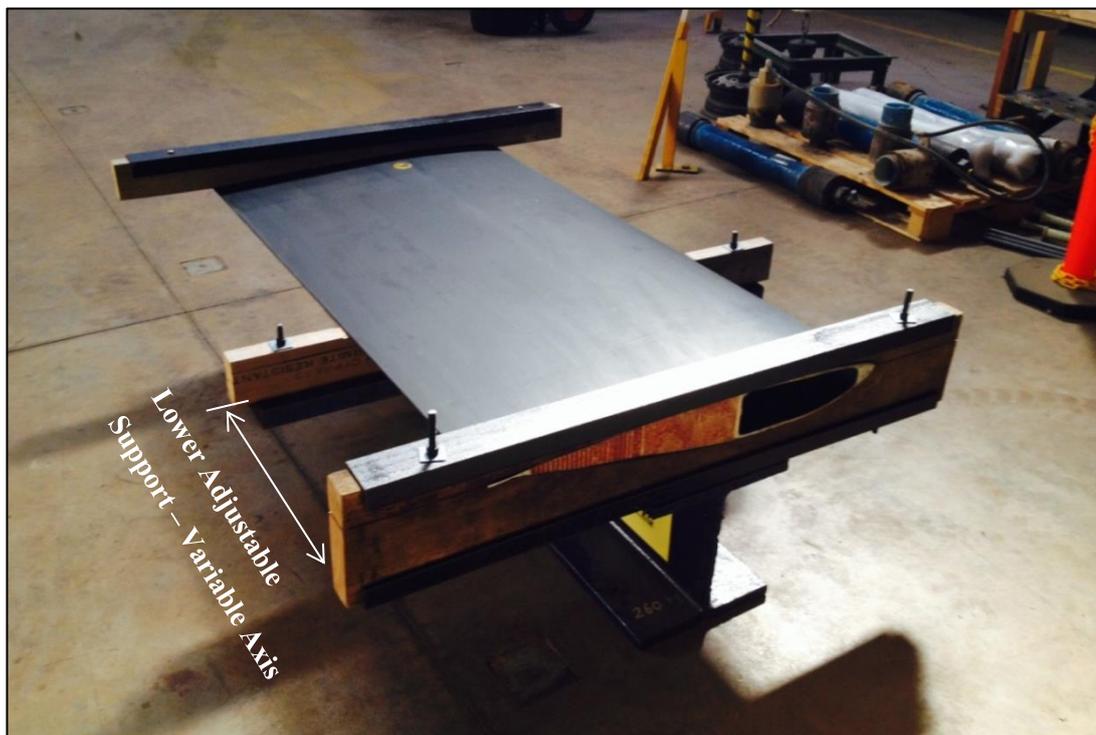
Figure 45. Lower adjustable support axis.

Following is the assembled blade test fixture with the blade section installed detailing the adjustable support plane of adjustment. **NOTE:** The lower adjustable support is not located in the final testing position.

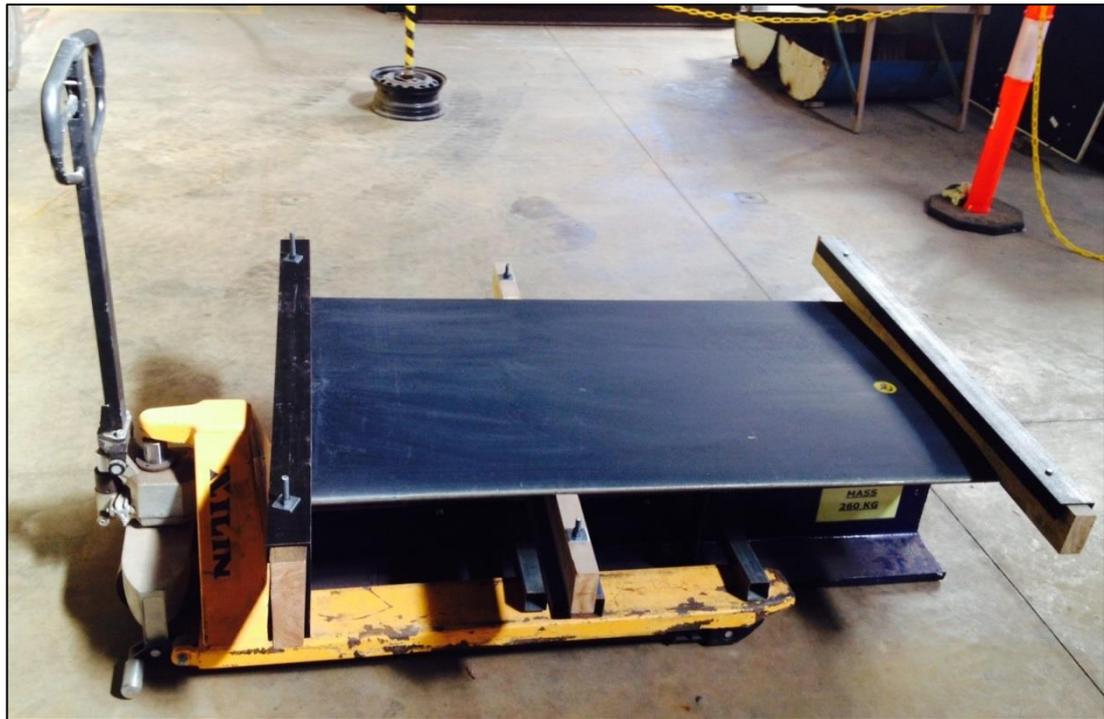
Figure 47. Movement trials of the assembled test fixture.

Given the weight of the fixture with the blade installed being approximately 300 kg a movement trail was required. This was trialled during the manufacture of the fixture, and prior to final fixture welding, which was successful. There was no concern of toppling or load run away within the testing facility at the CEEFC.

The pallet jack is installed and lifting the test fixture in Fig. 47 below.

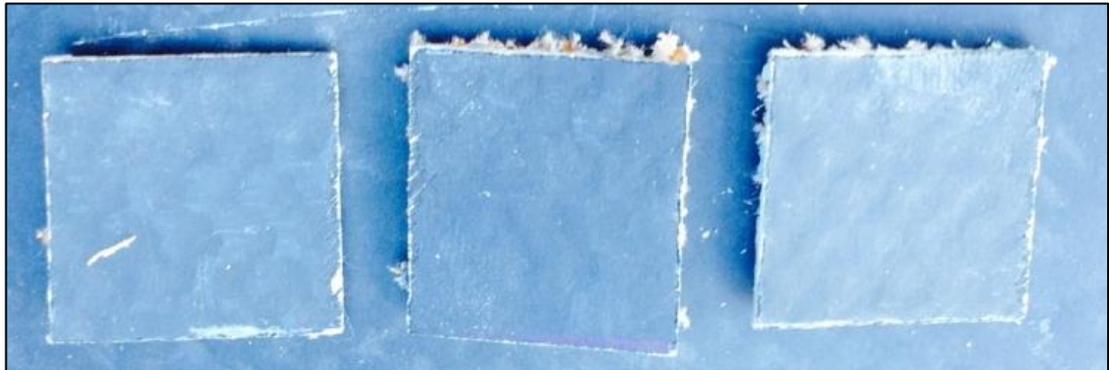
Figure 51. Final skin calcination test samples.

Calcination testing was conducted on both the D-spar and the skin with the skin samples pictured below.

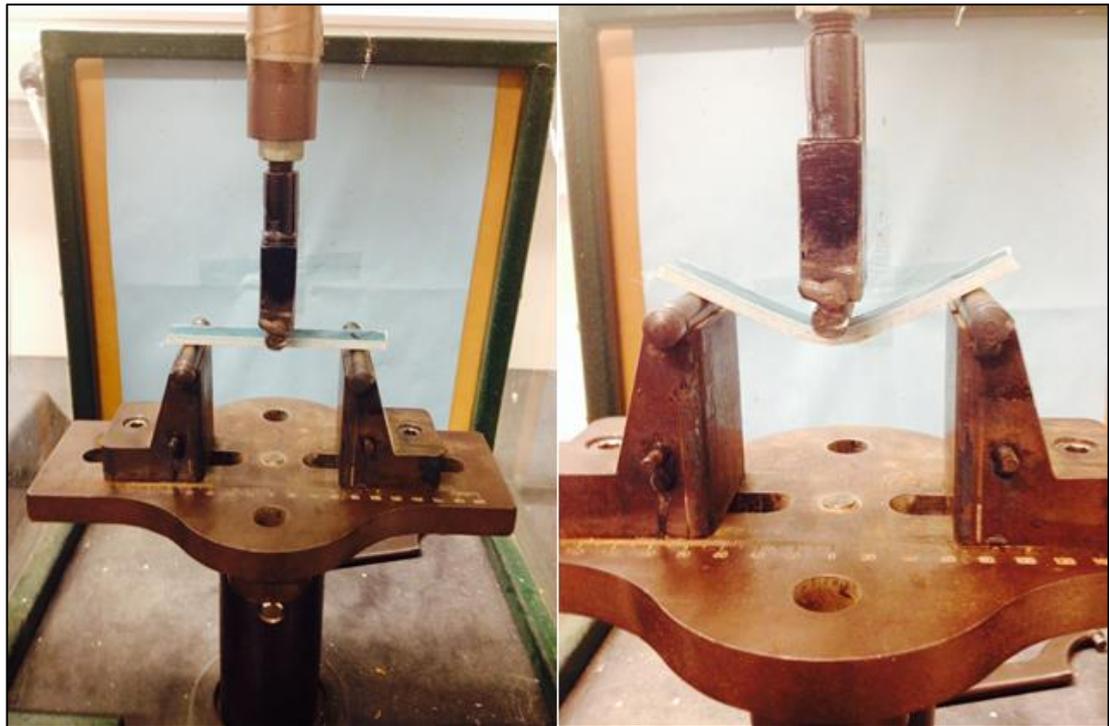
Figure 54. Flexural test close up view.

A closer view of a flexural test conducted on a D-spar coupon is provided in the following figure.

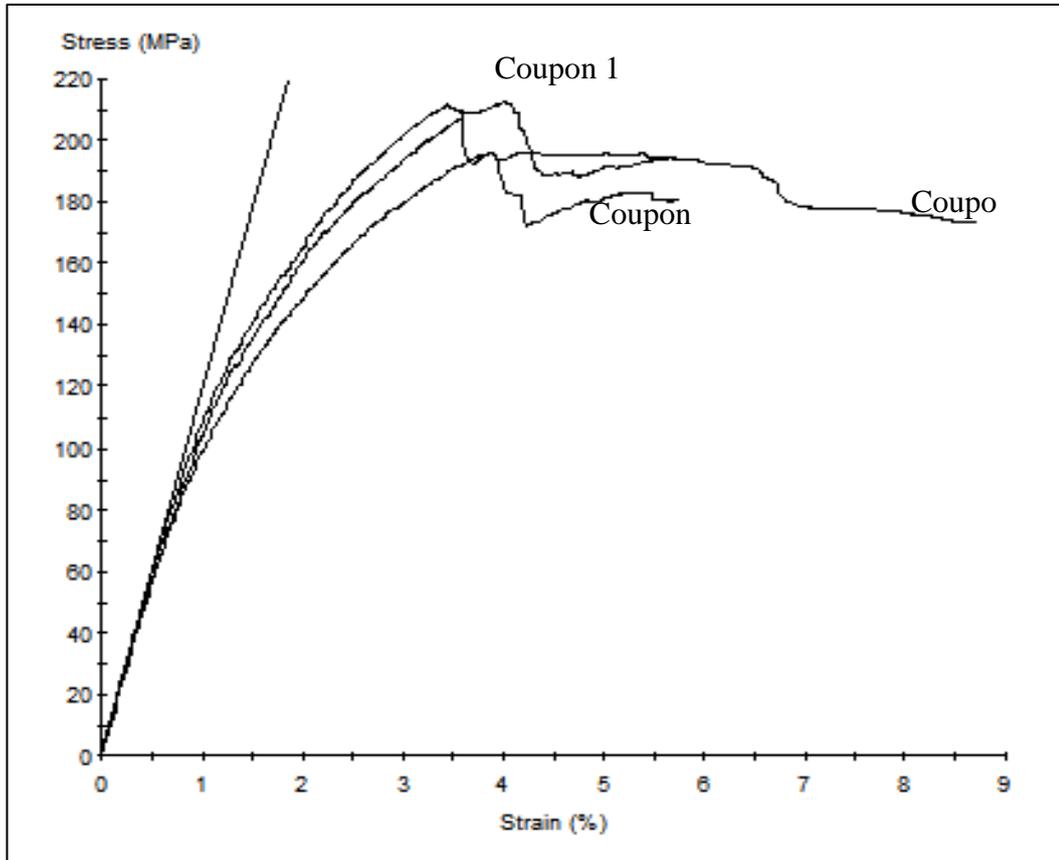
The following plot was generated by the flexural testing software and details the stress (MPa) vs strain (%) plot for the three individual D-spar test coupons.

Figure 55. Flexural test stress vs strain plot.

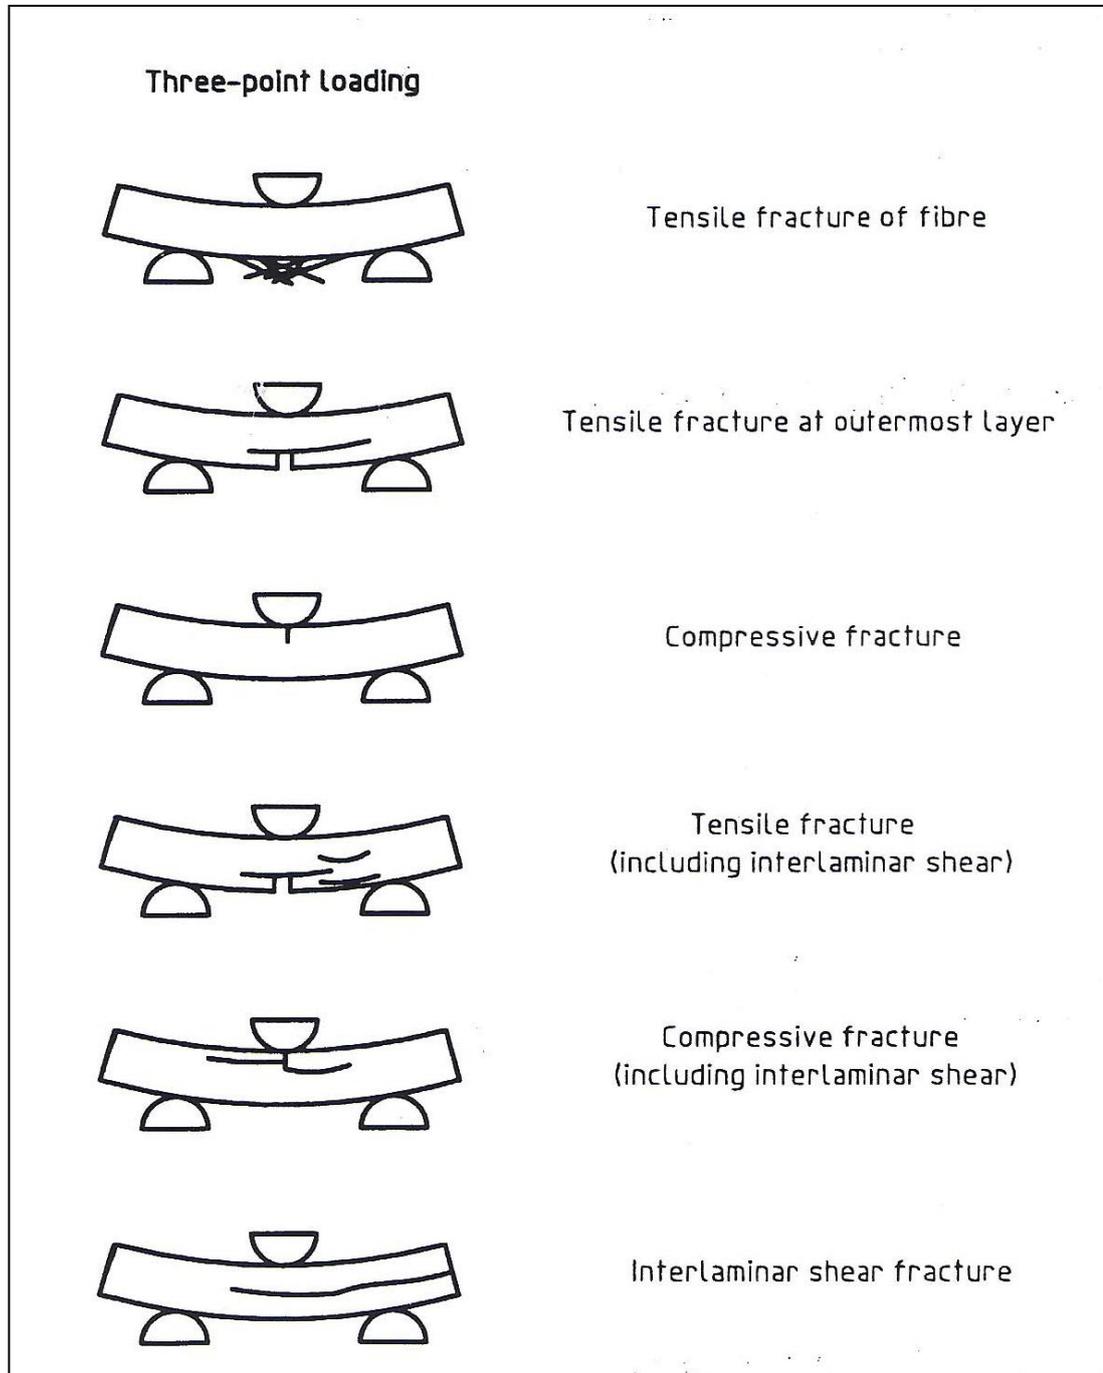
Following are typical failure modes for a three point loading test. Whilst not all inclusive it was reasonably expected that the final failure mode would be one of these, or a combination of modes.

Figure 56. Three point bending test failure modes (Source: ISO 14125: 1998, pp 18).

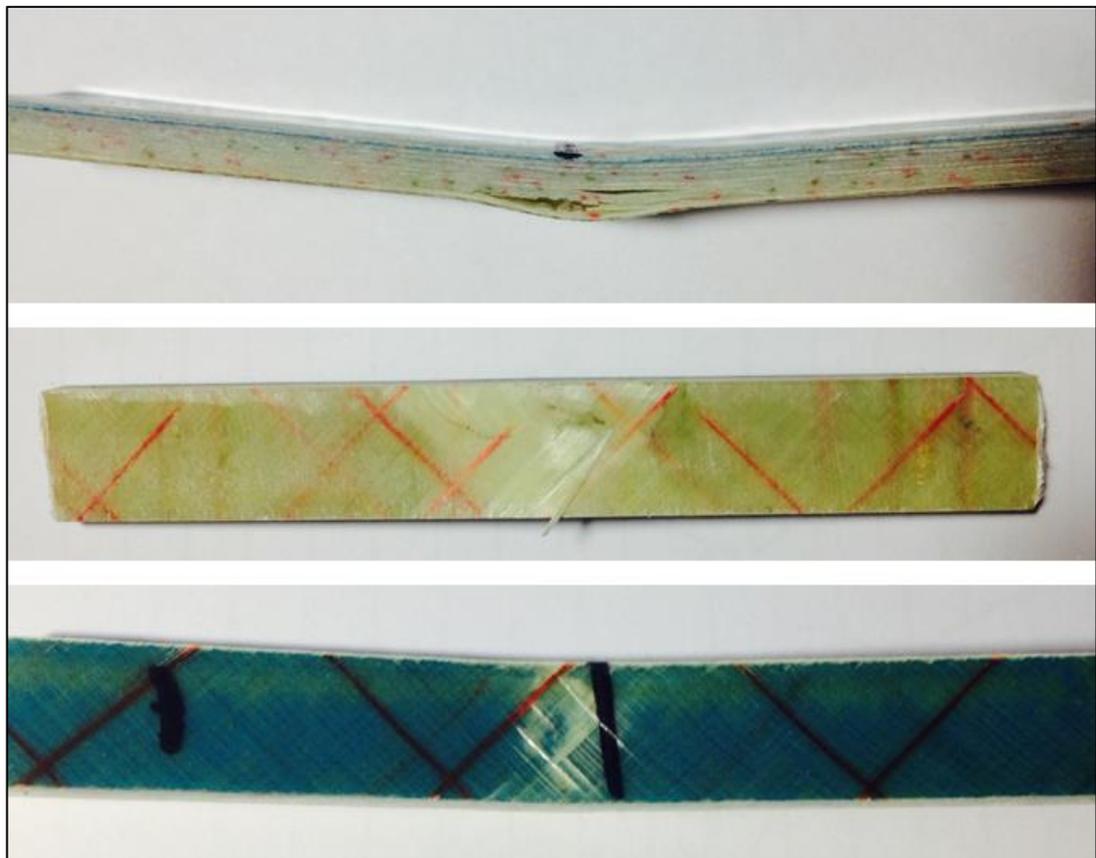
Whilst the test equipment recognised the failures as tensile fracture at the outermost layer, it can be seen in the following diagram of coupon 1, several modes of failure occurred. These include compressive fracture of the upper most surface, tensile fibre fracture and tensile fracture including interlaminar shear.

Figure 57. Flexural test coupon observed modes of failure.

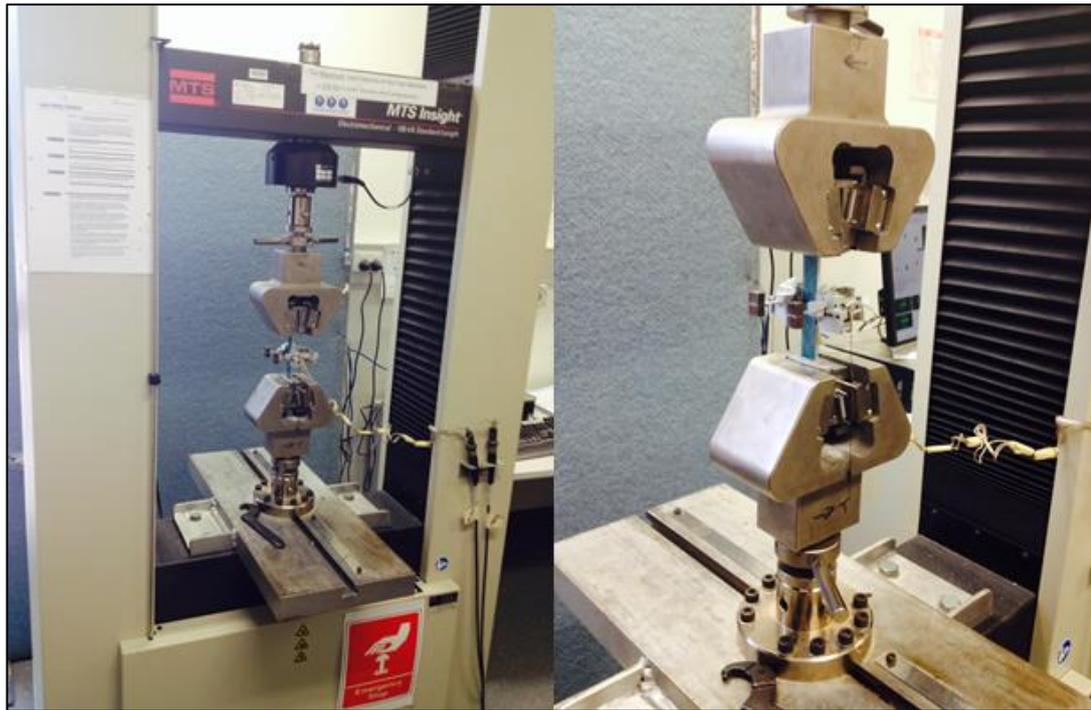
Figure 60. MTS Insight tensile testing machine.

The USQ CEEFC, MTS Insight tensile testing machine, which was used for the tensile testing, with a D-spar coupon installed is depicted in the Fig. 60.
