University of Southern Queensland
School of Mechanical and Electrical Engineering

**USE OF FIBRE-OPTIC (FBG) SENSORS IN THE STRUCTURAL
HEALTH MONITORING OF A BATTLEFIELD HELICOPTER ROTOR
BLADE**

ENG4111 and ENG4112 Research Project

Bachelor of Engineering (Mechanical)

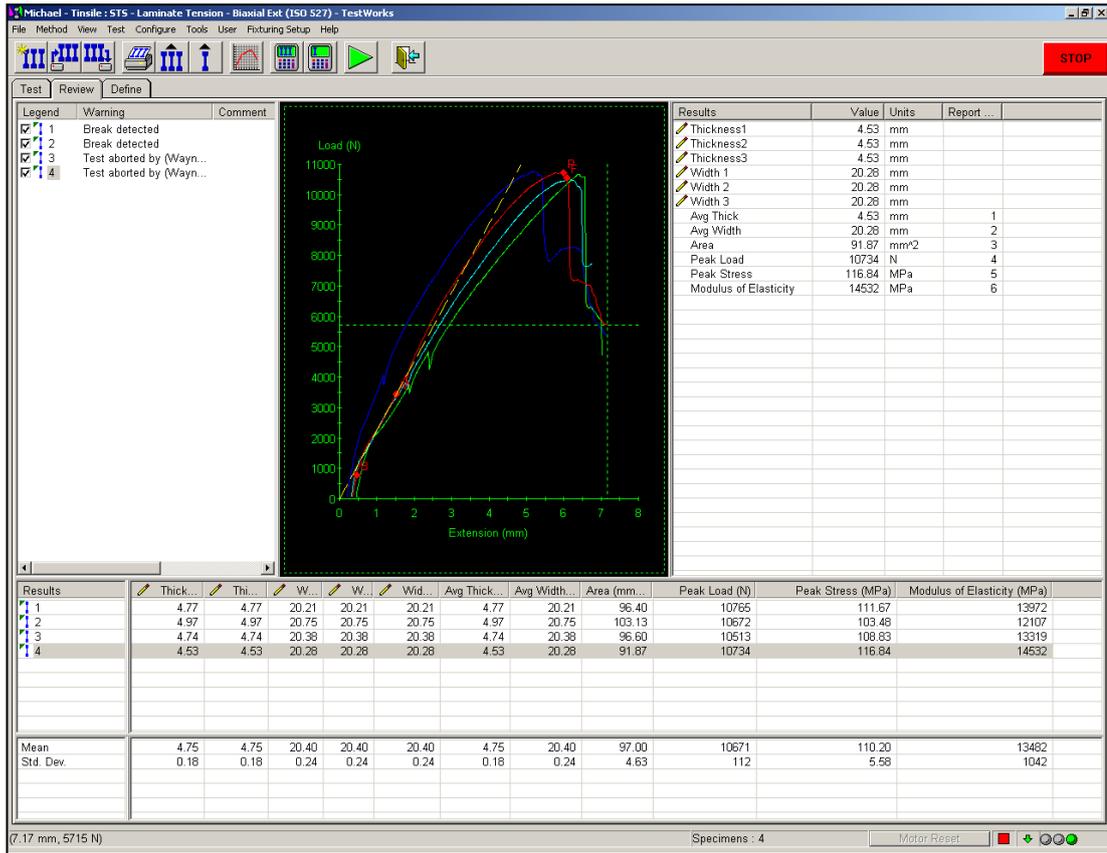
Fig. 61 is a screen capture of the computer calculated result data and a summary table for the four samples tensile tested:

Figure 61. Tensile test computer screen shot plots and data.

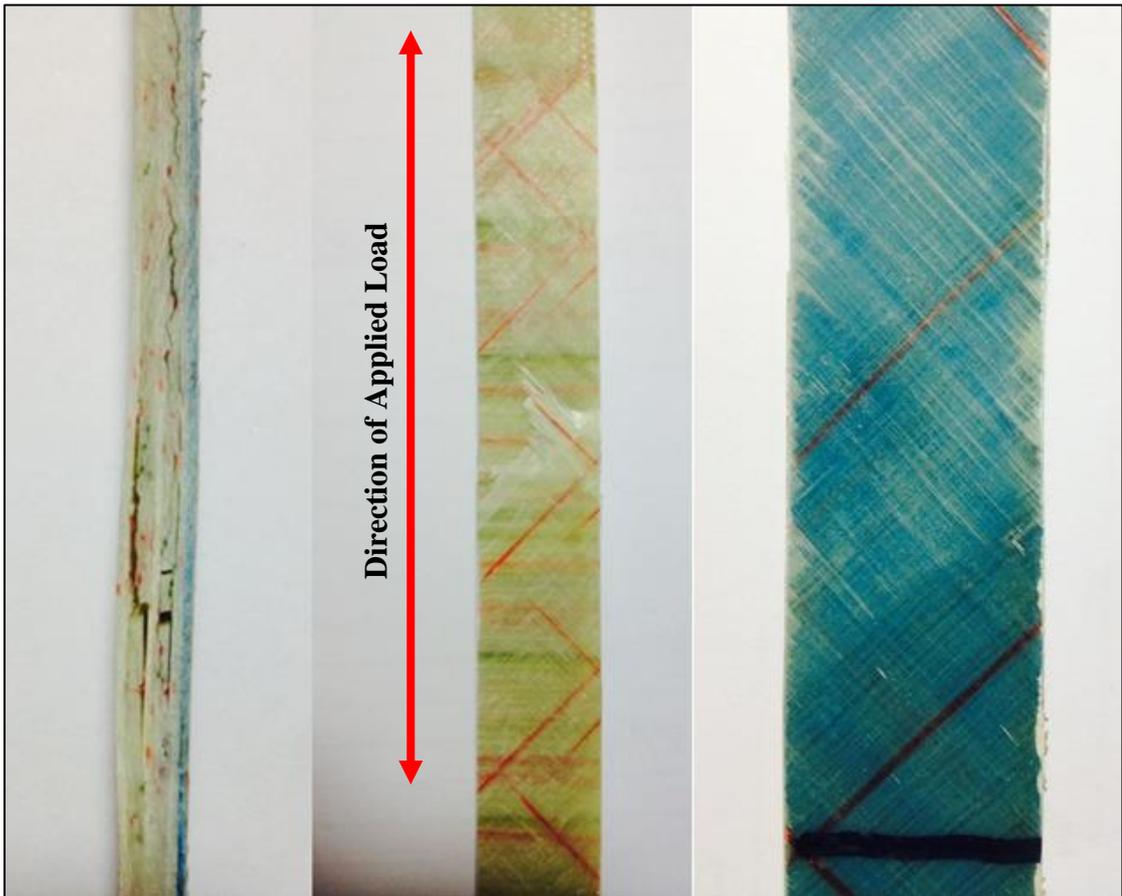
As can be observed in Fig. 62 the tensile specimens experienced transverse fibre stress and fracture, delamination and ply failure via fracture. It can also be observed that the surface transverse fibres are displaced and in some cases fractured where they are not constrained and supported by a subsequent ply.

Figure 62. Failed tensile test sample.

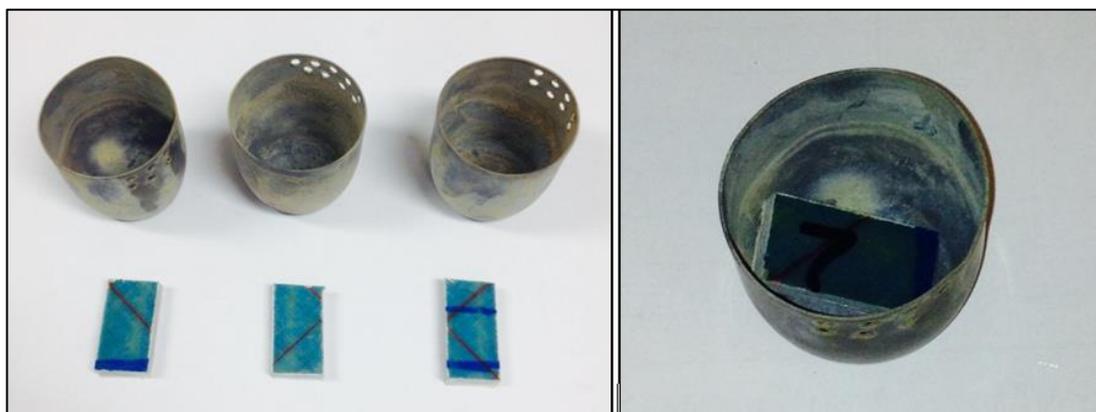
Figure 63. D-spar calcination samples and crucibles.

In accordance with the ISO, the mass of each sample must be within 2 – 10 grams for laminates with a minimum of 2 test samples. The following figures depict the D-spar and skin test samples used, with the three D-spar samples and crucibles prior to calcination, and a sample placed within a crucible presented first.

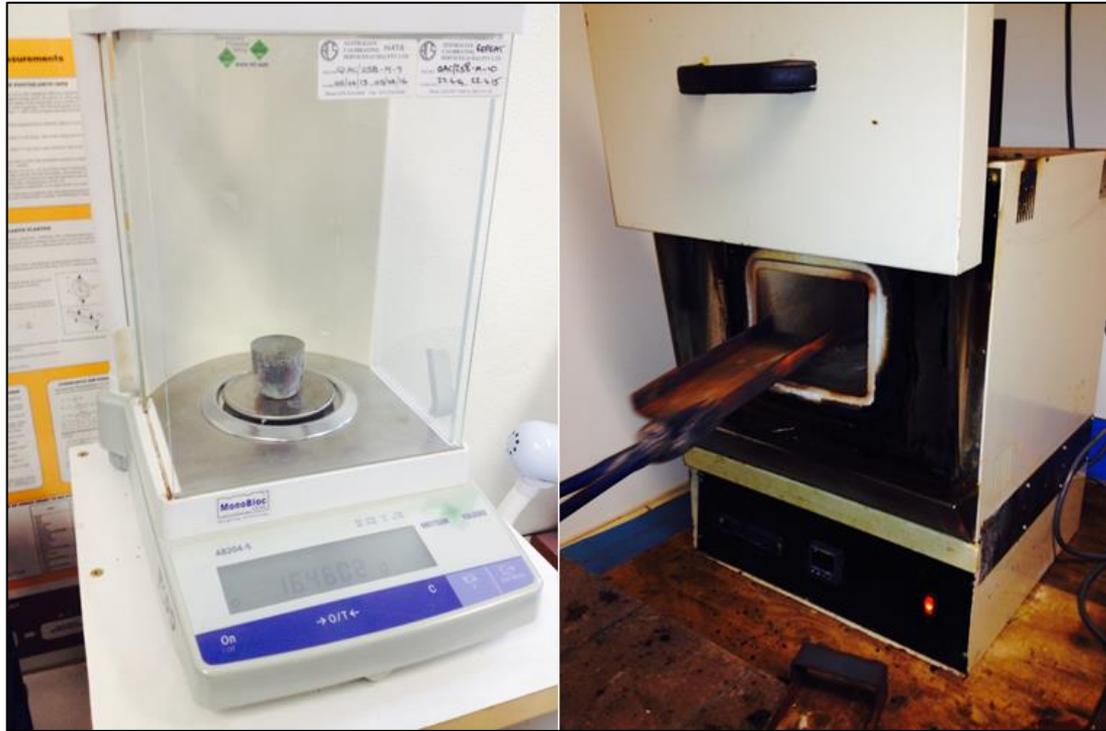
As it was unclear what level of temperature could be withstood by the glass fibres a furnace temperature of $575^{\circ}\pm 25$ was determined as appropriate via consultation with the CEEFC laboratory staff.

Figure 65. CEEFC electronic scale and temperature controlled furnace.

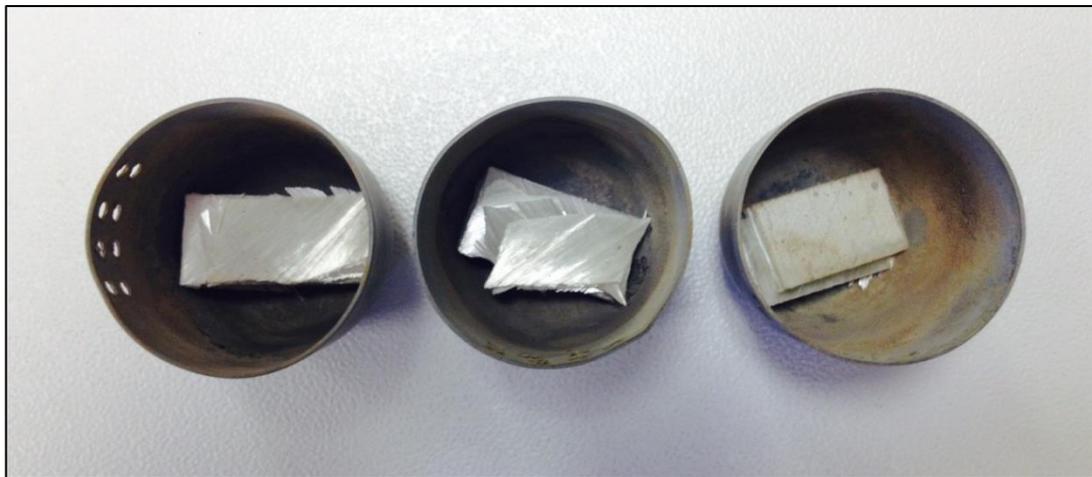
Figure 66. Three D-spar samples post calcination.

Figures 66 and 67 depict the D-spar samples post calcination and the skin sample pre and post calcination. In order to determine the laminate lay-up sequence and plie orientation they were each carefully removed from the crucible after weighing for separation and visual examination.

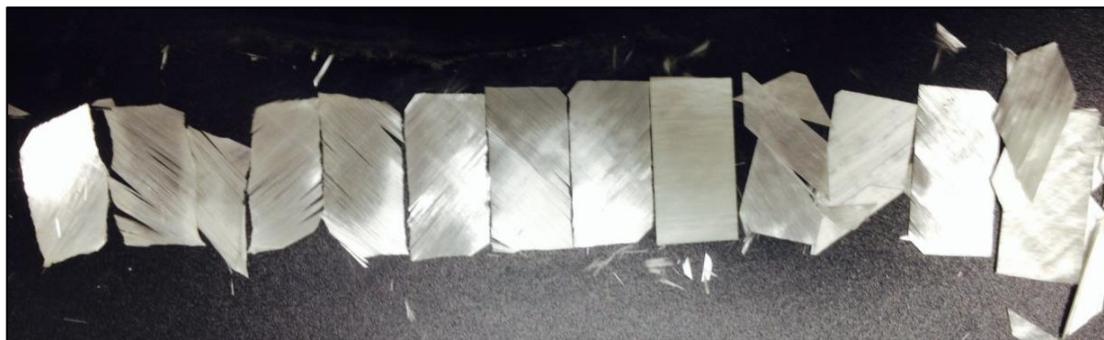
The D-spar samples, once removed from the crucible, were carefully separated into individual plies in order to determine the stacking sequence and orientation. Fig. 68 shows the D-spar plies post separation demonstrating the fragility of the plies and necessity for a methodical lay-out approach for inspection.

Figure 68. D-spar plies post separation demonstrating fragility.

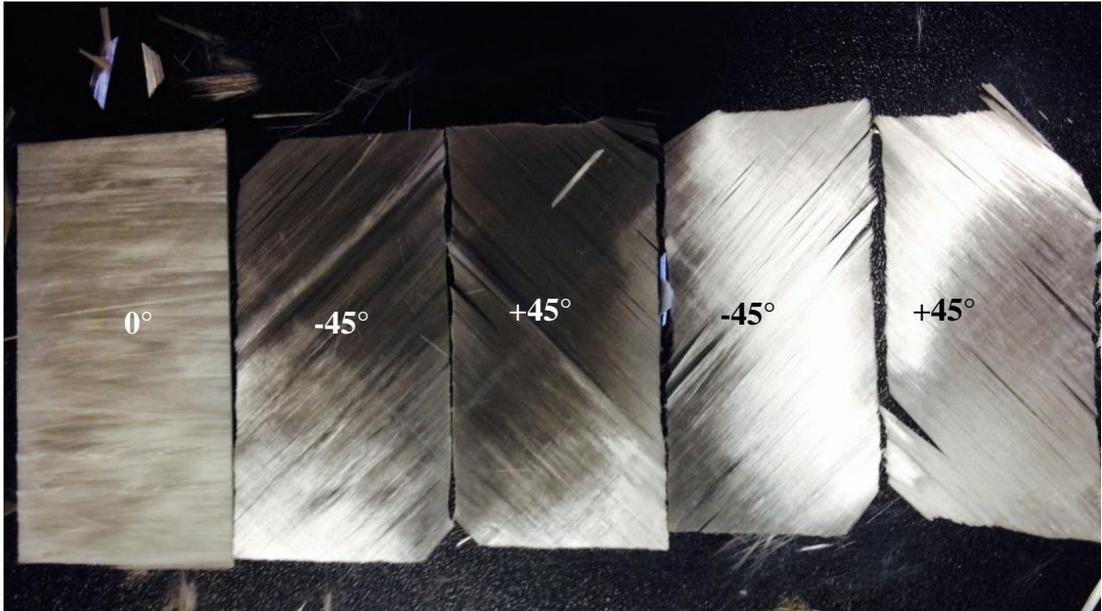
Each sample was deconstructed with the plie orientation noted, as in the D-spar samples in Figures 69 and 70 below.

Figure 69. D-spar plie orientation magnified view.

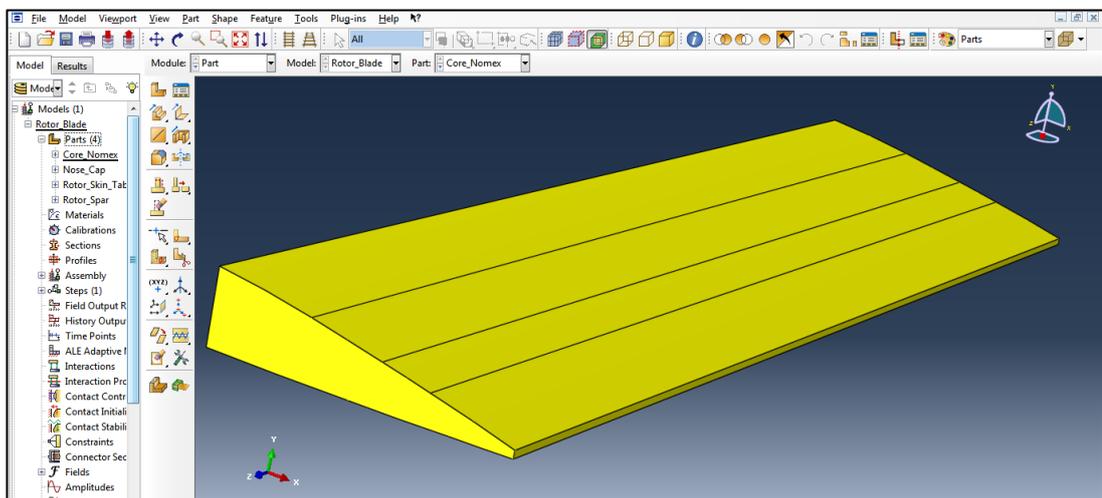
The Nomex honeycomb core was modelled as an isotropic material due to the lack of physical property data available in the public domain and the inability to determine the type of Nomex used. It was noted that the material has far greater compressive and tensile strength in the direction of the core perforations as opposed to transverse to them. As such a 50% reduction factor was assumed as adequate and applied.

Figure 79. FEA Nomex honeycomb core model.

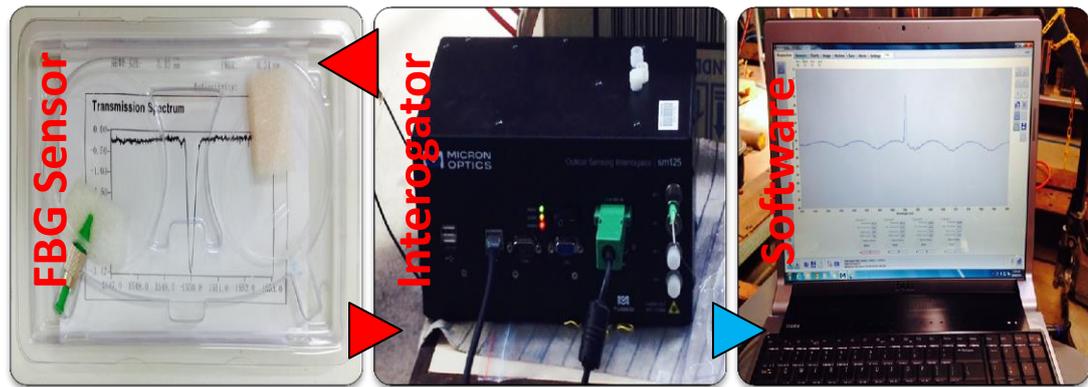
Figure 88. Overview of major FBG system components.

A diagrammatical summary of the FBG system is presented below with red arrows representing information flow via fibre-optics and the blue arrow representing information follow via a standard electrical patch lead. This system is discussed in greater depth in later paragraphs.

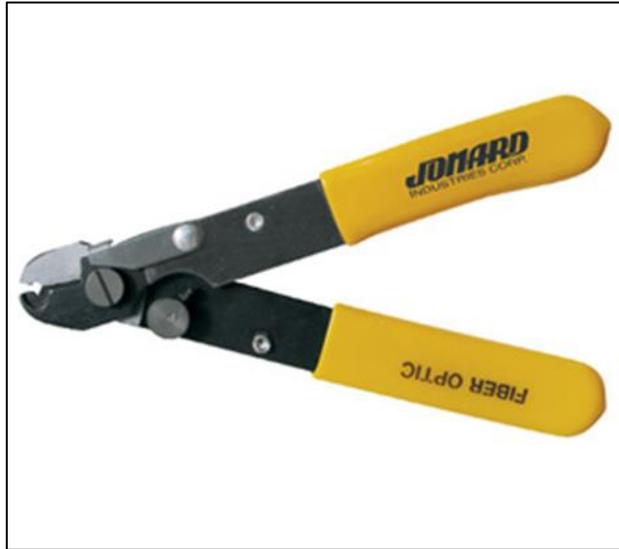
Figure 89. Typical optic fibre strippers.

1. **Cutting to length:** As part of the initial process a section of optical fibre is required to be trimmed to length. Once the length is determined the fibre can easily be ‘kinked’ and broken in the desired location by gently pulling the fibre taut.
2. **Stripping of outer cladding layer:** Once the desired length is obtained the end of the fibre to be spliced with the FBG is stripped of the lower refractive index cladding. This is achieved by using fibre optic stripping pliers with the correct diameter stripping recess relative to the fibre diameter.

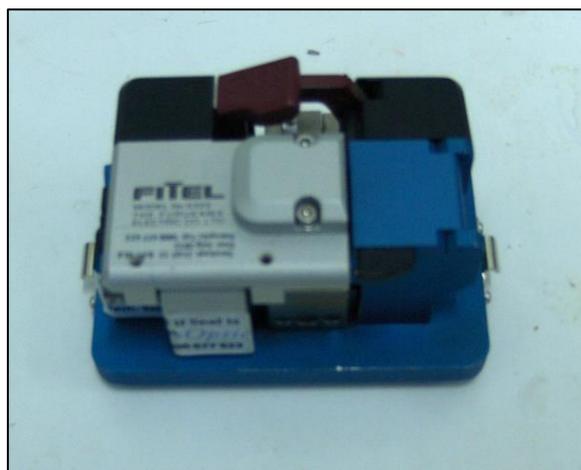
Figure 90. The Vitel high precision fibre cleaver.

- Squaring of optical fibre ends:** Once the cladding is stripped squaring on the optic-fibre and FBG ends to be spliced is required. This is achieved by aligning the fibre within a high precision fibre cleaver, as depicted below. Internal magnetic clamps locate and hold the fibre whilst a weighted blade mechanism cleaves the fibre in a single pass producing a square end to the fibres axis. Square ends are required on the both the FBG and fibre for accurate splicing.

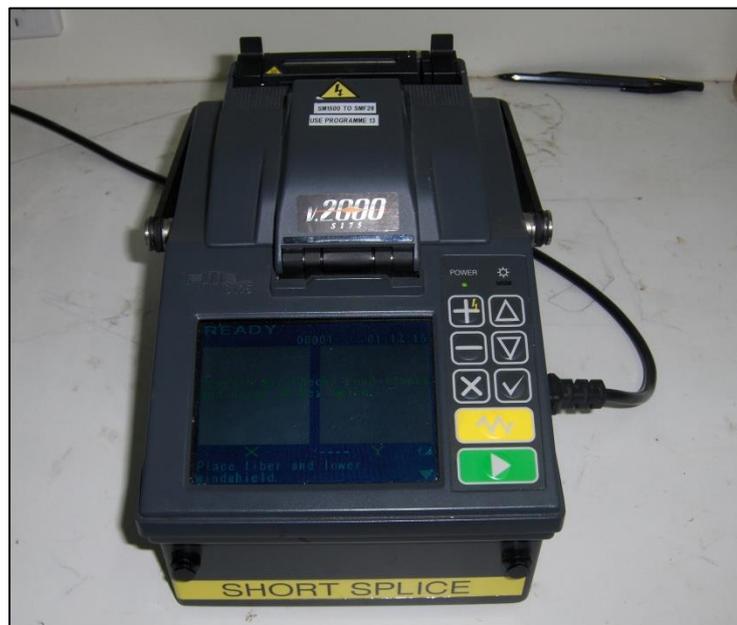
Figure 91. The Vitel v. 2000 s175 fusion splicing machine.

4. **Fusion splicing of FBG to optical fibre:** Splicing is achieved with the use of a direct core monitoring machine which creates a single fibre which may contain one or more FBGs. The actual splicing is a three phase process plus final test, once the squared fibre and FBG ends cleaned and positioned within the splicer. The fibres are restrained and located by a magnetic clamping arrangement. Once positioned, and the relevant information for the operation and fibre type are entered the machine begins the splice. This is an automated four stage process as follows:

- c. **Fusion:** Once the fibres are correctly positioned and any contaminants burned off the fibre ends are fused together to form a permanent splice. The splicer emits a larger spark that melts the optical fibre end faces without causing the fibres' cladding and molten glass core to run together. The molten fibre ends are then joined creating the final fibre splice.

- d. **Test:** A self-test of the resultant splice is conducted by the machine to estimate the refractive losses across the splice. Most fibre fusion splices typically display an acceptable optical loss of < 0.1 dB.

On several occasions whilst attempting to splice fibres errors occurred. These were largely due to contamination within the splicing process which required additional hand cleaning, and misalignment of the fibres within the fusion splicer. The misalignment was usually the result of the fibre fractionally moving during the clamping process and was easily rectified with adjustment. In all cases an adequate splice was achieved which passed the machine self-test.

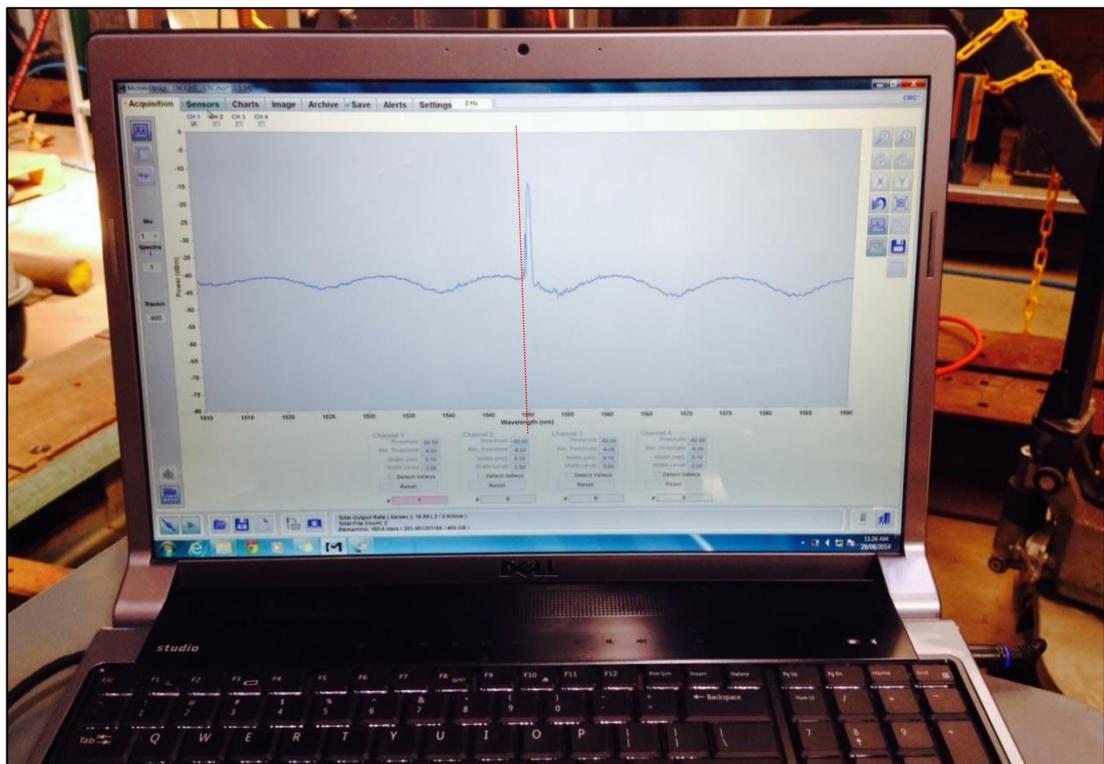
Figure 95 is a screen capture during actual testing depicting the movement of the peak value from the 1550.0 nm reference to the right indication a tensile strain condition.

Figure 95. Micron Optics, Enlight software was used for the FBG analysis.

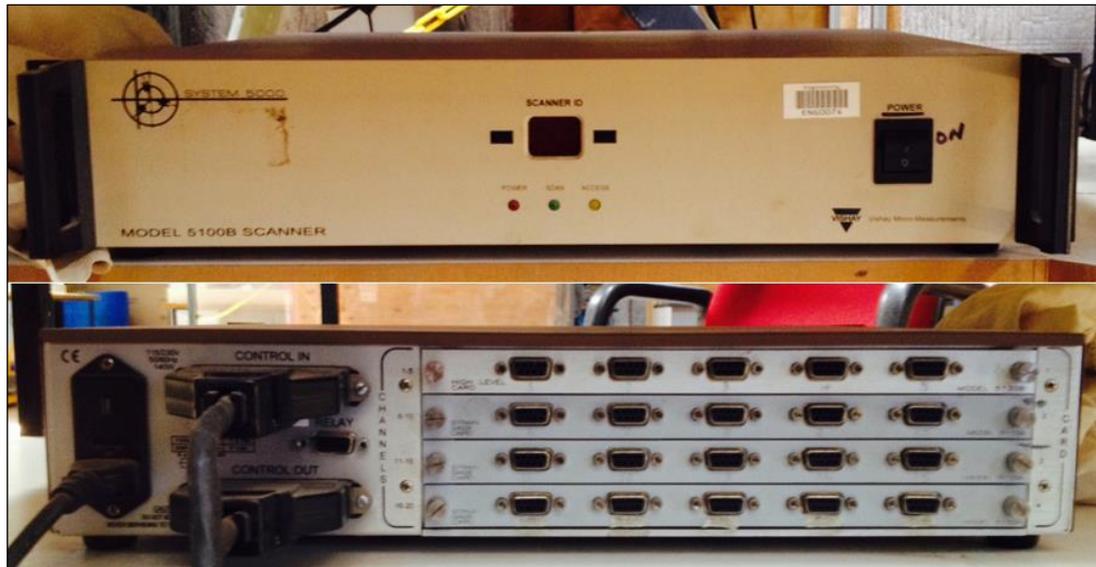
Figure 100. StrainSmart System 5000 (5100B) data acquisition system.

Once the bridged connectors had been completed they were each soldered to a strain gauge ready for use with the data acquisition system; the StrainSmart 5100B. This unit is able to accept 20 channels of inputs. Acceptable unit inputs relevant to this testing include strain gauges, strain gauge based transducers (load cells) and linear variable differential transformers (LVDT).

The load cell, LVDT and nine strain gauges were each assigned a channel within the software and provided a data input port into the data acquisition system pictured below.

The load cell provided load information in Newtons and allowed for accurate load application via a manually operated hydraulic pump. The LVDT provided displacement information to the data acquisition system in millimetres. Both parameters and the strain readings from all strain gauges were recorded for each test performed. This information allowed for comparative analysis as described in the following chapters.

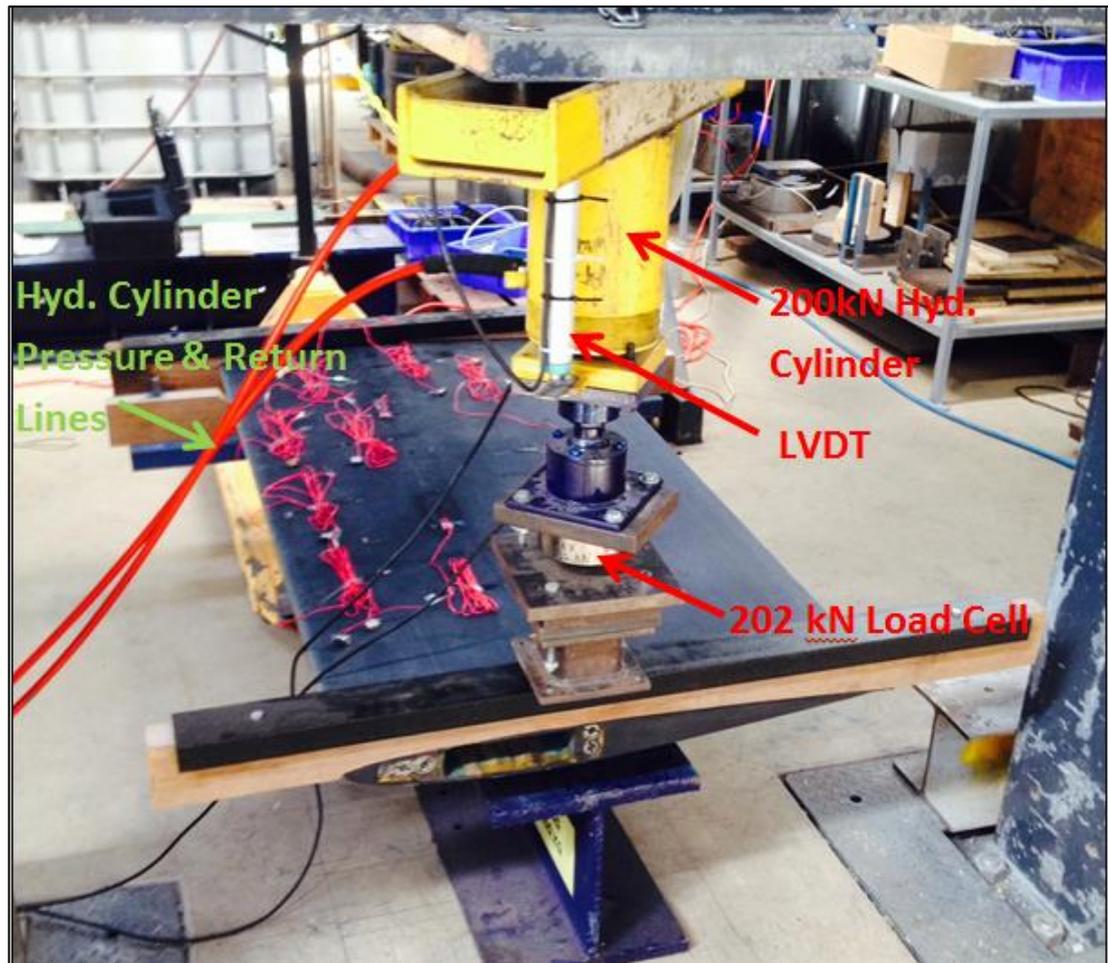
Figure 101. Hydraulic cylinder, lines, LVDT and load cell with FBG and strain gauge connectors present.

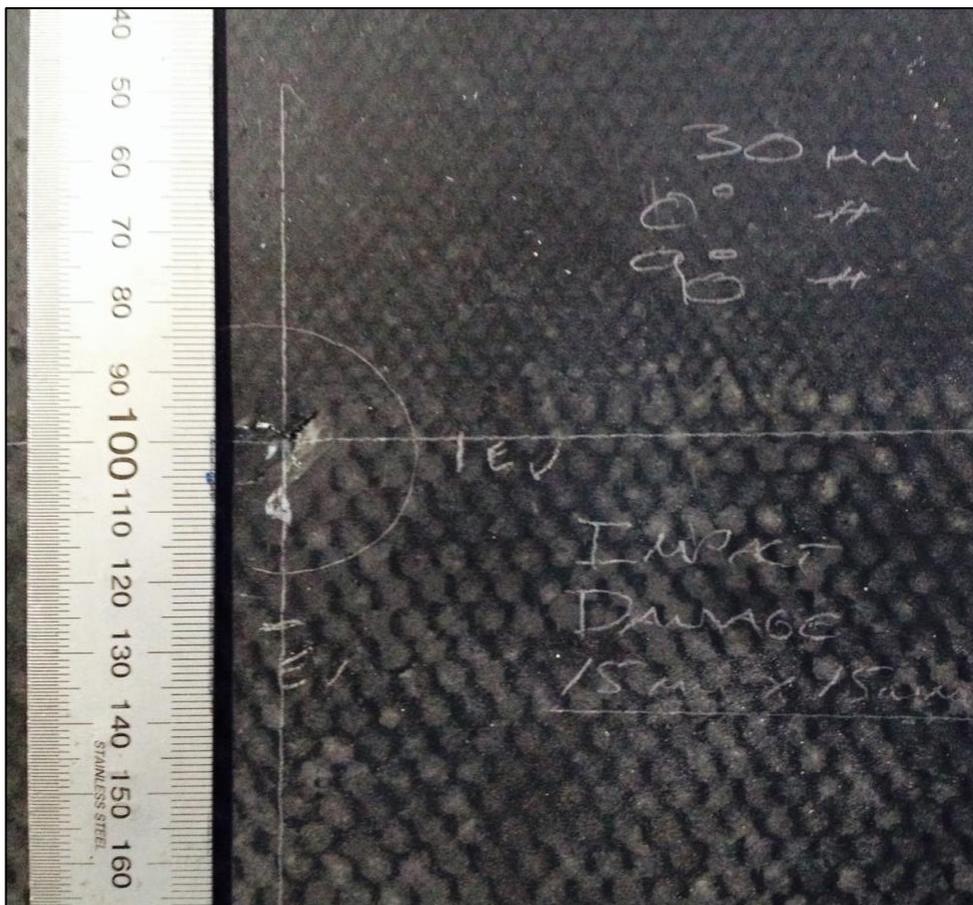
Figure 105. Blade test section 'accidental' damage.

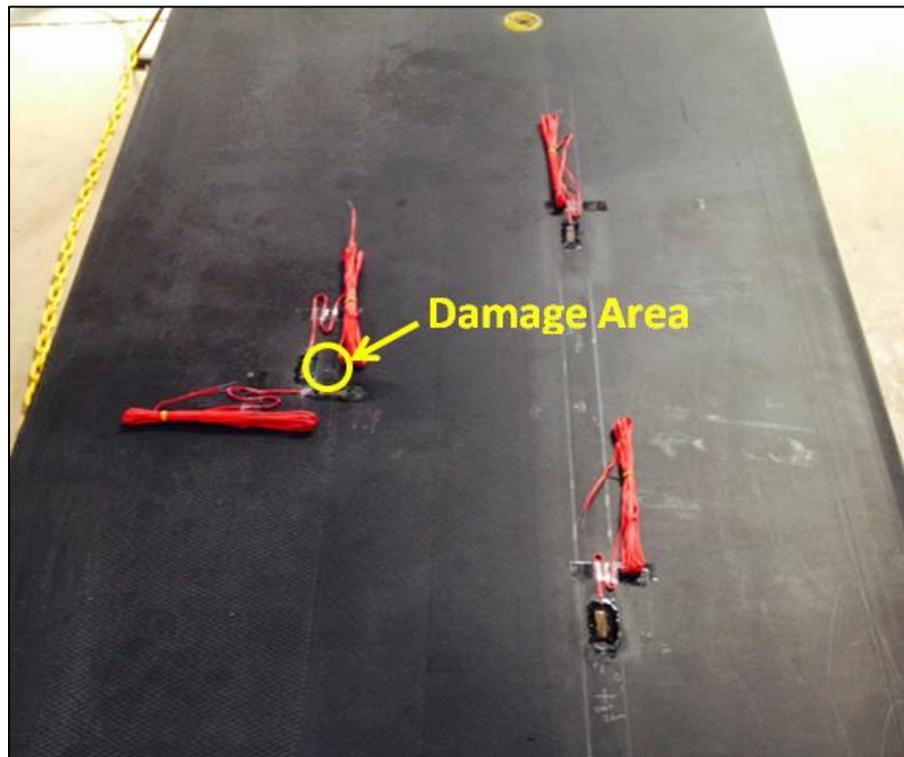
Figure 106. Impact damage location with strain gauges.

Typically this type of damage occurs on the lower blade surface and is more frequently occurring in the 'softer' trailing edge region. Coincidentally, the storage damage occurred in the same region.

As a result of this damage a longitudinal and transverse strain gauge was placed in close proximity to the damage in order to obtain strain readings for later comparison with the FEA model. These two gauges are at positions eight and nine respectively and are approximately 30.0 mm from the centre of the damage site as pictured below.

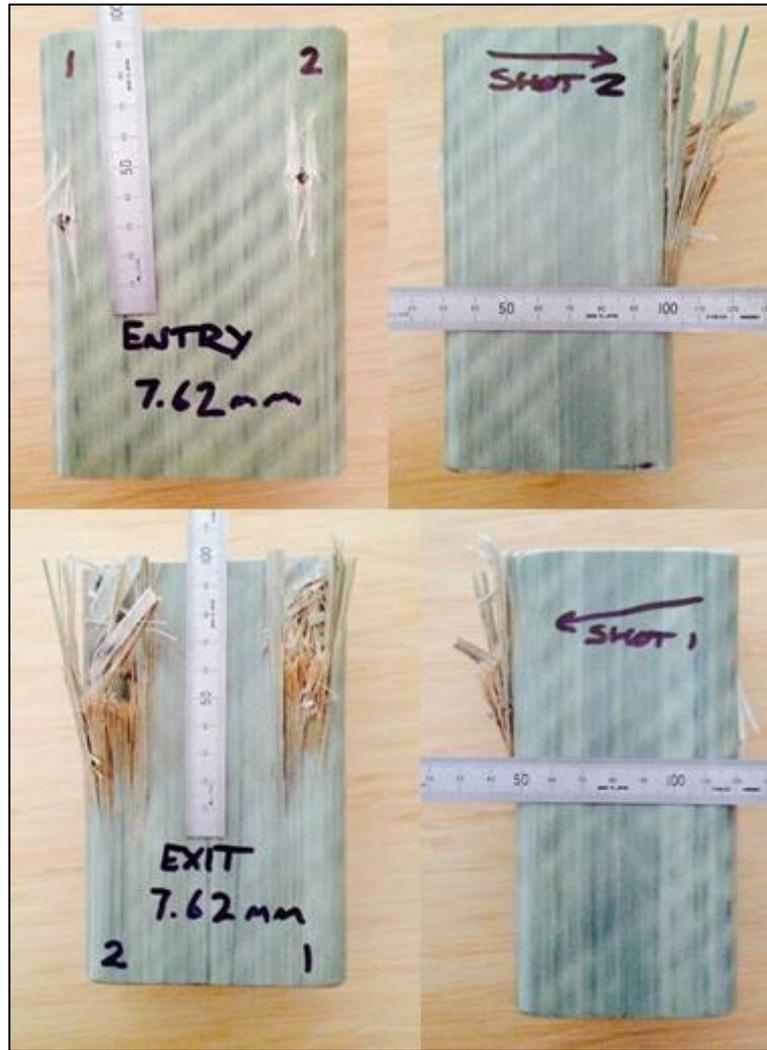
Figure 108. Resultant ballistic damage (external).

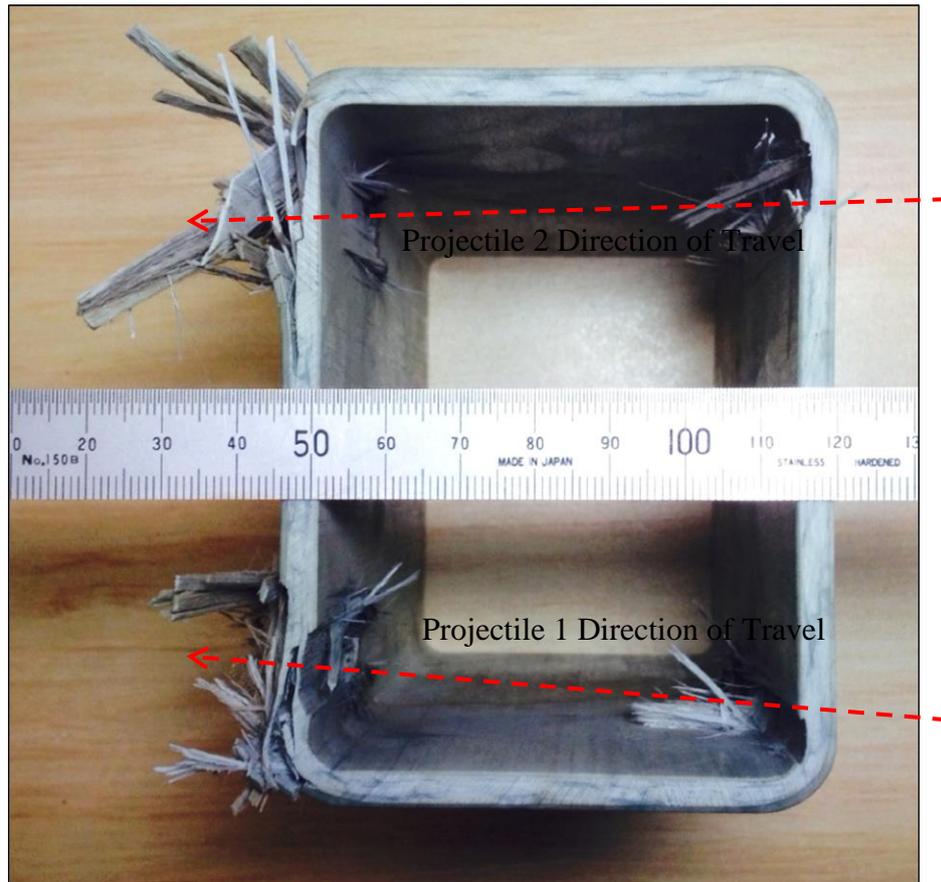
Figure 109. Top view of internal ballistic damage.

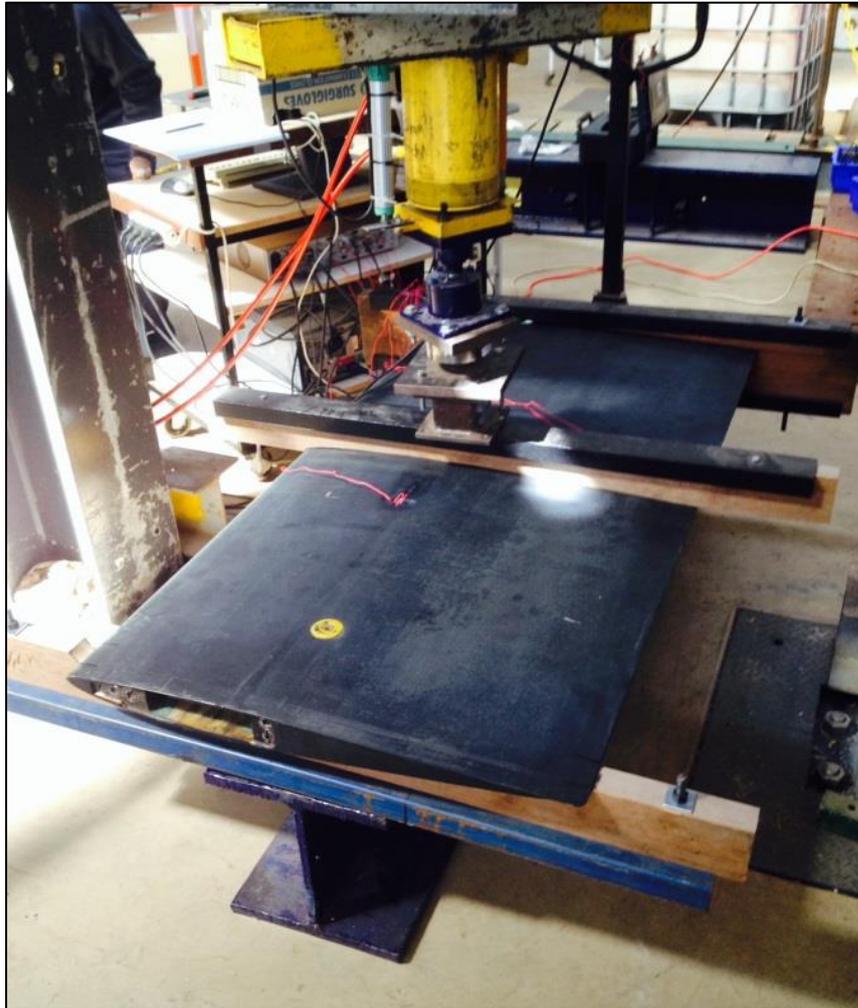
The mid-span load testing (Test 3) is pictured below as a guide to the test set-up.

Figure 110. Mid-span load testing (Test 3).

Additionally, deflection of the blade tip (or blade mid-point in the case of Test 3) was recorded by the LVDT and again displayed by the strain gauge system software.

At no time during any testing did the blade contact the test fixture main support compromising results. Under maximal load (2500N) the blade tip came to within 10.0 mm of the test fixture as presented below.

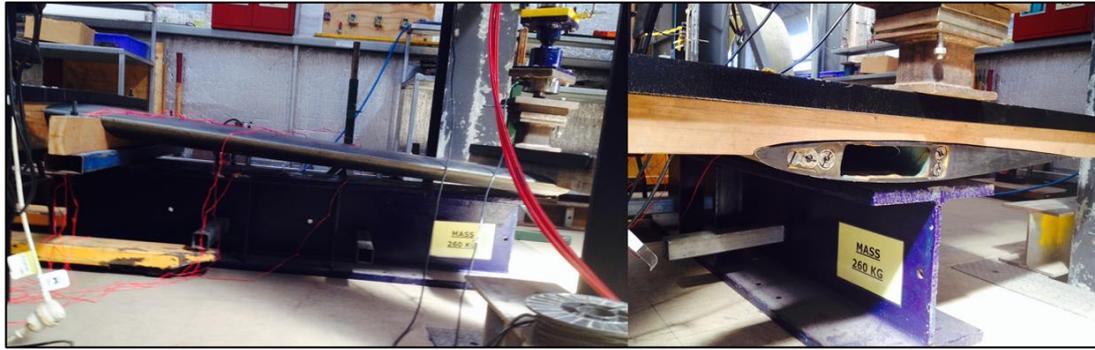
Figure 111. Blade deflection at the maximal 2500N cantilever load.

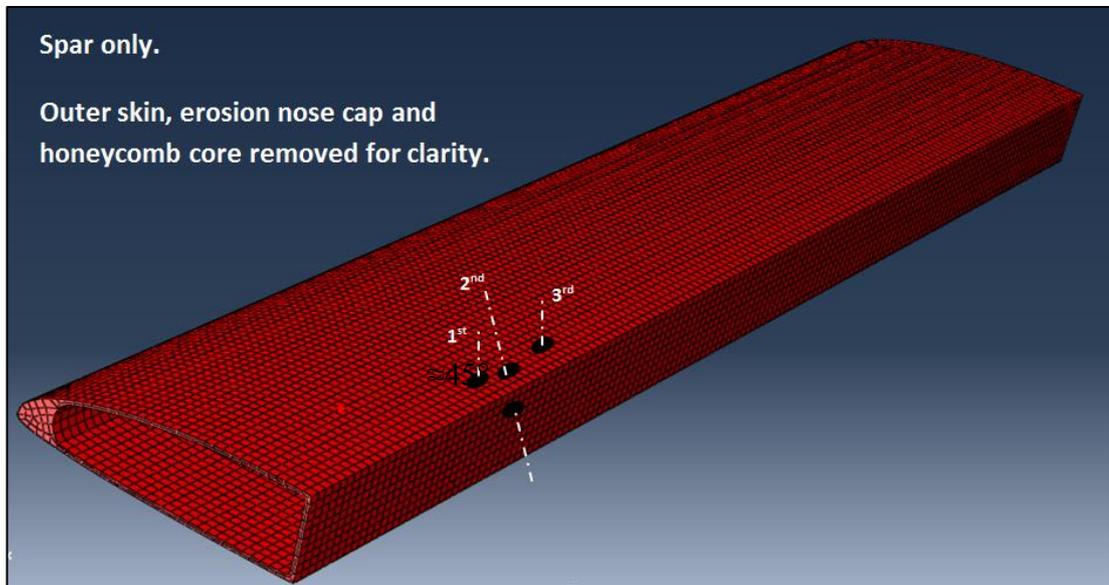
Figure 112. Location, axis and order of damage holes relative to the D-spar.

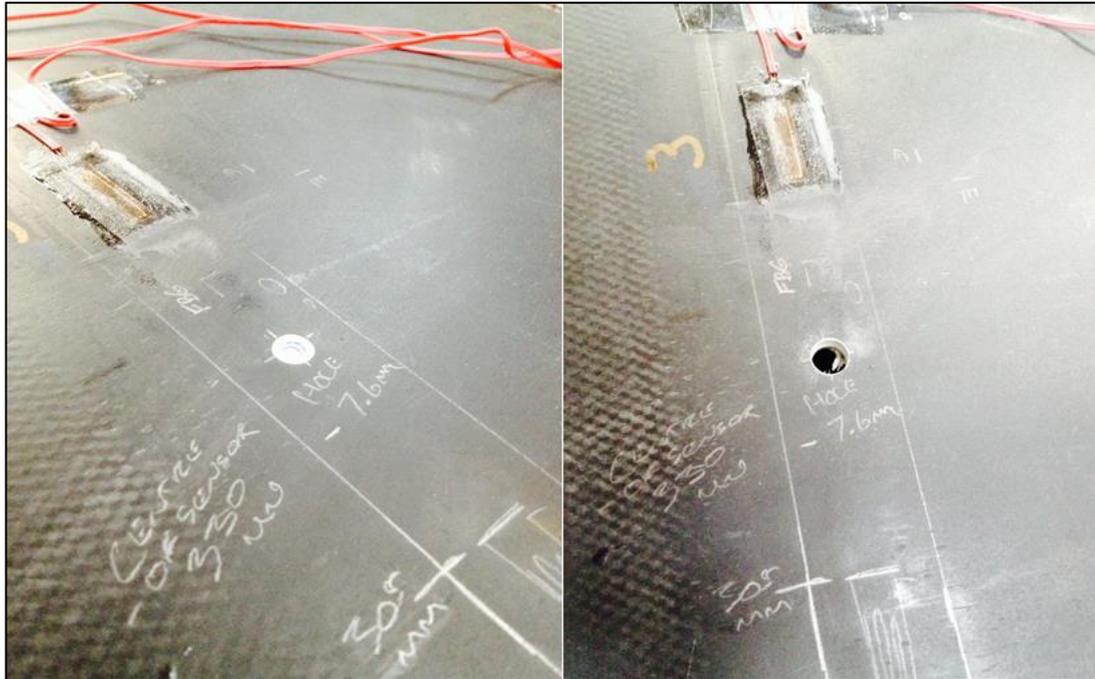
Figure 113. Hole 1 at 3.0 mm depth and full thickness.

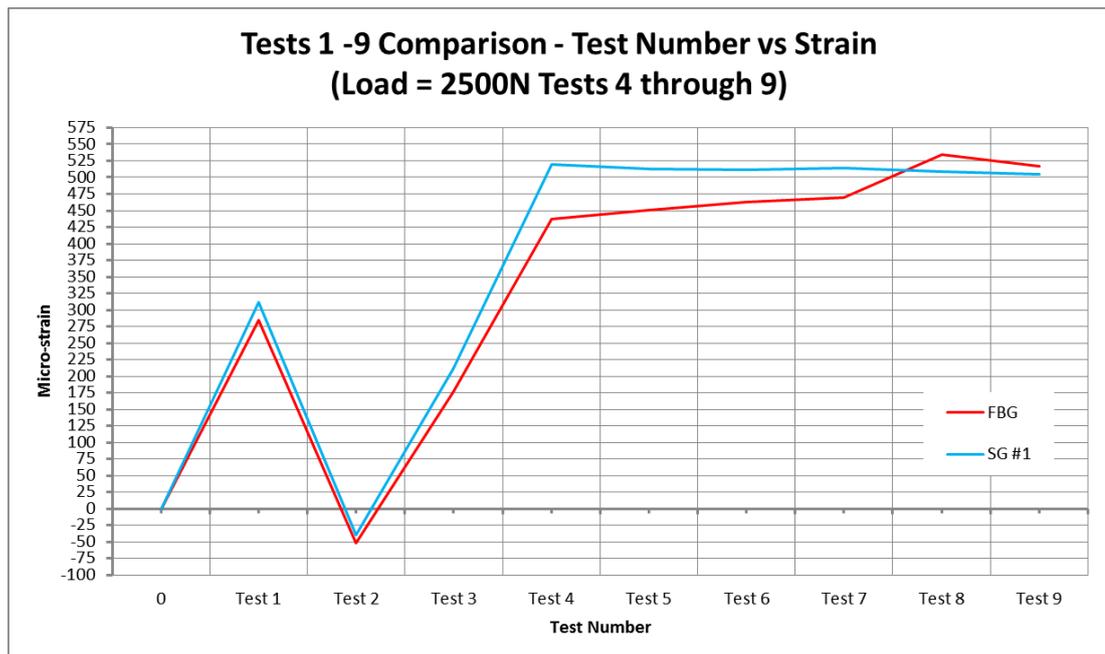
Figure 125. Test 1 – 9 Comparison plot of FBG & strain gauge #1.

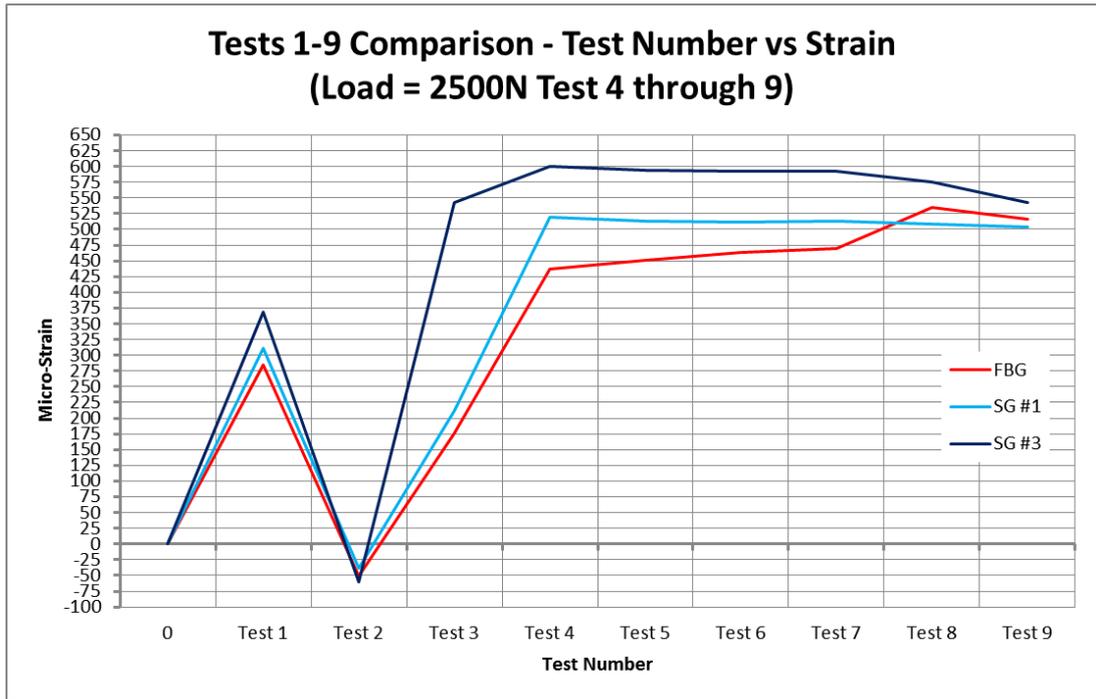
Figure 127. Test 1 – 9 Comparison plot of FBG & strain gauges #1 & #3.

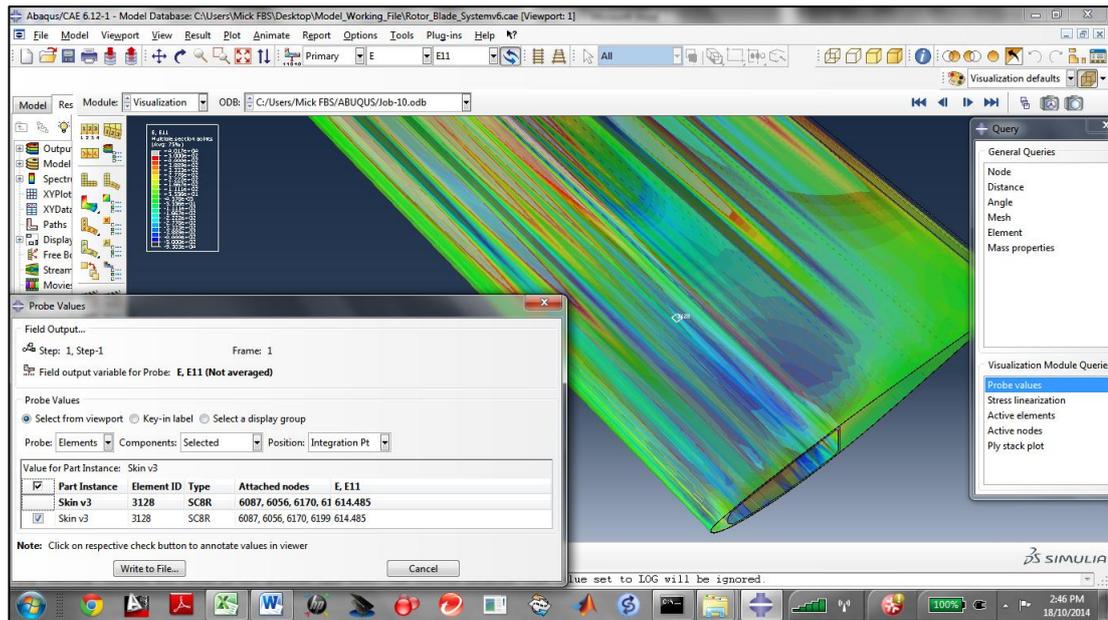
Figure 129. Abaqus Skin FEA strain gauge position #3 micro-strain (semi-translucent plot).

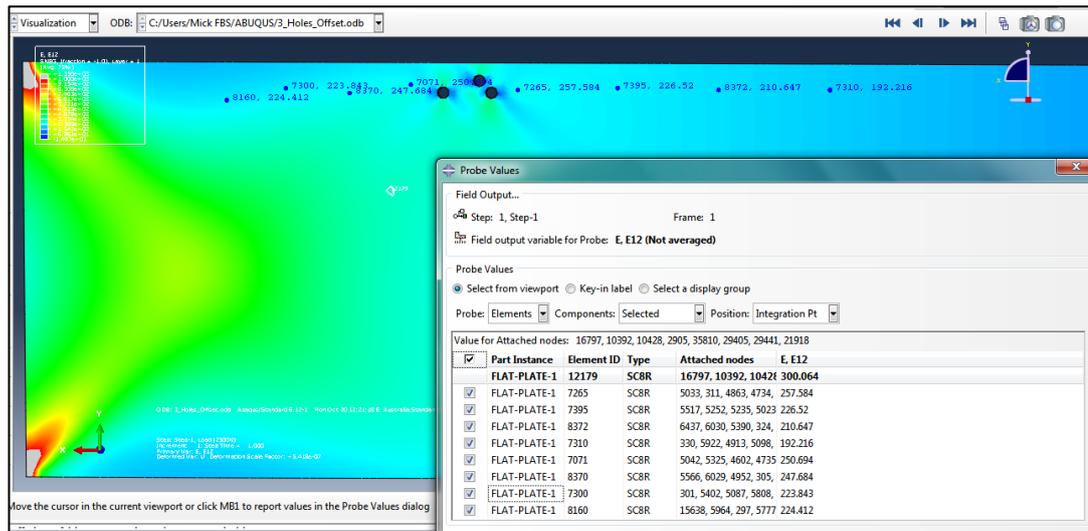
Figure 137. Test 9 FEA simulation micro-strain values.
