# **INVESTIGATION IN FAILURE ANALYSIS AND MATERIALS SELECTION IN TOTAL HIP REPLACEMENT PROSTHESIS**

A dissertation submitted by

**Courses ENG4111 and ENG4112 Research Project**

**Bachelor of Mechanical Engineering**

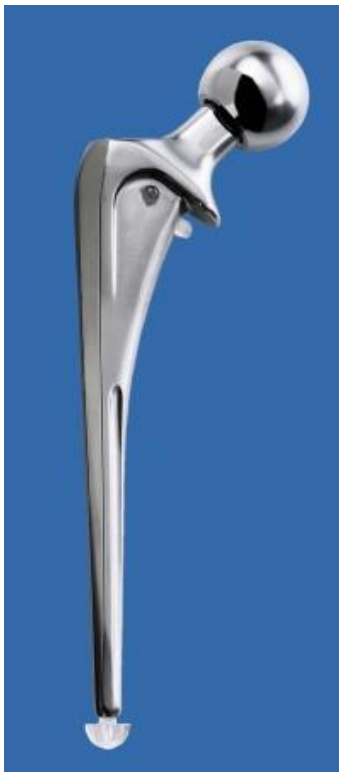
For femoral components with cemented fixation, acrylic cement becomes the standard (Harkess and Crockarell 2013). The cemented stem is placed in a neutral position within the canal to reduce the chance of thin cement mantle areas. The stem design needs to have various sizes available. The reason for this is to allow the stem to take up approximately 80% of the medullary canal cross sectional area. The optimal cement mantle is 4mm proximally and 2mm distally. The method used to create more uniform cement mantle and centralize the stem within the femoral canal is applying PMMA centralizers that are affixed to proximal or distal of the stem (see figure 2.4.1.1 below).

Figure 2.4.1.1: Integral proximal PMMA spacers and additional centralizer facilitate proper stem position and uniform cement mantle. (Harkess and Crockarell 2013)

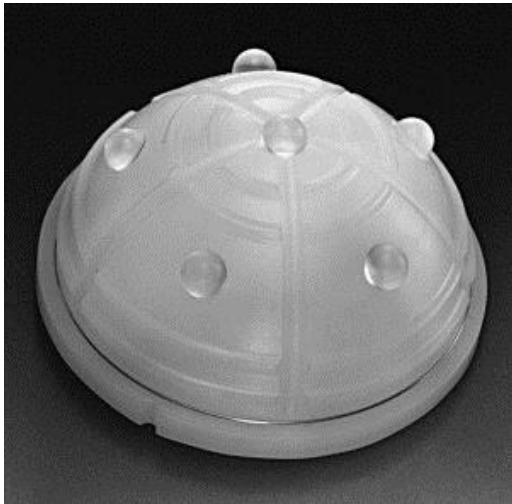
The acetabular socket for cemented fixation method originally used thick-walled polyethylene cups. The external surface was grooved to increase stability within the cement mantle. Figure 2.4.1.2 shows a typical type of cemented acetabular component that use polymethyl methacrylate spacers and textured surface to optimize the prosthesis and cement mantle interface.

Figure 2.4.1.2: Acetabular component designed for cement fixation (Harkess and Crockarell 2013).

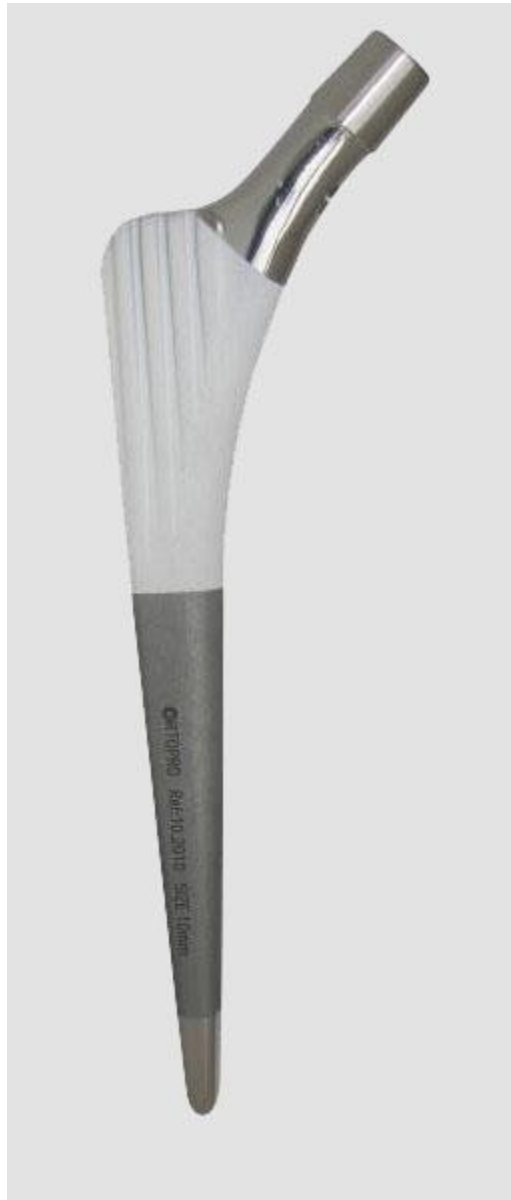
Figure 2.4.2.1: Troy Press-fit / HA Coated Cementless Femoral Stem (Covision Orthopaedics 2012)

Figure 2.4.2.1 shows a press-fit hydroxyapatite (HA) coated cementless femoral stem. This particular femoral stem uses cast titanium as the primary material. More analysis on materials selection for femoral stems will be provided in chapter 4.

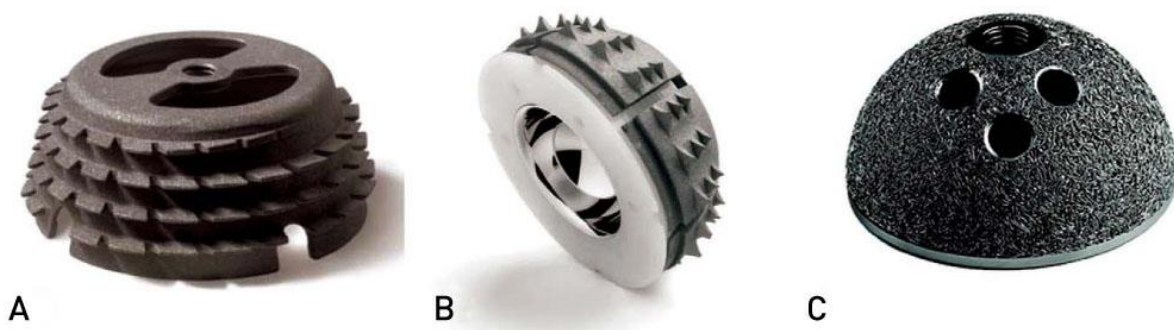
Figure 2.4.2.2: Cementless acetabular cups with different types (Yoon, Park and Lim 2013).

There are many types of cementless acetabular components. Figure 2.4.2.2 show some of the common types: A is the threaded type, B is expansion type and C is hemispherical type. When using cementless implants, the interaction between the bone and implant, bone quality and implant materials are the main factors that determine the survival rate and how successful the long-term follow-up fixation is. In general, this type of implant has shown high success rate in primary THR and relatively good performance on long-term follow-up (Yoon, Park and Lim 2013).

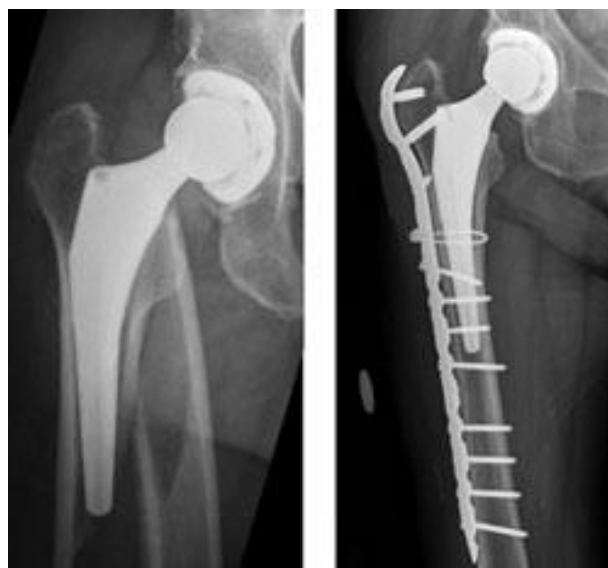
Figure 2.5.4.3b: X-ray taken shows the periprosthetic fracture (left) and the fracture has been treated with plate, screws and cable (right) (AAOS 2013)

Most cases of fractures require surgery. If the implant is still attached firmly to the femur, an internal fixation treatment is introduced. The bone fragments are first repositioned and held together with special screws, cables or by attaching metal plates to the outer surface of the bone as in figure 2.5.4.3b above (AAOS 2013). In some other cases, the stem of the implant is loose and to treat the periprosthetic fracture, the old implant has to be removed and replaced by a new implant. This is called joint revision.

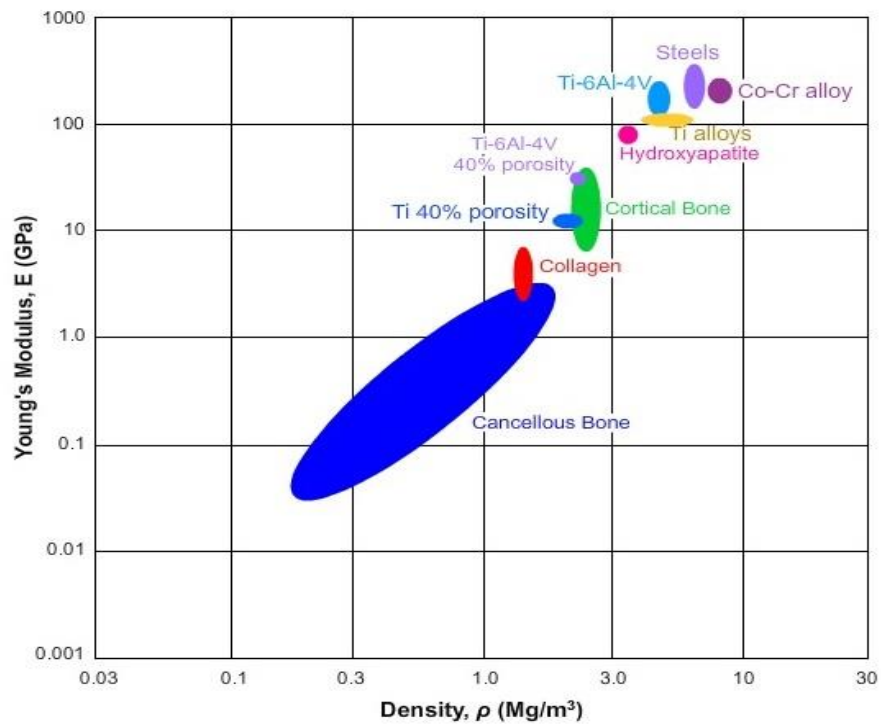
**Femoral stem replacement:  
Modulus - Density materials selection map**

**Femoral stem replacement:  
Toughness - Modulus materials selection map**

Figure 4.1b: Materials Selection Maps showing some of the most commonly considered metals for femoral stem replacements (reproduced from Capes and McCloskey 2006)

The first materials selection map on the top of figure 4.1b compares modulus and density of different types of bone and the common used materials. It can be seen clearly that steels have the highest Young's modulus and much higher than that of bone. This means that stress shielding will be a serious issue if choosing steels for designing femoral components. The American Iron and Steel Institute (AISI) type 316L is the primary stainless steel that is currently recommended for manufacturing implant devices (Newton and Nunamaker 1985). Many studies including Manivasagam, Dhinasekaran and Rajamanickam (2010), Hornberger, Virtanen, and Boccaccini (2012) and Raval and Choubey (2005) have shown a concern about the biocompatibility of 316L stainless steel and its corrosion resistance in vivo. Even though stainless steels are highly resistant to corrosion in nature, but localized corrosion can be found in these alloys when using in certain environment such as human body. These studies also mentioned that the corrosion products under corrosive attacks could be very harmful for humans. Aksakal, Yildirim and Gul (2004) reported that allergens such as cobalt, nickel, chrome and their compounds are found in stainless steel's corrosion products. Morais et al. (1998, 1999) claimed that 316L stainless steel releases toxic corrosion products to osteogenic cells. The differentiation and proliferation of these cells are also affected. Beyond a certain concentration of this may disturb the normal behavior of marrow cell culture.
