**Investigation into the Delamination of Composite Laminates on  
Aircraft Rudders due to Fluid Ingress and Icing**

**Samuel Gordon Campbell Pike**

**ENG4111 and ENG4112 Research Project**

**Bachelor of Engineering (Mechanical)**

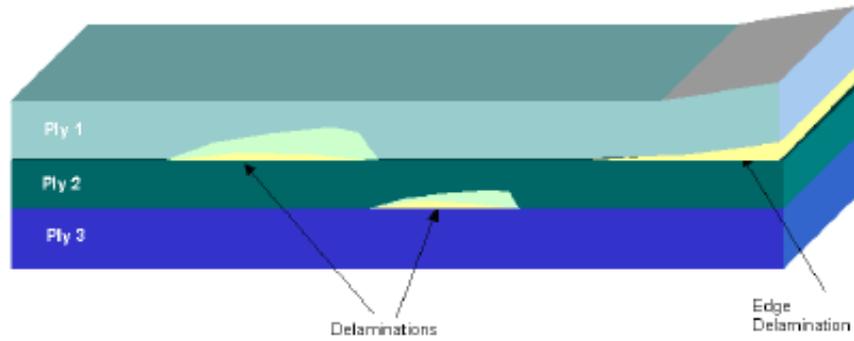
**Figure 8: Delamination (Russell & Street 1985)**

Delaminations in the fibre composite laminates Figure 8 are caused by many different factors: impact damage and subsequent cracking with the cyclic loads imposed on the airframe wing structure, UV and adhesive degradation after many years of flight loads and sun damage imposed on the airframes, and in the case of sports or experimental aircraft with the use of bonded joints, disbonding can occur when improper manufacturing techniques are carried out on non-pressurised aircraft (Authority 2010).

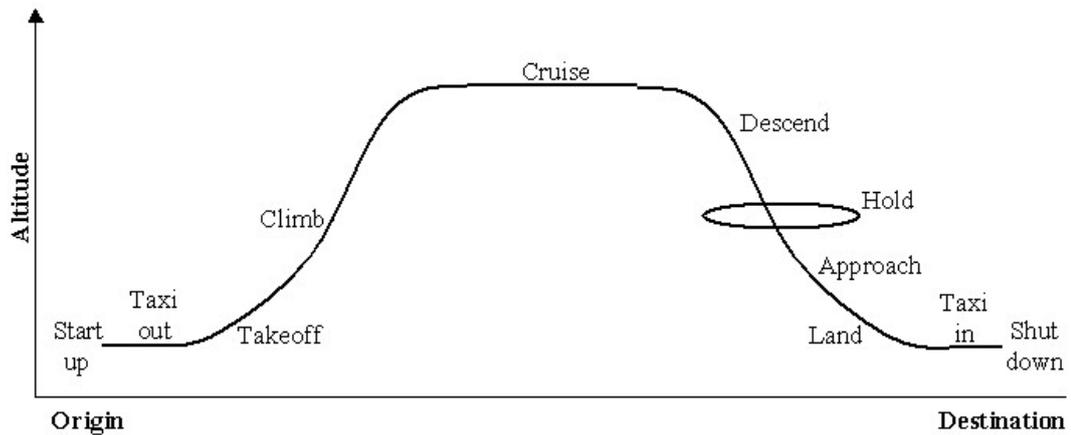
**Figure 9: Flight Cycle Profile of Aeroplane (Avionics 2000)**

Moisture Ingress into composite structures is one of the main causes of delamination in composite aircraft. What makes this mechanism especially problematic is what happens to the fluid when it is trapped inside an aircraft component. The Ground Air Ground cycle works by as an aircraft is climbing through 8000 feet, the fluid inside the composite laminate transitions from a liquid to a solid. While the aircraft is in cruise the fluid solidifies into ice, then as the aircraft descends back through 8000 feet the trapped ice thaws into a liquid state again.

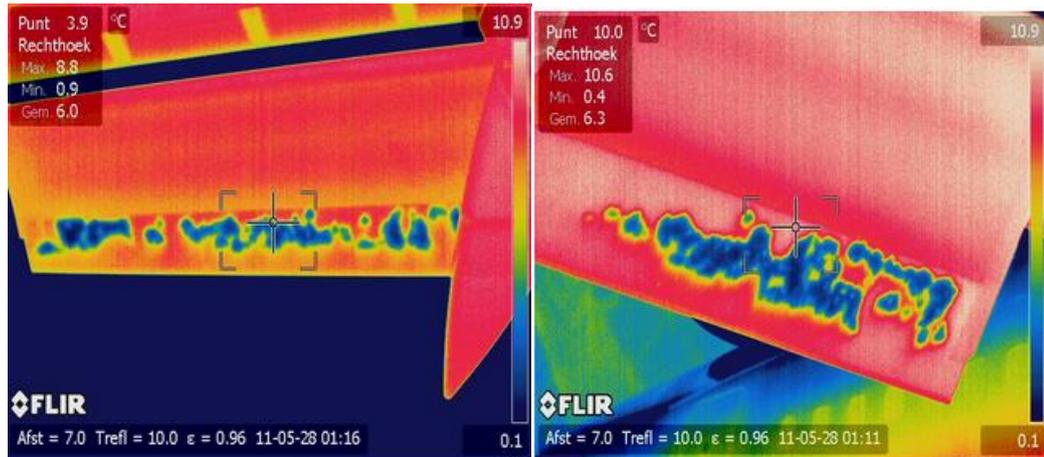
**Figure 11: Water Ingress in Flap of B767-200 (BV 2015)**

Many maintenance organisations have started to use Forward Looking Infrared Imaging Systems (FLIR) systems to detect moisture ingress in composite flight controls post flight. These tests have to be performed within an hour of the aircraft landing while there is a temperature differential between the ambient air and the temperature inside the composite flight control.

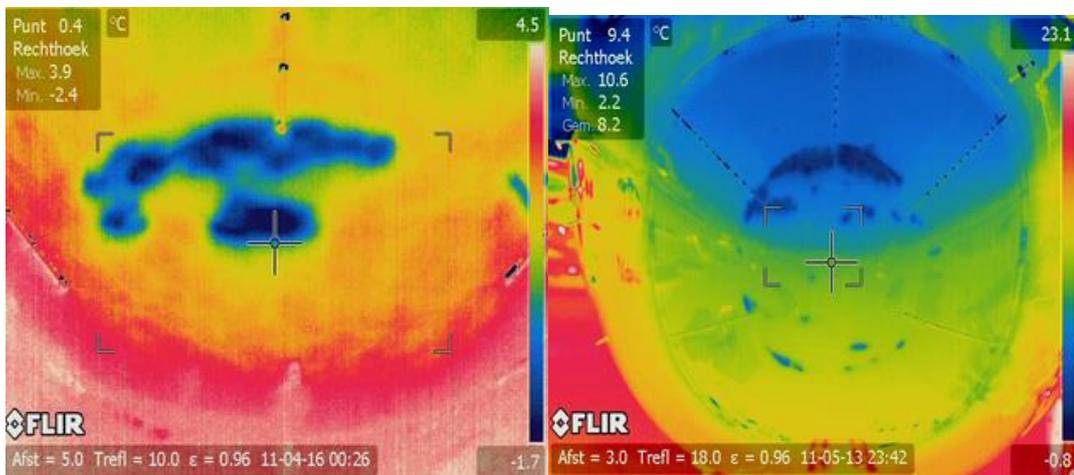
**Figure 12: Water Ingress in Radome of B767-200 (BV 2015)**

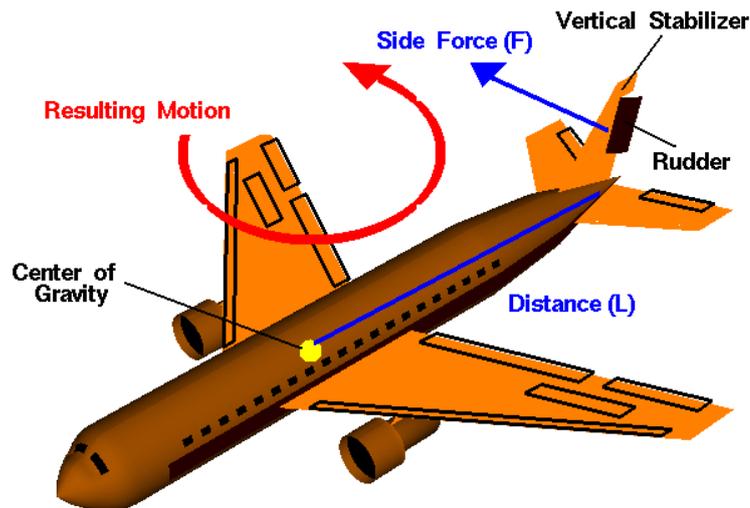
Figure 13: Vertical Stabiliser - Rudder (Benson 2014)

The vertical stabiliser which is attached to the rudder is used to prevent a yawing motion of the aircraft (Figure 13). The Rudder which is connected to the vertical stabiliser by hinges acts like a small tab varying the amount of force placed on the vertical stabiliser. In this way the yawing motion of the aircraft is controlled (Benson 2014).

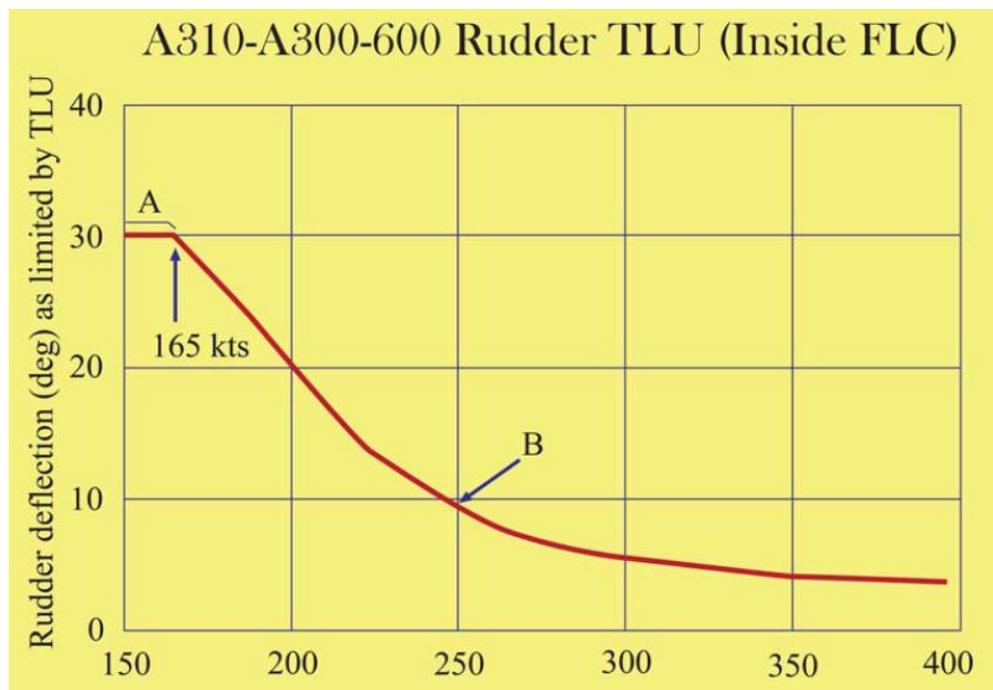
**Figure 14: Rudder Limiting System of the Airbus 310 (IFALPA 2010)**

In normal flight conditions, maximum design loads are never supposed to be reached because of a rudder limiting system. This provides reduced movement to the rudder as the speed of the aircraft increases. The operation of this system is as follows; as the speed of the aircraft over the ground increases, the rudder angle required to positively control the aircraft decreases, this is also transmitted through to the rudder pedal and the associated forces applied to the rudder also decrease. Therefore ‘Rudder travel is limited as a function of aircraft speed’ (IFALPA 2010).

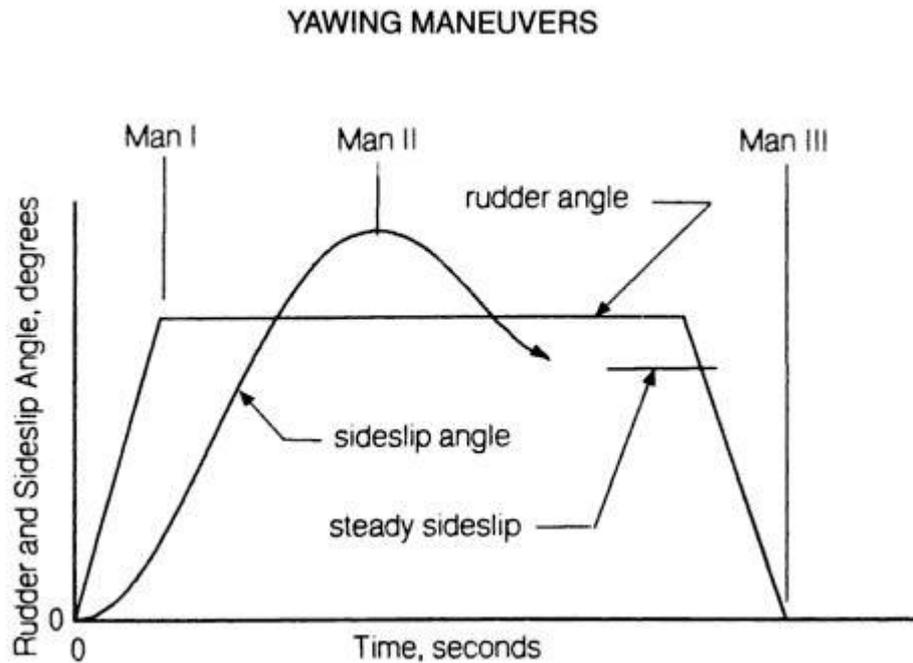
Figure 16: Aircraft Rudder Design according to FAR 25.351(a) (Lomax 1996)

These rudder conditions are labelled in (Figure 16) as Man I, Man II and Man III. In modern aircraft the loads applied on the rudder pedals are further reduced to around the 200lb mark by the advent of hydraulically operated flight controls, which relieves the force required to push the rudder pedals to excite a rudder movement.

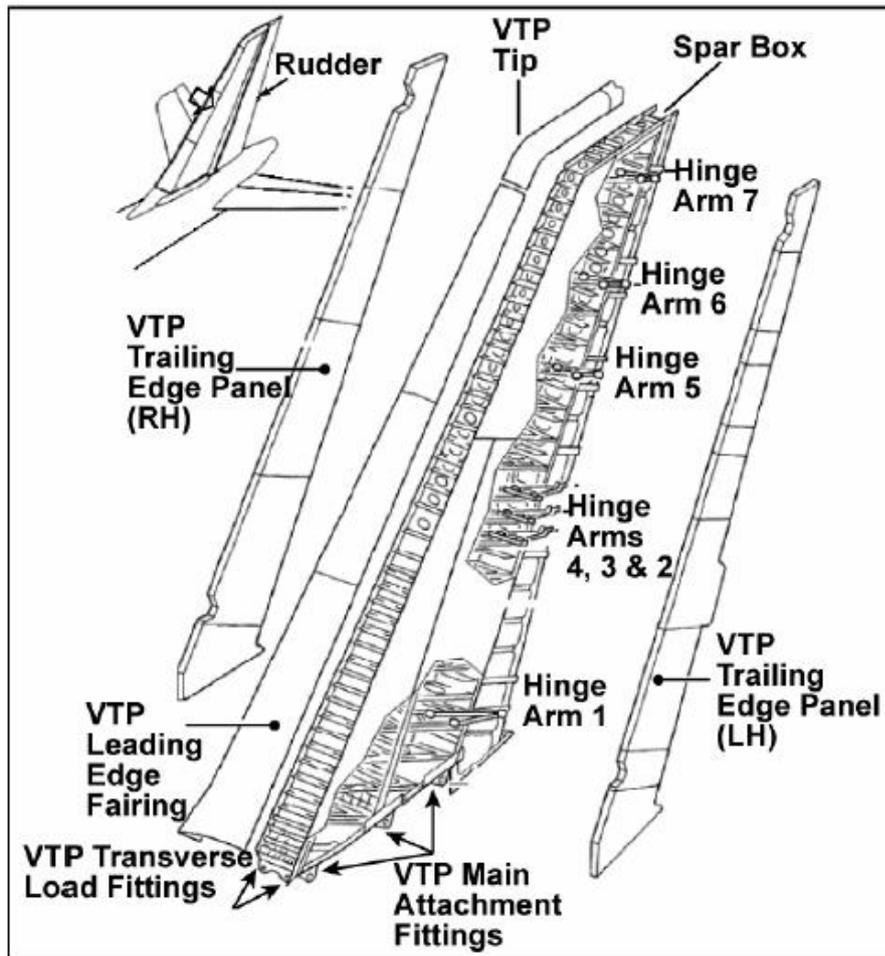
Figure 18: Vertical Tail Plane (Board 2005, p. 5)

The Spar box is an arrangement of trailing edge panels, 2 laminated (CFRP) spars (front and rear) plus a smaller spar extending to rib 5 which have transverse loading fittings on the fuselage side. 18 (CFRP) ribs, including the top and bottom rib encompass the edges of the box arrangement. The trailing edge spar has an aerodynamic fairing attached to it to fill the space between the rear of the VTP and the leading edge of the rudder (Board 2005, p. 5).

The rudder (figure 18) is made up of a front spar and fairing, two side panels made from single piece constructed Nomex aramid – based honeycomb core, (CFRP) face sheets, (GFRP) intermediate layer connecting the honeycomb to the CRFP face sheets and a layer of Kevlar on the interior face to act as a moisture barrier. The thickness of the side panels varies with the location on the rudder because flight loads are different at different locations.

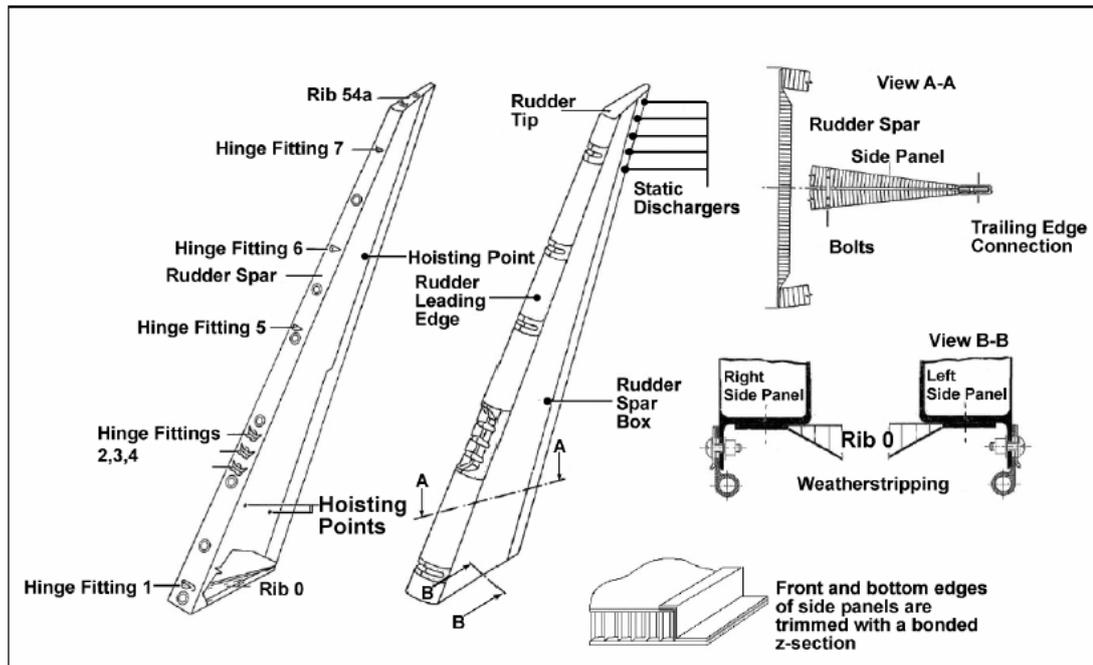
Figure 19: Rudder Design (Board 2005, p. 7)

The construction of the rudder skin (Figure 19) is a composite of an outer layer of CFRP factsheets over a GRFP layer then connected to the Nomex Honeycomb Interior. The CFFP layer acts as the structural layer and the Film Adhesive layer above is a protection against water ingress and corrosion. Lastly, a lightning strip of Aluminium is placed in 11 places along the rudder to act as lightning protection. The purpose of this lightning strip is to act as a sacrificial anode to direct the lightning through the rudder and out to the static wicks thus, dissipating the energy away from the sensitive composite laminates (Board 2005, p. 7).

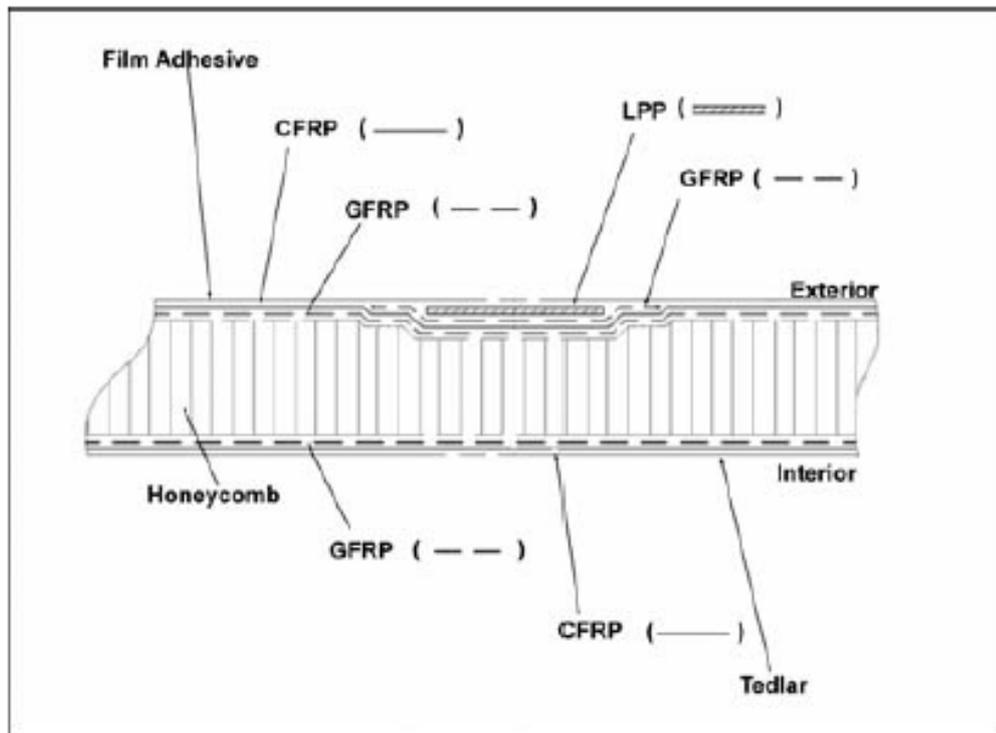
Figure 20: Rudder Side Panel Construction (Board 2005, p. 8)

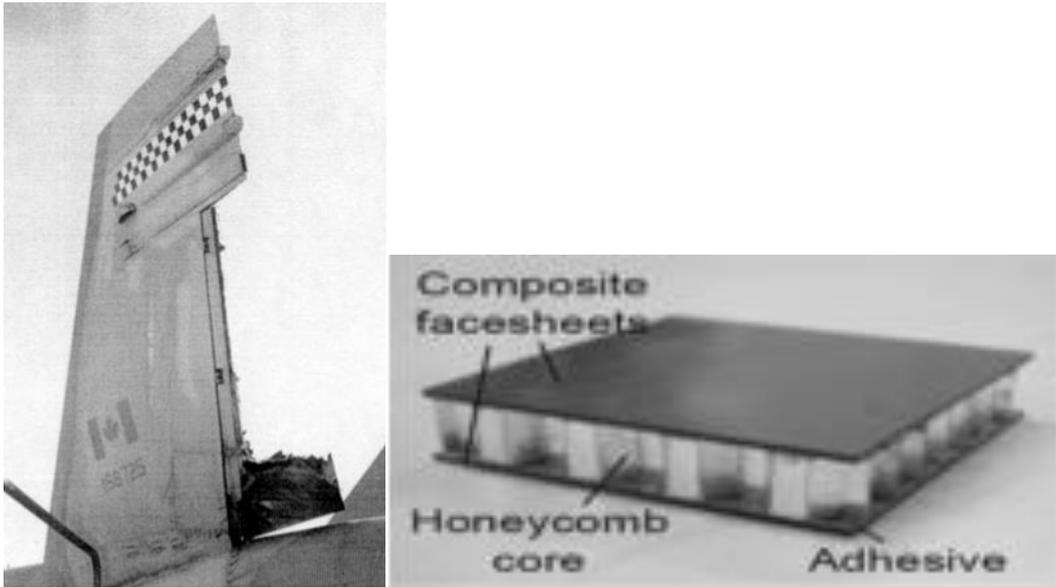
**Figure 21: F/A 18 rudder failure (Edwards et al. 2011) and Honeycomb sandwich (Minakuchi, Tsukamoto & Takeda 2009)**

In 1999, the rudder of an F/A 18 (Figure 21) separated from the aircraft due to long term exposure to water ingress between the Aluminium skin and the honeycomb core. The ingress of water caused the epoxy adhesive to separate the two surfaces and thus lead to the complete failure of the rudder on the vertical stabiliser as seen below (Edwards et al. 2011).

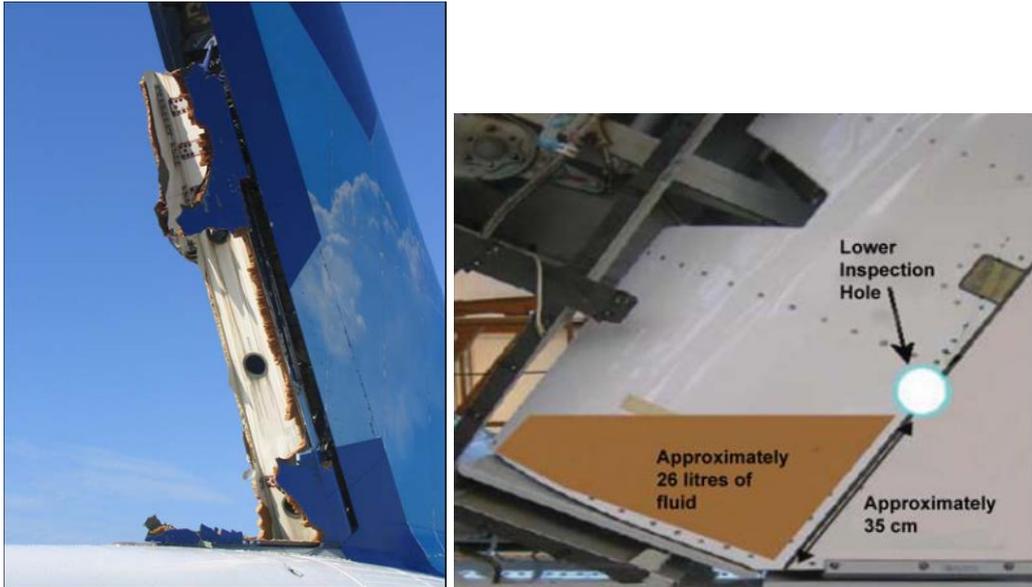
**Figure 22: Airbus 319-300 Rudder Separation and Fluid Ingress into Leading Edge of Rudder (Canada 2005)**

Subsequent inspection of the rudder revealed that only 16% of the rudder remained attached to the aircraft. As from the 1999 accident the Air Safety report revealed that fluid ingress resulting from a lightning strike had allowed a large build-up of fluid in the leading edge of the rudder, causing the honeycomb core to fill with fluid (Figure 22). This led to the flight control fluttering uncontrollably at high speed and thus a failure of the rudder flight control (Canada 2005).

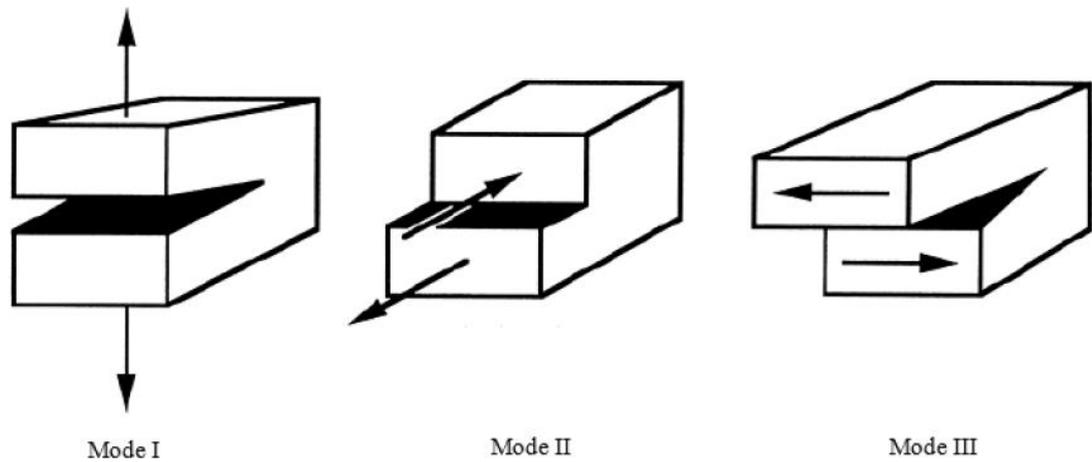
**Figure 23: Three Modes of Failure (O'Brien 2001)**

These three modes of failure are the major contributors of laminate crack growth in composite structures. In many delaminations, it is common to see geometry's mixed mode cracks.

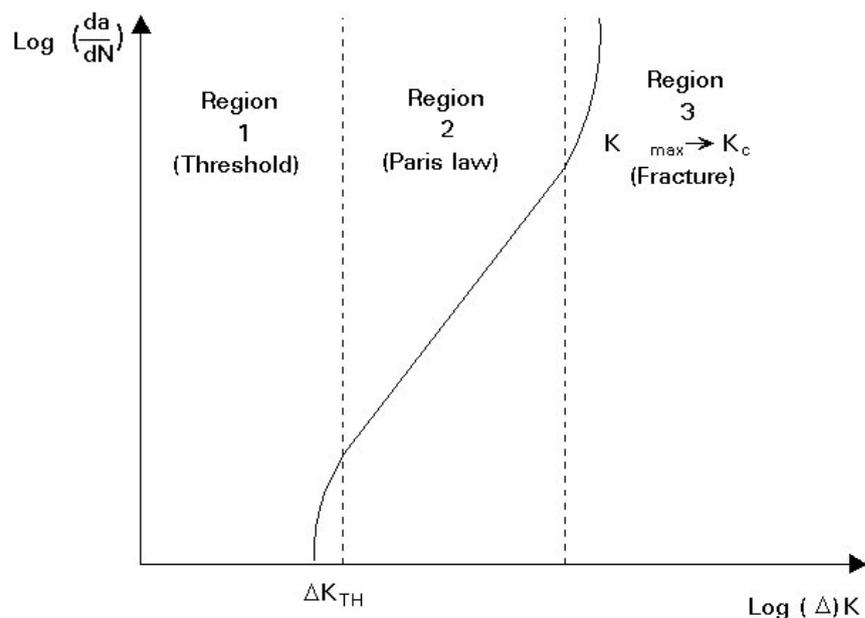
Figure 24: Typical Fracture Mechanics Fatigue crack propagation behaviour (University 2013)

The relationship between the fatigue crack growth rate and the range of  $\Delta K$  (stress intensity factor) can be presented on a graph as  $da/dN$  vs.  $\Delta K$ . Three regions are presented: Region 1 is the threshold region where cracks don't propagate. This threshold region is where  $\Delta K_{TH}$  depends on environmental conditions and average stress. Region 2 is where Paris Law comes into effect by taking the logarithm of both sides  $da/dN$  which should be proportional to the value of  $\Delta K$ . Therefore the slope of the line = m and the position on the line can be determined to be C. Region 3 is where the stress intensity factor approaches the material fracture toughness limit. Therefore at  $K_{max}$  the material fractures (Roe & Siegmund 2003).

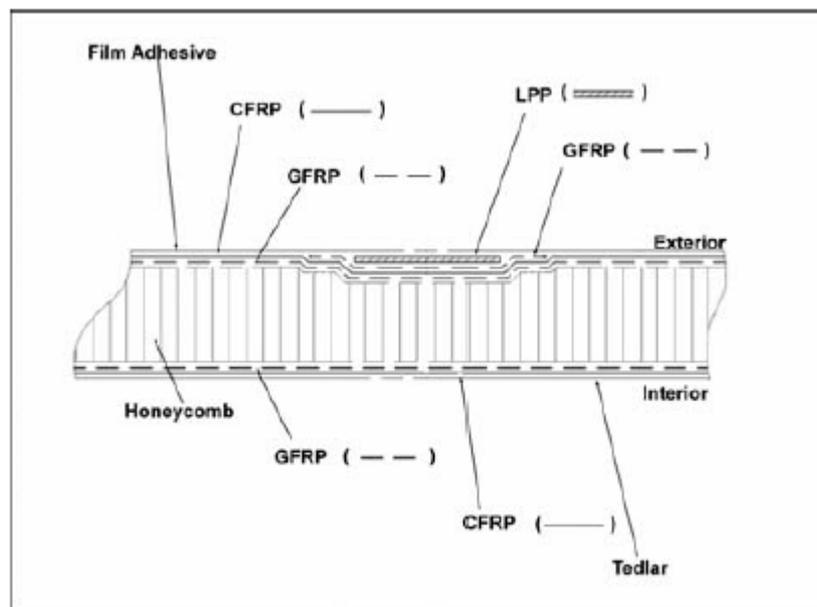
**Figure 26: Rudder Laminate Composite to base the Abaqus model (Board 2005)**

Using an Abaqus CAE 6.13 a model of a Rudder Composite laminate was formed based loosely on the makeup of an Airbus 310 rudder laminate sandwich. An actual rudder laminate was used to base the construct of the Abaqus model as seen from the figure below.

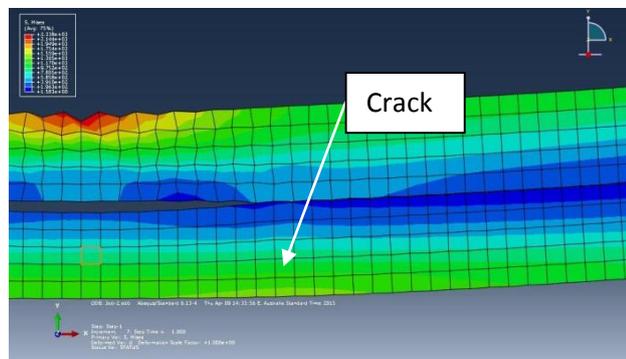
**Figure 28: Close up View of crack propagation with 10mm central loading**

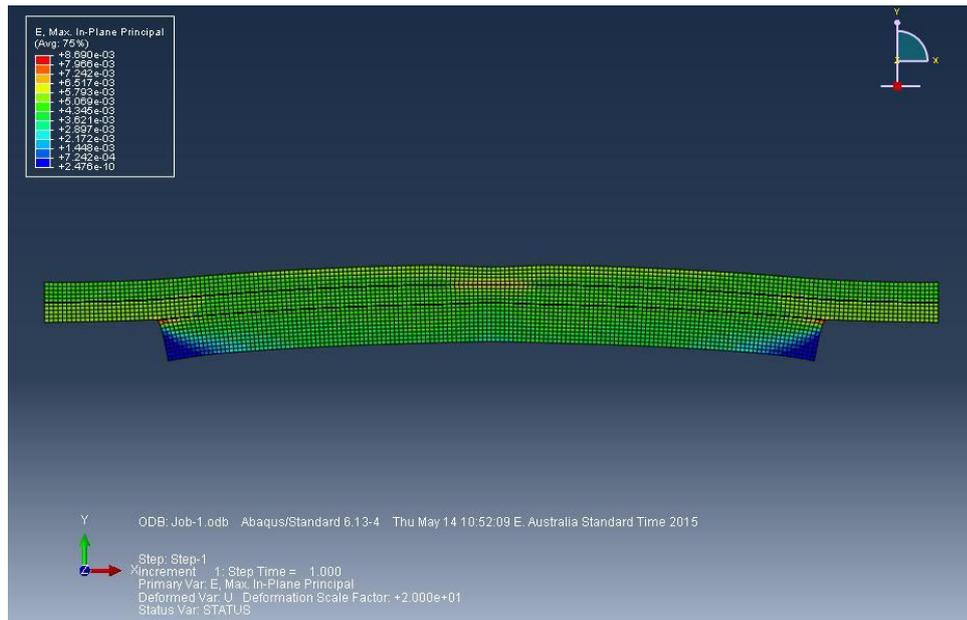
Figure 29: 1mm Tensile Buckling using Abaqus Model (without water)

In order to gain an understanding of the results that I might see during testing, I needed to first do some FEA modelling in Abaqus 6.13. Figures 29 and 30 below simulates via 2D analysis, a fibre composite laminate attached to a honeycomb core sample without ice. As the tensile and compression load is applied to both ends there is a buckling occurring along the fibre laminate. All FEA models were meshed to provide accurate data for further analysis.

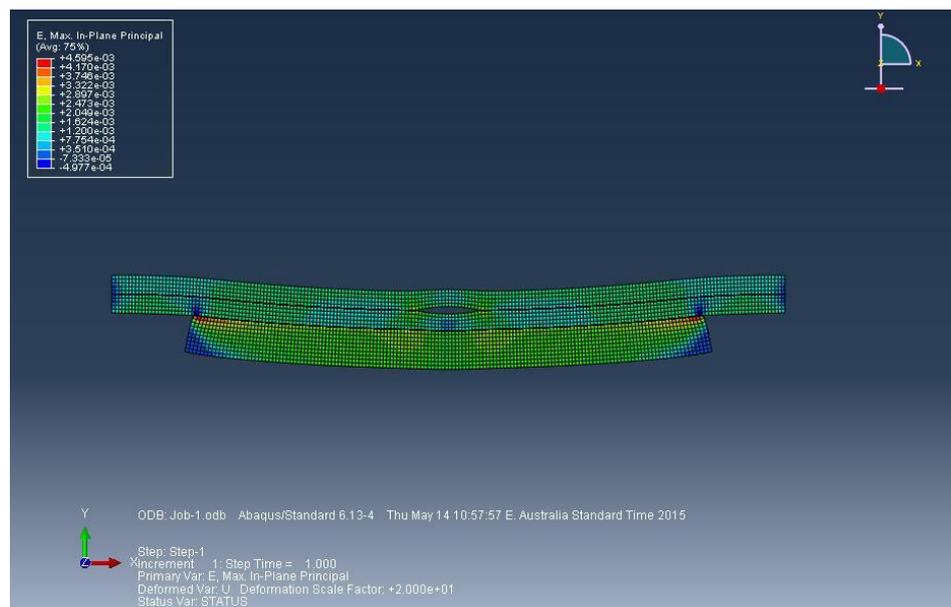
Figure 30: 1mm Compressive Buckling using Abaqus Model (without water)

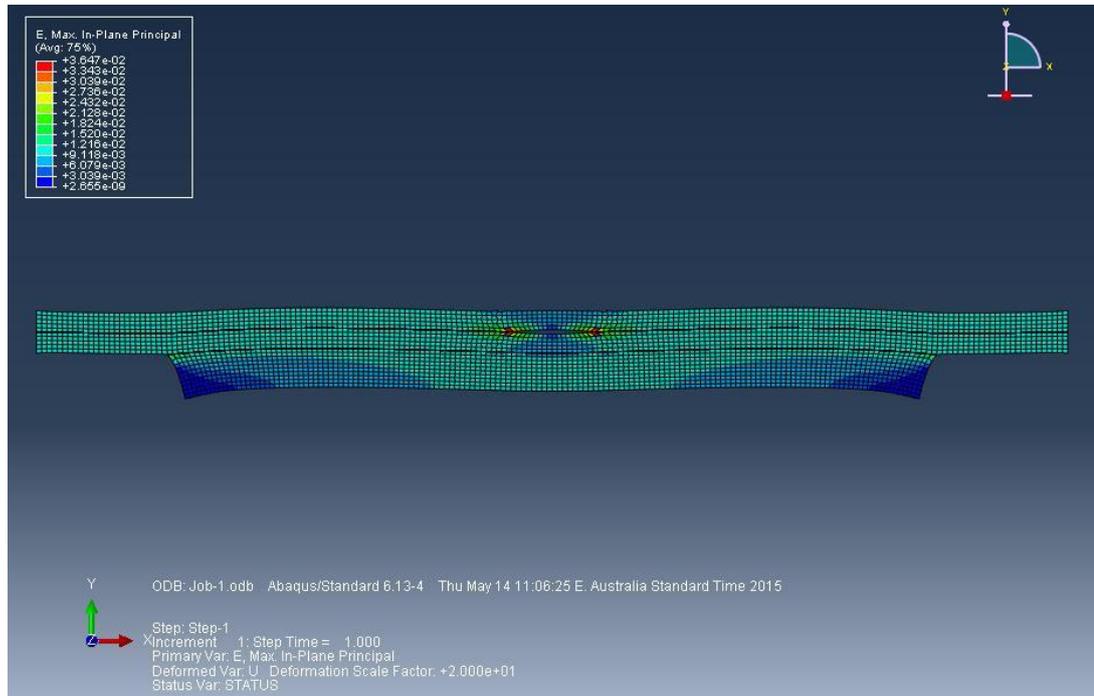
Figure 31: 1mm Tensile Buckling using Abaqus Model (with water)

As with the Figures above, buckling is occurring within Figures 31 and 32 and high stresses are also occurring at the ends of the timber inclusion simulating frozen ice. This is an area that will require further investigation within the testing phase of the project.

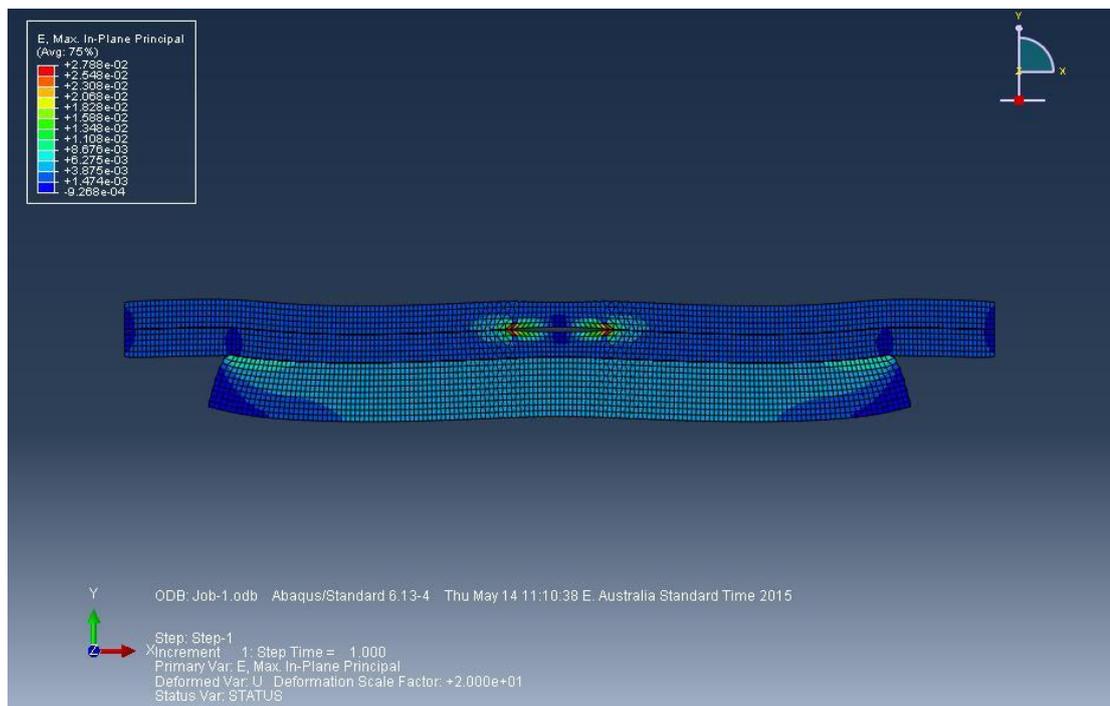
Figure 32: 1mm Compressive Buckling using Abaqus Model (with water)

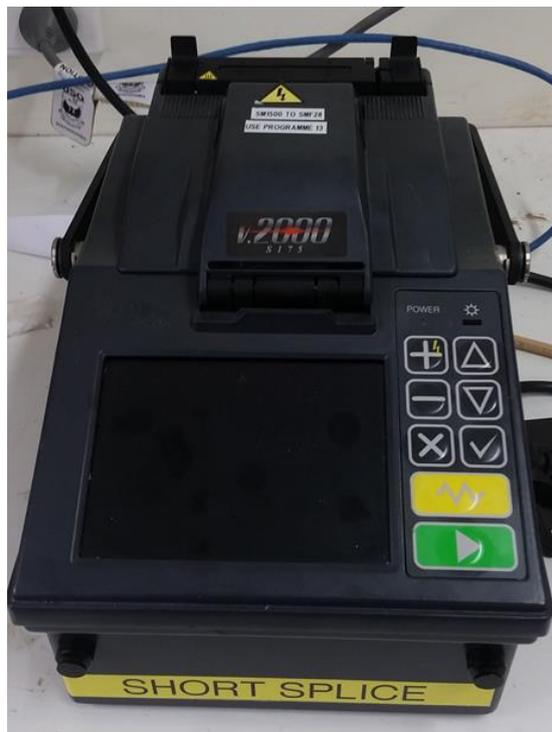
**Figure 36: The Vitel v. 2000 s175 Fusion Splicing Machine**

4. Fusion Splicing Machine: Both ends of the sensor are fused together using the Vitel v. 2000 s175 fusion splicing machine as seen in Figure (36). This is achieved via a three part process; the fibres are located and restrained using a magnetic clamp, they are then aligned, any impurities are burnt off, the ends are fused together, then finally a test is carried out across the spliced ends to verify that the fusion process has been successful.

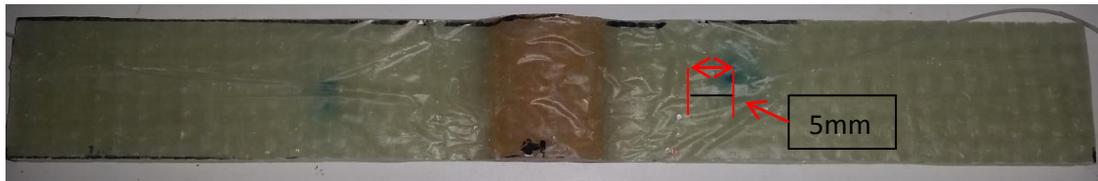
Figure 37: Placement of FBG

The 5mm FBG sensor was located between Strain Gauges #1 and #2 in between plies 6-7 in the fibre composite laminate.

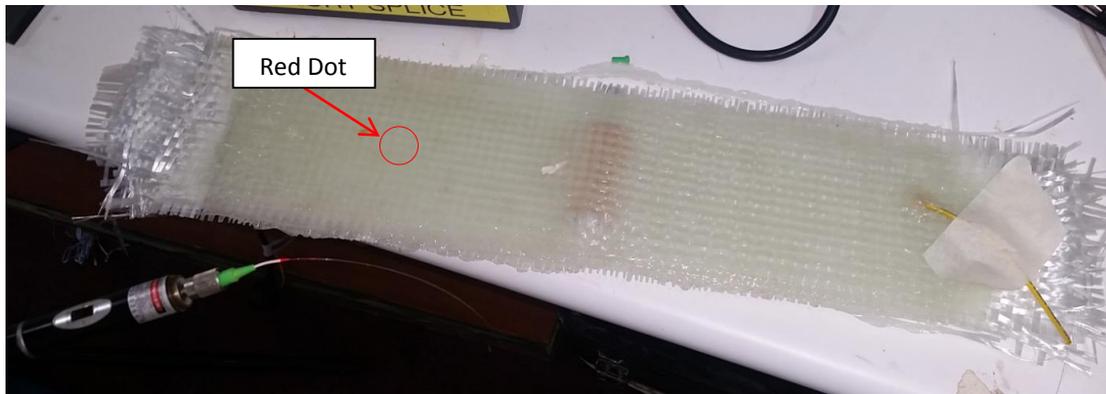
**Figure 38: Visual Indication from Laser Light Source**

end of the extension cable to determine that no part of the optical cable was broken (Figure 38).

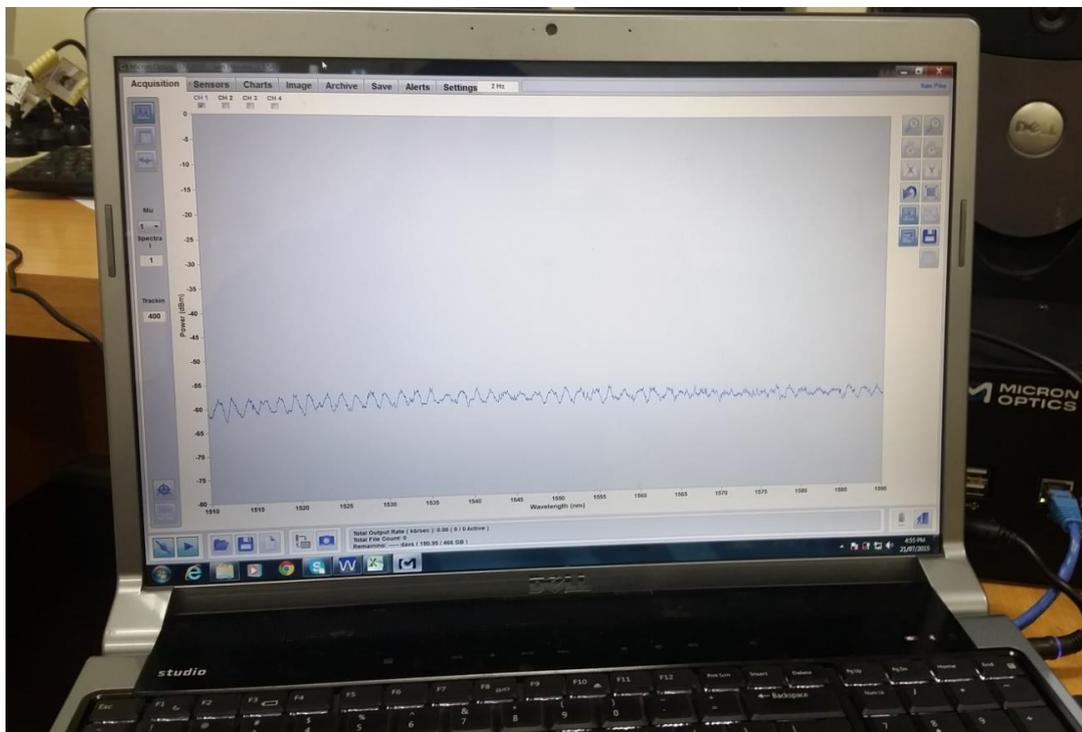
**Figure 39: Test signal validating FBG functionality.**

The second test was to connect the end of the FBG optical extension wire to the sm125 interrogator. The return signal could then be analyzed via a PC using the ENLIGHT – micron software. As a result of this test, the display returned an unloaded functioning signal as displayed in the figure 39 below.

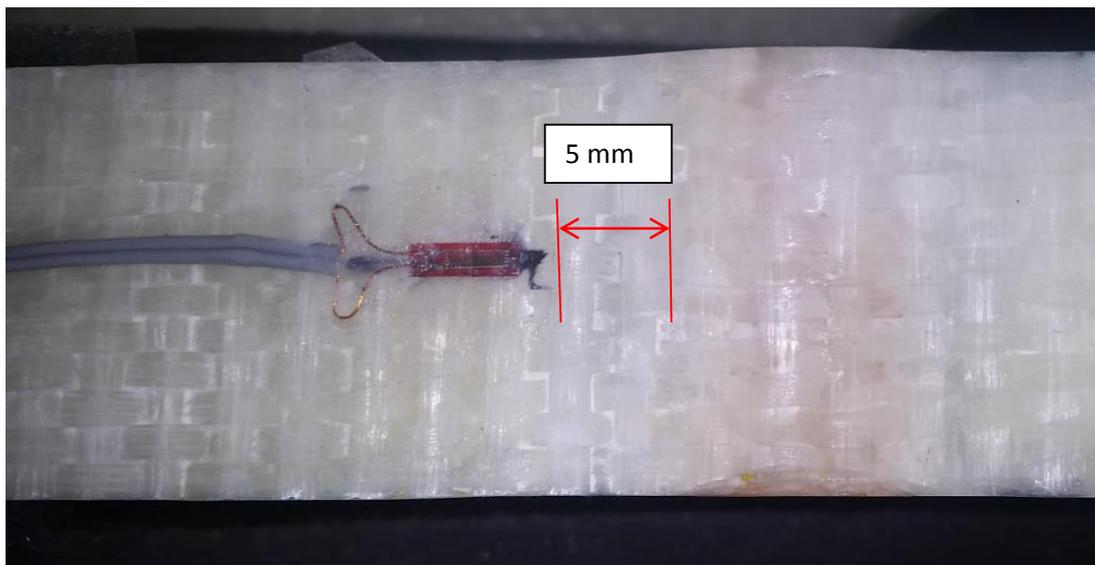
**Figure 40: Upper Strain gauge attachment**

The average cost of an FBG sensor is around the \$200 mark and this project only permitted the use of one of them per student. On the other hand strain gauges are much cheaper and 4 were used on the outside skin of the laminates for both the Tensile and 3 point Bending Samples. Figure 40 and 41 shows the placement of the sensors.

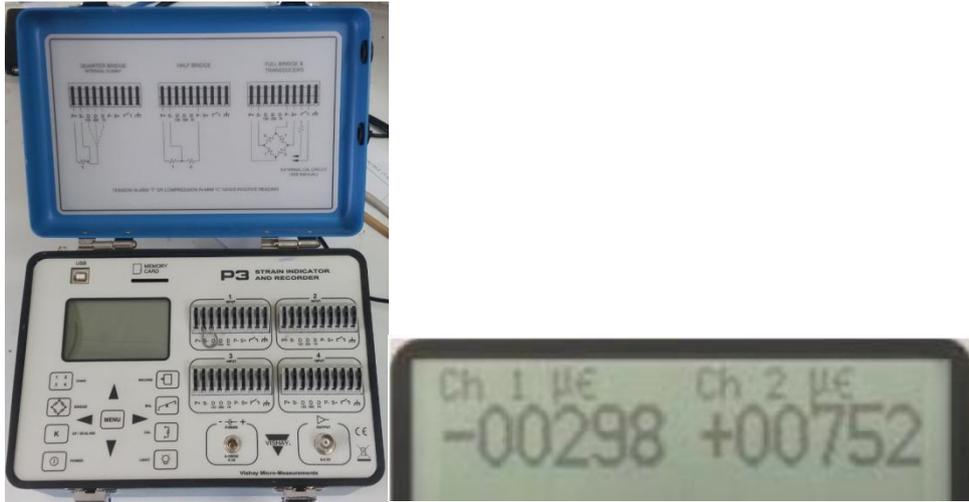
Each strain gauge has 1m of electrical wiring to attach to an electrical connection in this case the Vishay Micro Measurements P3 Train Indicator and Recorder was used to convert electrical resistances into usable data to be displayed on an LCD display. Two strain gauges were used per sample labelled Channel 1 and 2. Figure 44 shows the digital readout of each of the strains for both channels. These numbers were put into graphs which are displayed in Chapter 14.0 Results and Conclusion.

**Figure 42: Micro Measurements P3 Train Indicator and Recorder and LCD display.**

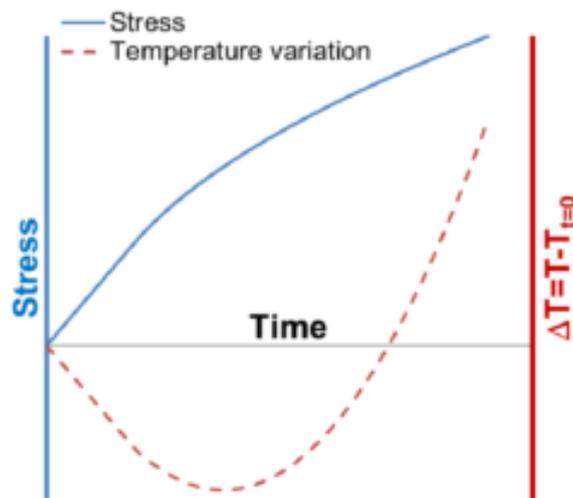
Figure 43: Stress and Temperature Stress as a function of time (Vergani, Colombo & Libonati 2014)

When a static tensile load is applied to a composite homogenous material, an initial decrease in surface temperature occurs as the material stretches elastically. This effect relates to the change in volume of the composite material. As the load increases, the temperature rises linearly till the minimum fatigue limit is reached, then the temperature increases till the material reaches a critical failure point. At the point of failure, the temperature climbs rapidly again. These three stages of thermoelastic stress are shown in Figure 45.

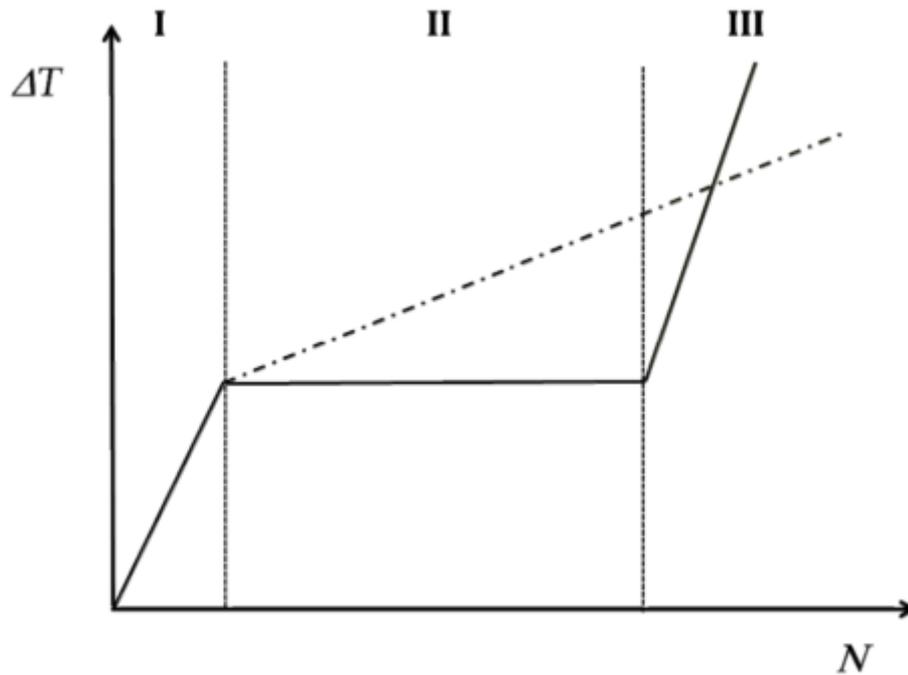
**Figure 44: Thermal profile of each interval (Vergani, Colombo & Libonati 2014)**

Due to the nature of the experiments required for this project, dynamic loading needed to be taken into effect as well as static loading. This would show the temperature increase of the outside surface and thus show crack propagation through the sample. As seen in Figure 44, the solid line is a solid homogenous material without the inclusion of any addition materials and the dotted line is a non-homogenous material and a closer representation of the inclusion of ice in a fibre composite sample.

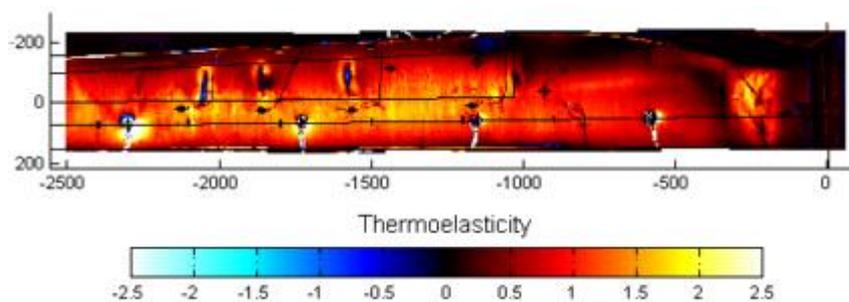
**Figure 45: Thermography data of a turbine blade (Dutton 2004).**

To accurately draw a plot of the damage propagation, only a single area needs to be analysed thoroughly. A typical example of the image that you would see by thermography is shown below in Figure 45. This shows a visual representation of the thermal stress inside a turbine blade and thus can be used as a quick reference tool to see if any further action needs to be undertaken on the component.

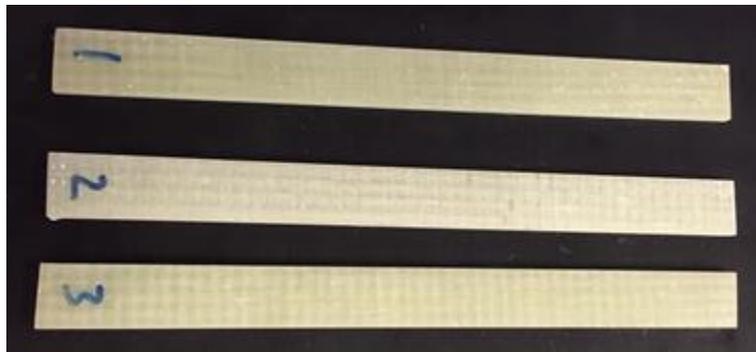
ISO 527-1 p9 (ISO 1996) requires that 5 samples be tested for each of the required testing parameters and more samples to be used if a more accurate mean value is required. In accordance to ISO 2602 it is possible to evaluate this by means of a 95% probability confidence interval. Due to the limited availability of materials for testing, only 3 test samples were able to be made – see Figure 34. Looking at Figure 47, the mean value for the Modulus of Elasticity was determined using these three samples.

**Figure 47: Material Property samples 12 ply 3 x (25 x 250)**

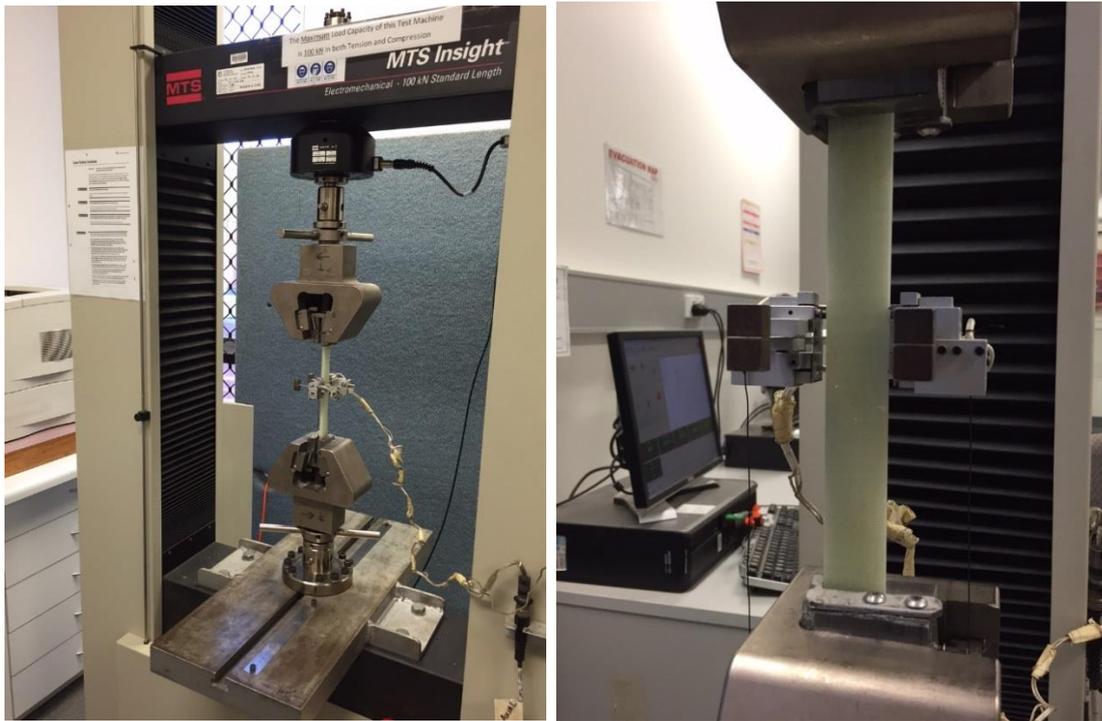
**Figure 48: Tensile Testing Machine (MTS Insight 310).**

The tensile testing procedure was conducted as closely as possible to ISO 527-1 and ISO527-4. The USQ CEEFC MTS Insight Tensile Testing Machine was used for the tensile testing as seen in Figure 48.

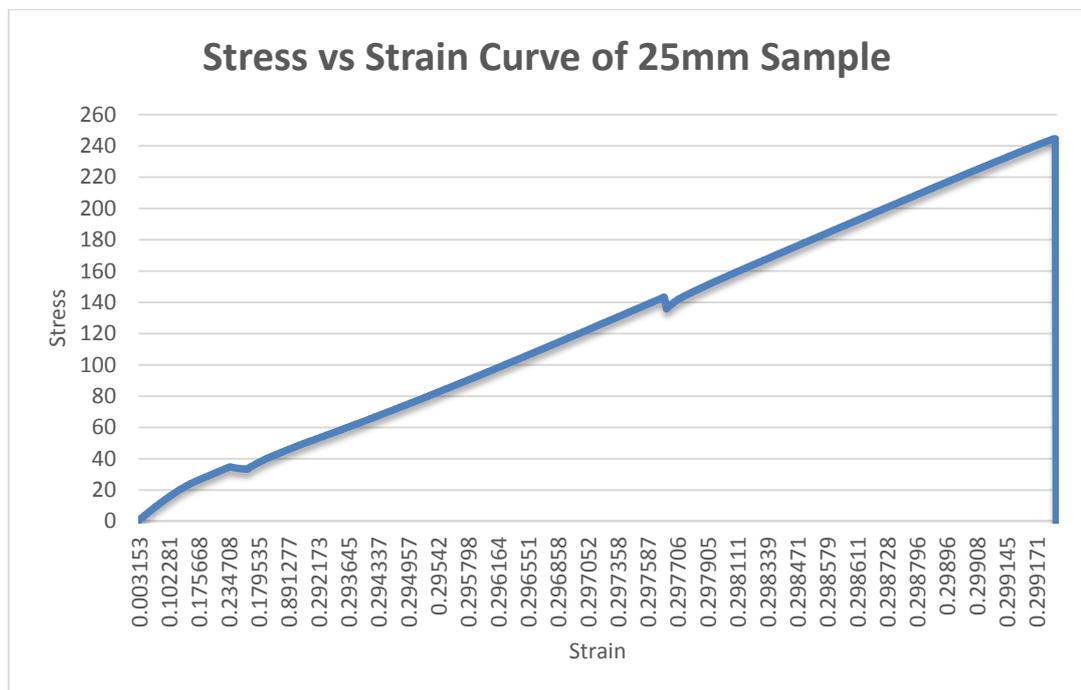
**Figure 49: 25mm Sample Stress vs Strain Graph**

The first dip at the 40Mpa range was caused by the removal of the extensometer; the second dip was caused when the fibres straightened suddenly at the 140Mpa mark. With the increase in stress, the fibres continued to strain eventually causing the sample to fail at an average Ultimate tensile strength of approximately 250Mpa.

Figure 49 below gives an indication of the stress strain curve for the three samples tested.

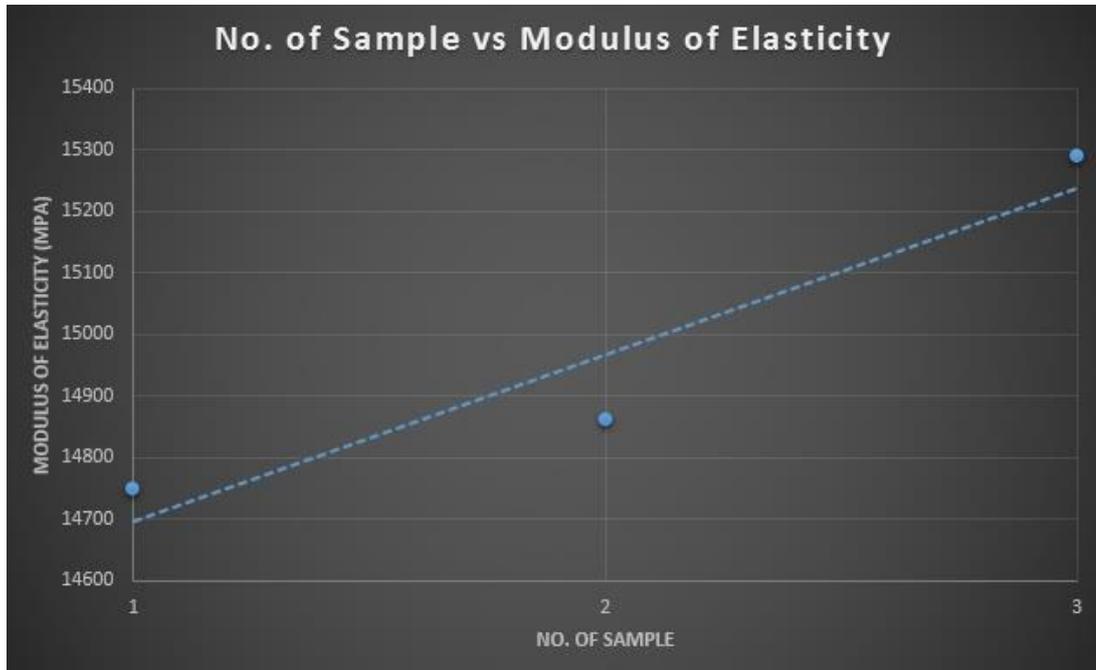
**Figure 50: Average Modulus of Elasticity across 3 samples**

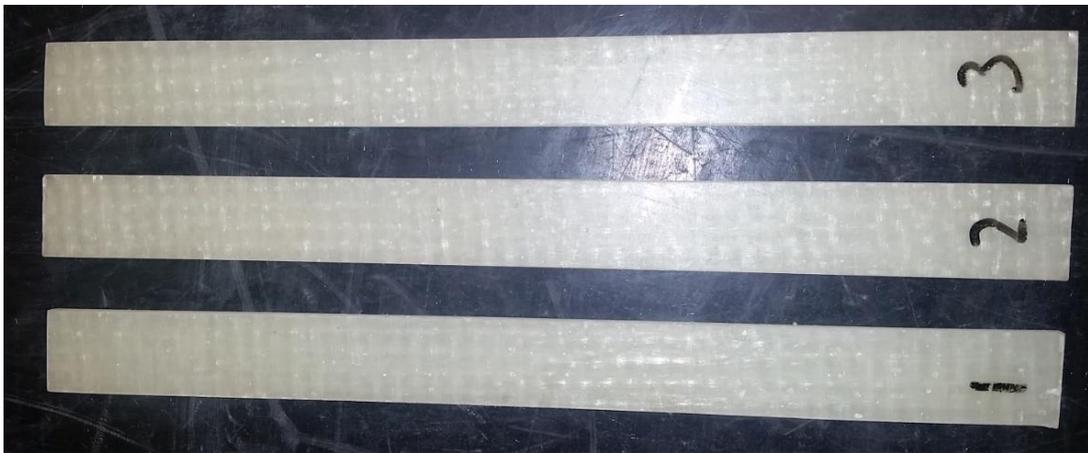
The flexural testing was carried out as close as possible to ISO 14125. The size and quantity of the samples were different compared to the standard due financial constraints. As the force required to break the samples was below 4KN, the MTS 310 testing machine was used instead of the much larger MTS 810 which was used for the tensile material properties testing.

**Figure 52: Three Samples Tested in three point bending**
