**Investigation into the Delamination of Composite Laminates on  
Aircraft Rudders due to Fluid Ingress and Icing**

**Samuel Gordon Campbell Pike**

**ENG4111 and ENG4112 Research Project**

**Bachelor of Engineering (Mechanical)**

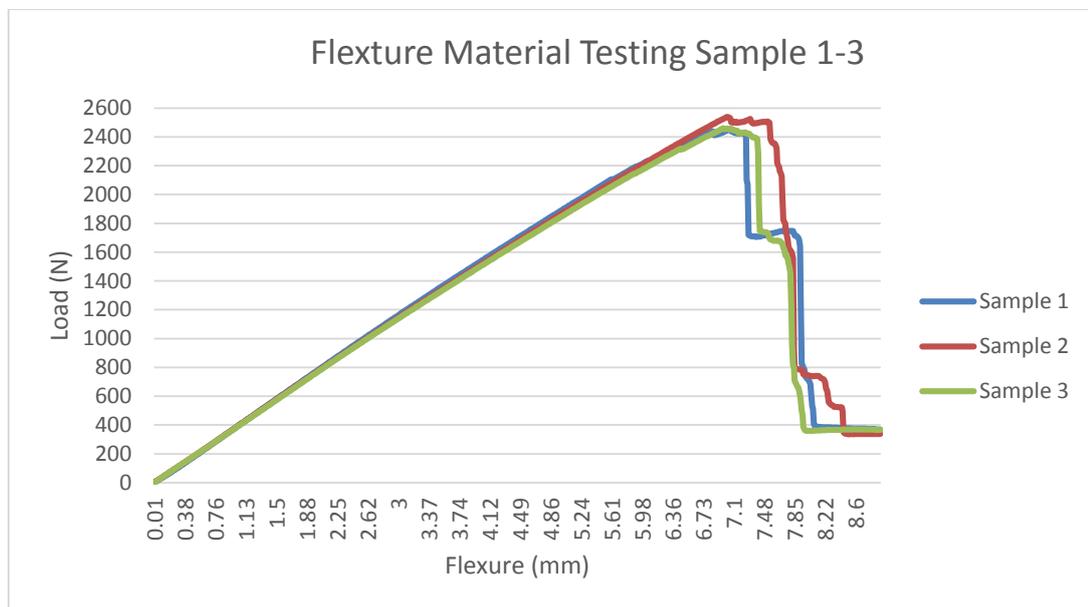
**Figure 54: Flexure vs Load Plot of Three Samples**

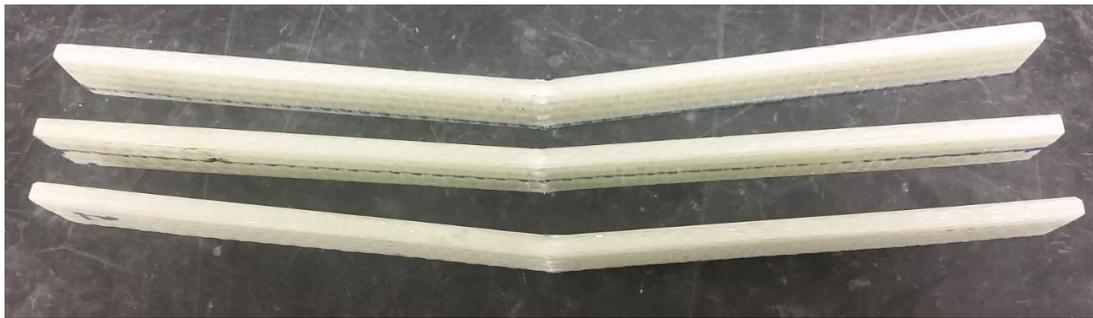
**Figure 56: Flexure Fracture at Outermost Layer.**

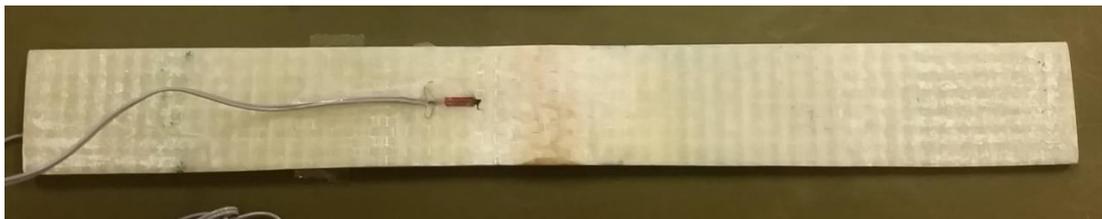
The initial tensile testing sample incorporated two pieces of timber 18mm wide placed horizontally perpendicular to the longitudinal axis at the midpoint of the sample. Two strain gauges were later placed 5mm from the ends of the timber inclusion on plies 1 and 12 on the upper end of the sample.

**Figure 57: First Tensile Sample Top View.**

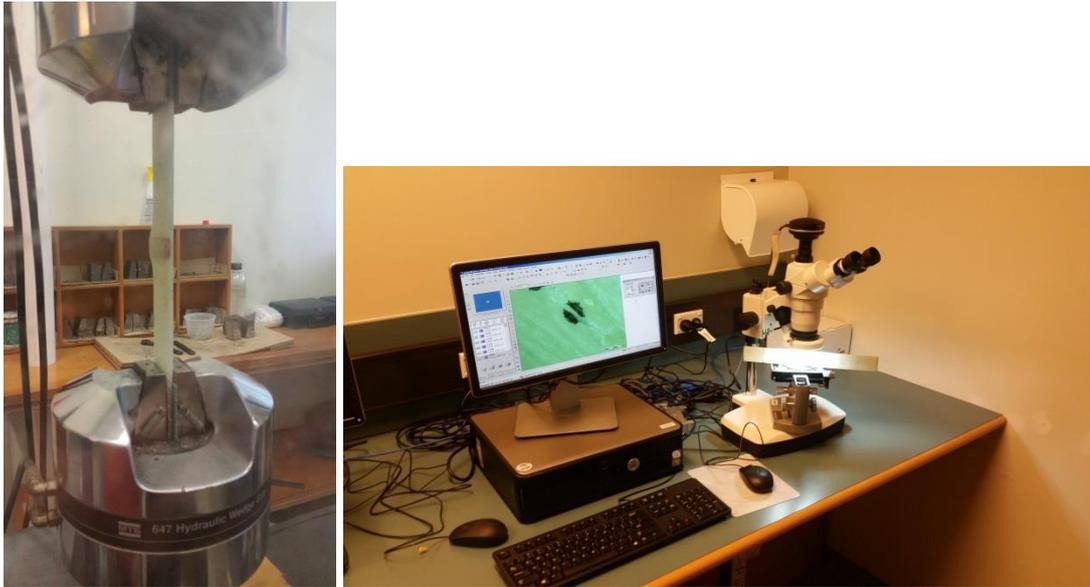
**Figure 59: Initial Testing using 1<sup>st</sup> Sample and Optical Measurement of Crack Propagation**

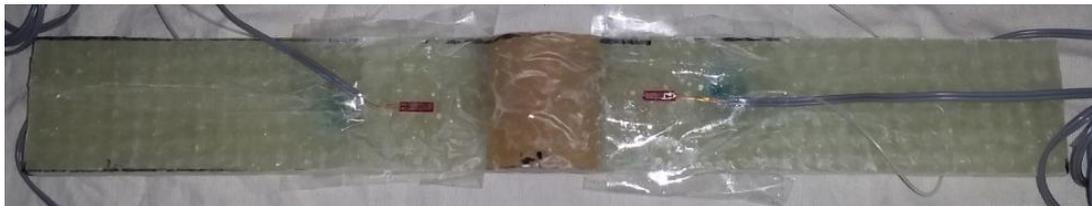
**Figure 61: 2<sup>nd</sup> Tensile Sample Top View**

The Second tensile sample incorporated an FBG sensor placed 15mm from the edge of the block of timber between plies 6 and 7. 4. Strain gauges were placed on both upper and lower surfaces of the samples to detect any cracks over a 5000 cycle time period. An attempt was made with the sample to control the position of the top fibreglass layers over the piece of wood embedded in the sample. This was done with pieces of wood weighed down with a 10lb weights while the sample dried as seen in Figure 62.

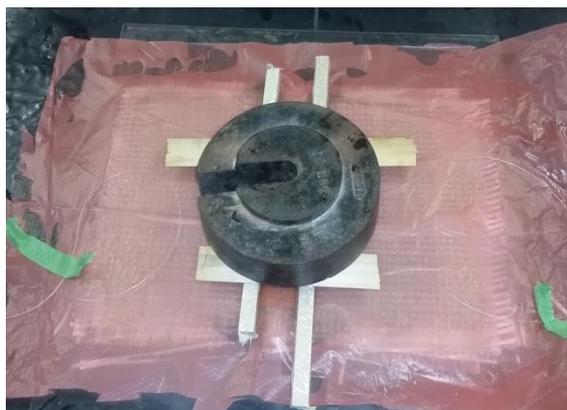
**Figure 62: Controlling the shape of the 2<sup>nd</sup> Tensile Sample**

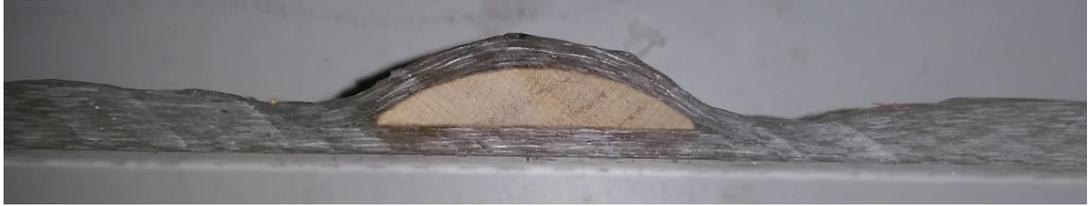
While the pre testing delaminations of the previous sample were eliminated, as seen in Figure 63, the edges were reduced in thickness from 6mm – 4mm. This made for a reduction in the ultimate tensile strength.

**Figure 63: 2<sup>nd</sup> Tensile Sample Side View**

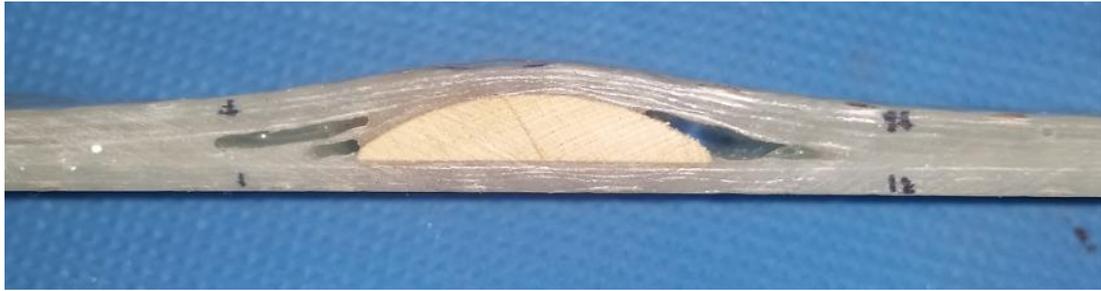
**Figure 66: Front view of Bending Sample**

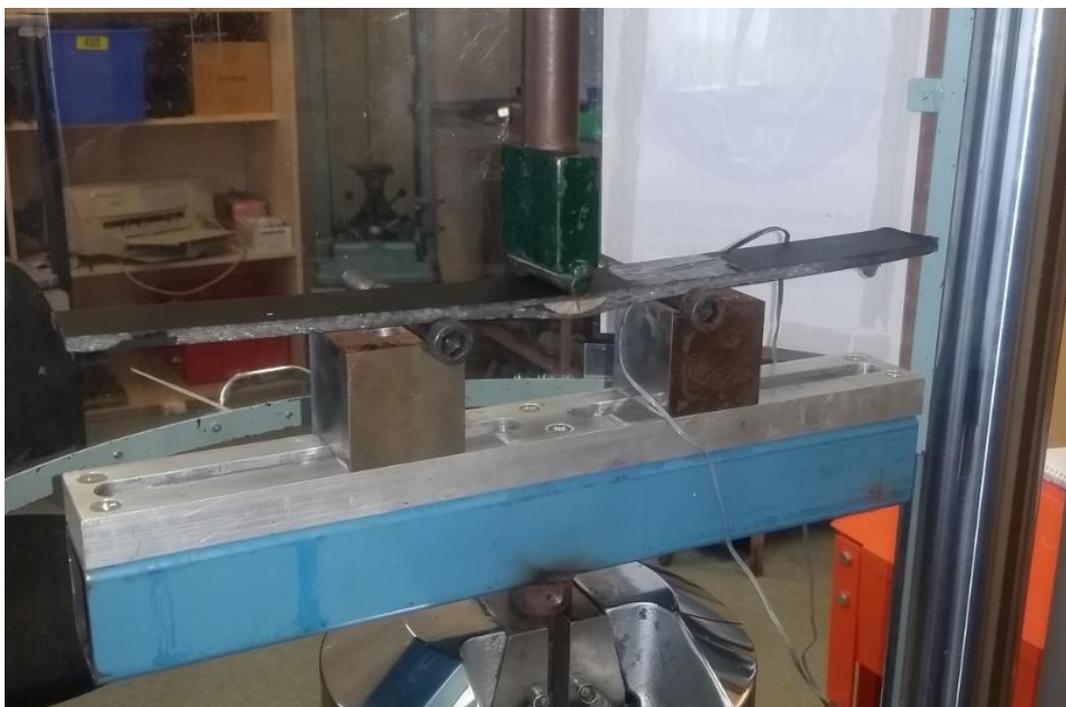
Due to the placement of the strain gauges on the three point bending sample, the lower supports were moved from 88mm apart to 120mm. The testing procedure was modified slightly to handle the increased distance. This increased the ultimate tensile load of the sample from 2.485KN to 3.148KN thus strains were taken in 2KN intervals from 1.600 – 2.400KN see Figure 69.

**Figure 69: Flexure Sample in fixture**

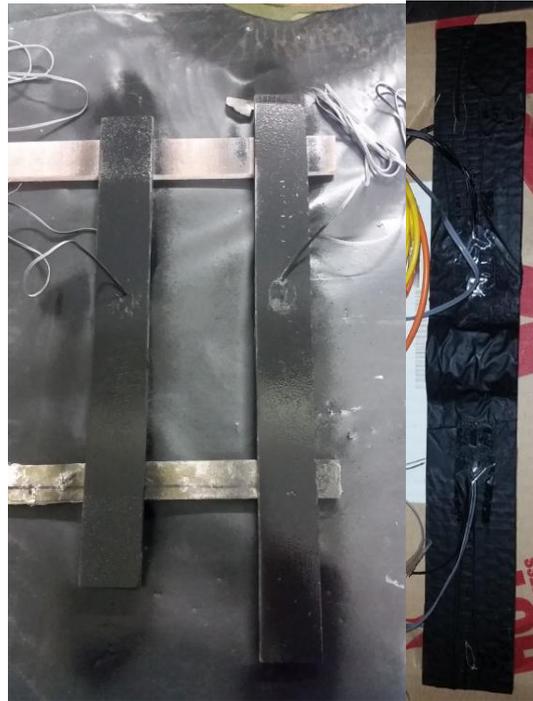
In order to accurately show heat accumulation within the structure of the composite laminate, the first and second tensile samples and the flexure samples were sprayed with enamel matt black topcoat as seen below in Figure 71.

**Figure 71: All three Samples Sprayed Black in preparation for thermographic testing**

This was done to increase the emissivity of the fibre composite which in turn increased the heat transfer between the two black bodies to retain any heat generated through fatigue testing cycles. The tensile samples were the only samples that could be used for thermography testing as the thermographic camera provided was unable to be positioned perpendicular to the sample. This is illustrated in the Figure 72.

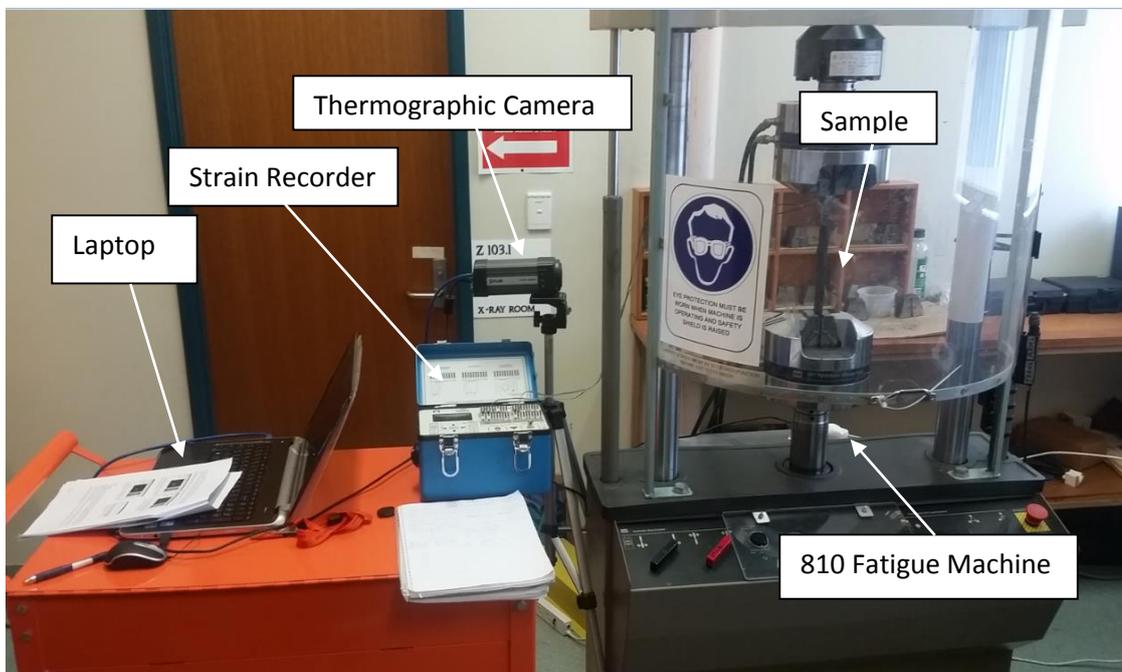
**Figure 73: Setup of 810 Fatigue Machine**

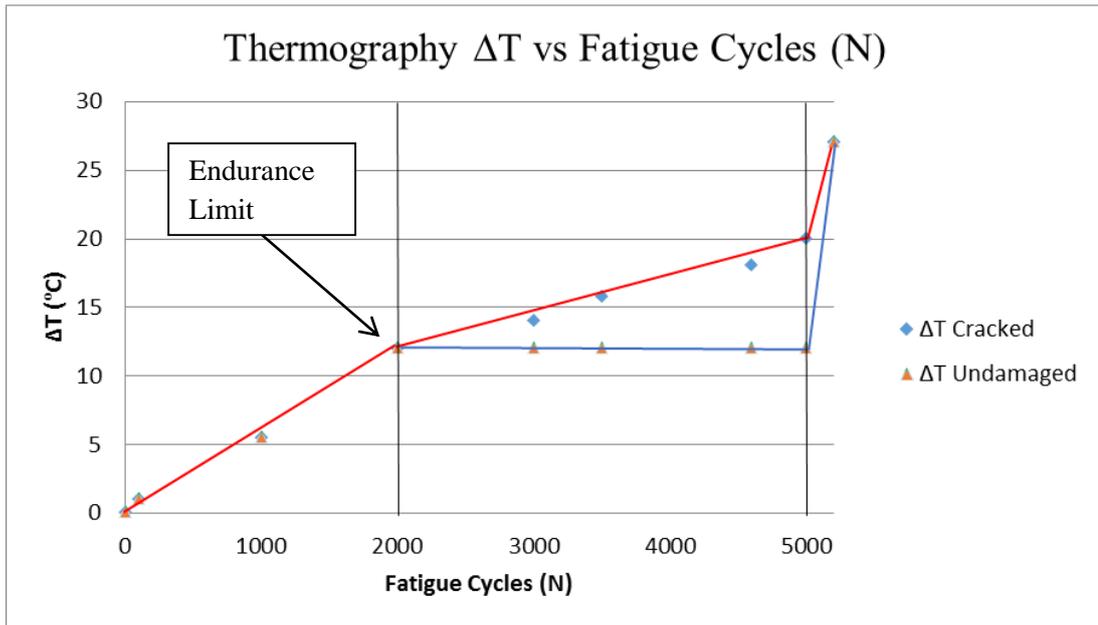
**Figure 77: Thermographic Results**

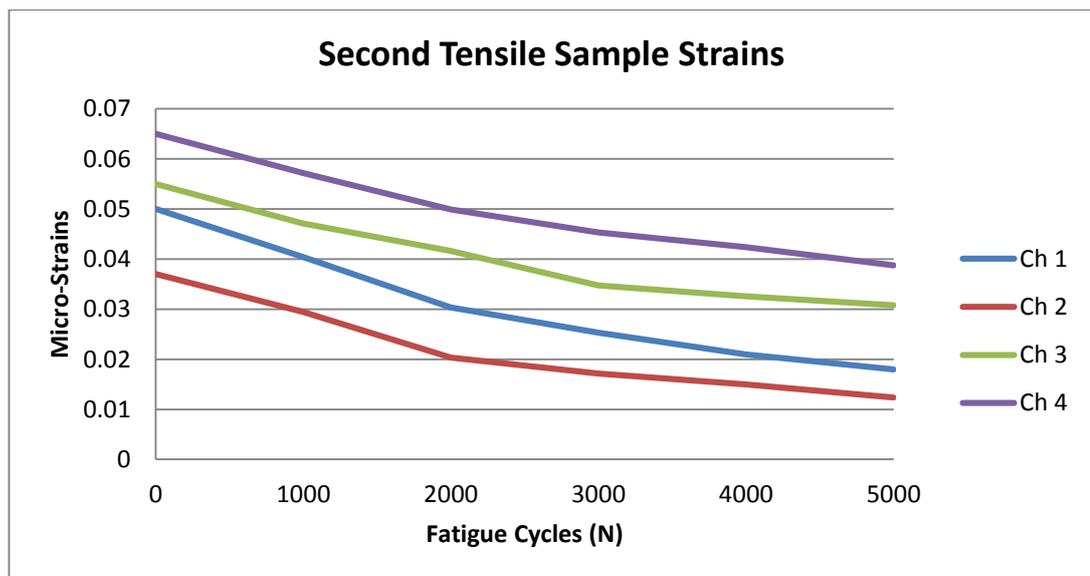
**Figure 79: Strain Data from Second Tensile Sample**

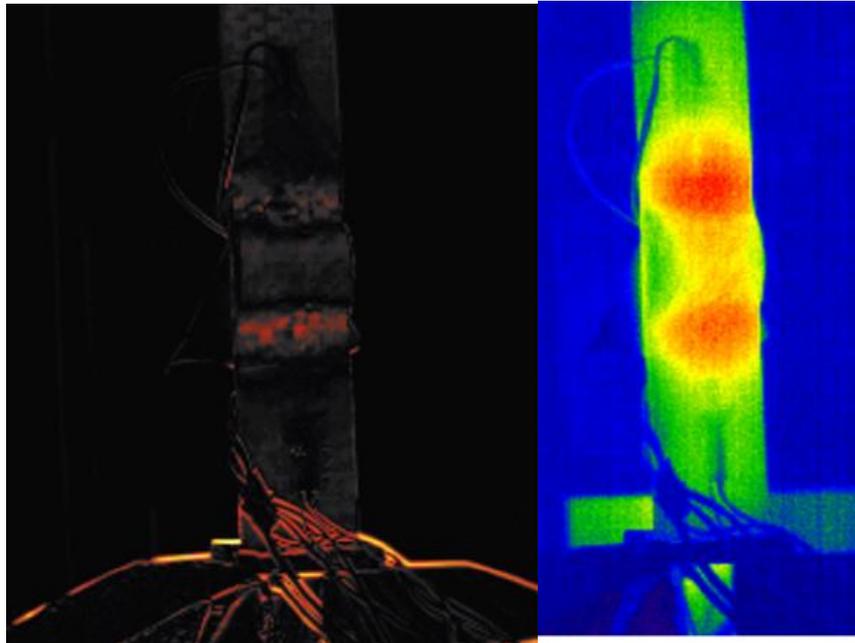
**Figure 82: Thermoelastic Stress under Tensile Load**

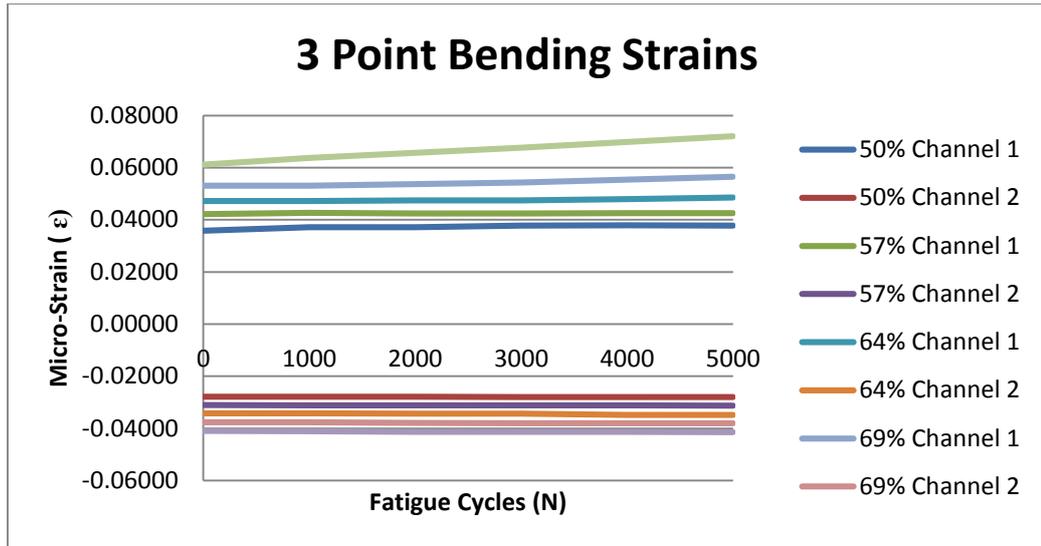
Figure 83: Three point bending Strain vs Fatigue Cycles
