**EXPLORATION OF EVAPORATION  
MITIGATION MEASUREMENT TECHNIQUES**

**ENG4111/ENG4112 Research Project**

**Bachelor of Civil Engineering with Honours**

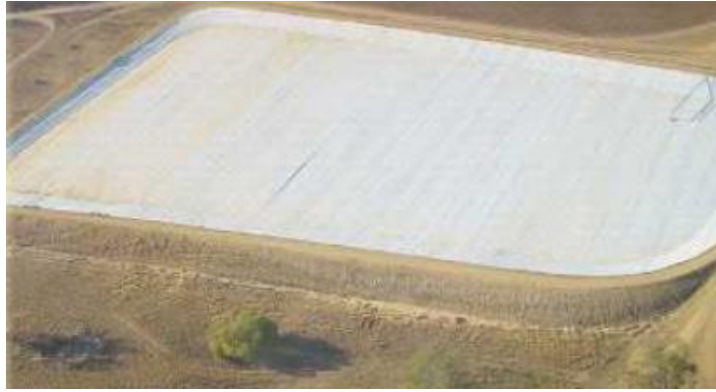
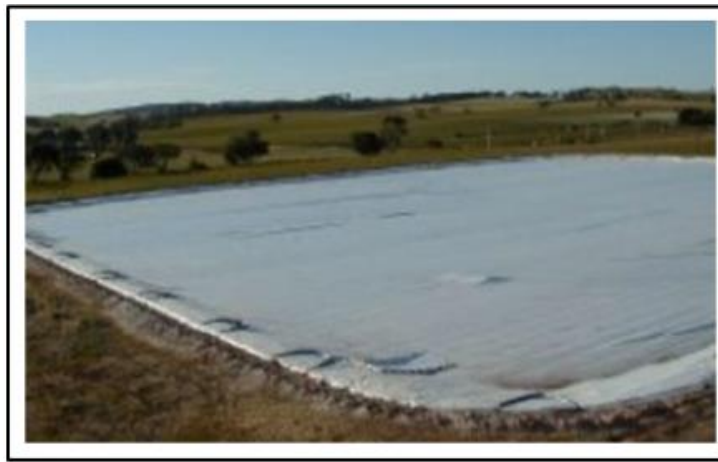
*Figure 2.2: Continuous floating covers in use at St George, QLD (Craig, 2008)*

Figure 2.2 and Figure 2.3 shown above illustrate evaporation control using continuous floating covers. The design of the plastic material incorporates a multilayered polyethylene membrane. The material is comparable to ‘bubble wrap’ and swimming pool covers, in that the product contains a membrane of air voids referred to as buoyancy cells. Commonly the outer surface of continuous floating covers is white, as this colour best reflects sunlight and radiation. The underlay of the cover is black, this significantly removes the presence of natural light in the water beneath the cover (Craig, 2008). The polyethylene material used to create the flat sheets for continuous floating cover is biodegradable and widely used in food processing. This reinforcing that the use of this material possess minimal threats towards the environment in which it is being used.

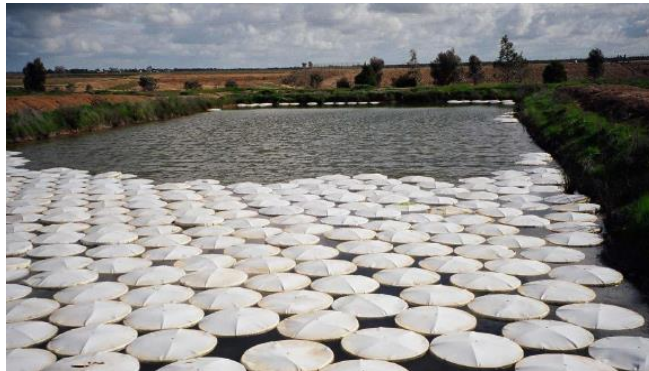
*Figure 2.5: Circular modular floating cover (Craig, 2008)*

Figure 2.5 shown above illustrates the movement of modular units to the windward end of the storage facility. The close-fitting formation is acting over the warmer water, where commonly highest evaporation levels take place.

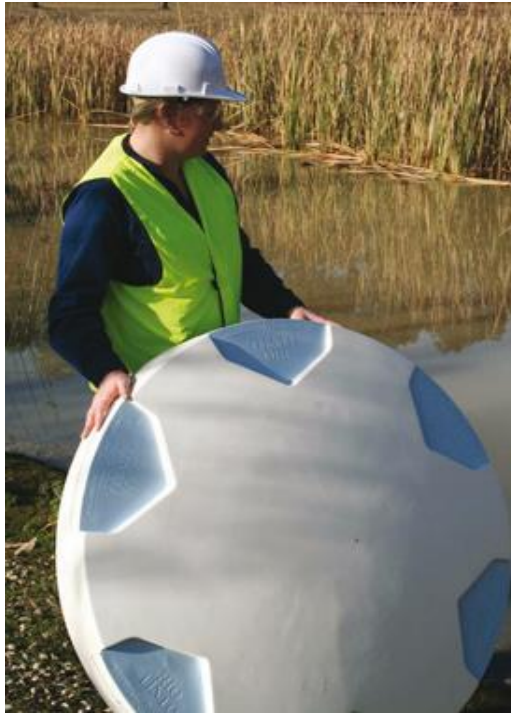
*Figure 2.6: Individual modular unit*

Figure 2.6 shows an example of a large modular floating unit. Larger units weigh more and are less prone to disruption from wind. During high wind speeds modular units can become overlaid, however the unique domed design quite often allows units to redistribute themselves. Modular floating covers, if effectively managed and implemented have the potential to be the most environmentally friendly cover type. Modular covers also allow a considerable level of natural light and oxygen to enter the water. Natural light is a necessary ingredient to help the water supply remains clean, healthy and free of bacteria and water borne diseases.

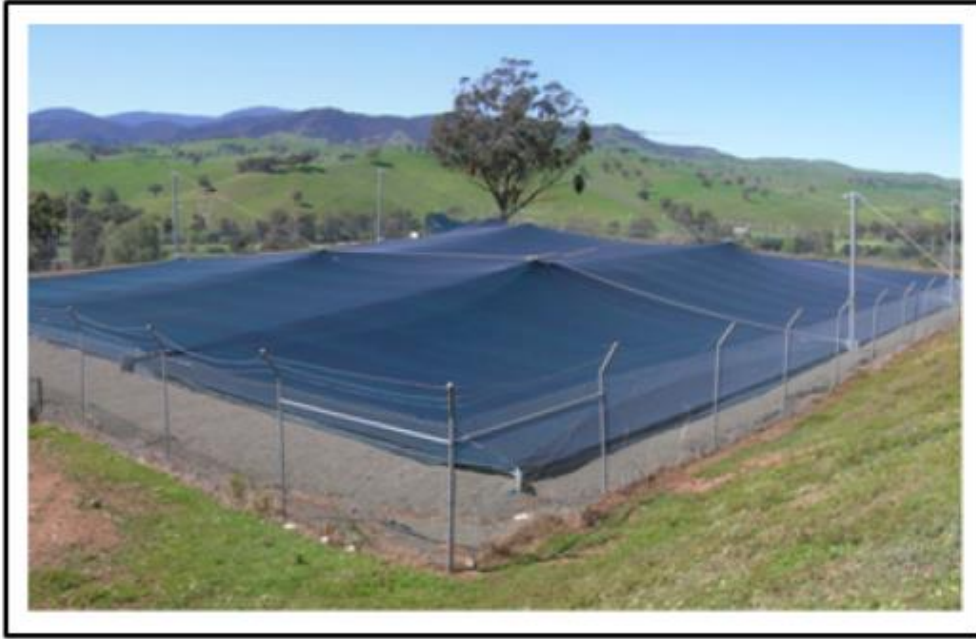
*Figure 2.7: SuperSpan suspended impermeable covers (Finn & Barnes, 2007)*

The pores design of the shade cover allows water to easily entry the storage facility while ensuring the cover will dry quickly. Shade covers also act as a barrier against debris and therefore allow storage water to remain relatively clean. When it comes to installation, shade covers are economically feasible with application best suited to water body less than 10 hectares. Water storage facilities larger than this require high levels of additional infrastructure development and this presents high upfront costs. Figure 2.7 and Figure 2.8 shown below illustrated examples of impermeable and permeable suspend shade covers in uses.

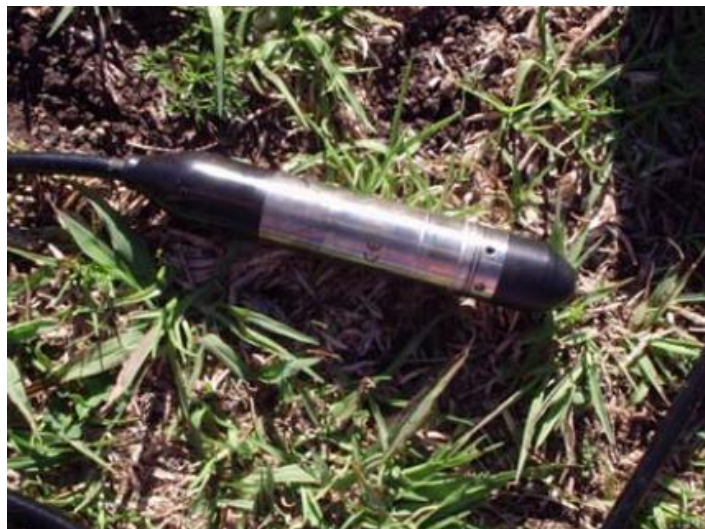
*Figure 2.11: Pressure Sensitive Transduces - Duck PMP 4030 PST*

The Pressure Sensitive Transduces measures depth pressure according to the electrical resistivity of a deforming micro-machined silicon crystal, isolated from the water with a corrosion resistant diaphragm (Craig, et al., 2008). The water pressure is calculated relative to atmospheric pressure and this is delivered by a crushproof air tube situated inside the transducer cable (Craig, et al., 2008).

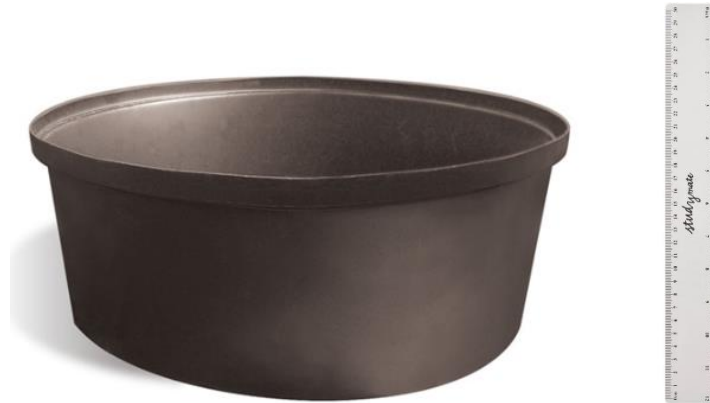
One of the simplest methods of measuring pan evaporation can be achieved using a basic ruler. A clear plastic ruler is generally the best option as it is transparent and easy to read. The position of the ruler is not restricted, as long as the ruler can be easily read positioning is optional.

The most common position of the ruler is in one of two locations; either against the tank wall or in the centre of the water storage facility. When attaching the ruler to the wall it is common to zero the ruler at the water surface and record evaporation as the water level in the tank drops. Measuring with a ruler provides an accurate, easy, and inexpensive means of monitoring evaporation rates in small storage test environments (Simonne, et al., 1995).

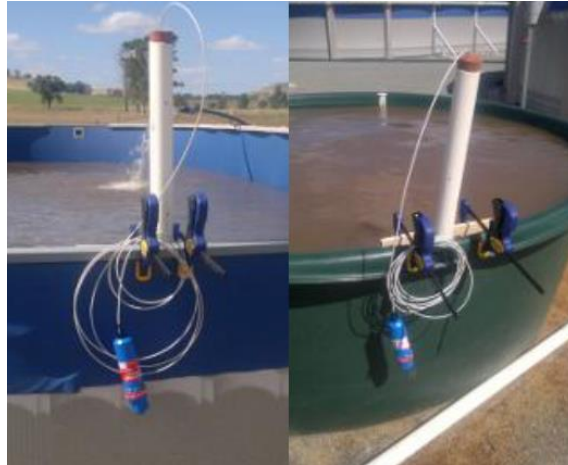
Figure 2.13: Odyssey's capacitance sensor probe

In 2011 a series of evaporative tests were undertaken on a site at Dookie, a small town in the Goulburn Valley region of Victoria, Australia. At the site six water troughs (water surface 3.7 m<sup>2</sup>) were used to conduct the evaporative research. The evaporative losses in these troughs was measured using an automatic water depth measuring devices called the Odyssey's capacitance water level sensor probe. This device is suggested to have an interval accuracy  $\pm 1$  mm. To improve measurement and system accuracy the device was encased using a section of PVC tube. The PVC tube was installed to shield the device and the water around the probe from wind-induced wave action. The Odyssey's capacitance water level sensor probe is a versatile piece of equipment capable of measuring and recording data at a range of intervals. In the 2011 research the device was used to record data at 10 minute intervals. The Odyssey's capacitance water level sensor probe has also been used in irrigation channel at Yanco Agricultural Institute, New South Wales, recording and logging hourly data (Prime, et al., 2012).

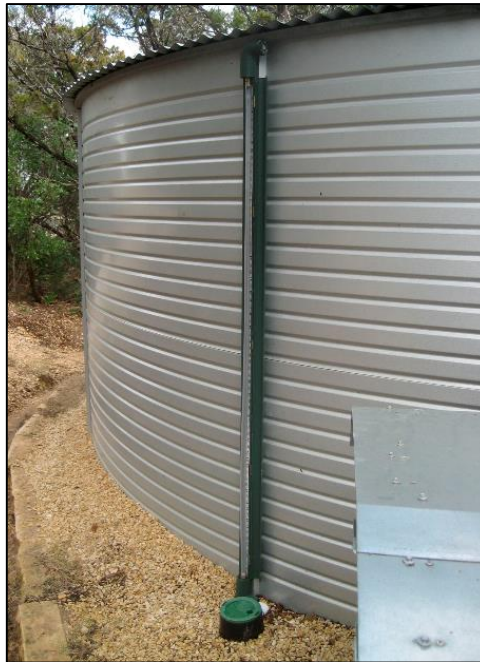
*Figure 2.14: External measurement gauge*

A further expansion from measuring with rulers may involve the plumbing of a calibrated clear plastic tube, which runs from the base of the tank to the full water level of the tank. The figure below highlights an example of a measurement tube or gauge located on the outside of the tank wall. As water in the tank evaporates and the water level drops, so too does the level of the water in the clear plastic gauge. A major benefit of this technique is it allows for measurements to be recorded easily from the outside of the tank. The major issue associated with this method is preventing algae from growing inside the tube and obscuring measurements.

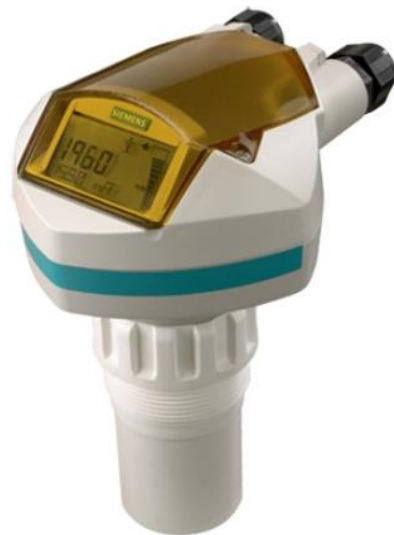
*Figure 2.15: SITRANS Probe LU – Ultrasonic Level Sensor (Siemens)*

The ultrasonic level sensors are used for non-contact level sensing, the sensors within the device emit high frequency waves. These waves are then reflected back to the emitter and detected by the emitting transducer which records a reading of the substance level (Siemens AG , 2015).

The SITRANS Probe LU, is one particular version in Siemens Ultrasonic Level Sensor range. This device would be extremely suited for evaporative research and application in water tanks. The device is capable of monitoring water levels, volume and flow monitoring of liquids in open channels and stored water (Siemens AG , 2015).

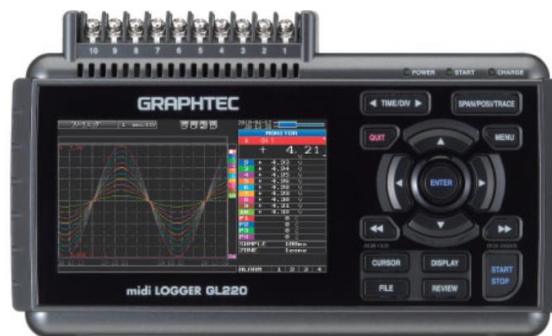
Figure 3.2: GRAPHTEC midi LOGGER GL220

The data logger used to conduct the temperature profile testing was a, GRAPHTEC midi LOGGER GL220. This device was loaned from the electronics workshop, University of Southern Queensland. The machine is capable of recording data at an extensive series of intervals, with ten channels. The product has a wide range of feature which makes it ideal for application within this evaporative research. The device can operate stand-alone or PC-connected operation, 10 analog channels, input-to-output and channel-to-channel isolation. USB PC interface allowing for easy download and collection of data. This product is highly durable and robust making it extremely suited to field research. The figure below shows the data logger (GRAPHTEC midi LOGGER GL220) used for the temperature profile testing.

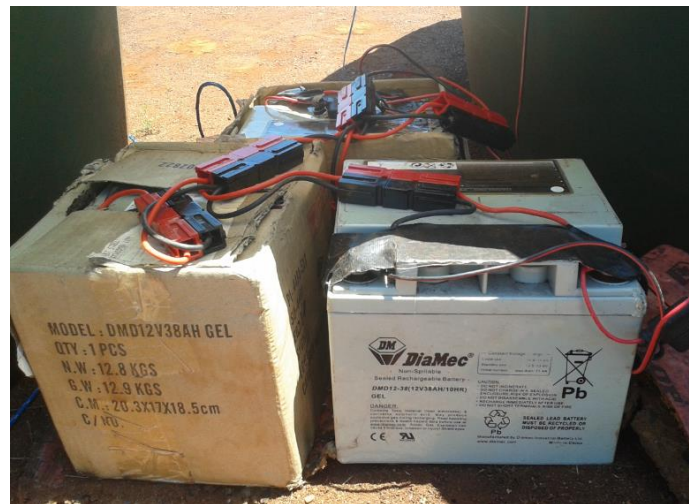
Figure 3.3: 12 volt battery supply

The data logger and the bilge pump were the two pieces of equipment which needed to be supplied power during the field tests. A series of three 12volt batteries was used as the main power source.

A major concern associated with the power supply was the bilge pump. This device demanded considerable power (Amp draw: 2.1 @ 12v) and concerns were raised as to whether the device had the potential to damage the batteries. If poor weather conditions were experienced there was a possibility that the solar panels would not supply necessary levels of power and this may cause the batteries to be drained below recommended thresholds. To overcome this concern a ‘battery controller’ was include within the power supply system. This device monitor the power levels with the batteries and power produced by each solar panel. The device was programed to automatically shut down the bilge pump if the bulk battery power fell below 11.5 volts and switch back at 12.5 volts.

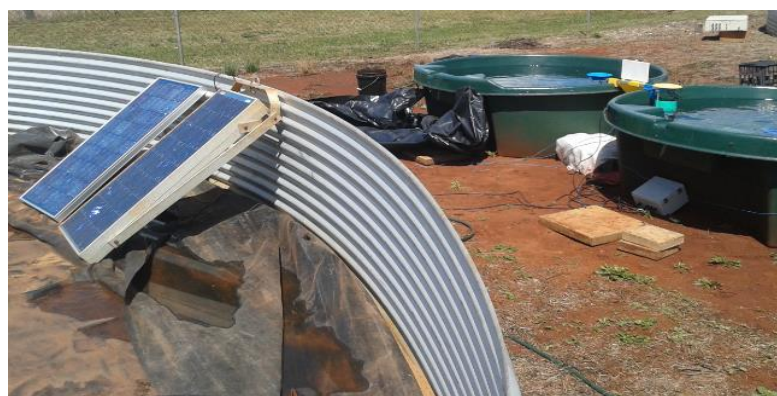
Figure 3.4 Solar panels (250watts)

Two 250 watt solar panels were also installed to ensure sufficient levels of power was maintained in the batteries. By installing the solar panels it meant that batteries did not have to be disconnected and taken off site for recharging.

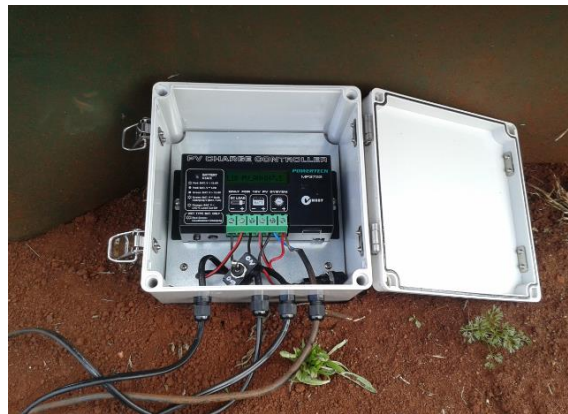
*Figure 3.5: Battery Controller*

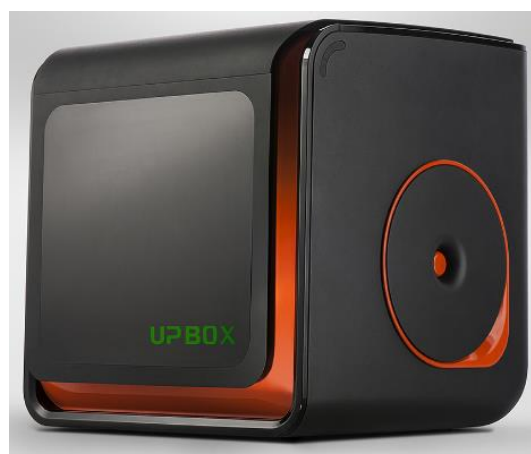
Figure 3.6: UP BOX 3D Printer by Tiertime

Various components of the test rig were produced using 3D Printer facilities available at the University of Southern Queensland Electronics Workshop. The printer model used was the UP BOX 3D printer by Tiertime. Each component was sketched using TINKER CAD and then exported to the 3D printer. The components were produced from ABS (acrylonitrile butadiene styrene) plastic.

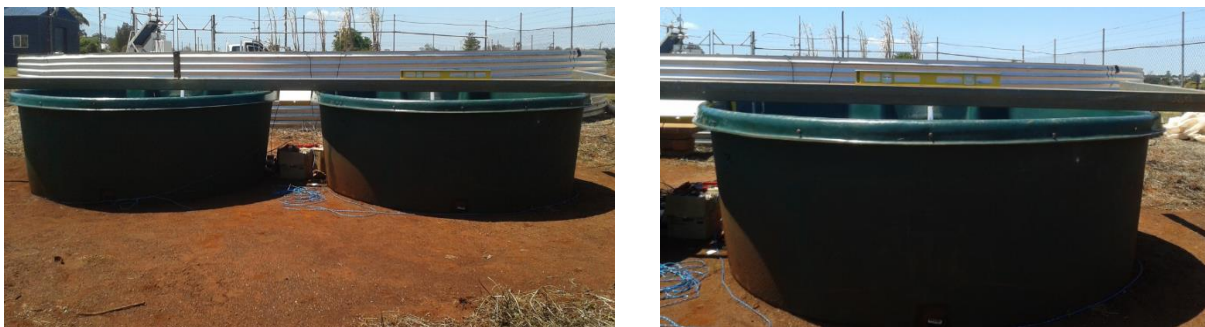
The next process was to clear and level the site. All weeds and clumps of grass were removed and basic gardening equipment (shovel, mattock and rake) were then used to level to surface. The water troughs were placed on the levelled surface and a spirit level was used to ensure that site had be properly levelled. Figure 3.9 illustrates how the spirit level was used to check the ground level of the site.

Figure 3.9: Tanks were levelled using a split-level and a section on steel tube placed across the top edge of the two tanks

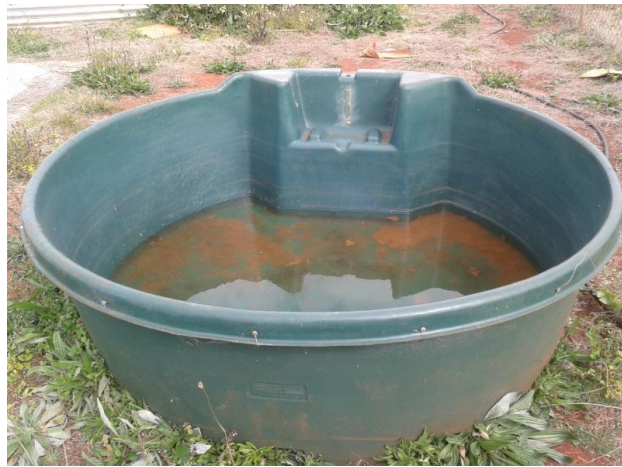
Two green polyethylene livestock water troughs were used as water storage facilities during testing. Detergent and scrubbing brush were used to remove algae and grim which had developed from the stagnant water pooled in the troughs. Furthermore once the tanks had been properly cleaned and thoroughly rinsed, the trough bung had to be replaced.

*Figure 3.10 Original trough conditions*

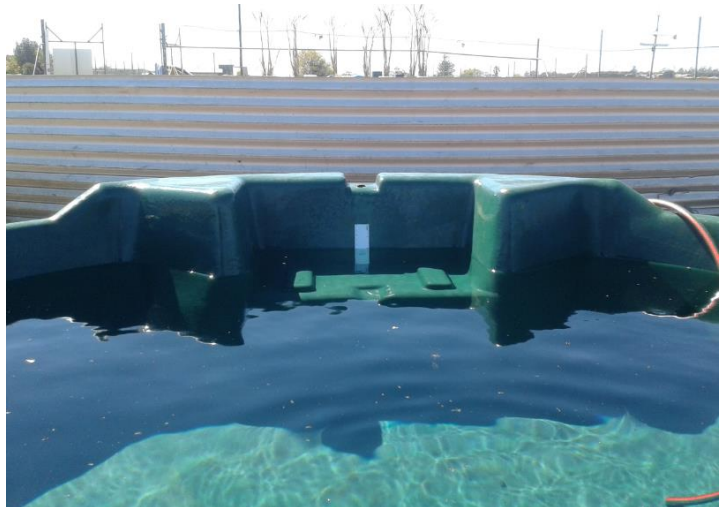
Figure 3.13: Positioning of Ruler

The rulers used to measure the evaporative losses within the tanks were fixed in a common location within the tanks. Figure 3.13 highlights the location where the ruler were positioned in the tanks. This location is where the float component of the water trough would otherwise be installed (if used for livestock purposes). The selected location was flat, and readings could be taken after a black cover was placed over the tank to reduce wind turbulence.

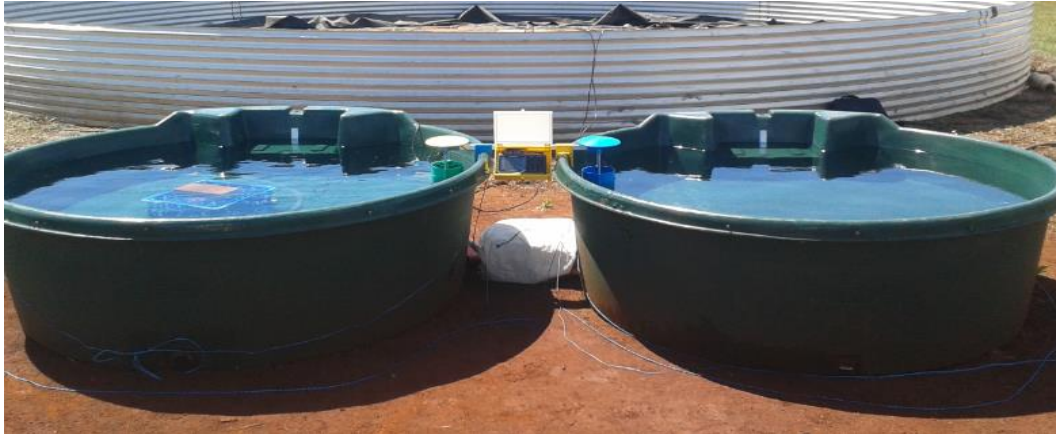
Figure 3.14: Test Set-up

Figure 3.14 highlights the test set-up implemented to analysis the air/water interface and evaporation loss in the water troughs. The following text discusses the major components of the set-up and the process undertaken to reach the final design.

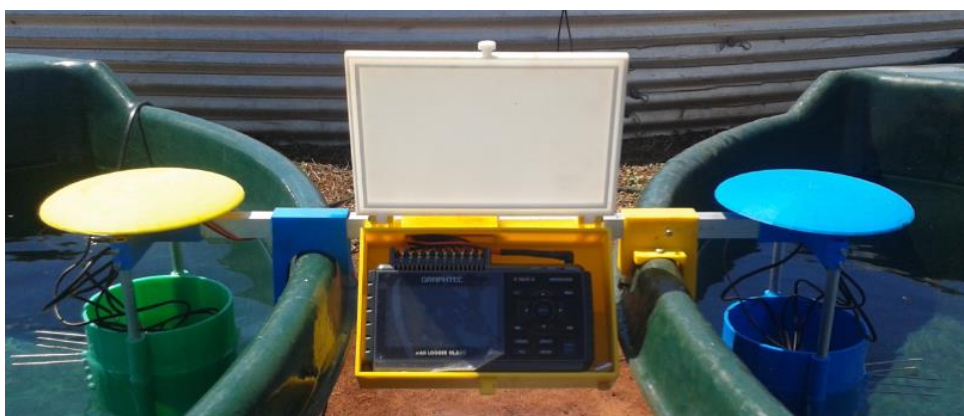
The apparatus supporting the data logger and the thermocouple vessels has been referred to as the test rig. By ‘sandwiching’ data logger between the two tanks it was possible to place five thermocouples in each tank. The leads were run from the floating containers up through the aluminium tube connecting to the data logger.

Figure 3.15: Test Rig support the data logger & thermocouple vessels

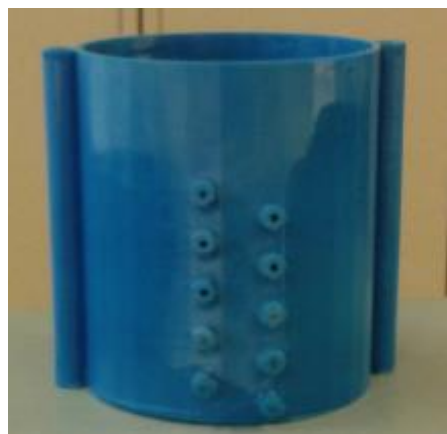
*Figure 3.17: Thermocouple vessel*

Ten holes were printed in the containers two columns of five holes spaced at 20mm increments. The holes had to be offset to achieve the desired spacing of 10mm.

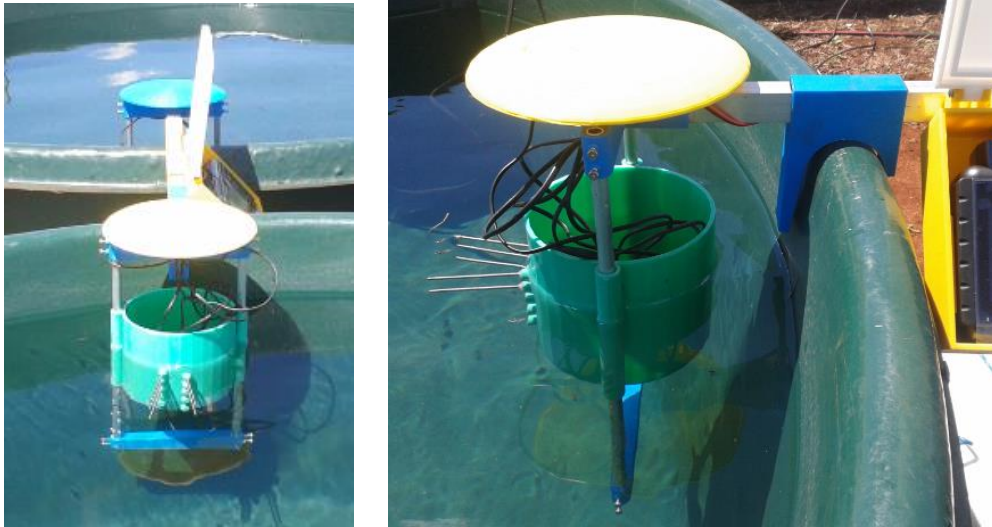
*Figure 3.20: Floating the thermocouple vessel*

Circular aluminium tube was used to hold the vessel in position. The vessel was designed to slide up and down with the changing water level; the guides on the outside of the vessel allowed this to be achieved. Brackets were created using the 3D printer and were responsible for holding the aluminium tube in the correct position. The thermocouple vessels were supported by a section of square aluminium tube spanning between the two tanks.

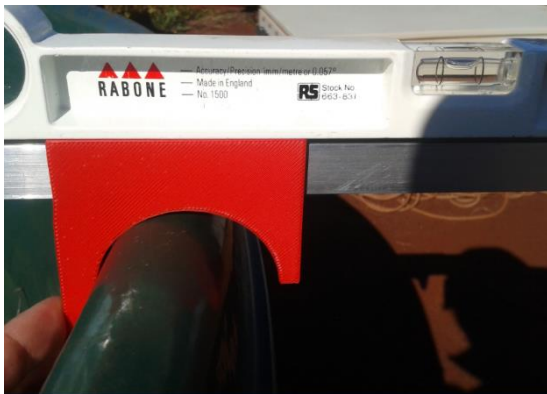
Figure 3.22: Test Rig - tank bracket

Figure 3.22 highlights the brackets (tank bracket) which were used to support and hold the test rig in the correct alignment. A number of prototypes of the bracket were produced before the final design was reached. In the below figure it can be seen how the alignment of the bracket was refined using a spirit level. The square tube needed to be level as this tube supported the thermocouple vessel. The tank bracket was fixed in position using a single self-tapping screw.

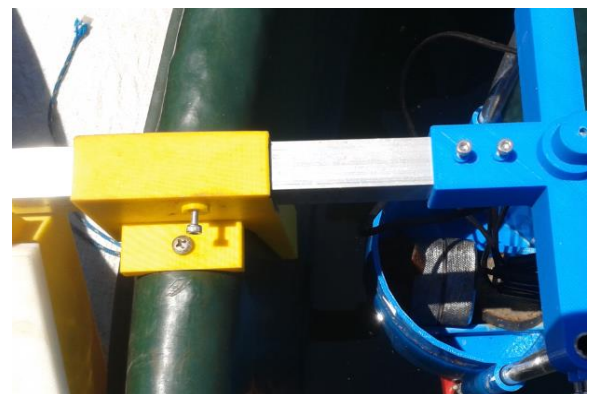
Figure 3.23: A single self-tapping screw held the test rig in position

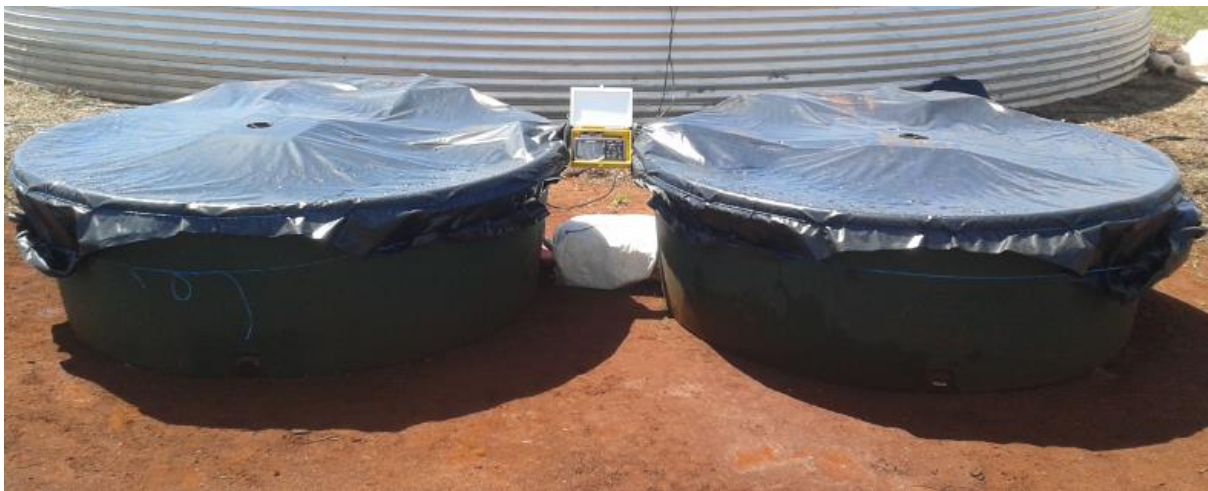
The black cover provided a method for warming the surface water, however the impermeable material preventing water vapour from moving and evaporation occurring. To allow water vapour to escape from the tanks a circular holes were cut in the centre on the cover. A flap was also included in the cover at the perimeter of the tank to ensure that evaporative losses could be measured (twice daily) using the ruler. The cover was supported by two milk crates staked in the centre of the tanks.

Some difficulties were experienced when applying the covers, especially around the test rig. Rope was used to hold the cover in position. Existing screws located around the outer lip of the water troughs provide usefully when securing the cover with the rope. Figure 3.24 illustrates the black covers used to artificially impose the water surface film.

*Figure 3.24: Artificially imposing a warm surface film*

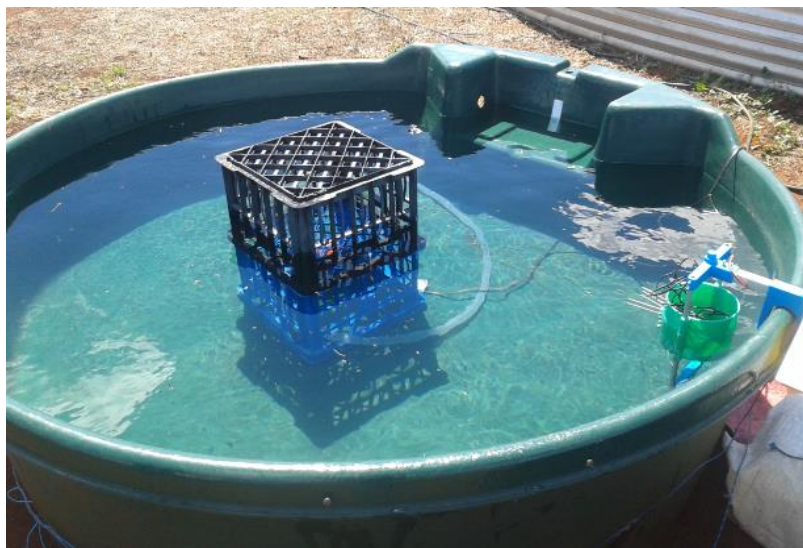
*Figure 3.25: Imposing a cold surface film was achieved by including a bilge pump in one tank*

Applying the black cover created a warm surface film in both tanks. Therefore a process needed to be developed to remove the warm surface film, while the black cover was still in place. Naturally a cold surface film presents when bulk air flow causes thermal convection to develop beneath the water's surface. Therefore a device was require to manually created convection and cool the water. A Bulge Pump provided a simple solution for providing the necessary turbulence within the water to eliminate the warm surface film. Figure 3.25 highlights what would be seen beneath the black cover when imposing a cold surface film. The bilge pump was positioned in the centre of the tanks, within the bottom milk crate. A  $\frac{3}{4}$  inch tube directed the water toward the outer perimeter, circulating and cooling the water within the tank.

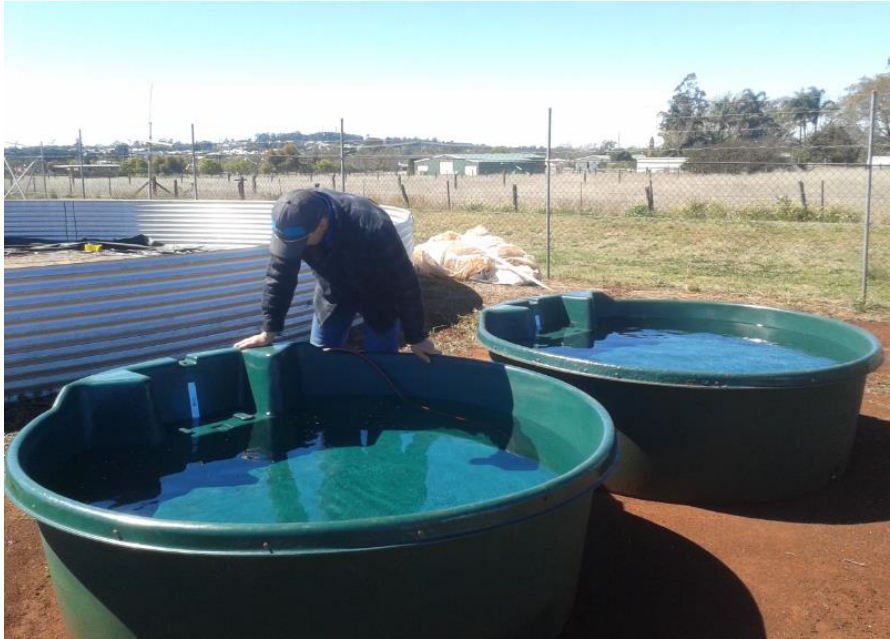
*Figure 3.27: Monitoring evaporation loss in the tanks*

Data collection involved reading and recording tank water levels morning (9:00am) and afternoon (5:00pm) for the period of one week. At the end of the week the tanks were refilled (topped up) and the testing could then continue for another week. Data recorded in the field was compiled within an excel spreadsheet for the purposes of modelling and graphical analysis.

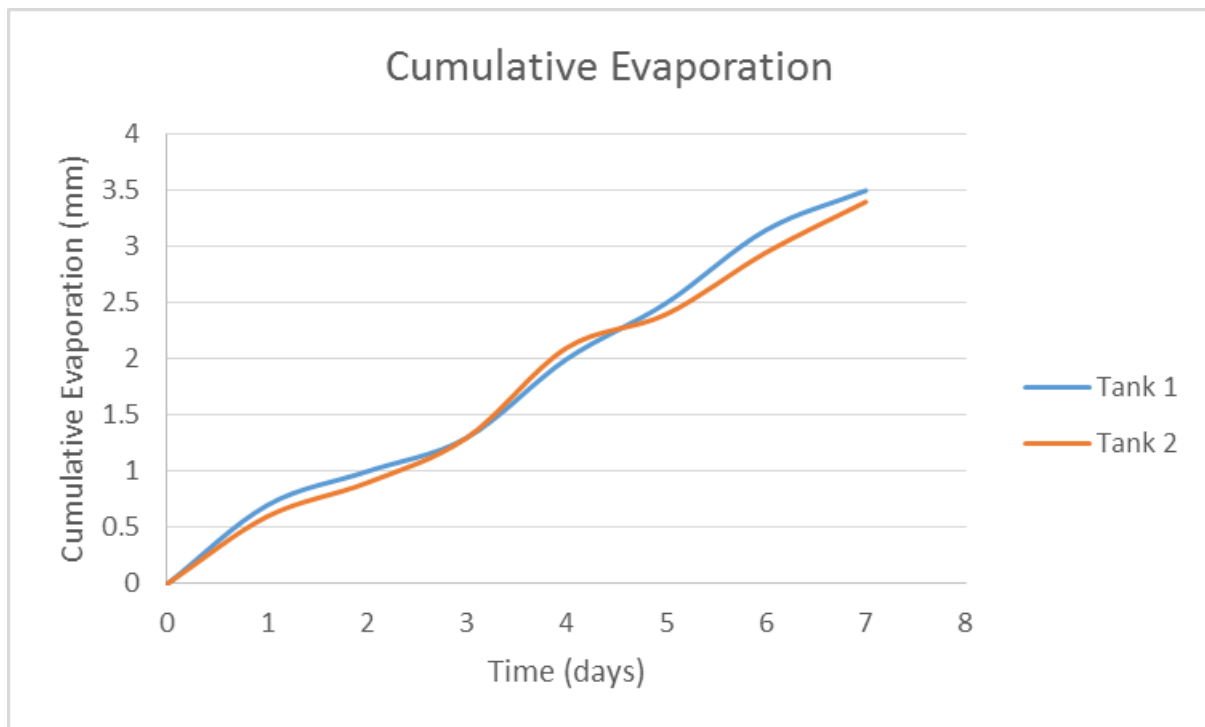
Figure 4.3: Cumulative evaporation over 7 day test period

Figure 4.3 illustrates the cumulative evaporation loss from tank 1 and tank 2. A linear trend can be identified for the cumulative evaporation. Minor fluctuations in the cumulative evaporation may be explained by human error associated with the ruler measurement technique.

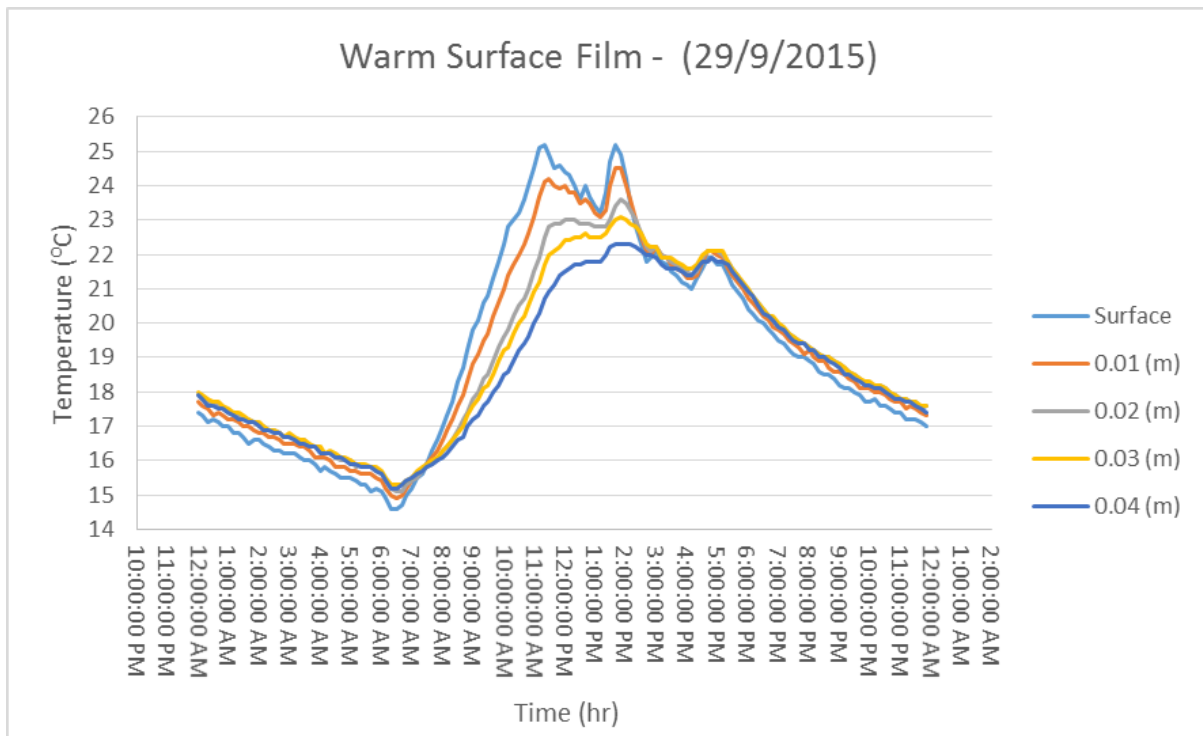
Figure 4.23: Test 2 - Temperature profile plot for disrupted warm surface film in Tank 2 on 29/9/2015. Ten minute temperature profile data has been analysed over one hour increments for a twenty-four hour period.

Overcast conditions developed around lunchtime and light rain (0.51mm) resulted in rapid cool of the surface film. A spike in air temperature late in the day further disrupted the warm surface film at approximately 5:00pm. Considerable stratification is evident between 12:00pm and 2:00pm. The warm surface film is imposed from seven hours between 8:00am and 3:00pm.

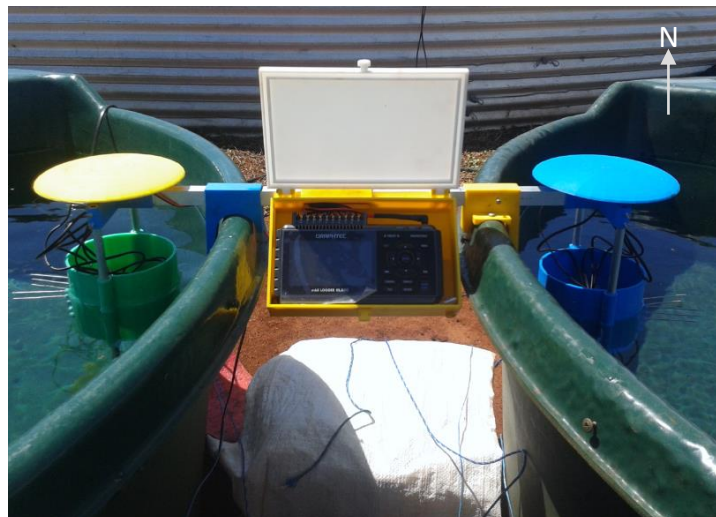
Minor inconsistencies were recorded between the surface thermocouple probes. It is believed that the east-west alignment may have influenced the surface thermocouple probe. Variations of 1 °C were recorded mid to late afternoon, with the tank to the west (Tank 1) recording the highest temperature. The thermocouple vessel lid did not shade the thermocouples in tank 1 from the afternoon sun. While thermocouple probes positioned in the tank 1 (green thermocouple vessel) experienced direct afternoon sun, thermocouple probes positioned in the tank 2 (blue thermocouple vessel) were shaded by the tank wall and vessel lid. To overcome temperature inconsistencies experienced at the surface thermocouple probe and north-west tank alignment is recommended.

Figure 5.1: East-west tank alignment

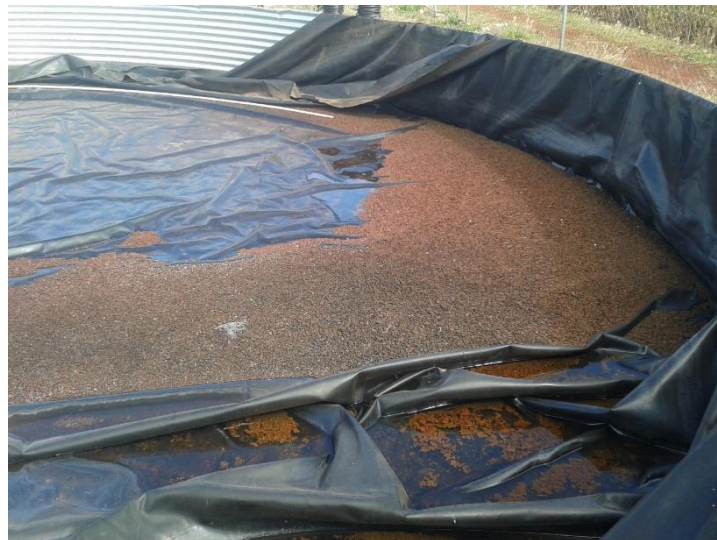
Considerable progress was made on restoring the three large ponds at NCEA Evaporation Compound Facility. As the site had not been used for evaporation research since 2005 the facility was highly dilapidated and was in considerable disrepair. On first inspection of the facility obvious issues were identified and these included; lining punchers and tears, rodent undermining of tank floor, vegetation and weed growth around the perimeter of the tank and stagnate waste water pooled within the tanks.

*Stagnate water pooled on plastic liner*

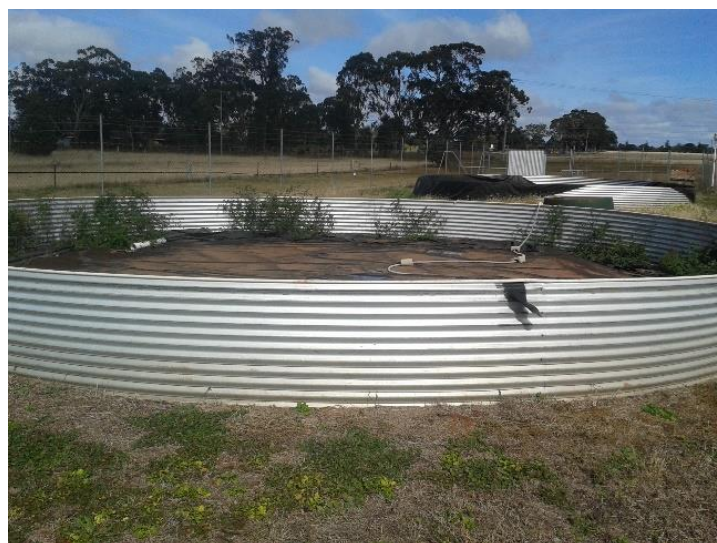
*Significant vegetation and weed growth occurred around tank perimeter*

The main works undertaken was the removal and realignment of the tank liners. There was a significant amount of vegetation build up around the perimeter of the tanks and this was firstly removed. The vegetation growth had harboured rodent activity. Rates and mice had formed tunnels and nest beneath the plastic greatly affecting the foundation of the storage ponds. The major area affect comprised of a two metre strip around the inside of the tank wall. The follow figures illustrate the before and after shots.

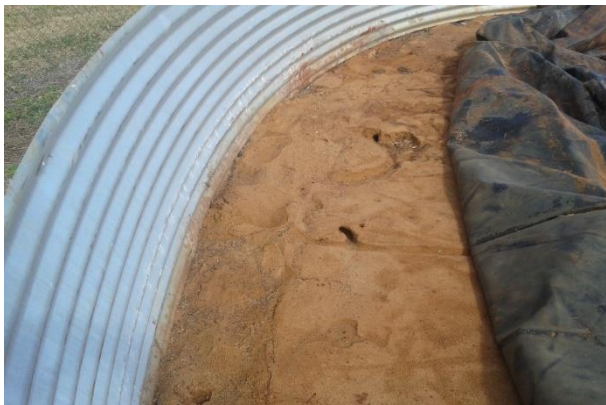
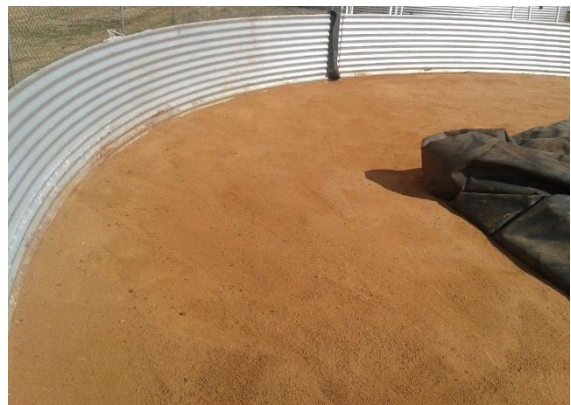
Once the sand floor had been re-levelled. Holes were patch (in the lining) and the tank liner was realigned.
