University of Southern Queensland

# Investigation of Scour Mitigation Methods for Critical Road Structures

**Bachelor of Engineering (Honours) (Civil)**

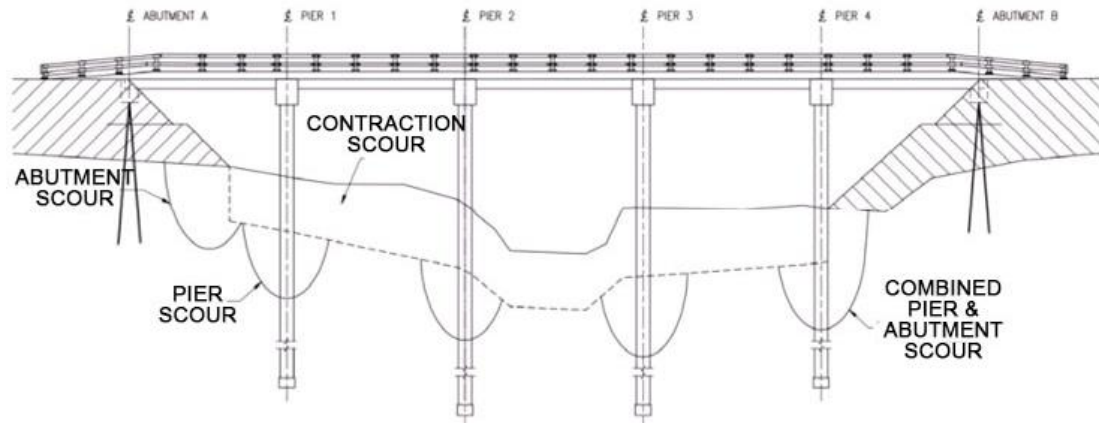
Figure 3.2, Scour locations on a Bridge (Department of Transport and Main Roads 2013)

An example of local scour and contraction scour can be found in Figure 3.2.

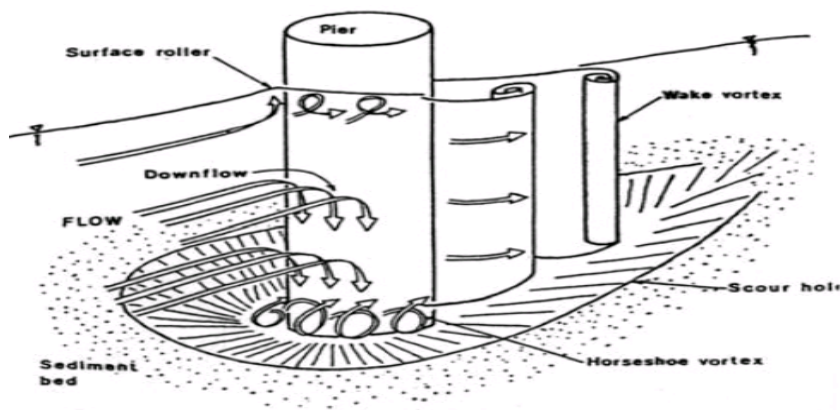
Figure 3.3, Flow activity on a pier and pier scour (Department of Transport and Main Roads 2013)

Pier scour occurs due to the increase in flow velocity and the generation of waves around the pier. When the flow first hits the pier, a downflow is created, which generates vortices at the base of the pier. The vortices then cause the scour hole and continue to grow until equilibrium is reached (Department of Transport and Main Roads 2013). The size and depth of the scour hole depends on the size and shape of the pier. More detail of the flows and vortices involved in pier scour can be found in Figure 3.3.

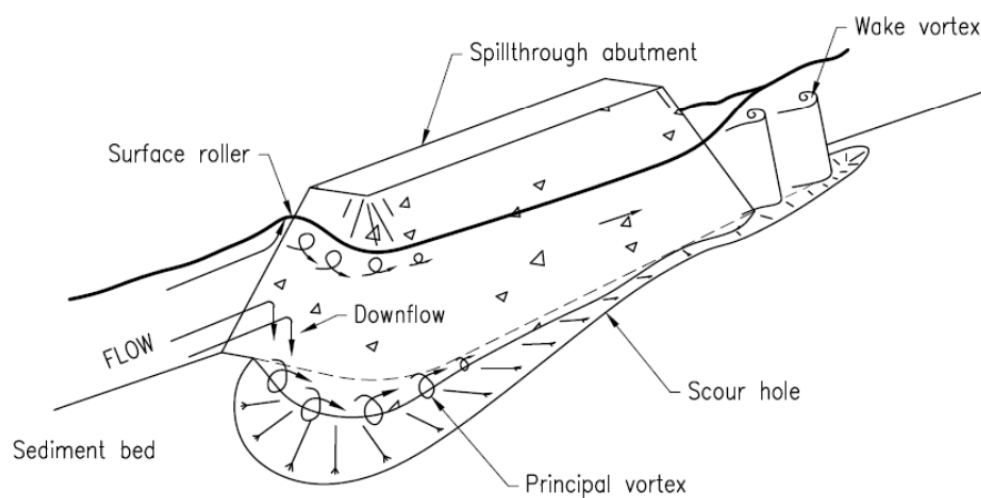
**Figure 3.4, Flow activity on abutments and abutment scour (Department of Transport and Main Roads 2013)**

Abutment scour is an extremely complex process and depends on numerous factors. Its scour depth depends on the abutment shape, flow around the abutment and channel, cross-section shape of the channel and field conditions – whether there is vegetation on the abutment and stream (Department of Transport and Main Roads 2013). Abutment scour can happen at the main channel bed and embankment, and can be worsened by the scour at the flood plain and contraction scour (Agrawal et al. 2005). Detail of the flow and vortices around the abutment can be seen in Figure 3.4.

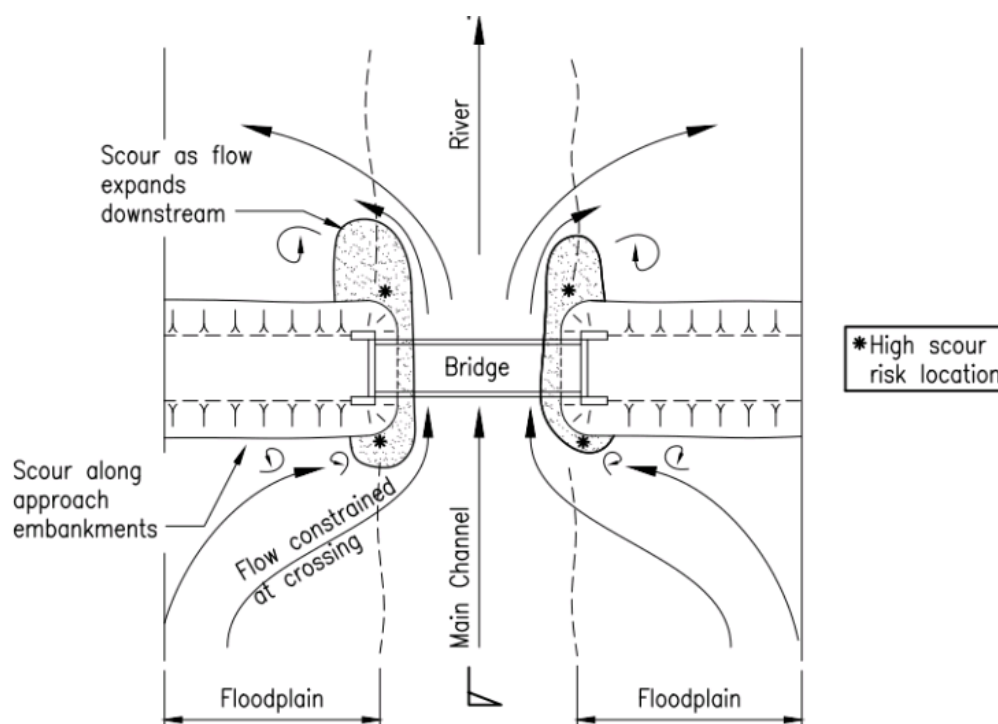
Figure 3.5, Contraction scouring at a bridge (Department of Transport and Main Roads 2013)

Contraction scour occurs when the flow area suddenly decreases, consequently increasing the flow velocity. In turn, the erosive forces around the contraction increase, removing bed material from the upstream to the downstream. Contraction scour is different from long-term degradation scour as contraction scour is often triggered after a flood event around the bridge structure, whereas long-term degradation scour occurs after a long period of time on the entire streambed

(Department of Transport and Main Roads 2013). Figure 3.5 shows the flows constrained by the contraction and the process of contraction scour.

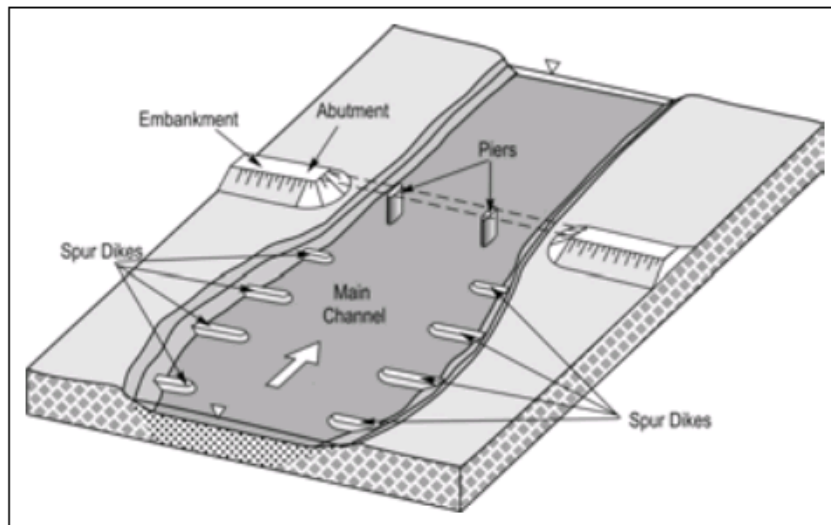
**Figure 3.6, Spur dikes at the upstream of the Bridge (Ettema et al. 2006)**

- Spur dikes: forces the realignment of the channel flow, the channel is often widened to decrease flow velocity (Figure 3.6).

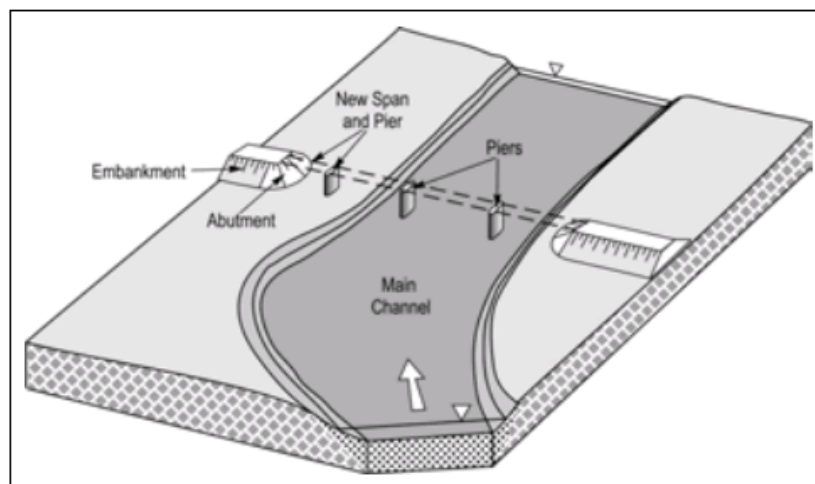
**Figure 3.7, Bridge channel widening (Ettema et al. 2006)**

- Bridge widening: only used when other scour countermeasures are infeasible or when the abutments are already washed out, a pier is often added, an illustrated diagram is shown in Figure 3.7.

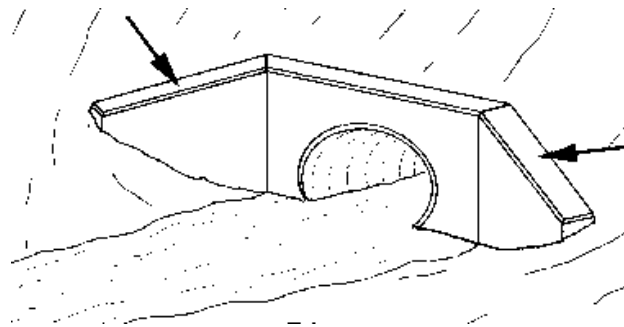
**Figure 3.8, Wing wall around a culvert (Ettema et al. 2006)**

- Removal of small and large trees: decreases the possibility of the channel being blocked by debris.
- Concrete filled mattresses: blocks do not washout and is easy to construct, however can be lifted by heavy flows.
- Wing walls: can be independent or attached to the abutment, extremely economical; acts as a retaining wall for the abutment and guides the stream into the bridge (Figure 3.8).

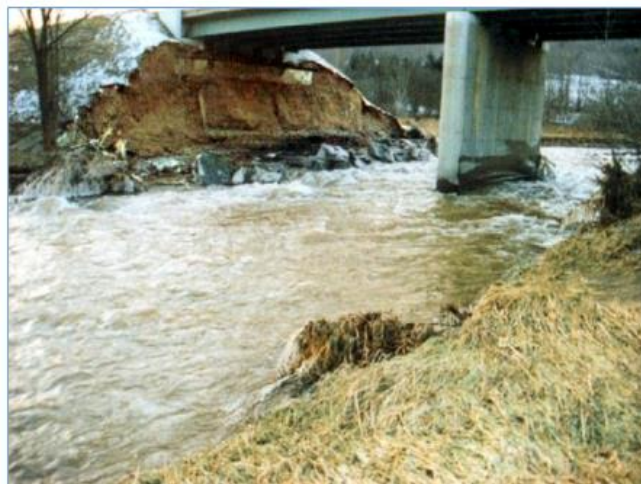
**Figure 3.9, Geotechnical failure of spill-through abutments (Ettema et al. 2006)**

- Spill-through abutments: a pier that is used as an abutment when an additional span might be added in the future, effectively limits scour depth; early slope erosion and geotechnical failure, shown in Figure 3.9, are frequent problems.

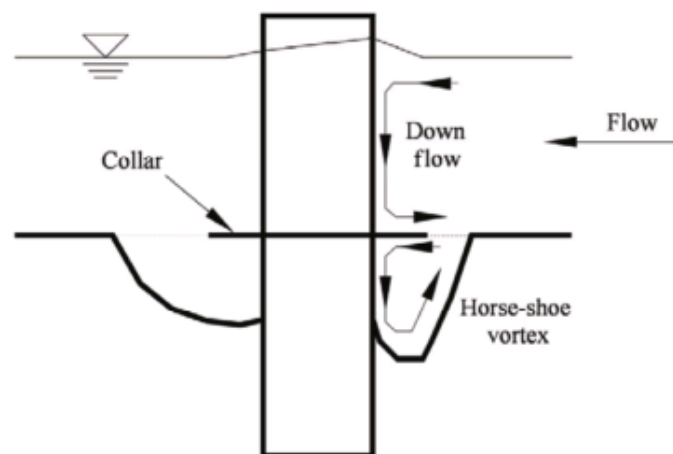
Figure 3.10, Effects of a collar (Zarrati et al. 2010)

Combining riprap with collaring, the risk of scouring at piers is effectively reduced as the direction of flow is altered (Figure 3.10). When a collar is added, the maximum reduction in scour depth is 57%. Additionally, the riprap volume required for scour protection is decreased when a collar is introduced. (Zarrati et al. 2010)

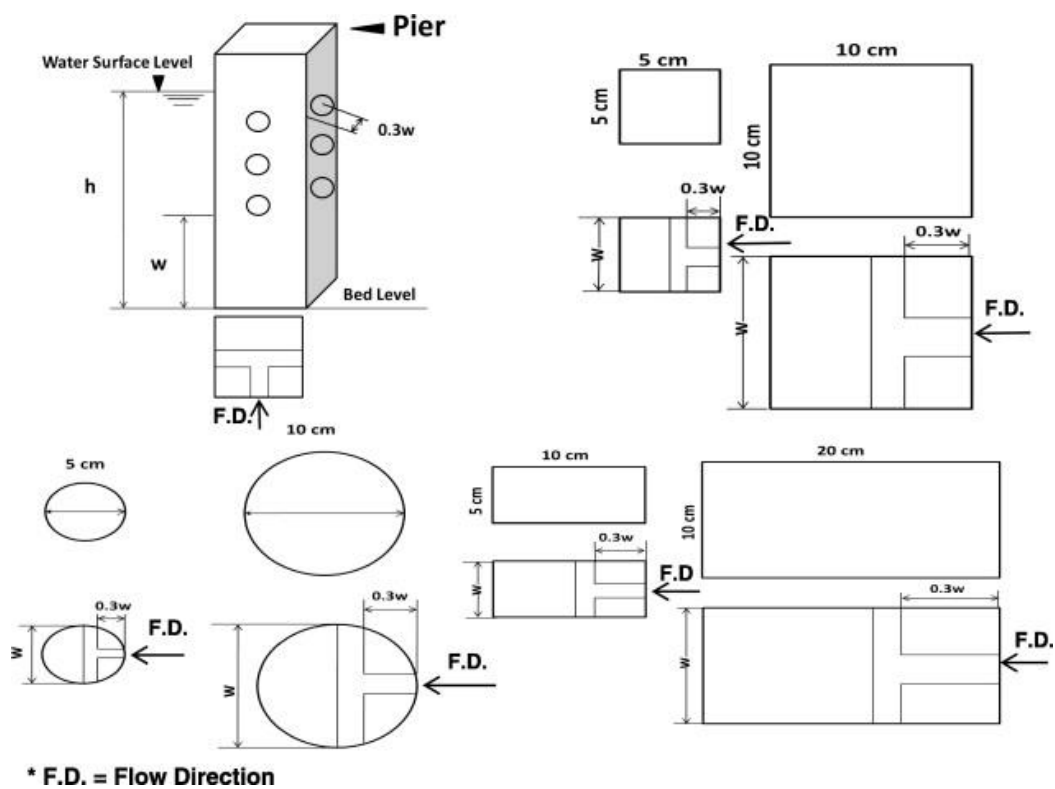
Figure 3.11, Piers shapes and opening arrangements (Entesar et al. 2013)

Around the vicinity of the pier base, the interaction with the water flow and the scour hole creates a horseshoe vortex. As the scour depth increases, the horseshoe vortex gradually diminishes. A method developed by Entesar et al. (2013) involves the use of openings along the piers side as shown in Figure 3.11. This effectively decreases scour depth by 45% as the vortex formation in front of the pier is reduced.

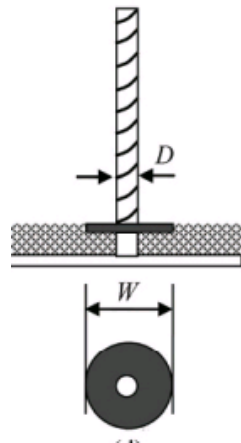
Figure 3.12, Pier with cable and collar (Izadinia et al. 2012)

A study conducted by Izadinia et al. (2012) found success in using cable and collar to reduce scour around bridge piers. An illustration of how the pier is prepared is shown in Figure 3.12. The purpose of the cable is to improve the efficiency of collar even more. In particular the best cable-pier diameter ratio is 0.15 and a cable thread angle of fifteen degrees. The scour depth reduction in comparison with installing a collar only is 12.85%.

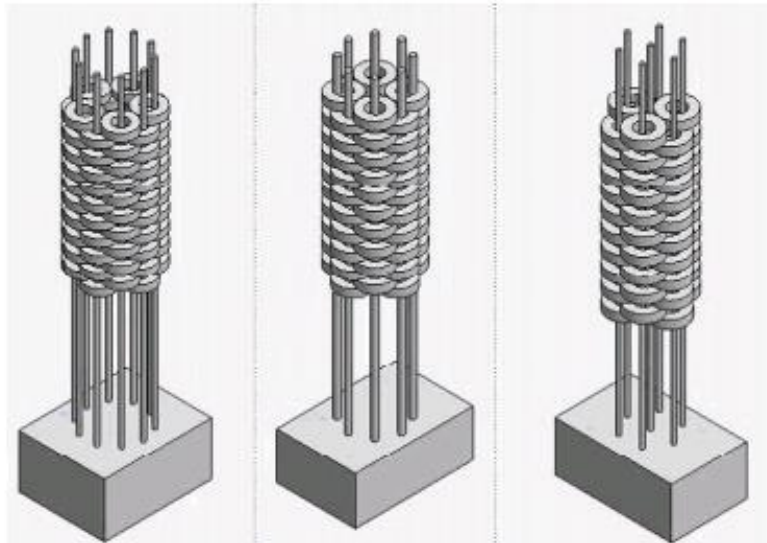
Figure 3.13, Configuration of different ring columns (Wang et al. 2011)

A ring column is a scouring countermeasure that involves interlocking rings, such as the ones shown in Figure 3.13. Along with the irregular surface, the rings allow the water to flow through the gaps, reducing the strength of the horseshoe vortex and water flow. The optimal configuration reduces the scour depth by 65% (Wang et al. 2011).

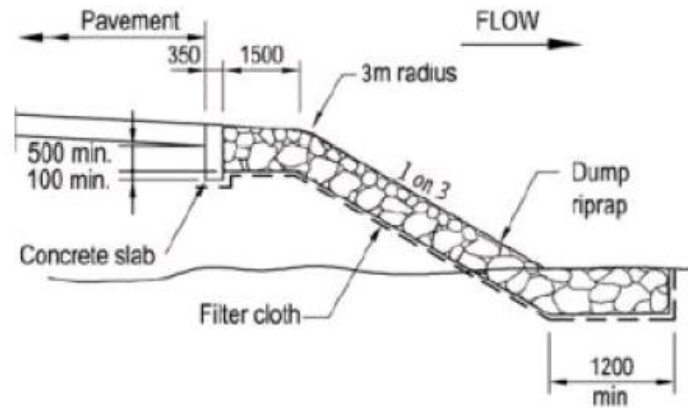
Figure 3.14, Riprap protection (Department of Transport and Main Roads)

Riprap, shown inFigure 3.14, is the most affordable type of erosion prevention method, which features graded rock dumped on a treated slope. To protect the floodway from high velocities at the change of grade, a toe length of 1 to 1.5 times the embankment height is prepared. Depending on the flow velocity, the class and thickness of the rock used can be determined. Additionally, a concrete cut-off wall might be included between the pavement and rock riprap if high velocity is expected.

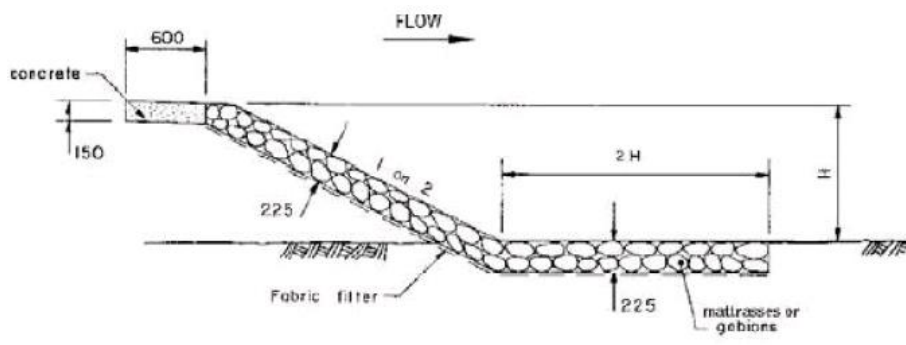
Figure 3.15, Rock mattress protection (Department of Transport and Main Roads)

Shown in Figure 3.15, rock mattress is a method that involves placing rocks within wire baskets or wire covering. This method is used when dumped rock is not available locally or cannot be imported economically. Similar to rock riprap, a suitable length toe is required and a cut-off wall at the interface may be required. It is also important to ensure that the wire enclosure should be smaller than the rock and the wire is coated with PVS to reduce corrosion.

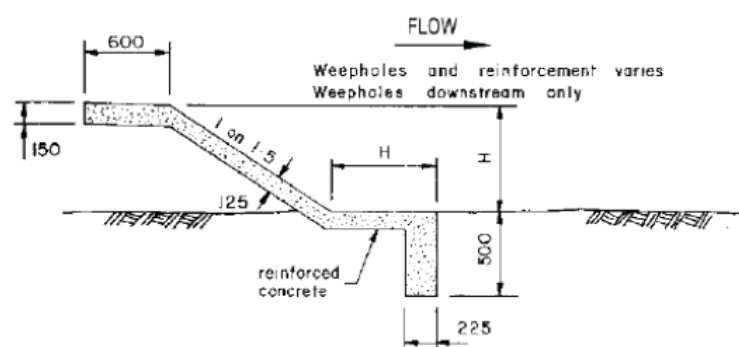
Figure 3.16, Concrete slab protection (Department of Transport and Main Roads)

Illustrated in Figure 3.16, concrete slab protection involves pouring plain or reinforced concrete on the intended surface. This protection type is used in high velocity conditions, and due to its high cost is only used when other types of protection are inappropriate.

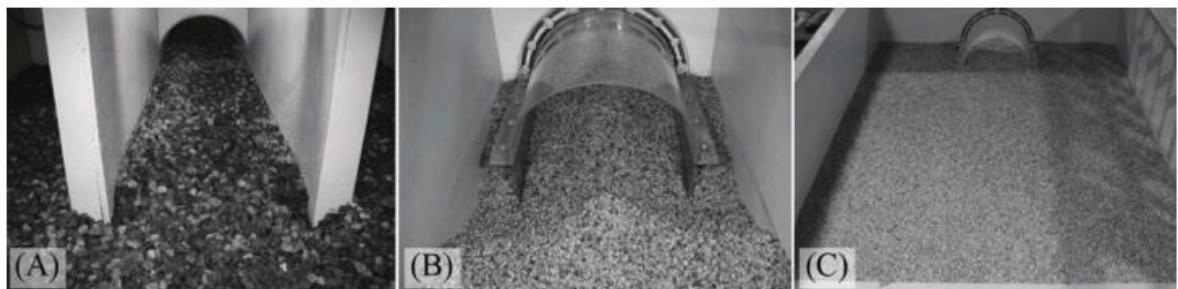
**Figure 3.17, Bottomless arch culvert entrance conditions (Crookston et al., 2012)**

Additionally, the entrance inlet traction ratio is also adjusted when the contraction percentages of 0% (A), 33% (B) and 75% (C) as shown in Figure 3.17. Out of the four rock types, the 16mm angular gravel performed the best due to its sufficient size and ability to resist movement. The rock also produced smaller local scour holes. However, it should be noted that angular rocks are more costly than rounded streambed materials. The contraction of the culvert entrance also decreased the scour

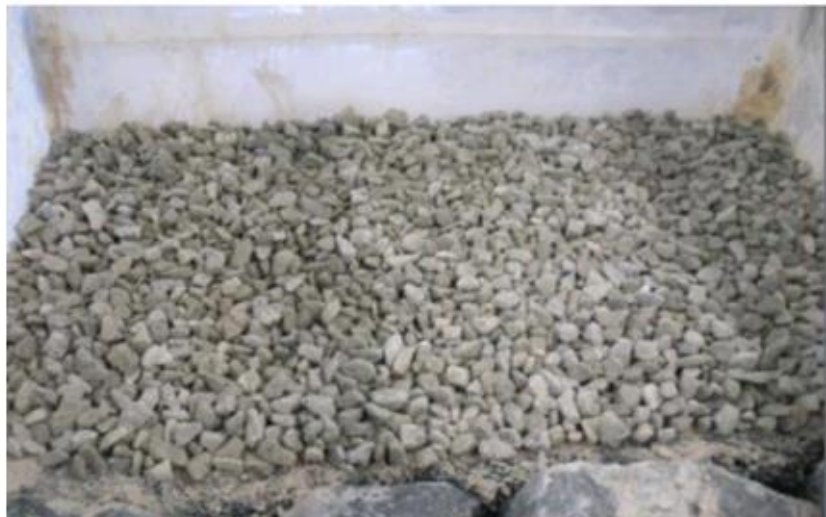
**Figure 3.18, Gravel underlayer on the levee (Johnson et al., 2013)**

Furthermore, riprap is also used frequently in levee scour protection. When riprap is accompanied with a gravel underlayer (Figure 3.18), its prevention ability jumped significantly. The scour depth and length reduction percentage of riprap by itself is 32% and 23.9%, respectively. However, after adding an underlayer, the reduction percentage increased respectively to 88% and 83% (Johnson et al. 2013). Sediment removal was avoided with the presence of an underlayer as the small pores reduce the flow interaction with the soil.

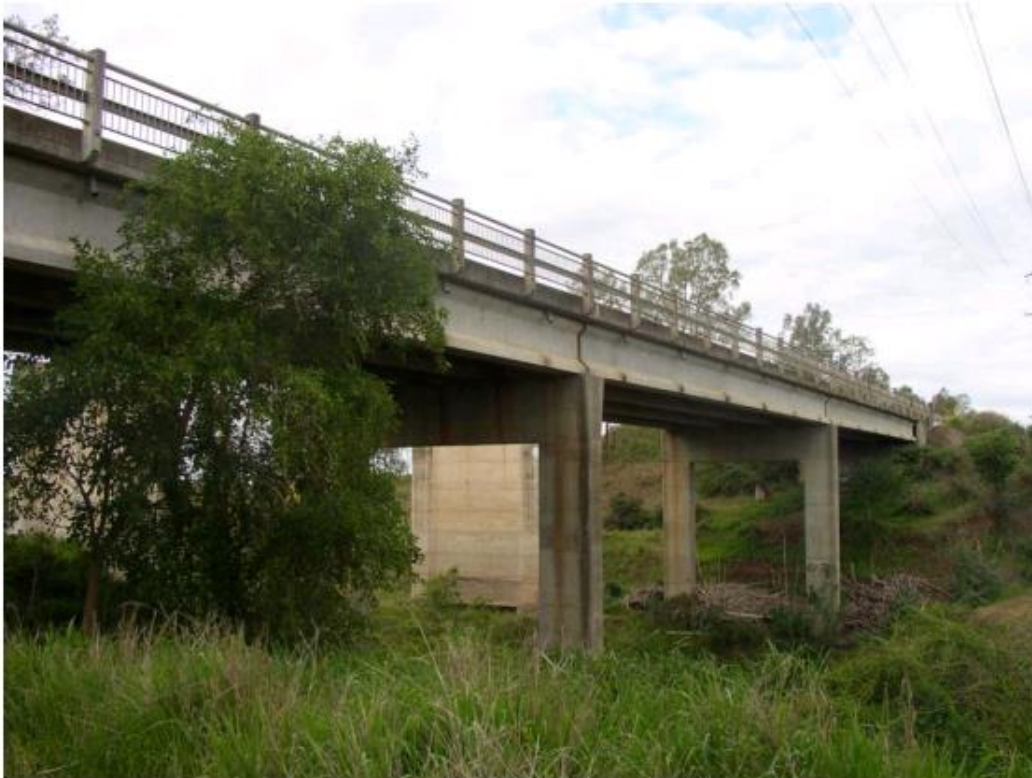
**Figure 4.1, Tenthill Creek Bridge (Setunge 2002)**

In HEC-RAS, the bridge dimensions must be defined in order to conduct the analysis. The Tenthill Creek Bridge is built in 1976, located south of Gatton, Queensland, Australia. A photo of the bridge can be seen in Figure 4.1. It spans over the Tenthill Creek and used to carry traffic from Toowoomba to Ipswich. The Tenthill Creek Bridge is a simple span reinforced concrete bridge and is 82.15m long and 9m wide (Setunge 2002). The bridge is supported by two abutments and two piers. Its specific design details can be found in Appendix C. The overall dimensions of the bridge are summaries in Table 4.1.

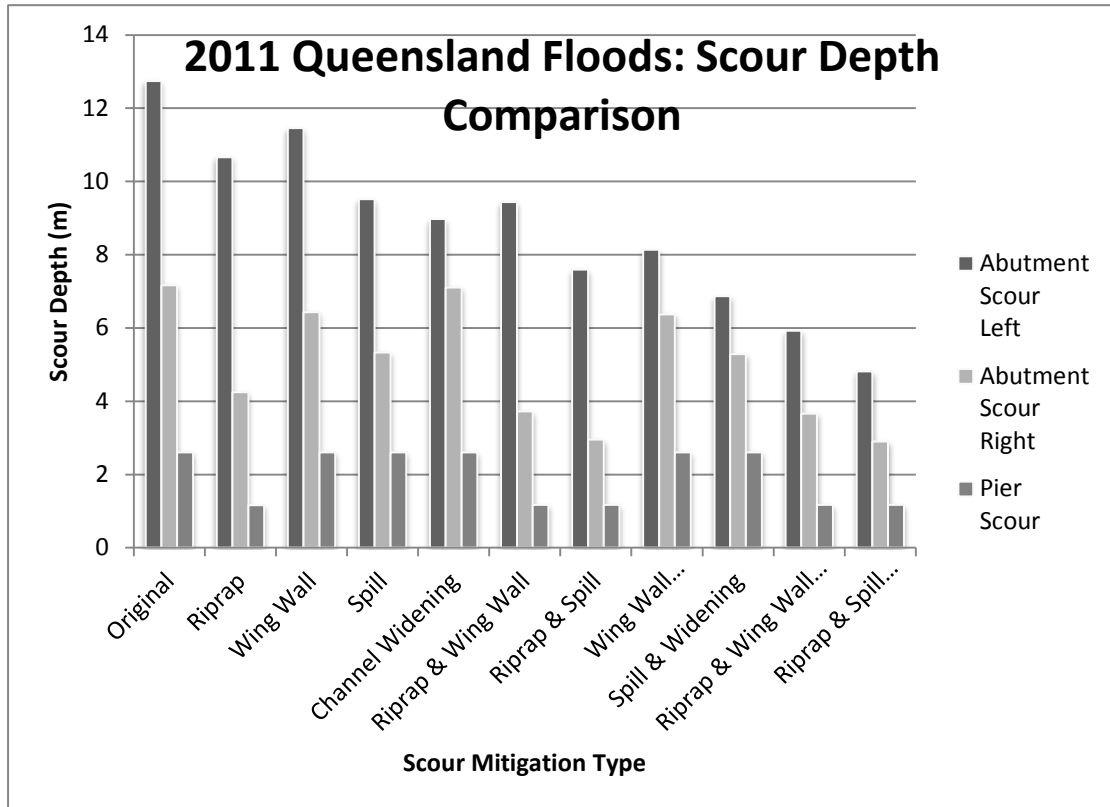
Figure 5.1, 2011 Queensland Floods: Scour Depth Comparison

Riprap & Spill	7.59	2.95	1.17
Wing Wall & Widening	8.13	6.37	2.6
Spill & Widening	6.86	5.28	2.6
Riprap & Wing Wall & Widening	5.92	3.66	1.17
Riprap & Spill & Widening	4.81	2.9	1.17

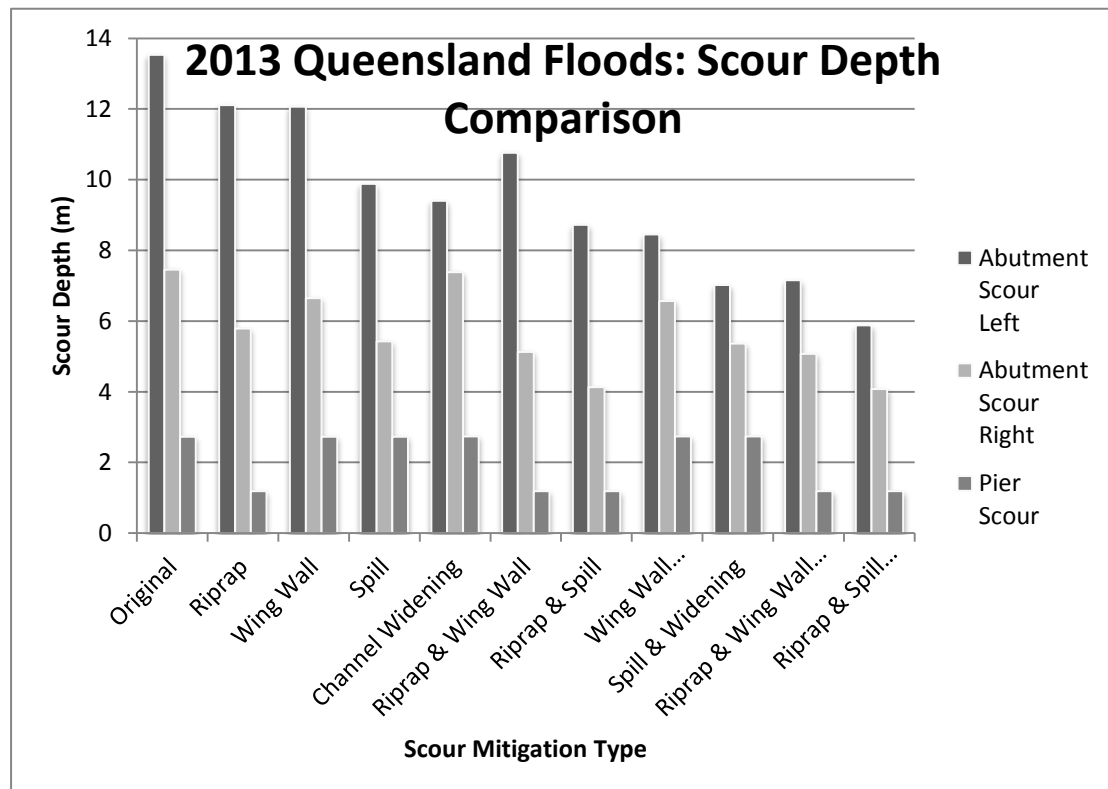
Figure 5.2, 2013 Queensland Floods: scour depth comparison

Scour Depth (m)		
	Abutment Scour Left	Abutment Scour Right	Pier Scour
Original	13.53	7.46	2.73
Riprap	12.11	5.79	1.19
Wing Wall	12.07	6.65	2.73
Spill	9.88	5.43	2.73
Bridge Widening	9.4	7.38	2.74
Riprap & Wing Wall	10.76	5.13	1.19
Riprap & Spill	8.72	4.13	1.19
Wing Wall & Widening	8.45	6.57	2.74
Spill & Widening	7.02	5.36	2.74
Riprap & Wing Wall & Widening	7.16	5.07	1.19
Riprap & Spill & Widening	5.88	4.08	1.19

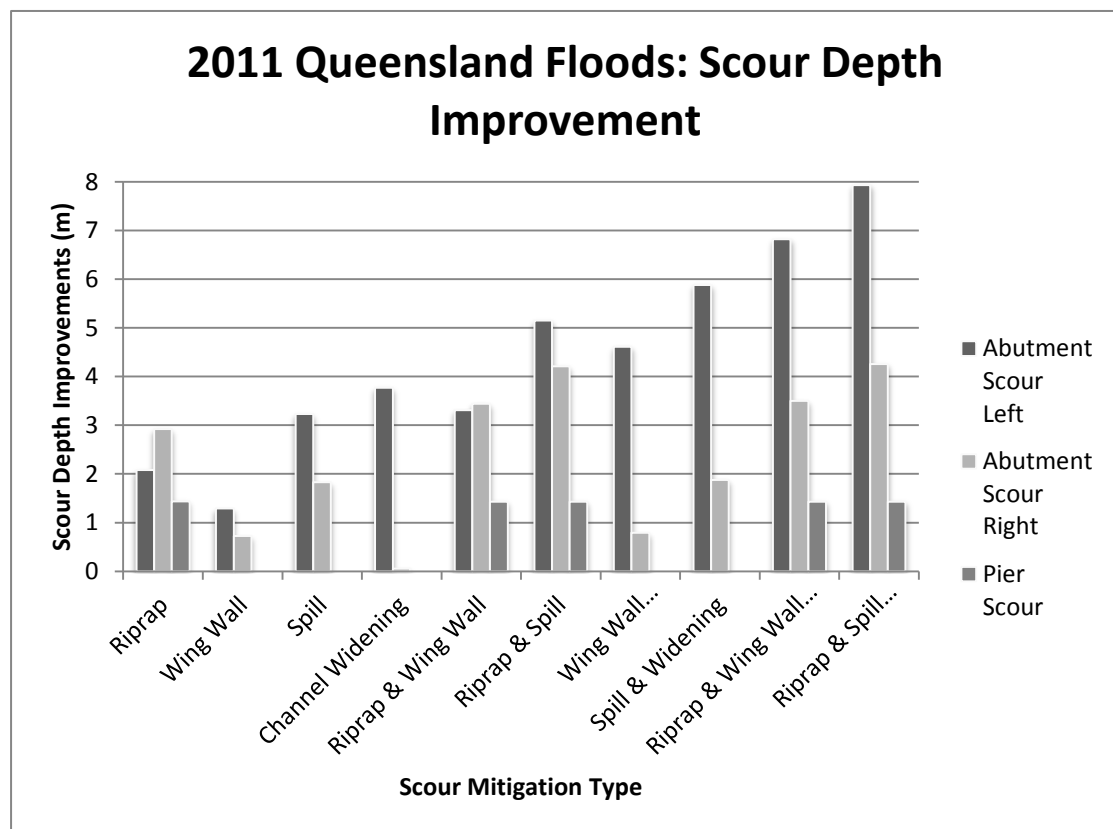
Figure 6.1, 2011 Queensland Floods: Scour Depth Improvement

In order to compare each scour mitigation method, the scour depth of the bridge without any protection is subtracted by the scour depth of each of the methods. The results are shown in Figure 6.1 and Figure 6.2, where the numerical details are shown in Table 6.1 and Table 6.2.

Comparing the methods by its own and ignoring the combinations, riprap decreases the scour depths all abutment scour and pier scour. The wing wall and the spill-through abutment decreases both abutment scours on the left and right side, but does not influence the pier scour depth. Widening the channel under the bridge and adding an additional pier significantly decreases the abutment scour depth at the left of the channel, but does not influence other scour depths.

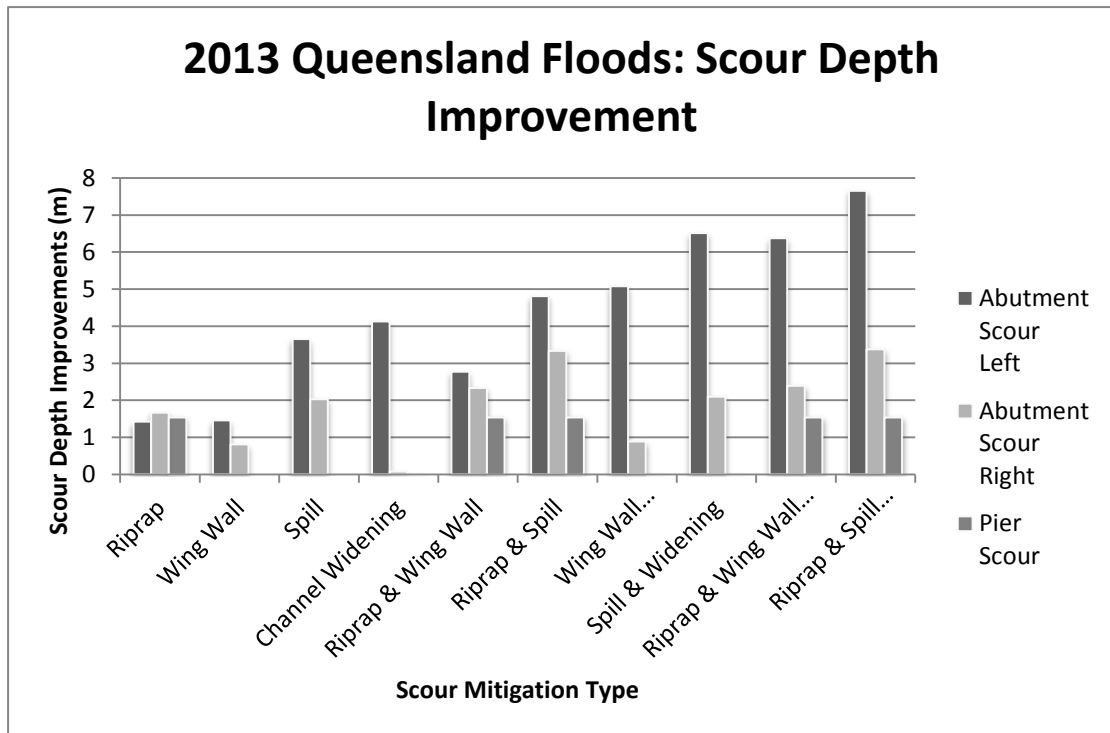
Figure 6.2, 2013 Queensland Floods: Scour Depth Improvement

These results are as expected, as riprap is applied throughout the channel bed, whereas the wing wall and the spill-through abutment are primarily used to decrease abutment scour. In the HEC-RAS model, the widening of the channel is applied to the left of the channel hence the decrease in scour depth is only on the left hand side.

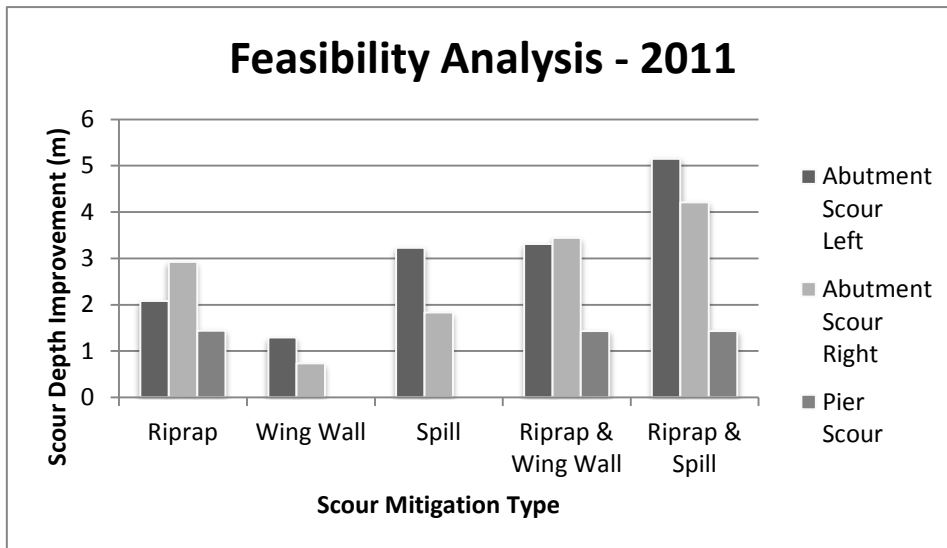
**Figure 6.3, Feasibility analysis for the remaining options - 2011**

As bridge widening is the least cost effective, methods that combine this are removed from the method selection list. To compare the options, Figure 6.3 and Figure 6.4 are produced. From both figures, it is evident that the two competing combinations are riprap with wing walls and riprap with spill-through abutments. The difference of the left bank scour depth reduction between the two options is approximately two metres, whereas the difference between the right bank scour depth reductions is approximately one metre. Moreover, the pier scour depths of the two methods remain the same.

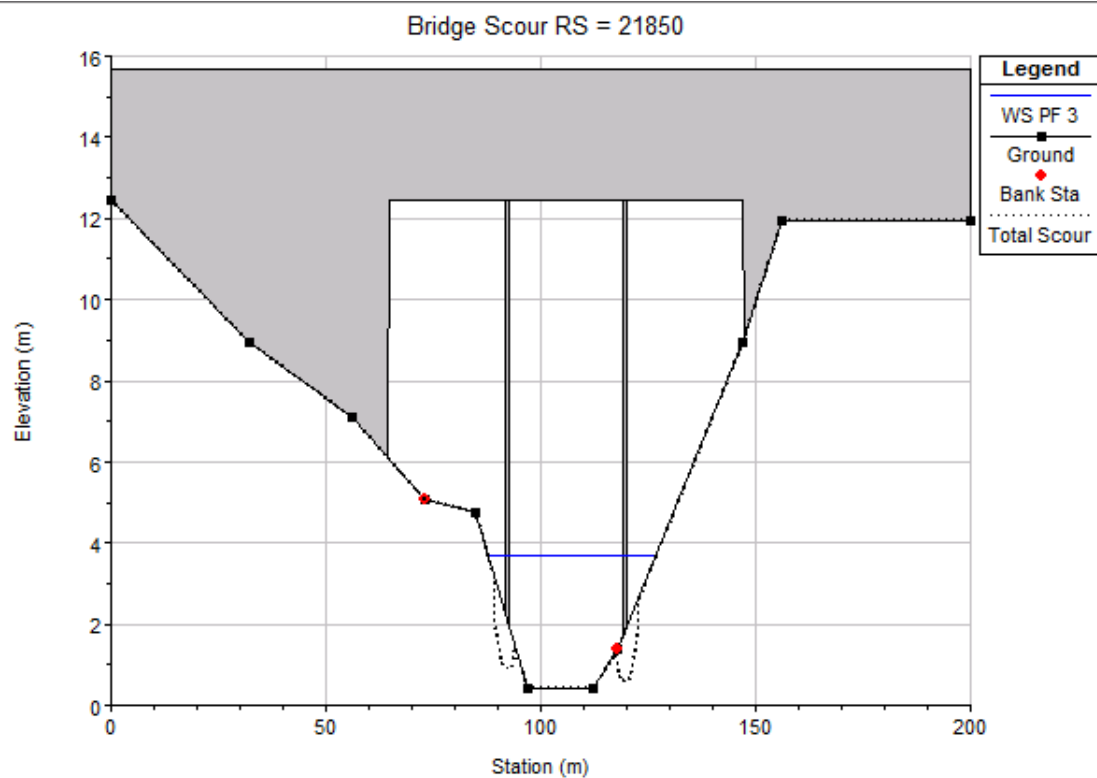
**Figure 6.5, Pier scour of the bridge when protected by riprap and wing walls - 2011**

Taking into account the possible geotechnical failure repair and construction costs of spill-through abutments, and the economic advantages of wing walls, the combination of riprap and wing walls ultimately is the most cost effective solution. Furthermore, riprap is adequate in preventing abutment scour when subjected to the average flow rate of the creek, where only pier scour is present (Figure 6.5).

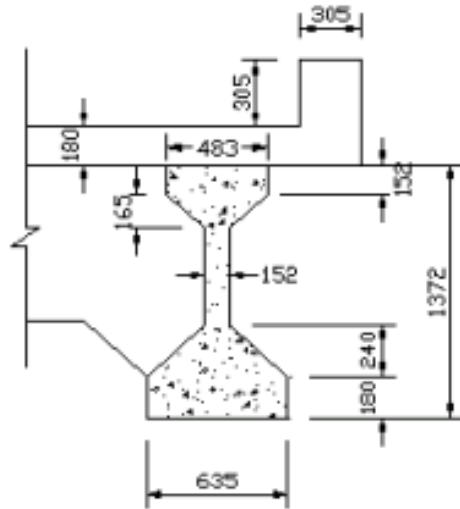
*Figure 2-4: Section details of a longitudinal pre-stressed beam*

The section details of a typical pre-stressed concrete beam is shown in Figure 2-4

Beam span = 27382 mm.
