3D Hydrologic Features Mapping with Imaging Rover

A dissertation submitted by
Declan Pettersson

in fulfilment of the requirements of
ENG4111 and ENG4112 Research Project
towards the degree of
Bachelor of Spatial Science (Honours) (Surveying)
Submitted October, 2016

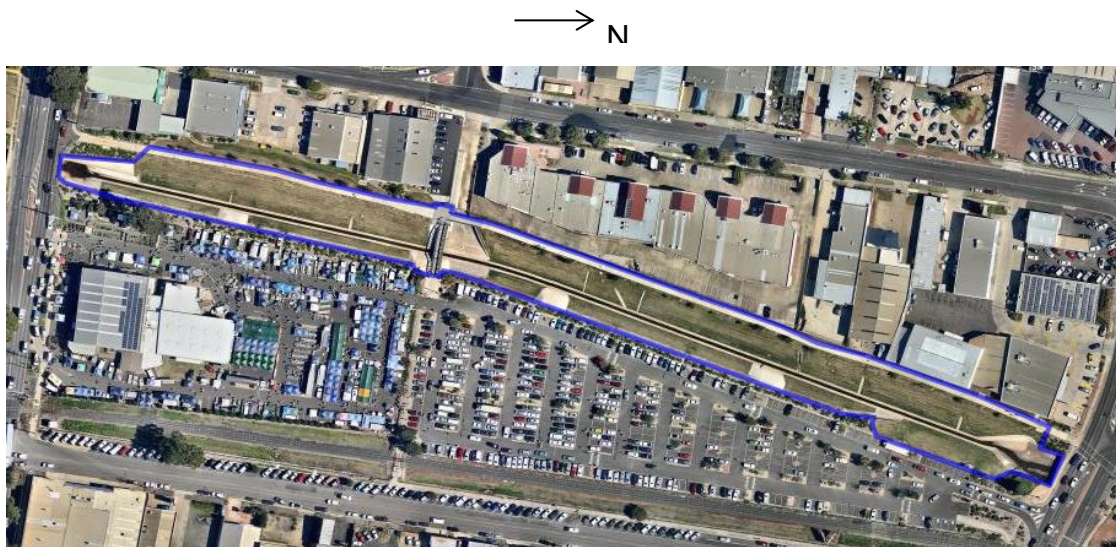
Figure 3.2. Satellite Image of the survey site (*NearMap, 2016*)

The survey site is located in Central Toowoomba. The site is a stretch of West Creek between Herries Street and James Street.

The approximate length of the site is 460m derived from satellite imagery. For the purpose of the dissertation, the site had to be a significant waterway affected by the 2011 Toowoomba floods. This particular stretch of West Creek has recently been redeveloped, so it serves as a good site to determine whether the changes are beneficial.

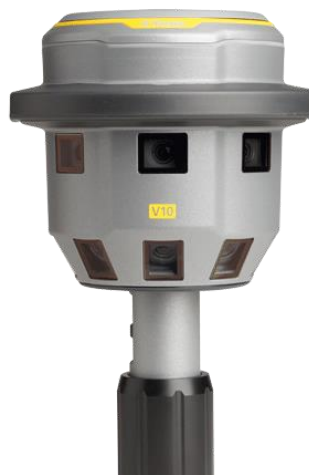
The Trimble V10 is an imaging rover that can generate survey accurate positions from images. It includes 12 calibrated cameras which are able to capture 60mp panoramic images.

Figure 3.3. Trimble V10 Imaging Rover (Trimble, 2016)

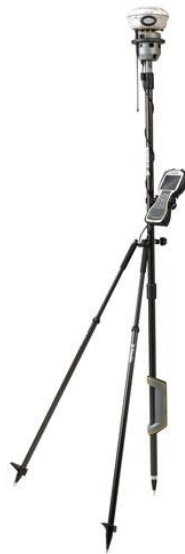
The V10 is positioned using a range pole and stabilised with a tripod. The range pole features a power supply near the base of the pole, and feeds the imaging rover via the pole; however external additions such as a GNSS receiver or tablet require an independent power source.

Figure 3.4. Trimble V10 range pole setup (*Trimble, 2016*)

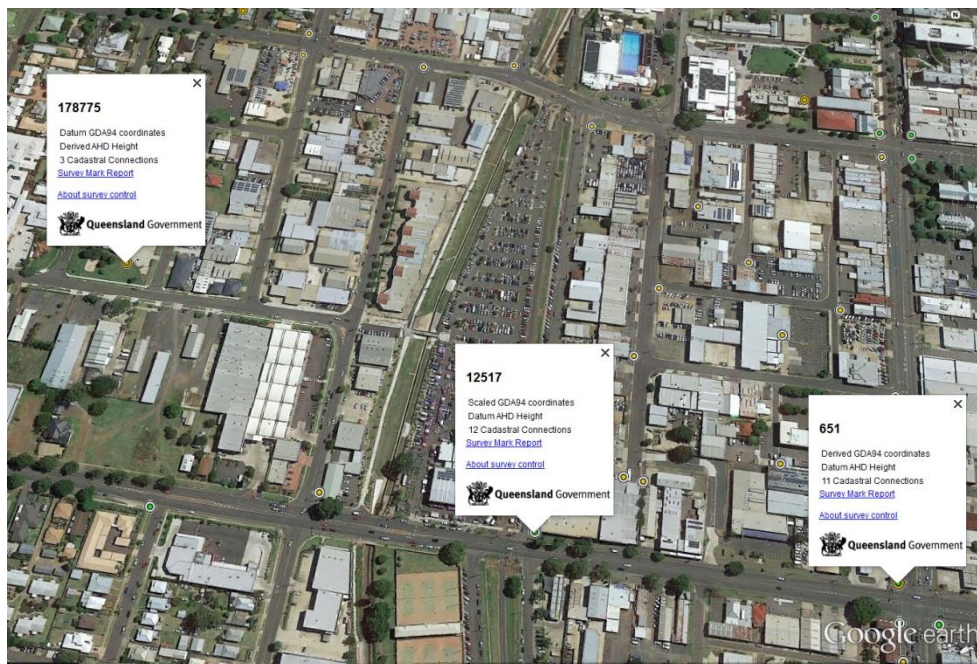
Figure 3.5. Location map of permanent survey marks used for control (Google Earth, 2016)

The selection of survey marks was the best available and provided good separation and geometry as they surrounded the site to minimise potential error.

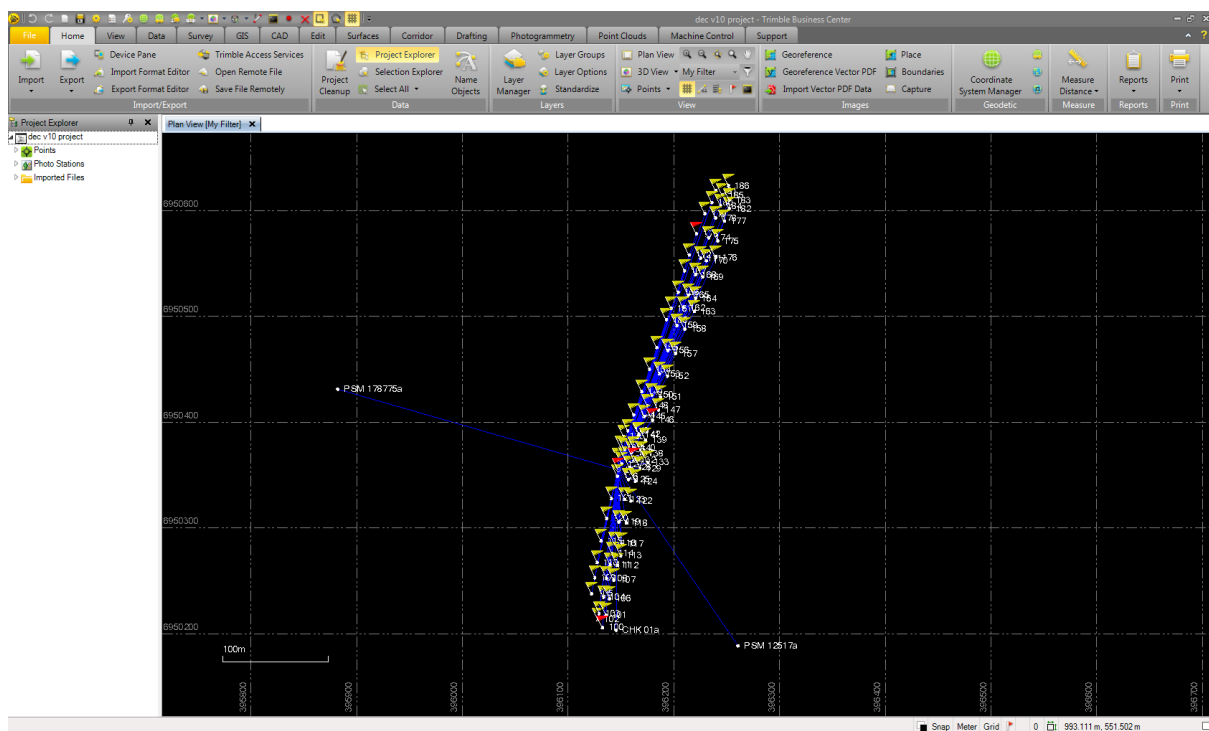
The first step was to extract the data from the Trimble Rugged Tablet PC and upload the raw data file (.job) into TBC. The photos from the survey are stored in a known location so TBC can access and import them into the program along with the .job file. It is important to note that the directory that the photos are stored in cannot be changed as TBC will no longer recognise the location and thus will not be able to import them. Once the data is imported, a basic layout of the survey can be seen with the spatial positions of the PSM's, check shots and photo stations.

Figure 3.6. Layout of photo stations within TBC

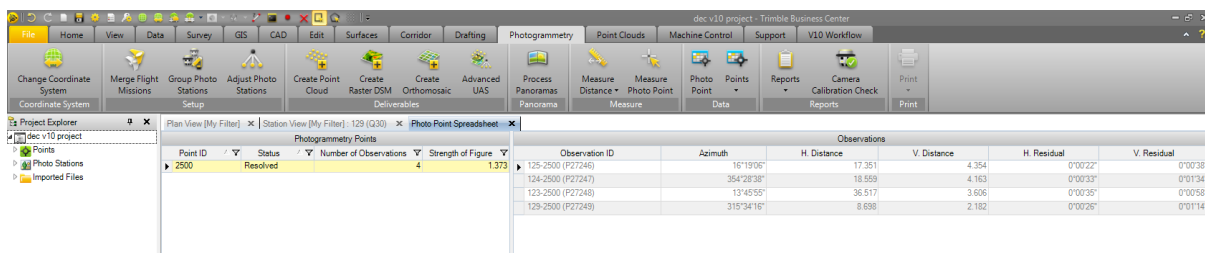
The photo point attribute data can be seen within the photo point spreadsheet. This provides information on the strength of the point (how accurate the coordinates are), the amount of connected photo stations, the bearing and distance from each connected photo station as well as whether the photo point is resolved or not.

Figure 4.2. Photo points attribute data

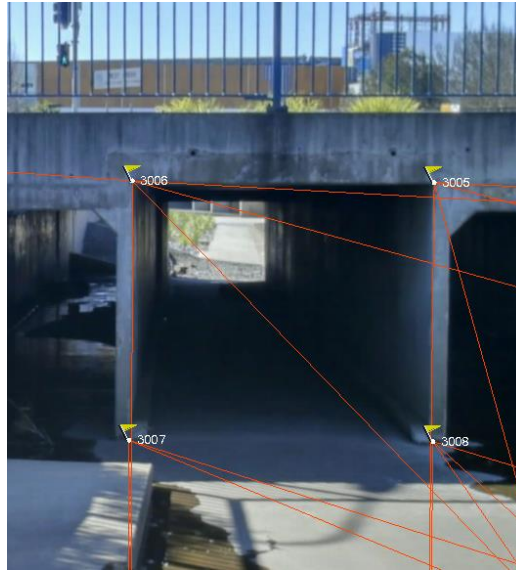
Figure 4.4. Analysis of eastern culvert

Four corners of the culvert were selected using the aforementioned process in order to determine the size. Each point was selected from a minimum of four photo-stations to ensure accuracy. Because of the sharp edges, the points were easy to replicate in all photo-stations. The inverse function calculated the left side to be 2.365m high, the top to be 2.701m wide, the right side to be 2.327m high and the bottom to be 2.745m wide. Accounting for user selection error, it can be assumed that the culvert's size is 2.70m x 2.35m. This results in an area of 6.345m². Water flow analysis can be tested on the site to determine the flow rates experienced in a storm; which then can be tested against the culverts to determine whether they can handle the flow. The same process of analysis can be applied to the rest of the image model to model the hydrological features, however with the generation of a point cloud; a much more in depth analysis should be theoretically possible.

Culverts also play a major part in the waterway structure and potentially have the biggest impacts on flooding if they are blocked or overwhelmed. The culvert on the norther end of the site was selected to be analysed as it is downstream and is most likely to get blocked.

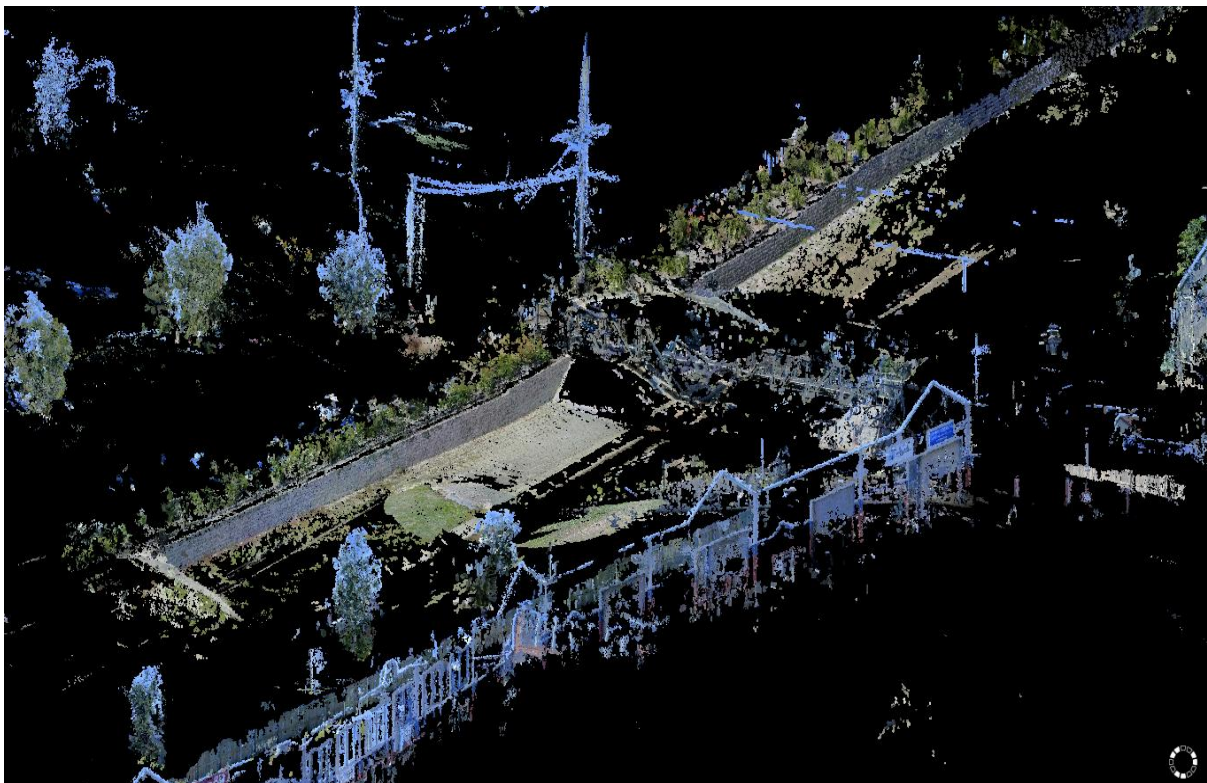
The point cloud that was generated for the project turned out to be extremely inconsistent and a significant amount of detail was excluded from the final model. A number of hydrological features were either completely missed or poorly generated. The point cloud was inconsistent throughout with ground coverage and grass being represented well in some sections and completely non-existent in others.

Figure 4.5. View of the point cloud showing inconsistency of data generation

The point cloud has failed to identify the channel running through the middle of the site and the main hydrological feature, the bridge, has large sections missing. The surrounding building facades and trees have been represented well for the most part but that was not the investigation of this project.

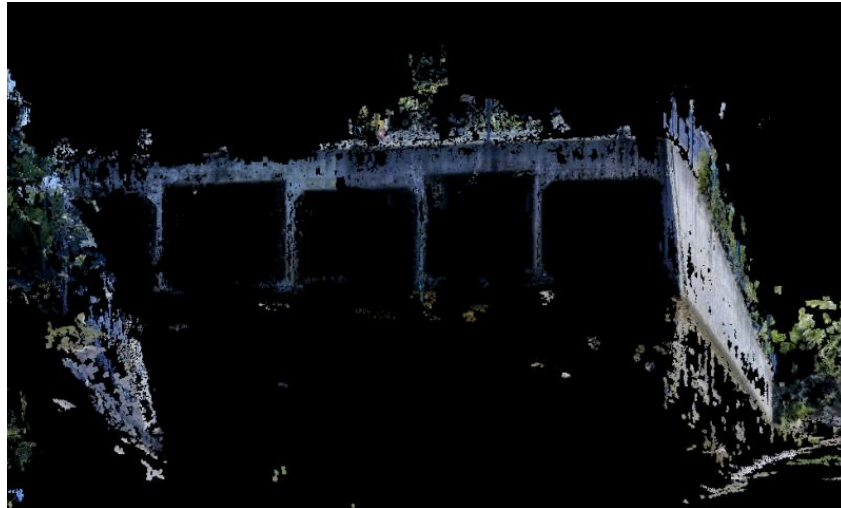
Image 4.6. Northern culvert in the point cloud

The culverts are represented quite well as they consist of sharp edges and it is easy for TBC to differentiate between the surfaces and create points. The channel on the other hand is essentially non-existent even though the grass and concrete offer completely different textures. It can be seen in both images that there are no points on the ground, making it extremely difficult to gather information regarding areas, volumes and heights.

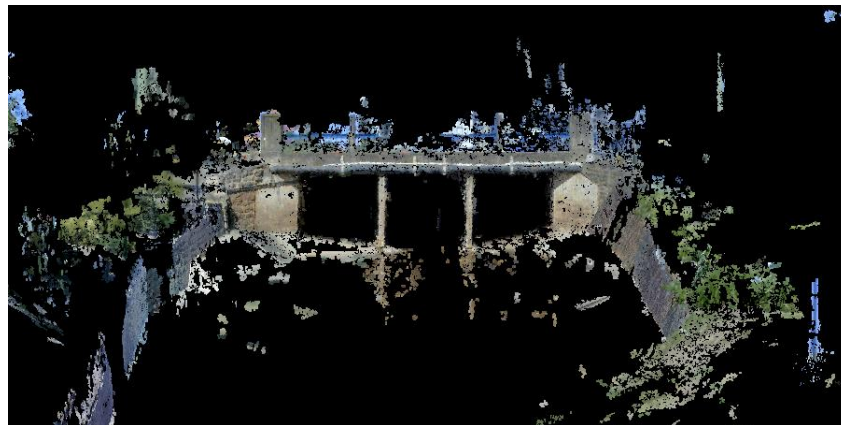
Image 4.7. Southern culvert in the point cloud

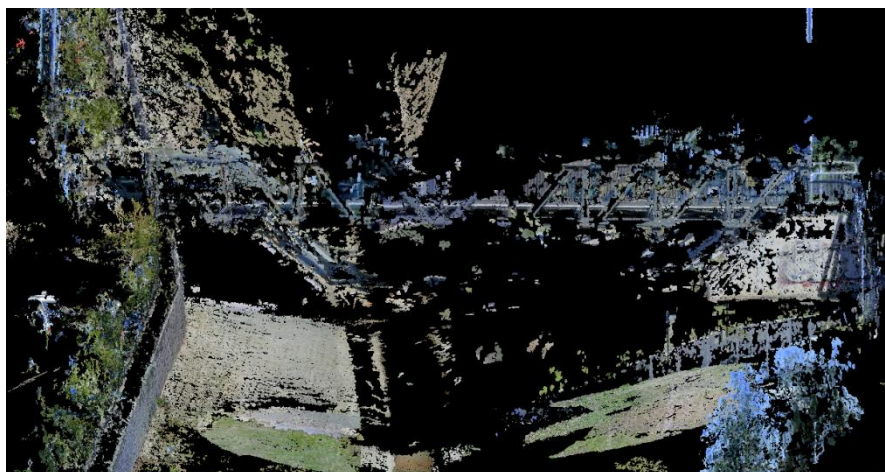
Figure 4.8. Point cloud representation of the bridge in the centre of the site

The image shows how sporadic the point coverage of the bridge is and the amount of detail that is missing. The opposite handrail of the bridge is virtually non-existent. A small amount of ground cover can be seen which consists of pavers and grass. It is interesting how TBC generates some patches of grass but ultimately leaves the majority of the ground surface out. There is not enough information to model or render the hydrological features and there is limited need for a point cloud to be generated if it is similar to this one.

The bridge in the centre of the site was mostly modelled, but it is quite patchy and large sections of the handrail and path are missing. Once again there is a distinct difference between the bridge and the surrounding objects, so it was expected that it would be represented much better than it is. It cannot be explained as to why TBC has generated some sections of the bridge, but failed to generate the whole feature. The culverts at both ends of the site have been generate quite well and the size and shape can be clearly seen, but the ground surface is lacking.

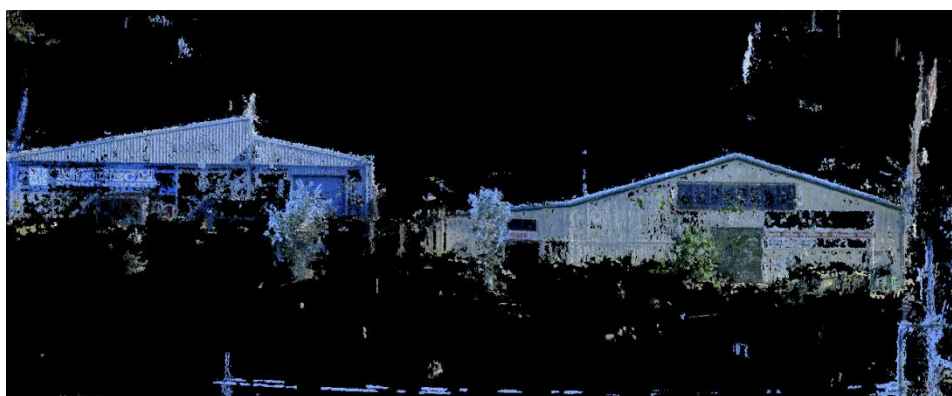
Figure 4.9. Building facades in the point cloud

The building facades were easily the most comprehensive features displayed within the point cloud. This is most likely due to the wide range of textures and detail present on the buildings. The buildings were outside the selected site, yet they were
