University of Southern Queensland
Faculty of Health, Engineering and Sciences

**Use of Wire Extensometers for Monitoring Pavement
Performance in Areas of Slope Instability**

Bachelor of Engineering (Civil)

Submitted: 24 October 2013

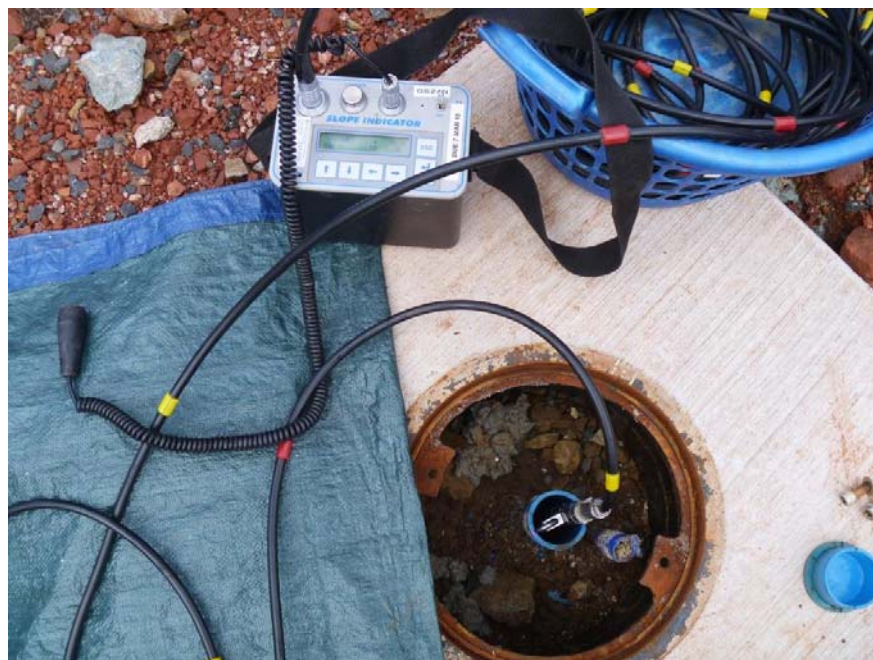
As seen in Figure 5, the cable is marked at half-metre graduations with a yellow marker and at metre graduations with a red marker. In addition, every 5 metres the cable is labelled with the corresponding metreage.

Figure 5 – Probe, cable and Datamate set up for reading inclinometer

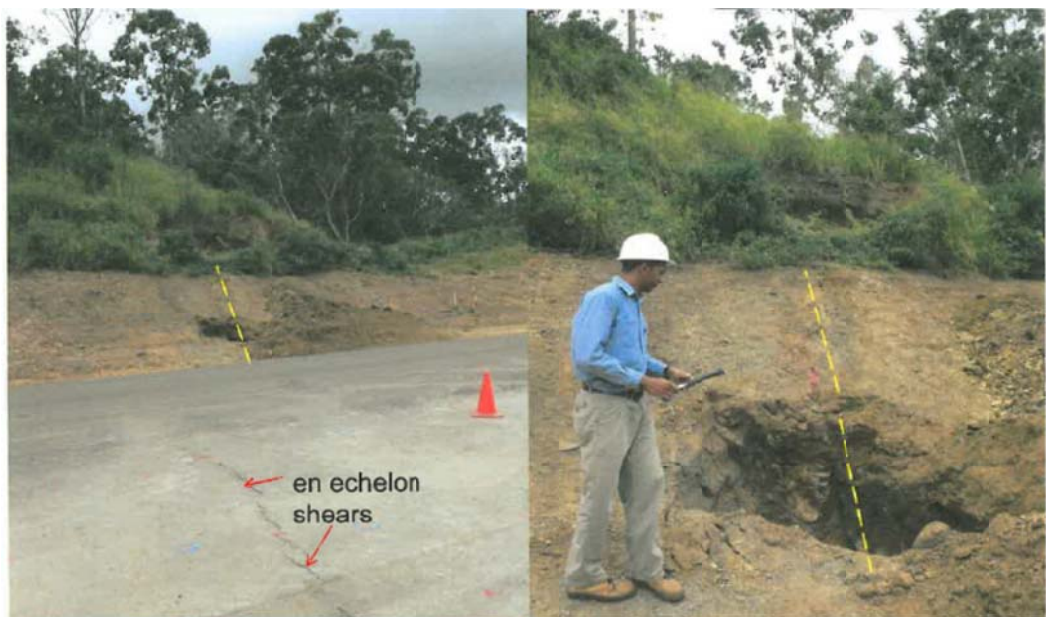
During the advanced stages of earthworks construction of the Springfield to Yamanto section, large scale landslide activity was detected in the vicinity of road cuts 3 and 4. The landslide activity is believed to be a result of the reactivation of a deep seated slow movement along shear planes associated with an ancient land surface (Starr et al. 2010). Figure 8 shows the severity of the observed shearing in the pavement and batter. This evidence of slope instability was discovered only days before the road was scheduled to be opened to the public.

Figure 8 – Shear cracking in pavement and batter at Cut 3 after heavy rainfall (Starr et al. 2010)

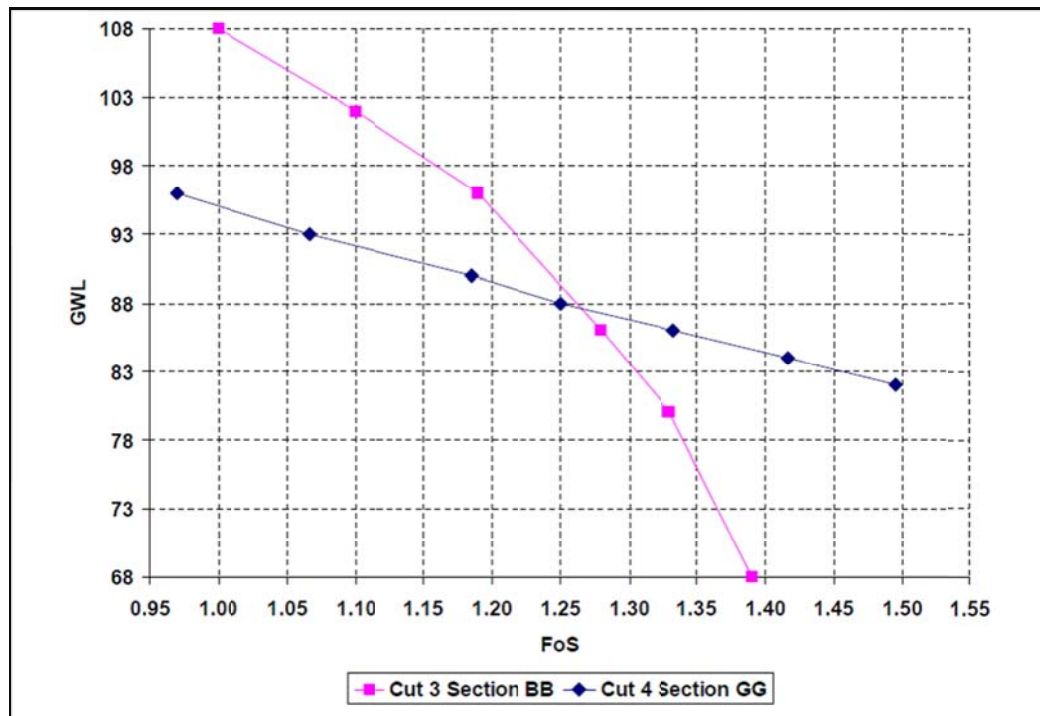
Additional modelling enabled a relationship between the groundwater level and factor of safety to be reached. This is shown in Figure 11.

Figure 11 – Plot showing influence of groundwater level on factor of safety

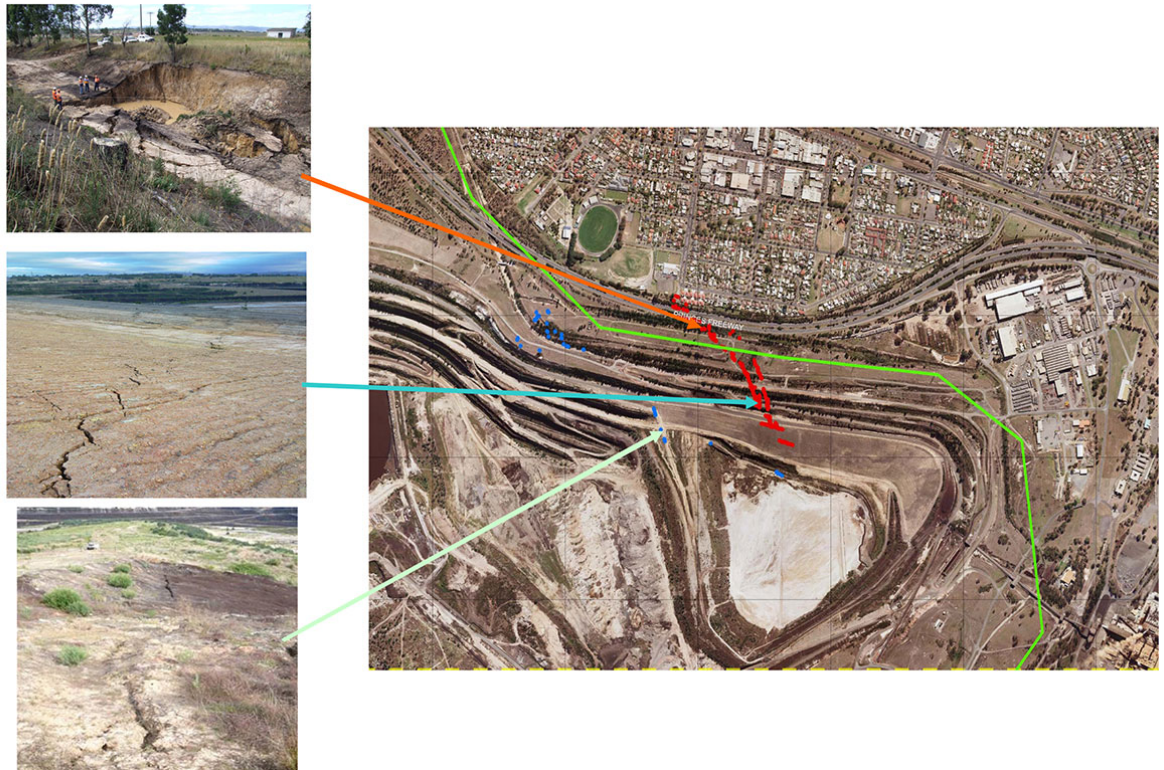
Due to the safety concern for road users, diversions were put in place for approximately 9 months so investigation and remediation could be undertaken (Sceney & Bignell 2011). Figure 14 depicts the location of the large sinkhole and cracking extending from the Hazelwood Mine to the Princes Highway.

Figure 14 – Sinkhole and cracking at the Princes Highway/Hazlewood Mine site, Morwell

In early February 2011, a significant rainfall event was associated with a movement event on the northern wall of the Hazelwood Coal Mine. As a result of the movement, cracks appeared across the mine batter, the surface of the Princes Highway and at the end of Hazelwood Road (Sceney & Bignell 2011). A large sinkhole also appeared at the top of the mine batter.

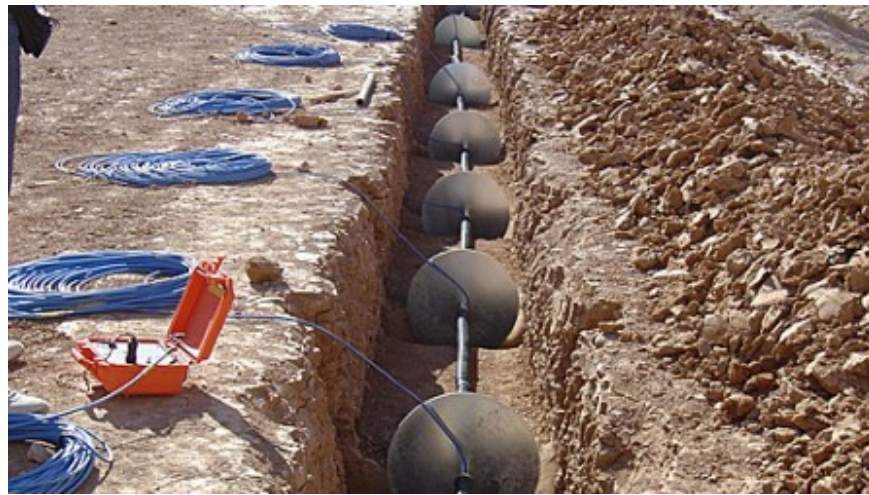
The soil strainmeter can be assembled in a series by using threaded rods to provide a bolted connection between the flanges. These components are linked together so that movement of one anchor relative to the other causes a change in the output of the potentiometer (DGSI 2013). The initial reading of the strainmeter is used as a datum. Subsequent readings are compared to the datum to calculate the magnitude, rate, and acceleration of movement (DGSI 2013). Figure 19 depicts SISGEO soil strainmeters in a typical installation. Note the large circular flanges which anchor the instruments in place when fill is placed around them.

Figure 19 – Soil strainmeter installation (SISGEO 2010)

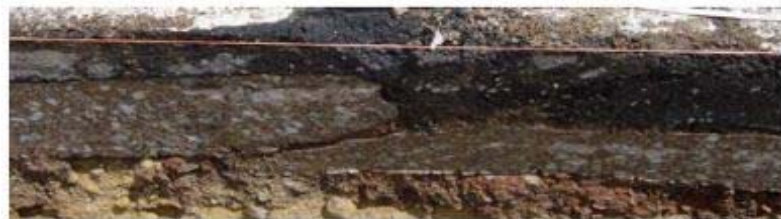
However, this was not the case on the Hume Highway. Shear/compression steps, 40 to 80 mm high occurred at two locations. Both steps occurred where irregular subsidence was observed in the form of elevated compressive ground strain (Nosenzo et al. 2013).

Figure 24 – Stepping in pavement surface caused by compressive strains (Nosenzo et al. 2013)

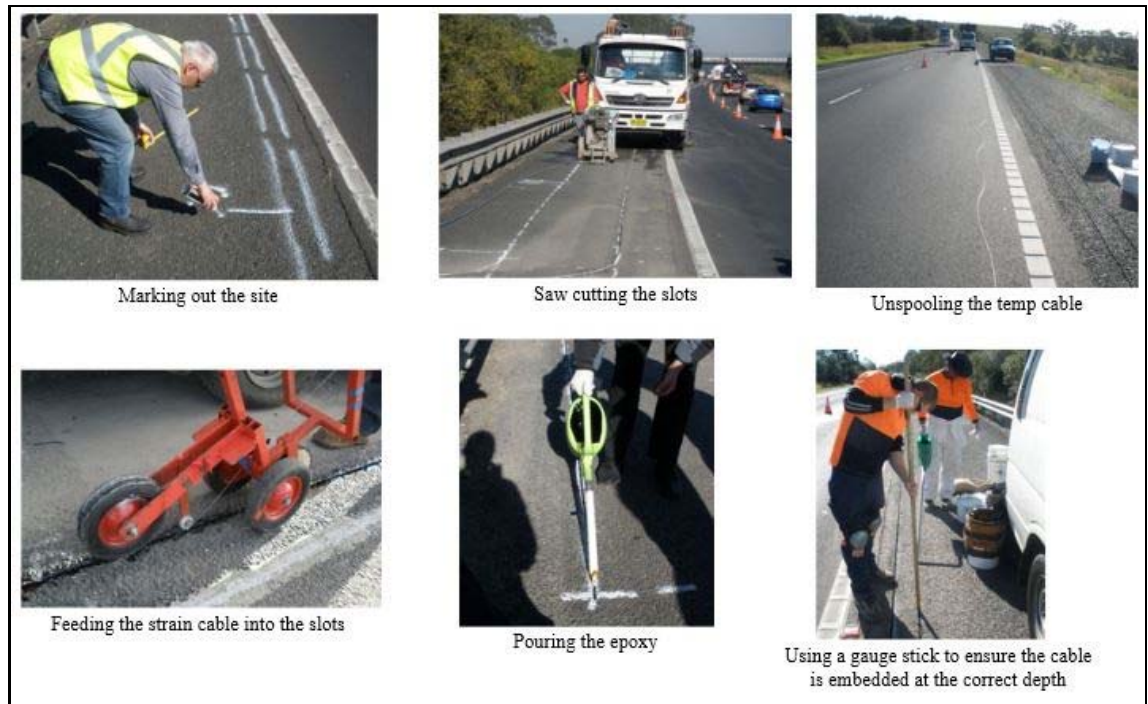
Figure 26 – Installation steps (Nosenzo et al. 2013)

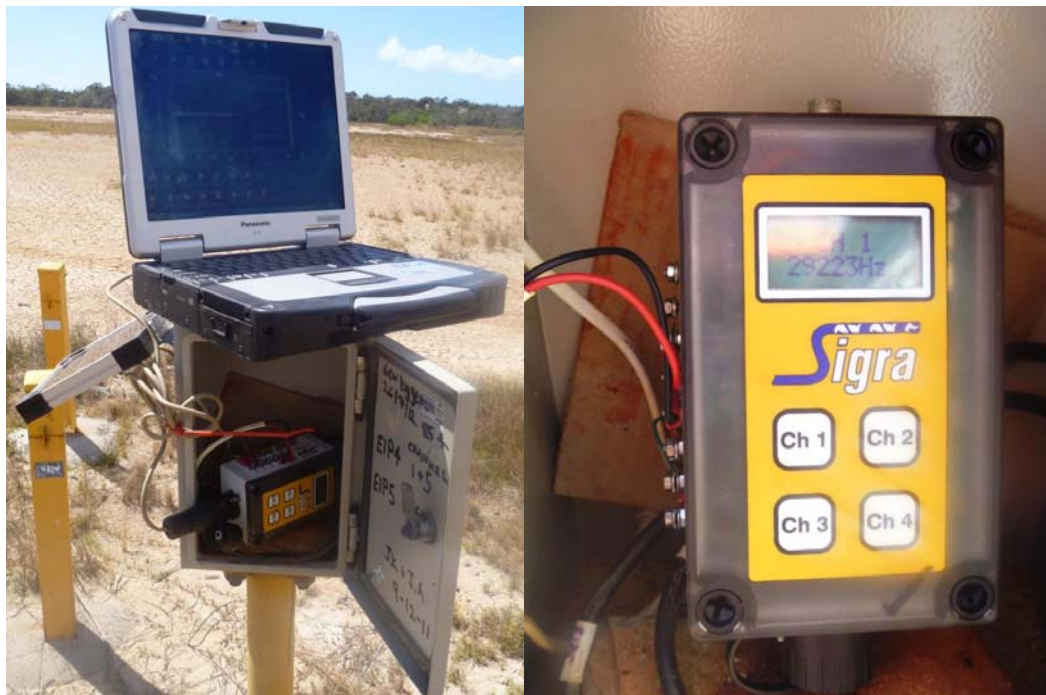
Data recorded by the logger is stored in the logger's memory until it can be downloaded to a PC. The logger can store at least 18000 – 45000 data samples, depending on the number of channels being recorded (Sigra 2009). An added advantage of this logger is the unit's liquid crystal display (LCD). This allows the current state of the instruments connected to the logger to be viewed in real time by use of the 4 buttons on the face panel of the logger. This can be seen in Figure 30. In this Figure, note the solar panel installed on the side of the cabinet. This 1-watt, 6-volt solar panel is sufficient to ensure the battery pack continuously remains at operational voltage provided the solar panel receives sufficient radiation.

Figure 30 – Sigra logger data retrieval with a PC

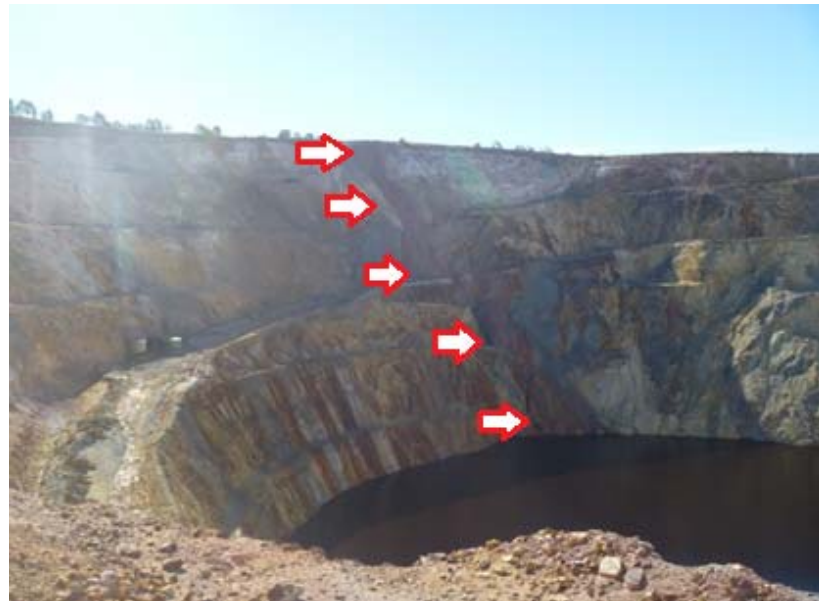
The southwest pit wall is host to a large fault known as the West Wall Fault. This fault consists of up to 8 m thickness of sheared rock and dips SE at an angle of 50 to 65° (Coffey Geotechnics 2011a). Figure 36 shows the extent of the large West Wall Fault.

Figure 36 – North west view of the West Wall Fault, July 2013

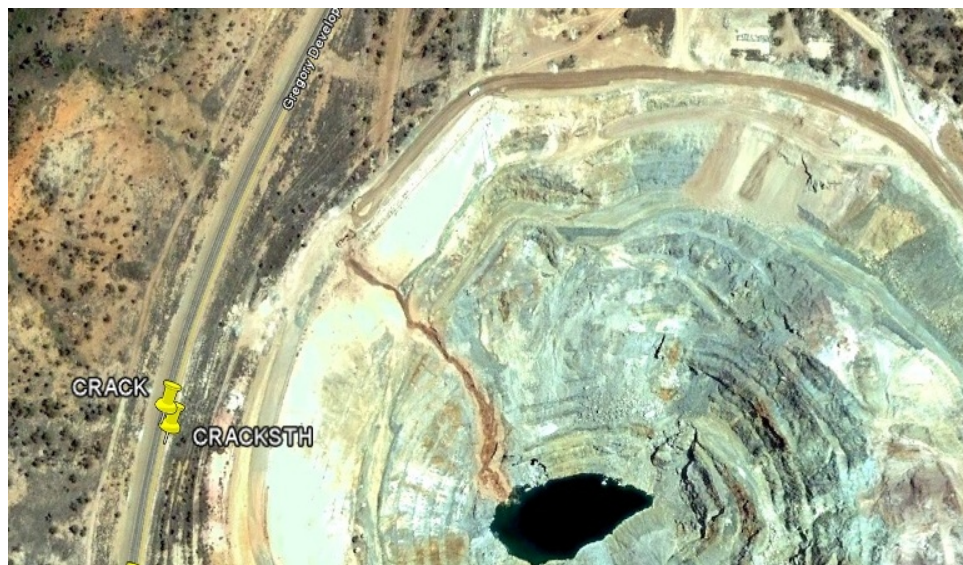
According to Coffey Geotechnics (2011a), on the evening of 18 July 2005, Thalanga staff reported cracking in the pavement of the Gregory Developmental Road, adjacent to the south-west wall. The total length of this cracking now extends over 100 m of the roadway, and at the closest point, the crack is only 50 m from the crest of the mine open cut pit (see Figure 37 & Figure 38). Geotechnical specialists were engaged, and recommendations were made to immediately seal the cracking and install survey monitoring prisms in this area in order to monitor possible ground movements.

Figure 37 – Marked location of pavement cracking (image courtesy of Google Earth)

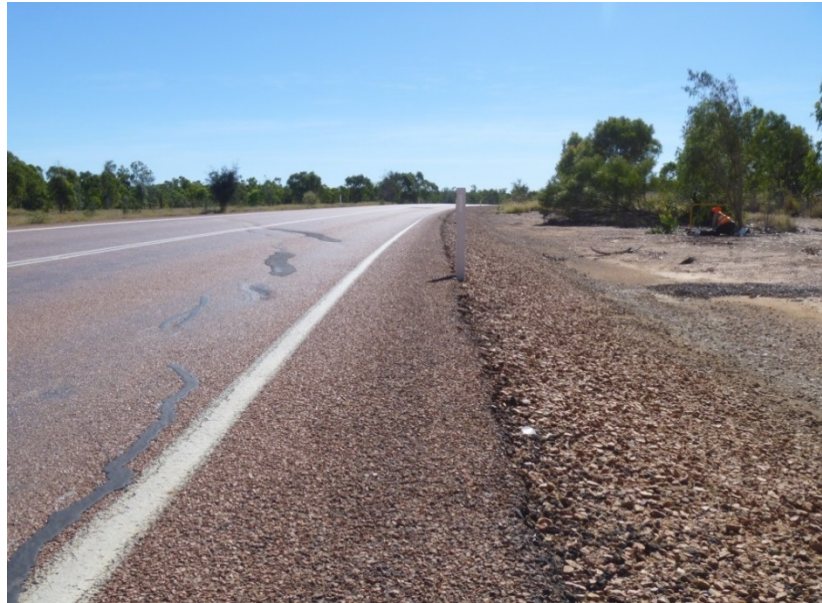
Figure 38 – Repaired pavement cracking, July 2013

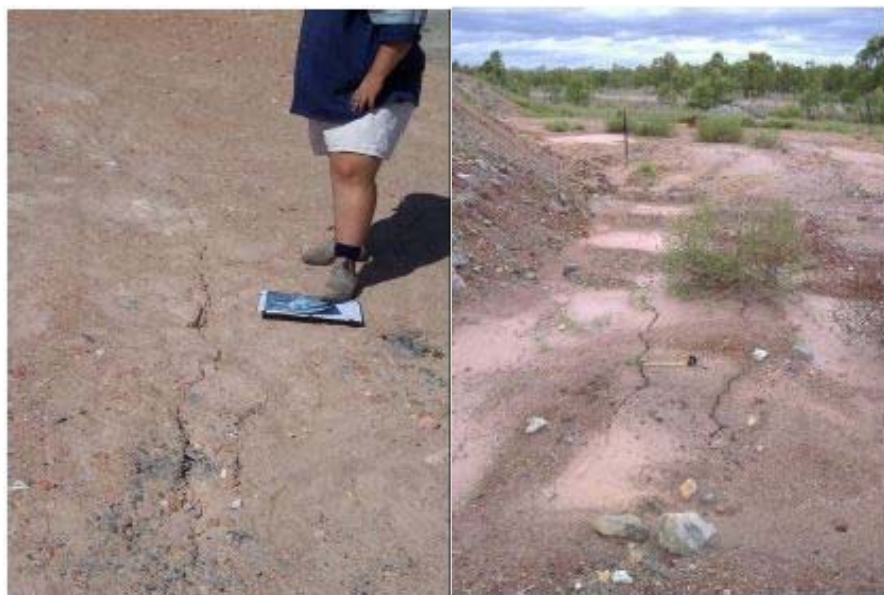
Subsequent site visits by Coffey Geotechnical staff also discovered cracking adjacent to the ground surface in the vicinity of the West Wall Fault. Images of these observed cracks are shown in Figure 39. However, it is noted that these cracks are no longer visible due to infilling over time.

Figure 39 – Observed cracking in the vicinity of the West Wall Fault (Coffey Geotechnics 2011a)

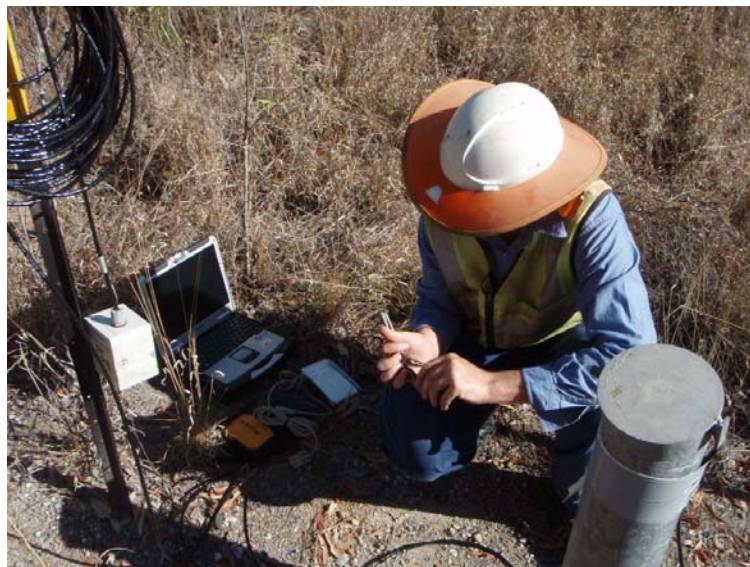
Although the well was located a fair distance from the site, the VWP installed in the well would give some indication of the ground water levels present, which would assist in later stages of data interpretation. The VW Mini Logger was programmed to take readings at 1 hour intervals in order to capture any changes in groundwater level accurately. Figure 42 shows the installation of the VWP and logger.

Figure 42 – Installation of VWP and logger in existing monitoring well

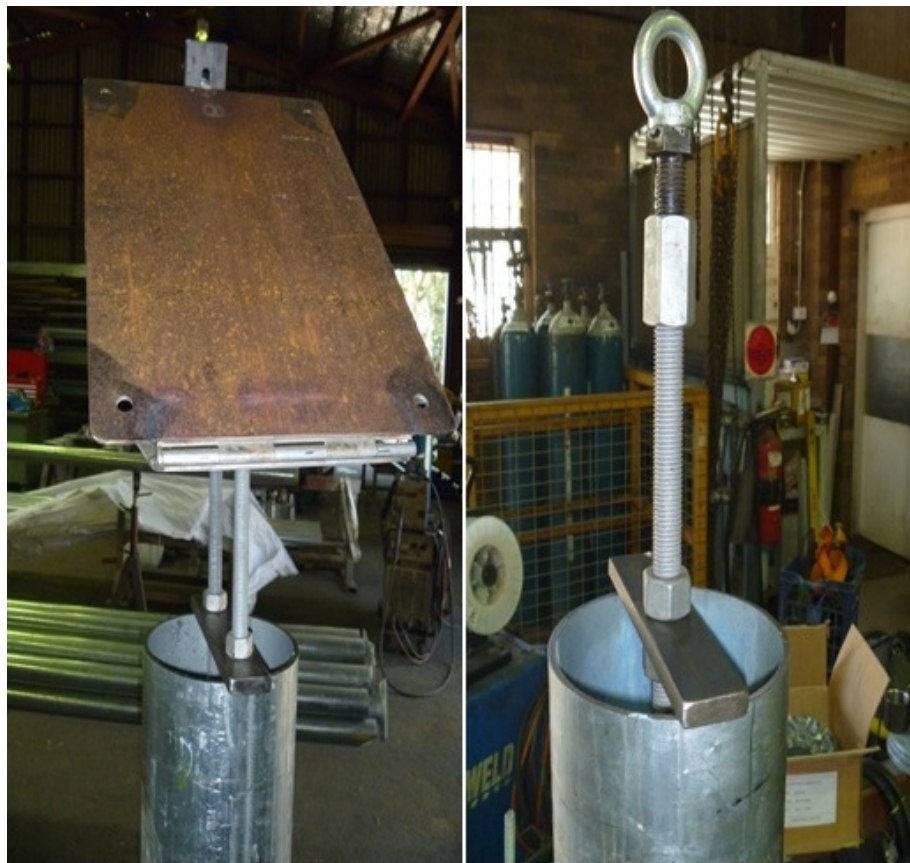
Figure 43 shows the live end and anchor end brackets before installation. Note the nuts and steel plate at the surface of the bollard. These allow the correct height to be set before they are set in concrete inside the bollard.

Figure 43 – Adjustable brackets: live end (left) and anchor end (right)

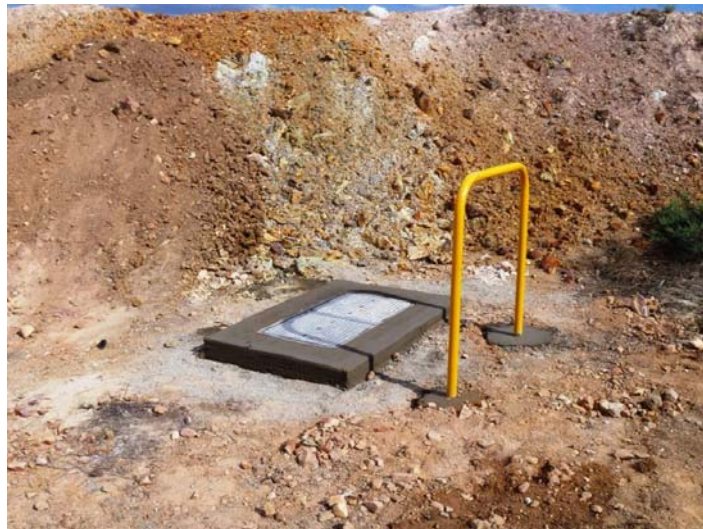
To mark the locations of the pits, and also to prevent them being damaged by vehicles, steel barriers fabricated from 50 mm pipe were installed beside each pit. A completed installation with the yellow barrier is shown in Figure 55.

Figure 55 – Completed installation with marker barrier

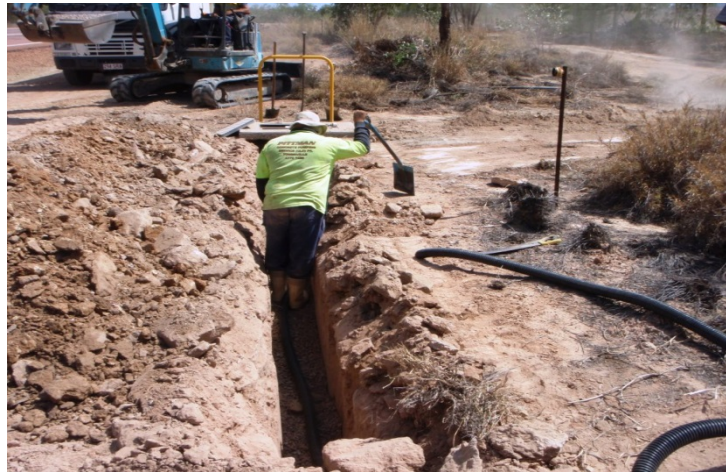
Figure 56 – Drainage trench for live end of pit

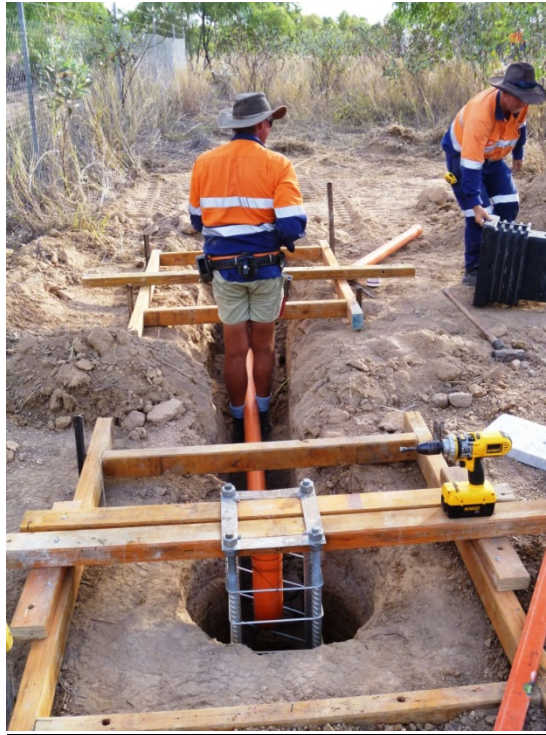
Figure 57 – Foundation formwork and reinforcement cage for communications pole

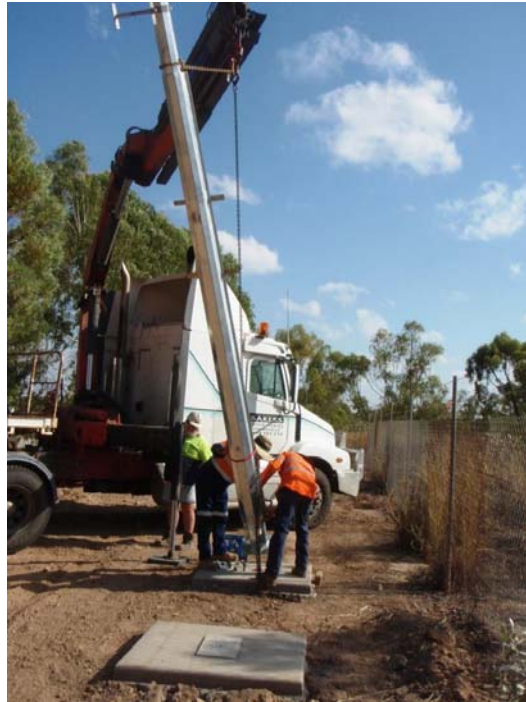
Figure 58 – Lifting hinged pole into place with truck mounted crane

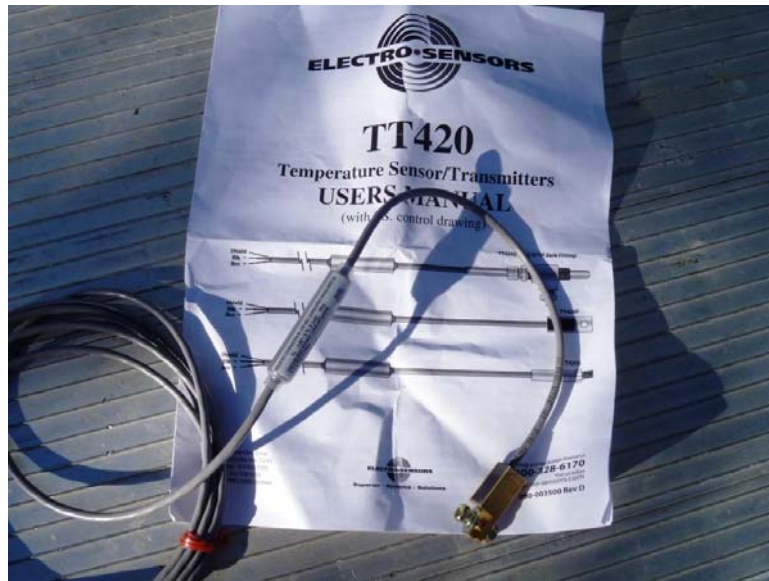
Figure 61 – 4 to 20 mA temperature sensor

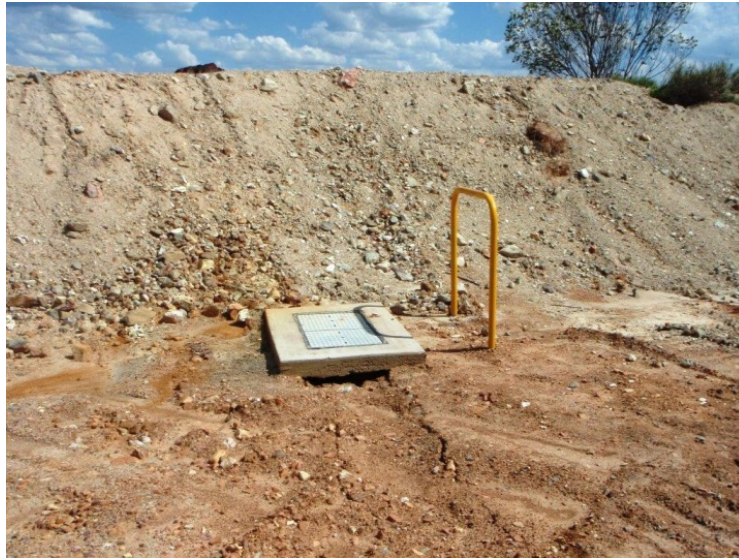
Figure 77 – Erosion and cracking around WE3 installation

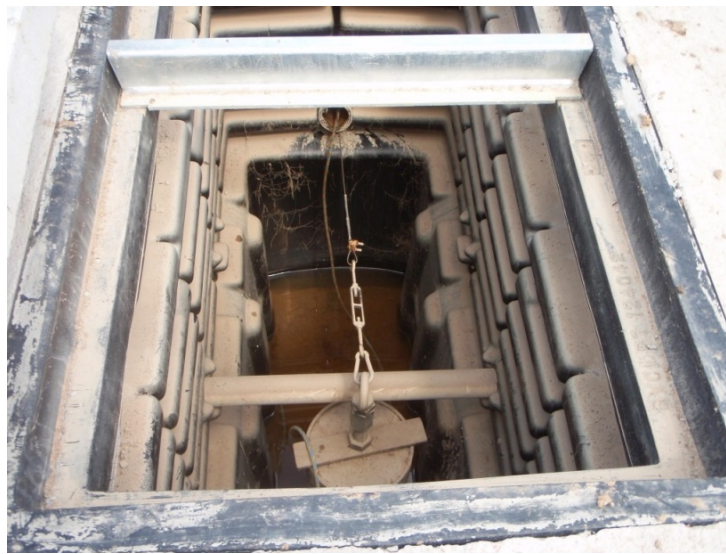
Figure 78 – Water at bottom of pit in WE2 anchor

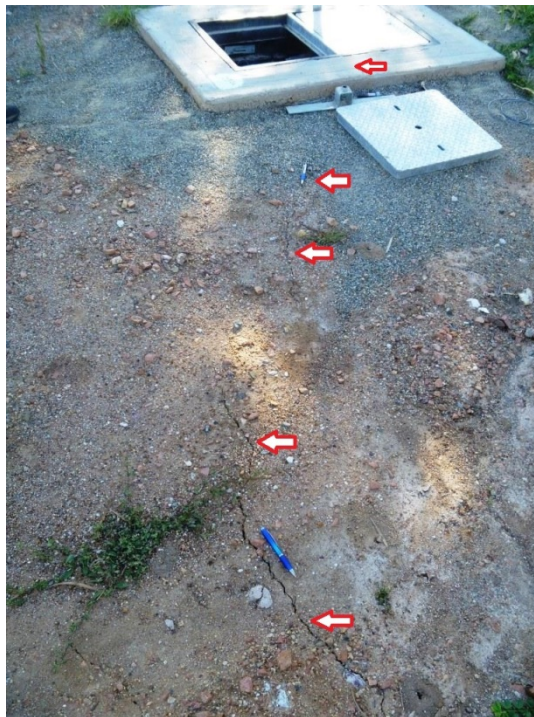
Figure 86 – Cracking in the vicinity of WE2A

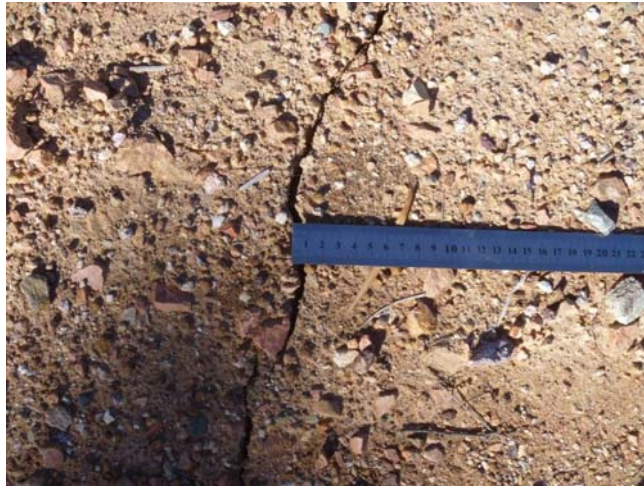
Figure 87 – Close-up of cracking at WE2A location
