Determination of Insitu Flexible Moduli of Modified
Pavement Materials.

Craig Gordon

Bachelor of Civil Engineering

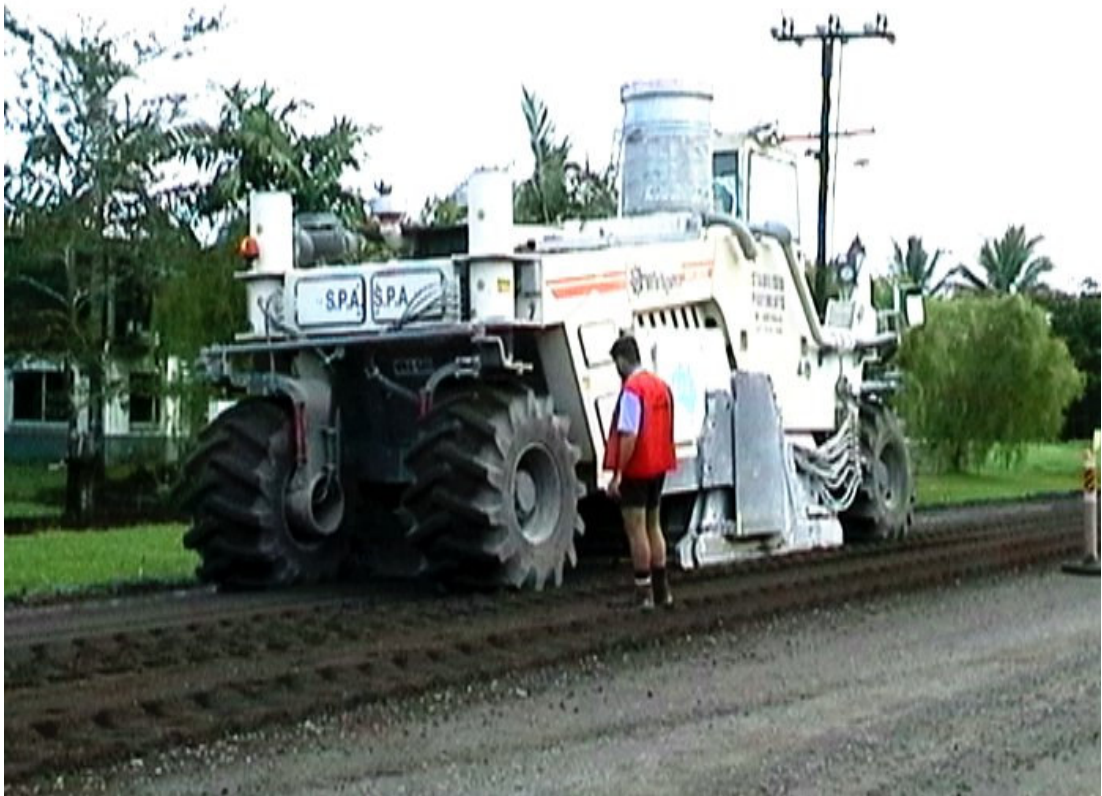
Figure 2.0 Stabilisation Machine

Recent years have seen the first major change in stabilisation equipment in 30 years with the introduction of the CMI RS500, now followed by a number of machines of a similar style from other manufacturers. These new machines are heavier, can have hot bitumen sprayed directly into the mixing chamber for foamed bitumen, are computer controlled for more accurate administering of additive, are more powerful with better mixing capabilities and can also mix to greater depths. Together with the development of accurate cement spreading equipment, it has led to the extension of stabilisation from the local government low-traffic roads through to major roads and highway construction with the introduction of deep-lift (i.e. depths to 400 mm of stabilisation in a single layer). These greater depths have called for new products to delay the set time, enabling full compaction and finish to be achieved.

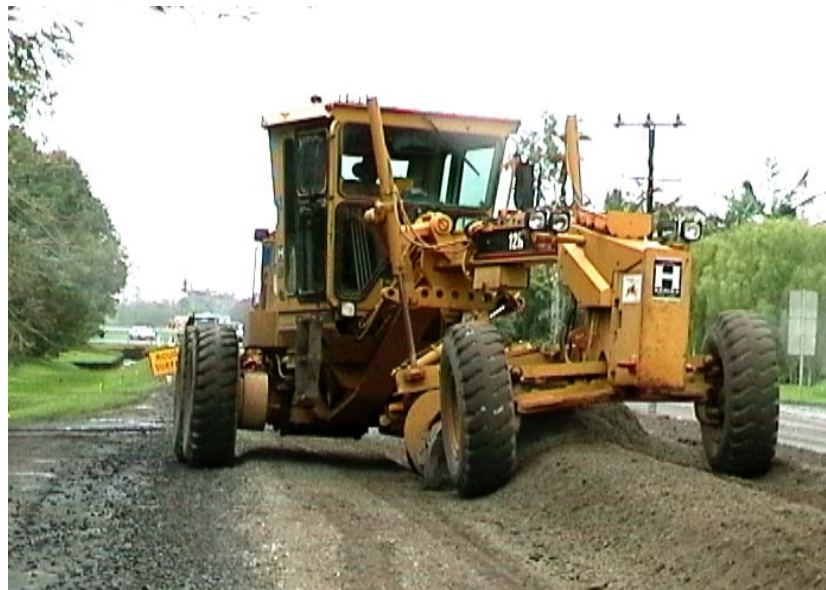
Figure 3.0 Grader trimming stabilised material

After stabilisation the pavement is then primed and two coat bitumen seal applied with 16 mm and 10 mm screenings used respectively.

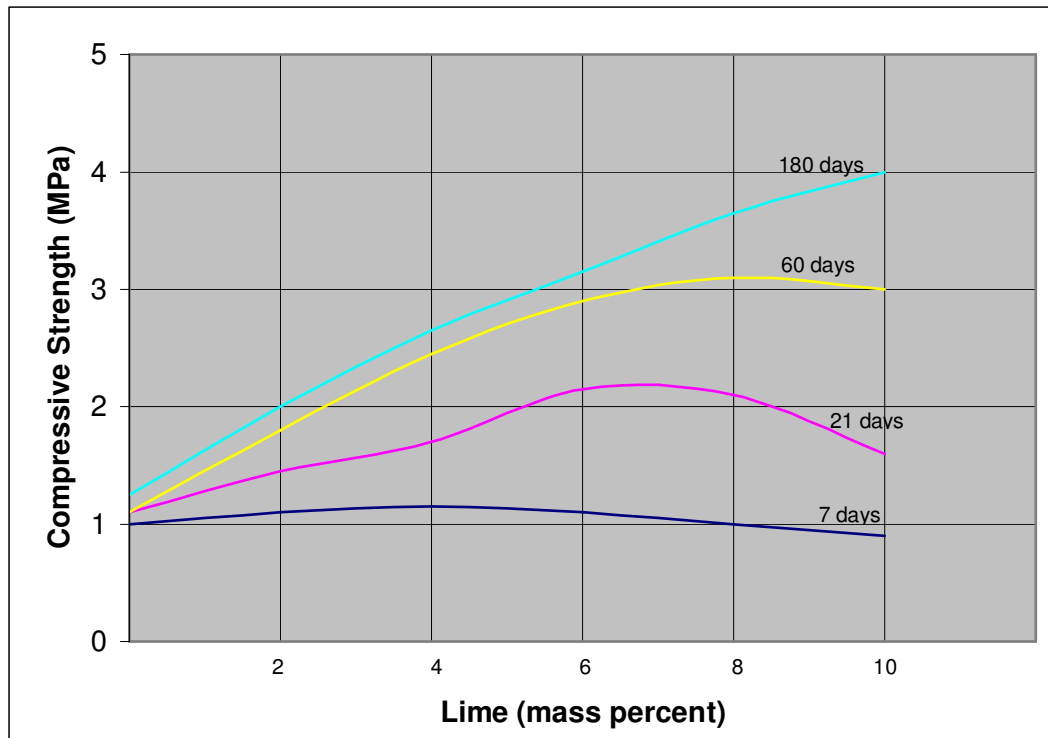
Figure 3.1 Typical Compressive Strength per % Lime

These two reactions result in a treated clay soil with decreased plasticity, lower affinity for water (greater volumetric stability and lower permeability), increased cohesion and strength (shear, compressive and tensile) and subsequently greater durability. While its effectiveness is vastly reduced with low to non-cohesive soils, lime is often used as a constituent in blends to react with clay fines in the soil and to act as a catalyst for the reactions of other additives in the blend, such as fly ash or slag (Auststab 2004). Figure 3.1 will illustrate the variations in strength with time and lime content for stabilised materials.

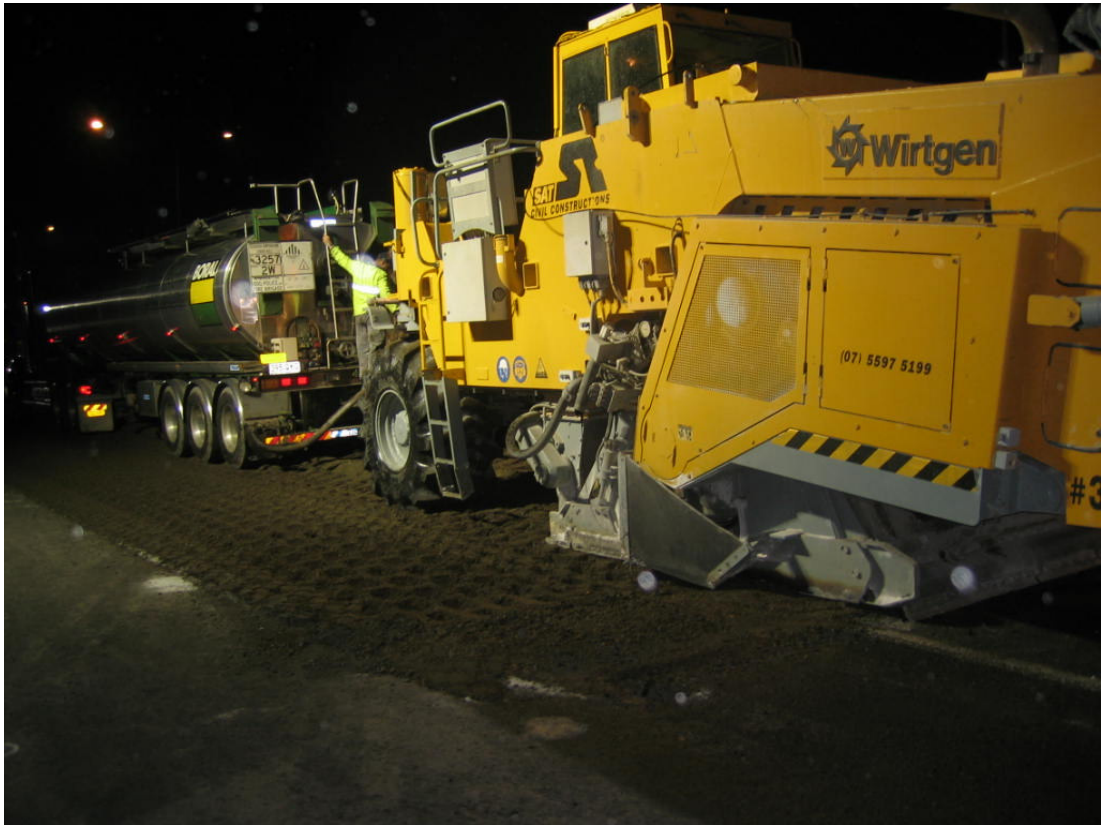
Figure 3.2 Foamed Bitumen Stabilisation

This expanded bitumen mist is incorporated into the mixing drum where the bitumen droplets are attracted to and coat the finer particles of pavement material, thus forming a mastic that effectively binds the mixture together. The stabilisation procedure can either be done insitu with specialised road rehabilitators or the pavements can be produced by a pug mill and paver construction procedure. The insitu stabilisation procedure is the only method used to date for foamed bitumen

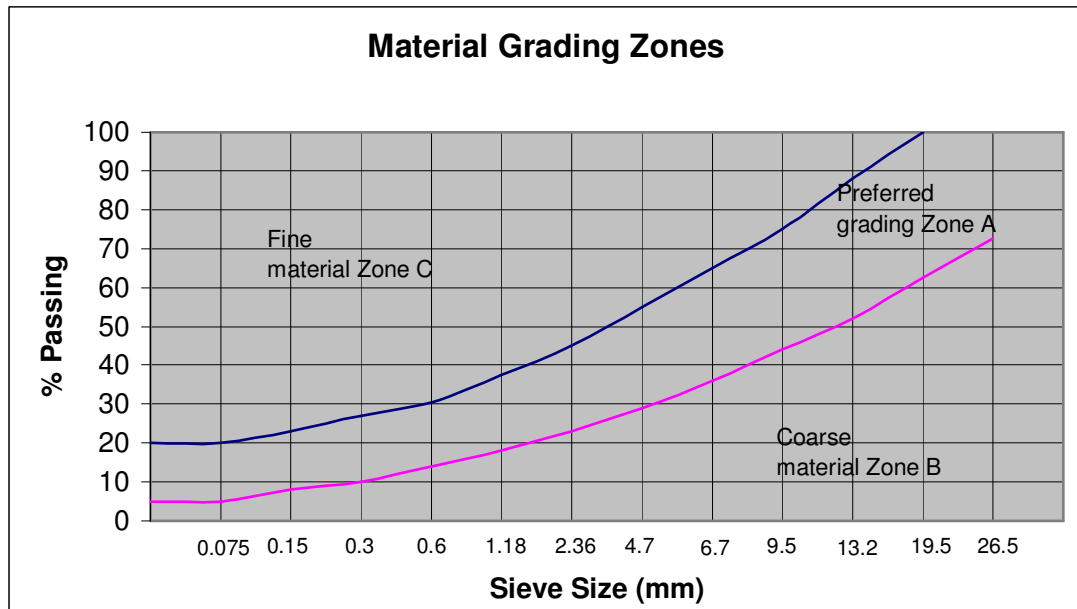
Figure 3.3 Material Grading Zones

Good results are obtained when the pavement material grading falls into Zone A, and successful stabilisation has occurred when part of the grading is in Zones B or C. The pavement materials should only be considered based on resilient modulus testing (Auststab 2002).

Good particle size distribution is required to achieve strength and durability

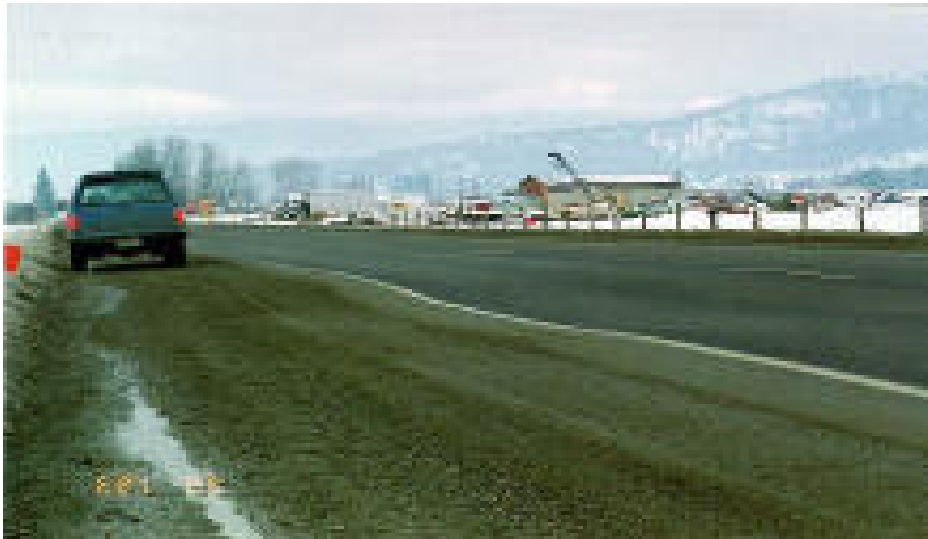
Figure 4.2.0 Road Pavement Depression

A localised area in the pavement that is lower than the surrounding area which may extend across several wheel paths though not confined to wheel paths.

Deformation is a change in the road surface as when compared with the intended constructed profile of the pavement. It can be caused by traffic conditions, environmental conditions, inadequate construction controls during construction or a combination of all or some of the above. It is an important element of a pavement's condition and may reflect structural inadequacies both in the pavement and below the pavement. The main attribute is always vertical displacement and has been standardised as the maximum depth obtainable under a 1.2 metre straight edge as depicted in figure 4.2.0. (Austroads 1987).

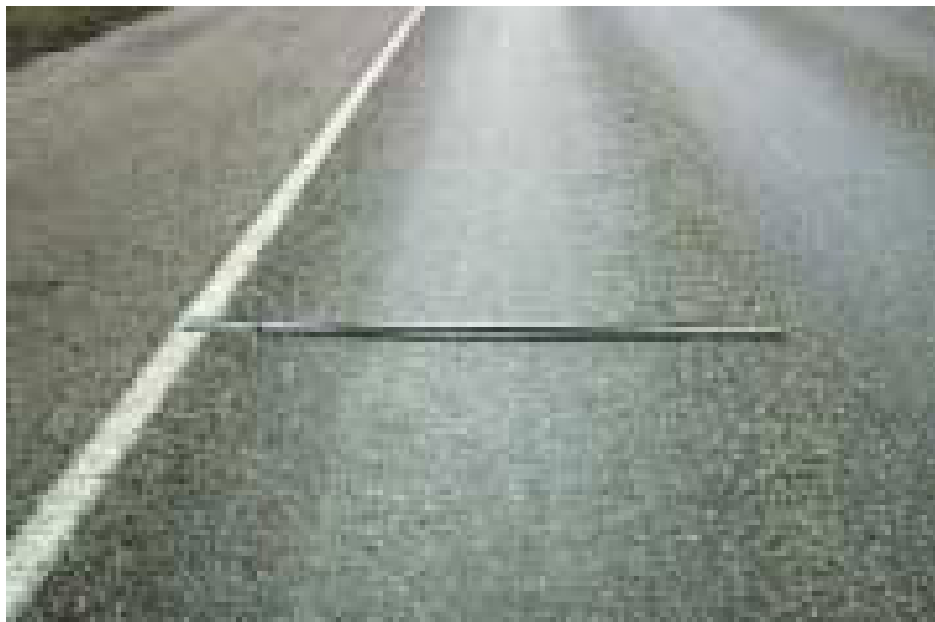
Figure 4.2.1 Road Pavement Rutting

A longitudinal deformation usually contained in the wheel paths of a pavement.

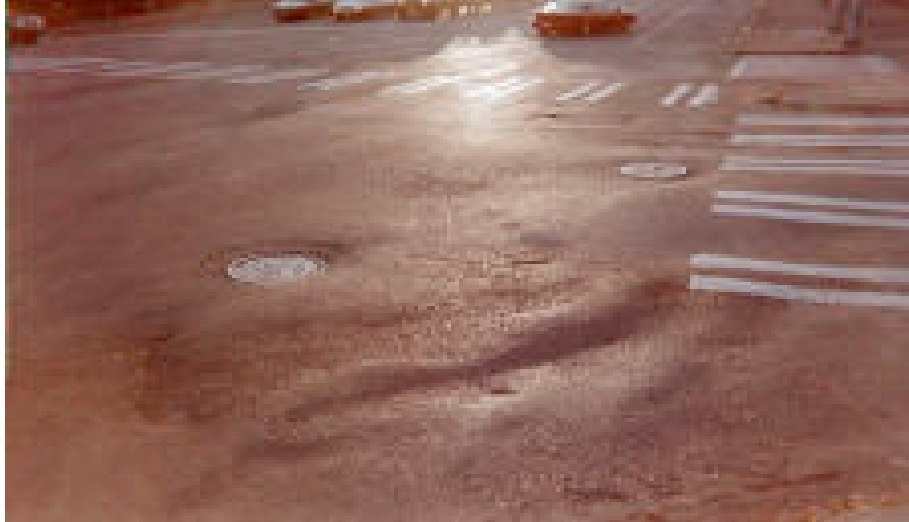
Figure 4.2.2. Road Pavement Shoving

Is a bulging of the road surface generally parallel to the direction of the traffic flow though transverse shoving can occur due to turning movements of the traffic.

Braking and accelerating movements are the main causes of pavement shoving.

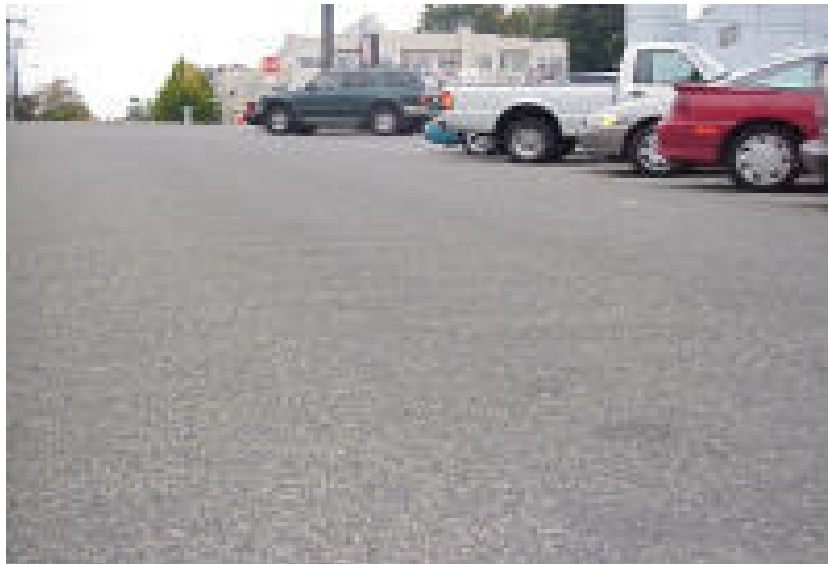
Figure 4.2.3. Road Pavement Corrugations

Are transverse undulations closely and regularly spaced usually with wave lengths less than 2 metres (Austroads 1987).

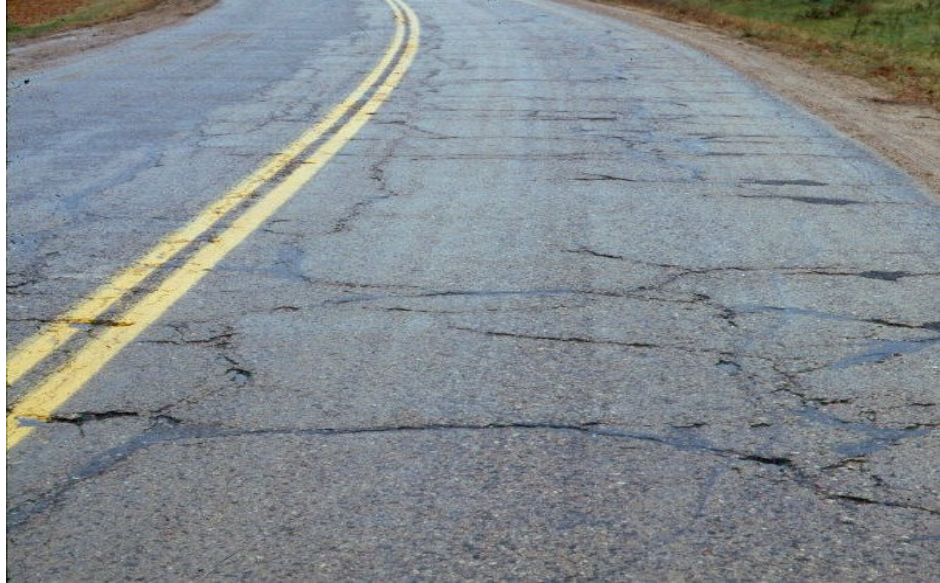
Consists of interconnecting cracks that form in a series of blocks. The blocks are usually greater than 200 mm in size and in some instances exceed 3000 mm in size. The cracks may reflect pavement layer joints underlying the surface layer. This is the reason why concrete pavements overlaid with asphalt predominately have this problem.

Figure 4.2.4. Block Cracking
SOURCE hotmix.ce.washington.edu

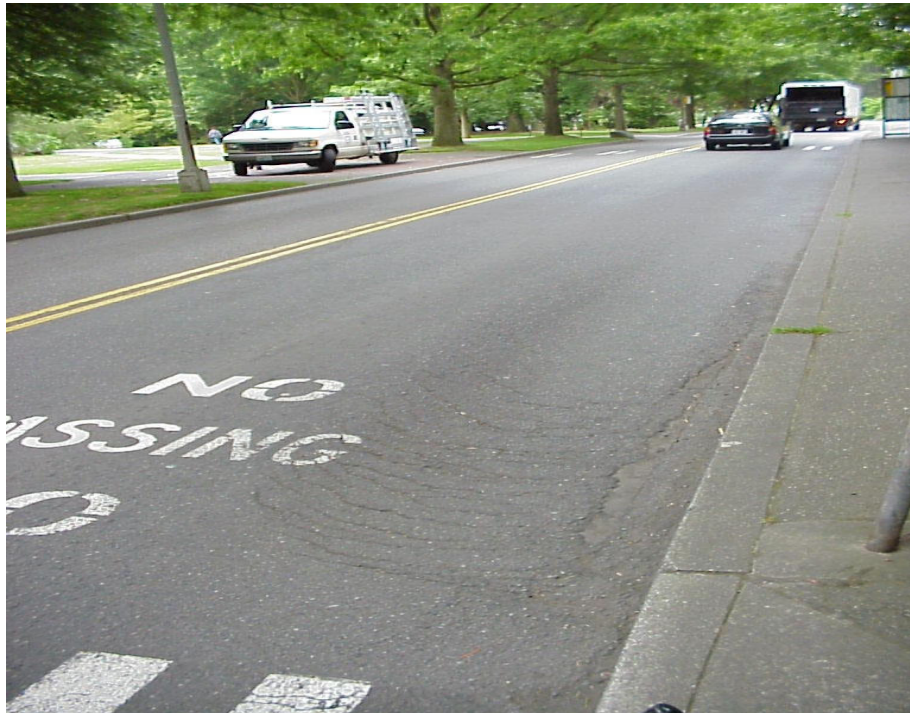
Figure 4.2.6 Crescent Shaped Cracks

Crescent or half moon shaped cracks commonly associated with shoving and are mainly associated with asphalt.

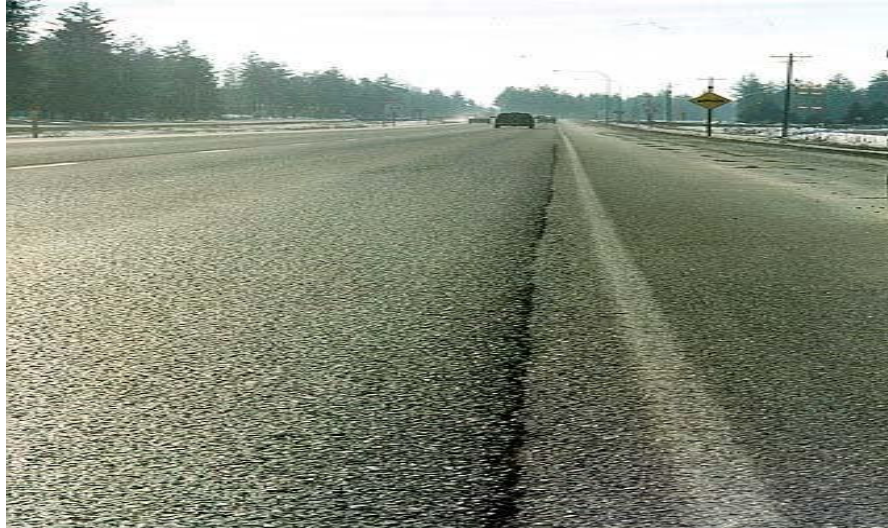
Figure 4.2.7. Longitudinal Cracking

A single crack or a series of parallel cracks running longitudinally along the pavement. Longitudinal cracking can be caused by poorly constructed construction joints, differential settlement, and reflection cracking from underlying layers or a volume change from expansive clays used in the embankment construction.

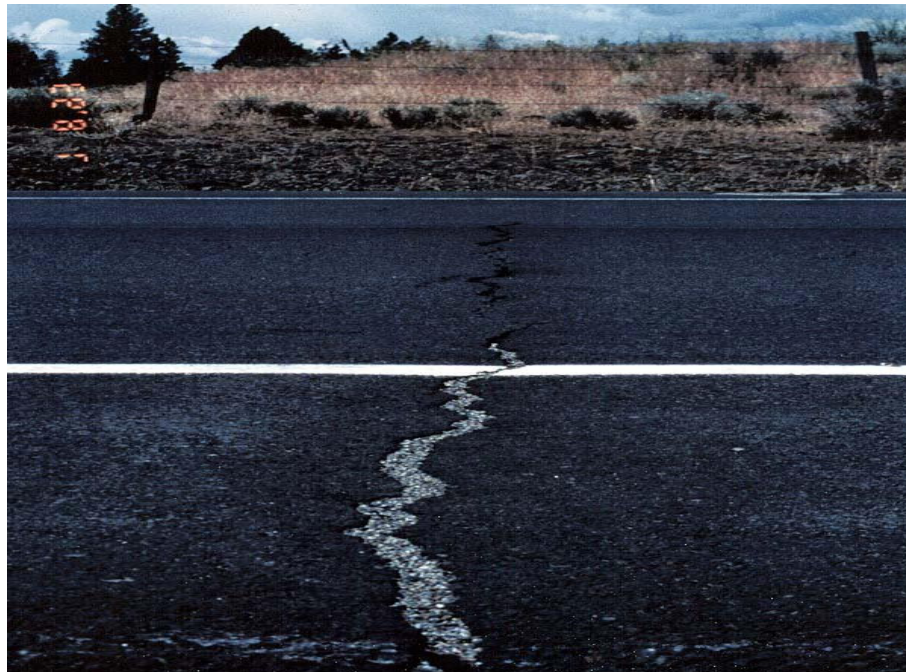
4.2.8 Transverse Cracking.

Is a crack running transversely across the pavement. This cracking can be caused by reflection cracking from underlying layers, shrinkage cracking or structural failure of a portland cement concrete base.

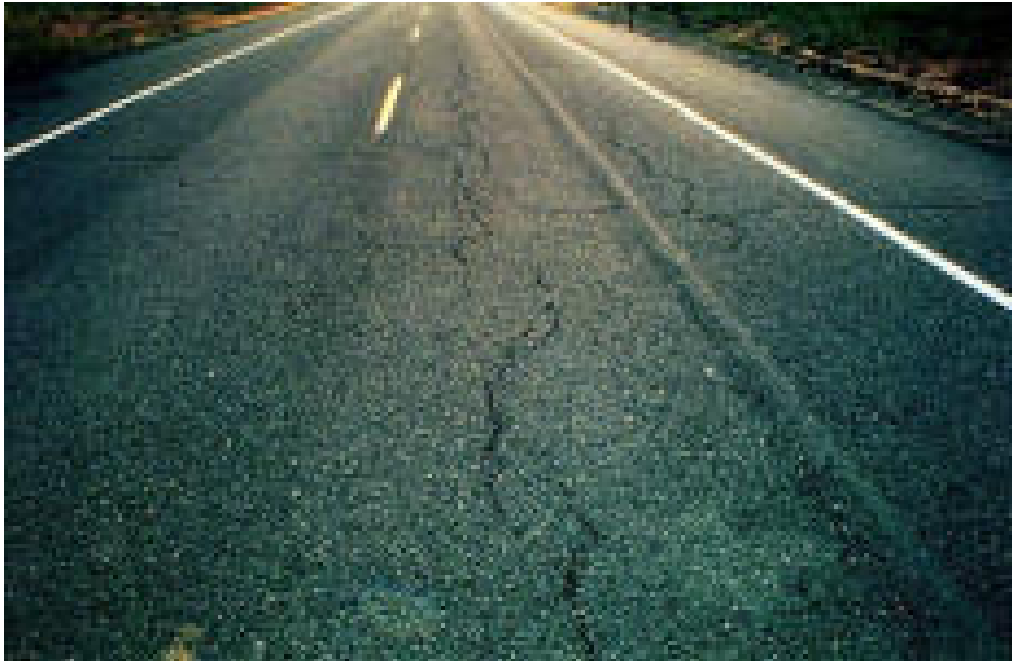
4.2.9 Meandering Cracks.

Are unconnected irregular cracks, varying in direction, usually singly (Austroads 1987). Some possible causes are reflection of shrinkage cracking in underlying layers, tree roots and differential settlement.

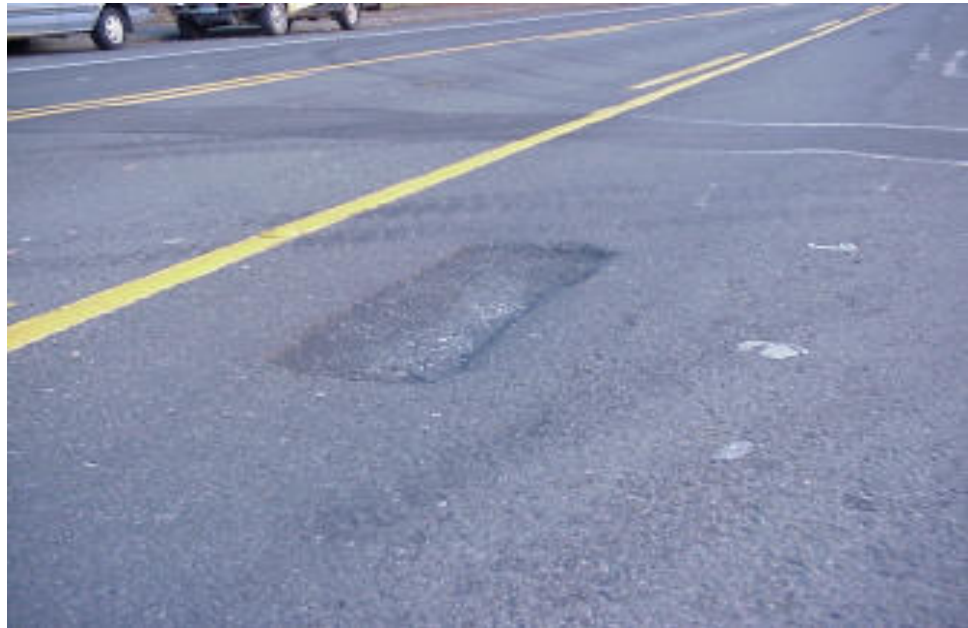
4.2.10. Potholes

An expedient patch is a surface repair without a dig out, an example being the filling of a pot hole with bituminous materials. A reconstruction patch is where material is excavated and then replaced and brought back to the existing profile of the surrounding material. The repair could be either just the surface layers or all pavement layers or combinations of these.

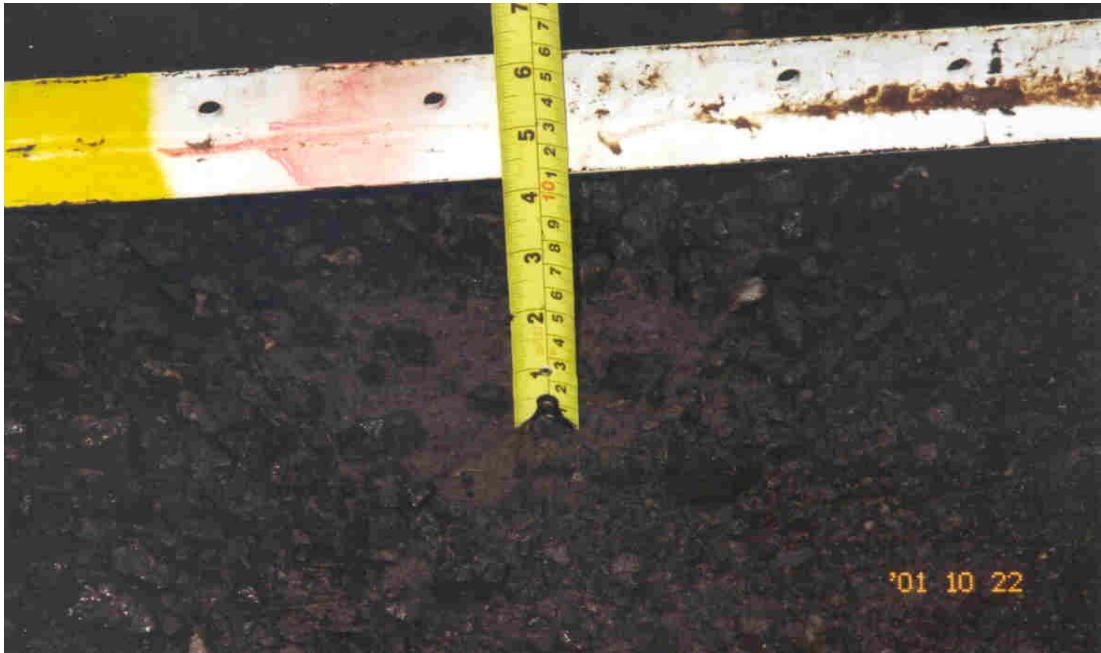
Figure 5.0 Rut measurement

Rut measurement was carried out by using a 1.2 metre straight edge placed across the outside wheel path and the rut depth measured with a tape measure approximately every 25 metres longitudinally along the road between the chainages stated for each location as noted in section 5.1 above.

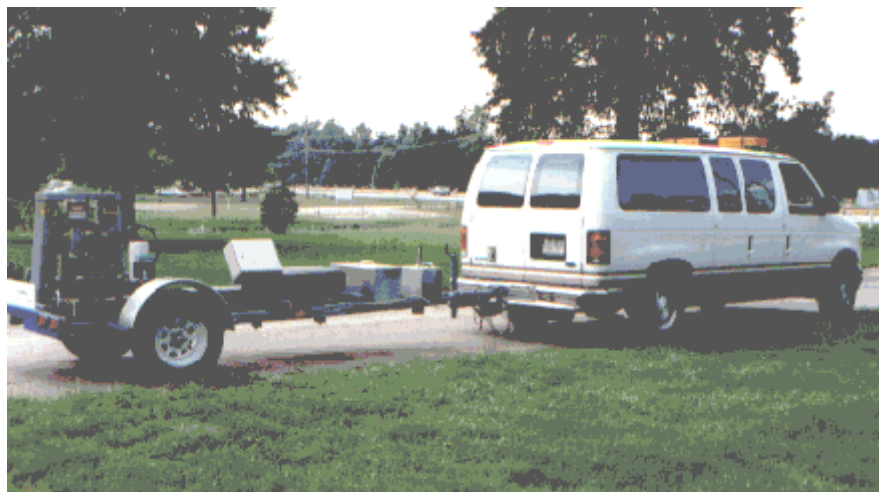
Figure 5.2 Falling Weight Deflectometer

The Falling Weight Deflectometer (FWD) is a machine that uses dynamics to assess the modulus of a pavement. The FWD is roughly the size of a small box trailer and can be easily towed behind a car and operated while attached to the vehicle.

The FWD works by dropping a 300 mm diameter disc weight that impacts the road at approximately 750 Kpa. The intent is to replicate the pressures of a single axle truck with dual tyres impacting on the road. Upon impact the pavement will deflect and the FWD has sensors spaced at every 150 mm out to 1500 mm to measure these deflections. Below is a diagram showing the weight on the ground with the 150 mm spaced sensors.

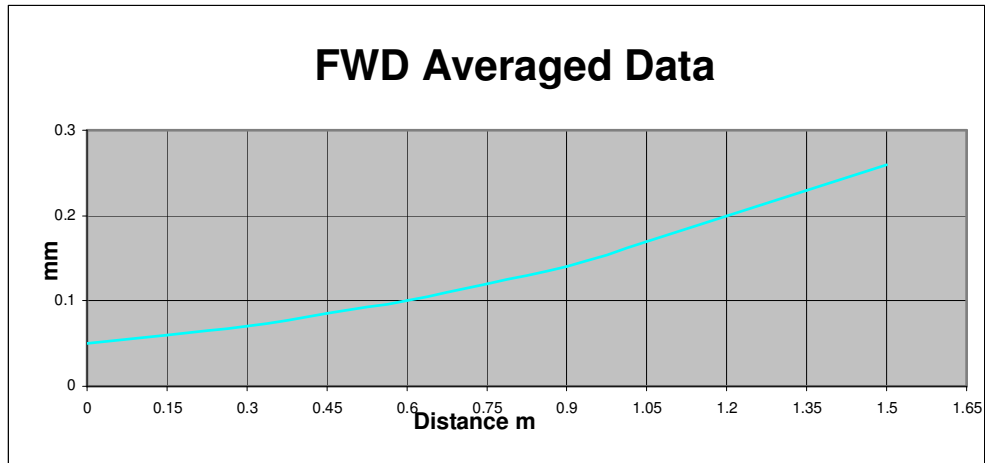
Figure 5.2.2 FWD Data

The data from all the 'hits' is then collected for each site; Appendix D has all the raw data for each site in question. Below is an example of the graphical representation of the data. The shape of the line is given the term 'bowl'.

In determining the moduli for each section, the above graph is critical to the results that are given. Further information on the above will be discussed in Chapter 6- CIRCLY Back Analysis.

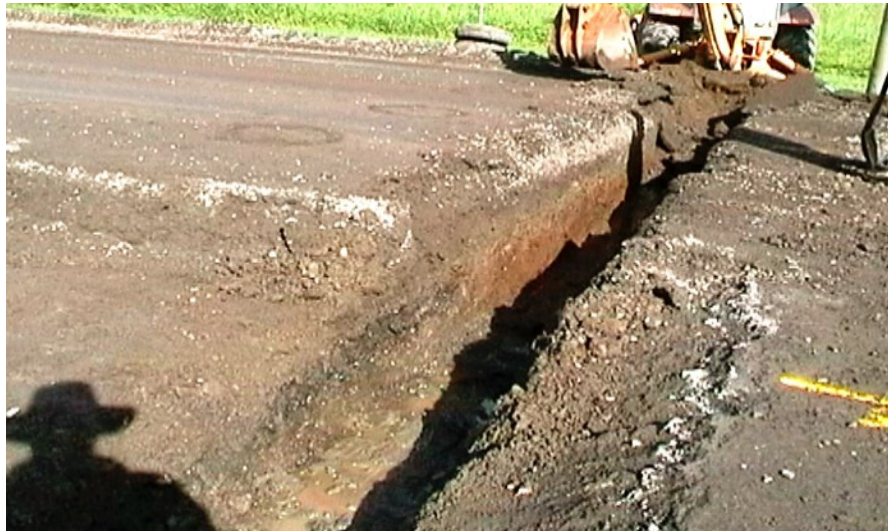
Figure 5.3 Pot Holing for soil sampling

It is necessary to compare the materials that were specified in the initial construction design with the materials that were actually used onsite. The gathering of soil samples is done by pot holing onsite and soil samples taken and then compared with the actual design. This is a verification process as construction methodology is sometimes changed but these changes are not recorded.
