University of Southern Queensland  
Faculty of Engineering & Surveying

# **Bridge Approach Guardrail Prioritisation**

**Courses ENG4111 and ENG4112 Research Project**

**Bachelor of Engineering (Civil)**

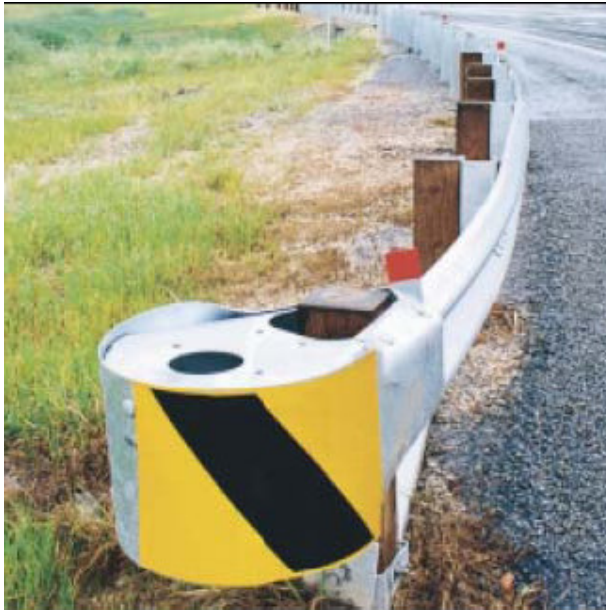
**Figure 2-1 MELT (Modified Eccentric Loader Terminal) – Gating End Treatment**  
Sourced (Vic roads 2005)

End Treatments are defined by Queensland Department of Main Roads, 2005 as either Gating or Non-Gating. A gating end treatment will allow the errant vehicle to pass through it but be slowed and redirected by the dissipation of energy. When using these types of end treatments it is important that there is an adequate clear zone behind the safety barrier system. Non-Gating end treatments do not allow the vehicle to pass through the terminal but redirect the vehicle along the travelled way.

Figure 2-1 shows an example of a type of gating end treatment used by Department of Main Roads Queensland.

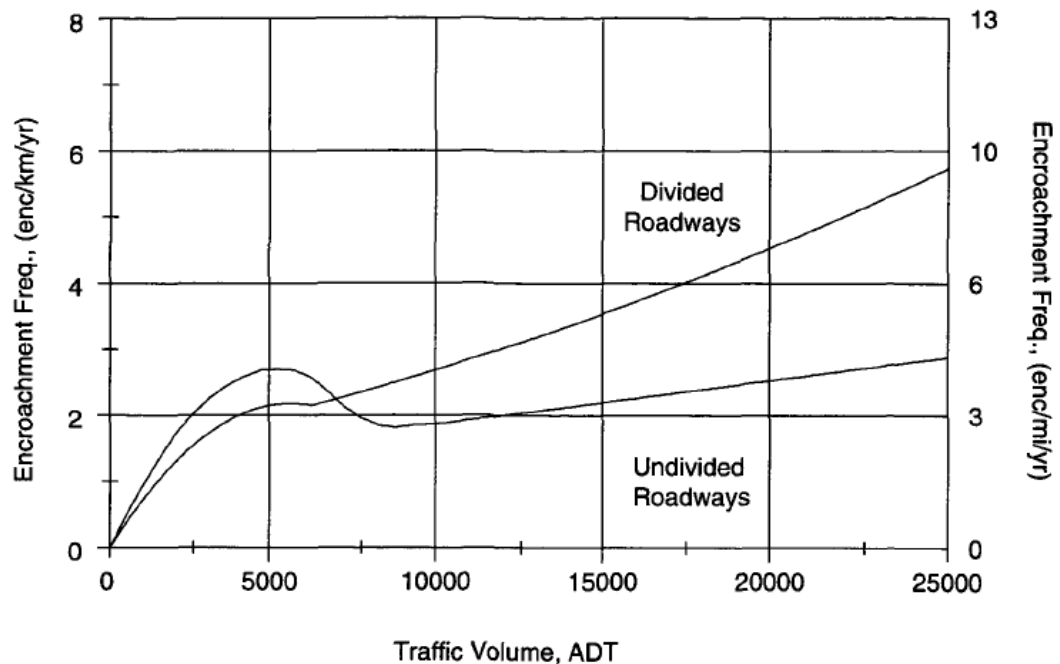
Figure 4-3 Cooper Methodology  
(Sourced AASHTO 2002)

The rating scores that were allocated to different levels of AADT came from what is used by AASHTO (2002) to determine the expected encroachments per kilometre per year for different AADT. Figure 4-3 below shows the graph known as the Cooper Methodology (AASHTO 2002) which was used to establish the rating scores for this factor.

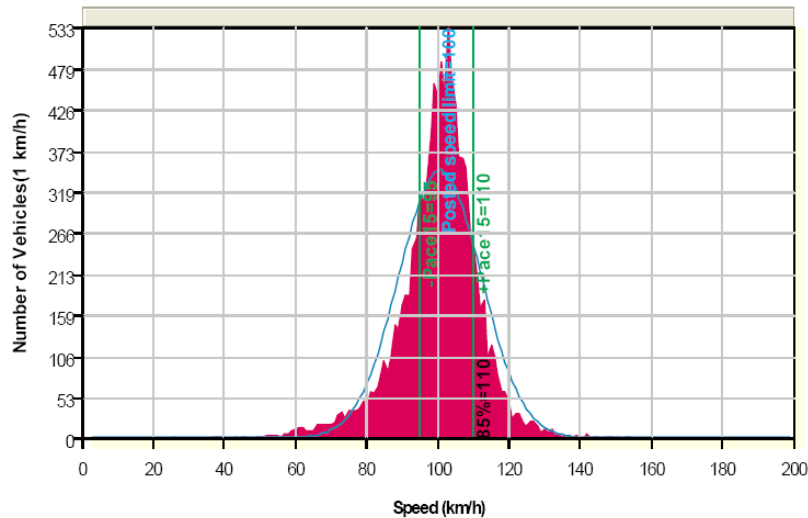
Figure 5-2 Example of Speed Histogram

**SpeedHist-85 (Metric) Site:** 20210.ON  
**Description:** 20210 ON 419  
**Filter time:** 10:00 Wednesday, 3 May 2006 => 12:39 Monday, 15 May 2006  
**Filter:** Cts(1 2 3 4 5 6 7 8 9 10 11 12 ) Dir(NESW) Sp(10,160) Headway(-0)  
**Scheme:** Vehicle classification (AustRoads94)

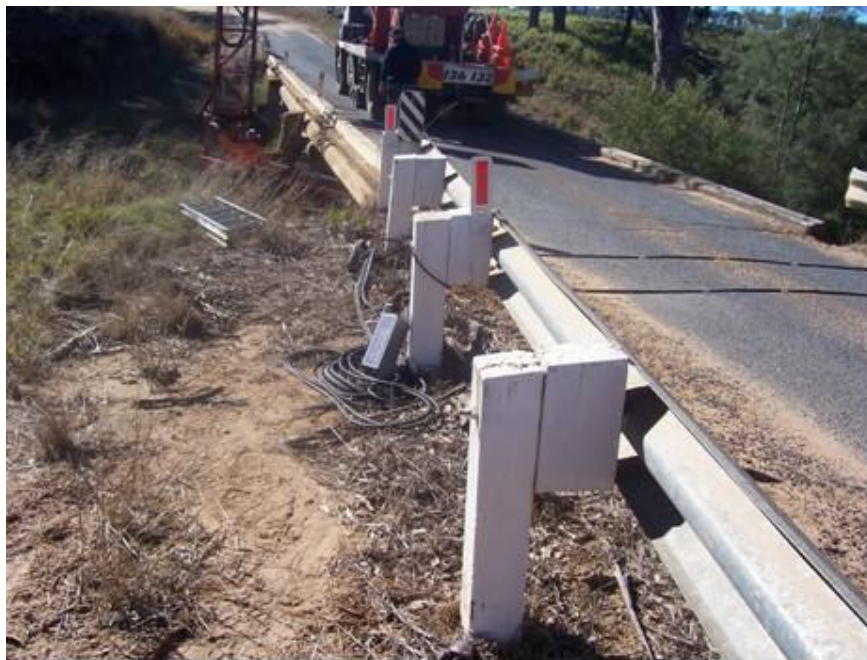
**Figure 5-6 Traffic Counter at Ironpot Creek**

Traffic counters were placed at these sites by Main Roads staff for three weeks so that the data collected could be compared with the supplied data for the sites. It is believed that the data collected in this time should be a reasonable representation of the annual traffic flow.

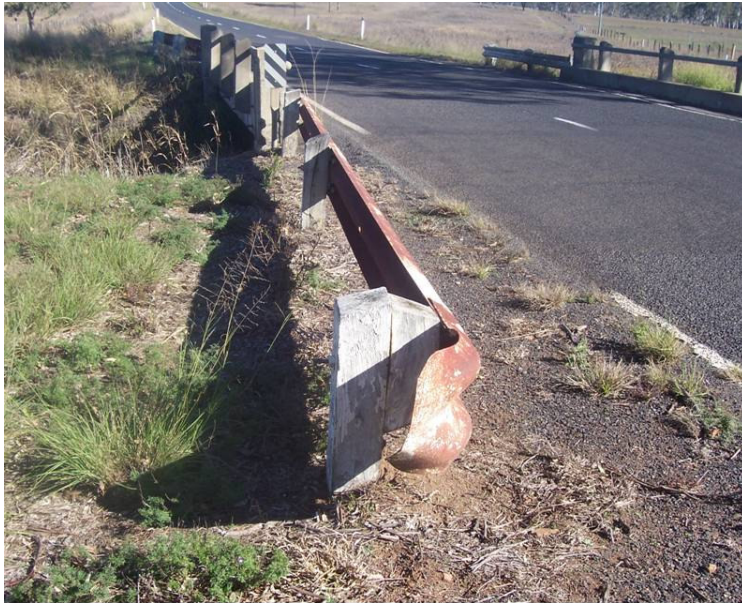
**Figure 6-1 Photo of Murdering Hut Creek End Treatment**

End Treatment: Fish Tail

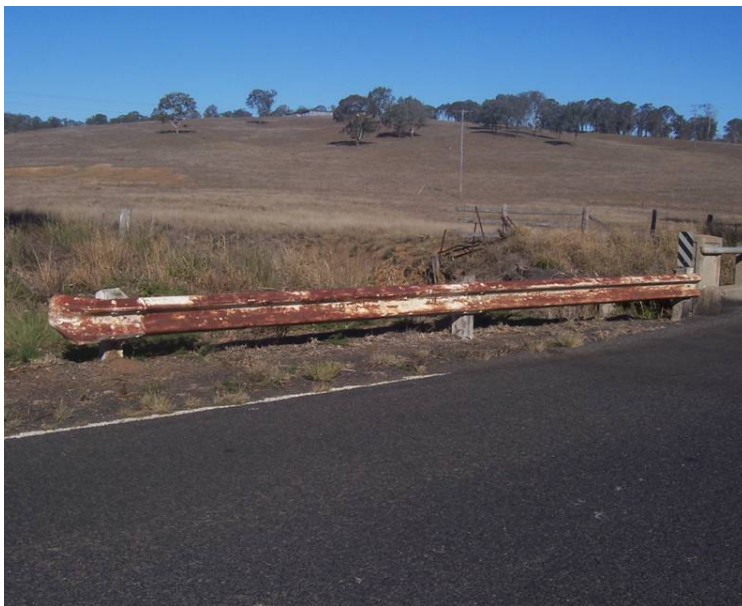
**Figure 6-2 Photo of Murdering Hut Creek Guardrail**

Guardrail: Structurally unsound due to timber posts rotting

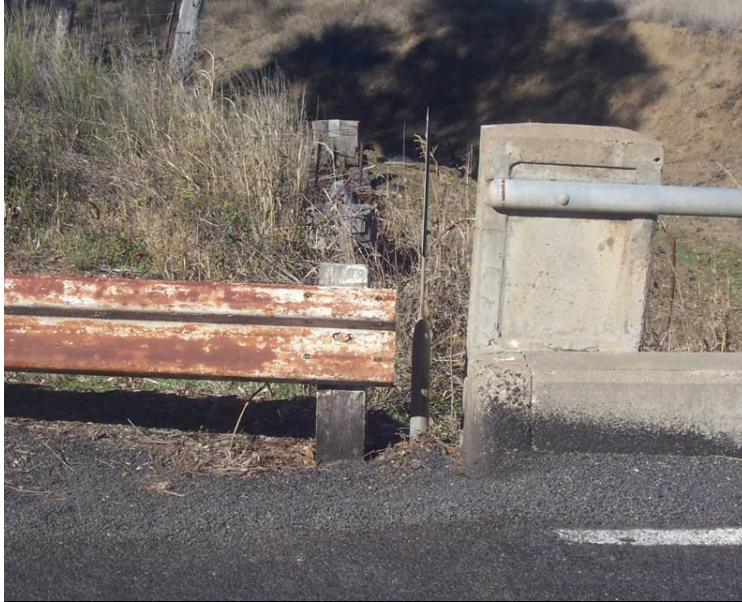
Figure 6-3 Photo of Murdering Hut Creek Transition

Transition: Not connected and no reduced post spacing

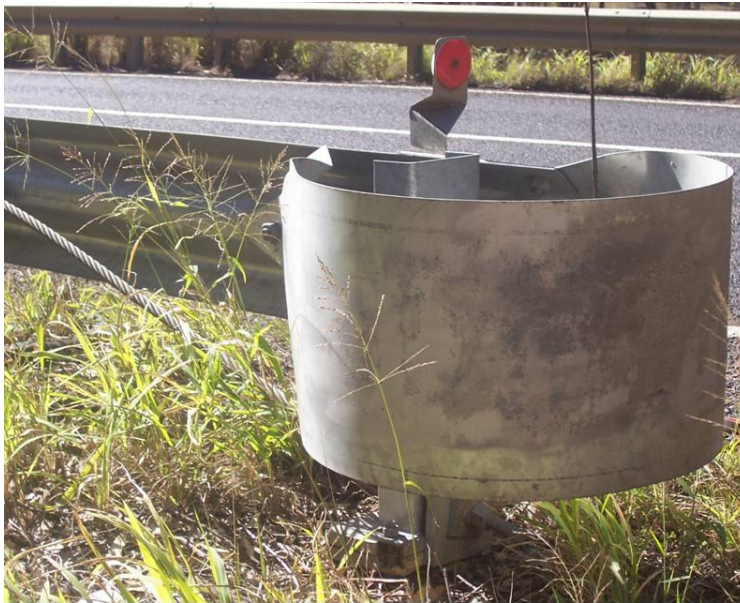
Figure 6-5 Photo of Rocky Creek End Treatment

End Treatment: End treatment meets previous standard (BCT)

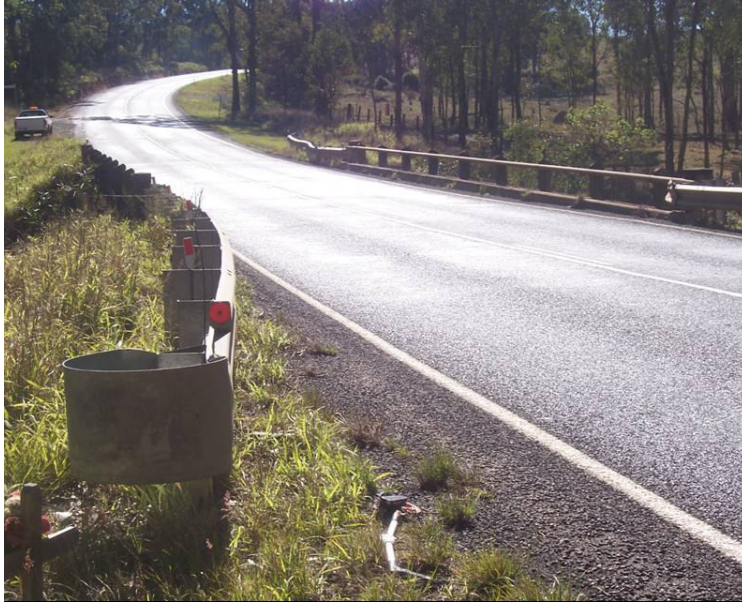
Figure 6-6 Photo of Rocky Creek Guardrail

Guardrail: Structurally sound but not to standard for height

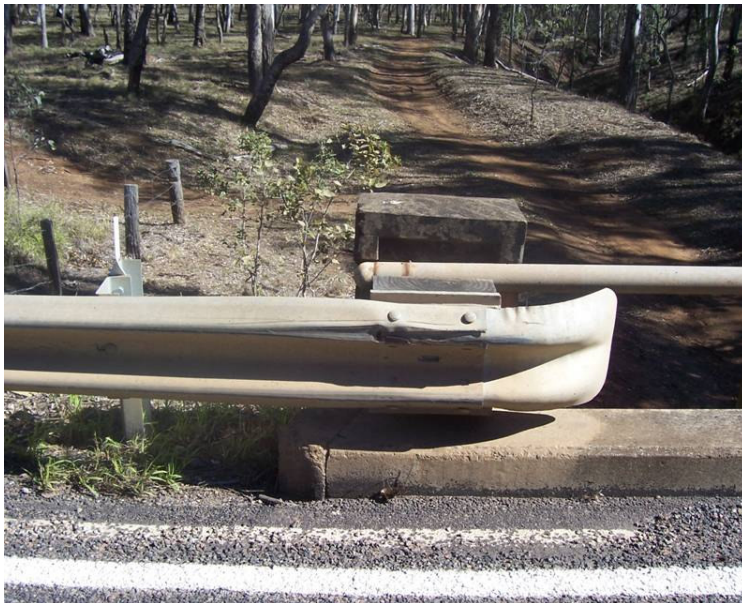
Figure 6-7 Photo of Rocky Creek Transition

Transition: Connected with reduced post spacing to 1 metre but does not quite meet current standards

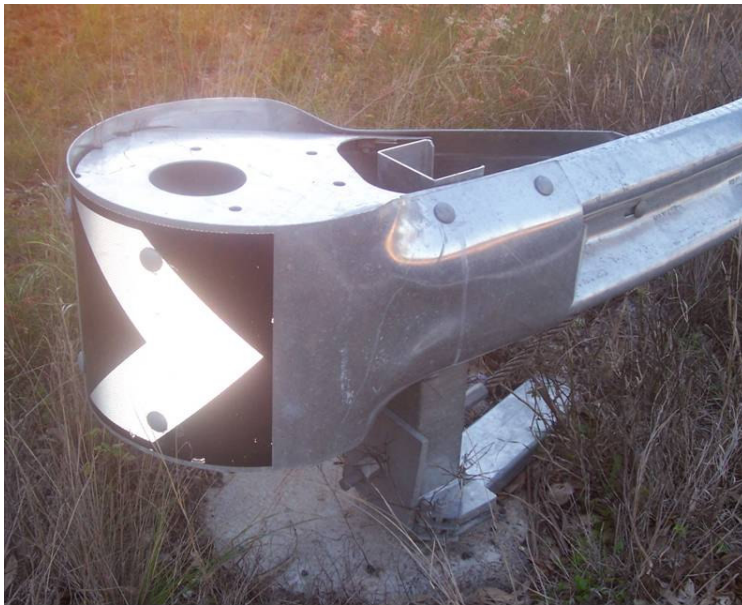
**Figure 6-9 Photo of Kratzman's Gully End Treatment**

End Treatment: Recently upgraded to current standards

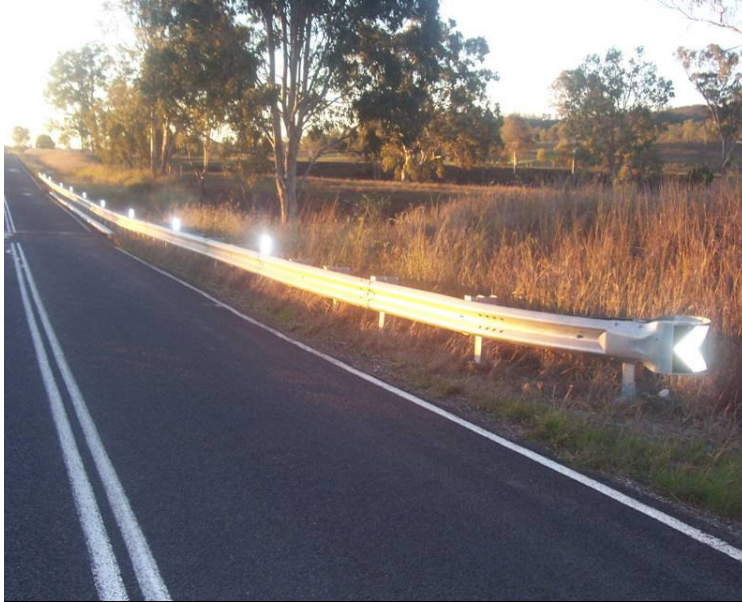
Figure 6-10 Photo of Kratzman's Gully Guardrail

Guardrail: Recently upgraded to current standards

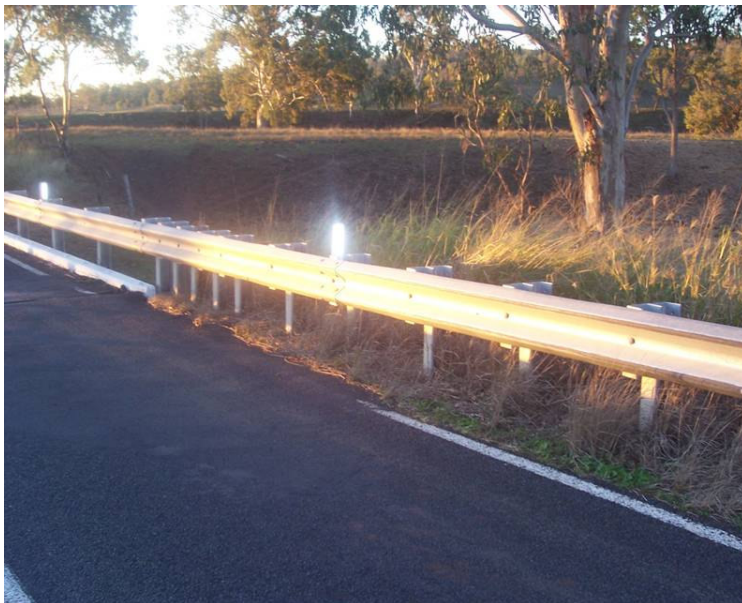
Figure 6-11 Photo of Kratzman's Gully Transition

Transition: Recently upgraded to current standards
