# **Investigation of A New Generation Degradable Implant Material**

Adrian Mark Gustafson

**Courses ENG4111 and ENG4112 Research Project**

**Bachelor of Engineering (Mechanical)**

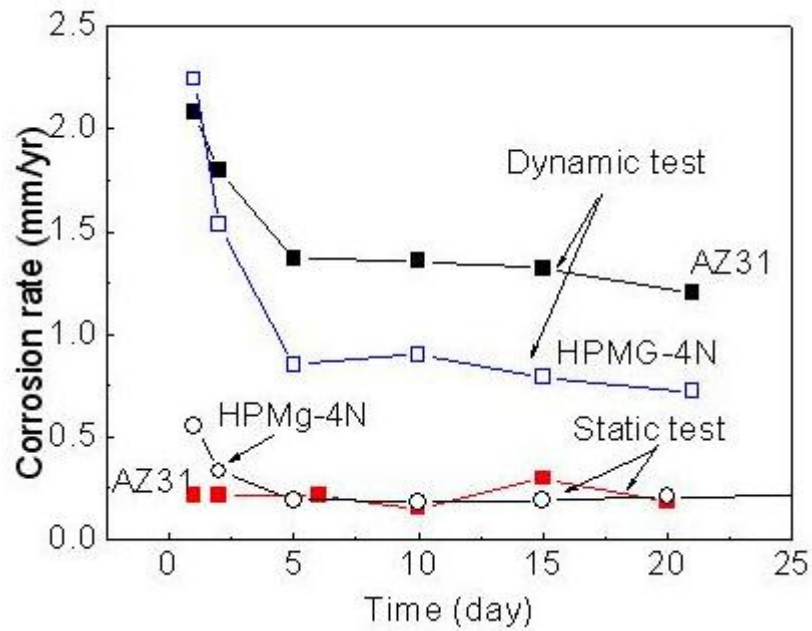
Figure 4: The corrosion rate of AZ31 and Mg(4N) in static and dynamic Hank's balanced salt solution (Shi. et al, 2005)

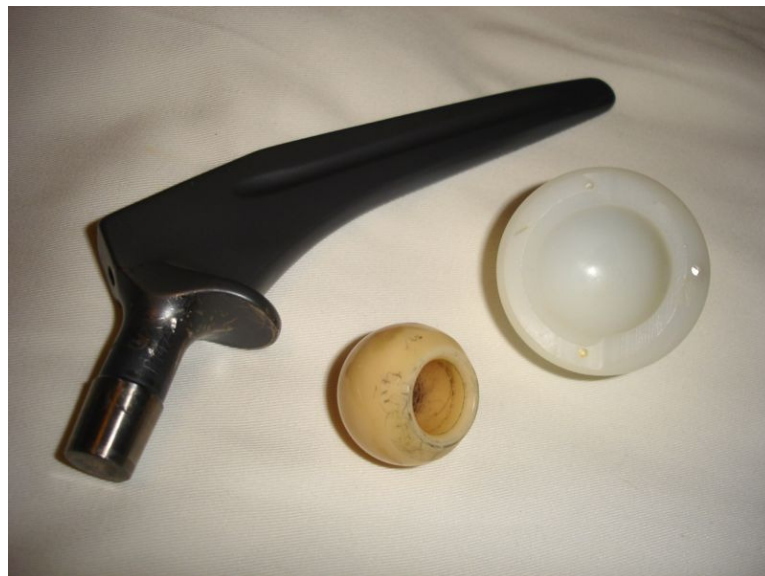
let us consider the hardness. The hardness determines the materials wear resistance. For example, consider a hip joint with a ball and socket. If one material is harder than the other, the harder material will wear away at the less hard material causing it to fail more rapidly. However, by having materials of the same hardness, they will both wear away at the same rate therefore reducing the amount of wear and lasting longer. Consider Figure 5 below. The common hip joint of a ball and socket made from titanium and ceramics. It can be seen that the ball and socket are both made from the same ceramic material, while the rod that connects the joint to the bone is made of titanium. This is to reduce the amount of wear in the joint, while providing strength to the connection of the bone via the titanium rod. However, for the purpose of this project, magnesium and its alloys would not be suitable to this application as they would corrode away over time, whereas these joints are more of a permanent fixture.

**Figure 5: Common ball and socket replacement hip joint.**

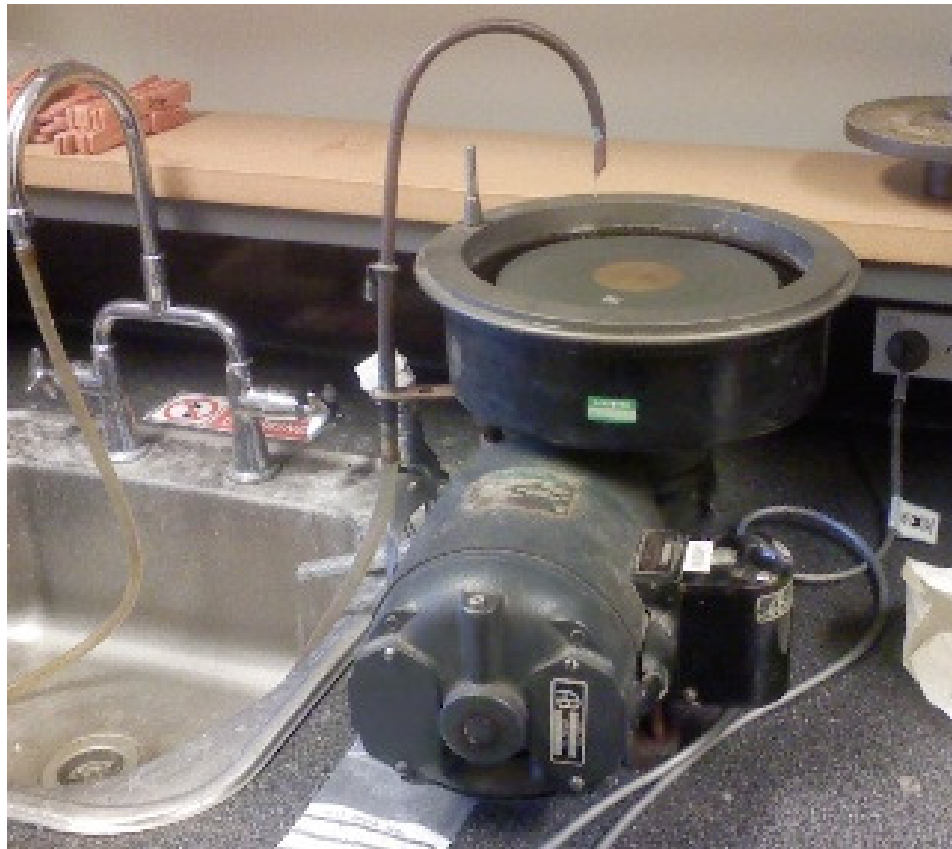
**Figure 8: The grinding apparatus used for the sanding the test specimens.**

It can be seen that the machine is connected to a tap. This is to allow water to wash the sandpaper free of residue from the specimens as well as keeping the specimen cool while it is being sanded. The friction cause by the sandpaper rubbing on the specimen can make the specimen very hot. To allow the specimen to be handled, the water provides the cooling needed. Figure 9 below shows a specimen being sanded. Once all of the sanding had been completed, the specimens were cleaned using ethanol to remove any oil that may have been left from being handled. Figure 10 and Figure 11 show the finished static and dynamic specimens respectively.

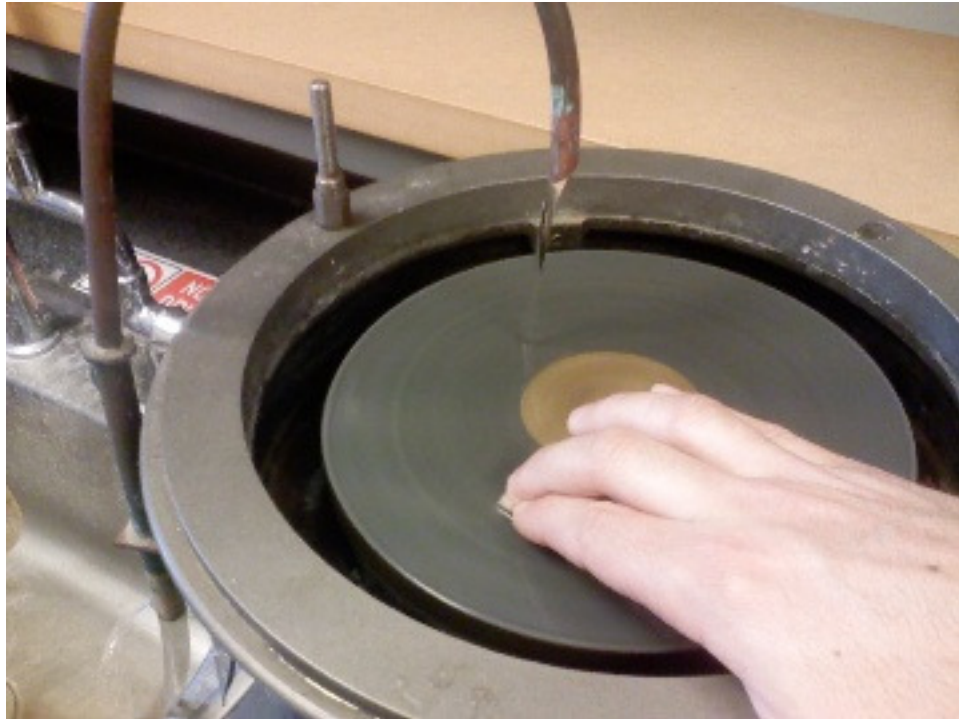
**Figure 9: The grinding apparatus in use with a constant flow of water as a cleaning and cooling fluid.**

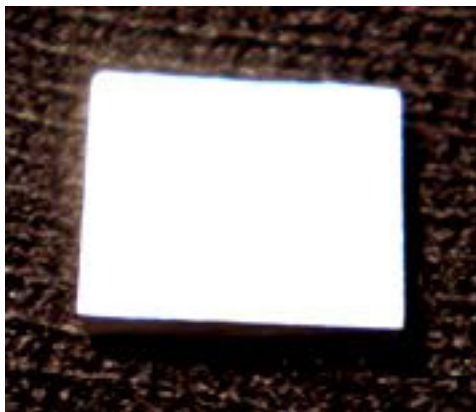
**Figure 10: Fully polished static test specimen.**

It can be seen that the surface finish of the specimens is very smooth. The two types of specimen are of different shape and size. This is so that the dynamic specimen can fit into the clear flexible hose. The two holes drilled in to the specimen were to allow the fishing line to be attached, linking all of

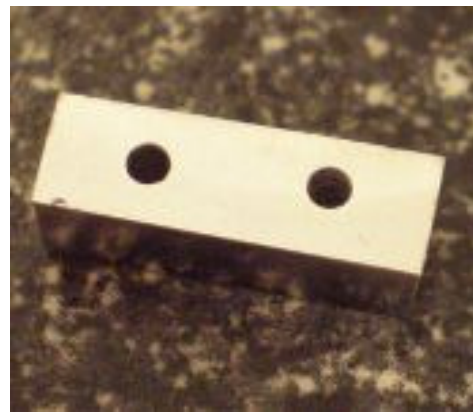
**Figure 11: Fully polished dynamic test specimen.**

the dynamic specimens together. These holes were drilled into the specimens with the use of a hand drill with a drill size of 2mm in diameter. The fishing line also held the specimens inside the hose and stopped them from moving. Fishing line was used so that there would not be any other metals inside the solution that may cause a reaction to occur. Thus, eliminate another variable.

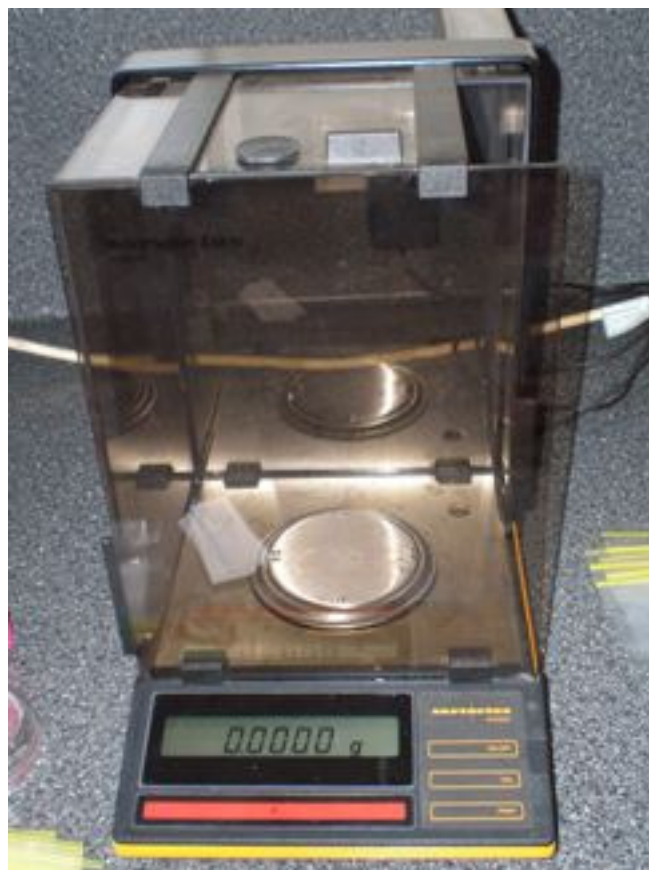
Figure 13: The highly accurate scales used for weighing each test specimen.

These scales measured in grams to an accuracy of four decimal places. For scales to be this precise, any variables that may influence the reading need to be eliminated. For this reason, the special enclosure is used so as not to allow any external forces to act on the specimen. Once every specimen was weighed and labelled, it was placed in its own sealed plastic bag to protect the surface finish.

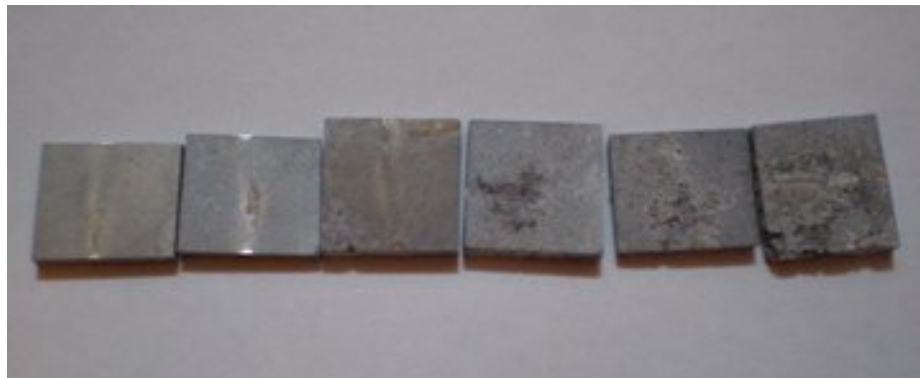
By analysing these specimens, information could be gathered that was not available from merely weighing the specimens alone. Figure 19 and Figure 20 below show one specimen for each day of the trial from both the static and dynamic testing.

**Figure 19: The static test specimens after 1, 2, 5, 10, 15, 20 days from left to right.**

It is clear to see on the first three static specimens the line where the insulated electrical wire was rapped around them. Although this is not a serious issue, there is still some corrosion resistance caused by the wire because the does not allow the solution to come into contact with the whole specimen. However, this does not seem to be an influence towards the end of the testing. The last three static specimens show no sign of the wire being any restriction.

Another feature that can be seen on both types of test specimen is the areas which were more affected by the corrosion. This is particularly clear on the fourth static specimen. Notice how the area in the middle of the specimen is much more corroded. This shows that certain areas of the specimens were more susceptible to corrosion. It is unclear why this is the case. However, this may be explained by the method used to cut the specimens. An angle grinder with a 1mm thick cut off wheel was used. Due to the fact that cooling fluid is unavailable when using a grinder, the grain structure of the surface of the specimens may have been changed. Some areas may have cooled faster than others, which in turn would change the grain structure of certain areas of the specimens. Although this is not certain, by studying the specimens under an electron microscope, this would be made clear.

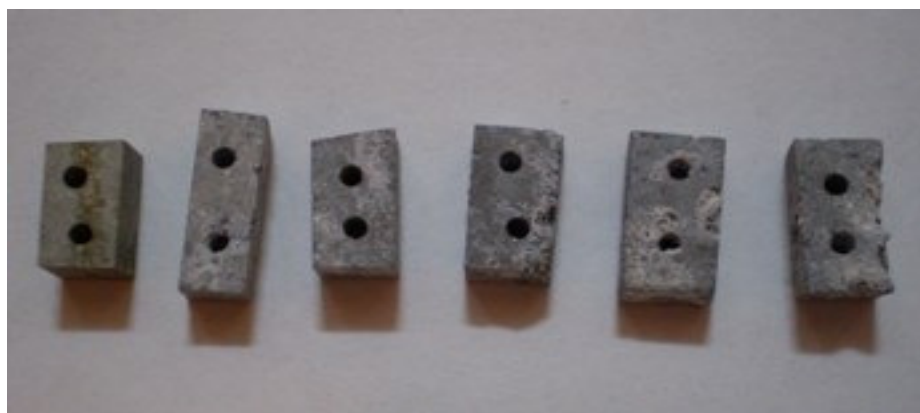
**Figure 20: The dynamic test specimens after 1, 2, 5, 10, 15, 20 days from left to right.**
