University of Southern Queensland
Faculty of Health, Engineering and Sciences

The Effects of Extreme Weather Events on Flexible Pavement

Towards the degree of
Bachelor of Engineering Honours (Civil)

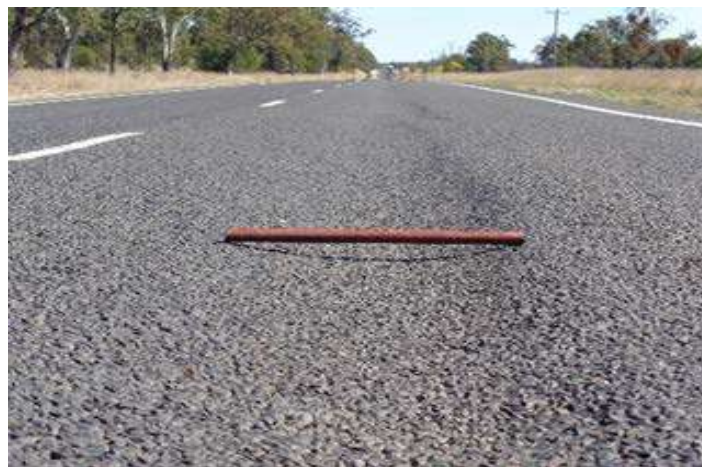
Rutting is a form of deformation typically evident in flexible pavements; it is caused by the passage of loaded wheels over the pavement surface. It is manifested as a longitudinal depression along wheel paths. Rutting may occur in one or both wheel paths (Austroads, 2019). The rut depth is usually measured from the pavement surface to the lowest point within the rut. Rutting is a pavement defect which may also present a safety hazard as it can cause vehicles to aquaplane in the event of rainfall when ponding occurs within the ruts.

Figure 2.2: Pavement rutting (TMR, 2017)

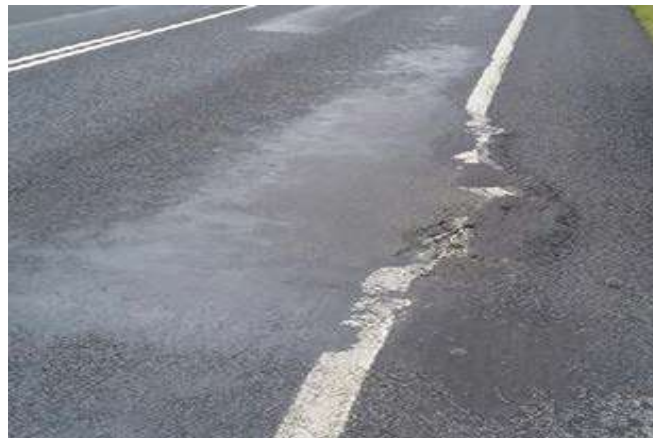
This is usually bulging of the road surface generally parallel to the direction of traffic and/or horizontal displacement of surfacing materials, mainly in the direction of traffic where braking or acceleration movements occur. Transverse shoving may arise with turning movements. Some possible causes of shoving include (AAPA, 2010):

- Inadequate strength in surfacing or base.
- Poor bond between pavement layers.
- Lack of containment of pavement edge.
- Inadequate pavement thickness.

Figure 2.3: Pavement shoving (TMR, 2017)

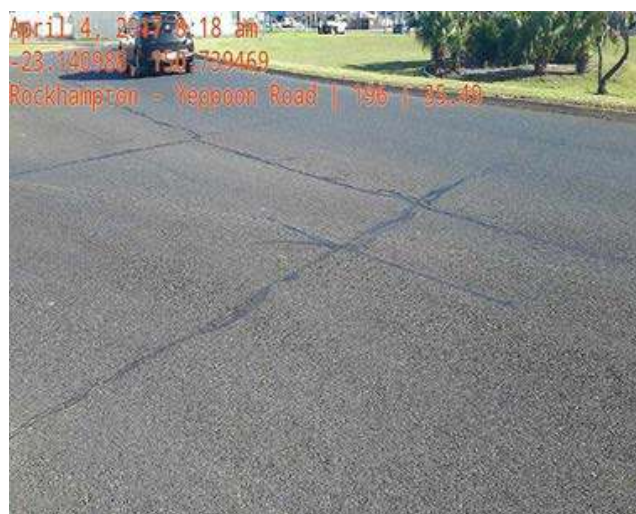
Interconnected cracks forming a series of blocks, approximately rectangular in shape commonly distributed over the full pavement. Cell sizes are usually greater than 200mm and can exceed 3000mm. Joints in pavement layers may reflect through the surface layer and appear as rectangular blocks, particularly joints in concrete pavements overlaid with asphalt (AAPA, 2010).

Figure 2.4: Block Cracks (TMR, 2017)

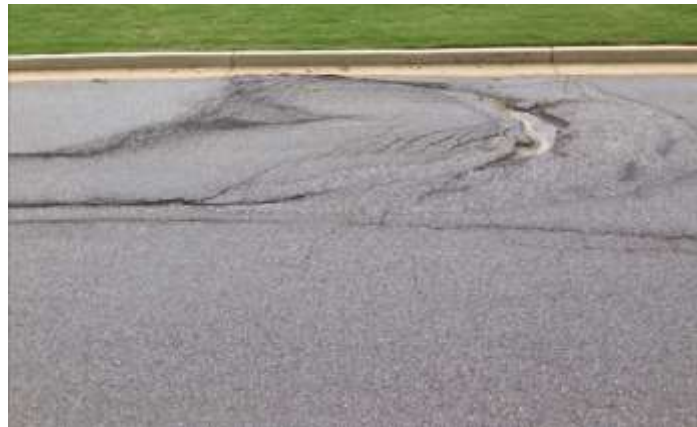
Half-moon or crescent shaped crack, commonly associated with shoving, often occurring in closely spaced, parallel group, mainly associated with asphalt (AAPA, 2010).

Figure 2.5: Crescent shaped crack (Grover Allen, 2017)

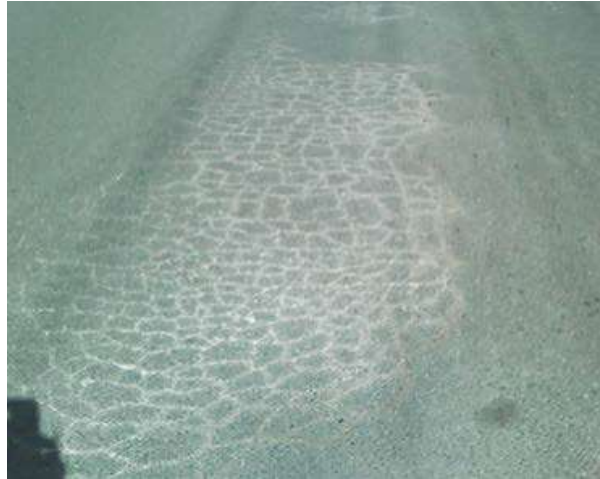
Also known as alligator cracks. Interconnected or interlaced cracks forming a series of small polygons resembling a crocodile hide. Usually associated with wheel paths and may have a noticeable longitudinal grain. Cell sizes are generally less than 150mm across but may extend up to 300mm (AAPA, 2010). This may be caused by insufficient pavement layer thickness, brittle base or wearing course due to age or cemented base. The failure can also be due to weakness in the surface, base or sub grade or poor drainage (TMR, 2017)

Figure 2.6: Crocodile Cracking (TMR, 2017)

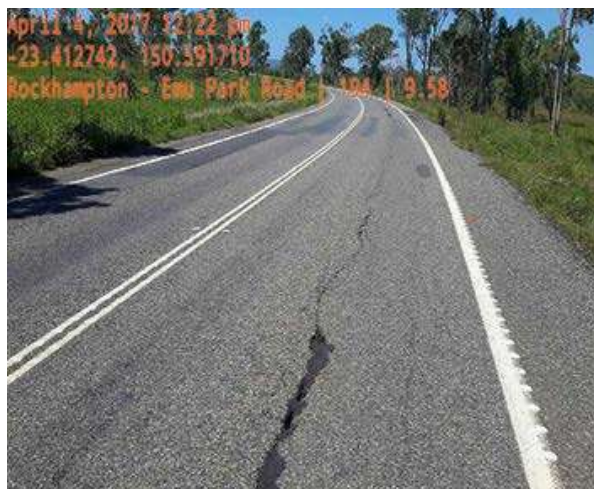
These are defined as cracks running longitudinally along the pavement. This can occur singly or as series of almost parallel cracks and some limited branching may occur. These cracks are primarily due to contraction and shrinkage of the surfacing layer or reflection from the underlying base layer joints, poorly constructed surfacing layer joints or subgrade settlement (TMR, 2017)

Figure 2.7: Longitudinal cracks (TMR, 2017)

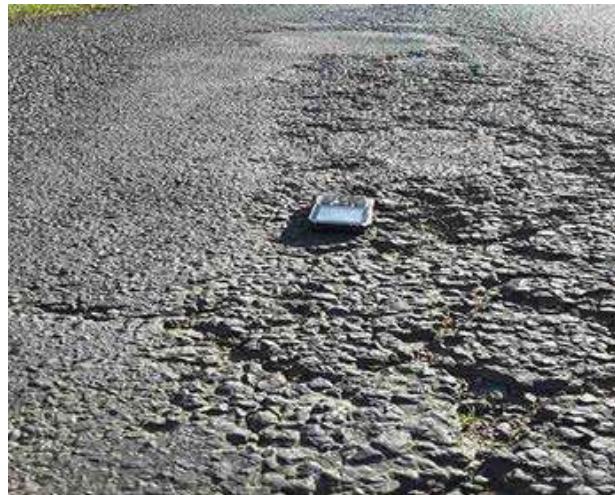
Initially fine aggregate breaks loose and leave small patches in the pavement surface, leading to progressive disintegration of the pavement surface by loss of both binder and aggregates. Possible causes include insufficient adhesion between the asphalt and the aggregate, deterioration of binder and/or stone, inadequate compaction or construction during wet or cold weather, and hydrophilic aggregates used during the constructions (TMR, 2017)

Figure 2.8: Ravelling (TMR, 2017)

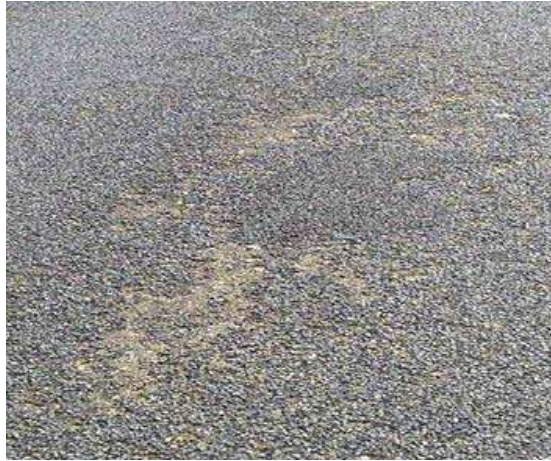
Removal of the coarse aggregate of a sprayed seal leaving the binder exposed to tyre contact – can happen as the loss of individual stones, or as the complete loss of stone in a localised area. Possible causes include: Low binder contents, poor binder to stone adhesion (dirty or hydrophilic aggregates, without effective pre-coating with adhesion agent or wet stone etc.), aging or absorption of binder, stone deterioration, incorrect blending of binder, inadequate rolling before opening the seal to traffic (TMR, 2017)

Figure 2.9: Stripping seal (TMR, 2017)

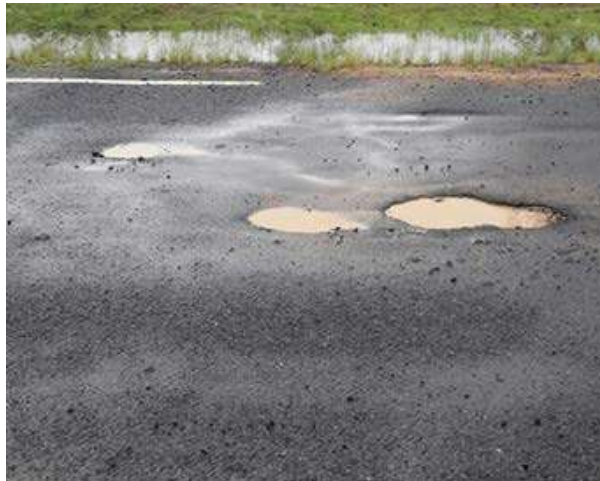
Potholes are bowl-shaped depressions in the pavement surface resulting from the loss of wearing course and base course material. They generally have sharp edges and nearly vertical sides at the top of the hole. Potholes are produced when traffic abrades small pieces of the pavement surface (cracking, delamination etc.) allowing the entry of water (AAPA, 2010).

Figure 2.10: Potholes (TMR, 2017)

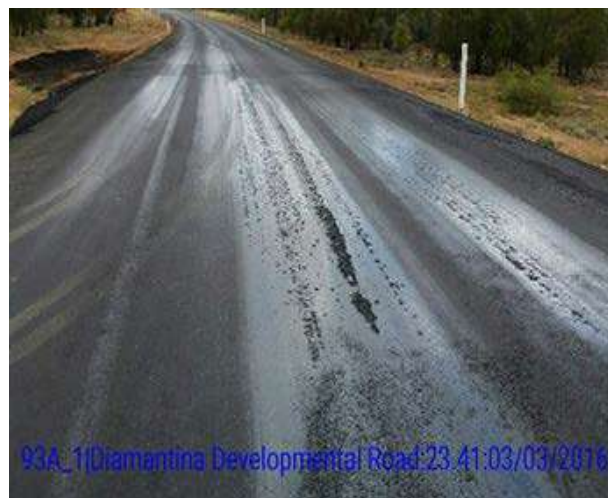
Presence of excess bitumen in the pavement surface layer which creates patches with low skid resistance due to inadequate tyre-to-stone contact. Possible causes include, excessive application rate of binder, with respect to stone size, excessive prime coat being incorporated into the seal, excess binder in underlying patch or flushed area, penetration of aggregate into low strength base and primer seal covered before volatiles in primer binder have evaporated (TMR, 2017)

Figure 2.11: Flushing, Bleeding seal (TMR, 2017)

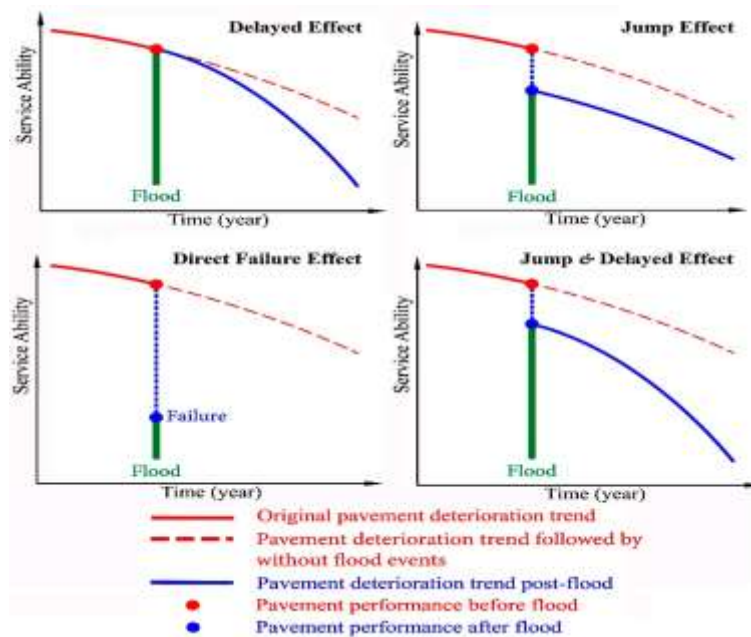
Lu et al. 2018, analysed the flood characteristics, pavement damage patterns and impact factors. A case study was performed to simulate the impact of flood events on pavement performance. Precipitation depth, duration, number of cycles and pavement structure designs are taken as variables in the performance simulation. The study concluded that the Pavement damage ratio increases as the number of event increased. The extreme events can potentially result in the loss of pavement life, which indicates the value losses of pavement assets.

Figure 2.20: Pavement damage patterns with the occurrence of flood hazards (Lu et al. 2018)

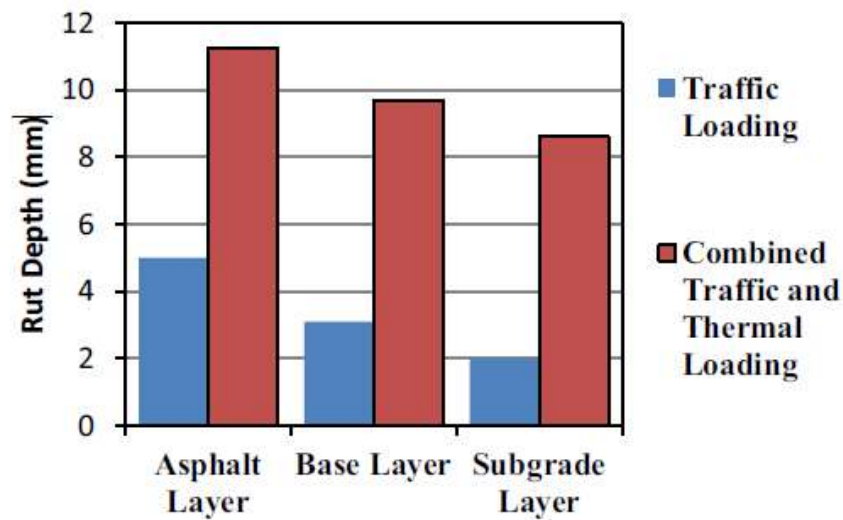
Alkaissi, 2020, examined the effects of pavement rutting due to increased pavement temperature using finite element analysis (ABAQUS). The obtained results demonstrated that; there is a significant effect of both thermal and traffic loading conditions on rutting damage of flexible pavement and higher temperatures will provide high rut depth by 2.29, 3.1 and 4.3 times for Asphalt layer, base layer and subgrade layer respectively (Figure 2.21). Furthermore, from the finite element analysis it's clear from both figures (Figure 2.22 and Figure 2.23) of deformation distribution for flexible pavement that the both thermal and traffic combined effects have more severe damage in the form of rutting.

Figure 2.21: Rut depth at flexible pavement layers under the combined effect of traffic and thermal loading (Alkaissi, 2020)

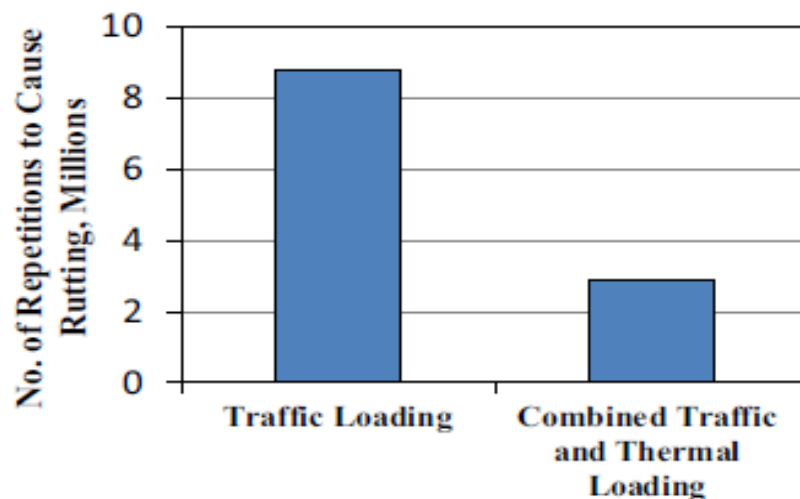
Figure 2. 24: Number of repetitions to cause rutting under both models of traffic and combined loading conditions (Alkaissi, 2020)

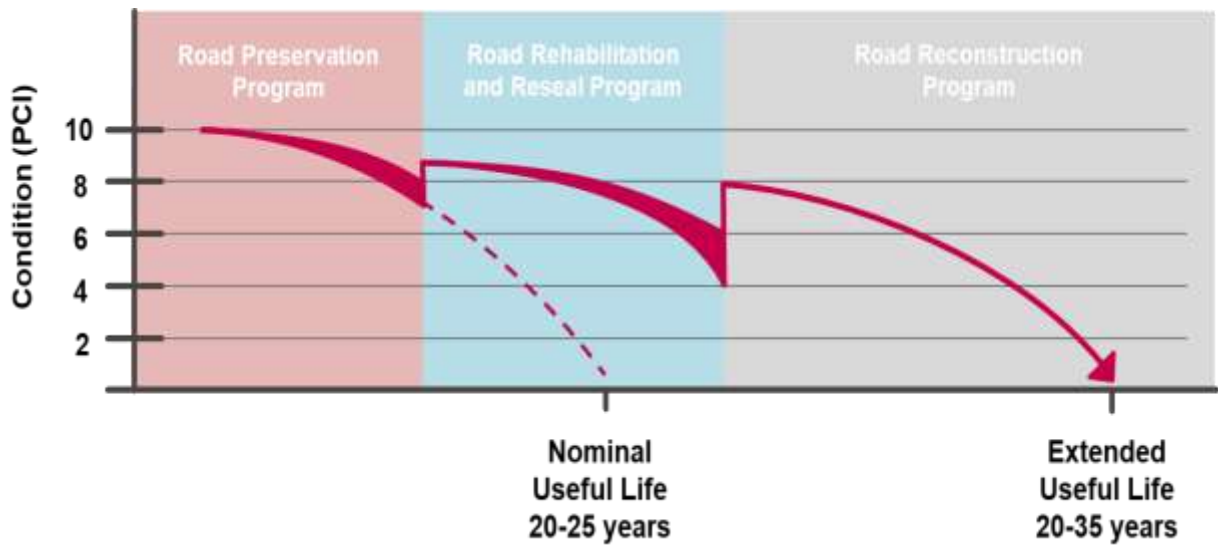
Using these values, it was possible to approximate the values for treatment methods such as reseal/rehabilitation, which was assumed to have a cost value of \$110/m², while for a recon it was assumed a cost value of \$350/m² would be adequate. Figure 3.3, demonstrates the steps that were taken in order to perform the cost analysis.

Figure 3.2: Types of intervention with the corresponding PCI (Sustainable Pavement Management Plan, 2019)
