University of Southern Queensland  
Faculty of Engineering and Surveying

# **Durability of Hybrid Concrete-FRP Bridge Decks**

In fulfilment of the requirements of  
ENG4111 and ENG4112 – Research Project

Towards the degree of  
**Bachelor of Engineering (Civil)**

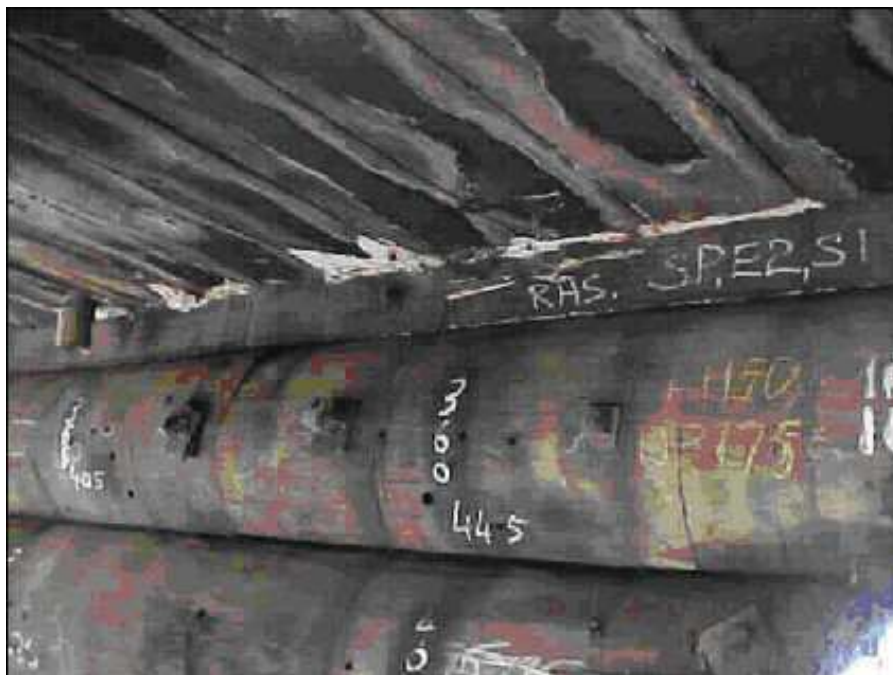
Termite attack is another problem with timber materials. To prevent termite attack the timber is chemically treated. If these chemicals leach into the environment more damage to the environment will be done. [2]. White rot is another problem with timber bridges. Figure 1.1 shows degradation caused by white rot. The figure shows where the fungus has degraded the timber bridge.

**Figure 1.1: White Rot Degradation of Frank Creek Bridge, Wide Bay District (Source: [3])**

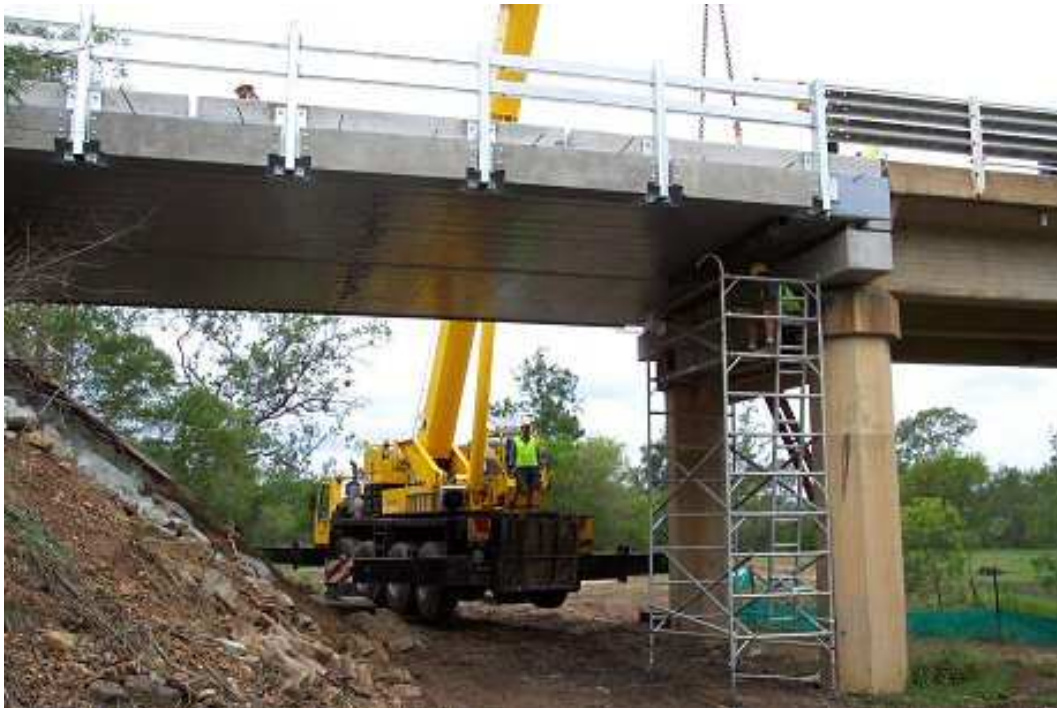
Two Australian companies, Wagner Composite Fibre Technologies (WCFT) and Fibre Composite Design and Development (FCDD), have already completed the technical prototyping of the hybrid concrete-FRP bridge. Also, the first FRP bridge deck installed in the road network in Australia has also been completed. This bridge was installed near Grafton, New South Wales in February 2003 [1]. This bridge can be seen in Figure 1.2.

**Figure 1.2: 1st FRP Bridge in the Australian Public Road Network (Source: [2])**

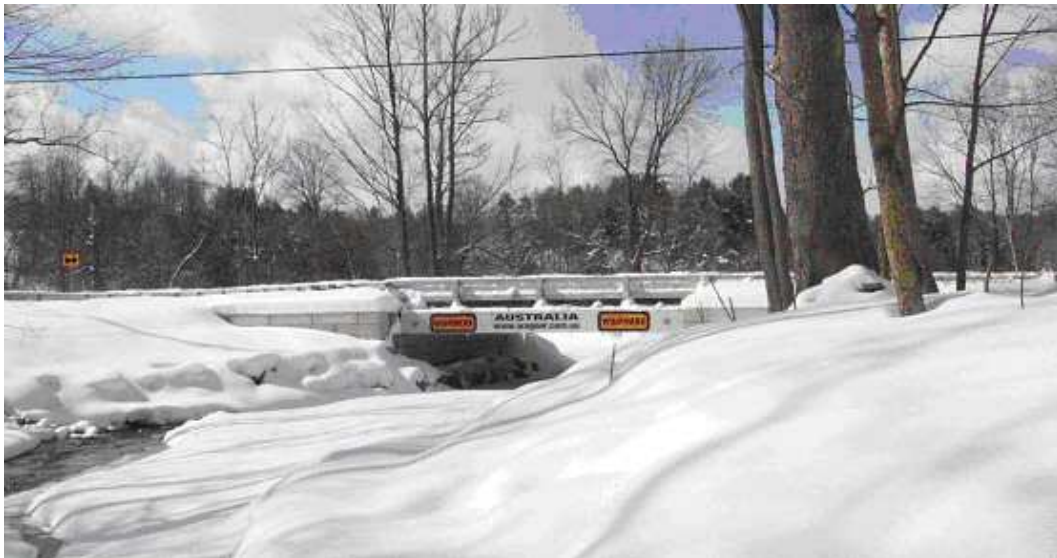
Freeze thaw cycling is another method of evaluating the durability of the different areas of the bridge. Evaluation of freeze thaw durability is not a major concern in Australia, however in snow prone areas like Canada, Russia and parts of the United States of America it is important. As WCFT has already constructed and installed a bridge in such an area, which can be seen in Figure 1.3, freeze thaw testing is important.

**Figure 1.3: Wagner Composite Technologies Bridge Installed in Erie County, New York, United States of America (Source: [2])**

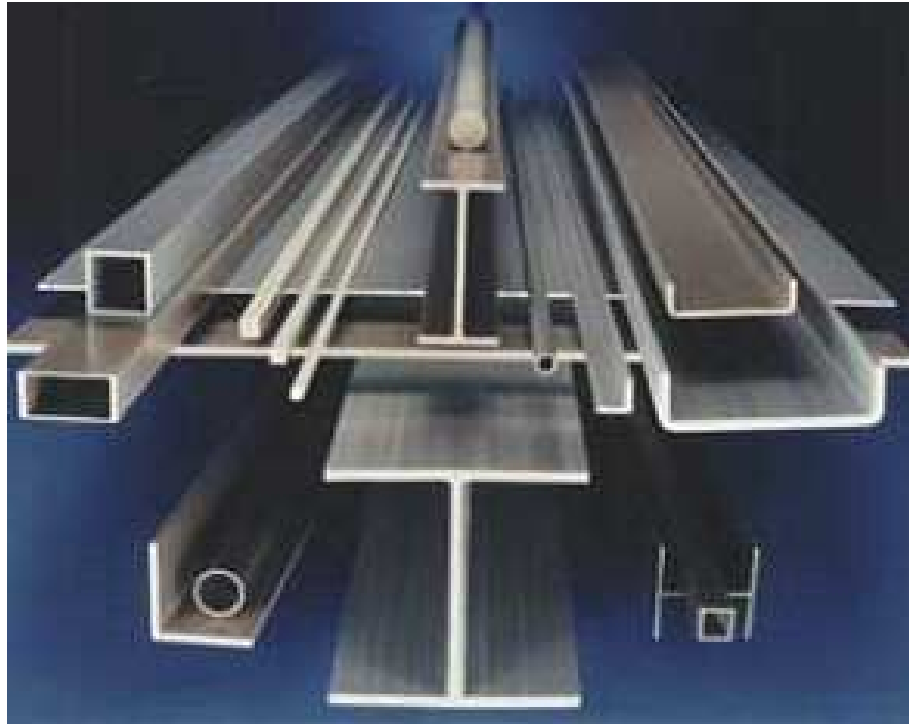
Throughout this process a set of pullers are used to keep the material moving at a constant rate. When the required length of material has been produced a cut off saw located at the end of the machine cuts the material. This process can produce a range of shapes. Figure 2.2 shows some of these shapes.

**Figure 2.2: Typical Pultruded Shapes (Source: [12])**

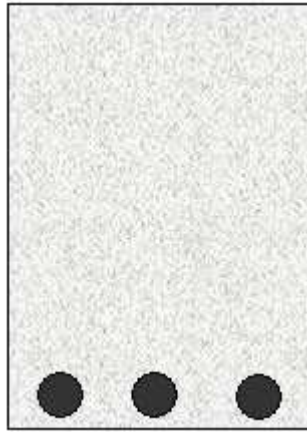
Concrete beams designed in this manner have two main disadvantages, the first being that 75 – 80% of the beams weight is not directly contributing to the strength of the beam [1]. The second disadvantage is that during service the reinforcing steel may corrode if the beam is placed in a moist environment and is not properly protected.

**Figure 3.1: Concrete Beam**

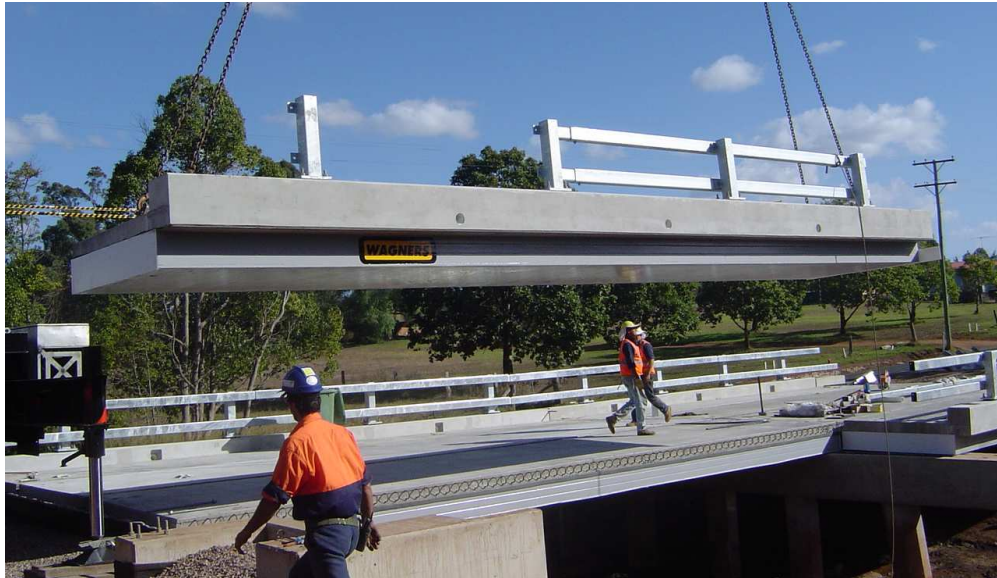
To construct the bridge deck, several of these beams are manufactured, and joined together as shown on Figures 3.5 and 3.6.

**Figure 3.6: Picture of a Hybrid Concrete-FRP Bridge Deck Produced by WCFT**

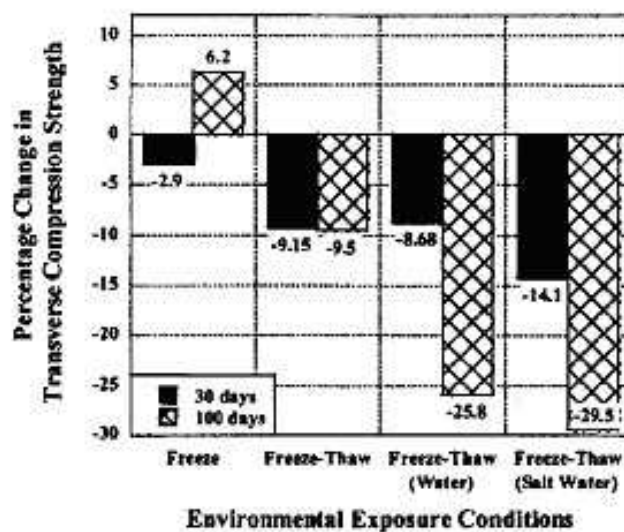
Karbhari et al. [19] used freeze thaw cycling to examine the FRP material. These experiments also showed the effect of different thawing solutions. The results of the tests conducted are shown in Figure 4.1 and 4.2. These figures show the change in strength when the samples were tested in tension and compression.

Figure 4.1: Change in Tensile Strength After 100 Days Exposure (Source: [19])

Figure 4.2: Effect of Environmental Exposure on Compressive Strength (Source: [19])

Both figures show that considerable damage has been done during the first 30 days of exposure. They also show that the damage to the samples is increased when the thawing cycle is conducted within a solution.

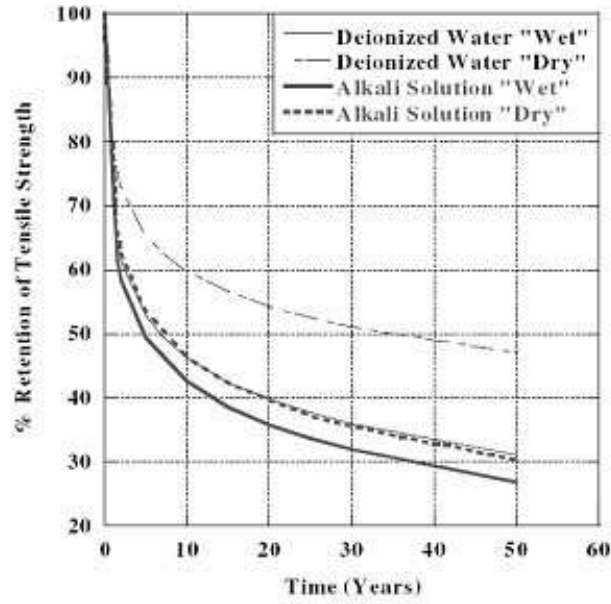
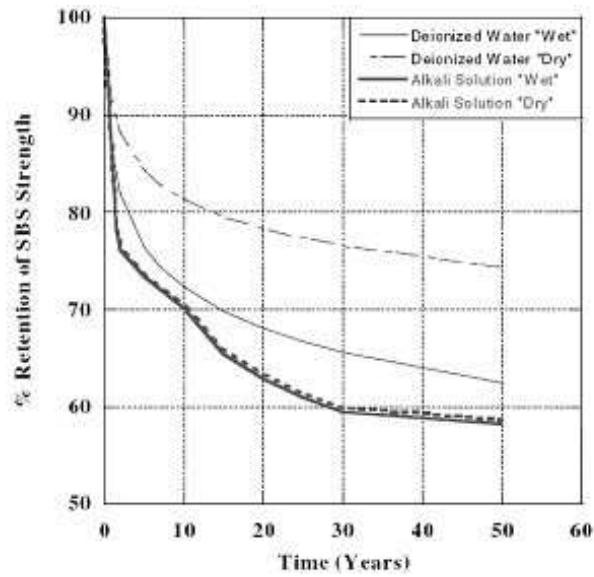
Chu et al. [21] conducted tests on pultruded material at a range of elevated temperatures. He determined that the samples tested by a short beam shear test reduced by 50%. This was after being exposed to 80°C deionised water for 75 weeks. He also found a 46% when an alkali solution was used. By conducting tests at elevated temperature a prediction of the strength retention can be determined. Figure 4.3 and 4.4 were developed from these experiments.

Figure 4.3: Prediction of Tensile Strength (Source: [21])

Figure 4.4: Prediction of Short Beam Shear Strength (Source: [21])

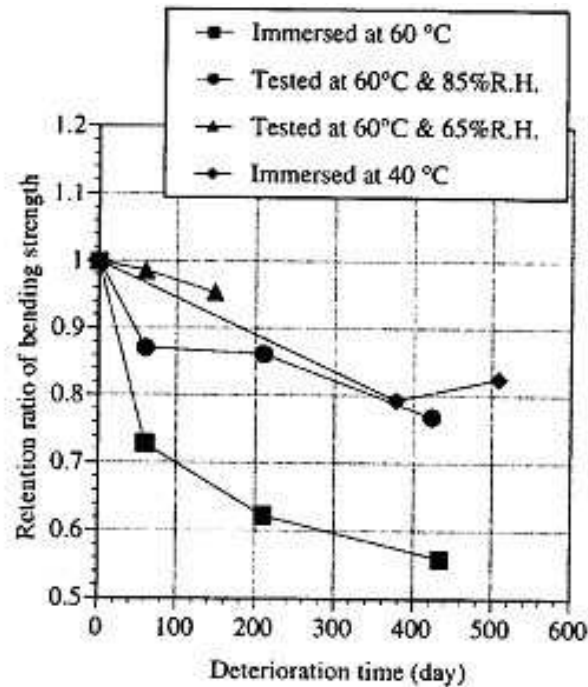
Chu's results are similar to the tests conducted by Nishizaki et al. [23]. Their tests were conducted at different humidity levels and immersion times. Figure 4.5 shows the test results determined from Nishizaki's investigations.

Figure 4.5: Retention of Bending Strength (Source: [23])

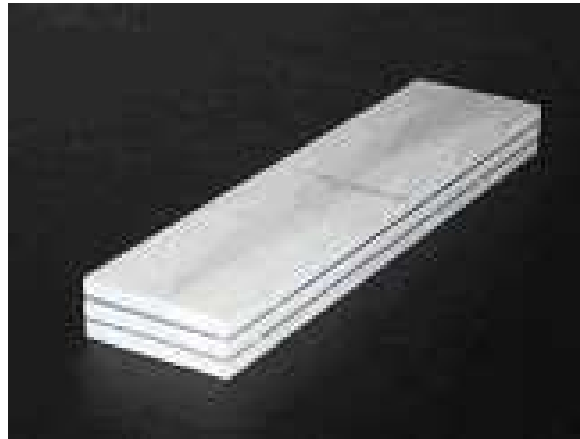
**Figure 6.1: Durability Test Sample**

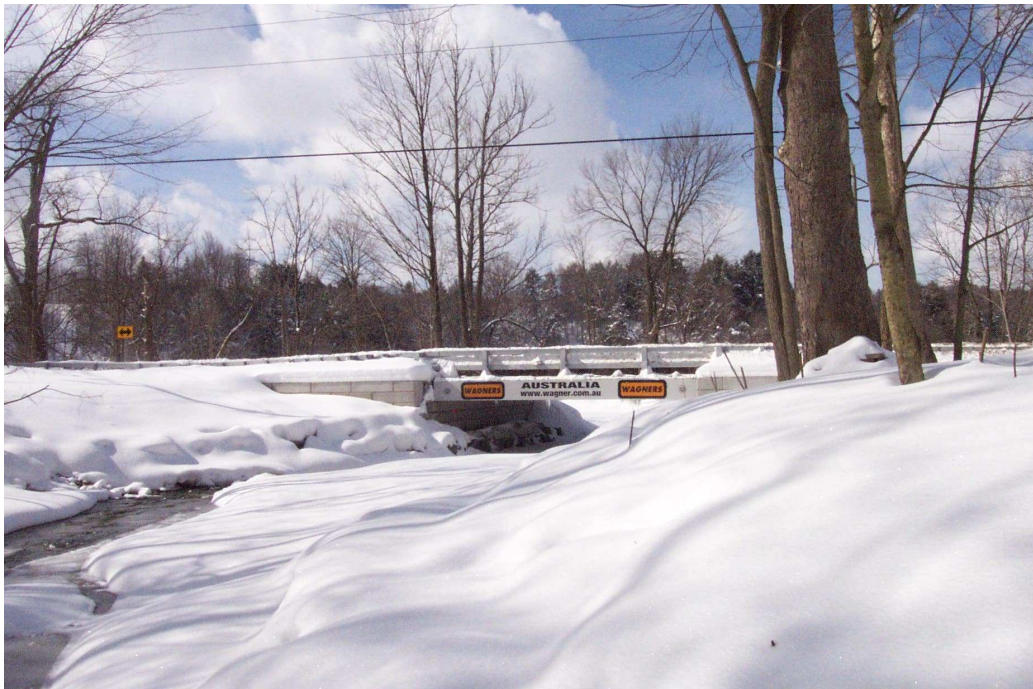
In Australia there is limited need to test for freeze thaw cycling. However, for this investigation it is important to study the effects of freeze thaw cycling because WCFT has installed a bridge in to Eire County, New York, United States of America. Figure 6.5 shows this bridge during the snow season.

**Figure 6.5: WCFT Bridge Deck in Eire County, USA (Source: [2])**

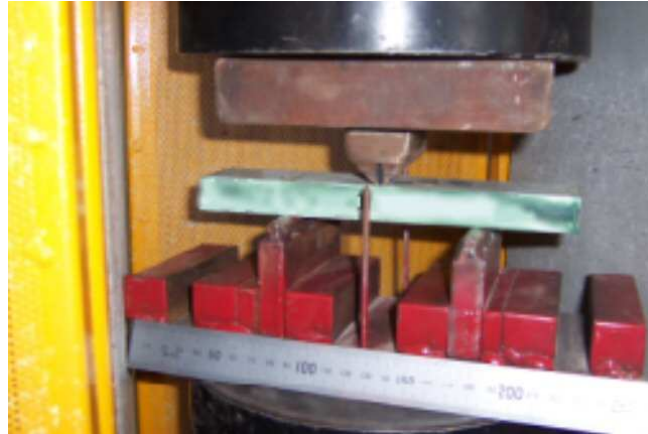
**Figure 7.5: Sample Set-up in Test Jig and Machine**
