An Investigation into design and construction of a leachate dam in Lismore

A dissertation submitted by
Phillip George

in fulfilment of the requirements of
ENG4111 and 4112 Research Project
towards the degree of
Bachelor of Engineering (Honours) (Civil)
Submitted October, 2021

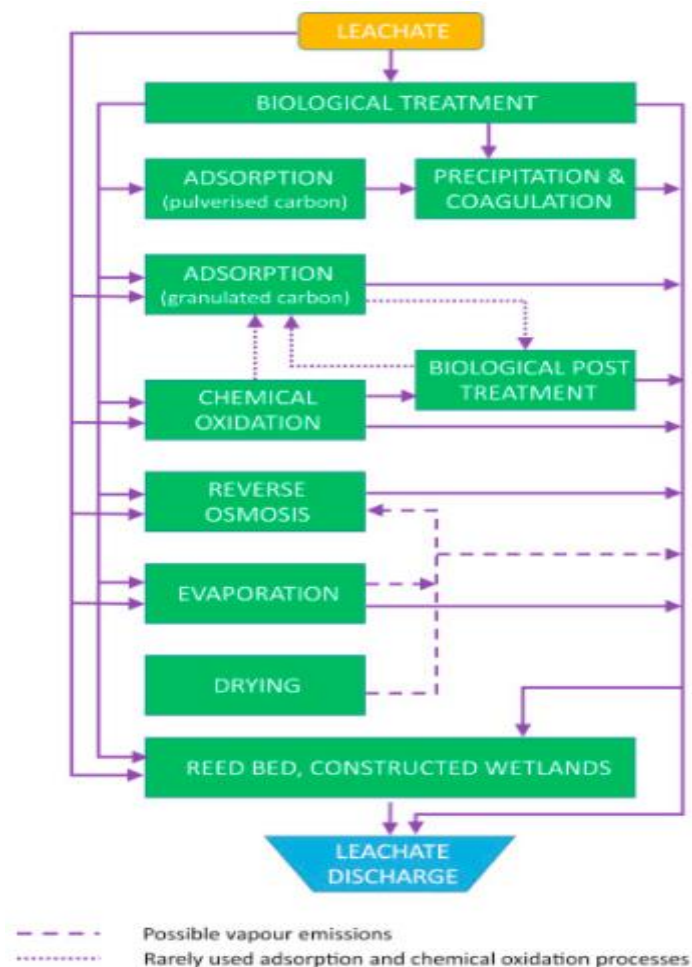
Figure 4. Diagram showing the process available to treat Leachate. (Ehrig, Stegmann, 2018)

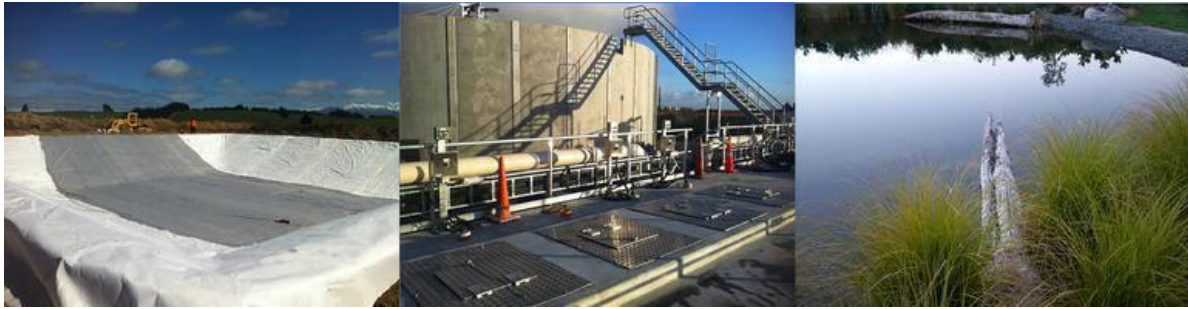
Figure 5. Example of liner for leachate dam, processing tanks and operational dam at Hampton Downs Landfill - North Waikato (IS Dam Lining, 2021)

- This project employed the use of geotextiles as well as geomembranes to improve durability and strength. During the deployment of GCL's, the liners are susceptible to damage from traffic above or rough surfaces below. The use of geotextiles mitigates this issue through the use of welded 1.5mm double textured HDPE.

- The company contracted to carry out the works employed HDPE liners on the Hampton Downs project because of its ongoing integrity. By welding the geomembranes together, an uncompromised seal can be achieved. A double weld is created with a cavity between the welds, this is then inflated to check if it can maintain pressure. If the pressure drops, the leak can be identified and repaired. IS lining provides several options for their liner's dependant on the client's project. HDPE, geotextile, RPP and GCL can all be considered based on requirements such as tensile strength, UV durability, chemical resistance and geomembrane density

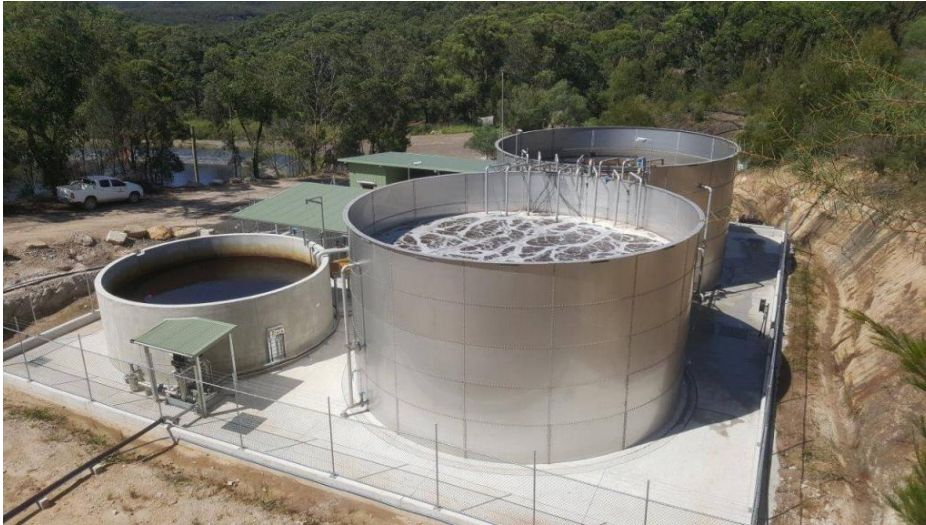
Figure 6. Stainless steel tanks at the Kimbrikki installation. (Kimbrikki news, 2019)

- The facility at Kimbrikki was commissioned in June of 2019 and within 4 months had processed one hundred million litres of landfill leachate. This system uses both aeration and chemical dosing to process the leachate before it is released into the sewer.

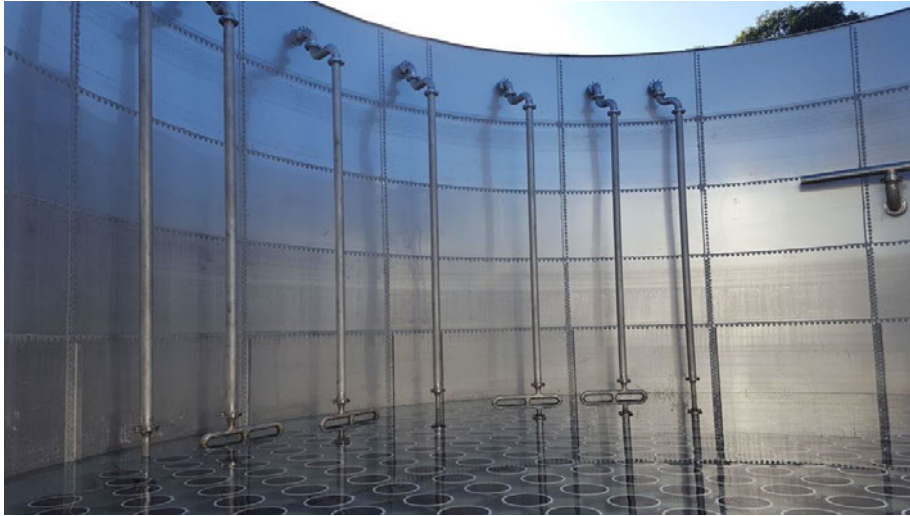
Figure 7. Lucas Heights stainless steel tank. (JPG Engineering, 2019)

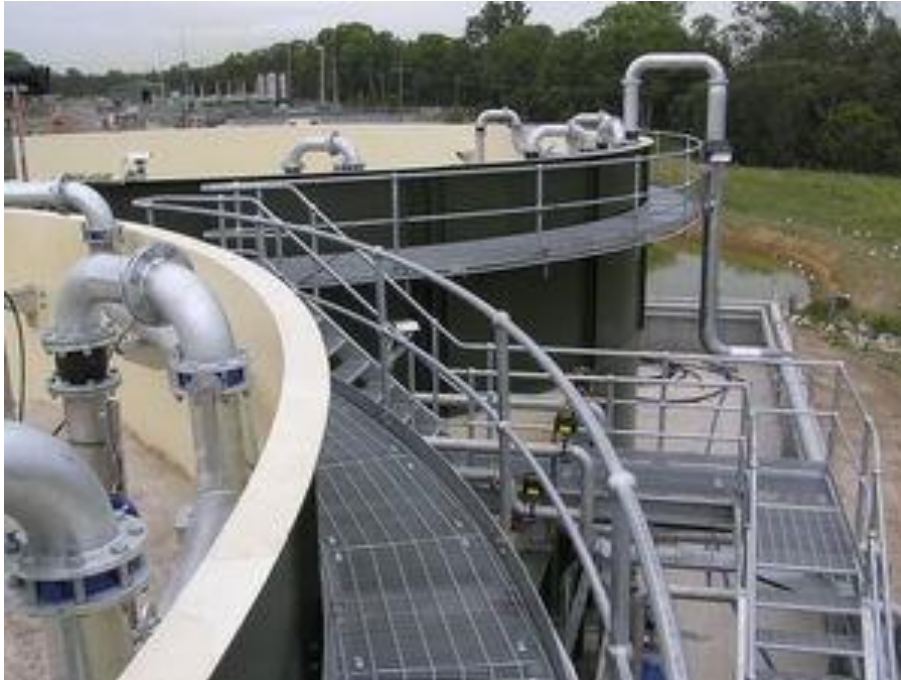
Figure 8. Landfill leachate treatment facility at Eastern Creek, Sydney. This plant uses ammonia oxidation to treat its leachate. (JPG Engineering, 2019)

- Currently treating approximately 400m³ of leachate per day when the ammonia level is at 1500mg/L. this processing level can be increased if the monitored ammonia level is reduced.
- The volume of the leachate dam to spill level is 8500m³. The average daily leachate inflow is 157m³ and the maximum recorded daily volume was 5656m³
- This pond currently services 7 cells. As stipulated by the EPA. The progressive capping and revegetation of the cells will reduce the level of contaminants as they are filled

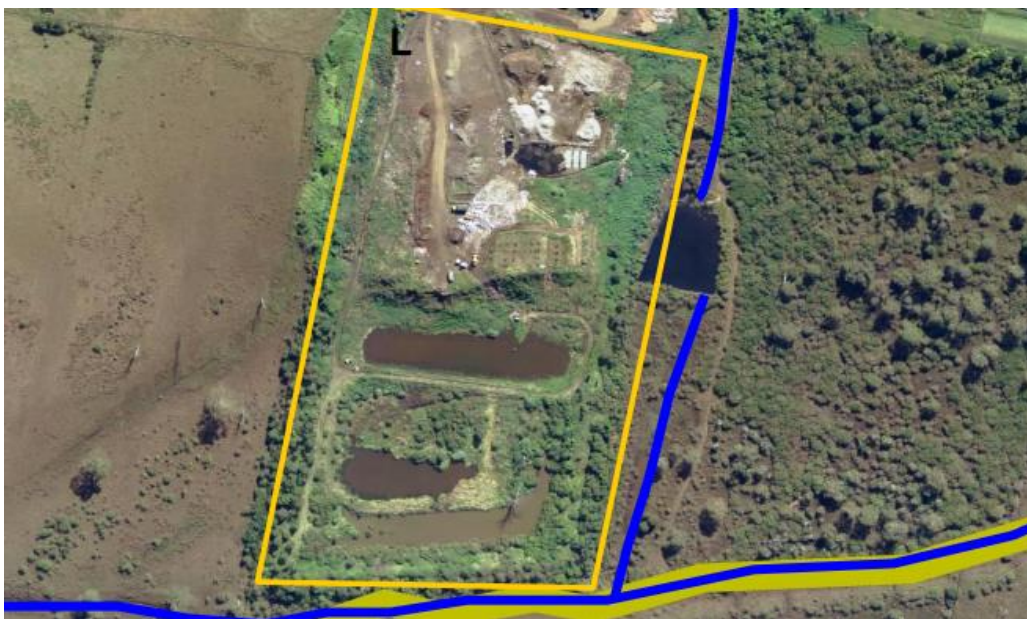
Figure 9. Aerial photo for Lismore Waste Facility from 2012. (LCC, 2012)

In 2012 the site had constructed a leachate dam that was reliant upon an evaporation method as a means of processing the toxic runoff. The dams were not constructed with an effective liner and subsequent testing of the water in the immediate area showed that this was an ineffective process and changes were required to ensure the stream below the facility was not contaminated due to runoff from the facility.

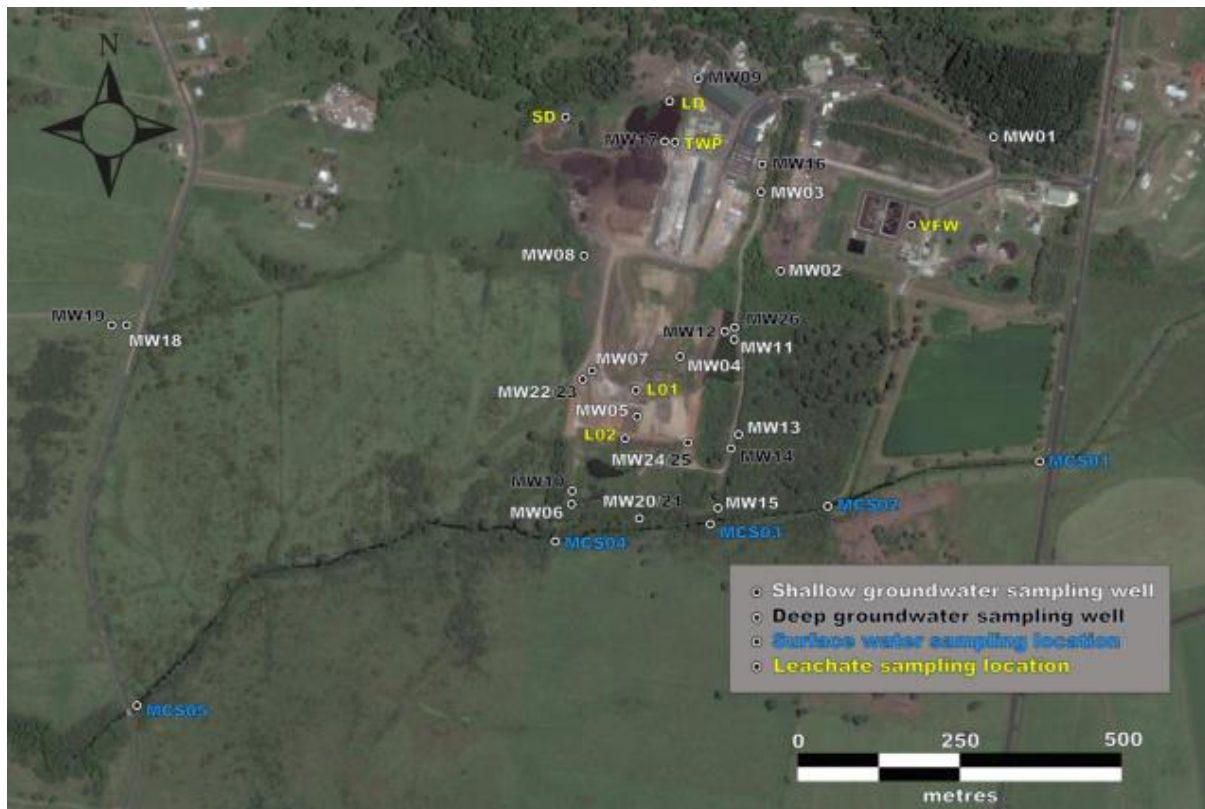
Figure 10. Aerial view of the well locations. (LCC 2019).

Figure 9 indicates the shallow and deep-water sampling wells in the vicinity of the waste facility. Surface water samples were taken from Monaltrie creek and most of the other points have both a deep and shallow wells.

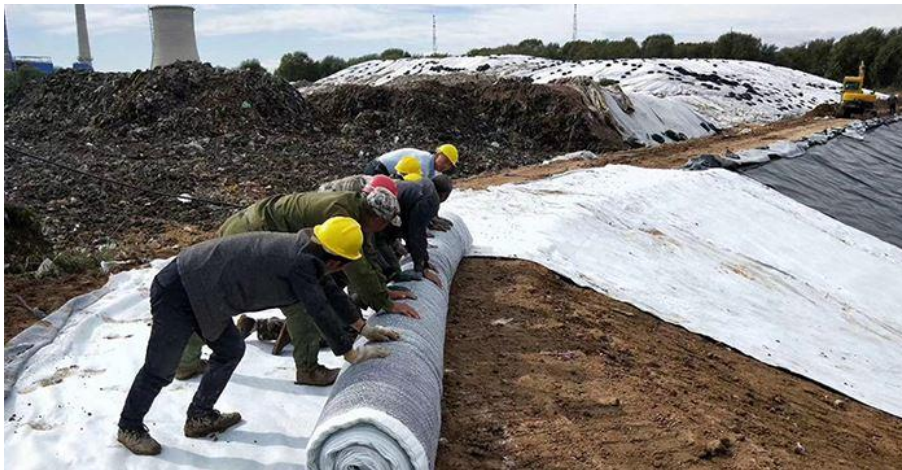
Figure 11. Installation of GCL in China. (MTTVS, 2021)

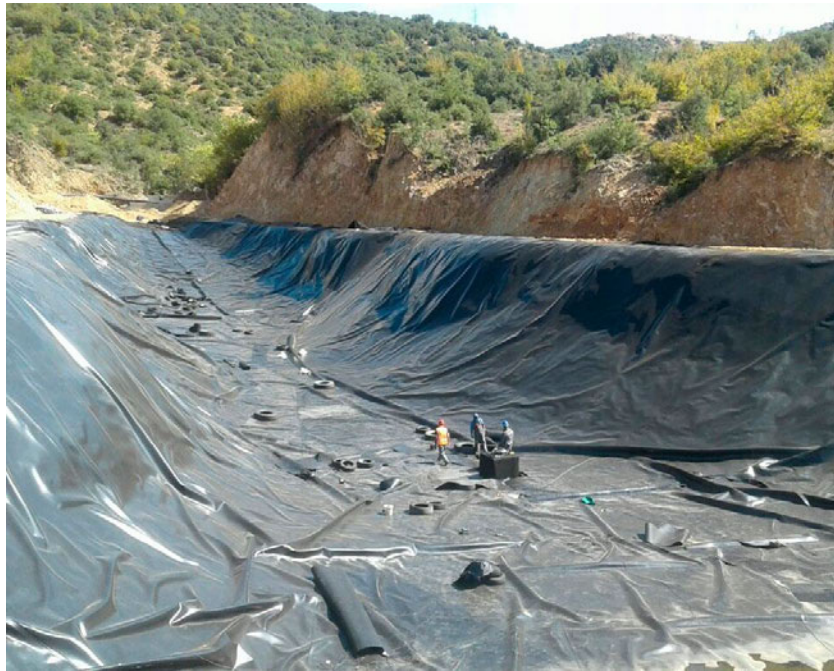
Figure 12. Installation of HDPE liners (Copin, 2019)

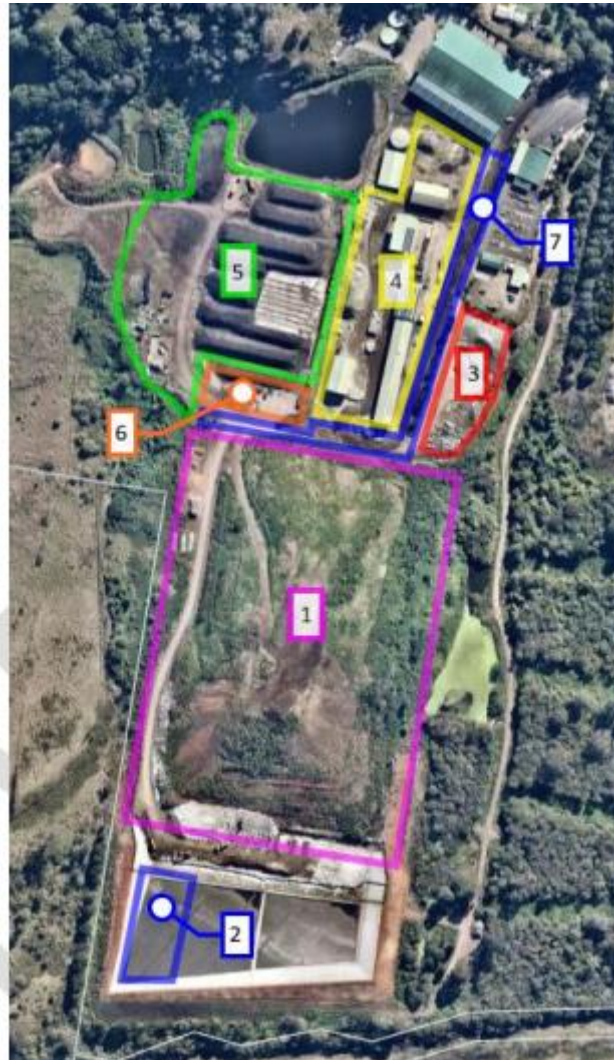
Figure 13. Aerial photograph of site (Newton, Denny, Chapelle, 2020)

The catchment area is shown in figure 9. The aerial photo of the site gives an overview of the site layout and figure 10. gives the site of the proposed position of the dam.

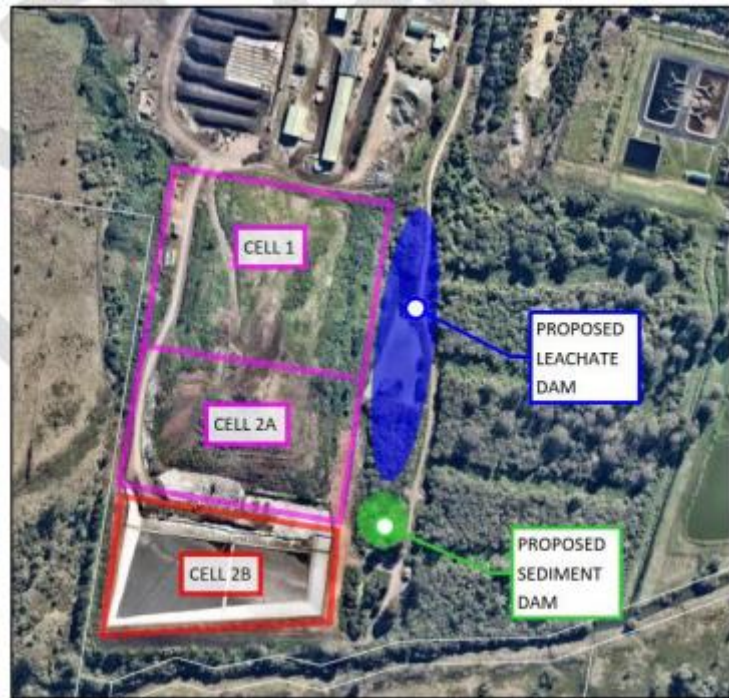
Figure 14. Proposed site of collection dam (Newton, Denny, Chapelle, 2020)

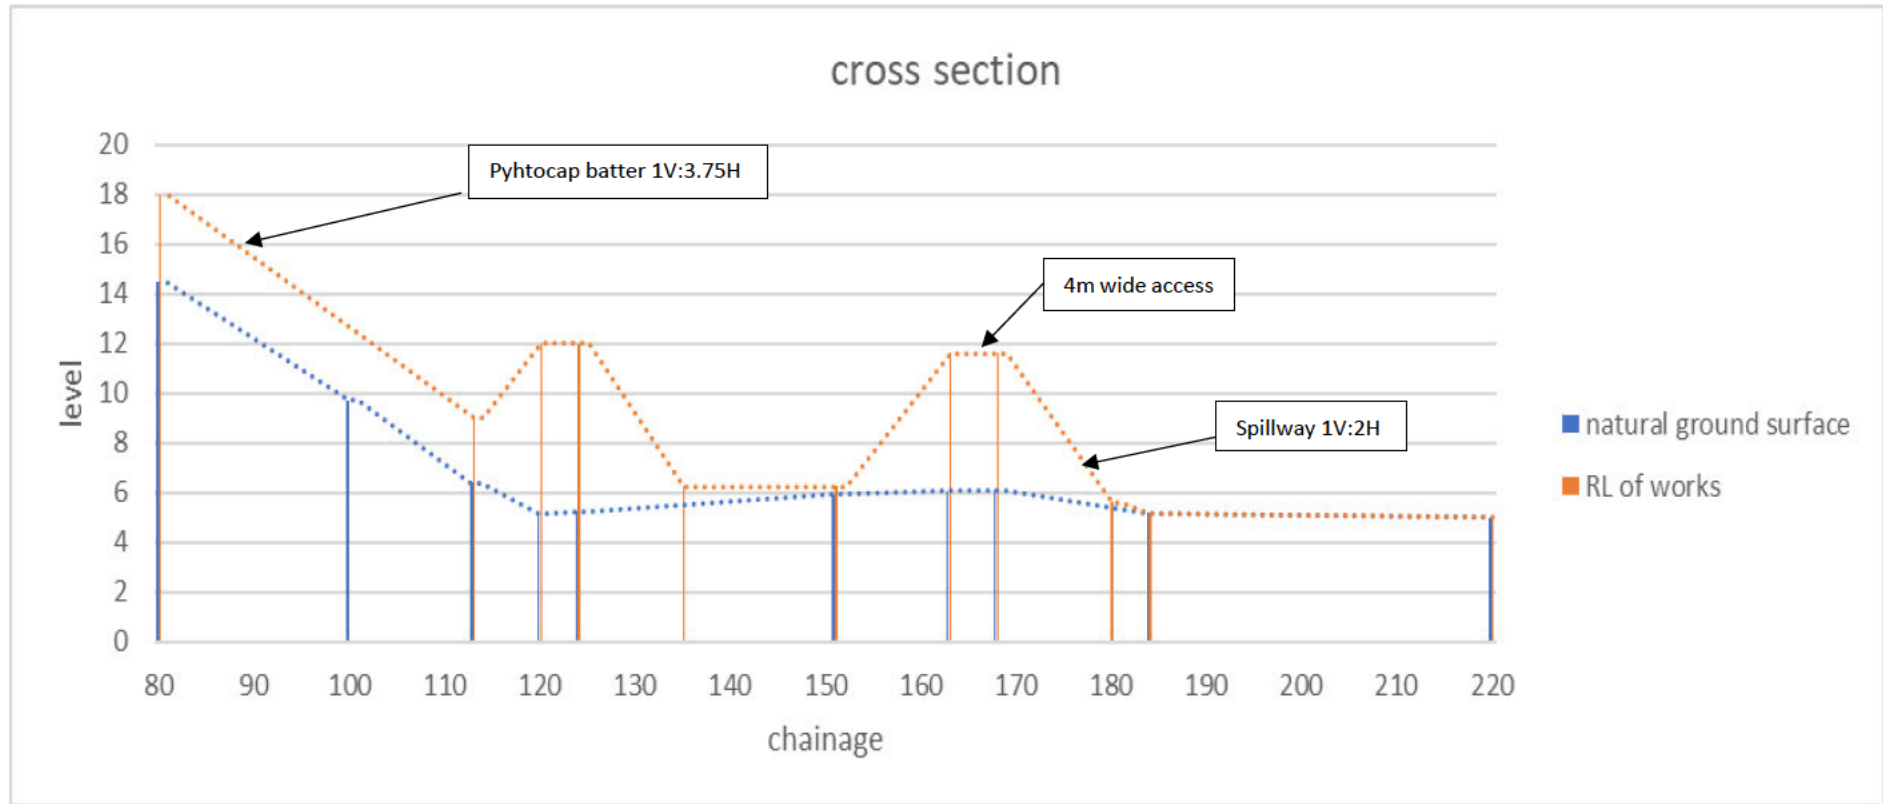
Figure 16. Cross section showing profile of dam walls.

Figure 11 illustrates the cross-sectional view of the dam's profile. The left side of the construction will be the stabilisation of the phytocap that will seal in cell 1. This is outside the scope of this project. The dams' walls will be constructed to RL 12.00 with batter slopes on either side at 2H:1V. there will be a 4m wide surface for vehicular access around the top. The base of the dam will not impede on the natural water table and will be at RL 6.28. The eastern wall will also have a 4m wide access at the peak of the wall at RL 11.60. The spillway will be positioned on the eastern wall.

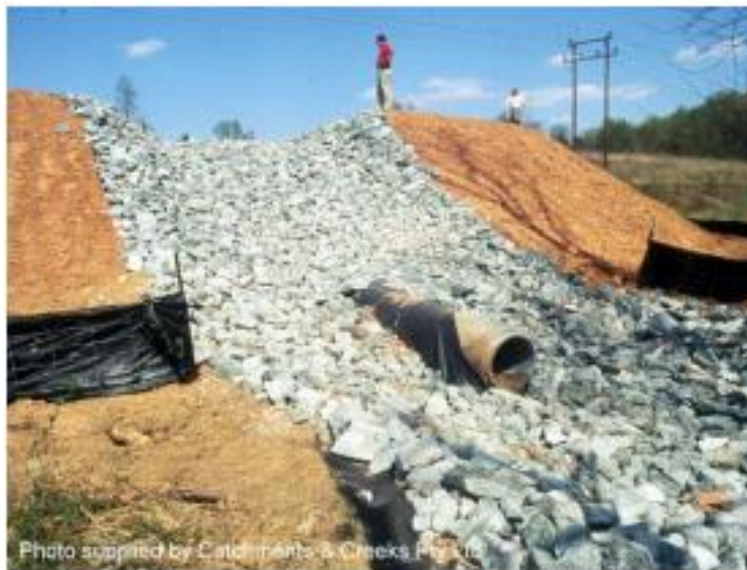
Figure 20. Example of spillway design. (Catchments and creeks, 2011)

- Shaping of chute face to ensure as far as practicable that water follows design path to the base of the chute.
- Placement of rock on chute face to arrest water speed and reduce chance of erosion.
- Placement of rock at the base of chute to allow water to discharge at low velocity.
