University of Southern Queensland

# **Retrospective Resilience of Jamberoo Mountain Road**

**Bachelor of Engineering (Honours) (Civil)**

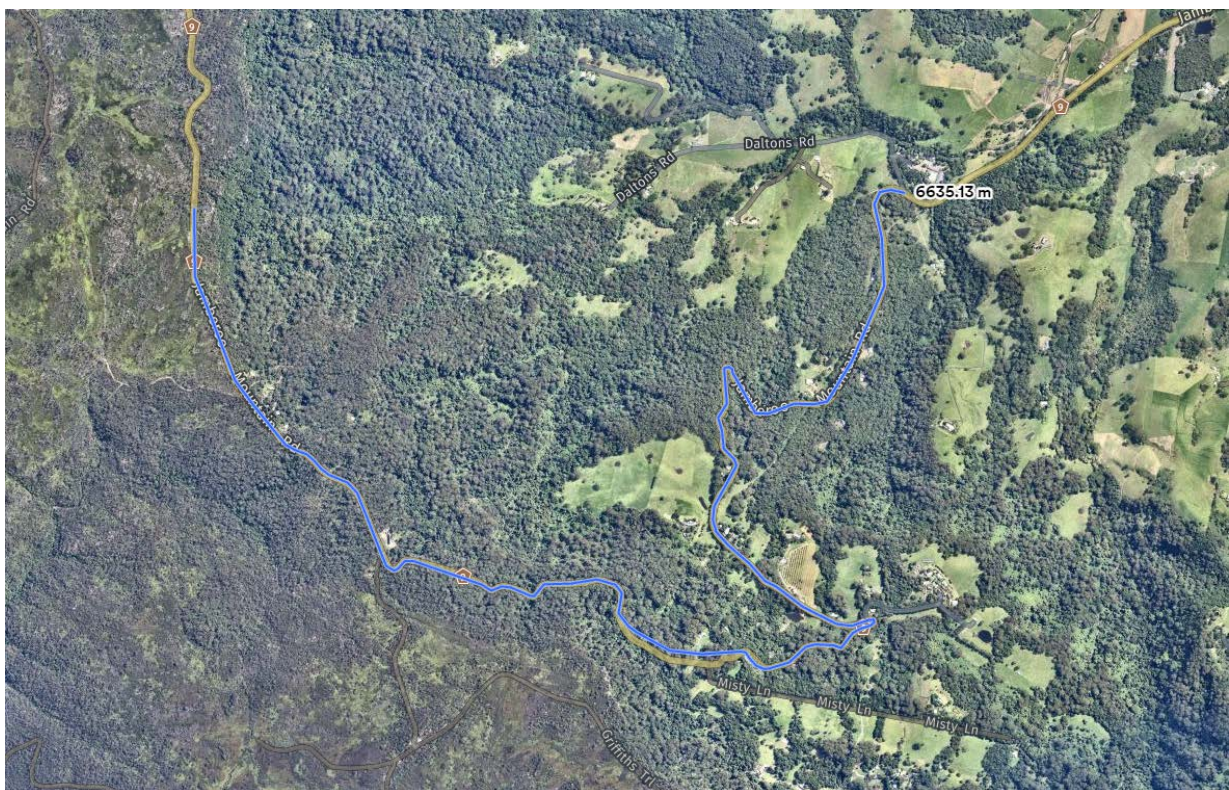
Jamberoo Mountain Road, MR264, is a Regional Road that links the townships of Jamberoo and Robertson, on the south coast of New South Wales. Owned by Transport for New South Wales, and vested to Kiama Municipal Council for maintenance and renewal, this road exists to link state highways to local council managed roads, and was gazetted on 8 January 1884 ('CONFIRMATION OF A PARISH ROAD' 1891; *Schedule of Classified Roads and Unclassified Regional Roads* 2023). This road is one of four roads that link the Illawarra to the Southern Highlands, and then on the Hume Highway, emphasising the road importance to the community. The impact on the communities is very significant when the road is closed as travel between the coast and the highlands takes a greater amount of time and is more congested through the alternative routes. One segment of the road, approximately 6.7 kilometres long, from the intersection of Daltons Road to the Jamberoo Mountain Lookout, has a change in elevation of 537 metres. This segment is shown below in figure 1.

Figure 1: Aerial Image of Jamberoo Mountain Road segment - 11/03/2023

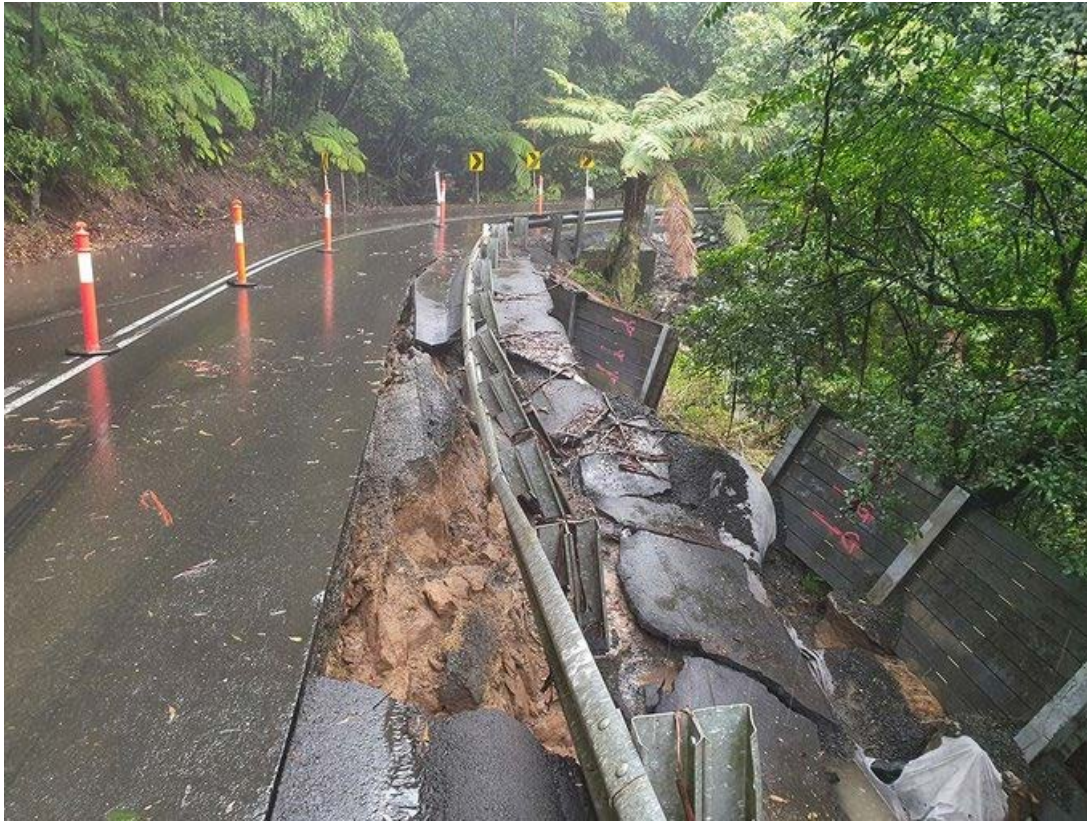
Figure two shows the landslide that occurred in 2020 on Jamberoo Mountain Road, approximately 4452 metres past the Daltons Road intersection. Figure three shows the damage at site 3D, approximately 3417 from the Daltons Road intersection, during the 2022 rainfall events.

*Figure 2: The 2020 Landslide on Jamberoo Mountain Road (Kiama Municipal Council, 2020)*

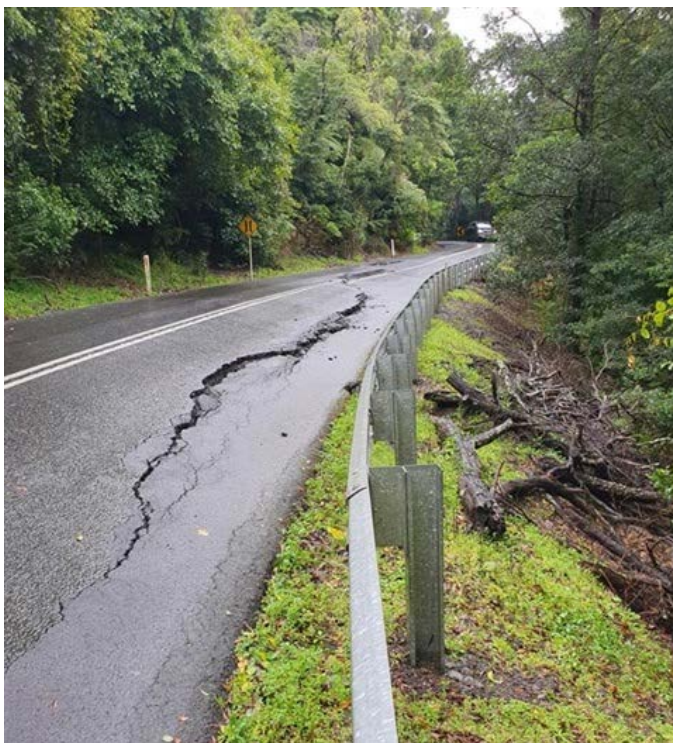
*Figure 3: Site 3D Jamberoo Mountain Road 2022 (Kiama Municipal Council, 2022)*

Sites 3B and D were slips that occurred below the road, resulting in structural damage to all road components. As indicated in Figure 3, a 600mm step occurred down the centreline of Site 3D. Site 3B had evident tension cracking along the outer wheel path, but the road surface had not slumped. These two sites underwent weighted assessment of the benefits of soil nails and stabilising piles, with piles being the preferred option by 0.5%. While the soil nails were cheaper to construct, the environmental impact of the nails was too great, in that they would lead to further destruction of vegetation.

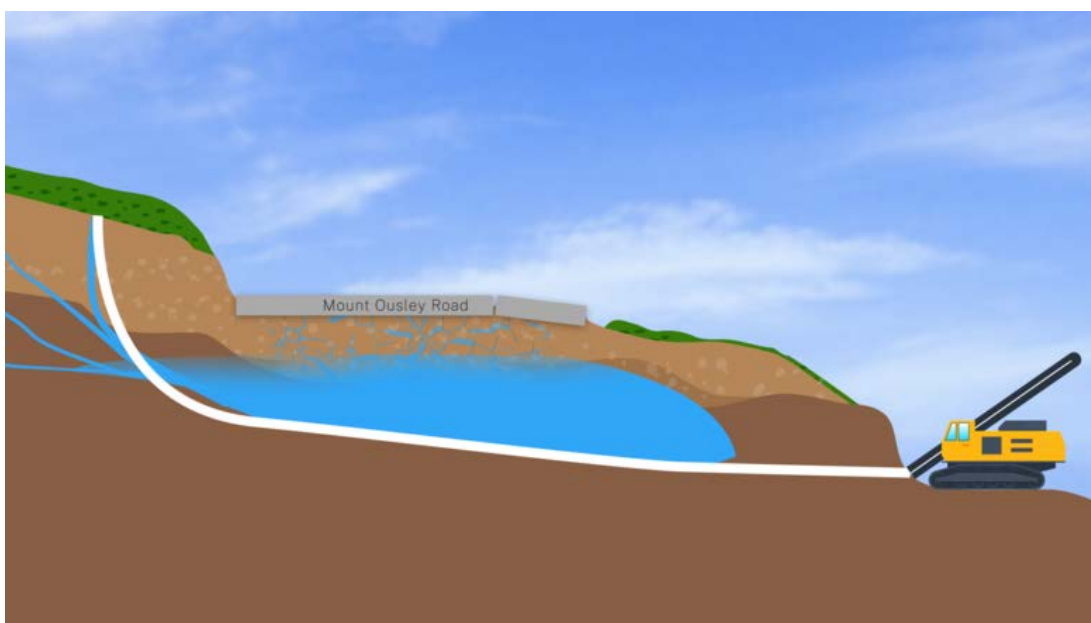
Figure four below show a simplified diagram, describing the construction process. This diagram was used as a part of Transport for NSW's community consultation. Figure five shows a snapshot of the detailed design plans for the installation of 12 HDD drains under Mount Ousley Road.

Figure 4: Diagram showing repair on Mount Ousley Road (Transport for NSW 2023)

The proposed repair Transport for NSW is undertaking involves the installation of 140mm Horizontally Directional Drilled Drains (HDDs), a drainage system composed of slotted pipes in between the colluvial soil of the slip and the rock below. It is stated on the Transport for NSW website that this solution will make Mount Ousley Road more resilient to natural disasters, such as the March storms (*Mount Ousley Road natural disaster recovery repairs* | Transport for NSW 2023).

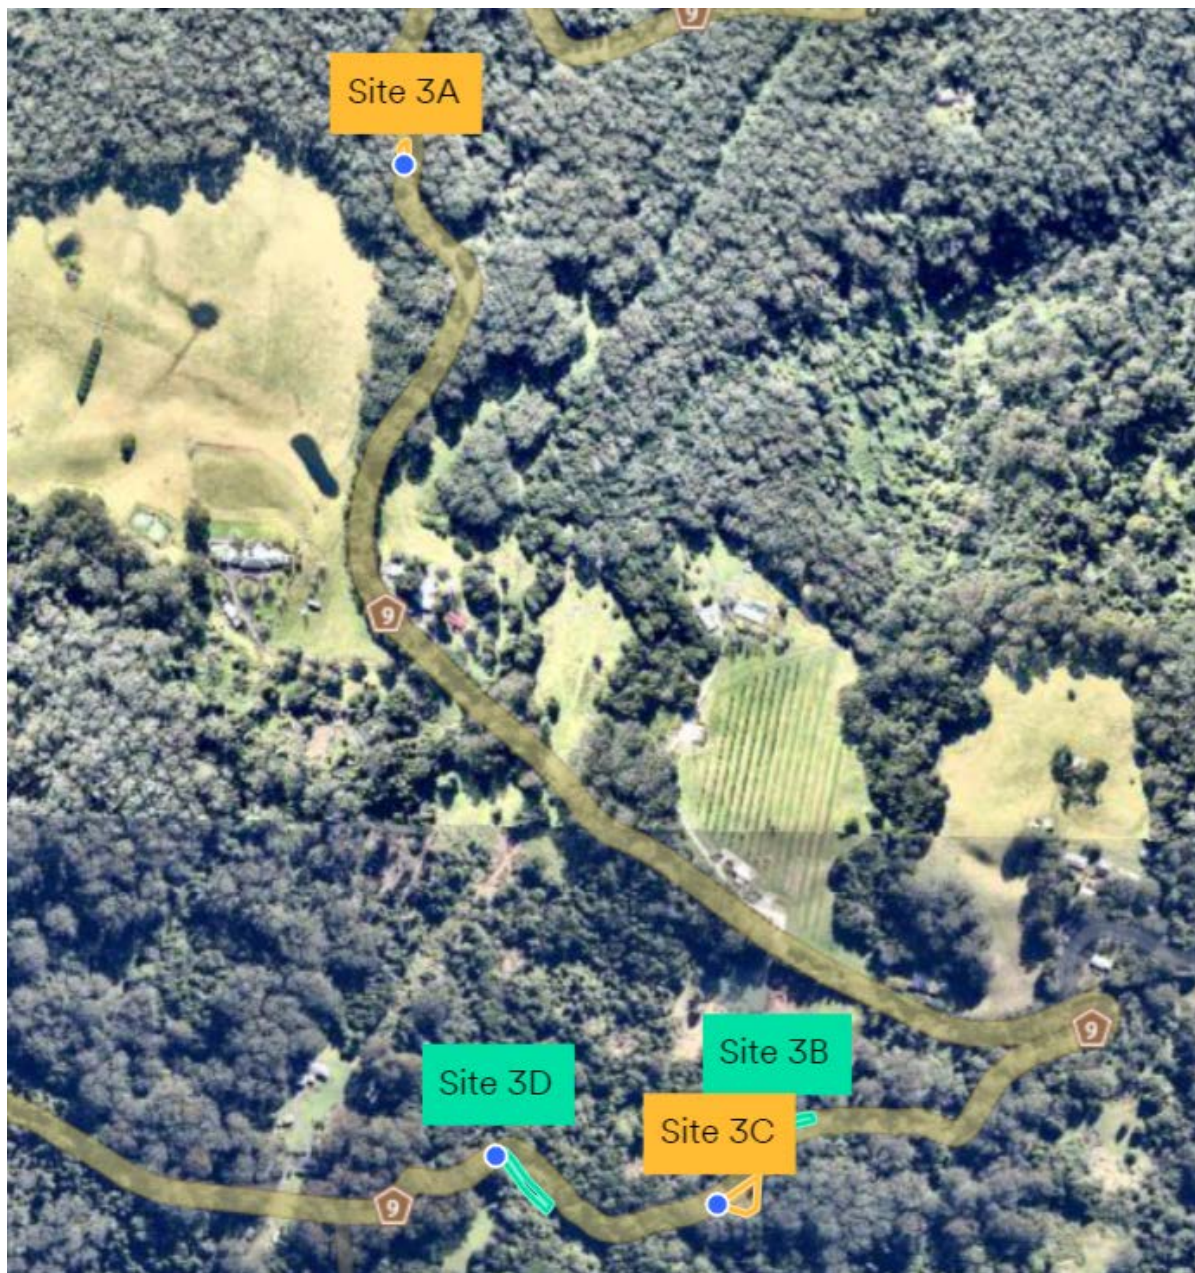
Figure 6: Aerial image showing the location of each failure.

To repair the landslides that occurred on Jamberoo Mountain Road in 2022, two separate design methodologies were prepared. The two separate design solutions were needed depending on the location of the failure, whether it was above the road, or below the road. Figure 66 above shows the location of the failures, with yellow markers indicating a failure above the road. Green markers indicate failures below the road.

The chosen solution for sites 3B and 3D (indicated on figure 6) on Jamberoo Mountain Road was the installation of stabilising piles with sleeper shutter retaining system and

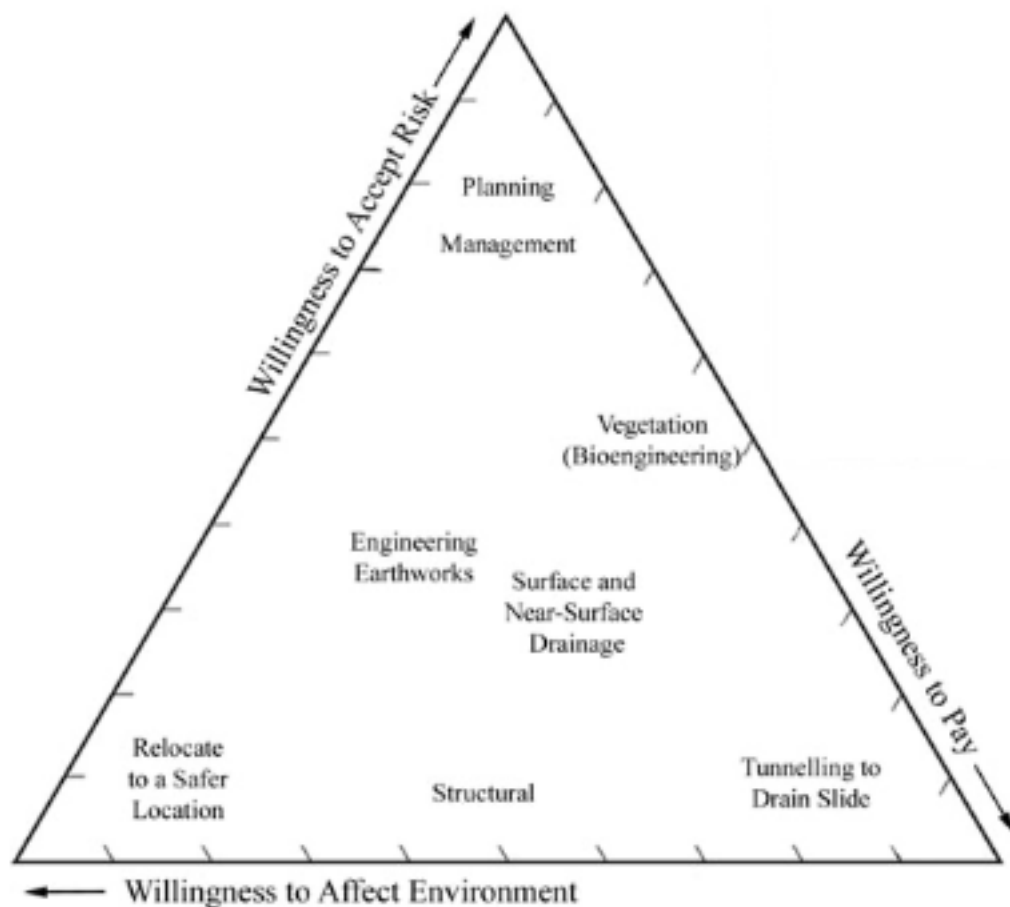
The current landslide management methods based off the research mentioned in the above paragraphs indicate the region's willingness to accept and mitigate risks. Methods that follow this approach are cheap to implement and effective when it comes to infrastructure protection, and is one of the apexes for the willingness diagram in Figure 9. The other apexes indicate either the willingness to alter the environment, or the willingness to pay. (Winter & Bromhead 2012). Options towards the willingness to pay apex are considered most appropriate for Jamberoo Mountain Road, as simply the infrastructure already exists in the landslide prone area and it is unlikely to alter the alignment of Jamberoo Mountain Road to avoid further slips.

Figure 9: The willingness diagram, comparing different methods of landslide management and remediation (Winter & Bromhead 2012)

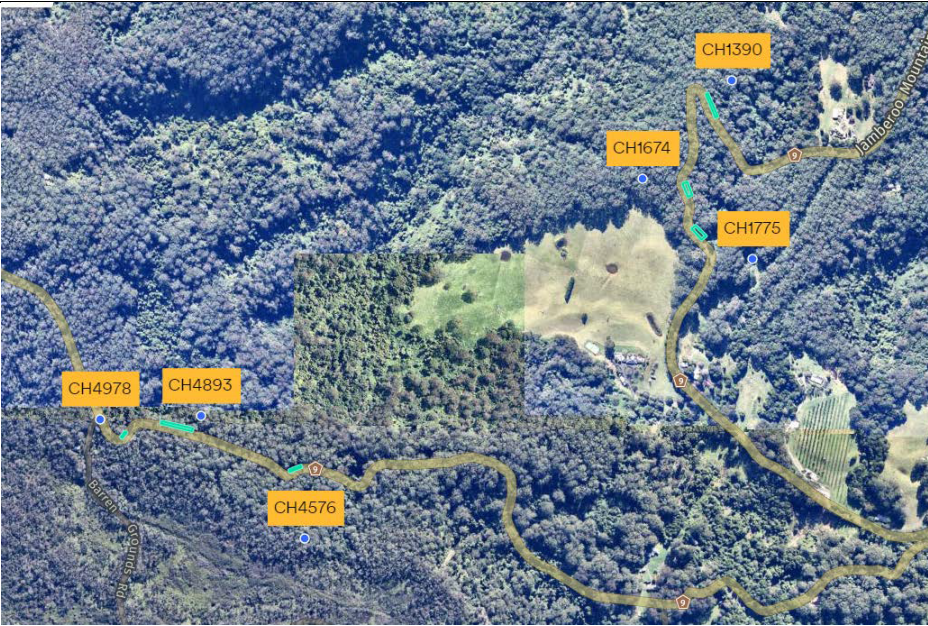
Project Name	Jamberoo Mountain Road slope stabilisation
TRIM Container and folder reference	SC3620
Brief	To stabilise 6 identified unstable sections of Jamberoo Mountain Road using soil nails to make the road more resilient to natural disasters such as rainfall events.
Location	Jamberoo Mountain Road, between Daltons Road and the Jamberoo Mountain Lookout, Jamberoo
Images

<p>Sites are identified by their chainage from Dalton Road intersection.</p>
Development Pathway	<p>State Environmental Planning Policy (Transport and Infrastructure) 2021</p> <p><b>2.109 Development permitted without consent—general.</b></p>
