Smart Condition Assessment of Tunnel Structures

A dissertation submitted by
Taylor Meerwald

in fulfilment of the requirements of
ENG4111 and ENG4112 Research Project
towards the degree of
Bachelor of Engineering (Honours) (Civil)
Submitted October 2023

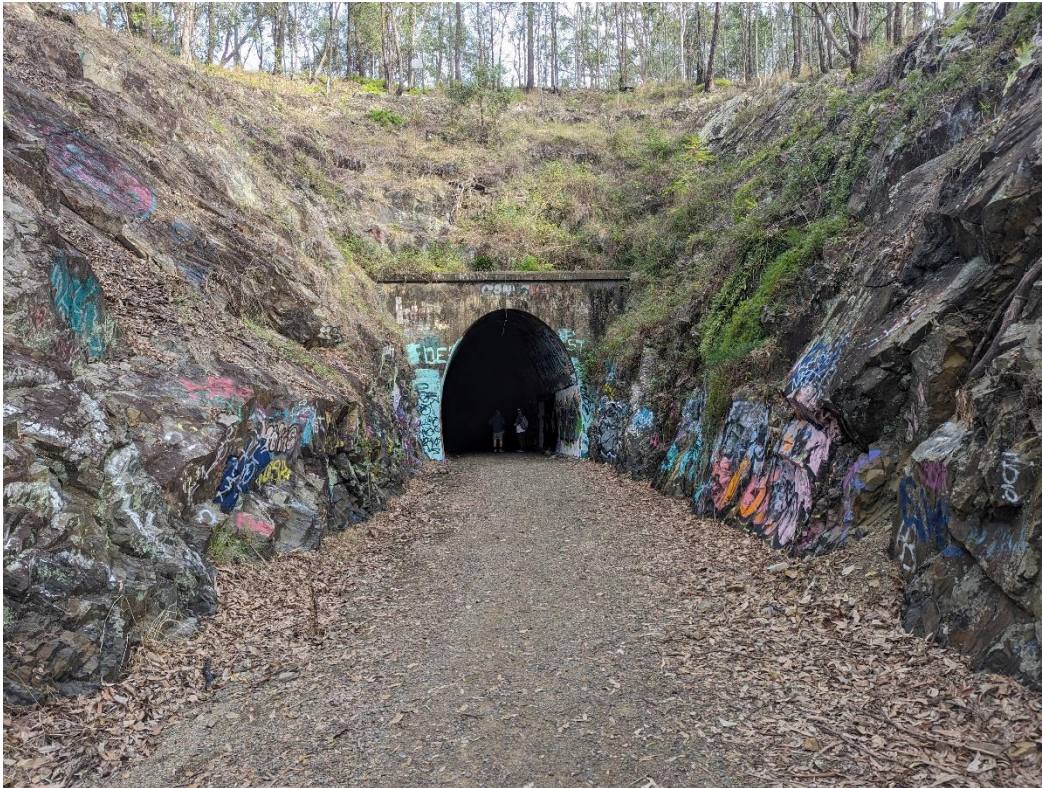
Figure 2. Ernest Junction Railway Tunnel Entrance

Data was sampled from the Ernest Junction Railway Tunnel in Molendinar, Queensland (Arts Queensland 2020). This tunnel was built between 1885-1889 (Arts Queensland 2020). It formed part of the Brisbane – South Coast rail line until it was closed in 1964 (Arts Queensland 2020). The tunnel is curved and runs for 114m long at approximately 21m under the crest of the hill (Arts Queensland 2020).

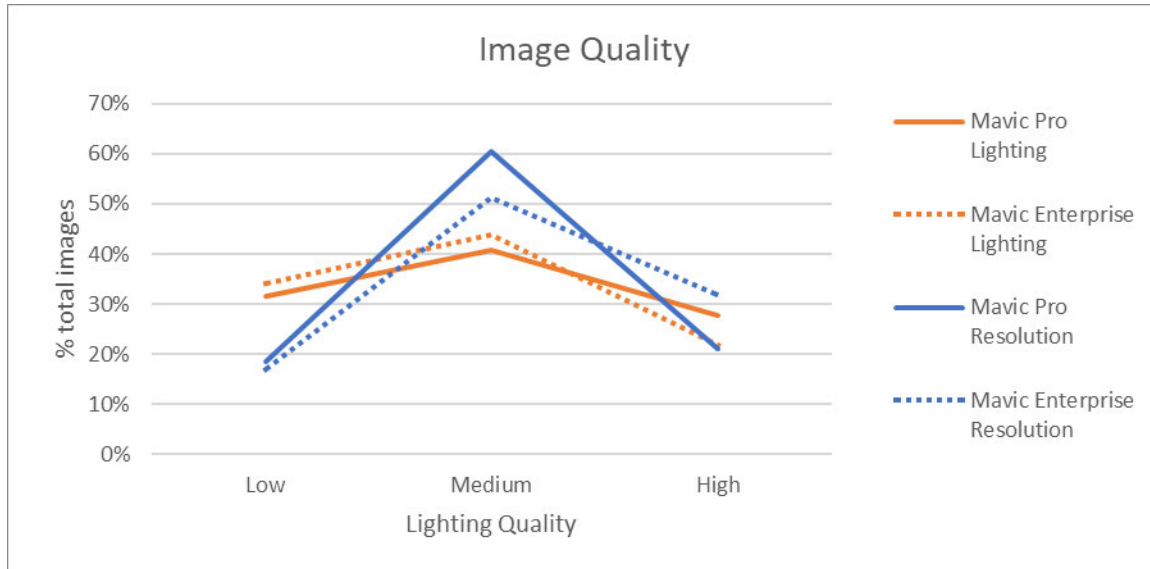
Figure 6. Distribution of Image Quality

The overall percentage of the lighting and resolution distribution was also graphed to highlight potential issues in accuracy of annotation and detection. As seen in Figure 6 below, the low and medium lighting for both models were reasonably similar. A slight decline in high lighting quality was seen in the Mavic Enterprise data set with respect to the Mavic pro dataset. This is most likely due to the number of images which were over exposed due to the brighter light and higher concentration of light in the frame. In terms of resolution, the Mavic Enterprise has a higher number of high-resolution images, which is to be expected with higher camera quality. However, it can be seen that for the medium and low-resolution images, the Mavic Pro dataset had a slightly higher number of images. Again, this is not unexpected as the difference is somewhat accounted for in the higher resolution images of the Mavic Enterprise dataset. Overall, it can be seen that resolution was largely improved in the Mavic Enterprise dataset in comparison with the Mavic Pro set. It can also be seen that the lighting did not necessarily affect the resolution quality of the images. Further information on the image quality distribution can be found in Table 2 Table 3 and Table 4 in Appendix D.

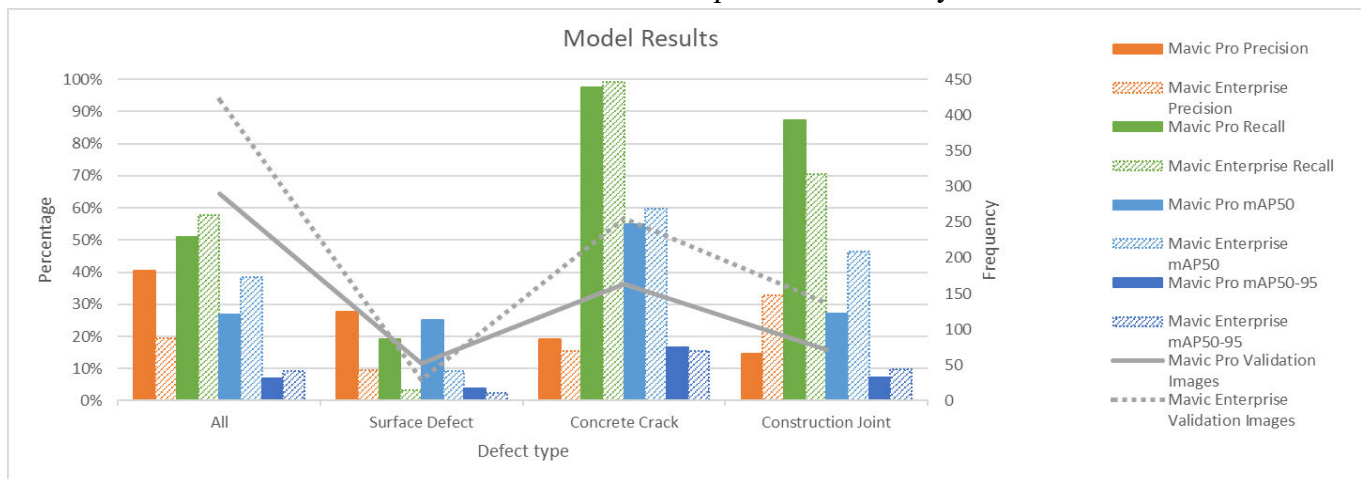
Figure 7. Model Results

The final analysis was conducted to show the number of images in each class compared to the precision, recall and mean average precision(mAP) values for different confidence intervals as shown in Figure 7. Across all classes, the Mavic Pro model showed better precision, however the Mavic Enterprise performed better in precision and mAP. The Mavic Enterprise dataset also had a larger number of validation images than the Mavic Pro dataset. From this we can infer that whilst the Mavic Pro model had a higher precision over all cases, the ability to detect defects and the confidence in these detected defects was higher in the Mavic Enterprise model.

The surface defect class was the class with the lowest instances in both models. It can be seen that the Mavic Pro dataset had slightly more images than the Mavic Enterprise dataset and this is reflected in the precision, recall and mAP statistics. Due to the small number of instances, this class is not taken into consideration for the overall performance analysis.

In the concrete crack class, the Mavic Enterprise again had a higher number of images than the Mavic Pro dataset. Similar to the overall values, the precision was lower than the Mavic Pro model but the recall and mAP at 50% confidence were higher. The mAP for confidence 50-95% was lower for the Mavic Enterprise model than the Mavic Pro model meaning that despite the larger number of images, the Mavic Enterprise model was not as accurate as the Mavic Pro model for the concrete crack class. Although, the recall being higher for the Mavic Enterprise model means that this model is more likely to detect defects.

The final class was the construction joint. As mentioned earlier, this is not so much a defect as teaching the models that crack like images with a certain degree of linearity may not be a concrete defect. The Mavic Enterprise model again had a larger number of images for this class and performed better in the precision and both mAP confidence intervals. Interestingly, it didn't perform as well in the recall which is different to most other classes in this analysis. It is unclear why this occurred as it is expected that a larger number of training examples would lead to a better ability to detect the defect. One explanation may be a confusion between the construction joint and concrete crack classes. This can be seen in the confusion matrix as both models had a large percentage of images confused for concrete cracks. This may be due to the significant difference in training images between the concrete cracks and other classes making the concrete class overfitted for the models in comparison to the other classes.

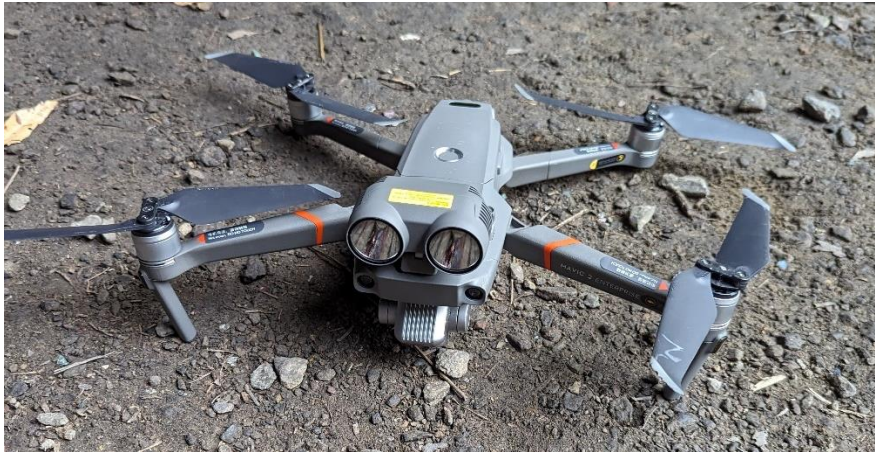
Figure 8. Mavic 2 Enterprise Advanced with spotlight attached at tunnel site

spotlight has an 11 lux rating at 30m. A photo of this setup is included in Appendix A Figure 8. The Mavic 2 Enterprise Advanced with spotlight attached at tunnel site Figure 8. The Mavic 2 Enterprise was manually controlled with the assistance of the onboard guidance system to prevent collisions. The height and distance from the wall were relatively consistent given the manual operation.

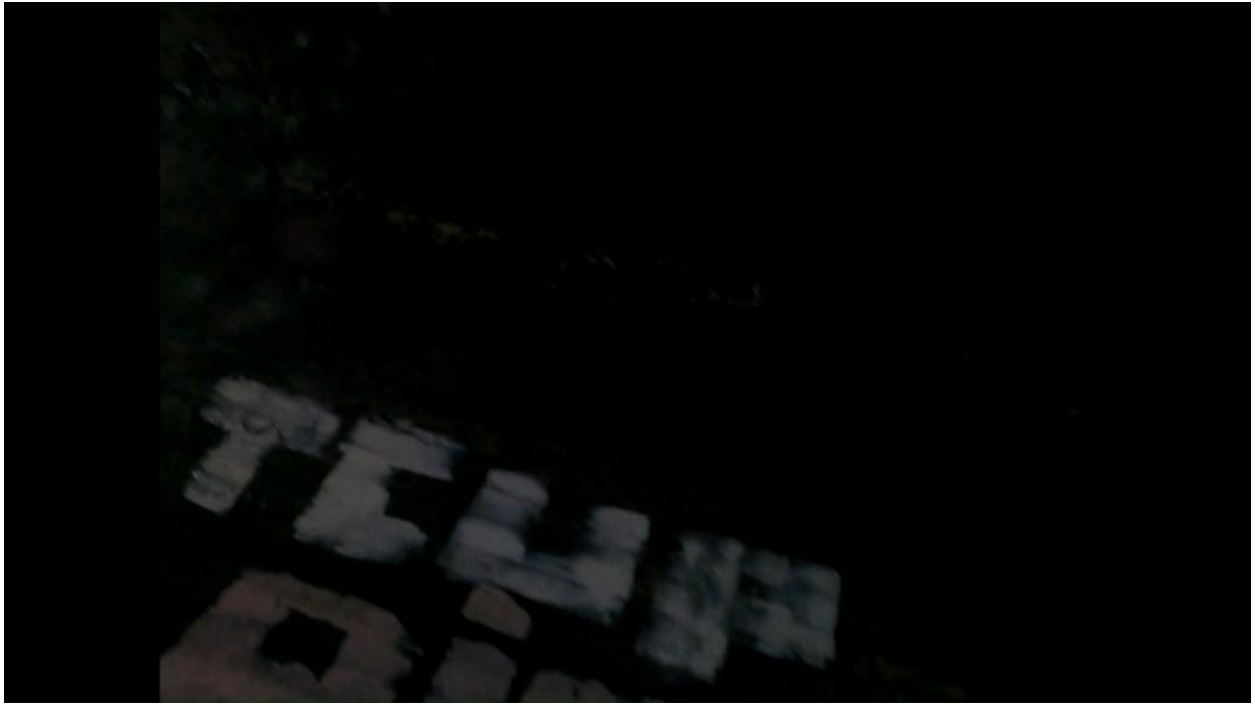
Figure 11. Example of low resolution, low lighting image

The program also allows the user to apply tags to images. Each image was tagged with a resolution and lighting quality of either low, medium, or high. Although this is a subjective criterion, there was only one annotator so any bias would remain reasonably consistent. Lighting quality was judged based on the percentage of the image that was not visible due to over or under exposure as well as the amount of manipulation required for brightness and contrast. For example, an image with more than 75% not visible or requiring the maximum brightness would be classed as having low lighting quality whereas an image which requires little to no change in the brightness and contrast settings and over 90% of the image is visible would be classed as having high lighting quality. Resolution quality was based on the clearness of defects in the entire image and when the image was enlarged. A low-resolution image was one which was blurry prior to enlarging. Medium resolution was classed as an image which was visible prior to enlargement but became blurry and difficult to read when enlarging. A high-resolution image was one that was still reasonably clear when enlarged. It is important to note that the amount of enlargement also affects how blurry the pixels of an image may become. As with the tagging of image quality, the enlargement was not entirely consistent, however every effort was made to enlarge to similar dimensions when looking for smaller defects. Examples of the image tagging can be found in Appendix B.

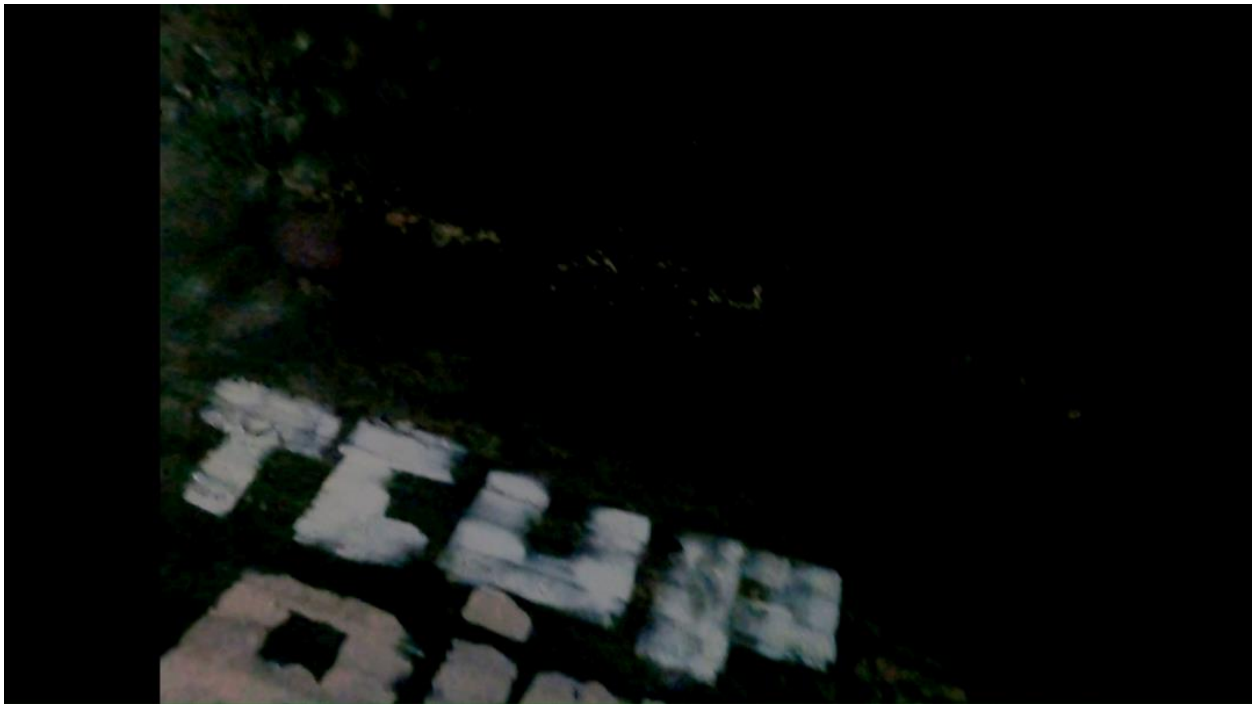
Figure 12. Example of low resolution, low lighting image with -20% contrast and +40% brightness

Once all of the images were labelled, the final dataset could be generated. Firstly, the labelled images were split into the training, validation and testing sets at a ratio of 70:20:10. A number of pre-processing steps were then completed including “auto-orientate”, “isolate objects”, “resize” and “auto-adjust contrast”. “Isolate objects” was chosen to allow for a larger dataset for training than there would be if an entire annotated image was used. This also allows the model to become familiar with looking for patterns in the defects rather than patterns in the image as a whole. “Resize” was chosen to ensure consistent image sizes and “auto-adjust contrast” was used to optimize the lighting, especially in those images with low lighting quality. The images were then augmented to increase the number of examples and help the model to look for different variations of the same defect. The augmentations steps included “90° rotate”, “blur” and “noise”. “90° rotate” rotated the images by 90° in clockwise and anti-clockwise directions and was chosen to ensure the model could identify different orientations of each defect type. “Blur” created a Gaussian blur of up to 2.5pixel to increase the model’s ability to detect defects in lower quality resolutions. “Noise” introduces a combination of black and white pixels at a 5% ratio to the entire image to also aid in the detection of defects in lower quality resolutions. Once the pre-processing and augmentation was complete, the images could be exported in a YOLOv5 Pytorch format. The zip file for the images was then added to a Google Drive so it could be accessed by the training program. Examples of the program can be seen in Appendix B.

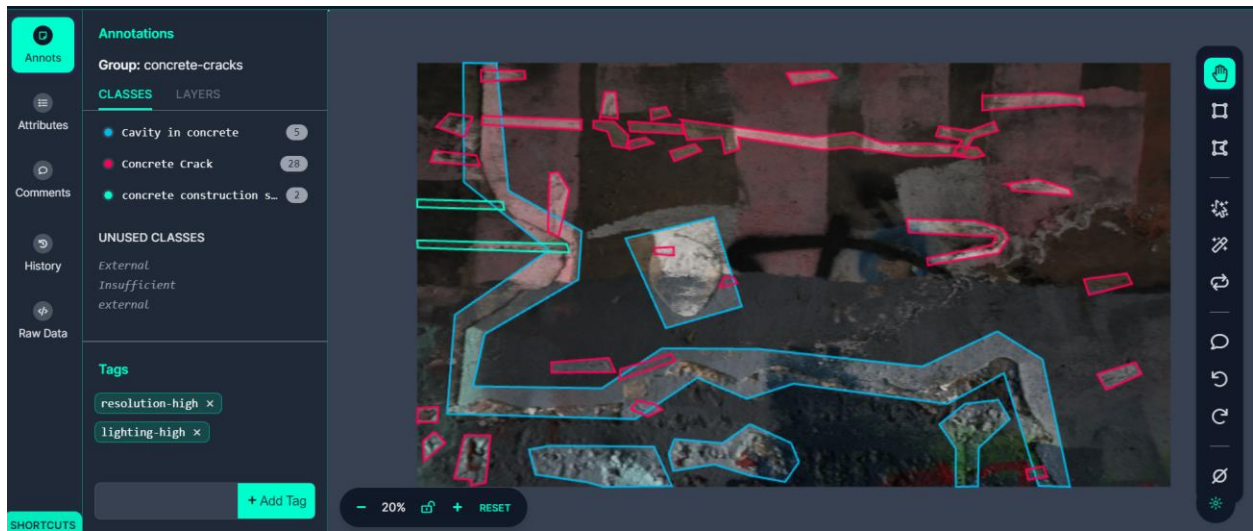
Figure 15. Example of annotated image in Roboflow

The video files were uploaded to Roboflow and images were extracted at a rate of 1 frame per second for both datasets. The project type was object detection to allow annotation and exporting of the images in the required file type for the model training. Roboflow allows you to change the brightness and contrast of an image and enlarge an image as required to place a square or polygon bounding box. Polygon bounding boxes were used in this project due to the complex nature of concrete cracks and to ensure that each bounding box was placed as close to the defect as possible. Each bounding box is then added to a class. The classes used were concrete crack, surface defect and construction joint. Concrete crack defects included a range of different cracks including horizontal, diagonal and spalling. These cracks were not separated in this study due to the difficulty in maintaining context of the direction of the crack, especially on the roof of the tunnel. Spalling was included with singular cracks due to the limited number of instances in the obtained images. A surface defect included areas of delamination, honeycombing or pitting in the concrete surface. Whilst a construction joint is not a defect, this class was necessary as there were many joints in the surface from the time of construction which could be confused with a concrete crack. Hence this class was included to prevent false prediction of a crack where an intended joint was located. This class will still be referred to as a defect in this report due to ease of reporting. There were two other classes that were added to some images but not included in the analysis due to irrelevance to the project aims and small number of instances; “insufficient” for areas of an image that were over or under exposed and “external” for areas outside of the tunnel. Examples of the image annotation and Roboflow program can be found in Appendix B.
