University of Southern Queensland
Faculty of Health, Engineering and Sciences

Impact Behaviour of Concrete Seawalls Reinforced with Different GFRP Bar Diameters

ENG4111/ENG4112 Research Project

Bachelor of Engineering (Honours)(Civil)

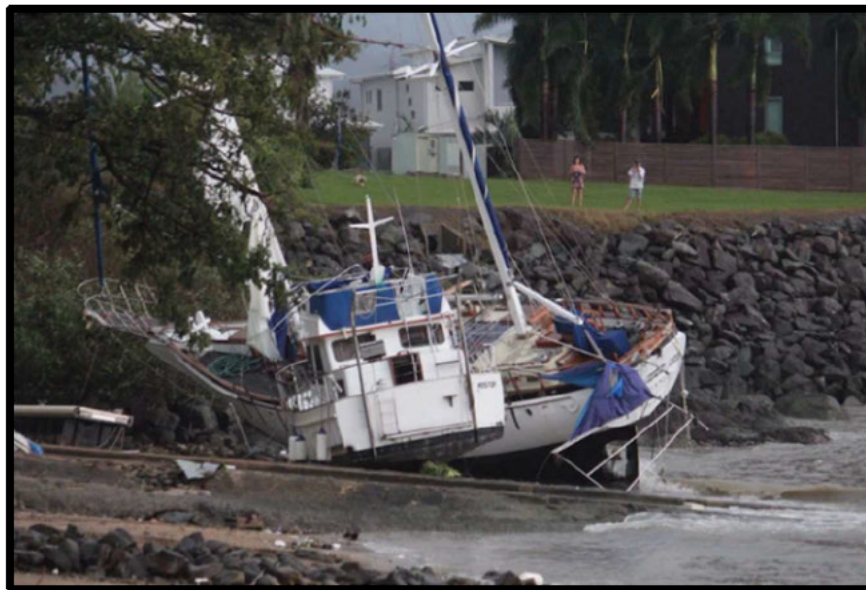
Figure 1.1: Effects of Cyclone Debbie at Abel Point Marina (ABC News 2017)

In 2017, the Northern Queensland region experienced the devastating effects of Cyclone Debbie. Various vessels and debris washed into Shute Harbour and Abel Point Marina in Airlie Beach, causing substantial amount of damage to the protective structures along the shoreline (ABC News 2017).

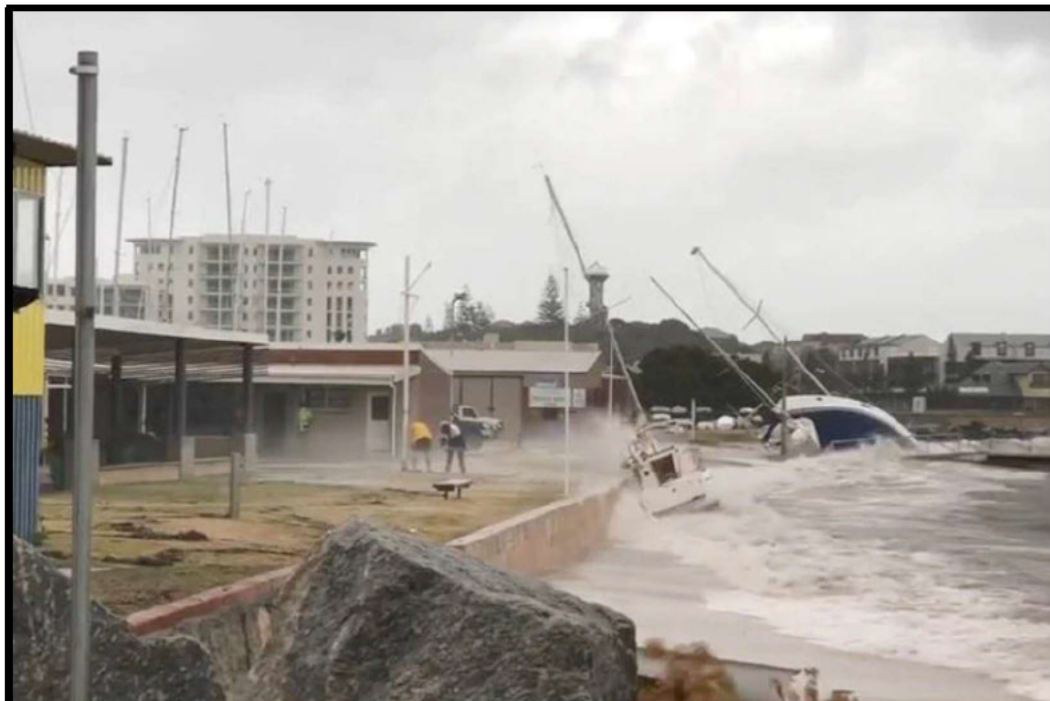
Figure 1.3 Yachts piles up at Koombana Bay Sailing Club (ABC News 2018)

The following year in 2018, the Western Australian coastline witnessed the devastating results of an extreme weather event where during a surge in tidal waves, multiple yachts broke from their mooring's. The loose yachts piled onto the shoreline at Bunbury's Koombana Bay Sailing Club (ABC News 2018).

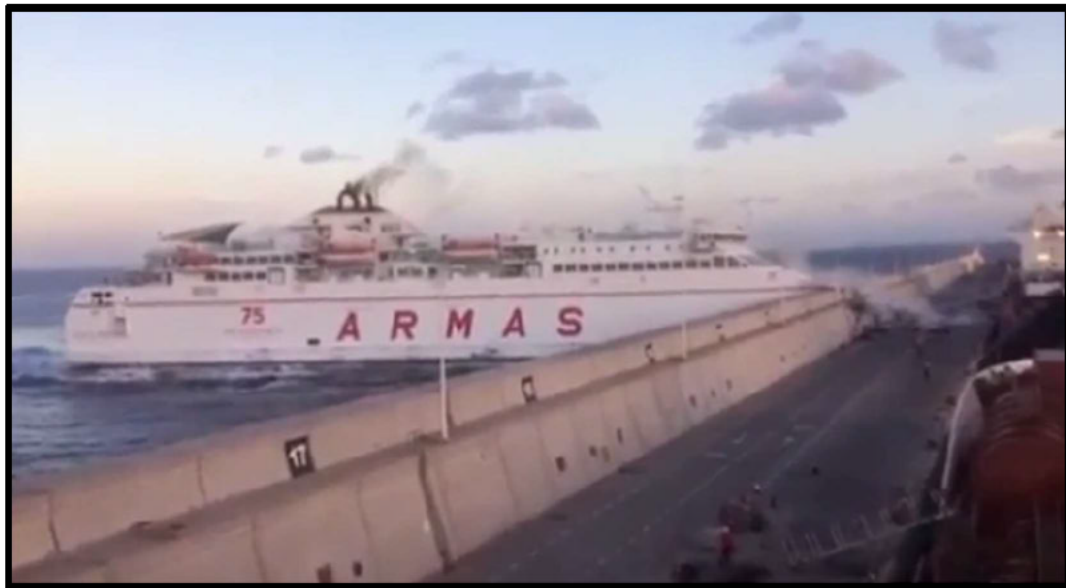
Figure 1.4: Ferry Crash in Canary Islands (The Sun 2017)

To illustrate the extent of damage a vessel can inflict on a seawall is the 2017 case of a ferry crashing into a seawall in the Canary Islands which ultimately led to a three-kilometre oil slick.

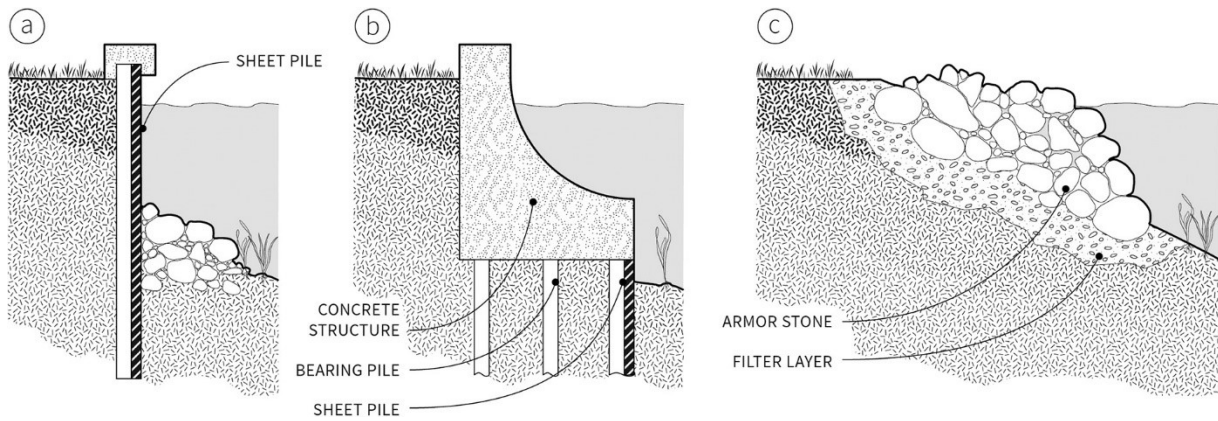
Figure 2.1: Designs for Coastal Protection: a) Vertical Seawall, b) Curved Seawall, c) Riprap (Hosseinzadeh et al 2022)

According to Hosseinzadeh et al. (2022), when it comes to selecting the correct seawall design for locations subjected to high wave surges and harsh wave conditions, the vertical seawall design (Figure 2.1 (a)) is optimal. Due to the vertical face, structure weight and friction created from the underlying surfaces, vertical seawalls are a trusted and stable protective solution that effectively counteracts the horizontal impact forces inflicted from waves and debris (Hosseinzadeh et al. 2022).

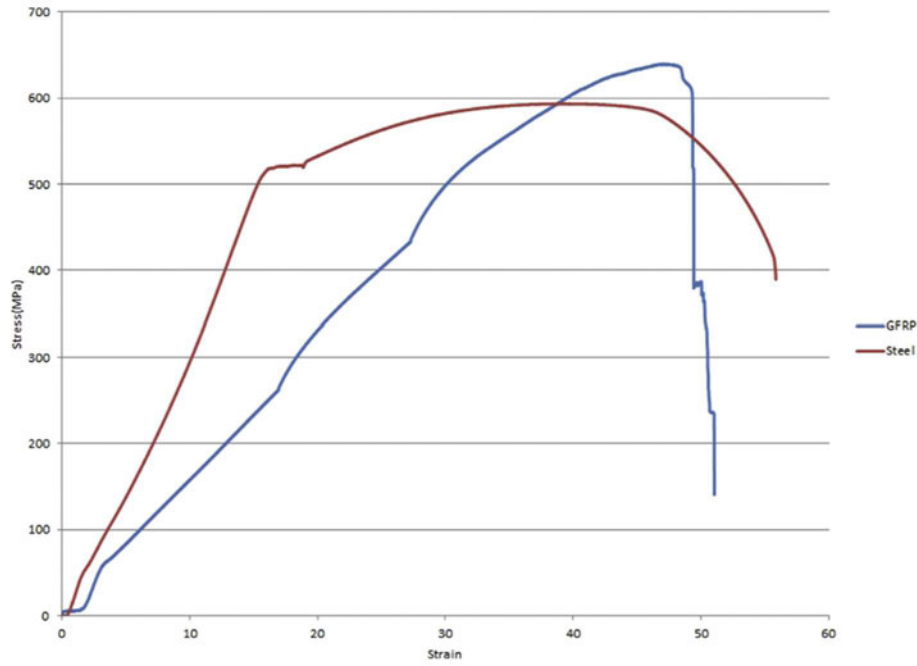
Figure 2.2: Tensile Stress-Strain Curve of GFRP & Steel Bars (Jabbar & Farid 2018)

A study completed by Jabbar and Farid (2018) applied the mechanical characterisations of GFRP reinforced concrete and compared it with that of steel bars. The investigation revealed that up until the yield point, the steel performs with a linear-elastic relationship, where it continues to deform while maintaining strength. The GFRP resulted in a higher yield strength than the traditional steel, however, unlike the steel, the GFRP bar loses strength at the point of yield (Jabbar & Farid 2018). These behaviour of the GFRP and steel is depicted in Figure 2.2.

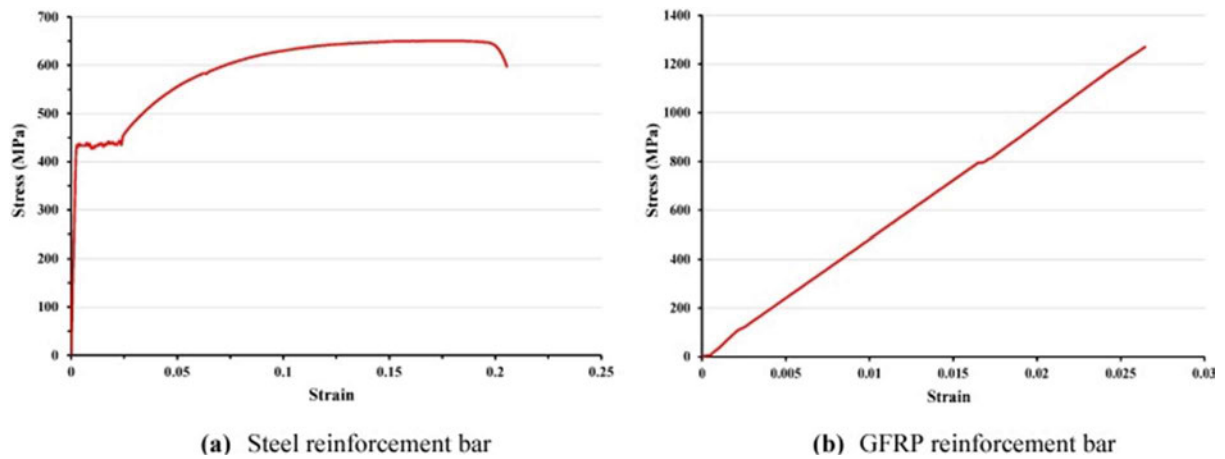
Figure 2.3: Comparison of Axial Tension Results of Steel & GFRP Reinforcement (Sadraie et al. 2019)

Likewise, a study completed by Sadraie et al. (2019) involved undertaking axial tension tests on 8mm diameter steel and GFRP reinforcements and revealed similar results to Jabbar and Farid (2018). As shown in figure Figure 2.3, the steel continues to deform while maintaining strength whereas the GFRP in comparison loses strength at the point of yield.

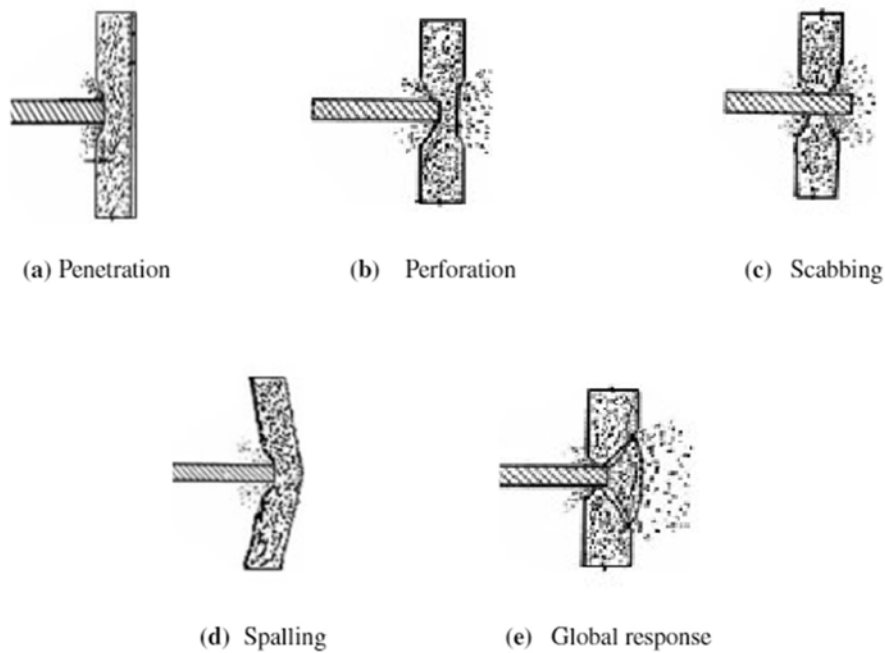
Figure 2.4: Different Forms of Impact Damage (Bangash 1993)

- (a) Penetration: This pertains to the measurement of the depth of the resulting crater in the target material (Figure 2.4 (a)).
- (b) Perforation: This entails the complete penetration of the target material by the impacting object, either with or without exit velocity (Figure 2.4 (b)).
- (c) Scabbing: This describes the expulsion of fragments from the opposite face of the target material upon impact (Figure 2.4 (c)).
- (d) Spalling: This denotes the expulsion of material from the impacted face of the target (Figure 2.4 (d)).
- (e) Global Response: This refers to the structural behaviour involving global bending, shear, and membrane action, as well as the changing mode of failure in concrete slabs (Figure 2.4 (e)).

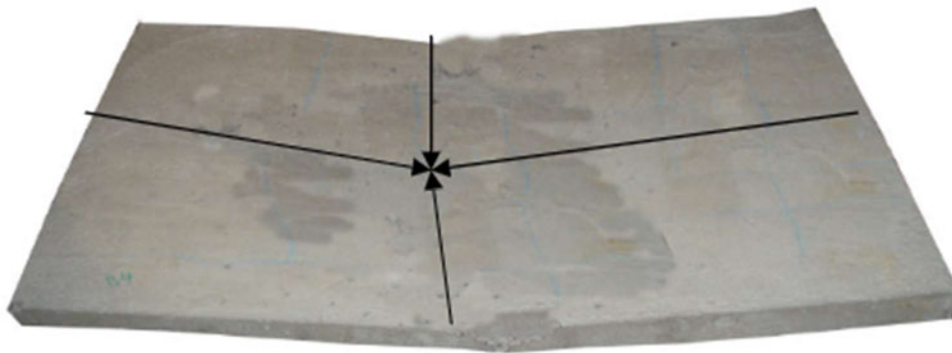
- Flexural mode: as shown in Figure 2.5 below, this failure mode involves cracking in the tensile zone and yielding steel (Tahmasebina 2011).

Figure 2.5: Flexural Mode

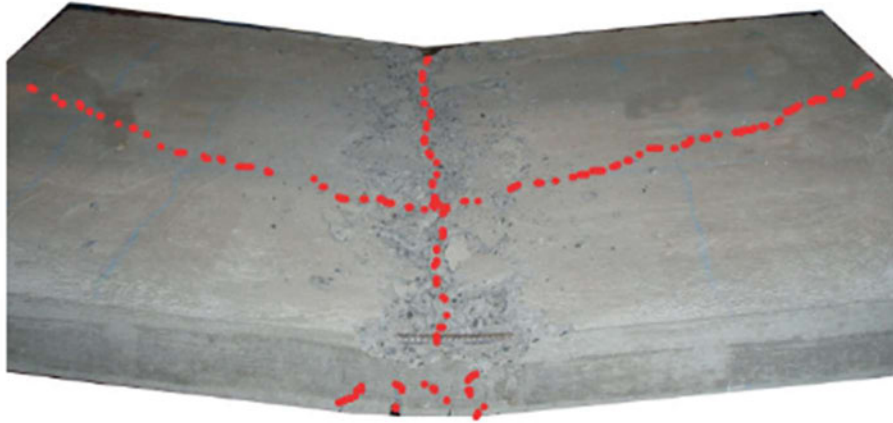
- Ductile Shear: this failure mode entails cracking in the tensile zone, crushing in the compressive region and yielding steel (Figure 2.6) (Tahmasebina 2011).

Figure 2.6: Ductile Shear

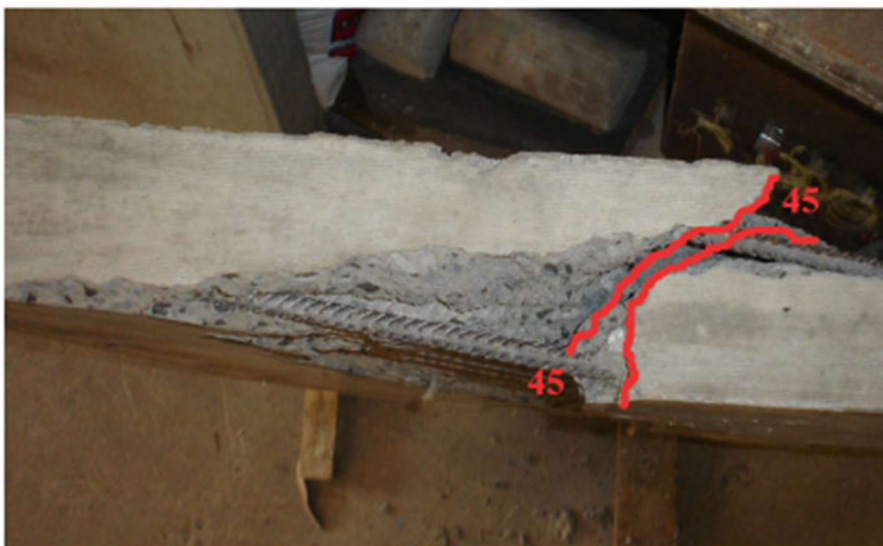
- Shear Failure: as demonstrated in Figure 2.7 below, this concept involves shear failure as 45° angles (Tahmasebina 2011).

Figure 2.7: Shear Failure

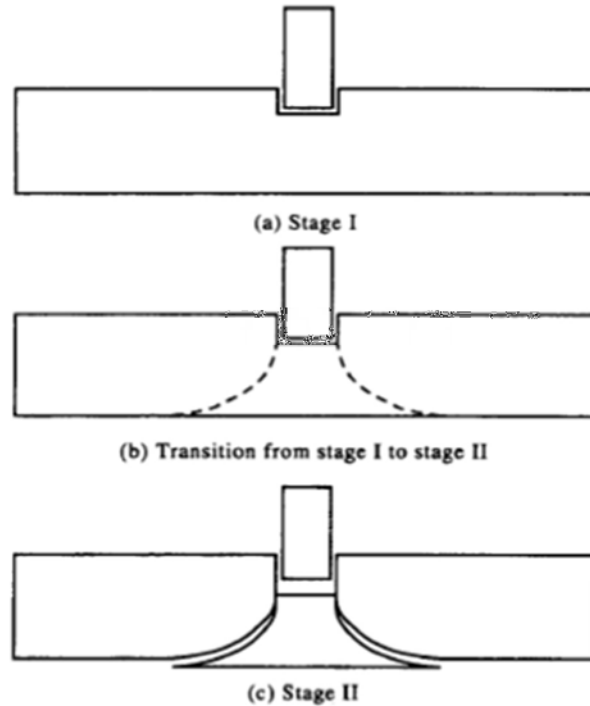
Figure 2.9: Perforation and Shear Punching Transition (Yankelevsky 1997)

Yankelevsky (1996) undertook a theoretical study with a primary focus on perforation and shear punching. The investigation encompassed two key phases which outlined the progression of a target being impacted and it leading to the development of punching shear as visualised in Figure 2.9.

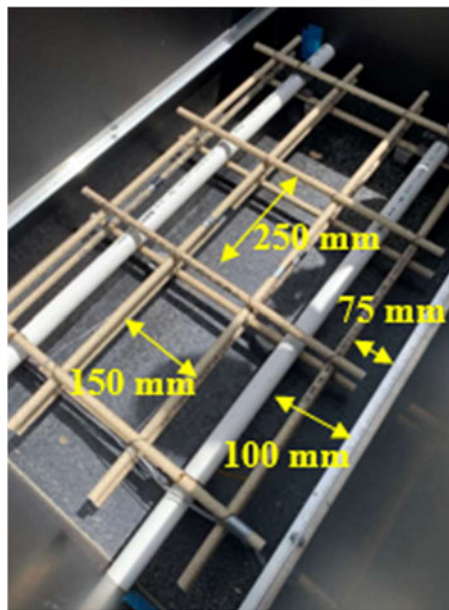
Figure 3.1: Test Slab Internal Reinforcement Configuration

A rectangular concrete slab from the UniSQ Centre for Future Materials (CFM) building was used as the preliminary test sample. The slab consisted of 12.7mm diameter GFRP bars with 30mm of cover. The internal reinforcement configuration is depicted in Figure 3.1.

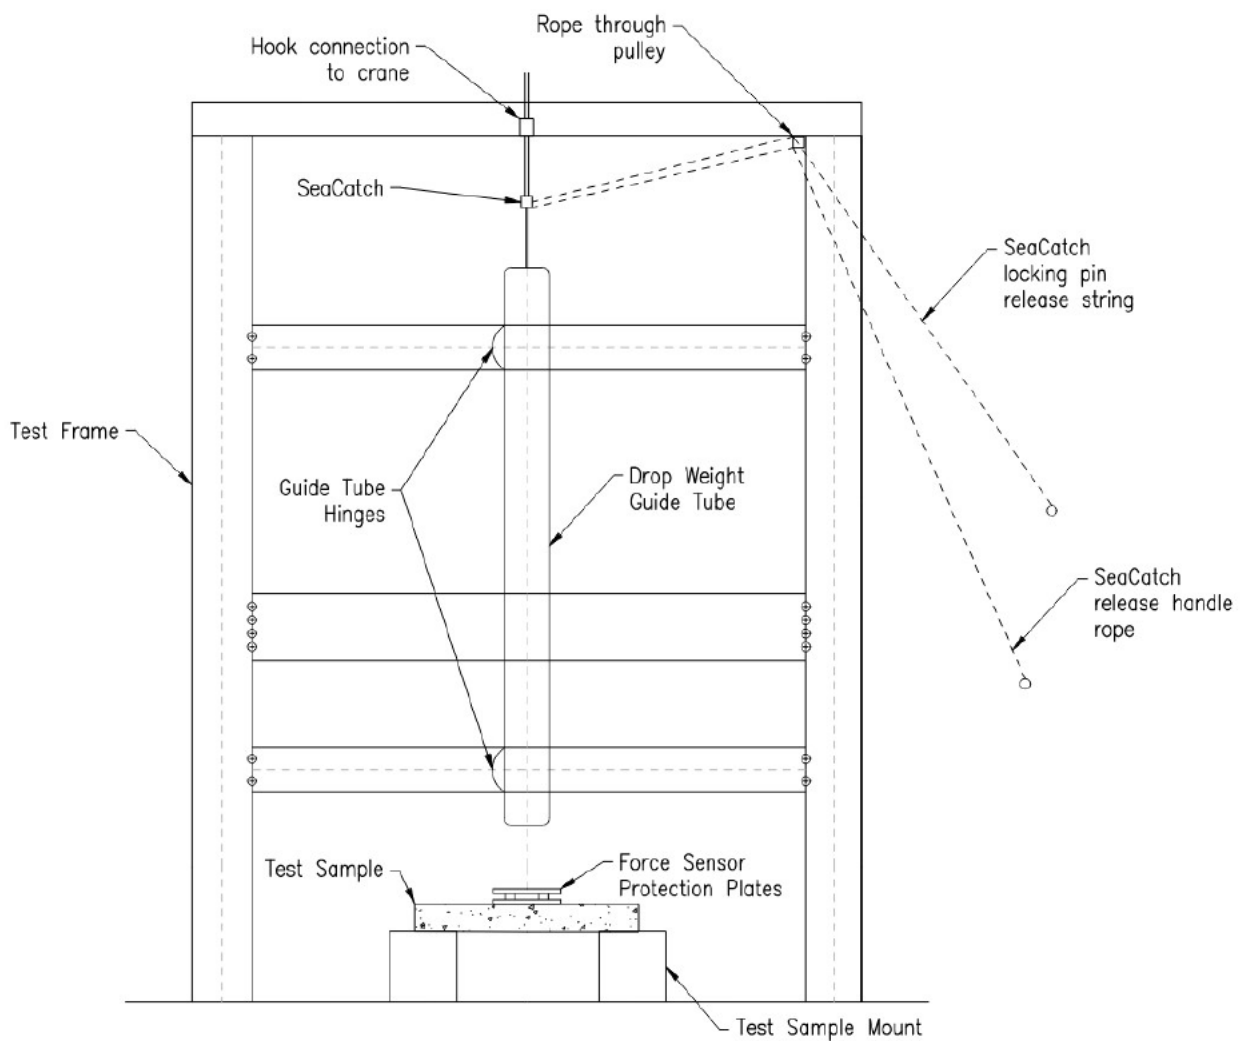
Figure 3.2: Theoretical Test Setup

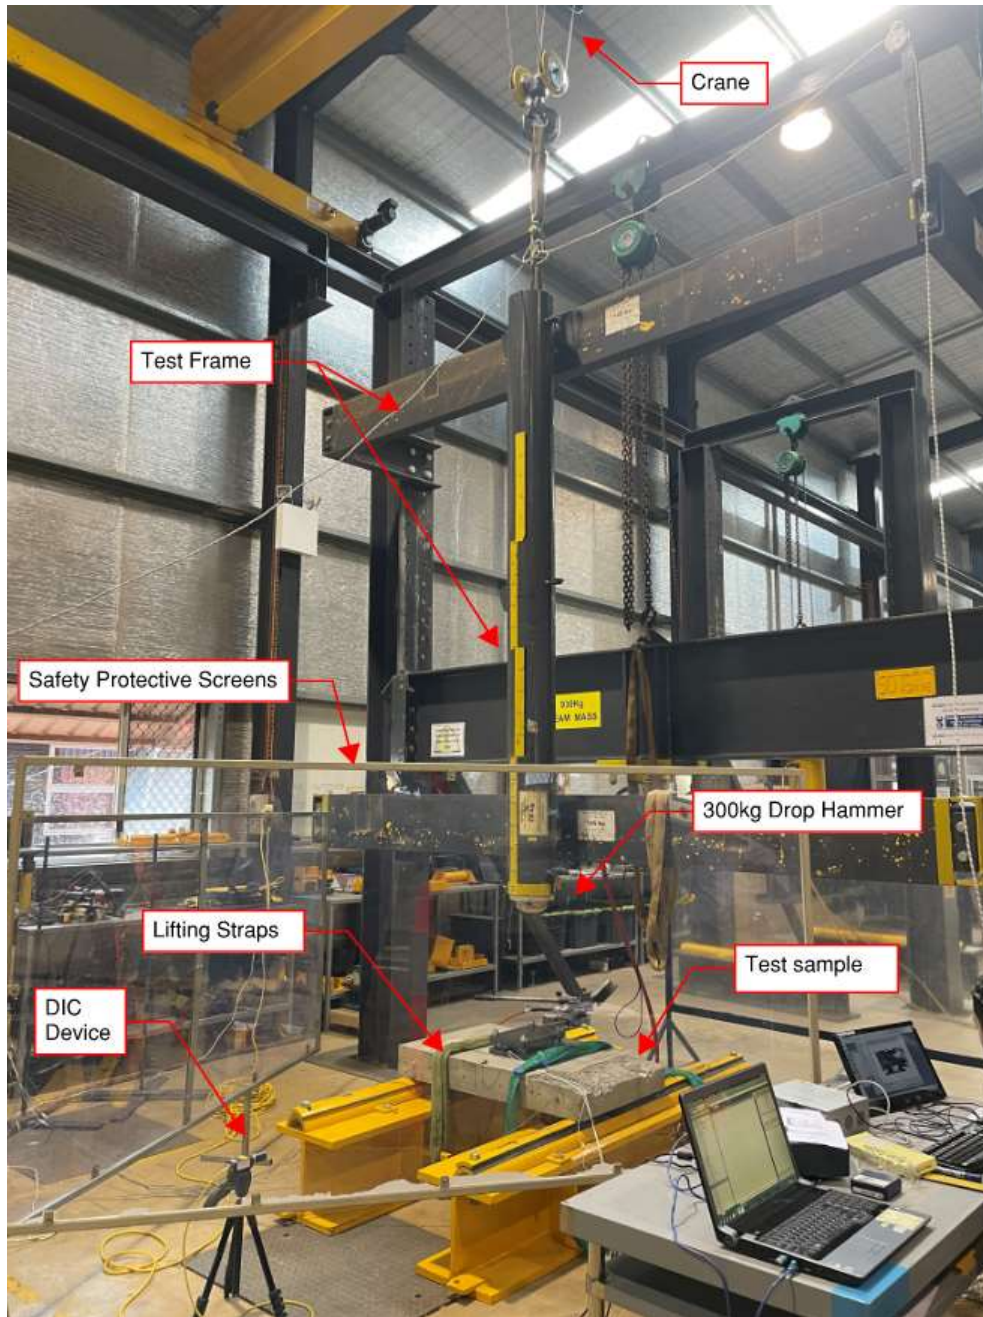
Figure 3.3: Preliminary Test Setup

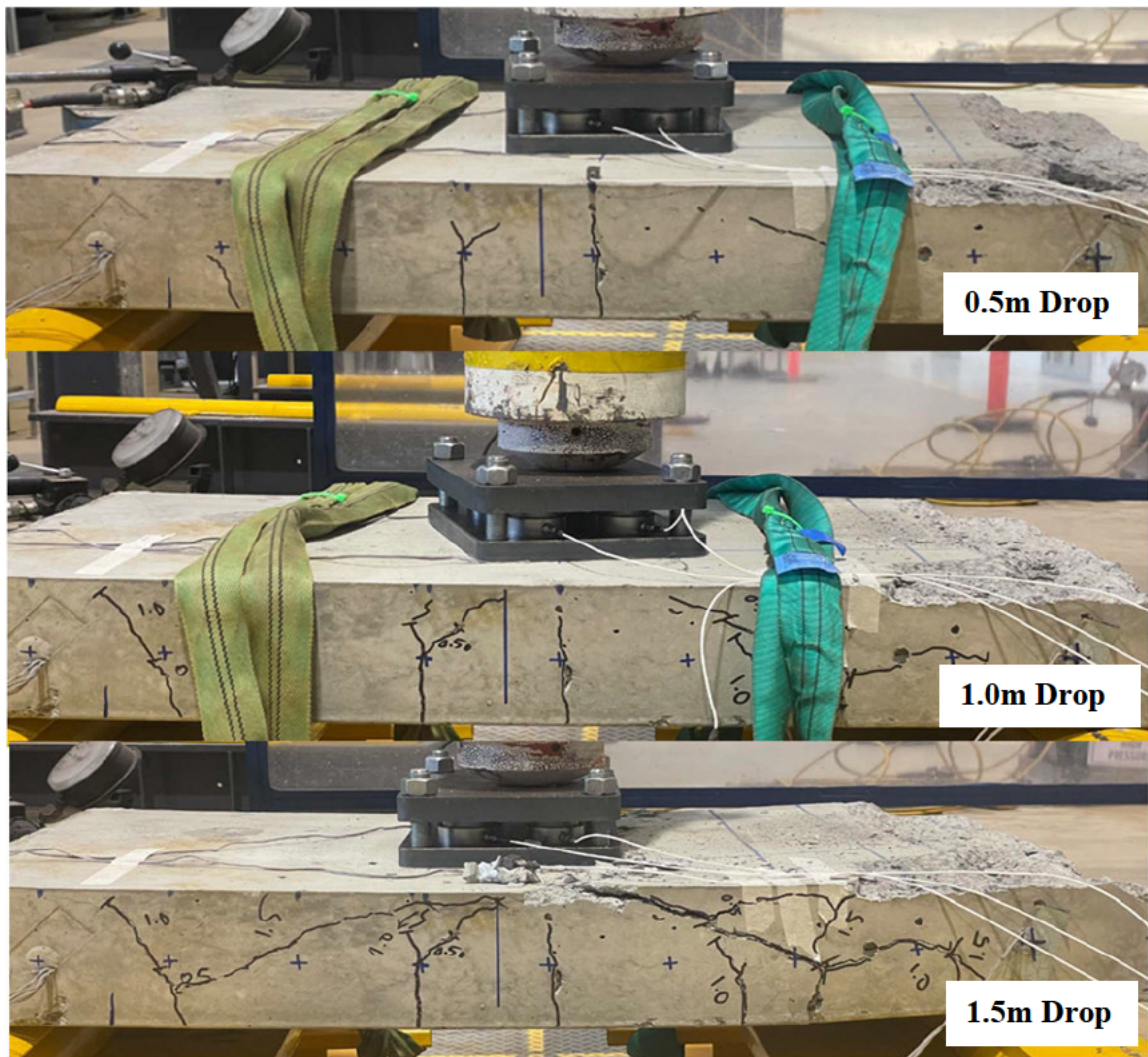
Non-destructive testing observations were completed to evaluate the response of the concrete slab under the impact of a drop weight from three different heights. As illustrated in Figure 3.4, the slab displayed minor tensile cracking following the impact of the 0.5m drop. Subsequent to the 1.0m drop, a notable increase in tensile cracking was observed, accompanied by slight indications of shear failure. Upon experiencing the 1.5m drop, the slab displayed extensive cracking within the tensile zone, crushing in the compressive region, and obvious deformation, indicating the yielding of the reinforcement. Closer scrutiny revealed apparent spalling on the top face. After the drop-test was completed, the slab was raised for removal and a thorough examination of the bottom face was conducted which revealed signs of punching shear and localised failure (Figure 3.5).

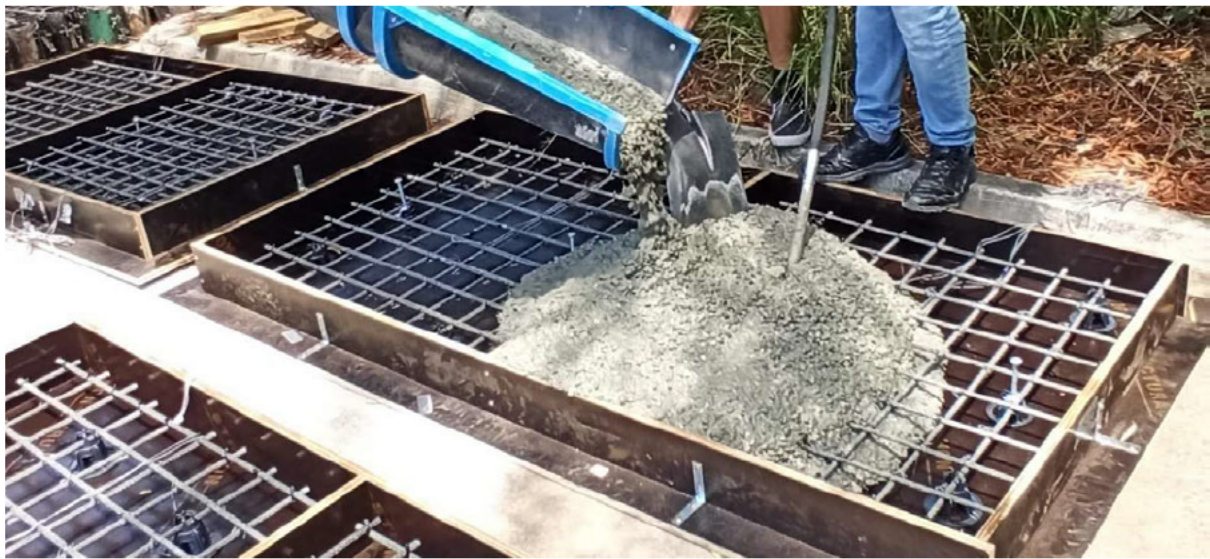
Figure 4.1: Slab Preparation at Beyond Materials Group

The concrete slabs to be evaluated in this research project were prepared and casted by Beyond Materials Group (refer to Figure 4.1). The configuration of each specimen began with first setting up the formwork and arranging each specimen with the correct reinforcement as per the details specified in Table 4.1. Four strain gauges were then attached to the reinforcement bars using adhesive. Once in position, to protect the gauges from moisture and aggregates within the cement mixture, each sensor was wrapped with tape. Concrete was then poured into each mould and was thoroughly vibrated to expel any trapped air and to optimise the density of the concrete. To achieve a finishing smooth and level surface, the cement was hand screeded. The slabs were then left for 28 days to achieve the design strength.

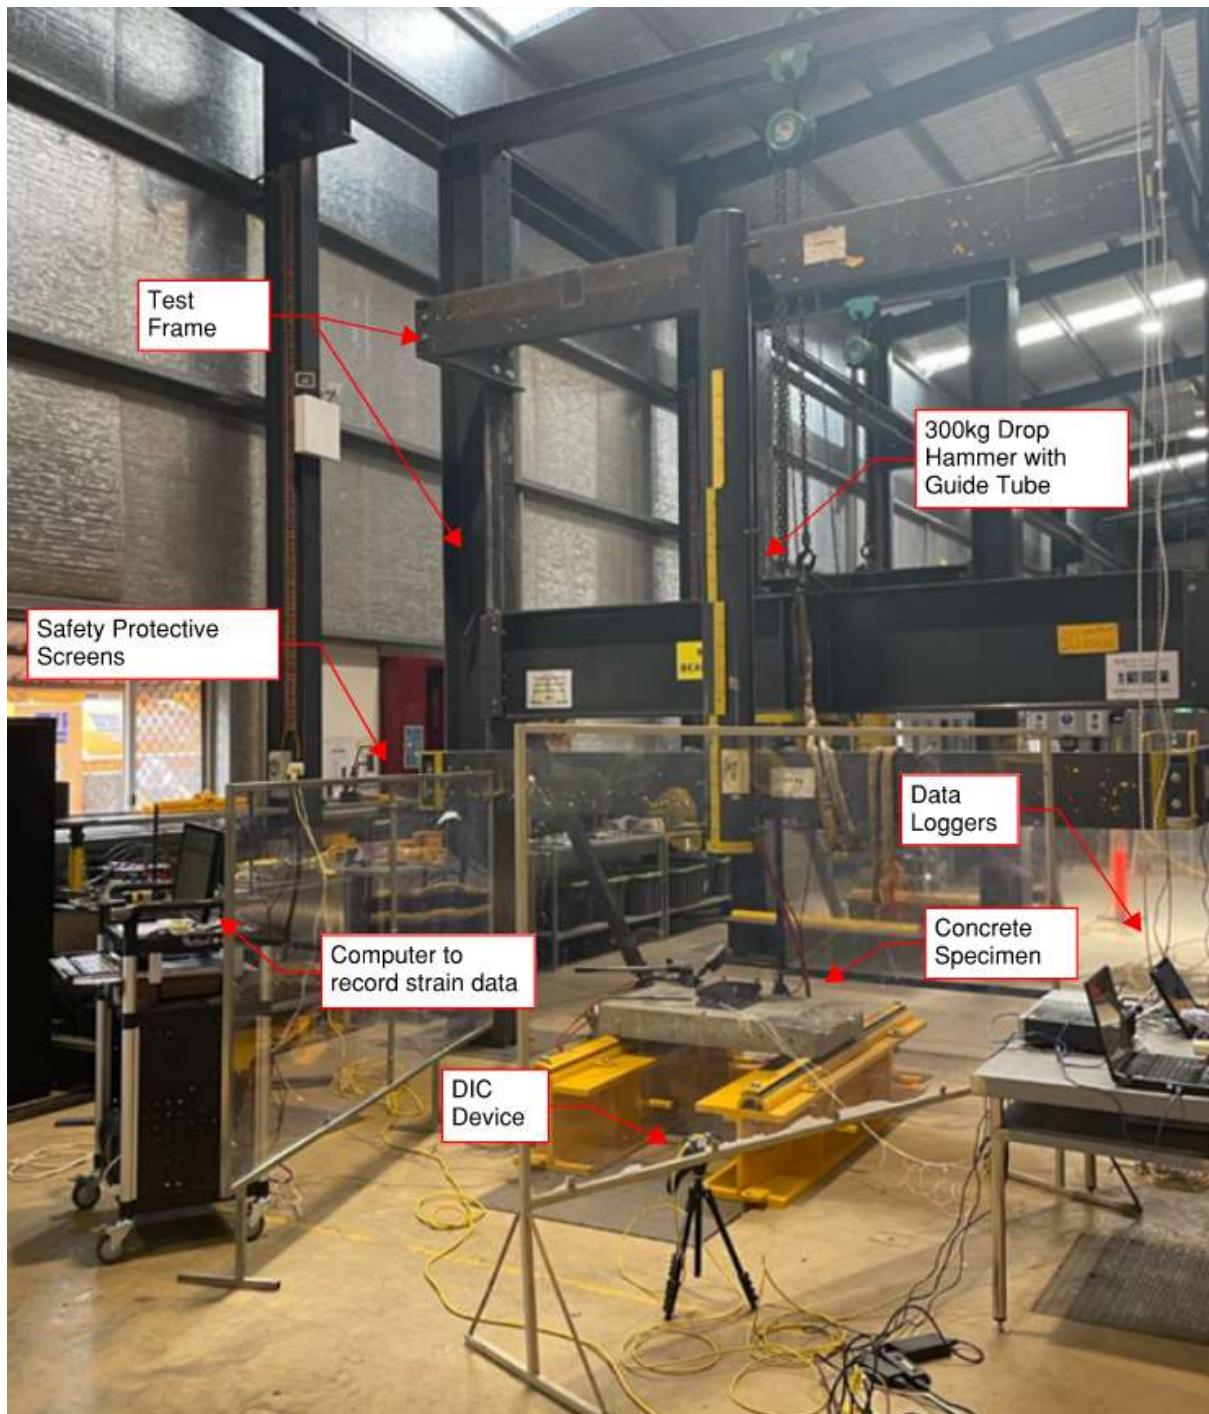
Figure 4.2: Official Testing Setup

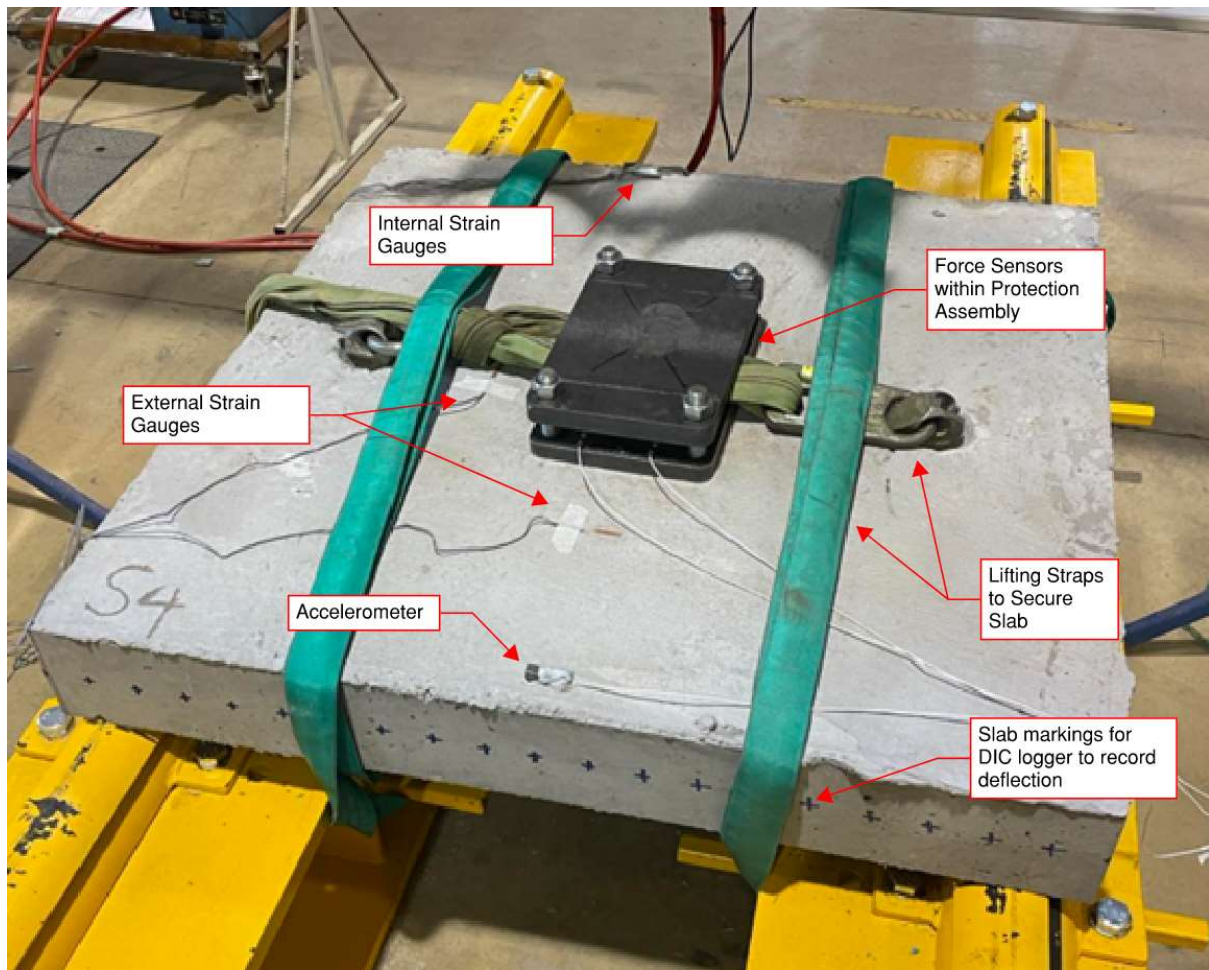
Figure 4.3: Slab Recording Equipment Setup

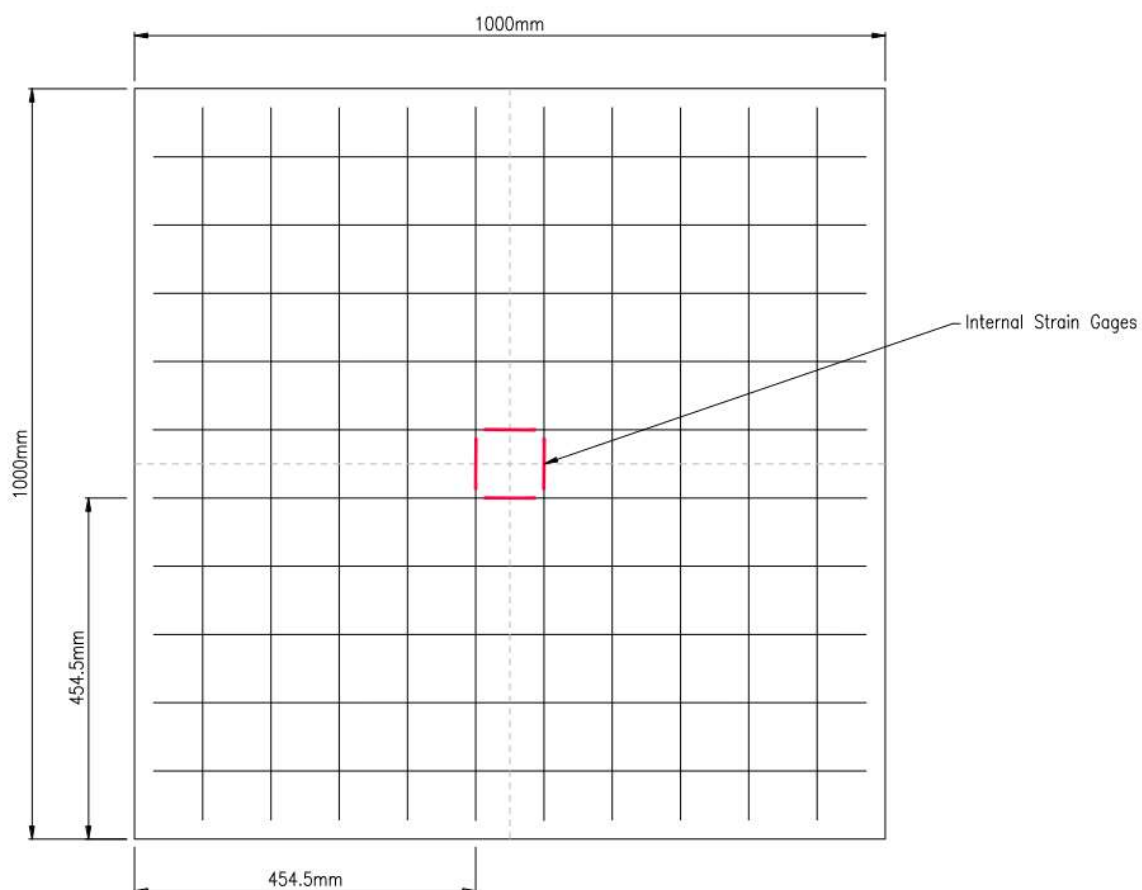
Figure 4.4: Internal Strain Gauge Locations

Four strain gauges were attached to the internal reinforcement before the slabs were casted (Figure 4.4). Another two strain gauges were attached using super glue to the compression side of the concrete slab as illustrated in Figure 4.3. The aim of the internal strain gauges was to assess the strain behaviour of the reinforcement when subjected to the impact load whereas the external devices were employed to assess the strain behaviour on the compressive side of the concrete specimens.

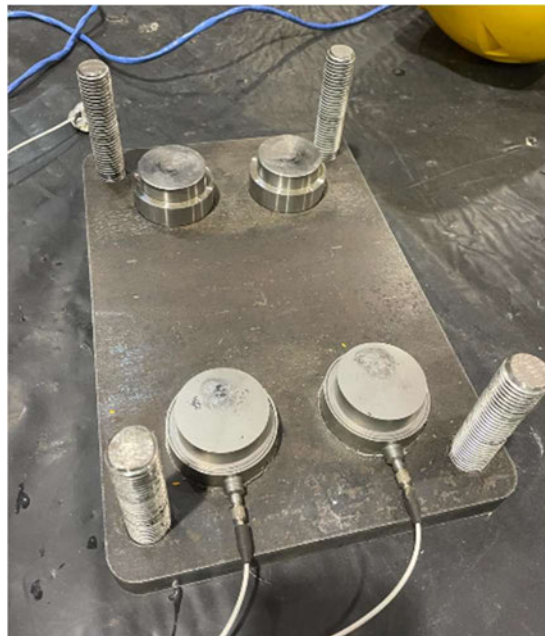
Figure 4.5: Force Sensors and Protection Assembly

For this experiment, two force sensors were utilised, however they were placed within a protective plate assembly as they were required to be reused with every test. The assembly consisted of a base plate where the force sensors were placed, then a protective plate which was screwed into place to ensure it was resting securely on top of the sensors. This required the development of two “fake” sensors to balance the plate and spread the impact force evenly (Figure 4.5).

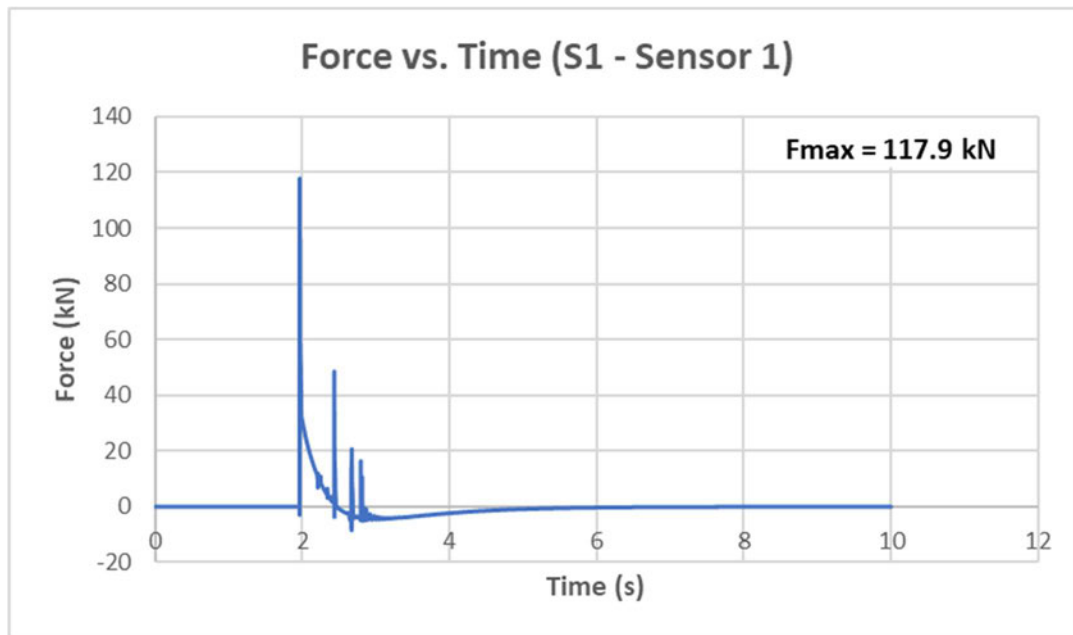
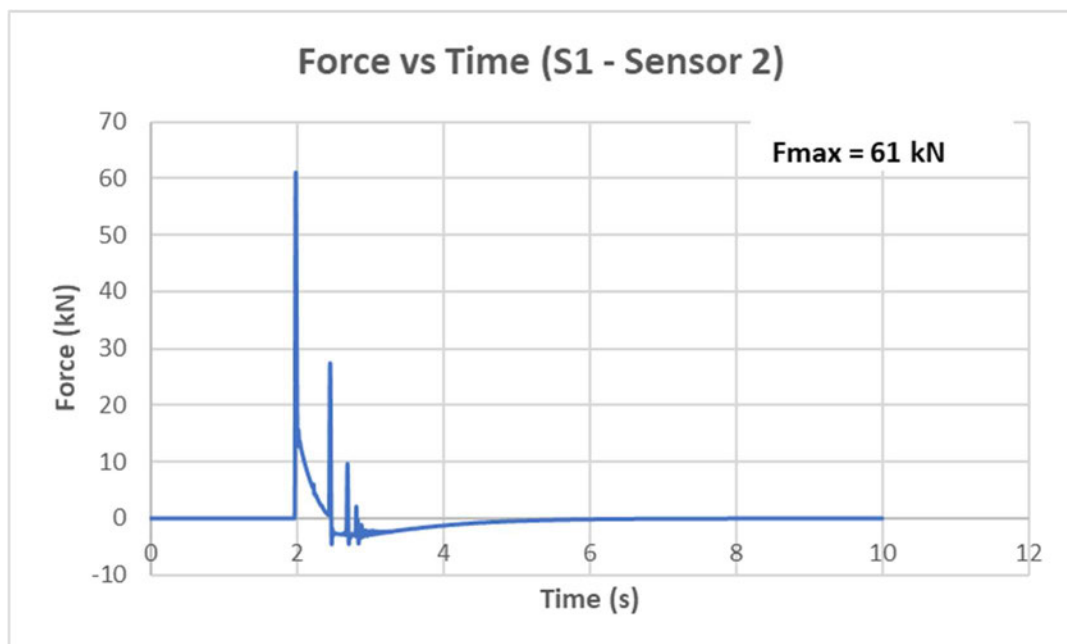
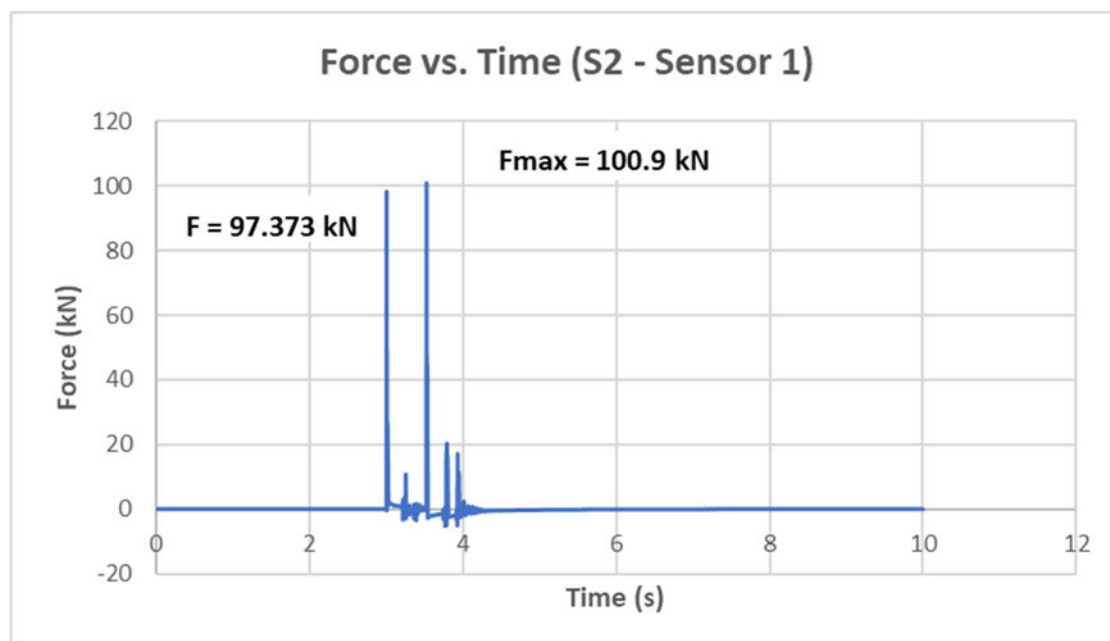
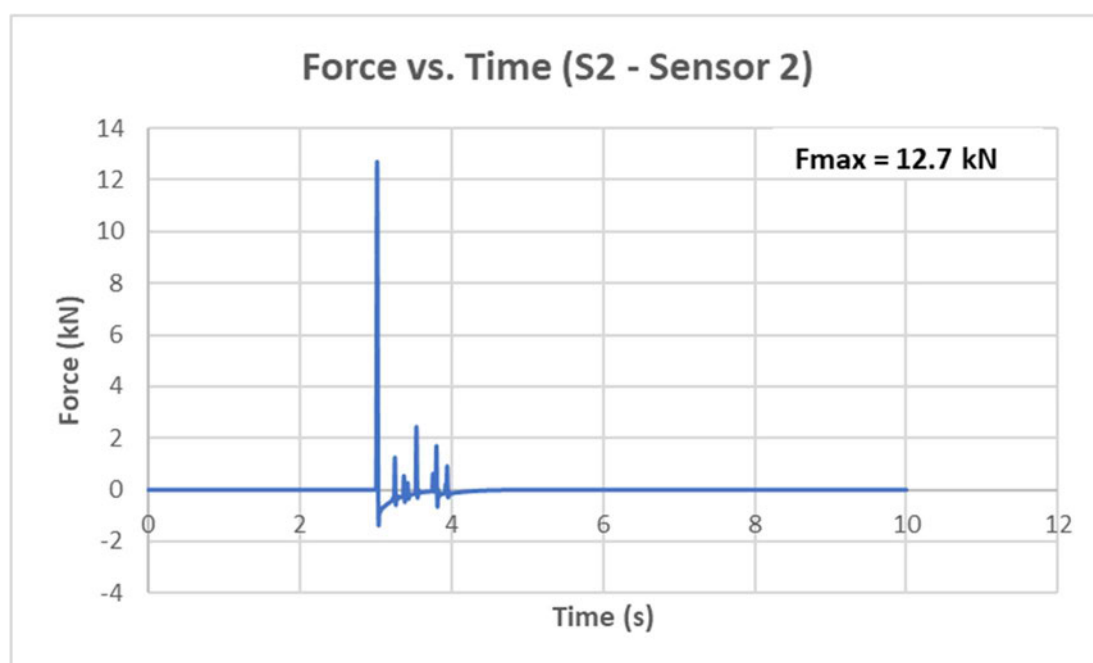
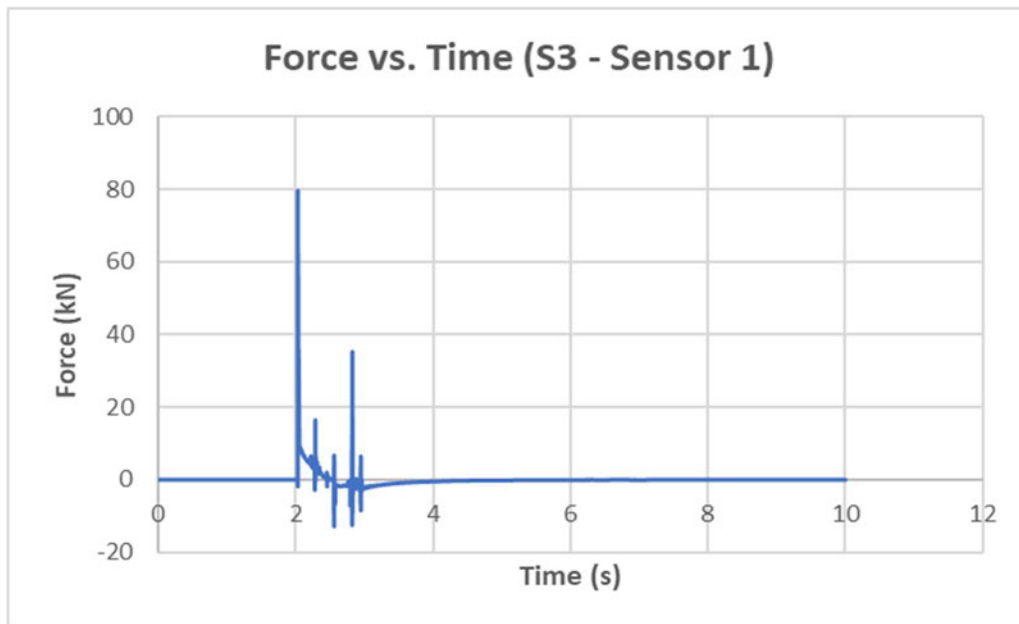
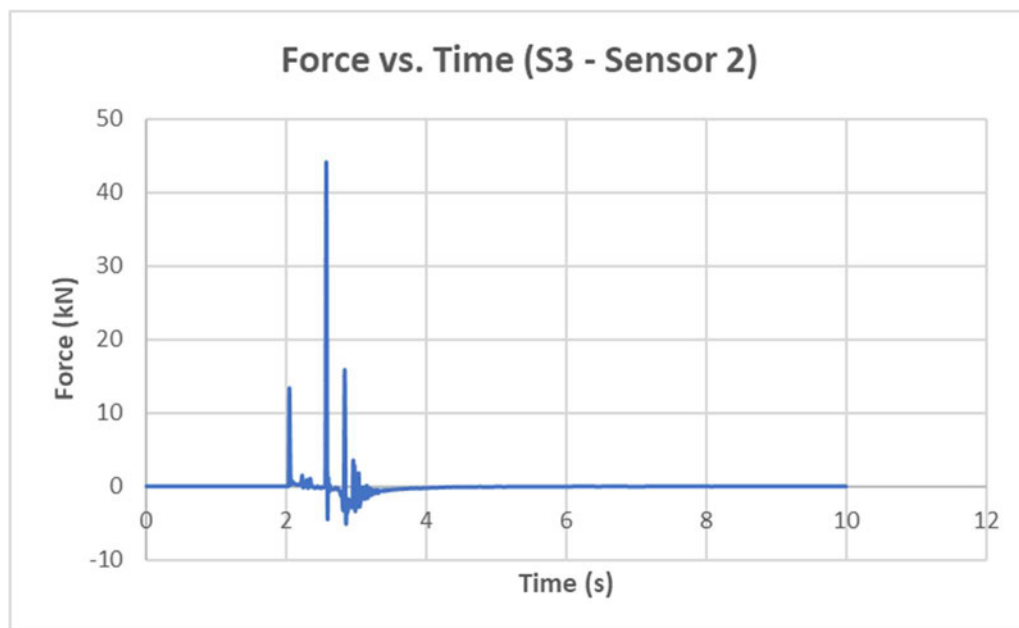
Figure 5.1: Force – Time Histories of S1 (Force Sensor 1)

Figure 5.2: Force – Time Histories of S1 (Force Sensor 2)

Figure 5.3: Force – Time Histories of S2 (Force Sensor 1)

Figure 5.4: Force – Time Histories of S2 (Force Sensor 2)

Figure 5.5: Force – Time Histories of S3 (Force Sensor 1)

Figure 5.6: Force – Time Histories of S3 (Force Sensor 2)

The effective dissipation of the impact forces for the samples reinforced with larger GFRP bar diameters can be accredited to the reinforcements ability to absorb more energy due to their greater-cross sectional area. The energy absorption assists in reducing the rate of deceleration and spreading the impact force across a larger section of the slab, thus mitigating the energy. This is supported by outcomes revealed from a study completed by Xiao et al. (2017), where it was demonstrated that an increase in bar diameters lead to a decrease in impact force and localised stress as the larger area allows for the forces to be distributed more effectively.

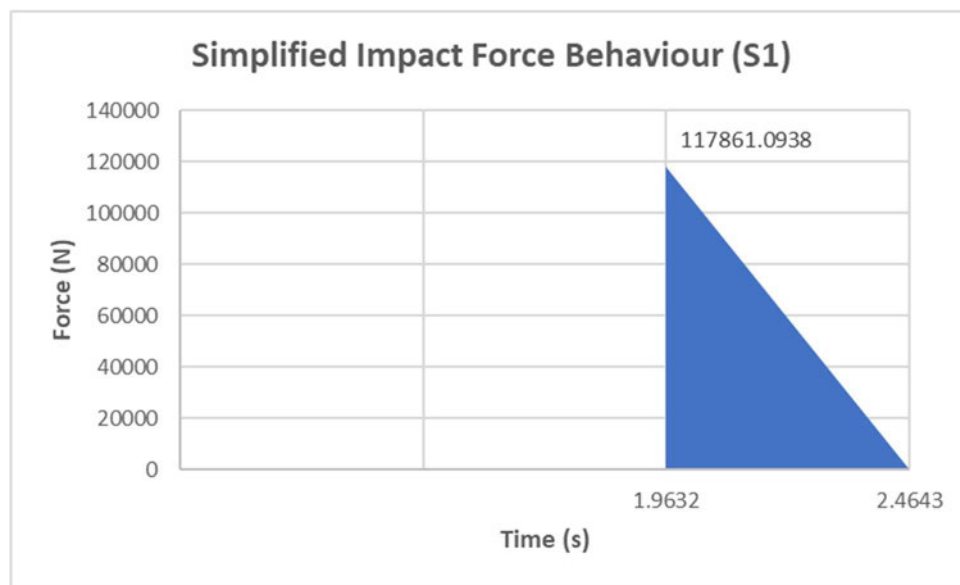
Figure 5.7: Impact – Force Curve (S1)

S1 recorded its maximum impact force of 117.9kN at $t = 1.963$ s. When evaluating the force data, the force sensors recorded a value of zero at approximately 2.464s which is when the hammer was about to rebound. This simplified impact force behaviour is represented in Figure 5.7.

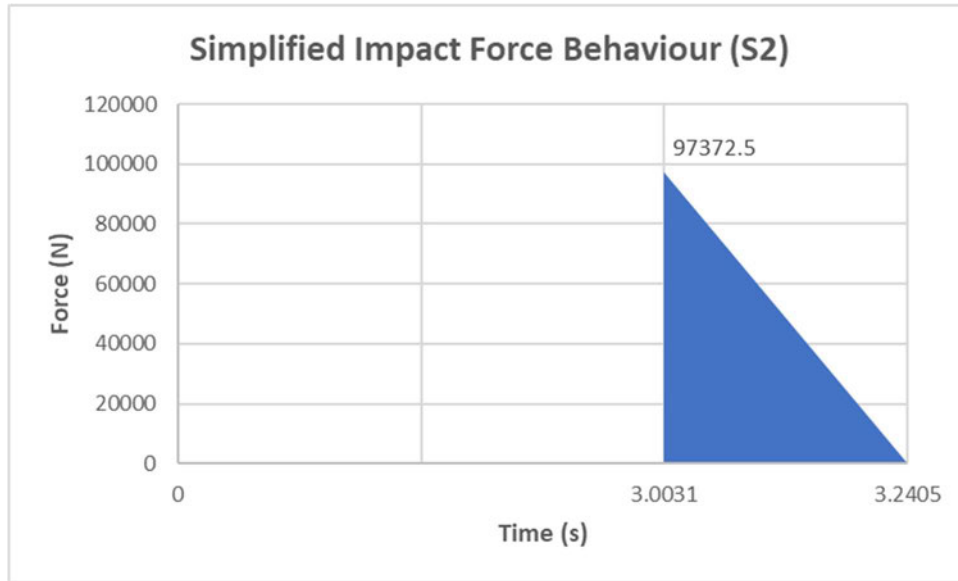
Figure 5.8: Impact – Force Curve (S2)

S2 recorded its maximum impact force of 100.9kN at $t = 3.524$ s, however this value was from the rebound impact. According to force sensor 1 for S2, the impact force magnitude the slab experienced was 97.373kN at $t = 3$ s. When evaluating the force data, the force sensors recorded a value of zero at approximately 3.241s which is when the hammer was about to rebound. This simplified impact force behaviour is represented in Figure 5.8.
