University of Southern Queensland
Faculty of Health, Engineering and Sciences

Impact Behaviour of Concrete Seawalls Reinforced with Different GFRP Bar Diameters

ENG4111/ENG4112 Research Project

Bachelor of Engineering (Honours)(Civil)

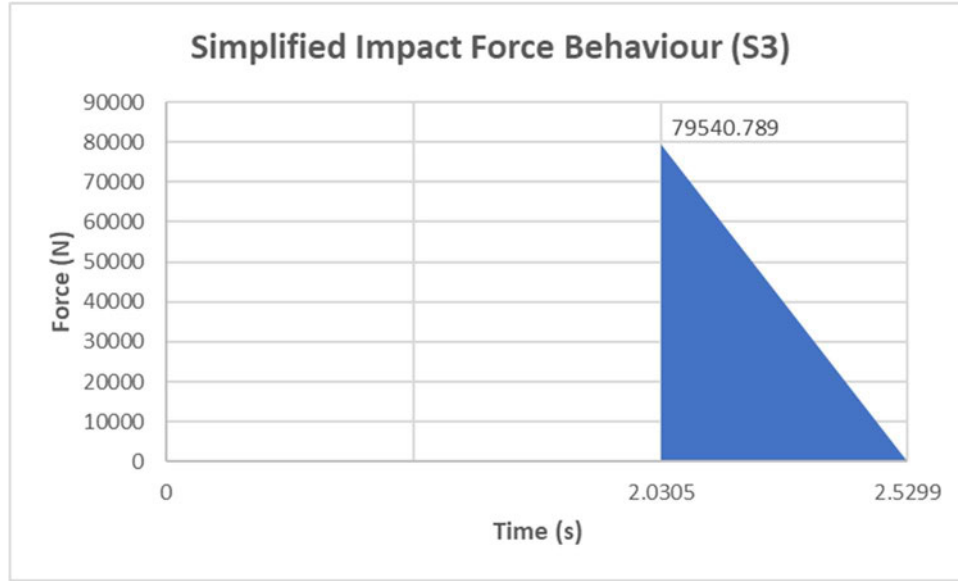
Figure 5.9: Impact – Force Curve (S3)

S3 recorded its maximum impact force of 79.5kN at t = 2.031s. When evaluating the force data, the force sensors recorded a value of zero at approximately 2.53s, indicating the hammers rebounding action. This simplified impact force behaviour is represented in Figure 5.9.

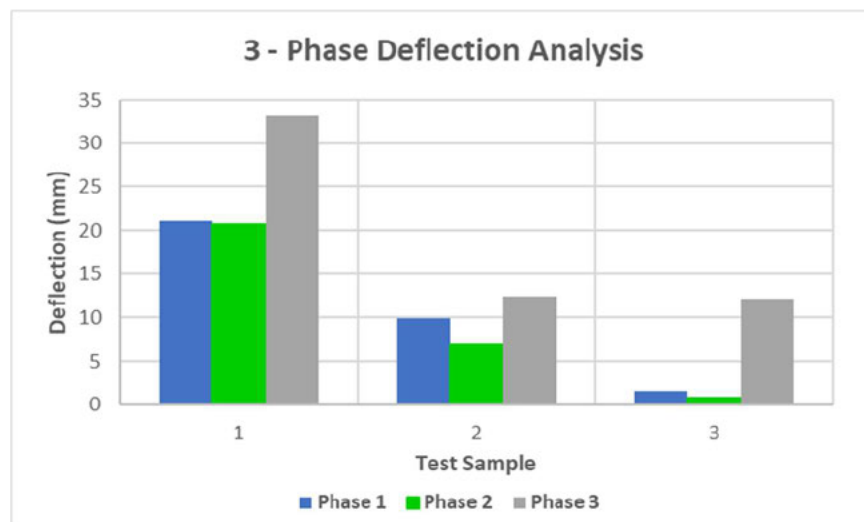
Figure 5.10: 3-Phase Deformation History

In terms of the slab's response during the initial impact, S1 recorded a deflection value of 21.07mm, S2 recorded a deflection value of 9.87mm which is 54% less than S1. Notably, S3 recorded the lowest maximum deflection value of 1.58mm which is 93% less than that of S1 and 84% less than that of S2. These results indicate that slabs reinforced with larger diameter bars are stiffer in nature thereby decreasing the specimen's deflection when subjected to an impact load. Conversely, S1 which is reinforced with small diameter bars, resulted in localised stress concentrations which leads to more significant deflection. This outcome is confirmed with the findings presented by Sadraie et al. (2019) which demonstrated that an increase in the reinforcement ratio results in a decrease in maximum deflection.

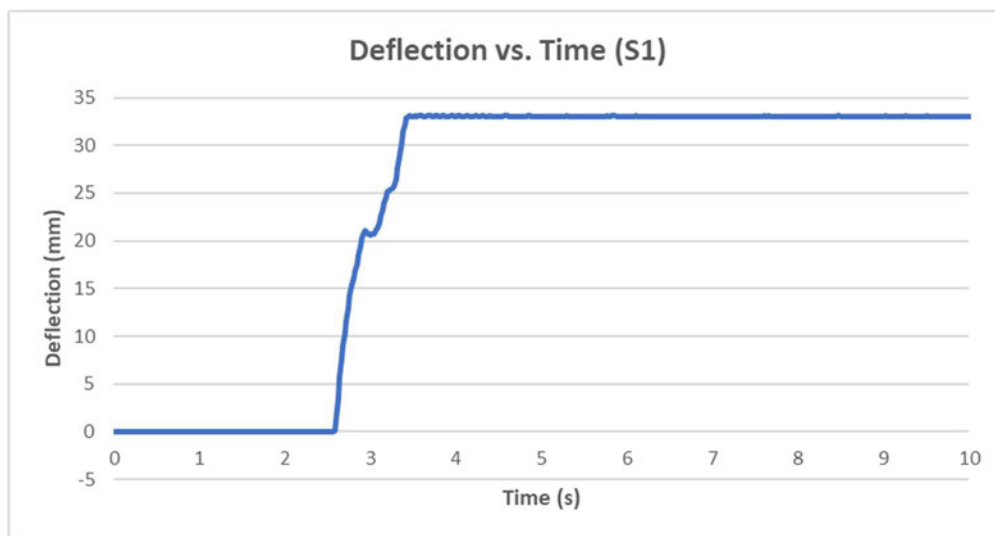
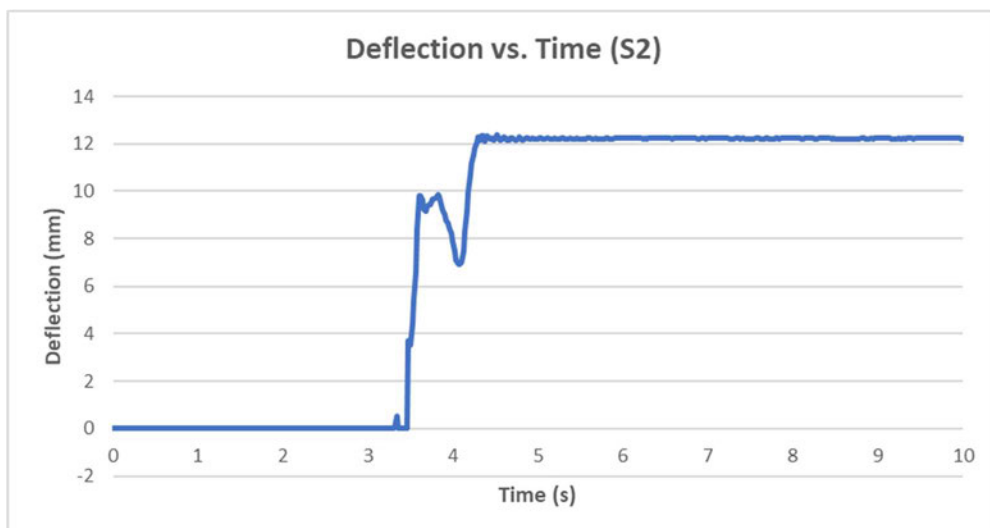
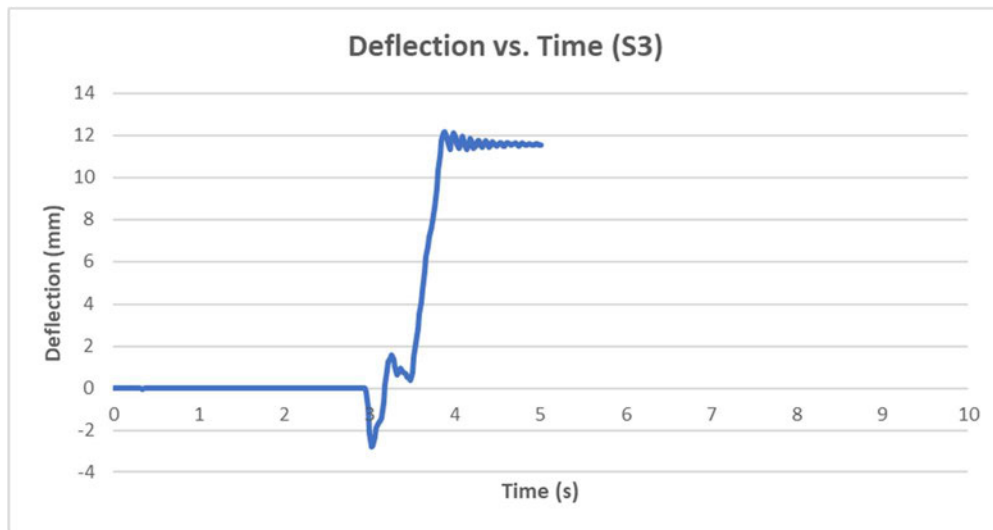
Figure 5.11: Deflection – Time History of S1 (8mm)

Figure 5.12: Deflection – Time History of S2 (10mm)

Figure 5.13: Deflection – Time History of S3 (13mm)

The residual deflection results for all three test samples indicate that S1 underwent plastic deformation during the impact. This is clear as the maximum residual deflection recording for all three samples was S1, which included the deflection from the initial impact when the bars plastically deformed plus the deflection from the hammer resting on top of the slab. This is reflected by the fact that S2 and S3 recorded different deflection values during the initial impact and rebound phases but resulted in similar residual deflection values. This suggests that neither S2 or S3 incurred plastic deformation and that the residual deflection is just a measurement of the hammer causing deflection while resting on the slab.

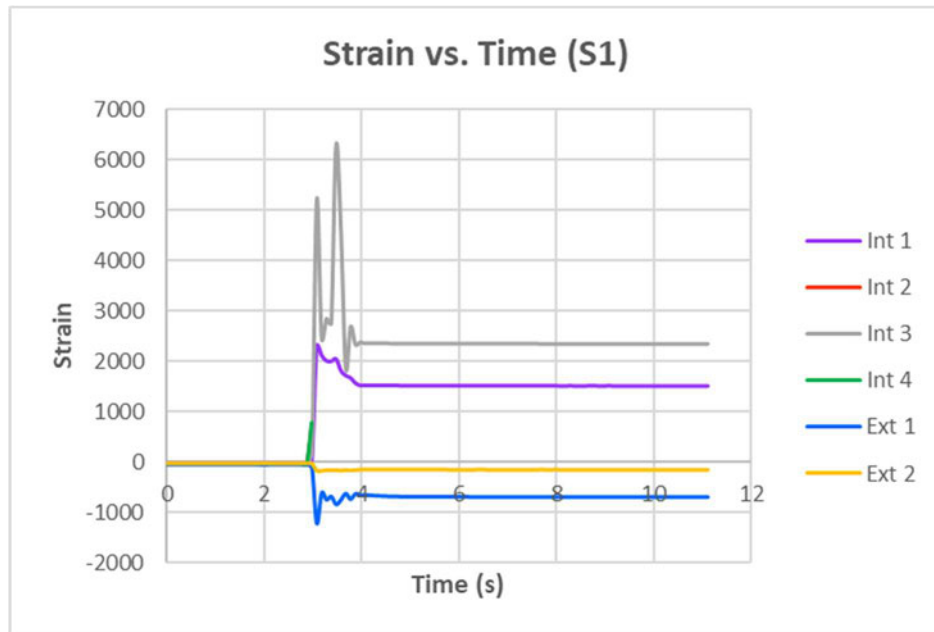
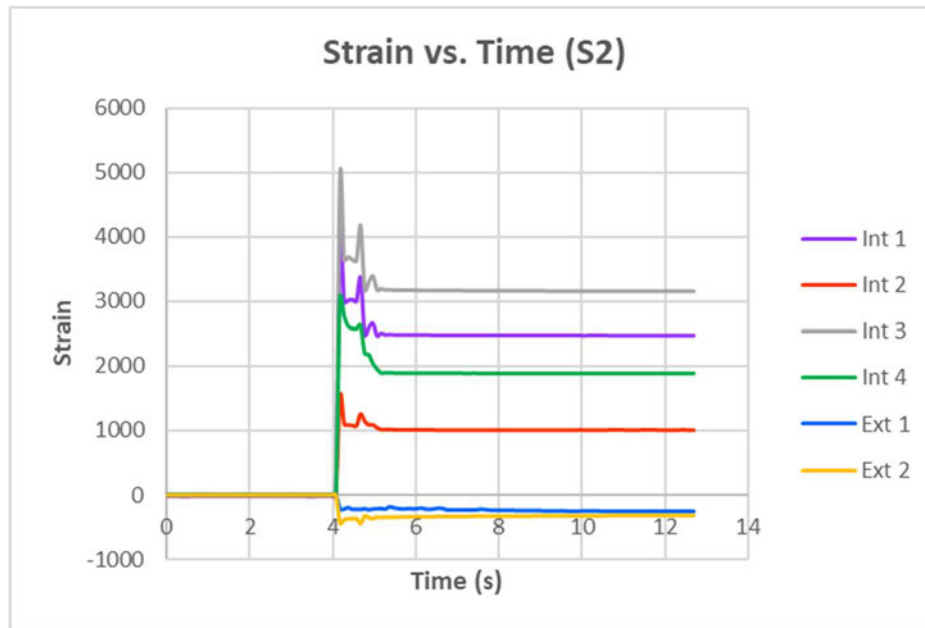
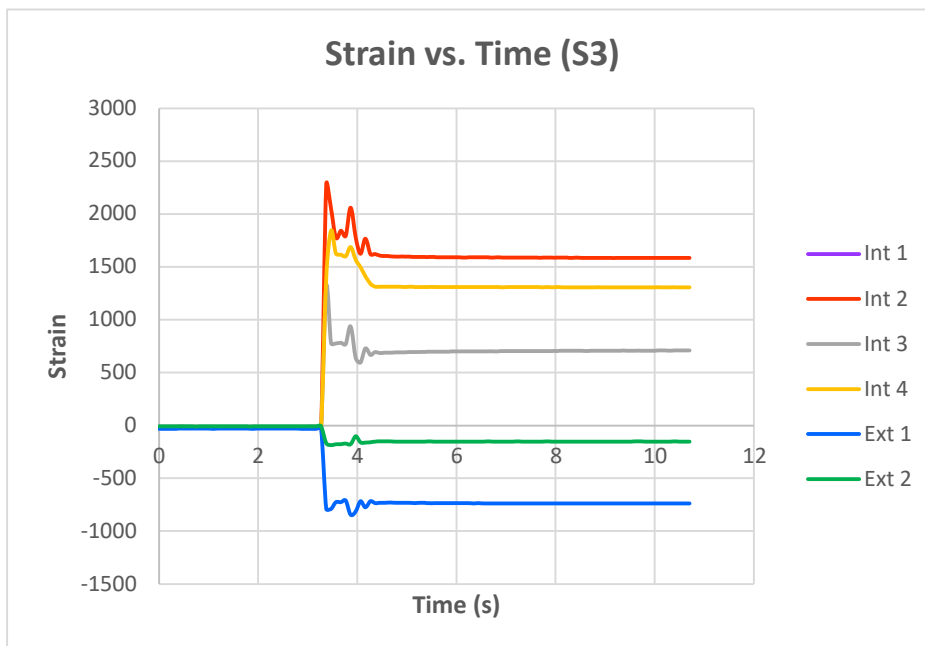
Figure 5.14: Strain – Time History of S1 (8mm)

Figure 5.15: Strain – Time History of S2 (10mm)

Figure 5.16: Strain – Time History of S3 (13mm)

The strain data obtained from S2 was less than the strain values recorded for S1. This response may be due to the increased potential for elastic deformation that smaller diameter bars hold. This flexible behaviour enables the slab to absorb the impact by deforming more internally and reducing the strain externally. The findings from this investigation are supported by research conducted by Said and Mouwainea (2022) and Khorramaian and Sadeghian (2017) whose study revealed that the GFRP bars only reached 50% of their predicted strain capacity.

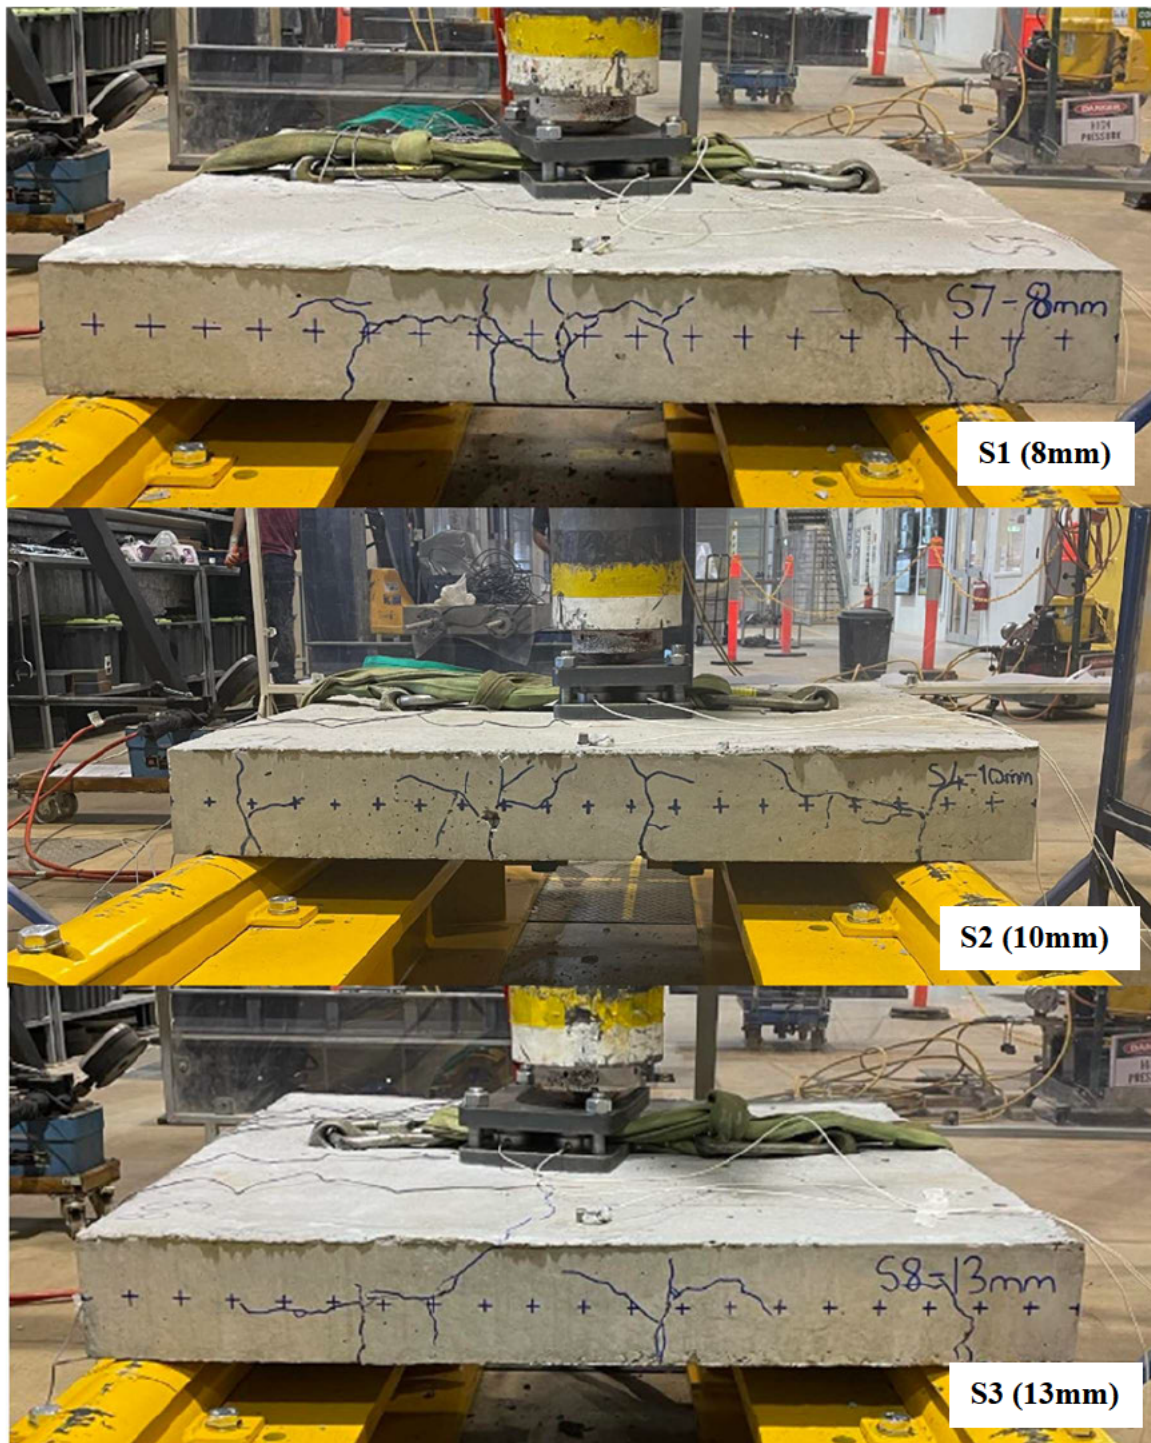
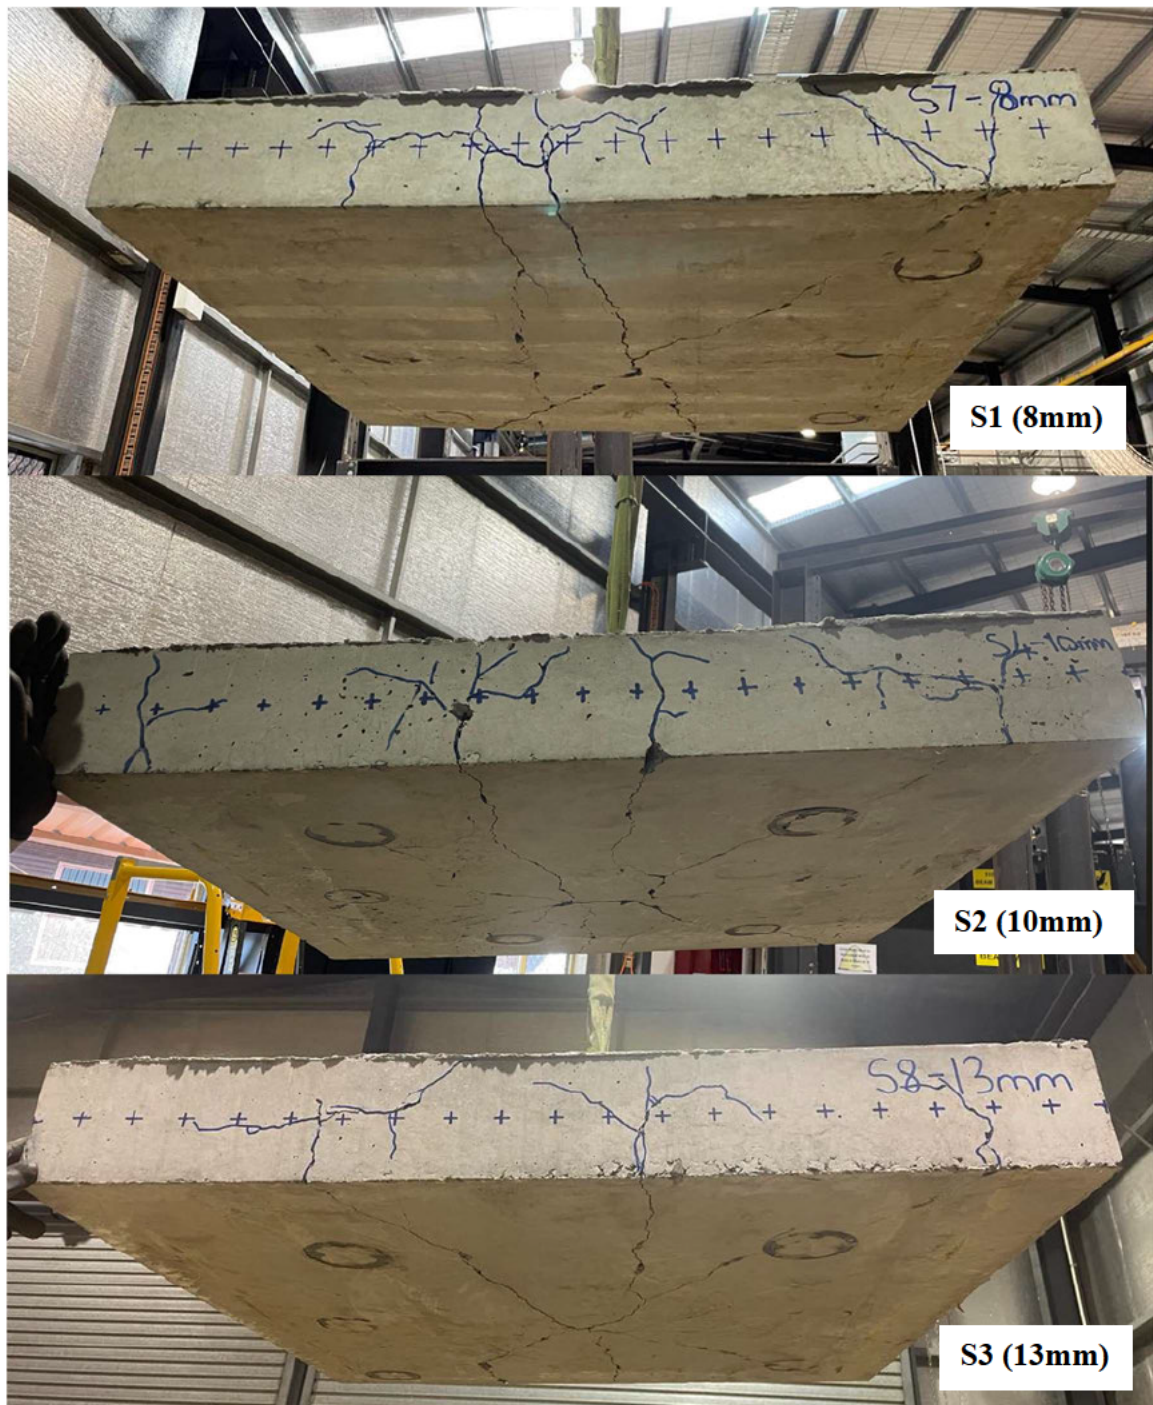
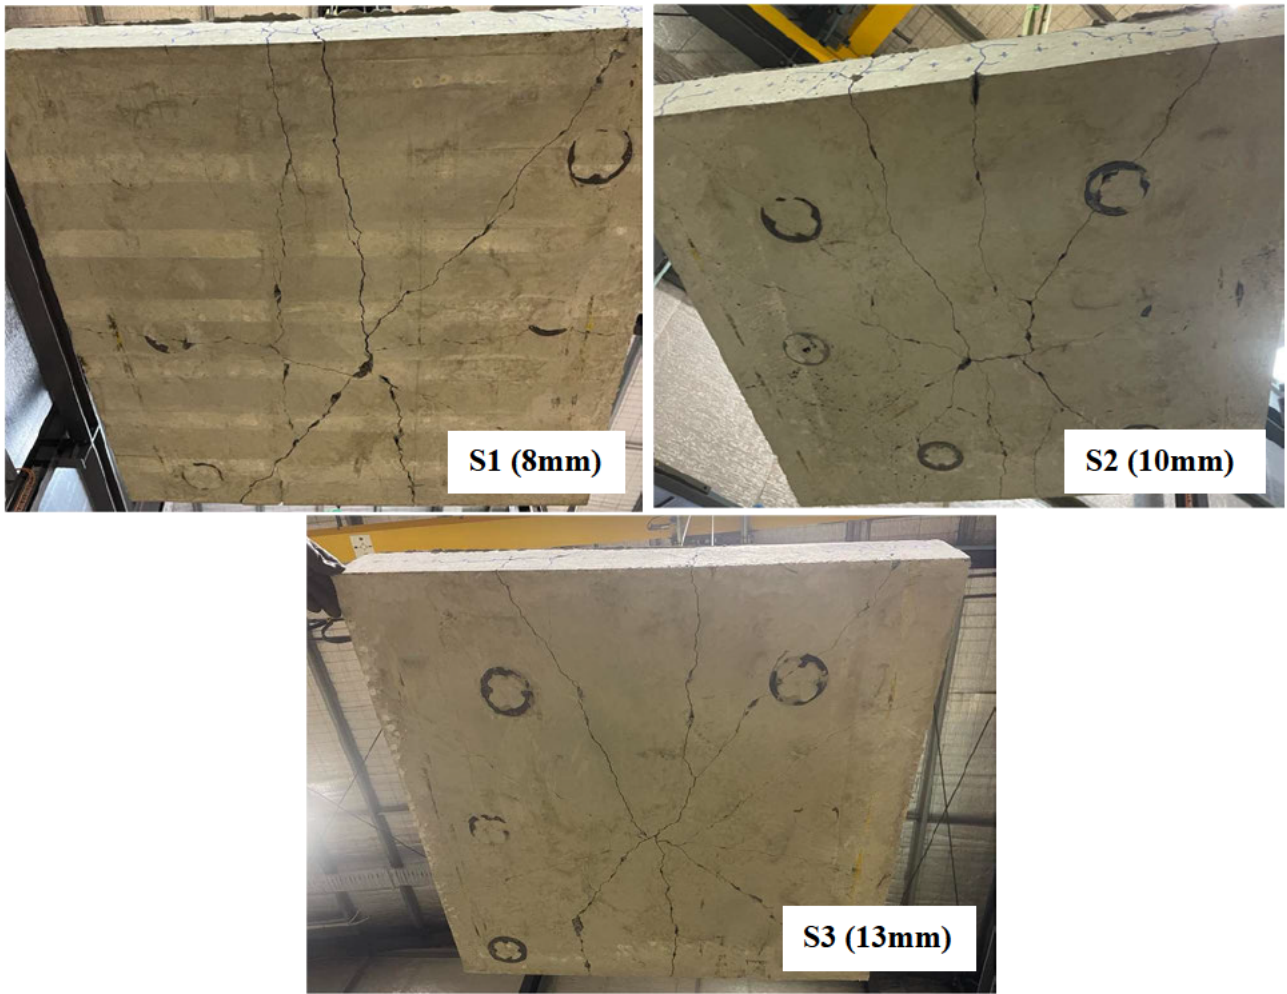
Figure 5.17: Cracking Pattern of Test Slabs (Side Face)

Figure 5.18: Cracking Pattern of Test Slabs (Angled View)

Figure 5.19: Cracking Pattern of Test Slabs (Bottom Face)

Conclusively, the response of are suggests that the increased strength provided from the larger diameter bars within the slab is directly related to its ability to withstand and counteract higher impact loads before experiencing cracking and other forms of structural damage. This is supported by a study completed by Gribniak, Rimkus, Torres and Hui (2018) which revealed that a decrease in stiffness provided by smaller diameter GFRP bars results in an increase of slab deformation and greater cracking. This is an unfavourable outcome as cracking is the primary cause of deterioration in reinforced concrete structures as it allows moisture to invade the concrete (Gribniak, Rimkus, Torres and Hui 2018).
