University of Southern Queensland  
Faculty of Health, Engineering & Sciences

# **Investigation of Culvert Failures During Extreme Flood Events**

**ENG4112 Research Project**

**Bachelor of Civil Engineering (Honours)**

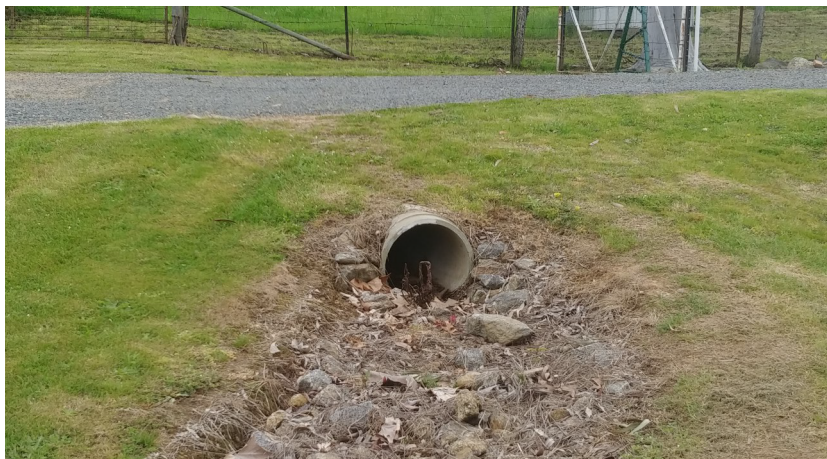
Figure 1.1: A small driveway culvert.

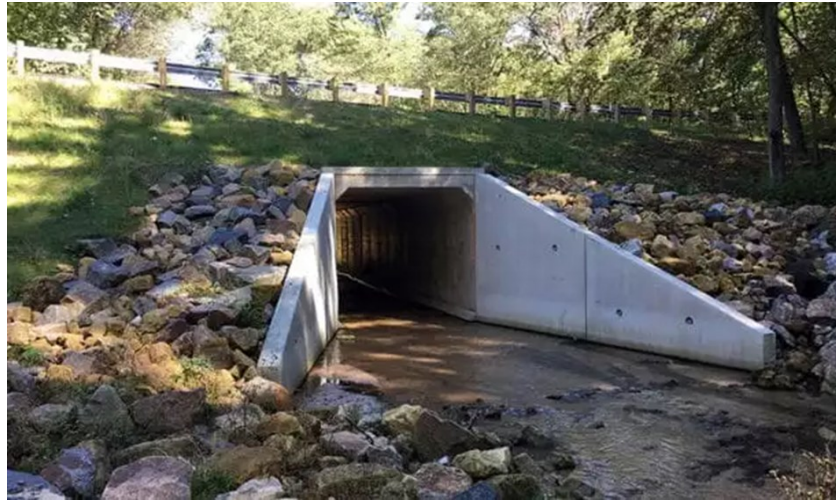
Figure 1.2: A larger box culvert supporting a roadway (Dream Civil 2022).

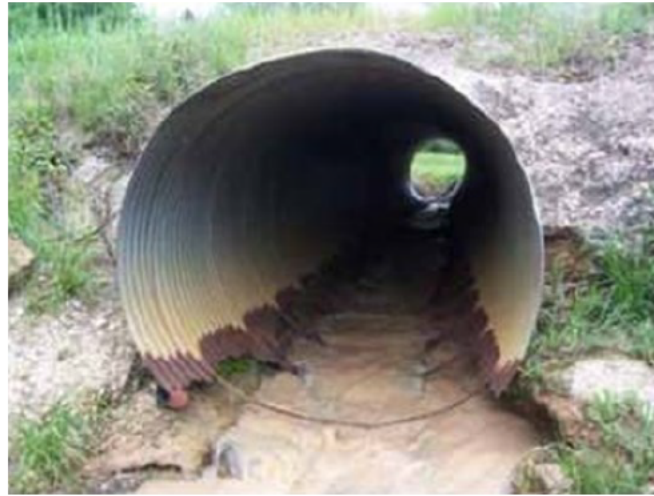
Figure 2.2 A CMP culvert with corrosion damage (Haghani & Yang 2016).

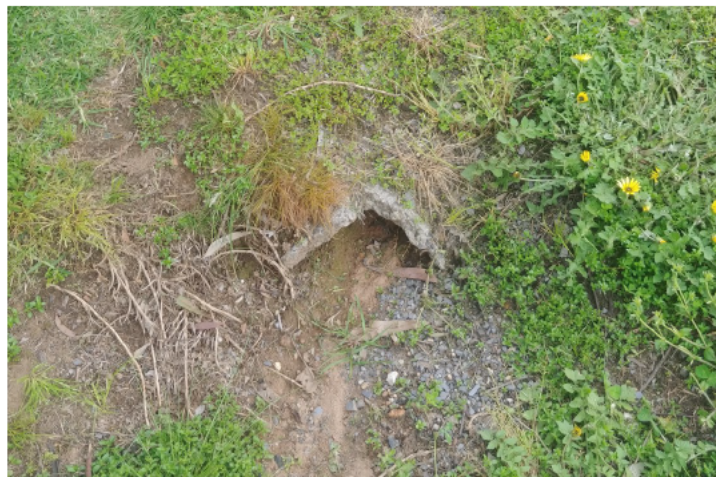
Figure 2.3: Mechanical damage on an exposed driveway culvert.

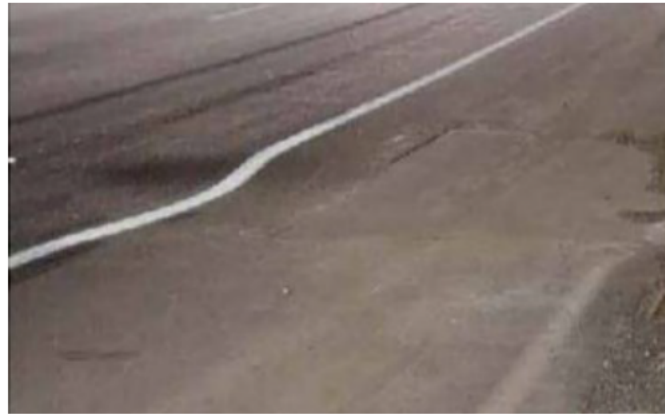
- Separation at joints of prefabricated culvert sections which can cause water infiltrate into surrounding fill material or overlying road base. This can be hard to detect and has the potential to cause major damage to the overall culvert structure and roadway.
- Piping which occurs when water seeps between the pipe and soil material creating voids. This leads to instability of the culvert structure and can cause damage to an overlying road surface (see figure 2.4). Piping usually occurs due to inadequate end treatments on the upstream side or poor compaction of soil around the culvert.

Figure 2.4: Road settlement due to piping (Piratla, Jin & Yazdekhashti 2019).

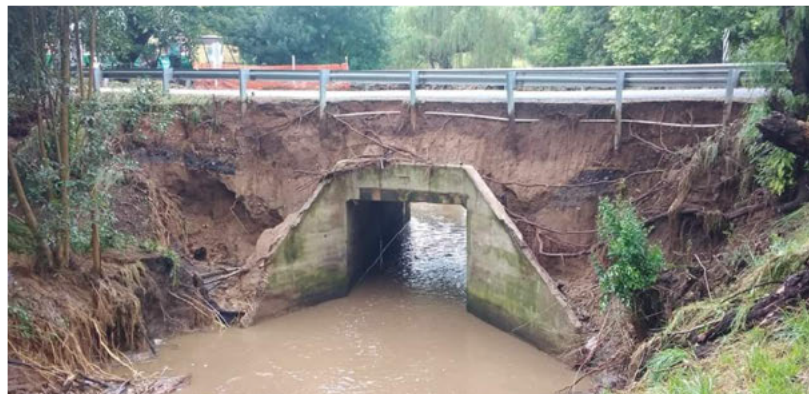
- Erosion of embankments on the upstream or downstream side of the culvert due to inadequate armouring or poor design/construction. Piping or overtopping typically causes erosion on the downstream side of the embankment (see figure 2.5).

Figure 2.5: Embankment erosion on the downstream side of a culvert.

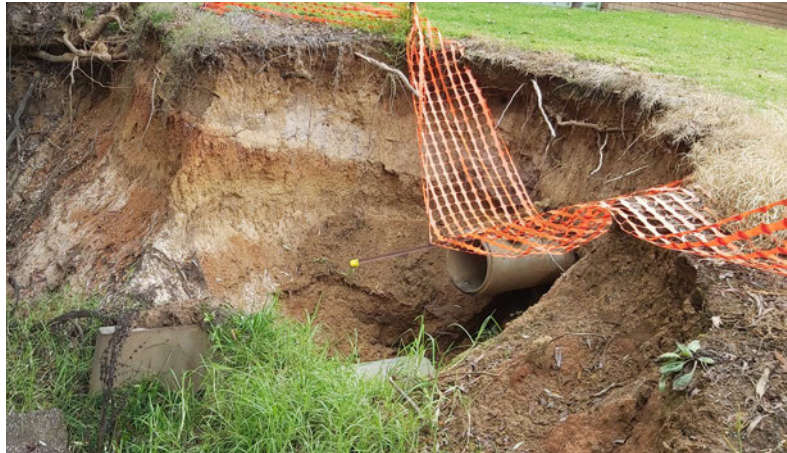
Figure 2.6: Severe scouring at a culvert outlet.

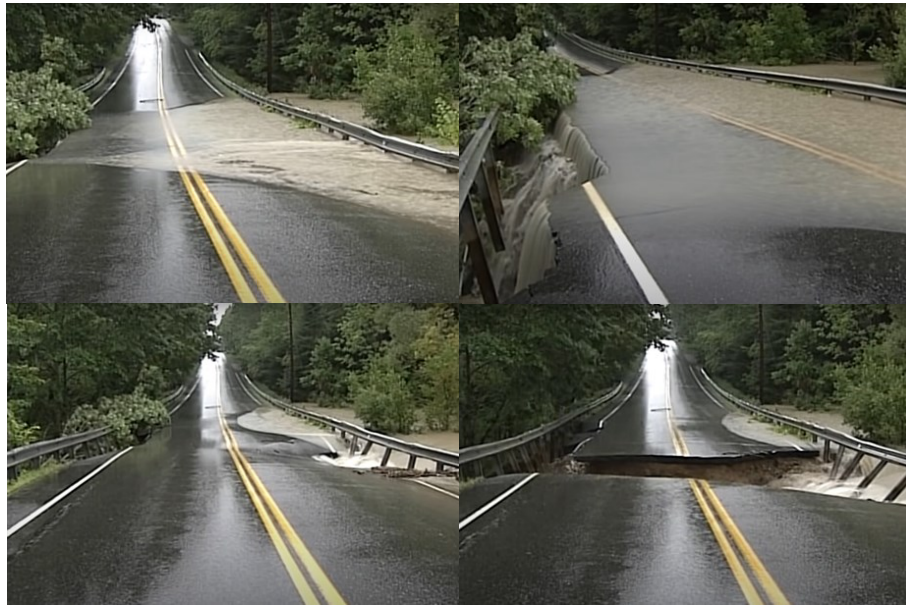
The studies were aimed at collecting observational data to be used for further research and highlighted the extent that this failure mechanism is observed during an extreme flood event. Figure 2.7 below illustrates this failure mechanism occurring during a flood event.

Figure 2.7: Progressive failure of an overtopping culvert (Vermont Local Roads 2012).

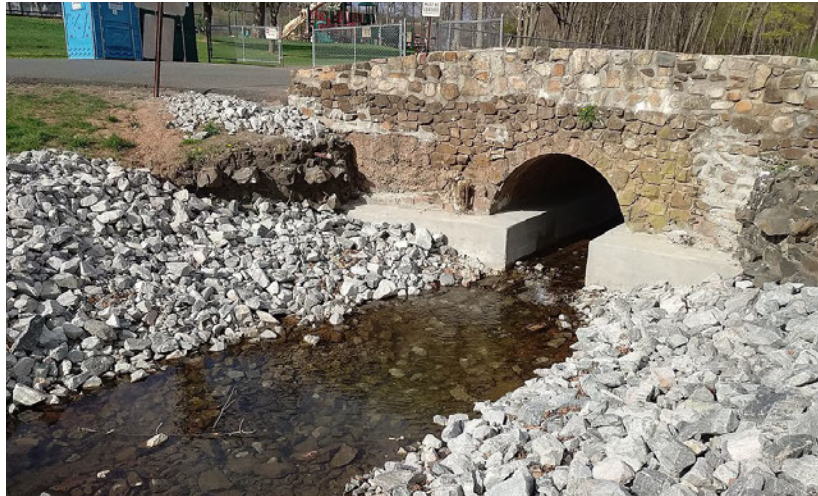
Figure 2.8: Riprap Protection at a culvert outlet (Wikipedia 2022).

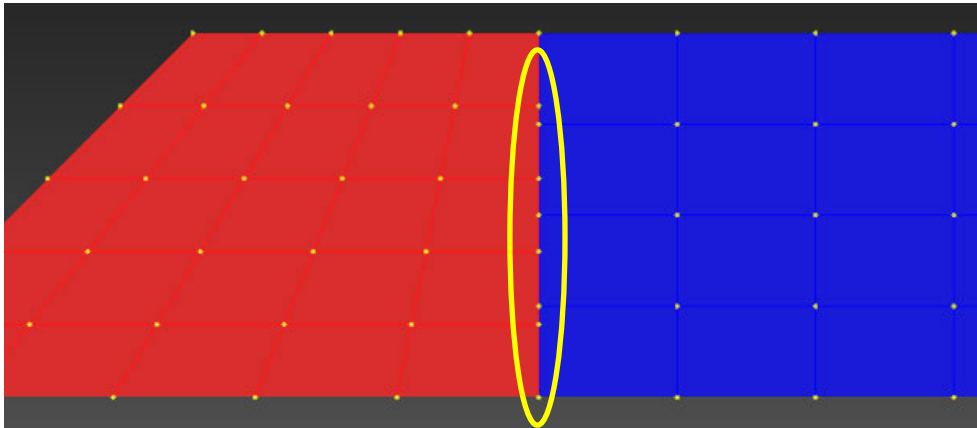
2. Brick elements are then subdivided into smaller elements to create a mesh of desired size. During this process, it is imperative to ensure that elements are subdivided in a manner which does not result in discontinuities in the mesh. Discontinuities occur when neighbouring element are subdivided unequally resulting in nodes not aligning along a common axis (see figure 3.1). This causes instability in the model and will result in incorrect outputs from the software.

Figure 3.1: Discontinuity of mesh between brick elements.

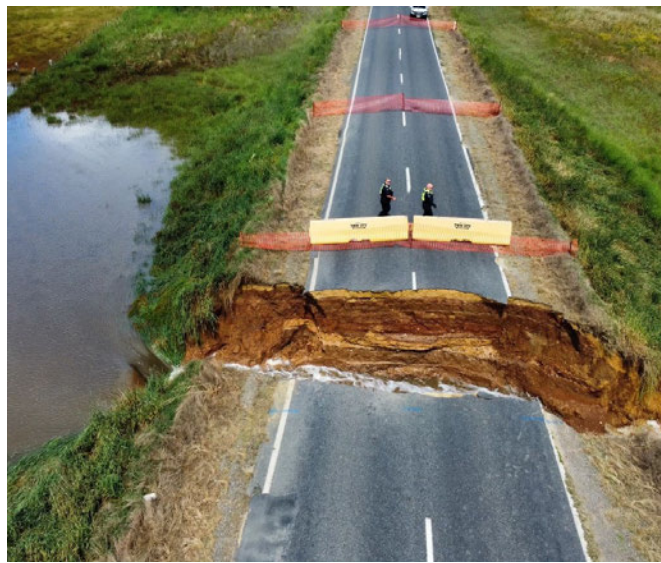
One of the most notable of these failures occurred near Rutherglen, Victoria, where an entire section of the roadway and embankment was washed away due to a complete blockage of the culvert (see figure 4.1).

Figure 4.1: Culvert failure near Rutherglen, Victoria (Indigo Shire Council 2022).

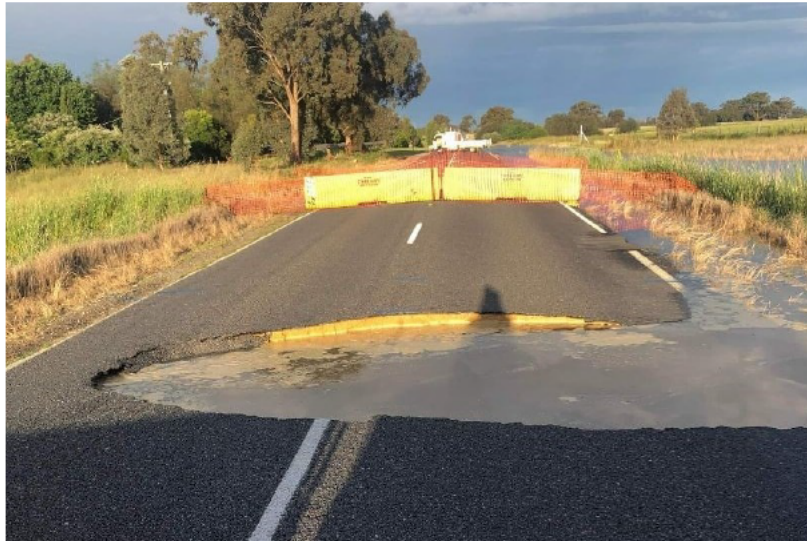
This increased the plasticity of the soil causing the embankment and roadway to begin failing progressively from the upstream side (see figure 4.2) until the pressure induced by the upstream floodwater was able to wash the remainder of the embankment away. This caused the culvert itself to become completely dislodged and resulted in a large, impassable chasm being created in the roadway.

Figure 4.2: Culvert failure near Rutherglen, Victoria (Indigo Shire Council 2022).

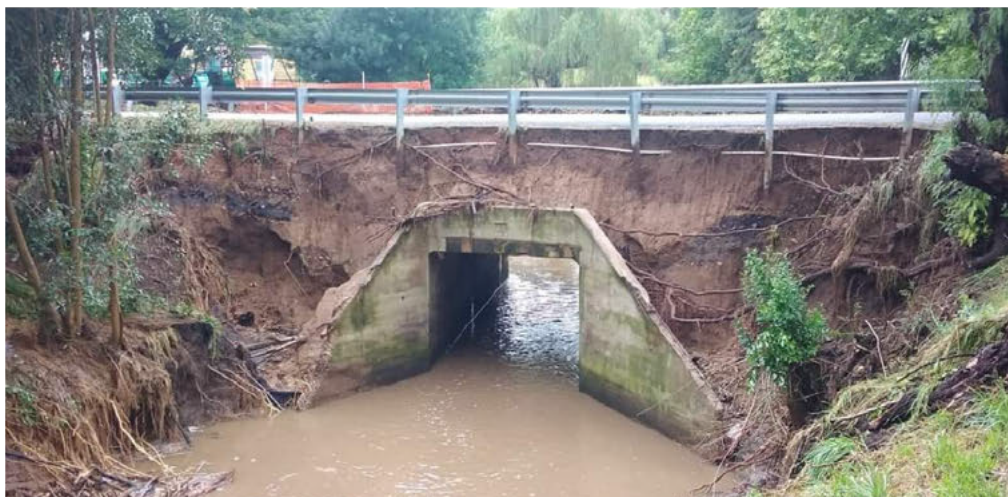
Another culvert in the township of Bethanga was badly damaged during a heavy storm where the hydraulic capacity of the culvert was exceeded and water overtopped the roadway. This event caused significant erosion damage to the downstream side of the embankment (see figure 4.3).

Figure 4.3: A major culvert failure in Bethanga, Victoria.

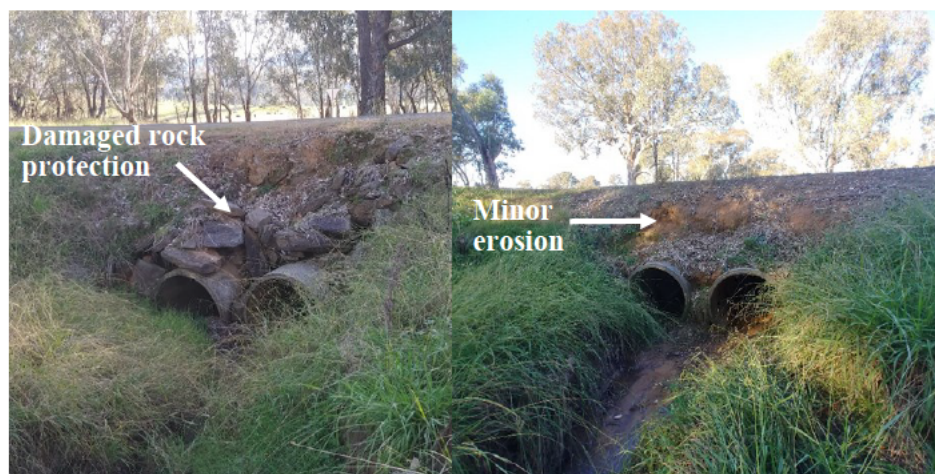
The first culvert was of a substantial size and consisted of two 1200 mm reinforced concrete pipes (RCPs) providing road access across a small, natural creek. This culvert showed signs of minor erosion damage at the top of the embankment on both the upstream and downstream sides (figure 4.5) which suggested that flood waters had overtopped it during the major flood event.

Figure 4.5: Damage to a culvert on the upstream (left) and downstream (right) side.

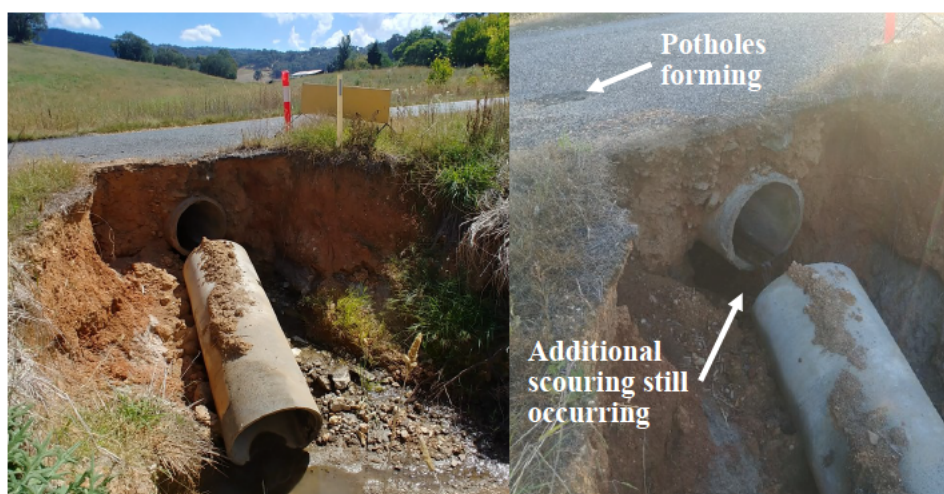
The 2nd culvert was relatively small and consisted of a single 750 mm RCP providing road access across a small creek. The upstream side of the culvert was undamaged however, the downstream side had suffered severe erosion damage most likely from heavy scouring at the culvert outlet during the flood event and may have been exacerbated by water overtopping the roadway (figure 4.6).

Figure 4.6: Scouring damage to a culvert on the downstream side.

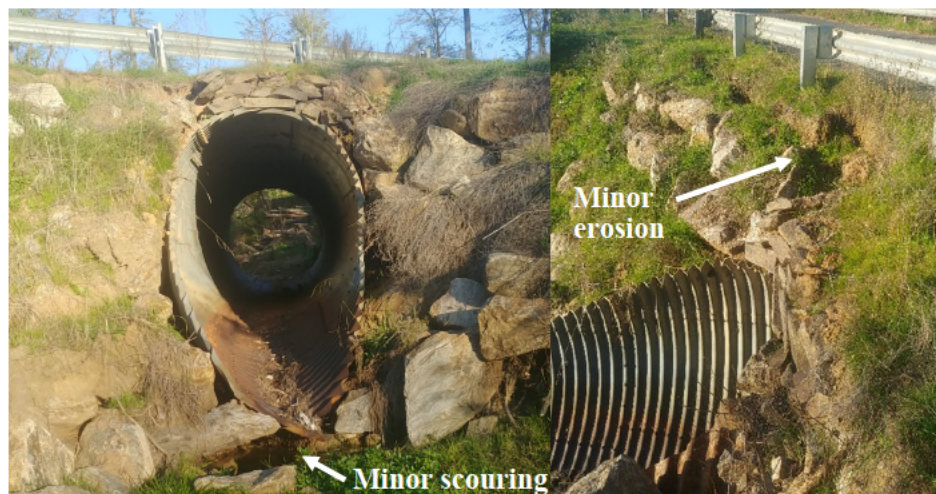
The 3rd culvert was relatively large and consisted of a single 2000 mm diameter CMP providing road access across a large natural channel approximately 10 m wide with steep side slopes. Some minor erosion damage was visible on the downstream side at the top of the embankment (figure 4.7) suggesting that the culvert may have been overtopped during the major rainfall event.

Figure 4.7: Minor damage to a CMP culvert on the downstream side.

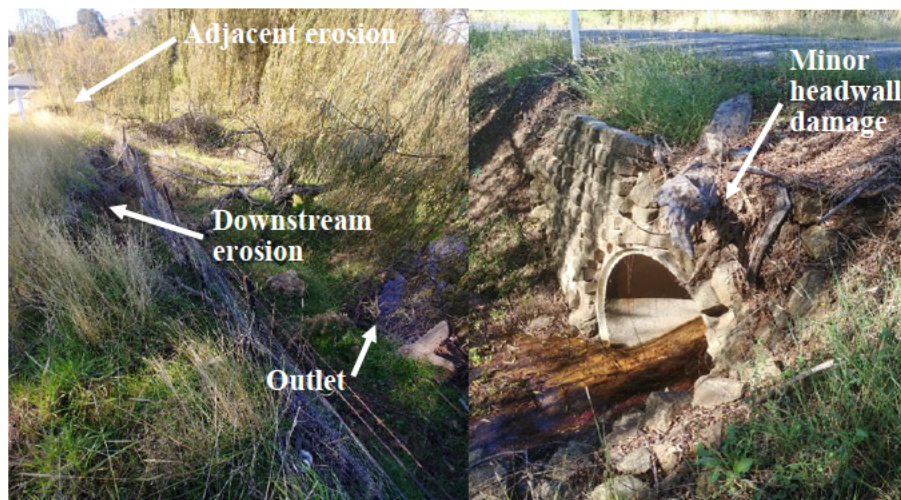
The 4th culvert was of a substantial size and consisted of a single 1500 mm RCP providing road access across a small creek. This culvert showed signs of moderate erosion damage on the downstream side with the upstream side remaining mostly undamaged due to the presence of a stone headwall though the headwall itself had received some minor damage (figure 4.8).

Figure 4.8: Culvert 4 downstream (left) and upstream (right).

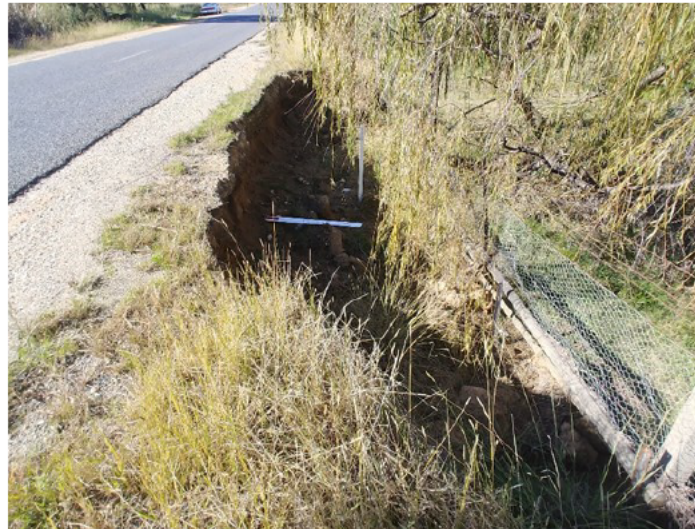
Though damage to the downstream embankment was extensive, it is likely that further damage would only occur if the culvert were to be overtopped again in a similar event. This would have the potential to cause damage to the roadway and effect road users however due to the length of the culvert, complete failure would be unlikely.

Figure 4.9: Erosion damage adjacent to culvert 4 outlet.

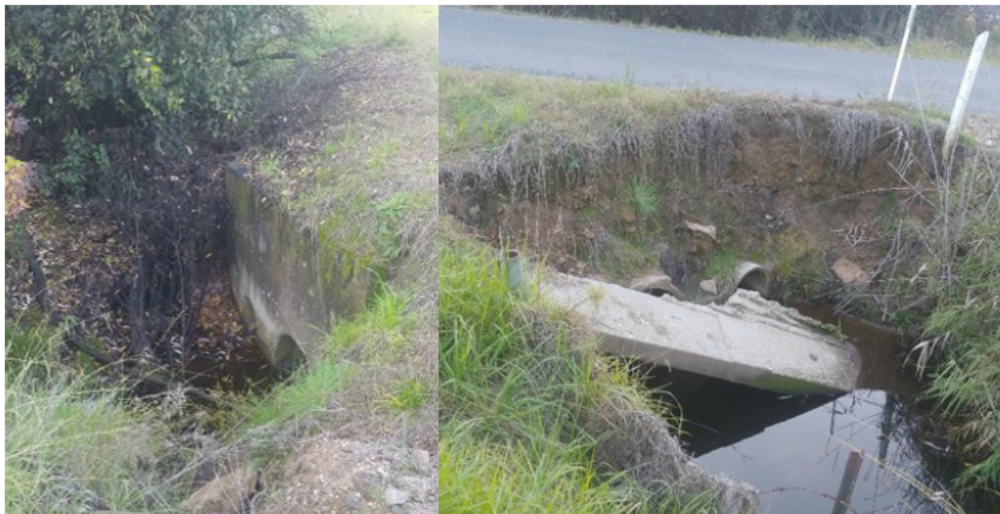
The 5th culvert was relatively small and consisted of a 450 mm RCP and a 900 mm RCP providing road access across a small creek. The upstream side of the culvert was completely undamaged due to the presence of a concrete headwall however, the downstream side (figure 4.10) suffered substantial erosion to the embankment.

Figure 4.10: Culvert 5 upstream (left) and downstream (right).

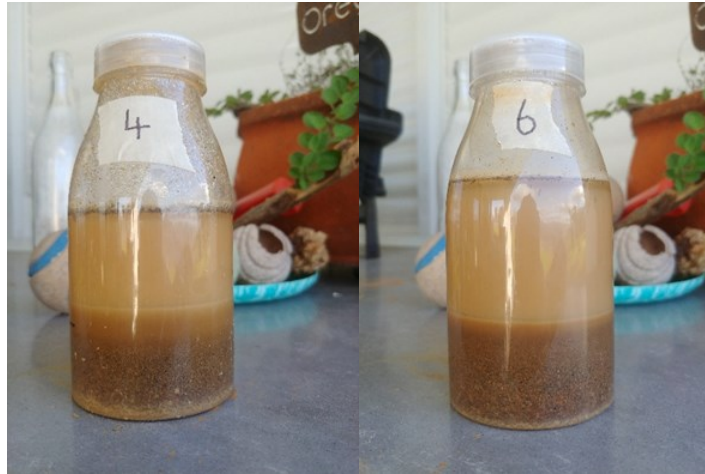
A number of soil samples were collected from the embankment of each culvert to conduct the soil classification testing shown in figures 4.11 and 4.12.

Figure 4.12: Soil test for culvert 4 (left) and culvert 5 (right).

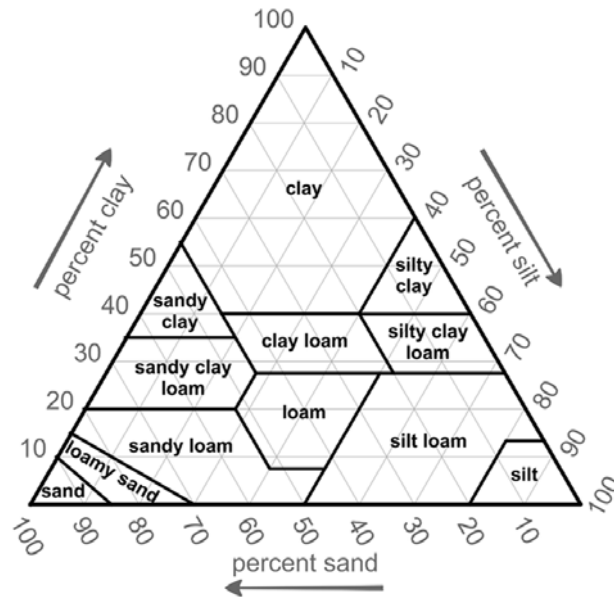
The average proportions of sand, silt and clay in the soil materials for each culvert have been used to classify the type of soil most commonly used as fill material for the embankments using the United States Department of Agriculture (USDA) soil classification triangle in figure 4.14.

Figure 4.14: USDA soil classification triangle (Lebauer 2011).

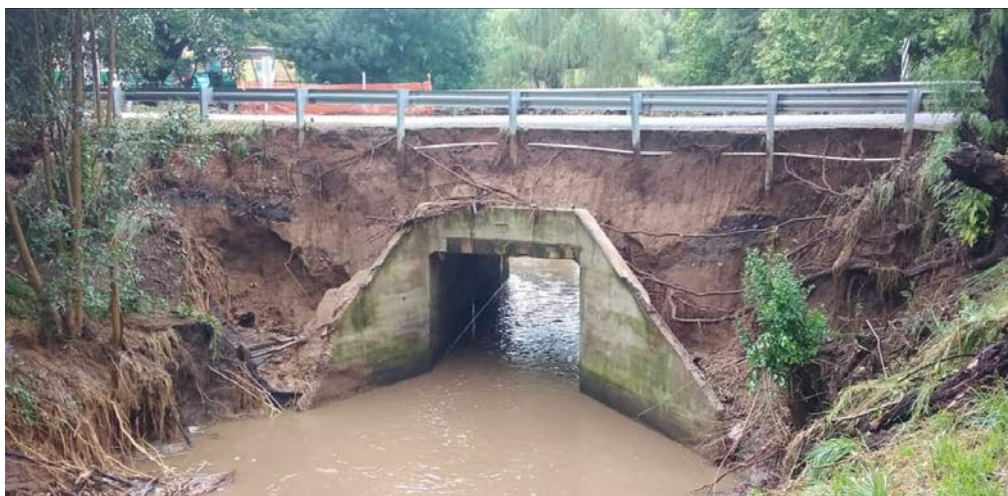
This is supported by figure 6.4 which shows the box culvert analysed in chapter 4 where the downstream side of the embankment failed despite the presence of a substantial concrete headwall.

Figure 6.4: A heavily damaged box culvert analysed during the field investigation.

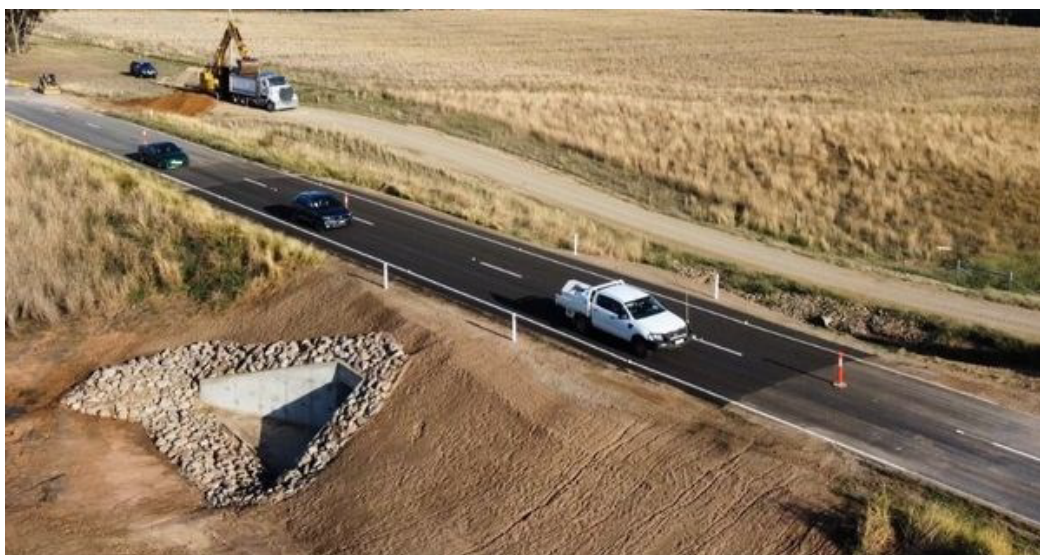
Figure 6.10: Replaced culvert near Rutherglen, Victoria (Indigo Shire Council 2023).

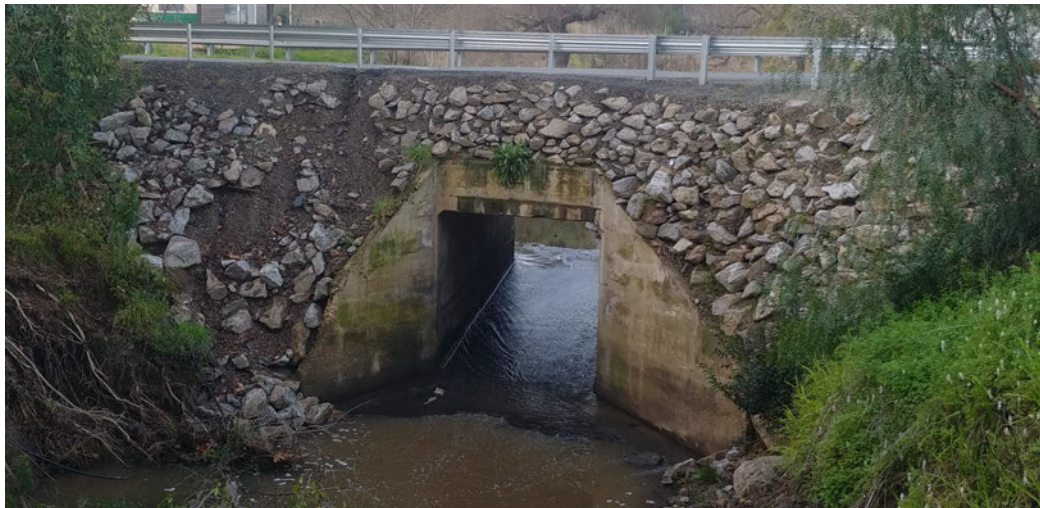
Figure 6.11: Repaired culvert near Bethanga, Victoria.

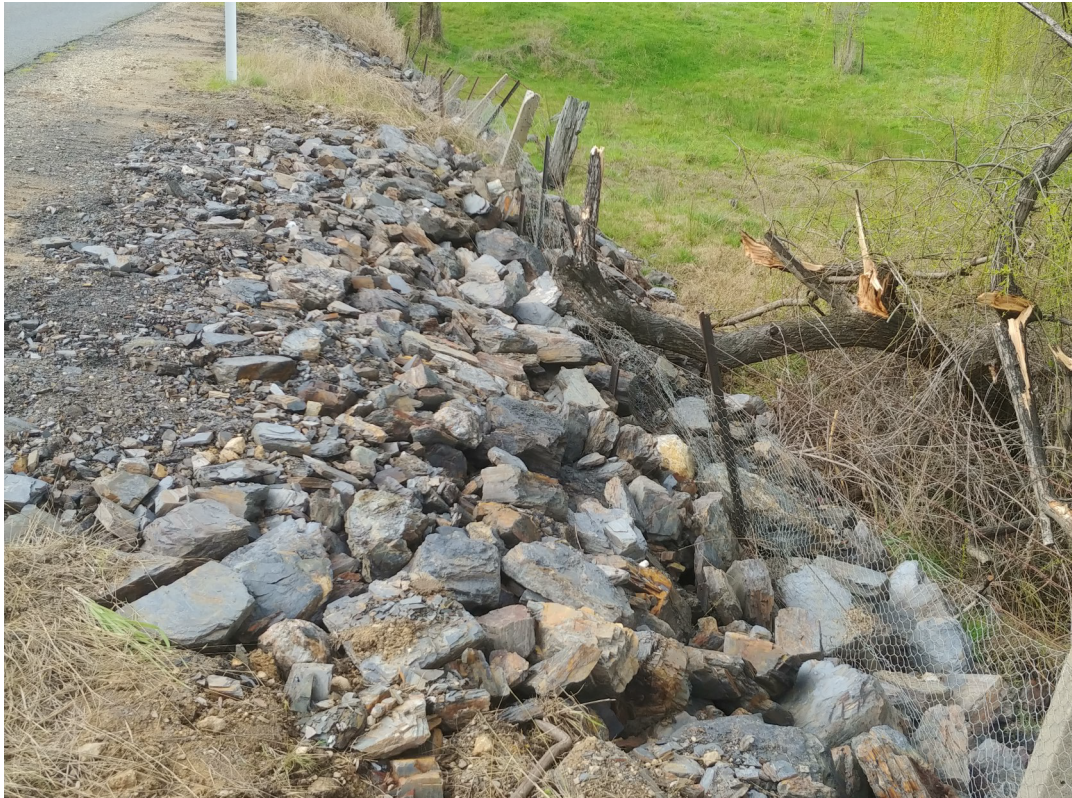
Figure 6.12: Culvert repair using crushed rock and rip rap.
