University of Southern Queensland
Faculty of Engineering and Surveying

Impact of Pavement Material for Flood Resistance on Rural Roads

November 2024

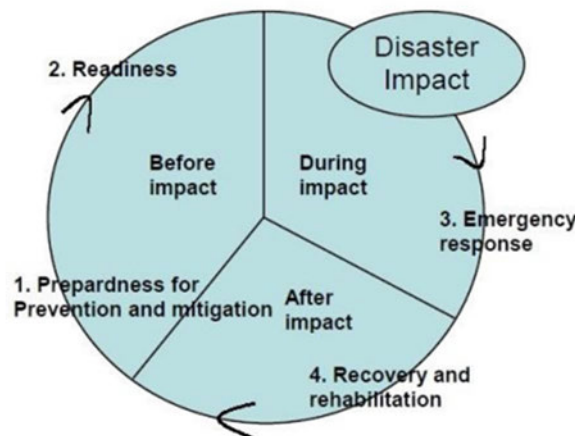
- Aim at improving the system's readiness and preparedness prior to a flood event
- Aim at improving the system's response during a flood event
- Aim at improving the system's recovery following a flood event

Figure 1 – Flood Mitigation Cycle (Mark and Djordjevic, 2006)

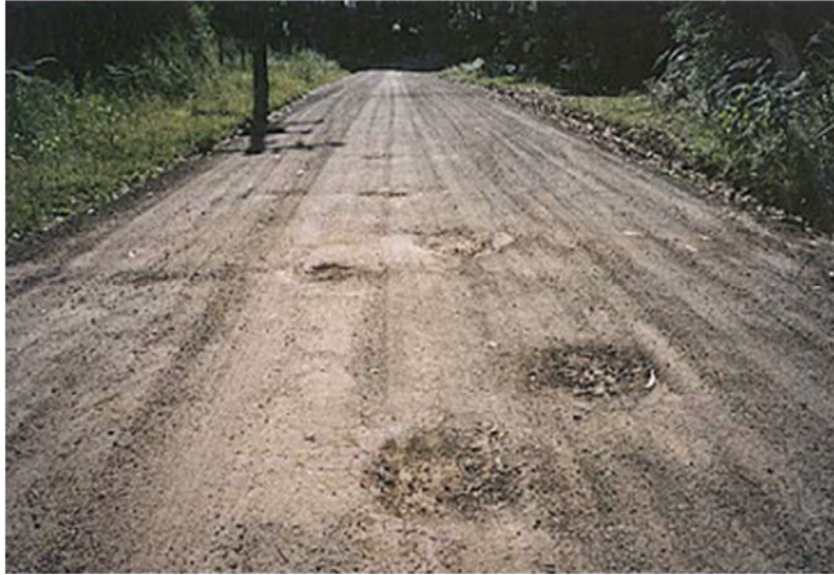
Potholing is described as “a steep-sided or bowl-shaped cavity extending into layers below the wearing course.” (Austroads, 2011, pp. 153). This is quite a common issue for sealed and unsealed roads and is generally caused by a loss of surface material due to ravelling, stripping, cracking and/or delamination and from moisture entering base layers of the road through cracking, resulting in softening of these layers. Poor quality pavement materials are also a common cause.

Figure 10 – Potholing Defects (Austroads, 2009, pp. 54)

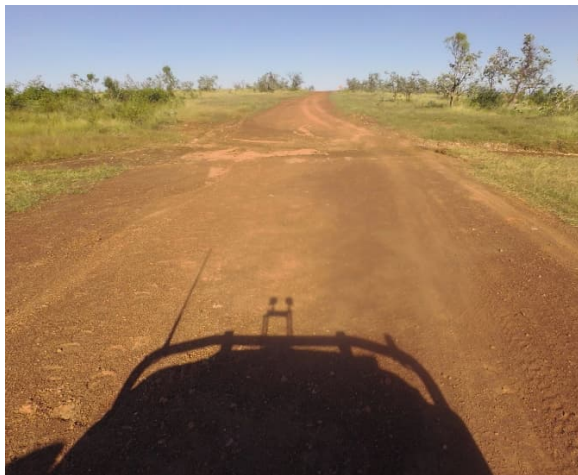
Figure 11 shows Normanton – Burketown Road following the 2023 Tropical Cyclone Jasper (taken 31/03/2023) and Figure 12 shows the rectification of that area (taken 12/07/24). The damage photo shows transverse scouring/depression caused by flood waters flowing across the road.

Figure 11 – 2023 Damage Photo (CH 88585)

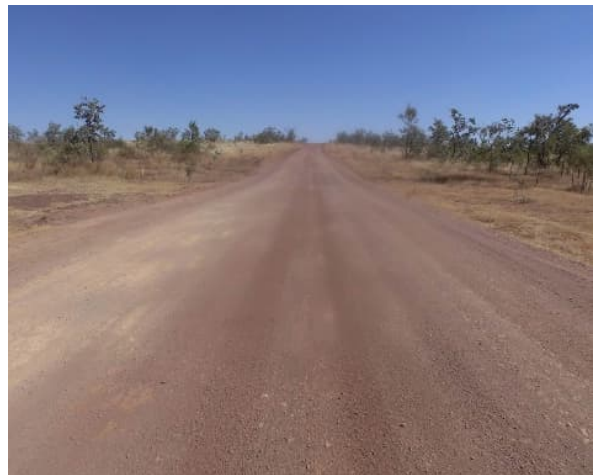
Figure 12 – 2023 Rectification Photo (CH 88585)

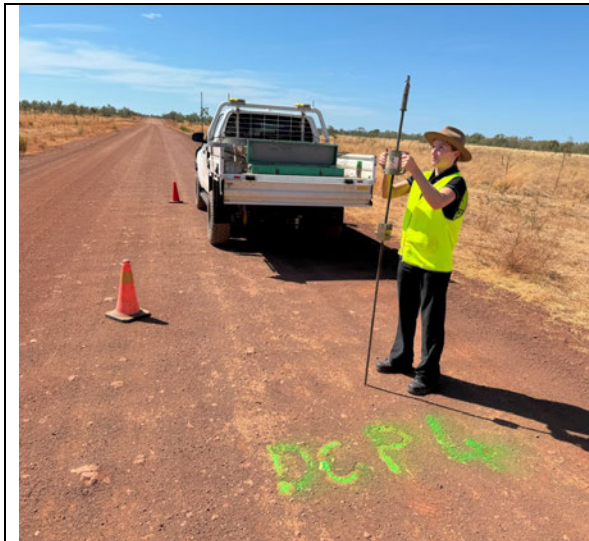
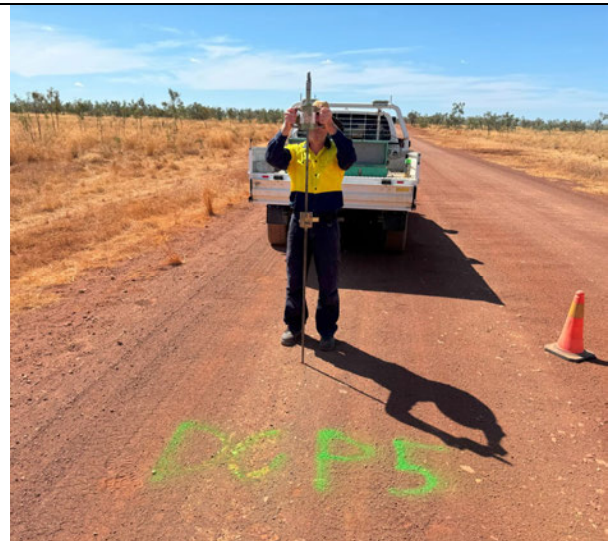
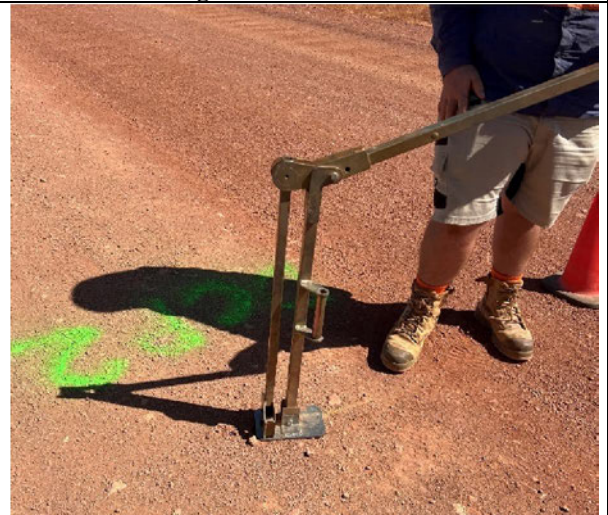
10 DCP tests were successfully performed at approximately 100m intervals along Normanton – Burketown Road from chainage 89650 to 90950. Figure 14 - Figure 17 demonstrate some of the testing in action, including hitting the cone into the ground by dropping the weight and removing the cone once it has been imbedded 1m.

Figure 14 – DCP4 Test

Figure 15 – DCP5 Test

Figure 16 – DCP6 Test

Figure 17 – DCP2 Removal

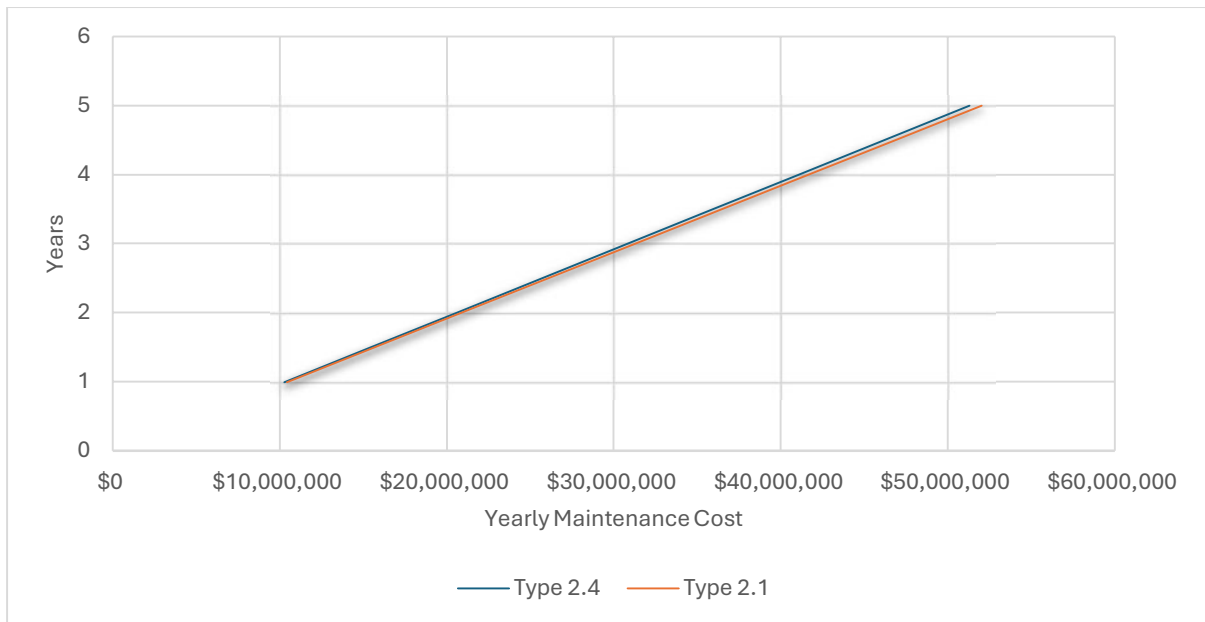
Figure 21 – Estimated Yearly Maintenance Costs
