University of Southern Queensland

# Measuring and monitoring of grain silos using laser scanning and total stations

**Bachelor of Spatial Science (Surveying)**

**October 2008**

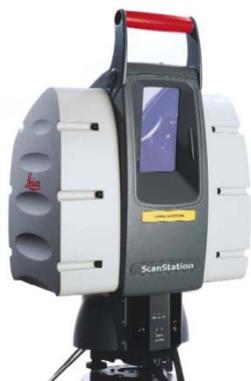
**Figure 2.1: Leica ScanStation2**

The ScanStation2 has the ability to setup over a known survey station and back sight to a known point. The scanner is also able to calculate a resection off 2 or more known points and is even able to traverse (reference). The ScanStation2 is also able to stake out known points. See appendix A for more ScanStation2 specifications.

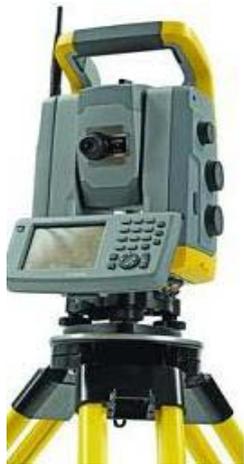
Figure 2.2: Trimble S6

The S6 has Direct Reflex technology that allows it to measure to surfaces or objects without the need of a survey target.

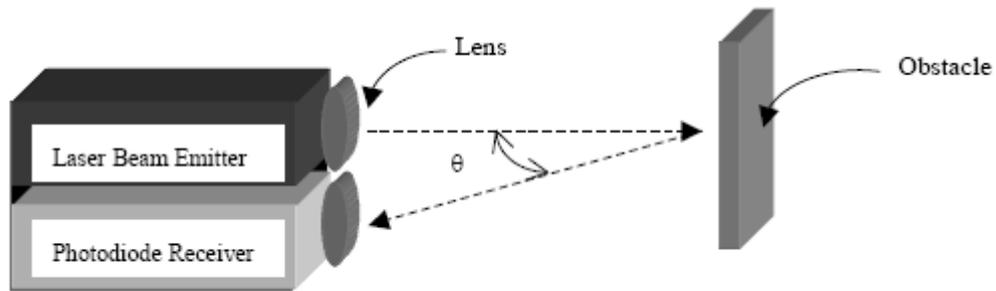
Pulsed time of flight is when the laser scanner sends out short pulses to the object or surface being scanned. The time recorded for the pulse to reflect back to the scanner is proportional to the distance travelled (Uren & Price, 2007). The laser pulse is scanned horizontally and vertically by rotating mirrors in the laser scanner. Like the phase modulation, true colour and laser intensity can be recorded.

**Figure 2.1: Time of flight method.**  
 (Source: <http://repository.upenn.edu>)

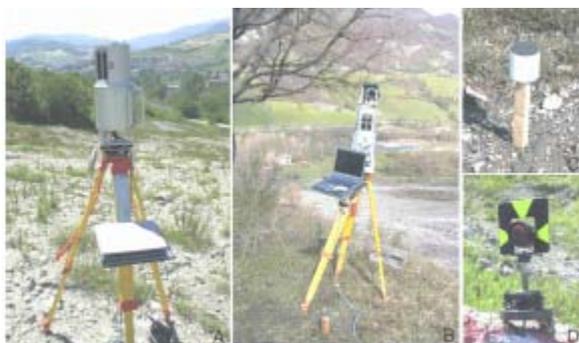
Bitelli et al (2004) used laser scanning to monitor a land slip site in Northern Italy (Fig. 1). Usually this type of work would be done by aerial photogrammetry methods. The traditional method of airborne surveying was compared to terrestrial laser scanning of the land slip site, which was 40,000 square meters in size. The authors found that the laser scanner provided a fast, accurate and relatively cheap way to monitor mid-size landslide areas compared to airborne survey techniques. A problem Bitelli et al (2004) found with the laser scanner that if the area had been heavily vegetated laser scanning would have been nearly impossible.

**Figure 2.2: Using laser scanning to monitor land slides.**

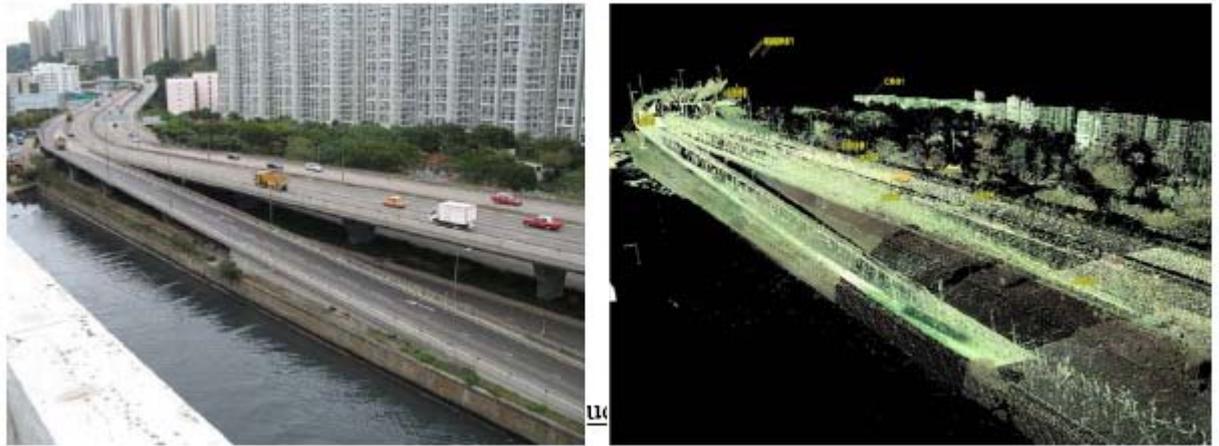
**Figure 2.3: Picture of area to be laser scanned and the point cloud**  
(Source: [www.fig.net](http://www.fig.net))

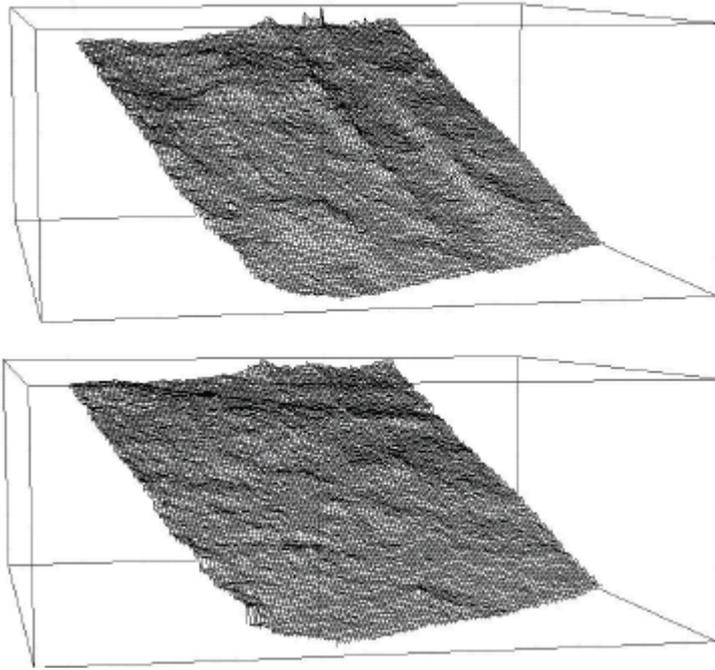
Schmid et al (2005) utilized laser scanning to monitor soil erosion in logging areas in south west Germany (Fig. 3). Laser scanning was used to scan the surface before logging, immediately after logging, and 1 year after logging. The scanner produced surface models of the area that showed the affect of the logging equipment tracks on the soil. This information was used to predict soil erosion patterns. A laser scan taken 1 year after logging showed the weather exposure to the surface area and any erosion that occurred during the year. By analyzing the surface models, the volume of soil removed by erosion was calculated.

**Figure 2.4: Monitoring heavy machinery tracks using laser scanning.**  
 (Source: [www.isprs.org](http://www.isprs.org))

Figure 3 shows that the laser scanner produced accurate surface models of the logged area and was also able to model the track marks of the logging equipment. One drawback of the laser scanner was the need to clear any vegetation on the ground, so an accurate surface model could be produced.

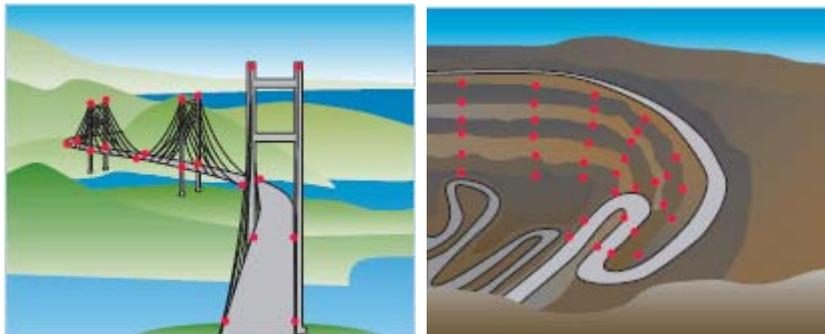
Deformation monitoring is carried out on many large structures such as bridges, dams, mines and large buildings. Traditional surveying techniques involved placing targets over the structure being monitored and distance and angle measurements made at various epochs in time. This process is costly and labor intensive.

**Figure 2.5: Bridge and Mine monitoring**

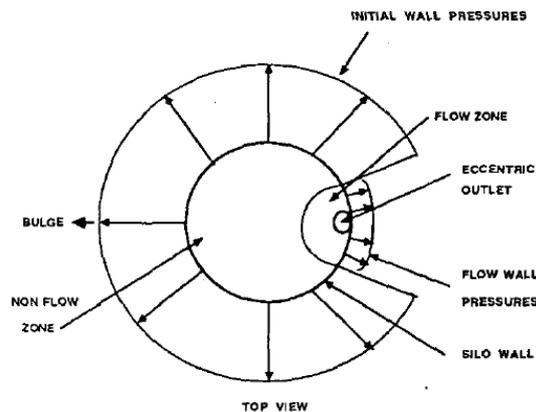
(Carson, 2004). When silos are unloaded, eccentric flow patterns can develop and cause stress and tension on the silo wall that the eccentric flow intersects (Figure 5). This in turn will lead to horizontal and vertical bending of the silo structure.

**Figure 2.6: Silo Bending**  
(Source: [www.jenike.com](http://www.jenike.com))

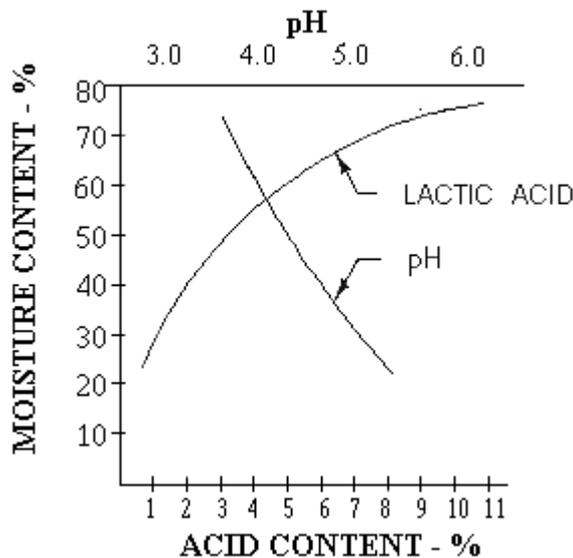
Silage acid deterioration occurs when moist plant material is stored in a concrete silo. Hydrated plant material produces lactic and acetic acids. The higher the moisture content of the material being stored in the silo, the higher is the rate of silage acid produced (Figure 6). When acids come into contact with the Portland cement, concrete strength decreases (Bellman, 1996).

**Figure 2.7: Acid content in grain silos**

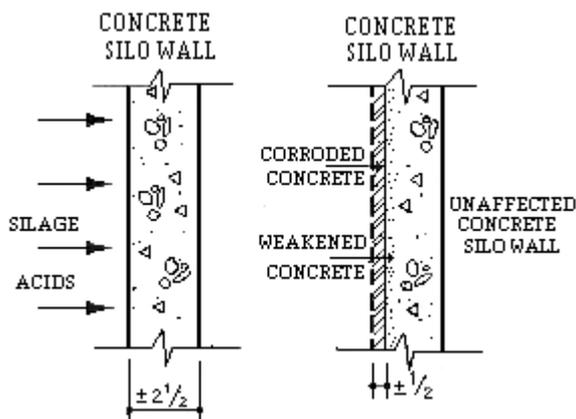
The effect of acid deterioration is very serious because the acids attack the bottom of the silo which is the part of the wall that carries the greatest vertical pressure (Bellman, 1996). Silage acids reduce the thickness of concrete silo walls and this can lead to complete failure of the structure (Figure 7).

**Figure 2.8: Silo wall Damage**

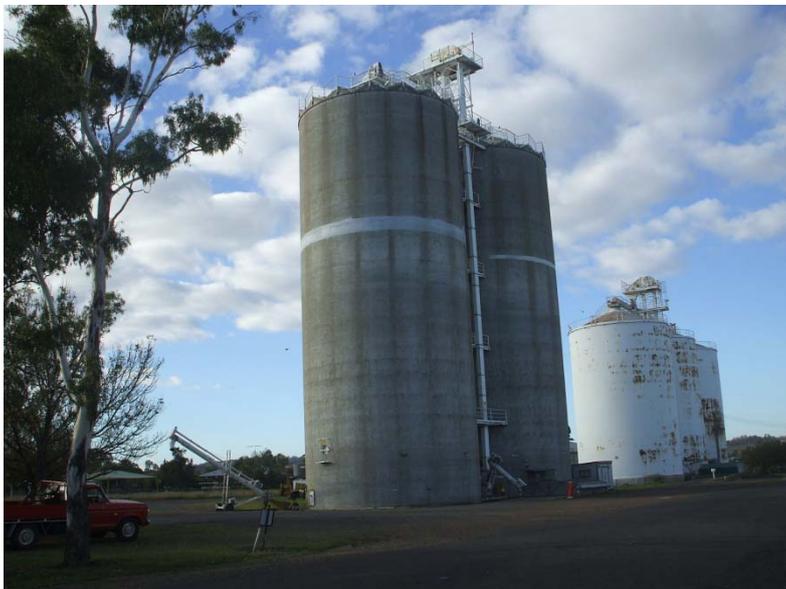
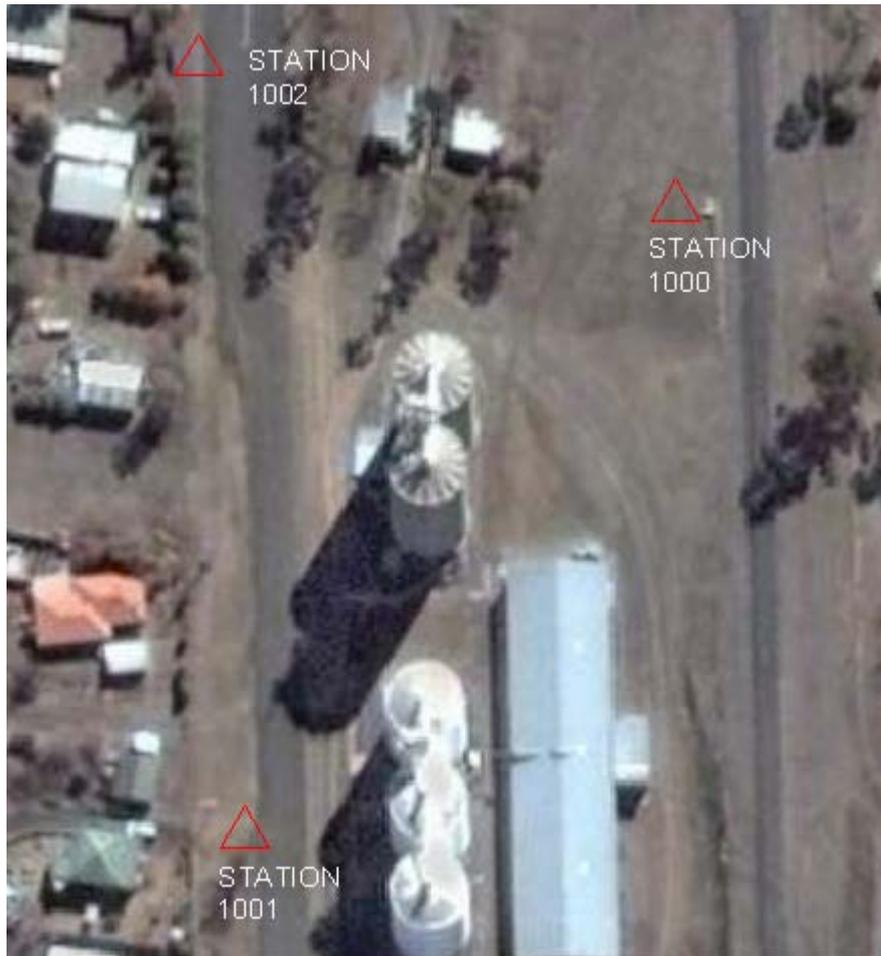
Figure 3.1: Cambooya Test Site

The grain silo site that will be used will be the Graincorp grain facility at Cambooya. The facility is equipped with two 30 metre tall grain silos with a diameter of 10 metres. There are also 2 large prefabricated steel silos to the east of the main concrete silos and a large grain shed behind the steel silos.

A road runs along south of the concrete grain silos and a railway line runs to the north. This presents position problems for survey the control network due to safety and line of site difficulties.

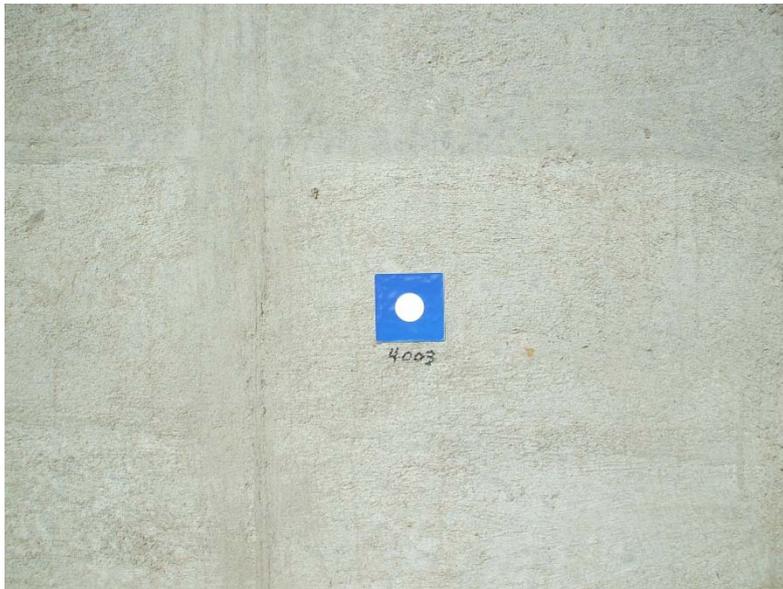
**Figure 3.3: Leica HDS target**

The targets to be used for monitoring positions on the will be the Leica survey targets are included in the ScanStation2. These survey targets are able to be automatically recognised by the ScanStation2 while also be able to be used as a target by the Trimble S6.

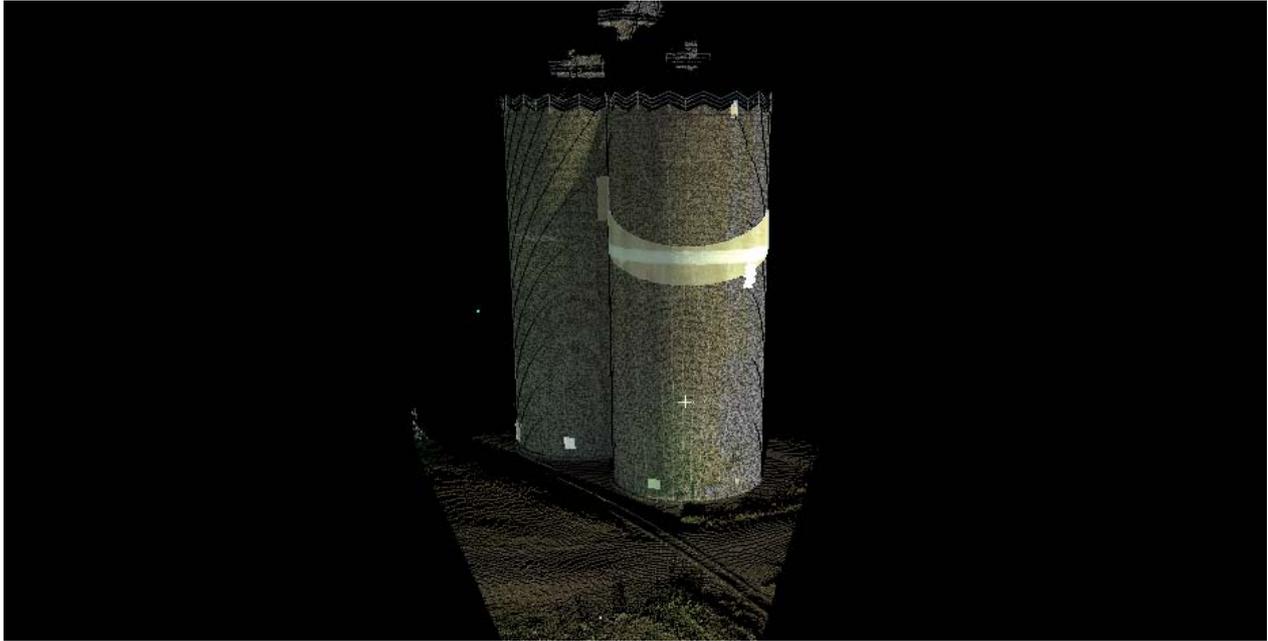
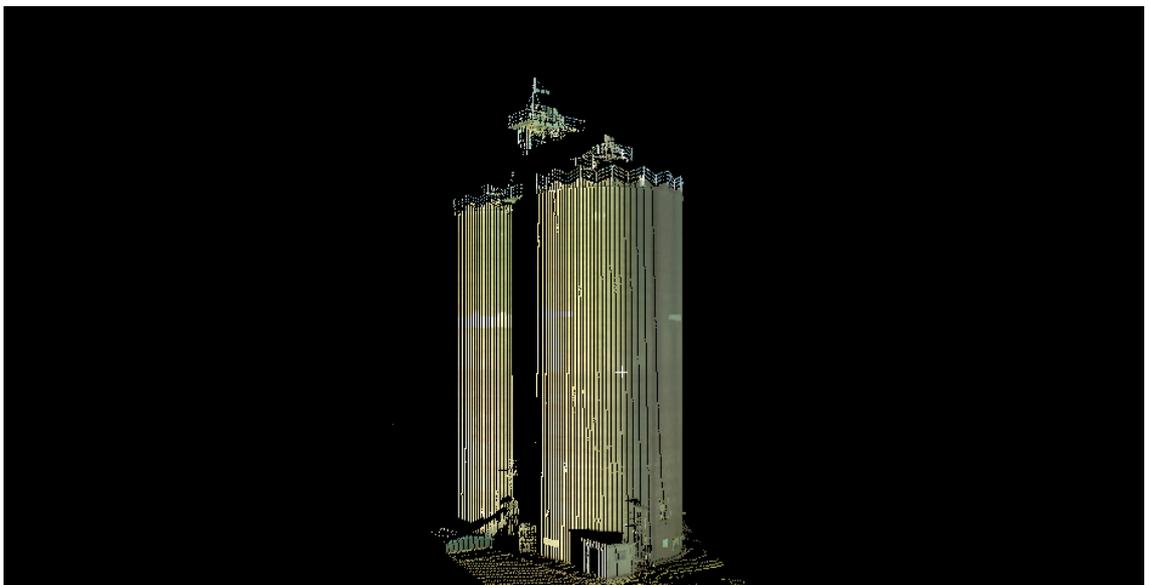
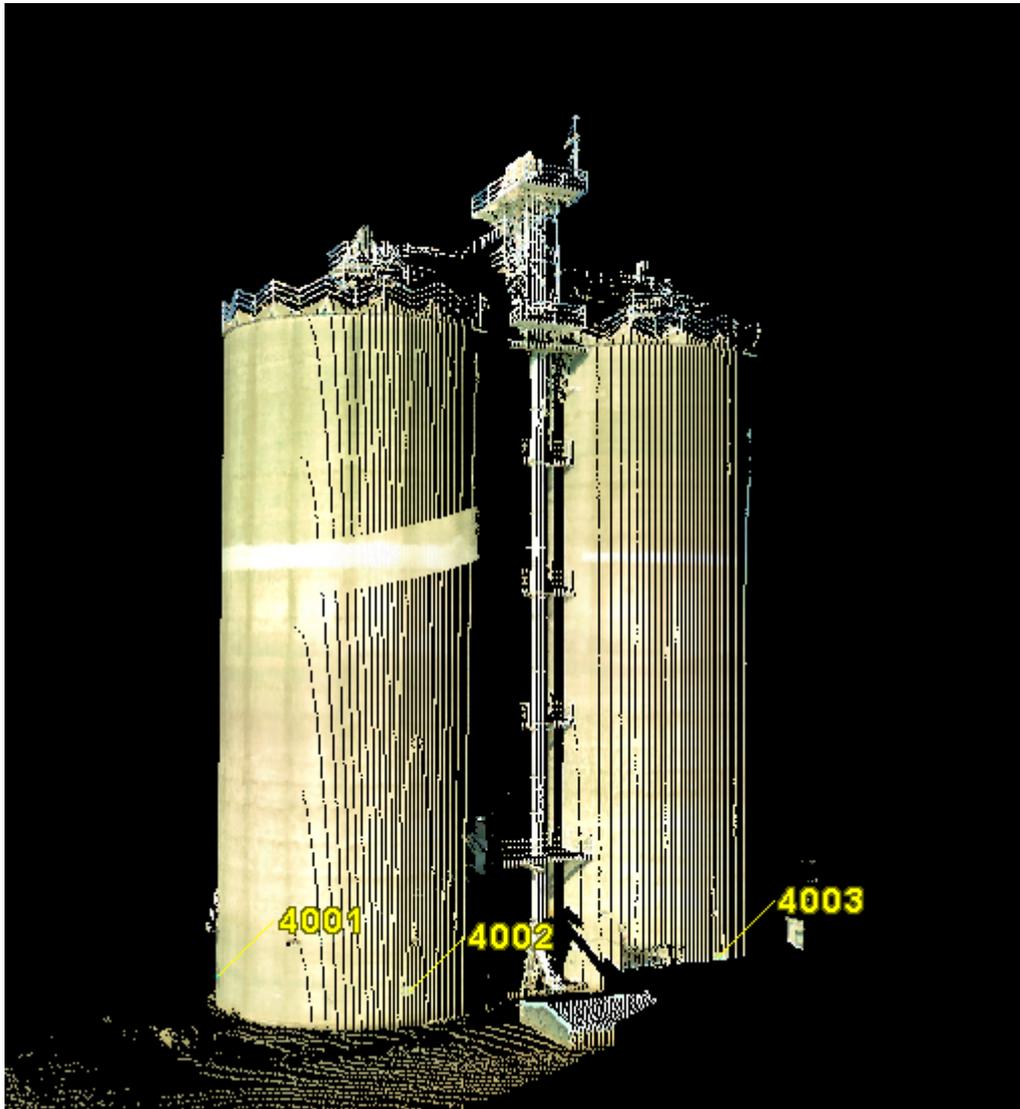
Figure 4.1: Scan from survey control station 1000

Figure 4.2: Scan from control station 1001

**Figure 4.3: Scan from survey control station 1002**

As can be seen in figures 4.0, 4.1 and 4.2, the Leica ScanStation2 was able to successfully scan the grain silo from the three survey control stations. The three Scan Worlds were then registered to together to form a complete 4D model of the grain silo.

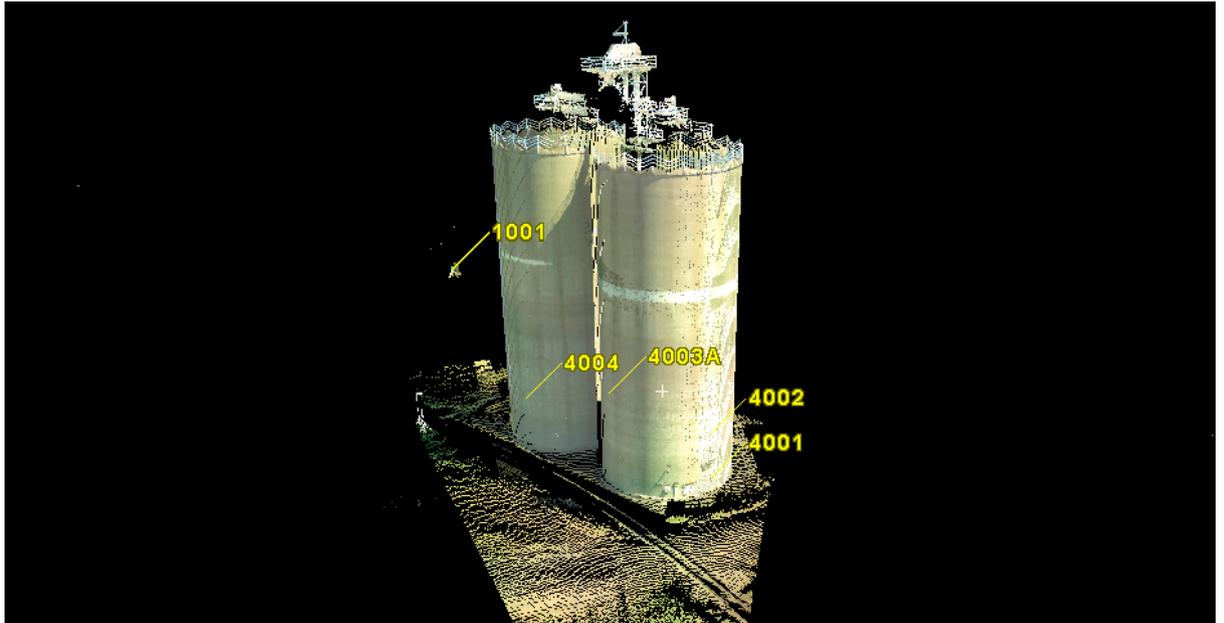
Figure 4.4: Registered Scan World

The 3 Scan Worlds were successfully registered together and figure 4.3 shows the complete 3D model of the structure.

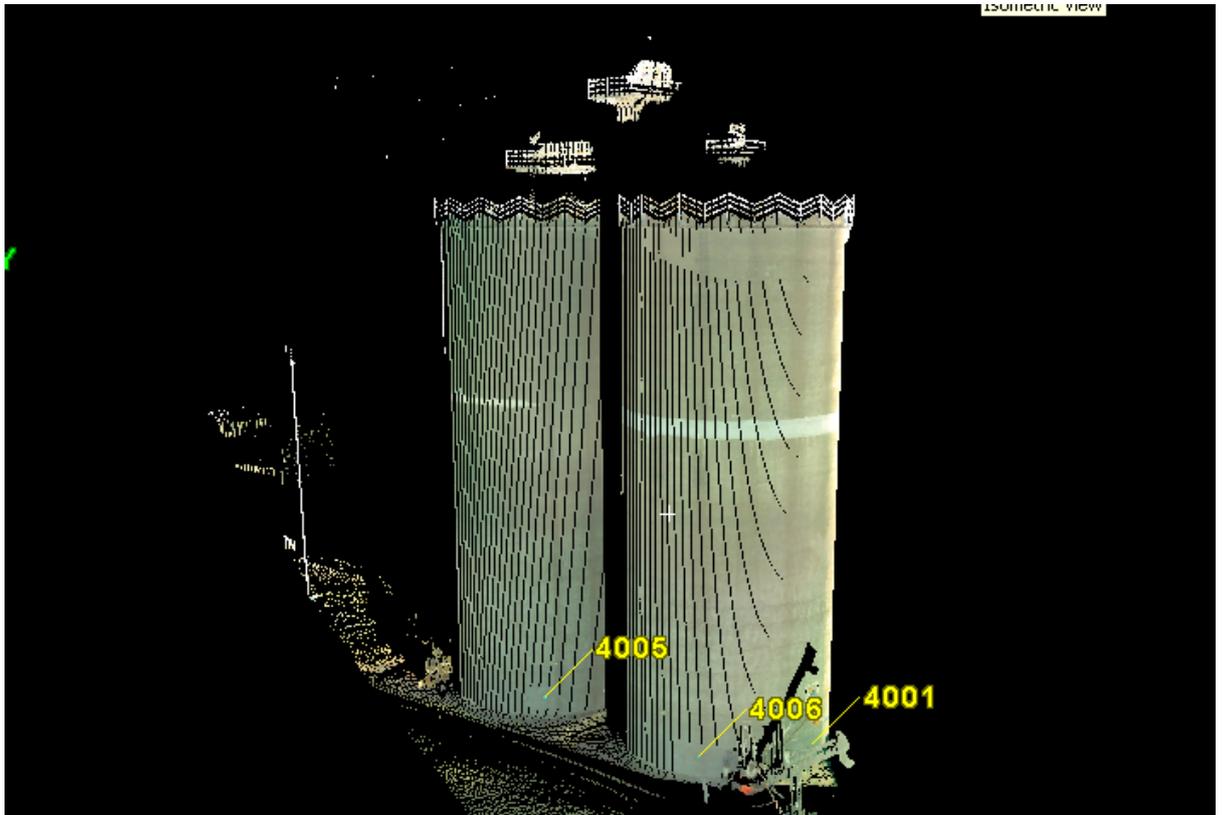
Figure 4.5: Scan World 1000

Scan World 1000 is the second scanning session from the control survey station 1000. As can be seen the HDS survey targets 4001, 4005 and 4006 were acquired during the scan. As can be seen a large portion of the eastern side of both the northern and southern grain silos was acquired.

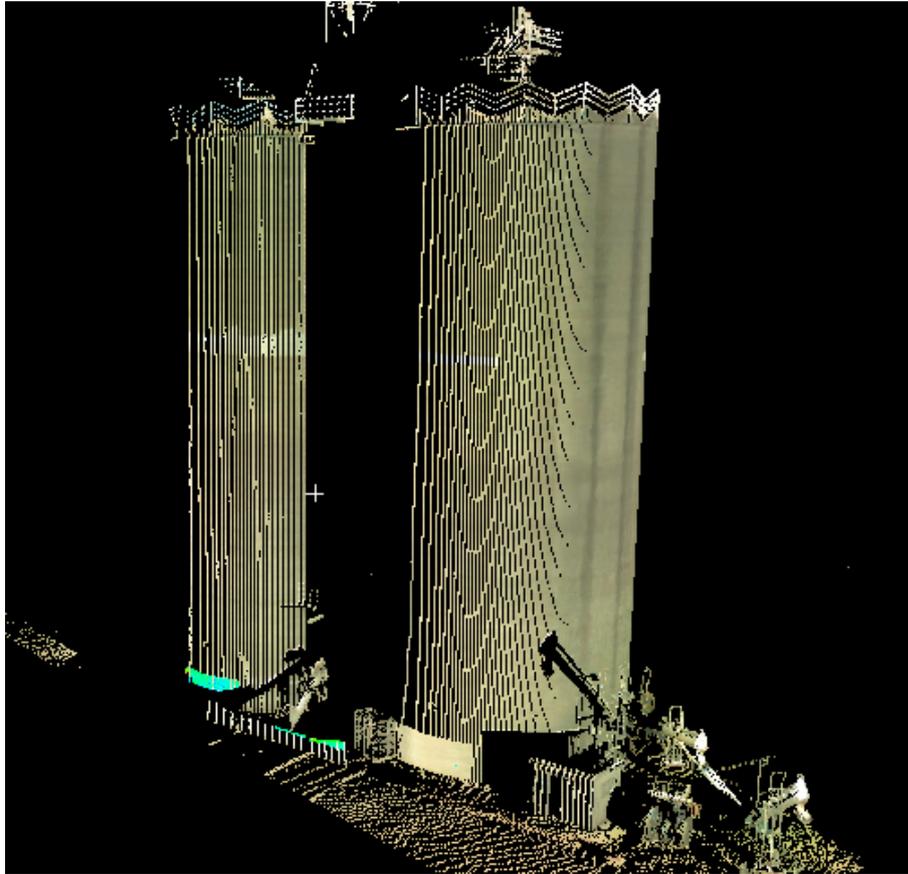
**Figure 4.6:** Scan World 1001

Due to the machinery being parked in front of target 4004 i was unable to obtain any results for the HDS target 4004. The HDS target 4003 was able to be obtained in Scan World 1001. This obstruction has affected both the Scanstation2 and the Trimble S6 which was also unable to obtain any readings for 4004.

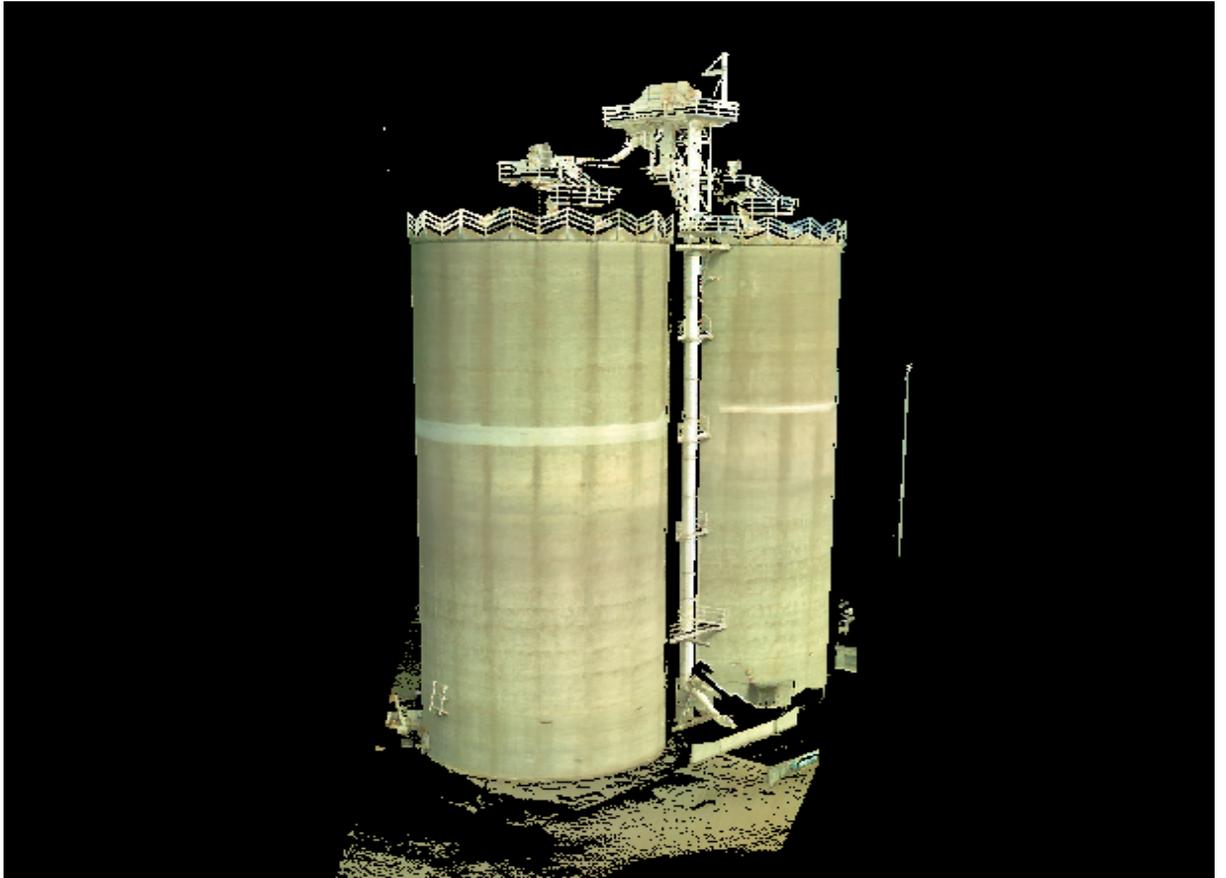
**Figure 4.7: Scan World 1002**

Figure 4.22 shows the resulting scan after a scan was taken from the survey control station 1002. As can be seen the scan has picked up a good proportion of the western sides of both the northern and southern grain silos as well as the access facility between the silos.

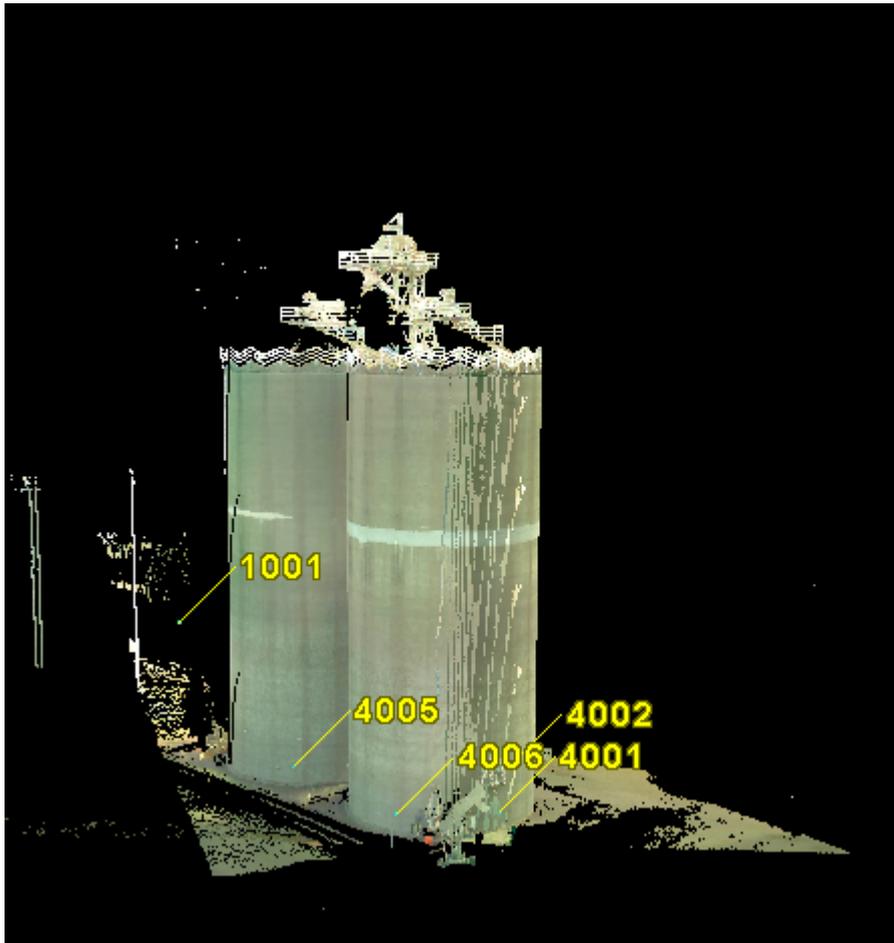
Figure 4.3: Registered Scan World

Figure 4.23 shows the 3 Scan World sessions registered together to form a complete 3d model of the grain silo. As can be seen the 3 Scan Worlds fit into each other quite well and as the error table will show in table

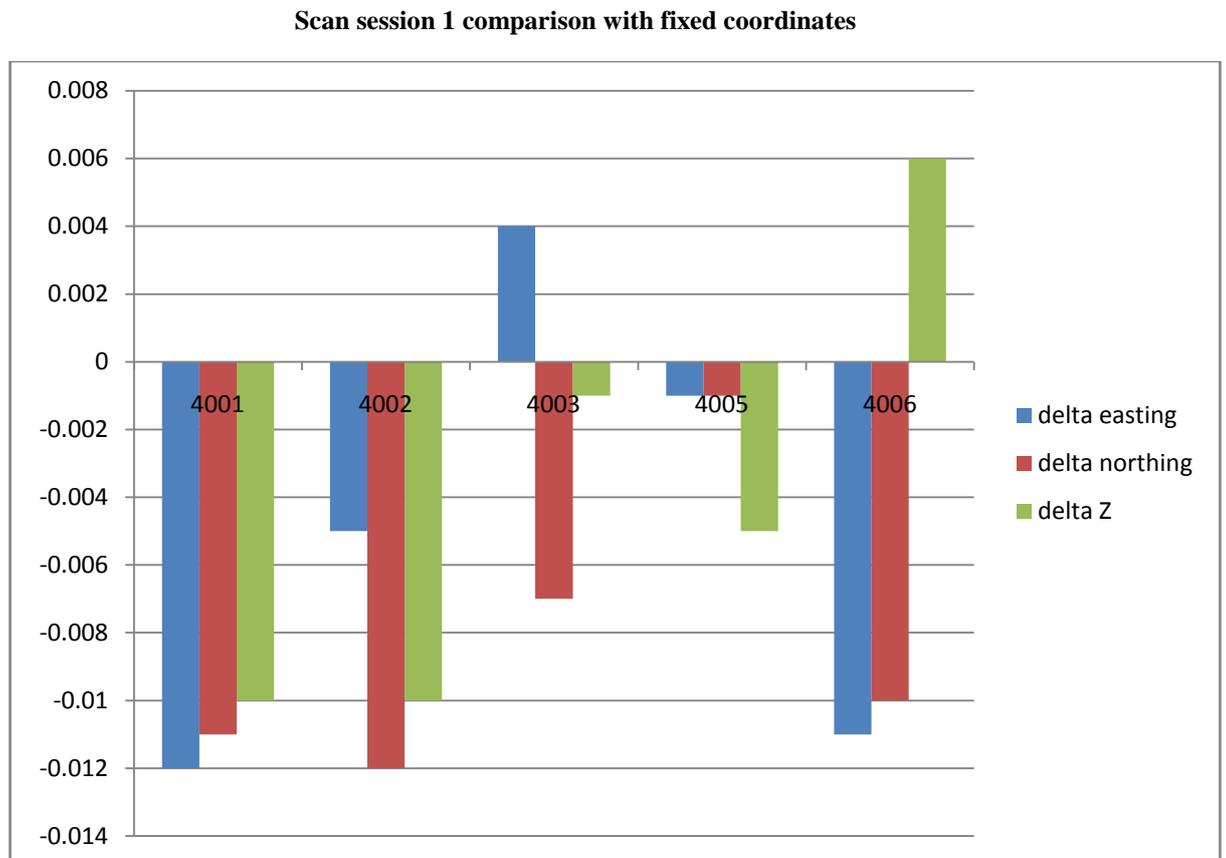
Figure 4.4 shows a comparison between the coordinates of the first laser scan session and the fixed coordinates for the HDS targets.

**Figure 4.4: Scan session 1 comparison to fixed coordinates**

As can be seen in figure 4.4 the differences are quite large compared to the differences between the coordinates picked up by the Trimble S6.

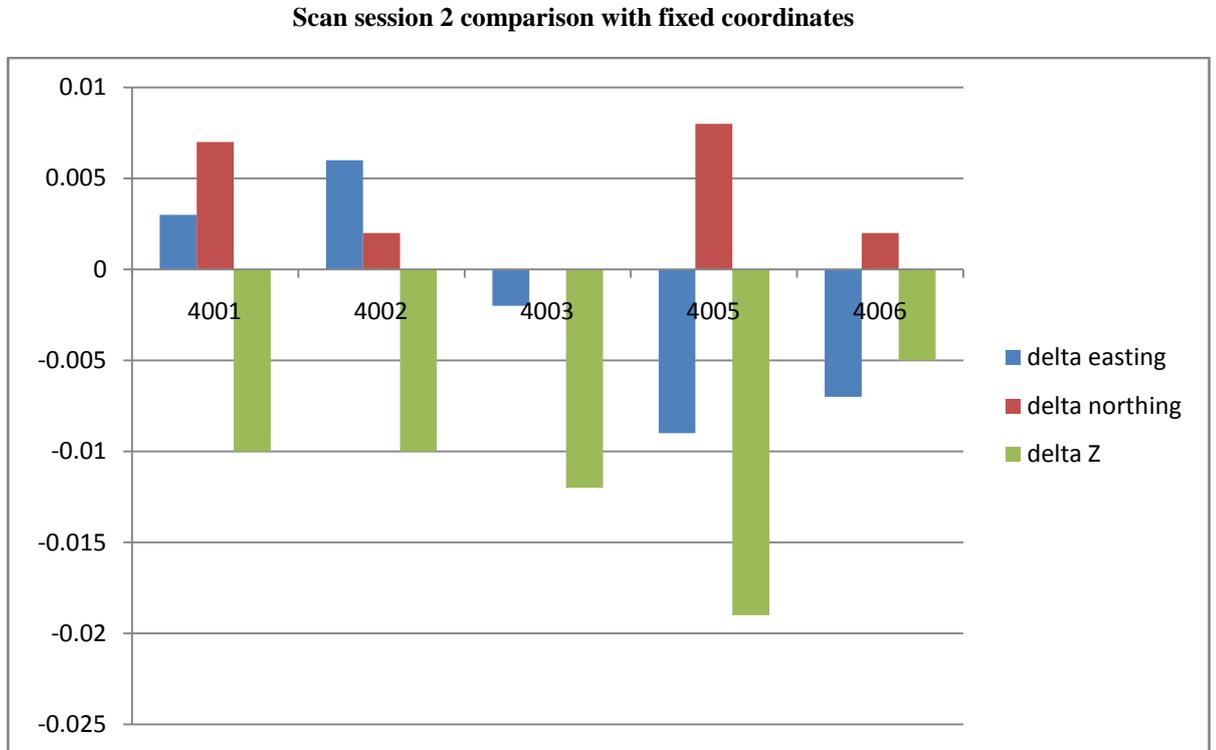
Figure 4.10 illustrates the movements between the fixed coordinates and the scan session 2 coordinates.

**Figure 4.10: Coordinate comparison between fixed and scan session 2 coordinates**

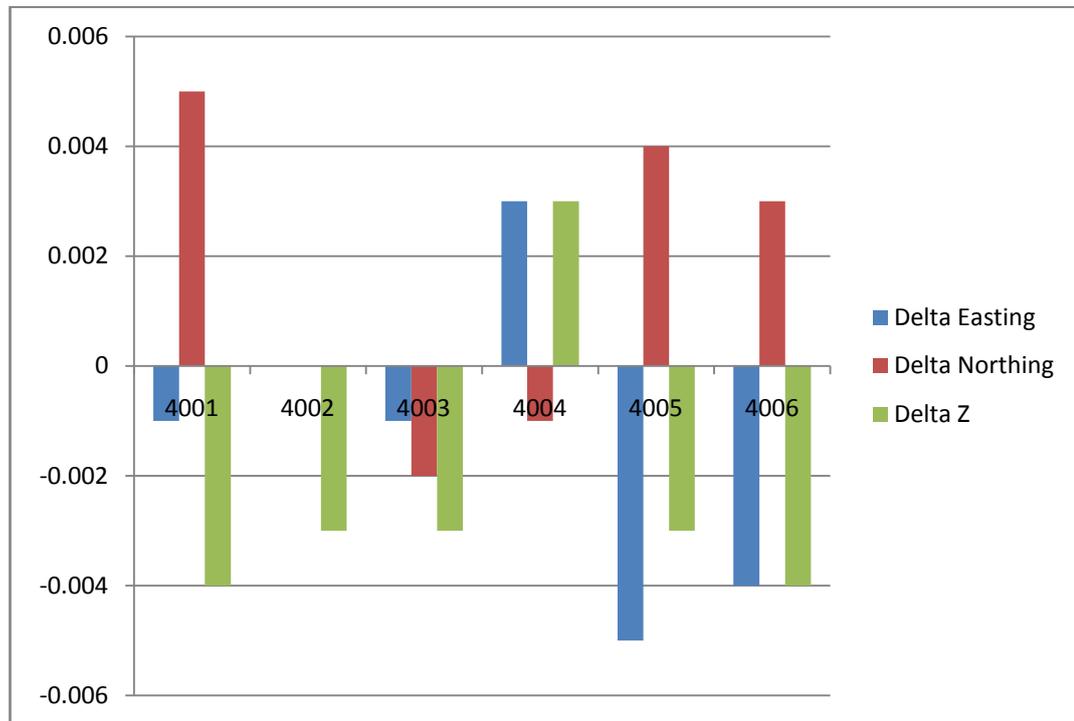
**Figure 4.11: Comparison between first session coordinate and second session coordinates.**

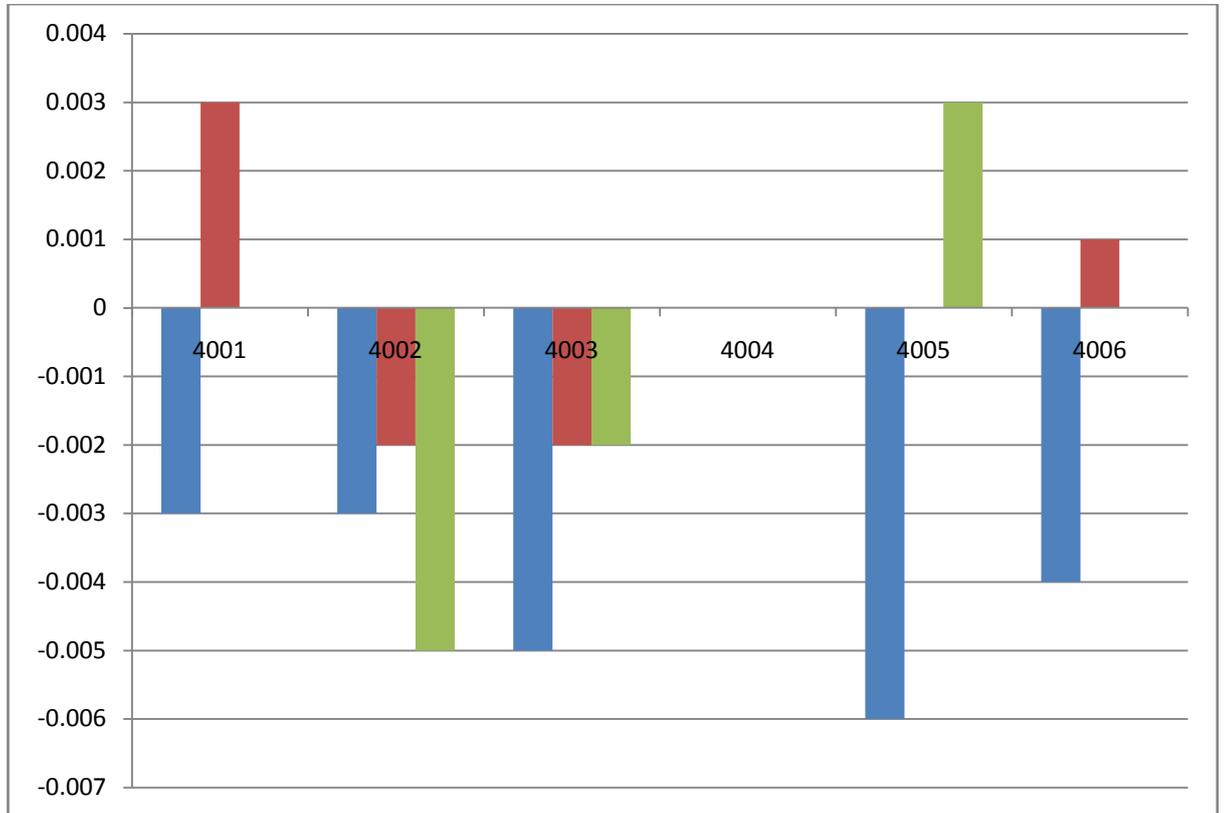
**Figure 4.12: Session 1 and session 3 coordinate comparison.**

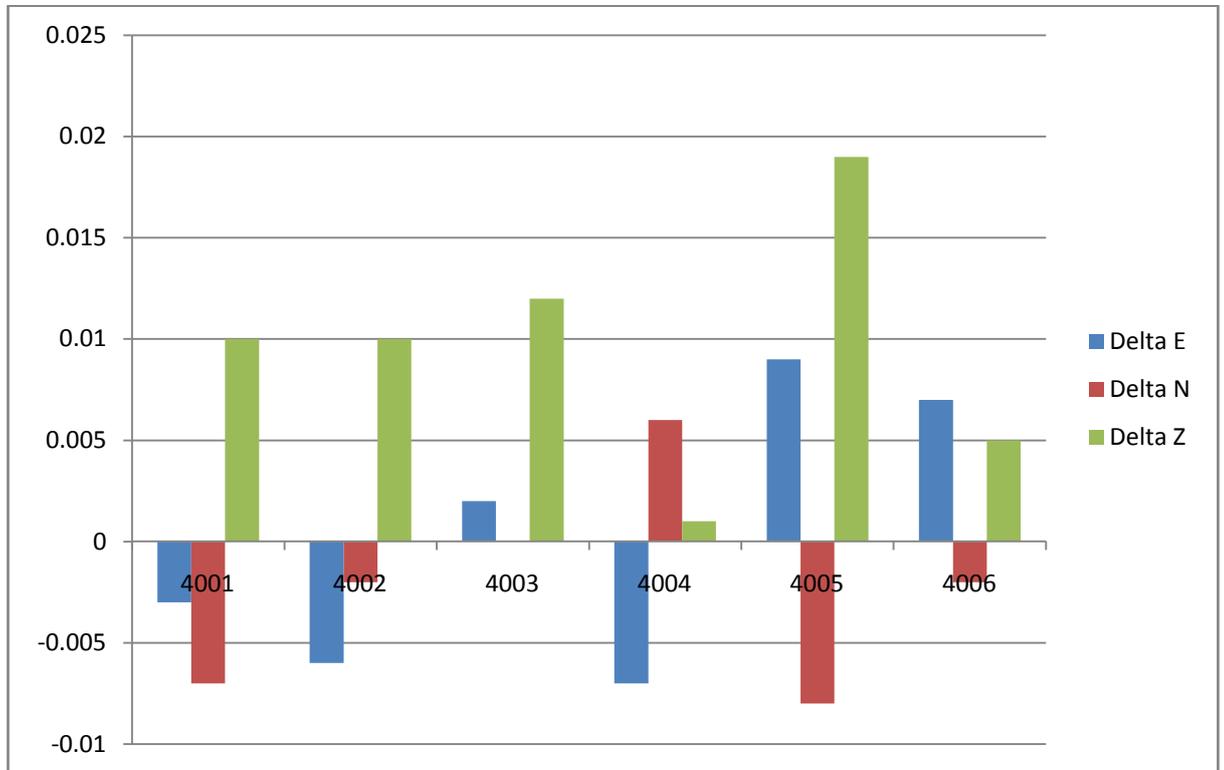
**Figure 4.13: Coordinate comparison between survey session 1 using the Leica ScanStation2 and survey session 1 using the Trimble S6**

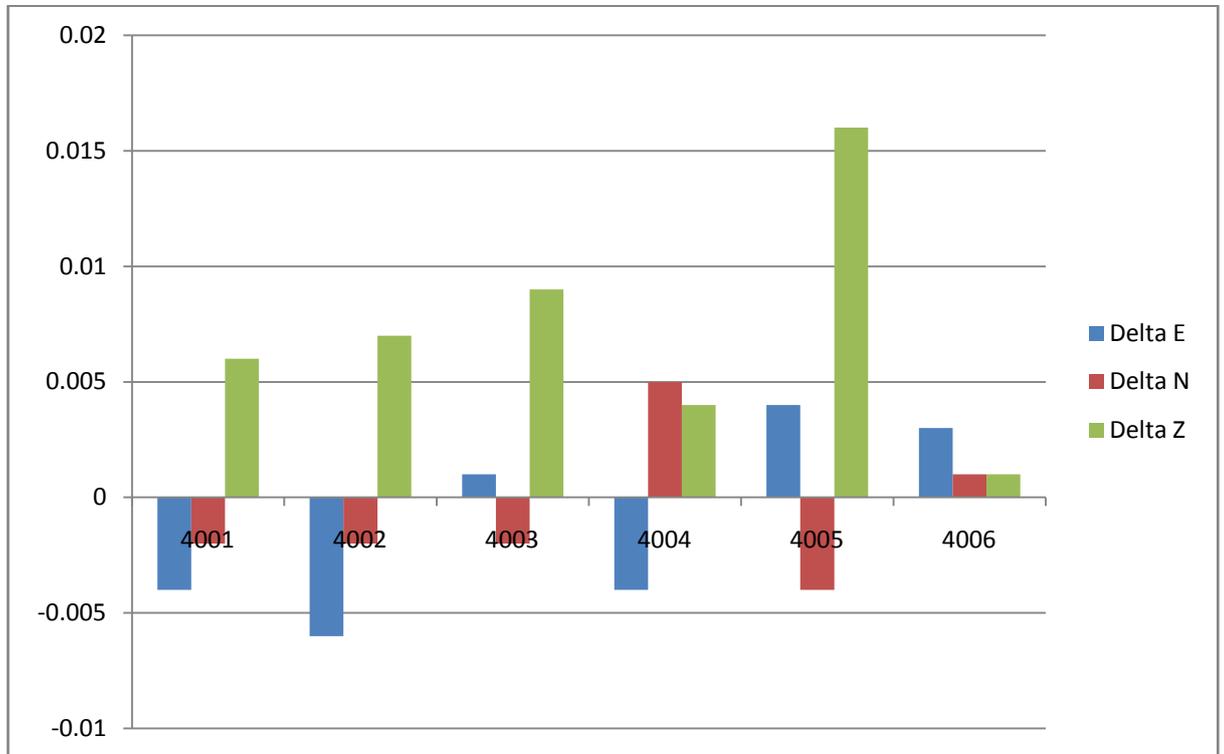
**Figure 4.14: Coordinate comparison between survey session 1 using the Leica ScanStation2 and survey session 2 using the Trimble S6**

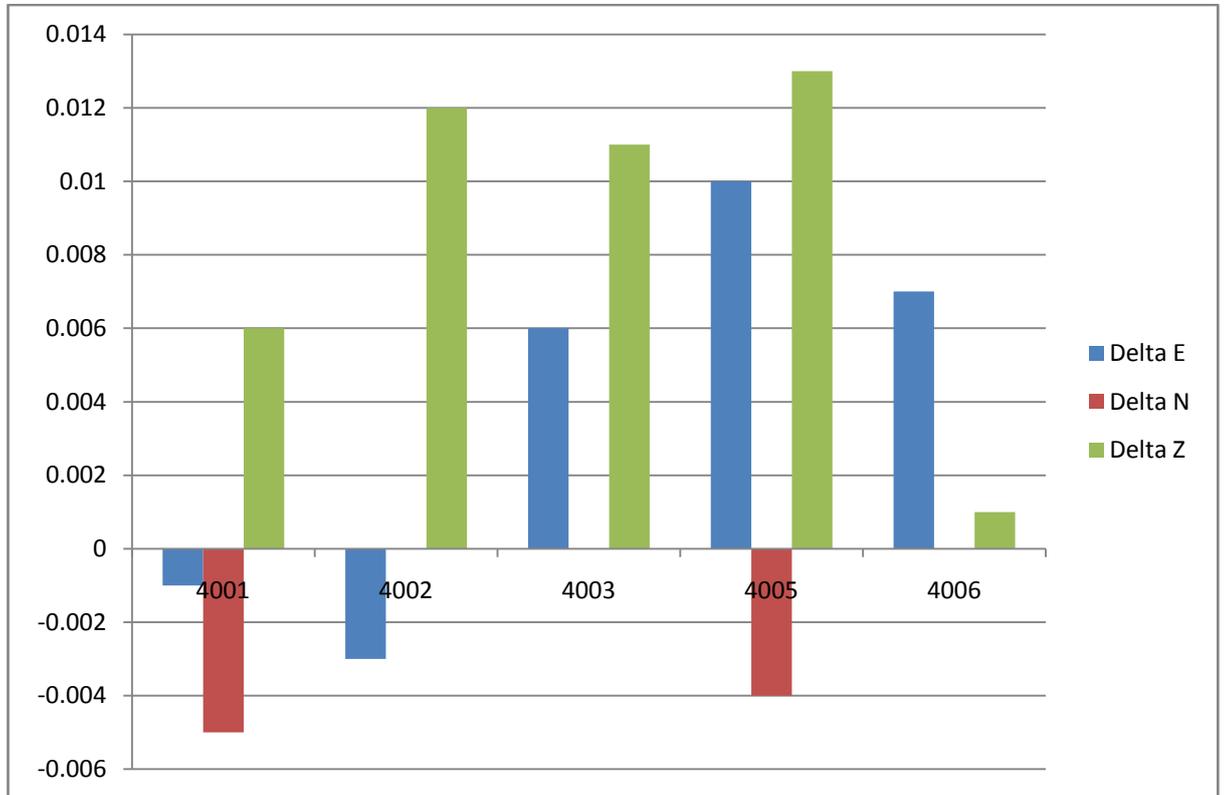
**Figure 4.15: Coordinate comparison between survey session 1 using the Leica ScanStation2 and survey session 3 using the Trimble S6**

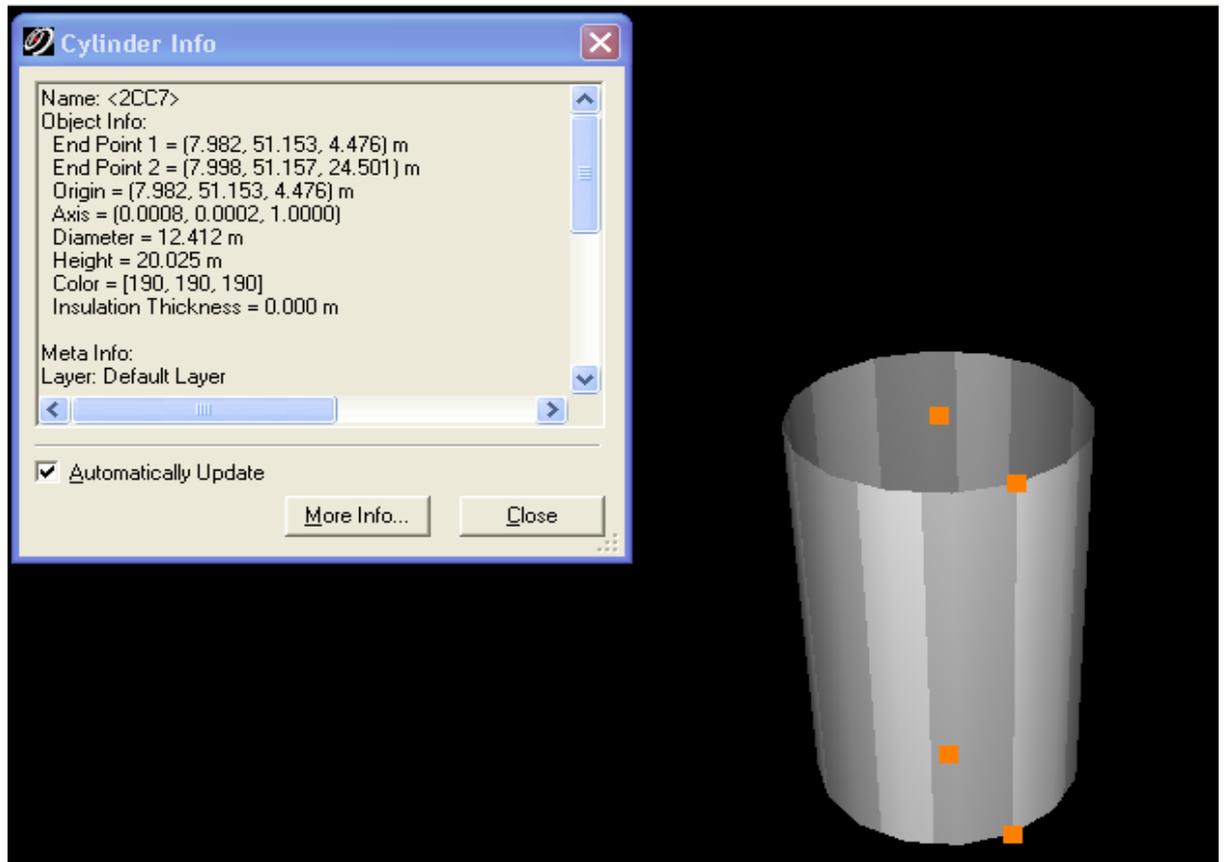
A 20 metre section of the registered scan was selected and transferred to a new modelspace. The point cloud was then modelled into a solid cylinder using the 'fit to cloud' command.

Figure 4.16: Northern grain silo solid model

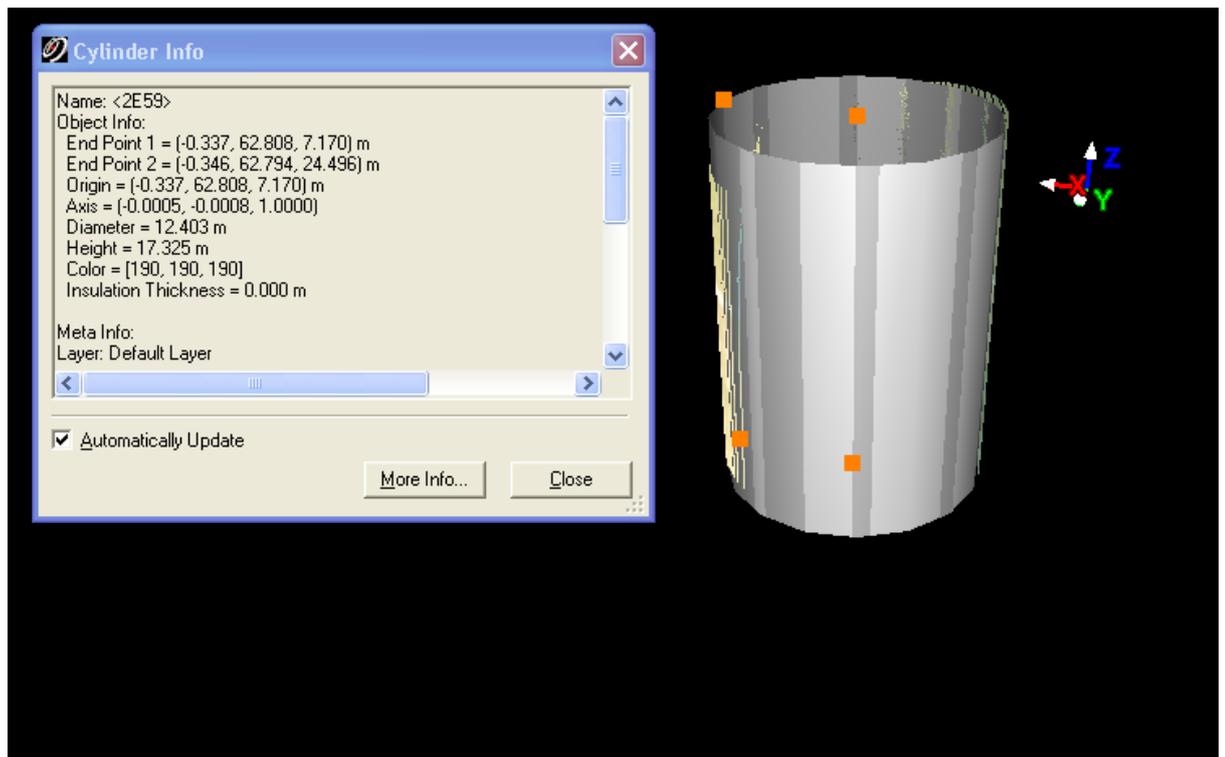
A section of the southern grain silo was then selected and copied into a new model space. Like in the northern silo the command 'Fit to Cloud' was used to model a solid of the grain silo.

Figure 4.17: Southern grain silo solid model
