University of Southern Queensland

# Measuring and monitoring of grain silos using laser scanning and total stations

**Bachelor of Spatial Science (Surveying)**

**October 2008**

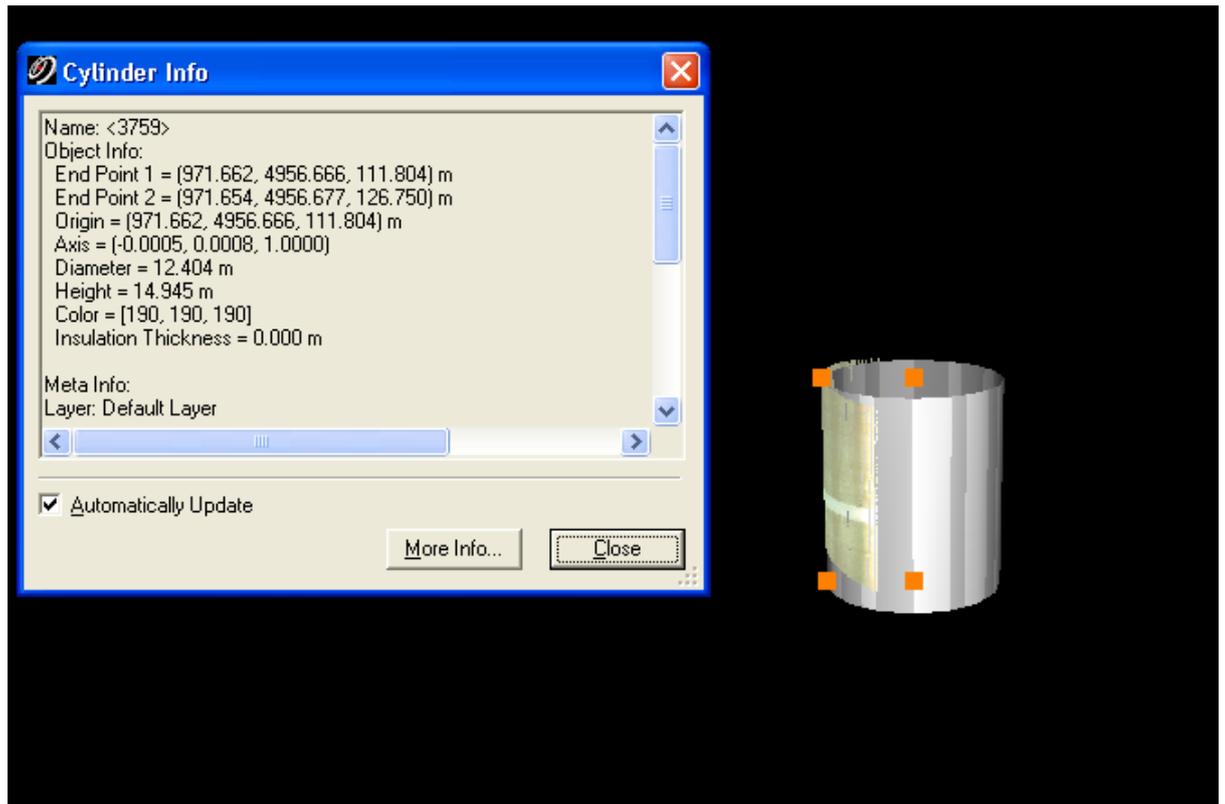
The northern silo was modelled using the same procedure as the first scan session. A 14 metre section of the silo was selected and copied to another modelspace. This was then modelled into a cylinder.

**Figure 4.18: Modelled section of northern grain silo**

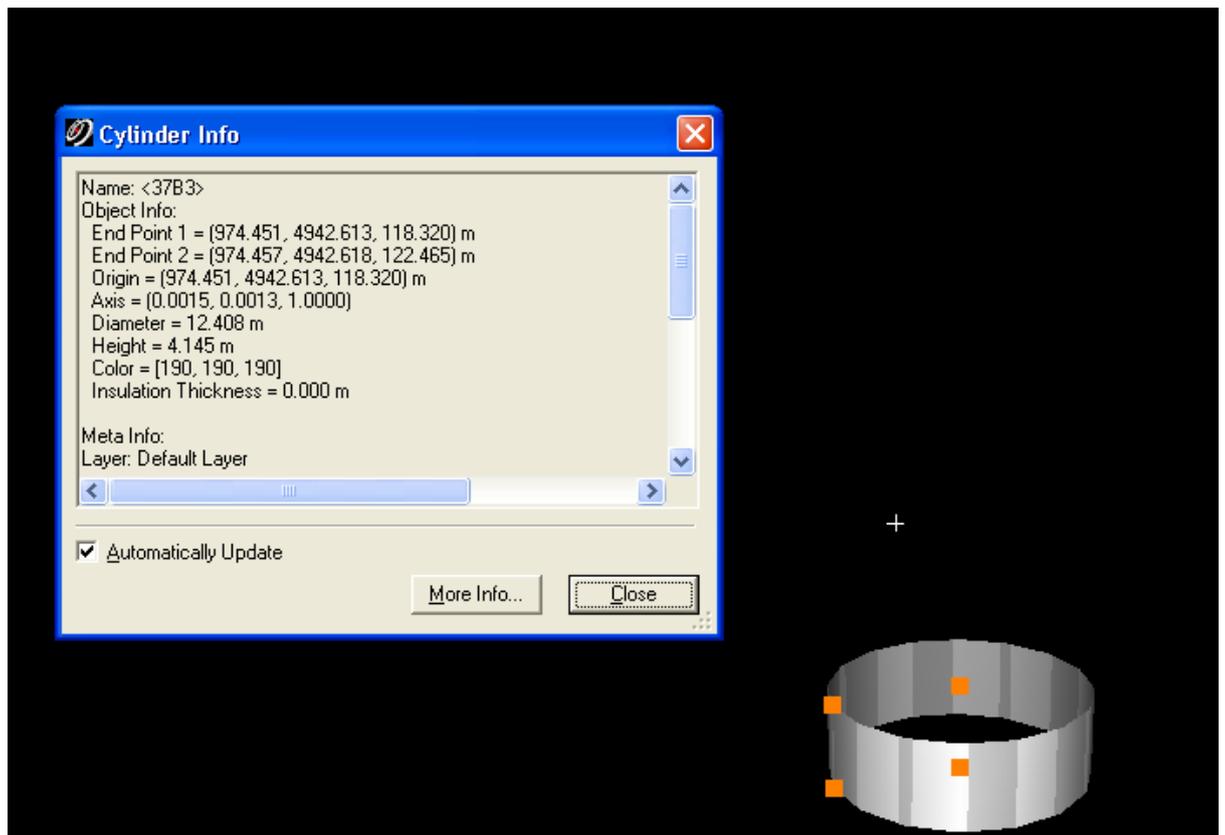
A section of the southern silo was then selected and copied into a new modelspace. This was then modelled into a cylinder.

**Figure 4.19: Modelled section of southern silo**

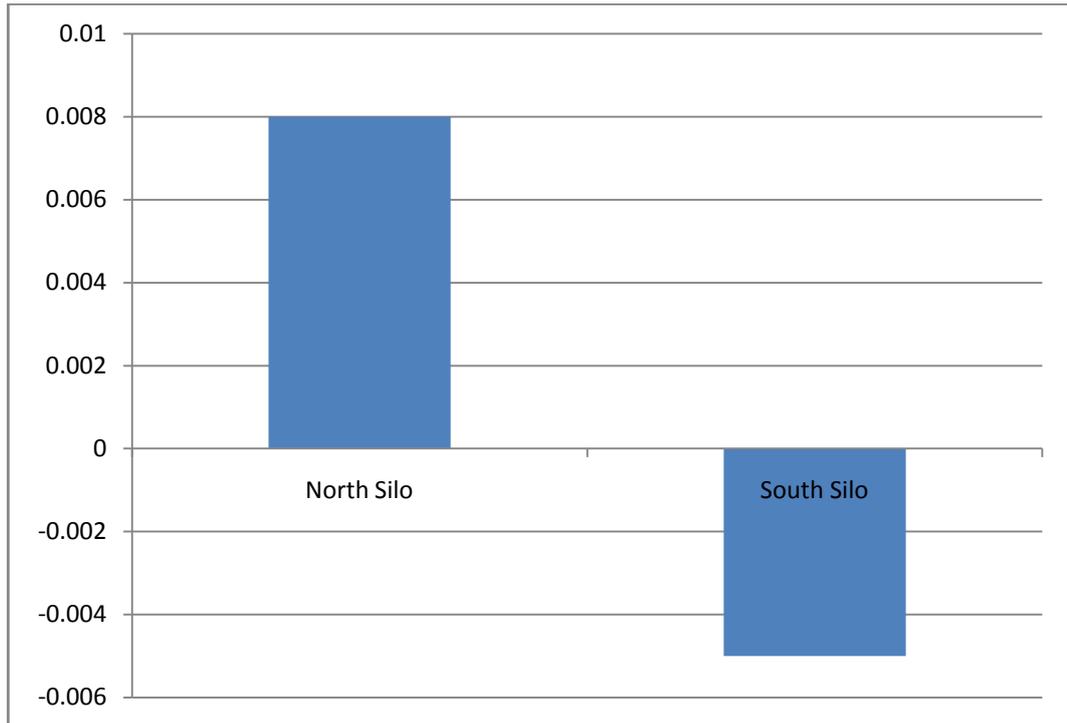
**Figure 4.20: Diameter differences between scan session 1 and scan session 2.**

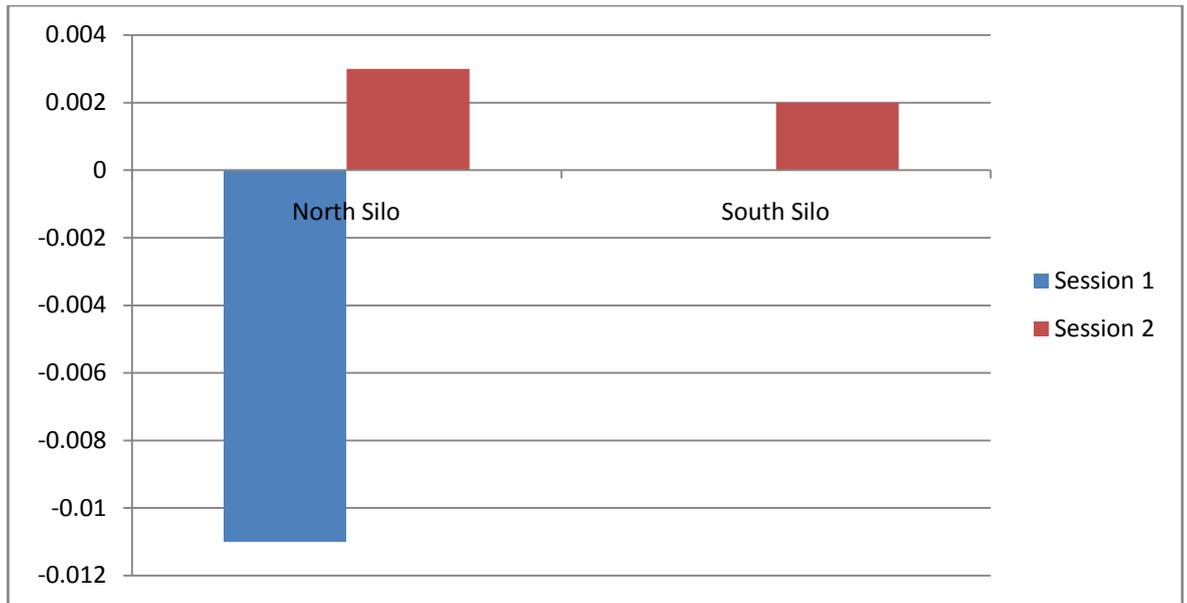
Figure 4.20: Diameter Differences between Trimble S6 calculated diameter and Leica ScanStation2 diameter.

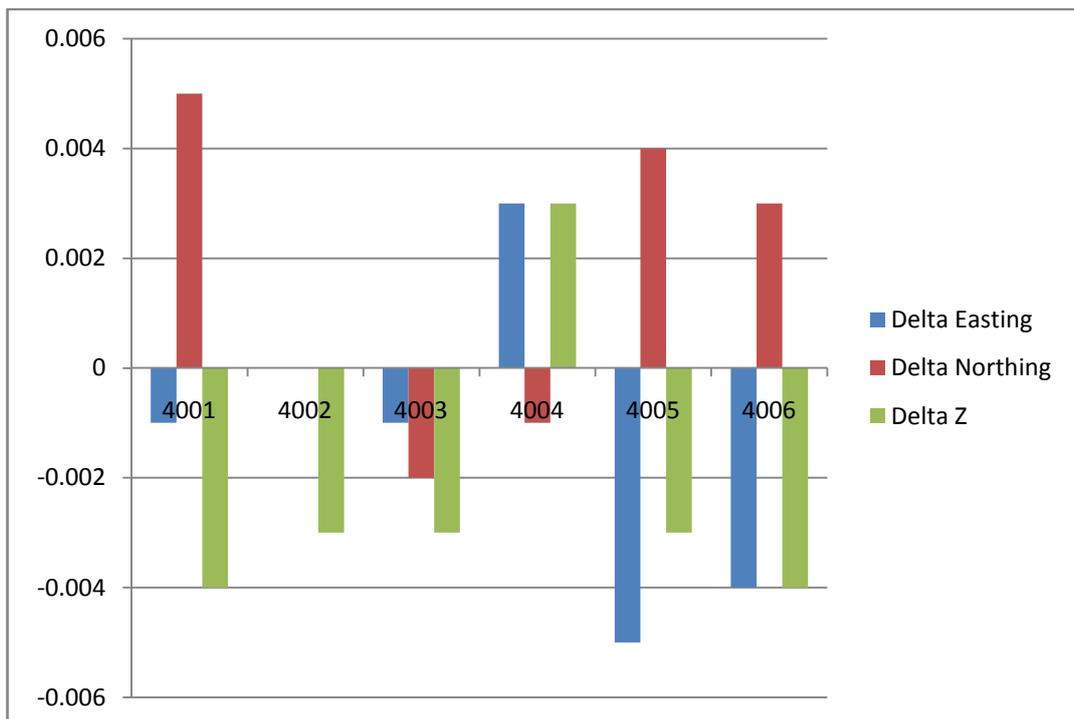
**Figure 5.2: Trimble S6 survey session 1 and Trimble S6 survey session 2 comparison.**

caused by the silo being filled with grain at the time of the second survey session. These results were not unexpected as the Trimble S6 has a stated accuracy of  $\pm 3\text{mm}$  and 2ppm. Because the differences in coordinates were so small it can be safely assumed that there was no or minimal deformation in the grain silo during survey session. The conditions that the survey sessions were conducted in were very similar in that there was an ambient temperature of around 20 degrees Celsius.

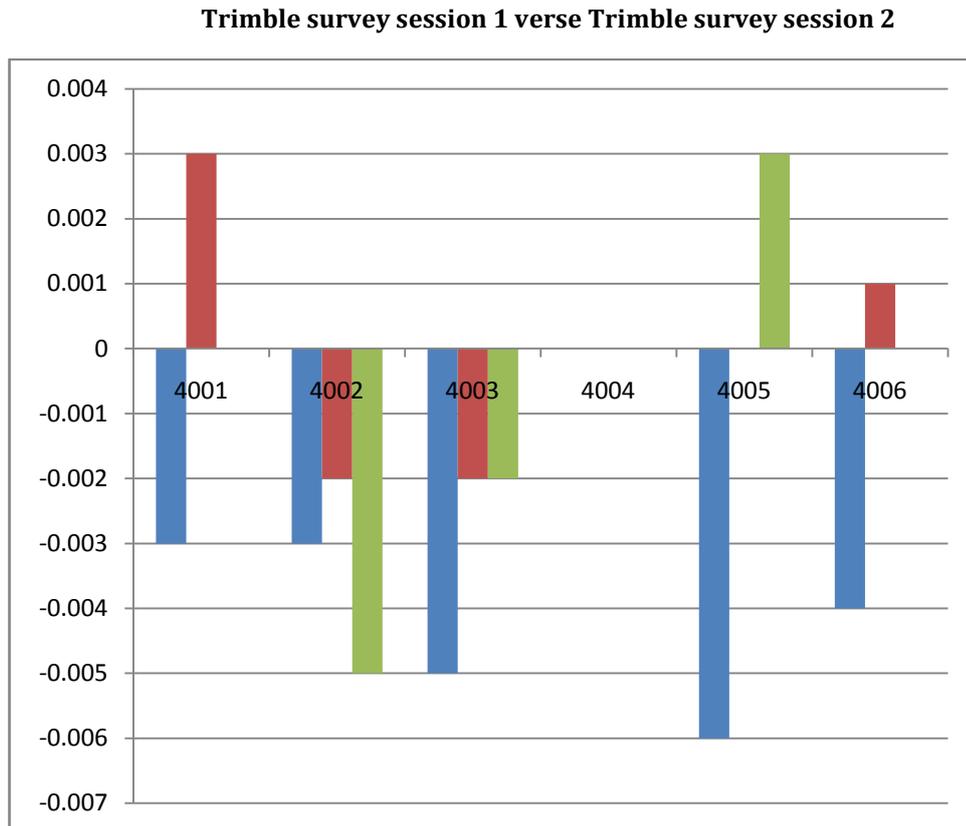
Figure 5.3 shows the coordinate comparison between survey session 1 and survey session 3. Again as shown in Figure 5.3 the differences were again quite small between the survey sessions.

**Figure 5.3: Trimble survey session 1 verse Trimble survey session 2**

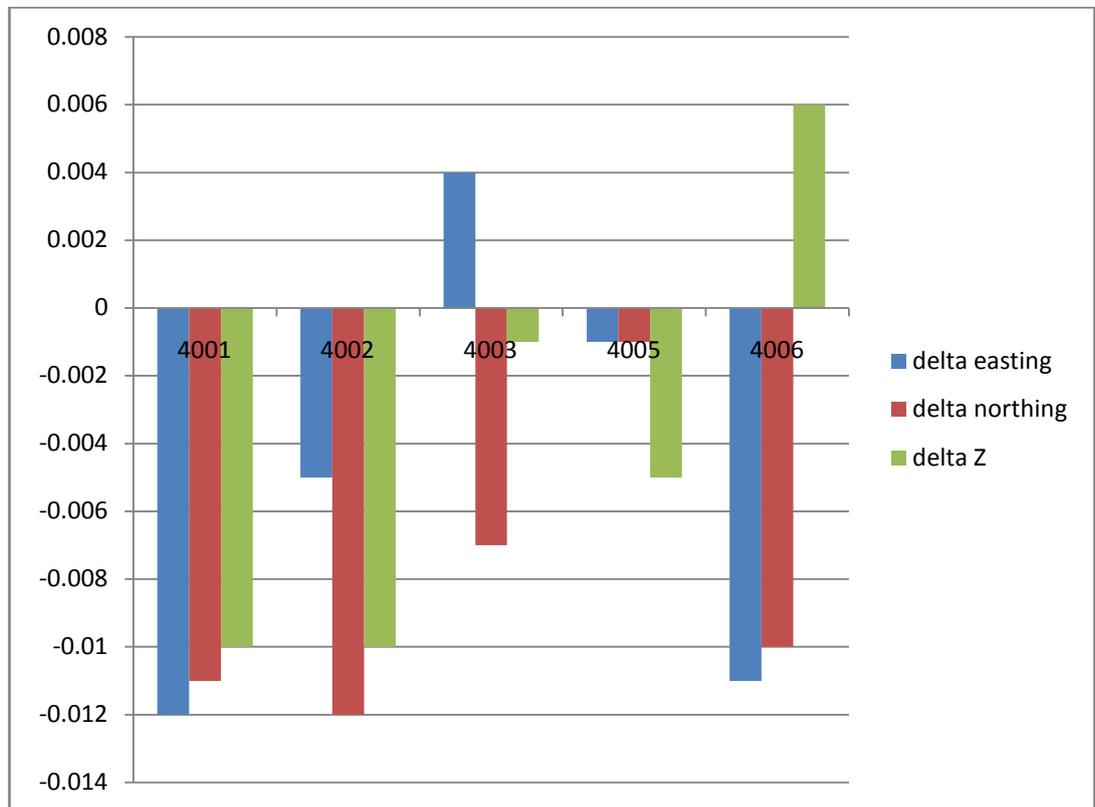
Figure 4.9: Coordinate comparison between fixed and scan session 2 coordinates

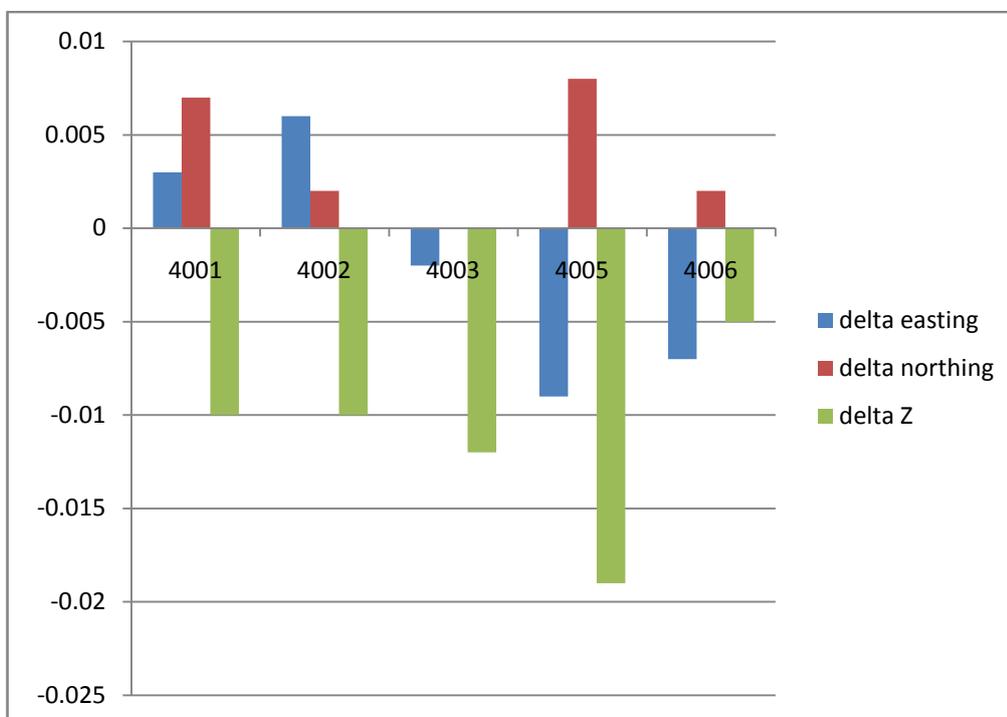
**Figure 4.10: Coordinate comparison between fixed and scan session 2 coordinates**

As in Figure 4.10 the differences in the coordinates are again quite large. As in the Trimble survey session 2 HDS target 4004 was not able to be surveyed as machinery was in the way. The delta differences are again around the 10mm difference. Again this result was not unexpected and again showed that the Trimble S6 was more accurate in the survey of the HDS targets. It was interesting to note that all the Z deltas were in the negative. This was similar in the Trimble survey session 2 and I believe that this shows a slight downward movement in the silos foundations when the silo is loaded with grain. This movement in the silo is very small and is not unexpected in structures of this size.

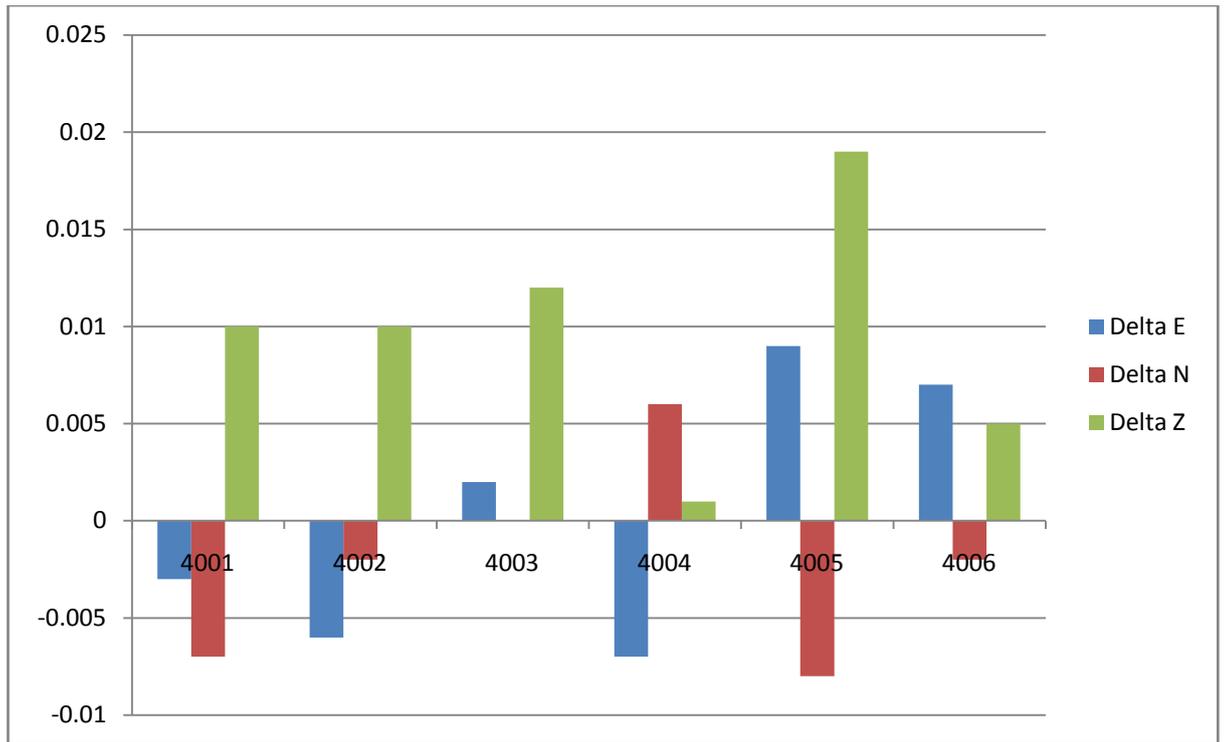
**Figure 4.12: Coordinate comparison between survey session 1 using the Leica ScanStation2 and survey session 1 using the Trimble S6**

As shown in figure 4.12 the differences in coordinates quite profound. While the survey sessions weren't conducted on the same day the sessions were conducted in similar weather conditions and around the same time of day. As discussed in section 5.2 and 5.3, both the Trimble S6 and the Leica ScanStation2 showed little movement of deformation in the grain silo structures but as shown above the difference in coordinates is quite different. Most of this can be contributed to the fact that the Leica Scan Station2 is not as accurate as the Trimble S6 when surveying HDS targets.

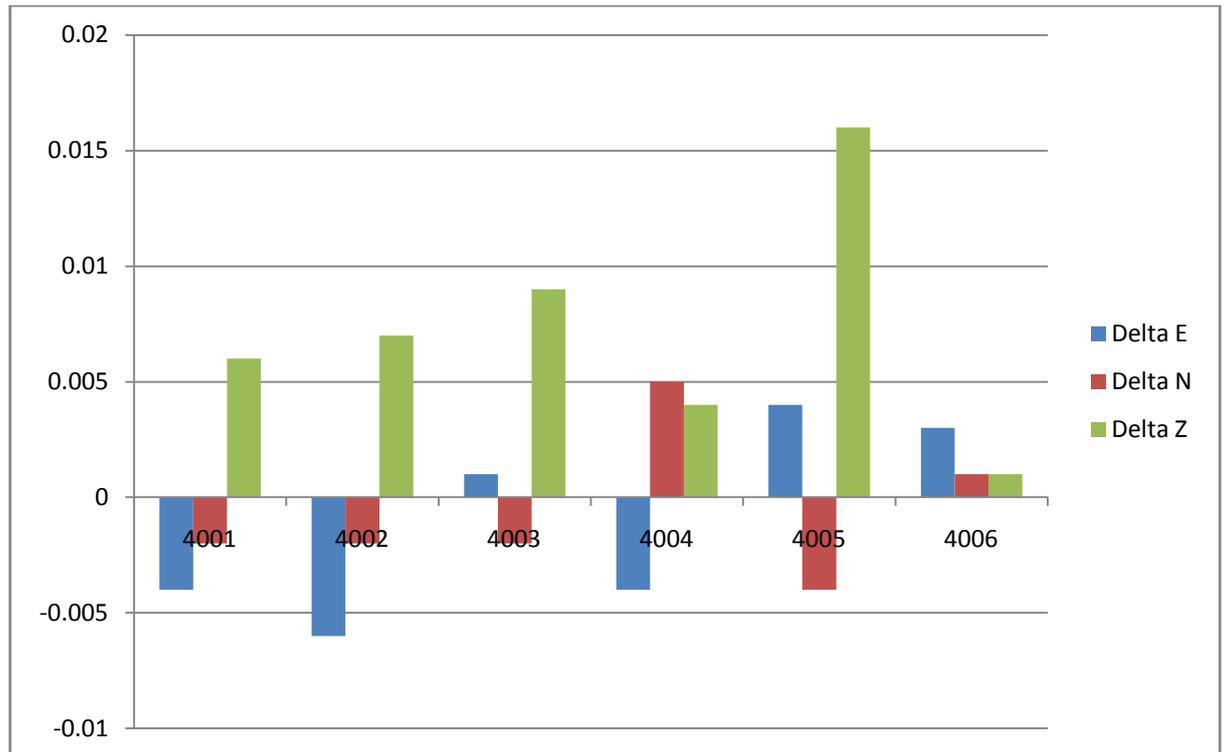
**Figure 4.13: Coordinate comparison between survey session 1 using the Leica ScanStation2 and survey session 2 using the Trimble S6**

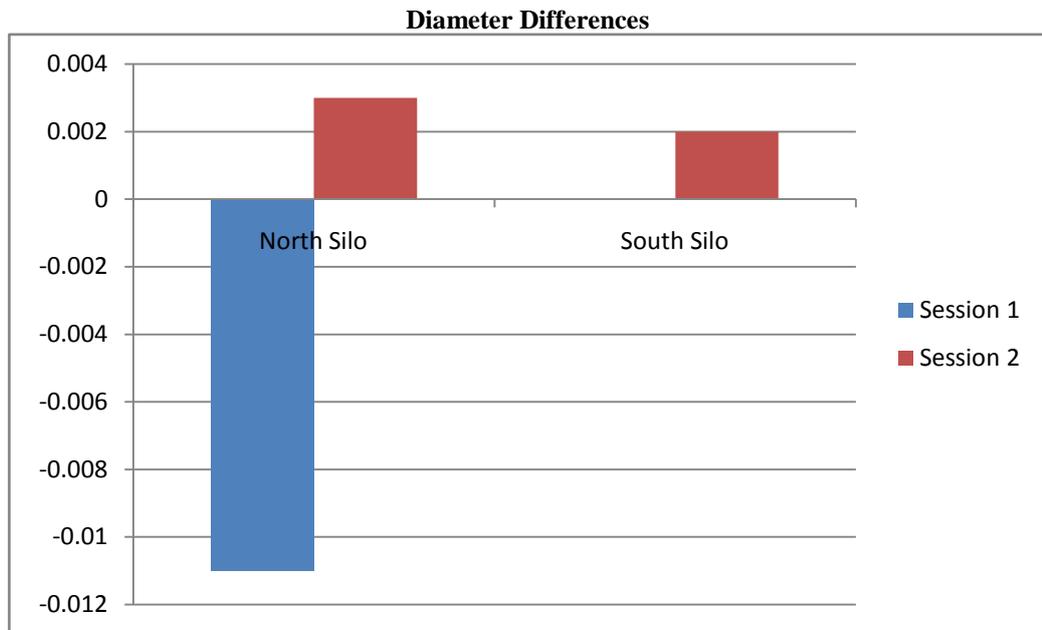
Table 5.7 shows the difference in the diameters between the Trimble S6 and the Leica ScanStation2.

**Figure 4.21: Coordinate differences between Trimble S6 calculated diameter and Leica ScanStation2 diameter.**
