**ALTERNATE PAVEMENT TYPES ON REACTIVE SOILS
IN THE IPSWICH COUNCIL AREA**

Jeffrey John Crone

Bachelor of Engineering (Civil)

Submitted: October, 2009

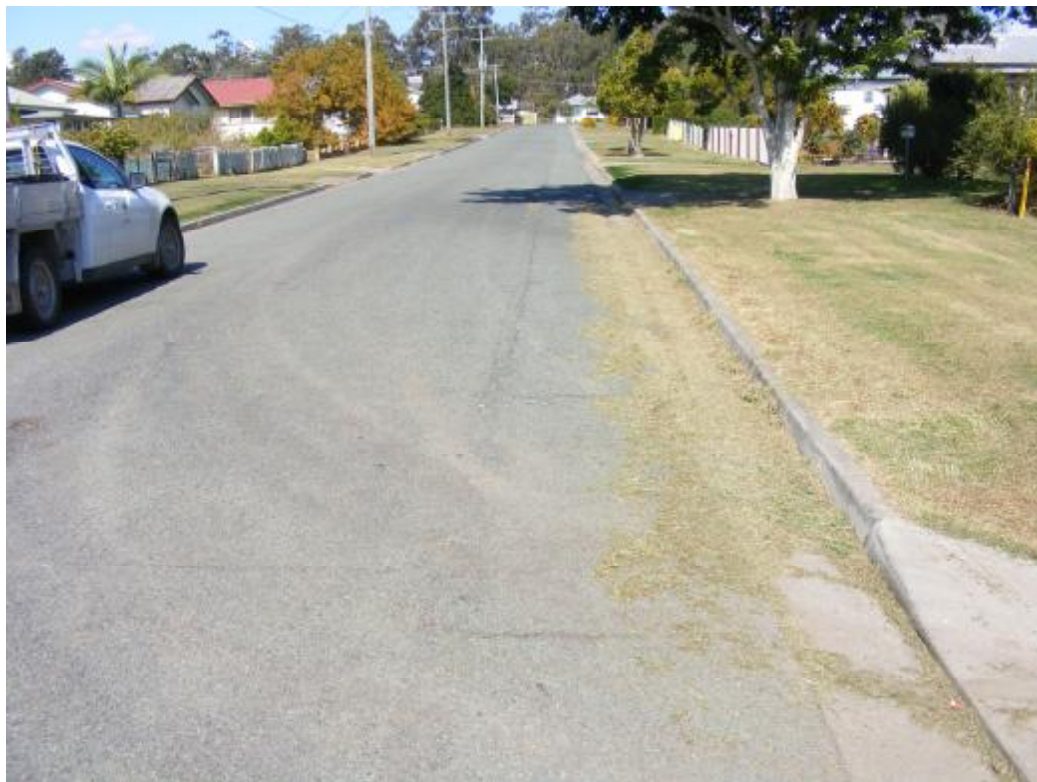
Phillip St is a short suburban street carrying a reasonable amount of traffic at 258 vehicles per day, as it feeds traffic from the main Brisbane Road into other residential streets behind it. It is in a very old section of Ipswich and typically has gas and water services at very shallow depths, which is why the decision to cement stabilise was taken, rather than a full depth gravel pavement. Also typical of the older sections of Ipswich, the original road was widened with a lean mix sub base to allow for kerb and channel. The problems with lean mix will be discussed in a later section, however as figure 4.1 shows, the problems with lean mix widenings are obvious.

Figure 4.1: Lean mix widening reflective cracking on Phillip St

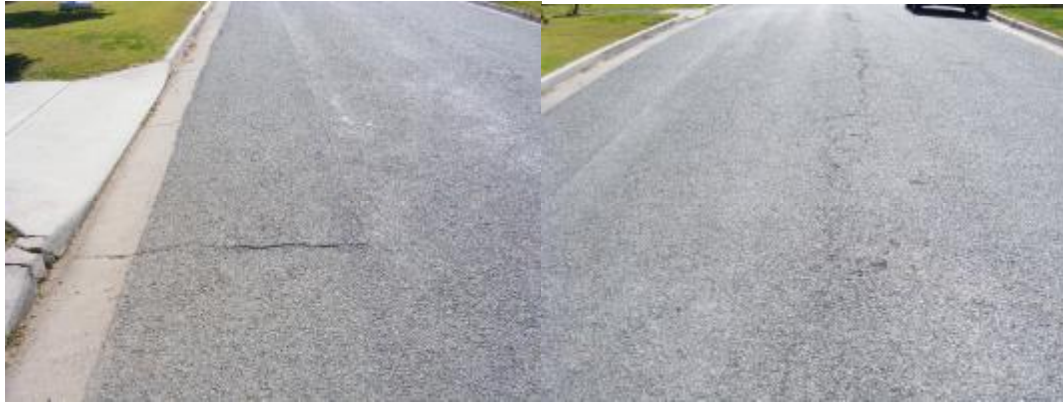
The cement stabilisation works were undertaken in early 2001, which makes it about 8.5 years old at the time of the investigation. First inspected in 2004, no signs of cracking were evident, however, by January 2007, block cracking was occurring. Figure 4.2 reveals the extent of the cracking

Figure 4.2: Block cracking in Phillip St

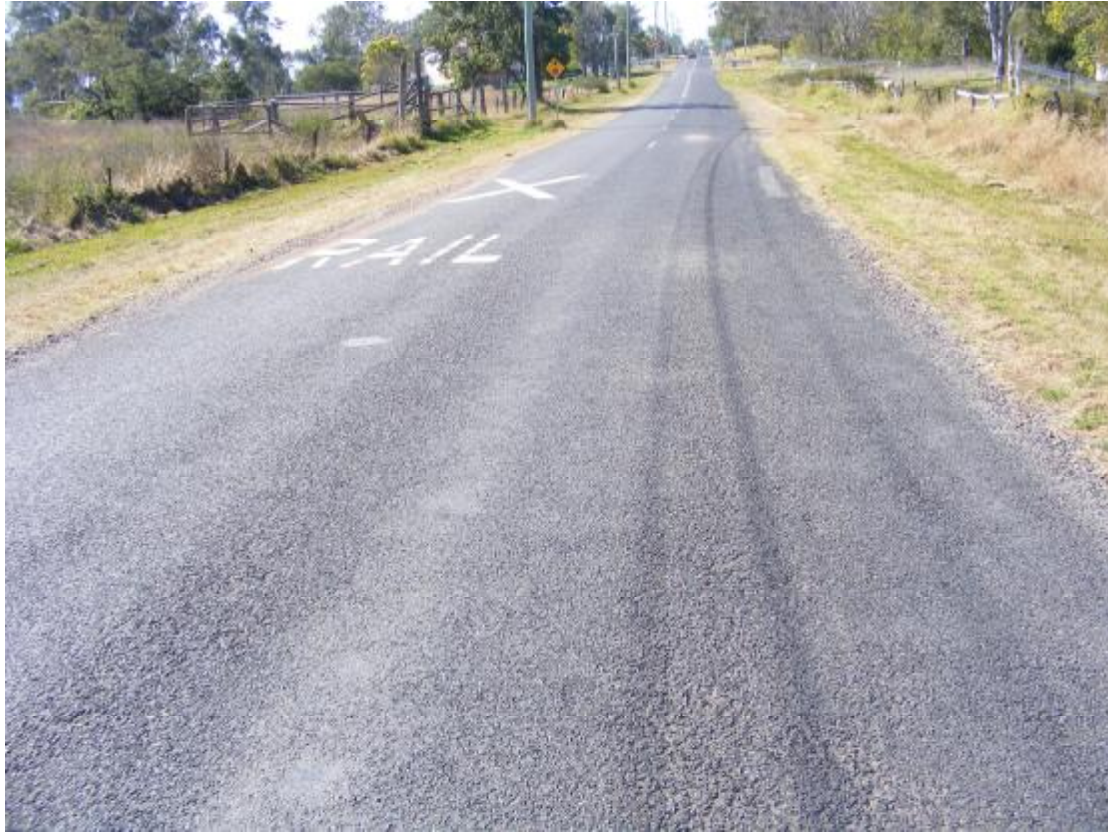
In stark contrast to Phillip St, Mary Street Blackstone, with 266 vehicles per day is in perfect condition for its age, despite being stabilised in 1998, some 3 years before Phillip St.

Figure 4.3: Mary St Blackstone – perfect condition for its age

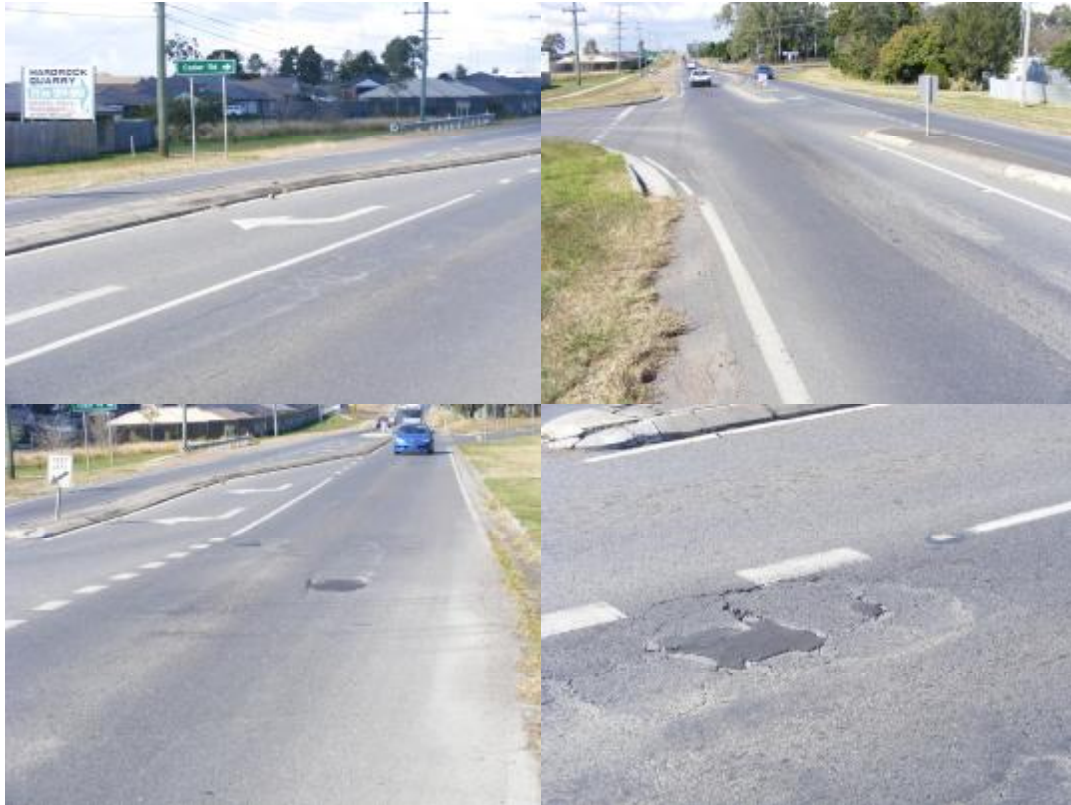
Redbank Plains Road is a very high traffic distributor road carrying approximately 14000 vehicles per day. It was treated with a 4% GB cement stabilisation of the top 175mm of base in late 2002 and is showing severe signs of distress with rutting and cracking evident. This time the road was sealed with a primerseal and 50mm DG14 asphalt, which seemed to become the standard from late 2001 onwards.

Figure 4.4: Bad rutting and cracking on Redbank Plains Road

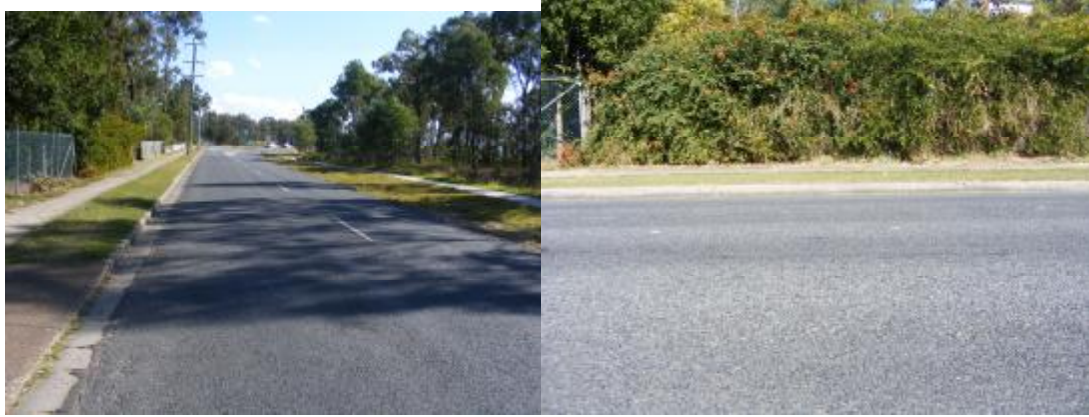
At first glance, the reasoning behind Brennan Street having significant rutting was not obvious. The traffic count was 1687 vehicles per day, and while significantly more than Phillip or Mary Streets, it was nowhere near the volume of Redbank Plains Road. Brennan Street was a 4% GB cement stabilised of the top 150mm of base in late 2000, followed by prime and 2 coat seal. Originally inspected in 2004, it showed no signs of cracking, however now in 2009, while it still had no cracking, it showed significant rutting in the wheel paths that now need rectification.

Figure 4.5: rutting deformation on Brennan Street Bellbird Park.

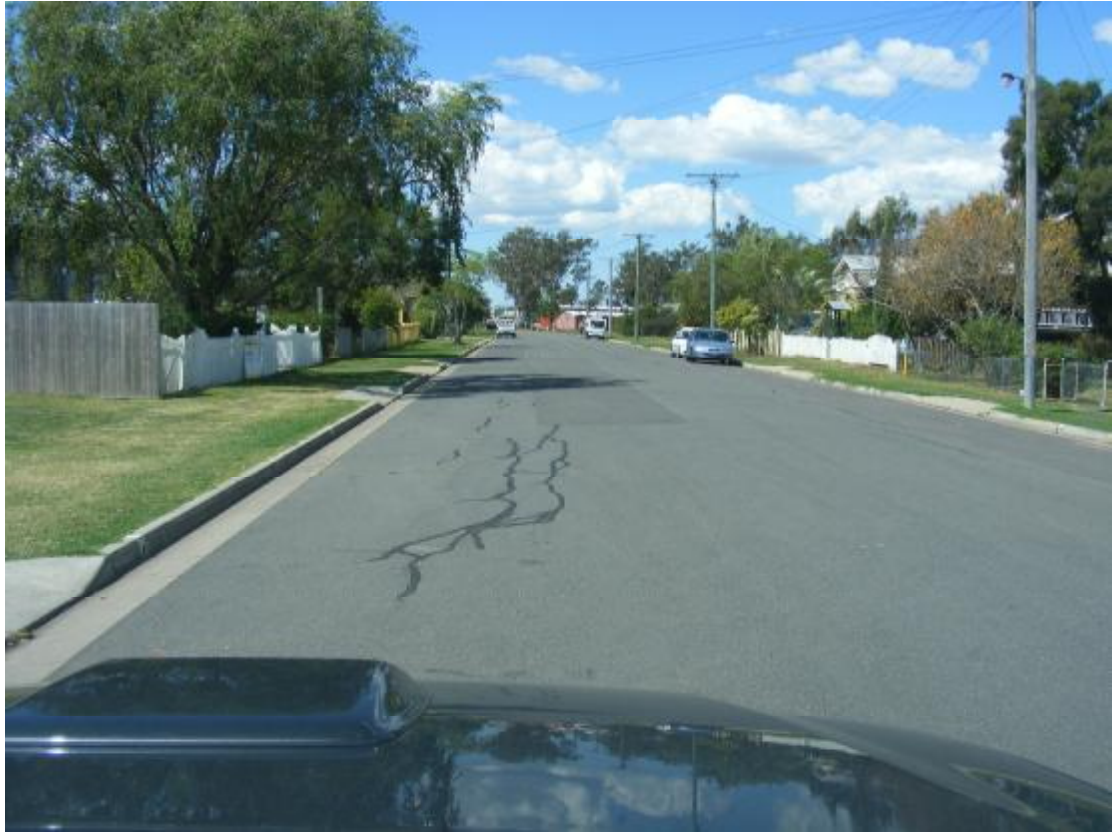
Today, Madden Lane still serves 30 residential houses and a small side street, its condition is generally poor with significant longitudinal cracking and some large failure repair sections, especially alongside the kerb . The lack of any deformation along the kerb line and pavement in general tends to indicate that the stabilised subgrade is carrying the required load, so there must be another issue causing the cracking. Noting that the pavement width is 11 meters, reference to Austroads (2003) “Guide to best practice for the construction on insitu stabilised pavements” indicates that when 4 side by side passes of the stabiliser are required, such as in this case, that this should be done over 2 days otherwise excessive shrinkage occurs. This appears to be the case on Madden Lane and this problem will be explored with an upcoming investigation on Suffield Drive.

Figure 4.6: Madden Lane Rosewood longitudinal cracking

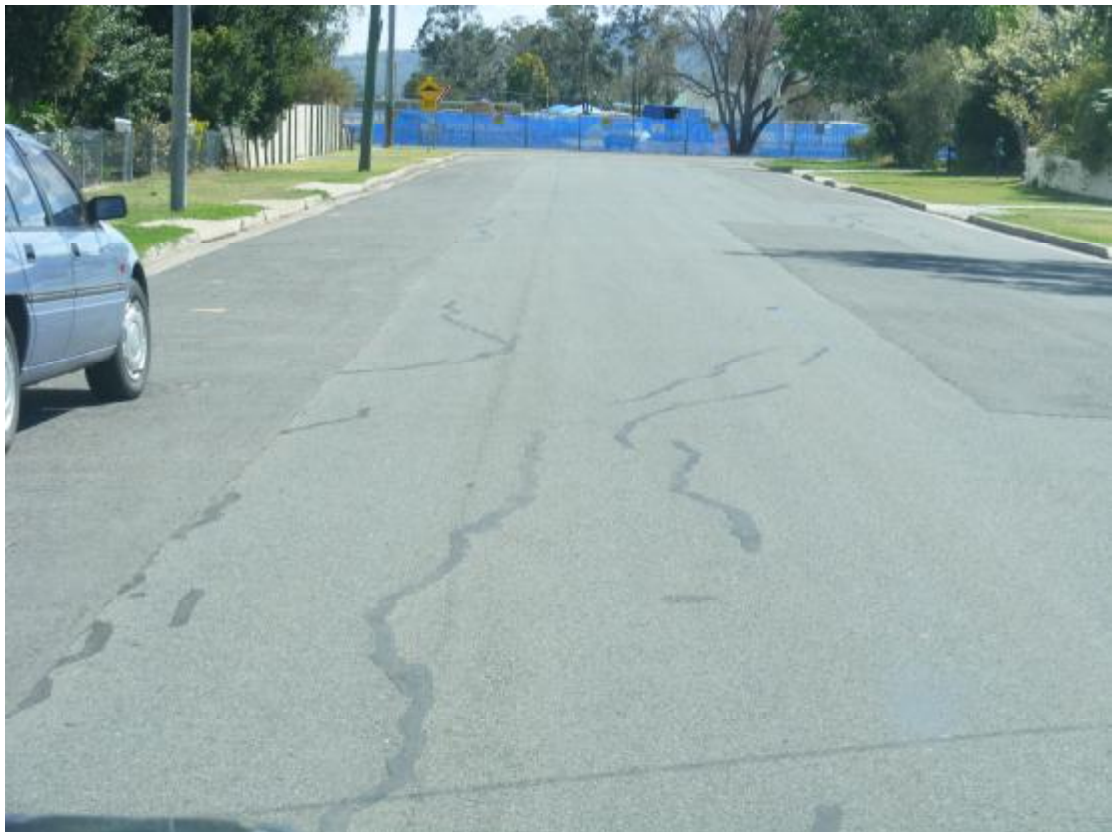
Figure 4.7: Madden Lane Rosewood failures and cracking

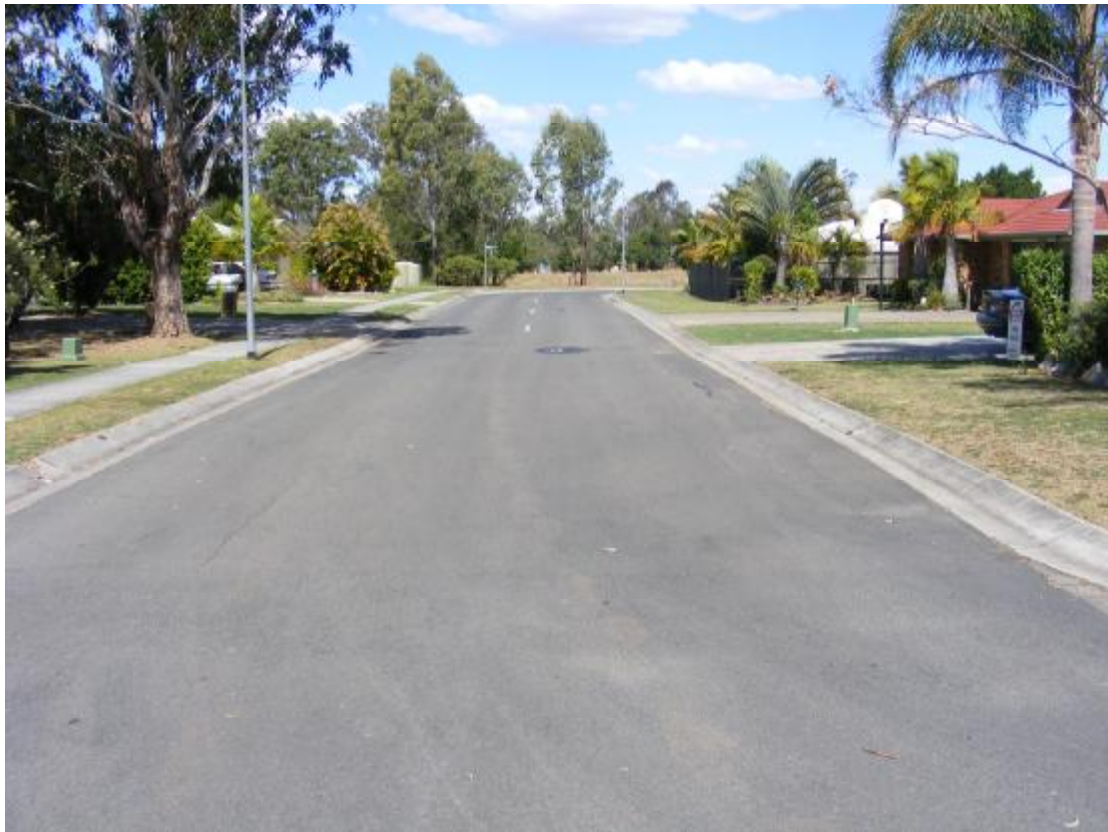
Bernadette Crescent is within a kilometre of Madden Lane and shares the same very poor subgrade. It was a lime stabilisation project performed in 1998, 3 years earlier than Madden Street. Plans are no longer available for this pavement however it is understood it is a 6% lime stabilisation with 2 layers of gravel. The pavement in this case is extremely cracked and significant deformation is occurring in the pavement itself to the point where it is ponding water and the kerb is also shifting around. Bernadette Crescent is only a very narrow street at 5m lip to lip of kerb, so it is assumed the cracks are not due to lime shrinkage. Without first hand knowledge of the process involved, the only conclusion that can be drawn is that the stabilisation process was performed incorrectly, as the movement evident in the street can be directly attributed to subgrade failure.

Figure 4.8: Bernadette Cres Rosewood, kerb and pavement deformation, ponding water

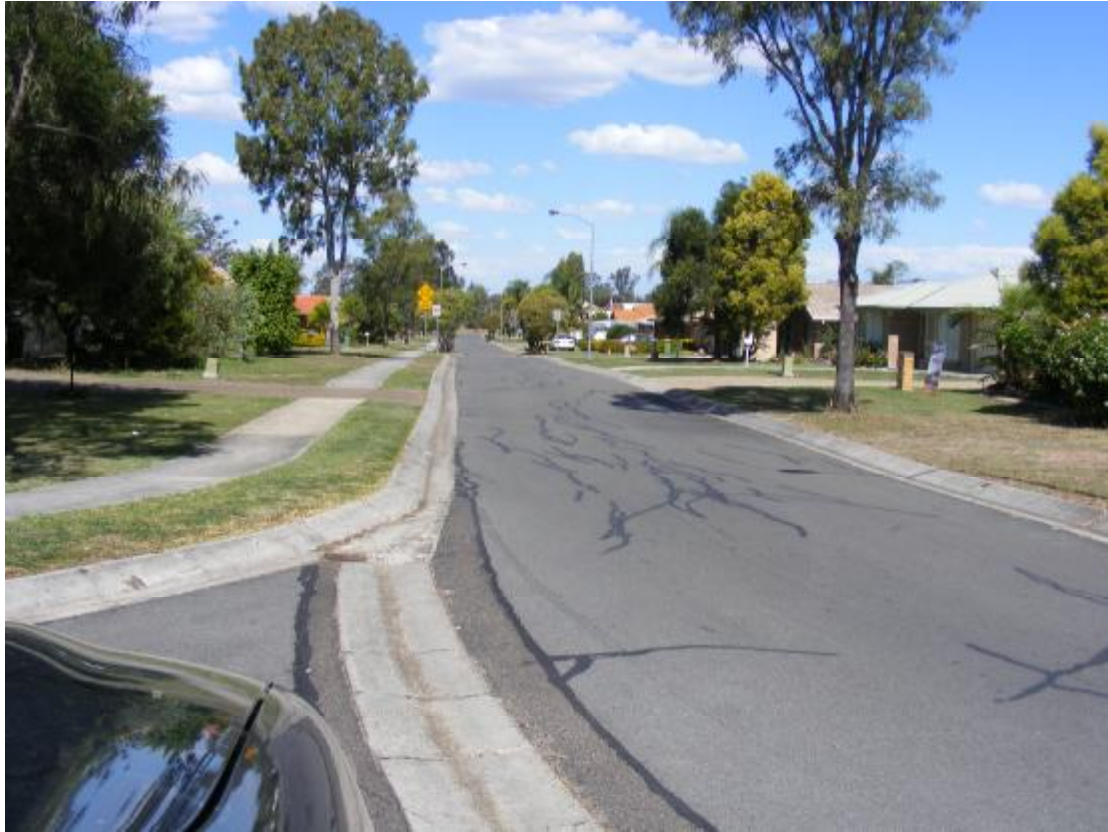
Figure 4.9: Bernadette Cres Rosewood, cracking and kerb misalignment

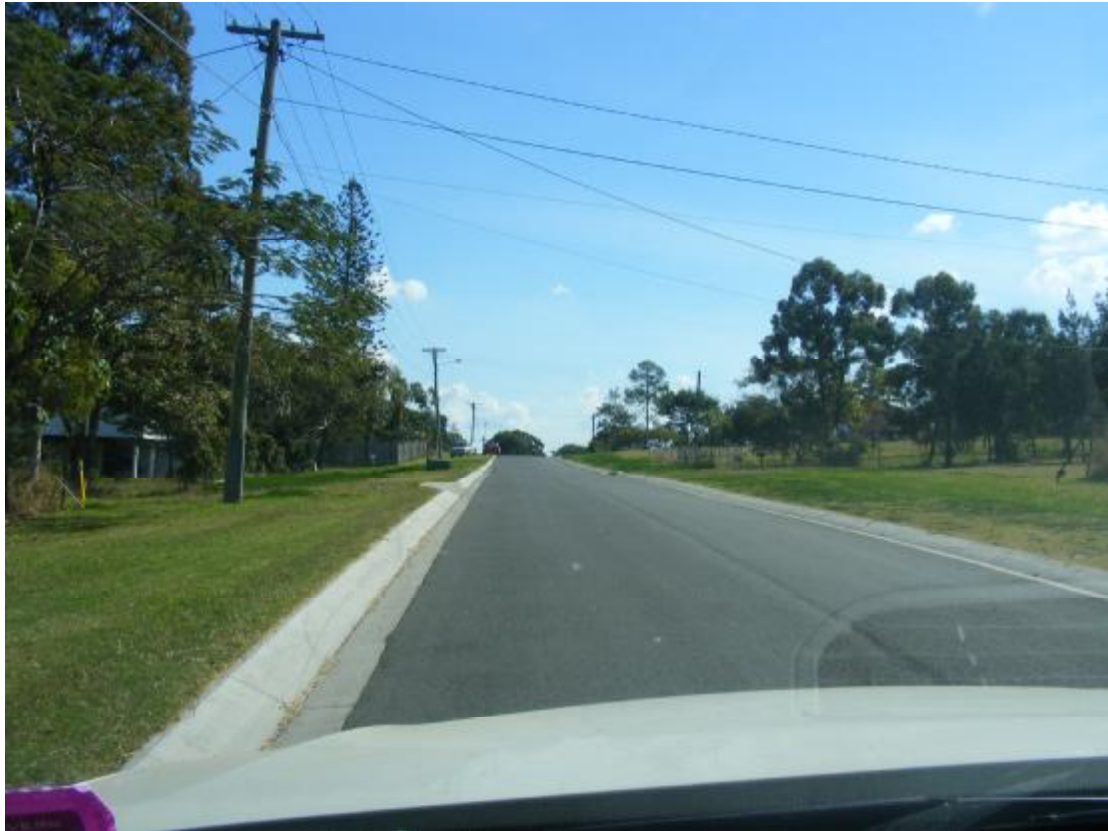
Current analysis of Boscawan Cres show the pavement to be in perfect condition with no cracking or rutting evident in the majority of the pavement. There is a small section that is an exception, this is noted below in the lean mix analysis.

Figure 4.10: Boscawan Crescent in perfect condition

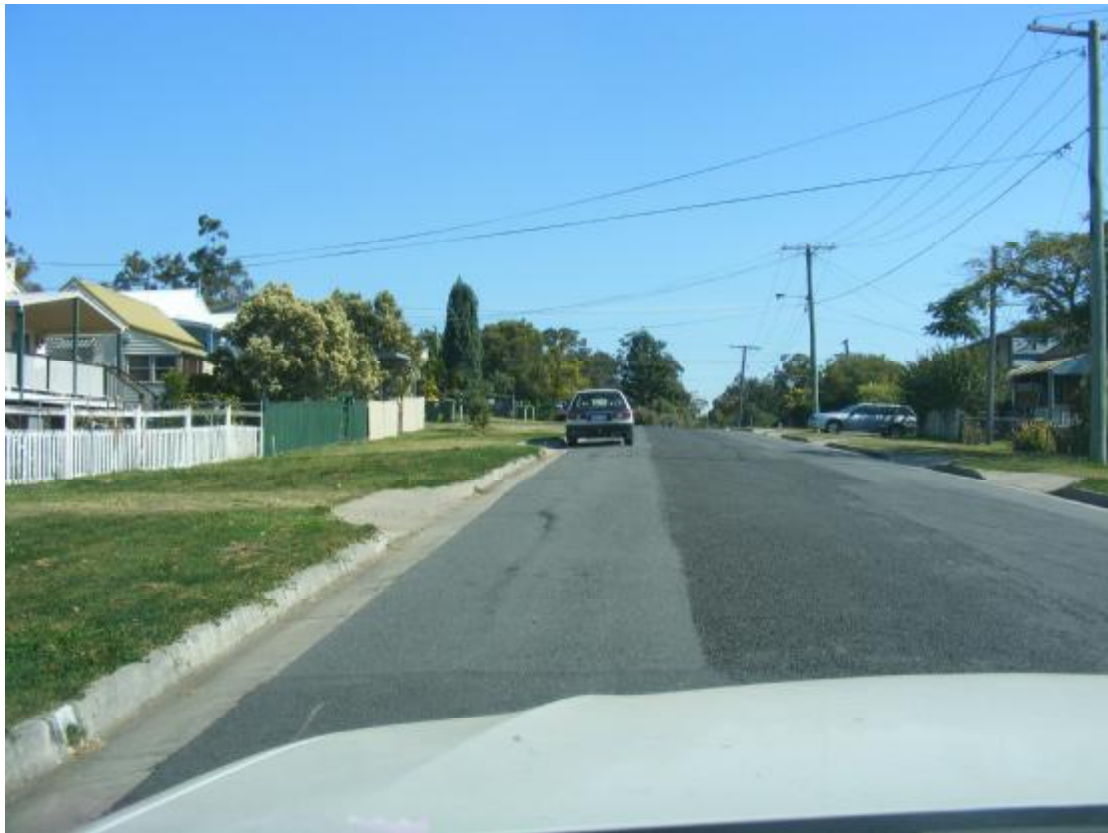
Ross St Ebbw Vale is typical of the majority of lean mix widenings undertaken by Council. Ross Street, constructed in late 2004, was a 4m wide local street consisting of 200mm gravel and a bitumen seal. The procedure followed was to widen 1.5m on either side of the existing road by excavation to the blacksoil subgrade, a 200mm layer of lean mix, construction of the kerb and channel, placement of 150mm of lean mix in front of the kerb, and lastly placement of a 25mm asphalt surface. The result, 5 years later is obvious.

Figure 4.11: Rutting of lean mix pavement in Ross St Ebbw Vale

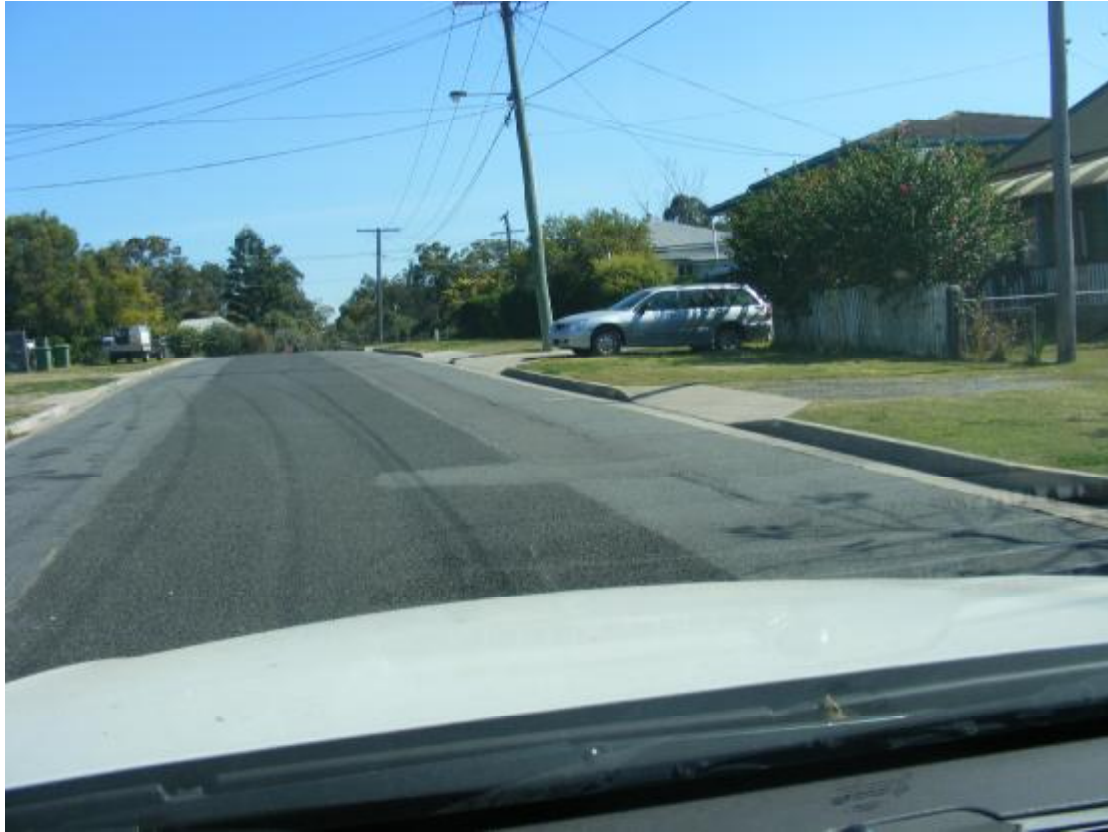
Figure 4.12: Rutting and cracking of lean mix pavement in Ross St Ebbw Vale

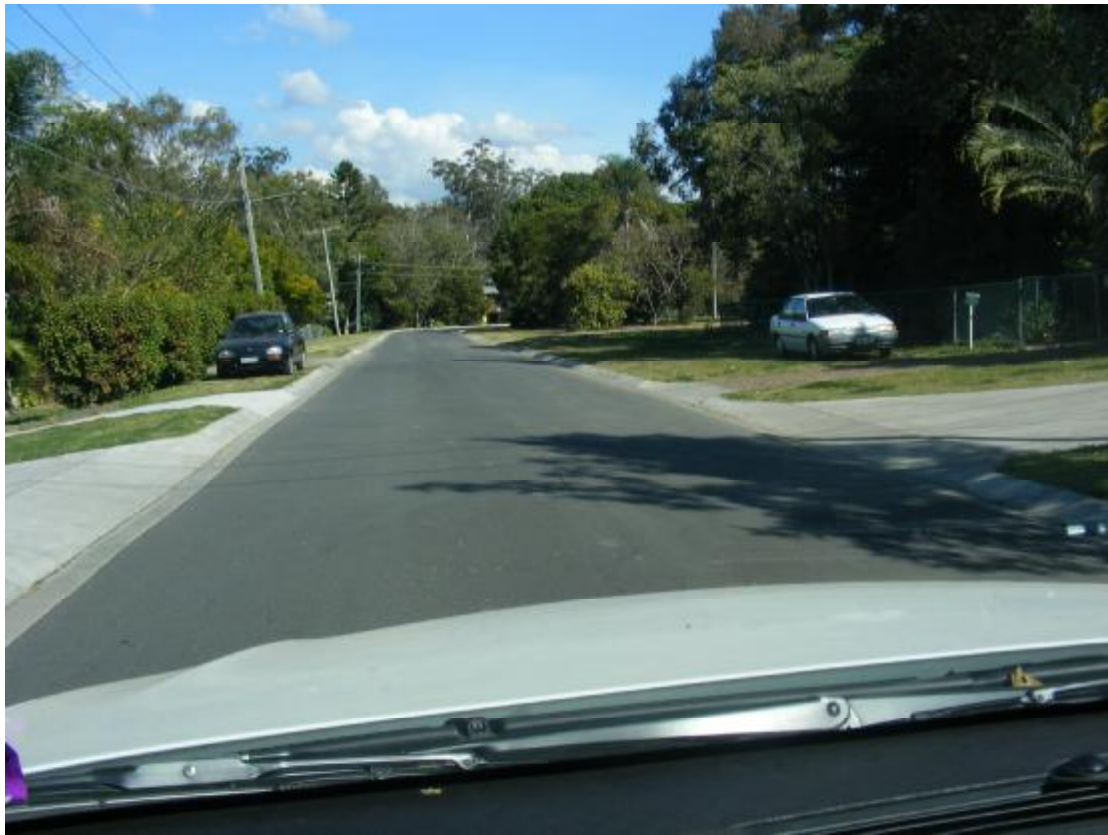
Previously visited in the lime stabilisation analysis, it was noted that there an exception to lime stabilisation works investigated. This section was a full depth lean mix pavement, 10 meters either side of a high pressure gas main, as the 40 tonne lime stabiliser machine was prohibited on top of the gas main by the gas company. The result, given that the rest of the 3.5 year old road is in perfect condition, is disappointing.

Figure 4.13: distant view of Boscawan Cres showing crack over gas main

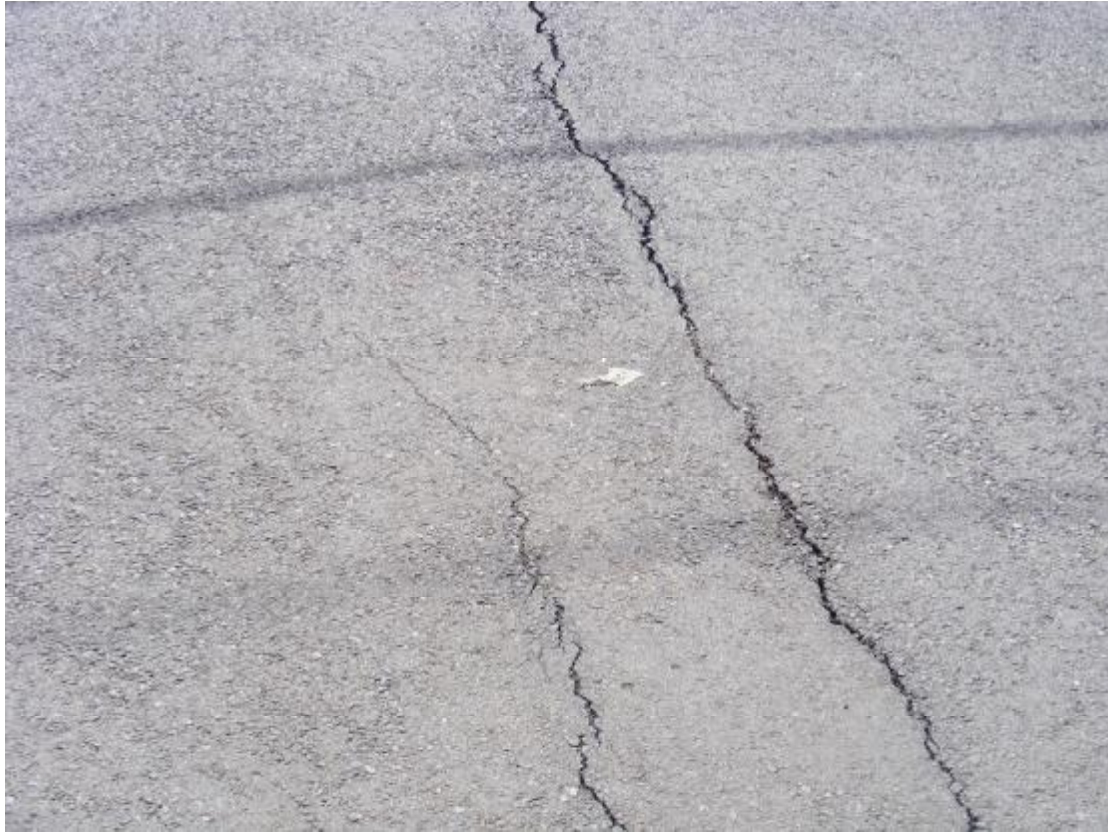
Figure 4.14: Close up view of Boscawan Cres showing crack over gas main

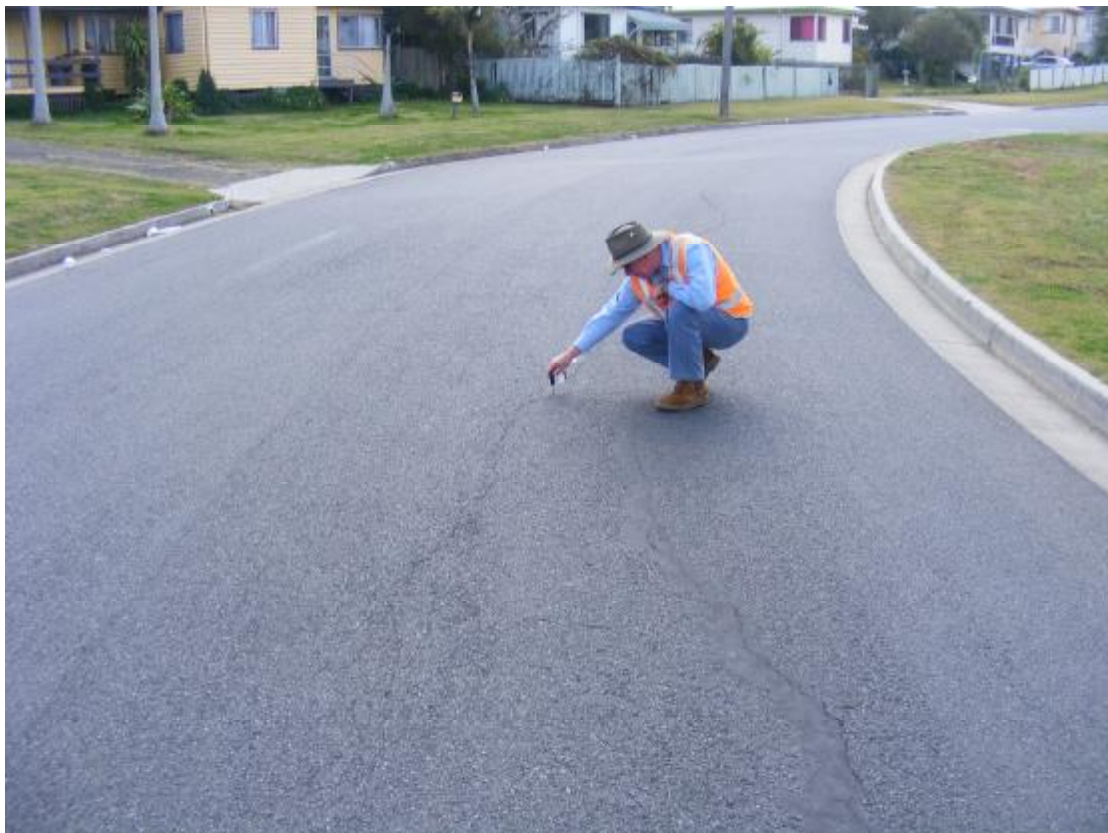
Constructed in late 2005, the pavement is now shows extensive signs failure through block cracking. Although, not clear in the figures below, a wider view of the street shows patterns in the cracking, believed to be where one load from the concrete truck finished and a second load, possibly with a different combination of aggregate, moisture and cement content, started. The possible delay between subsequent loads could indicate that the lean mix did not bind to its neighbour leaving large blocks of base material to move independently.

Figure 4.15: Cracking in Margret Street large enough to fit a key down.

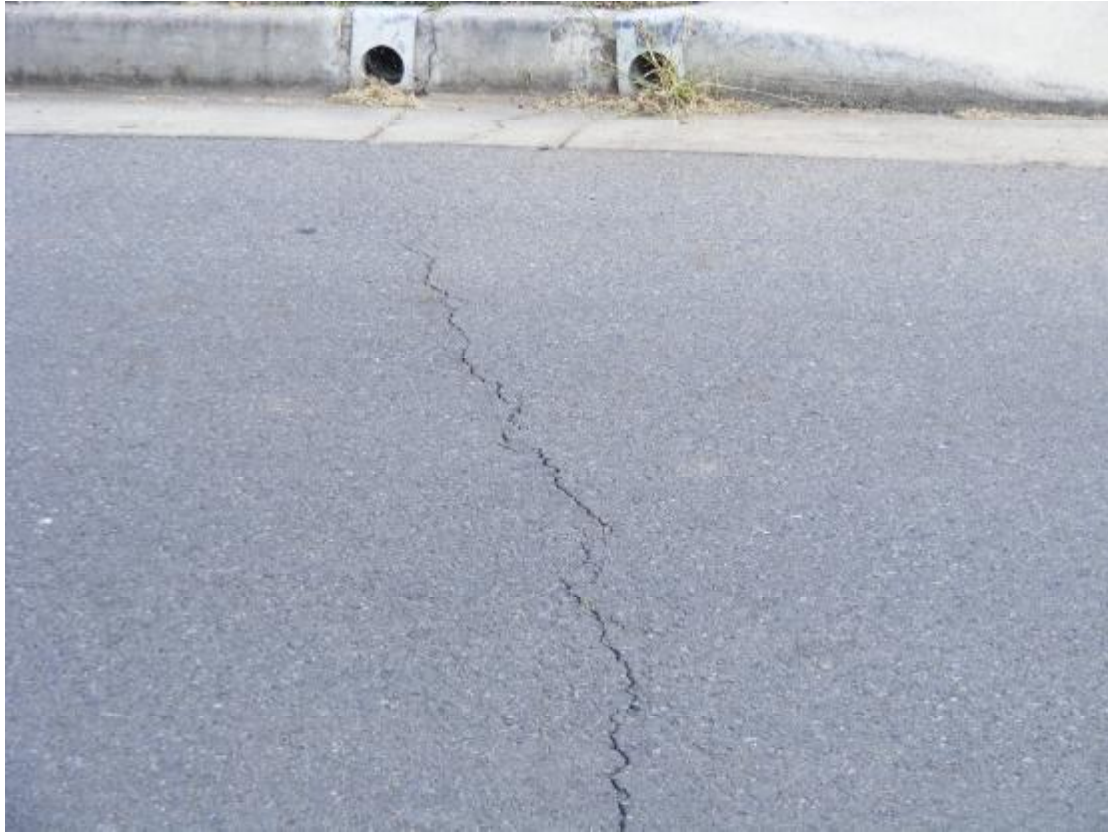
Figure 4.16: Close up view of block cracking in Margret Street

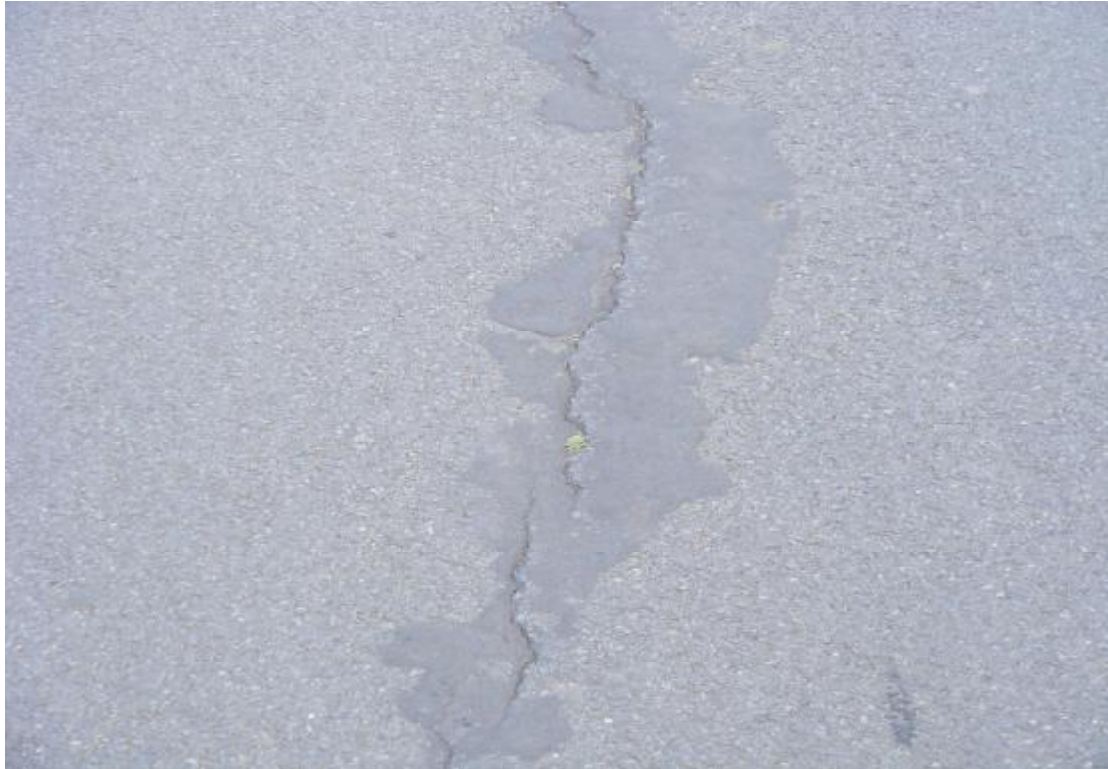
To date there are no signs of movement or rutting of the pavement, possibly due to some of the cracks receiving crack treatment as soon as noticed, however the ones noted during this analysis needed similar treatment before moisture reaches the blacksoil subgrade.

Figure 4.17: Margret Street crack sealing

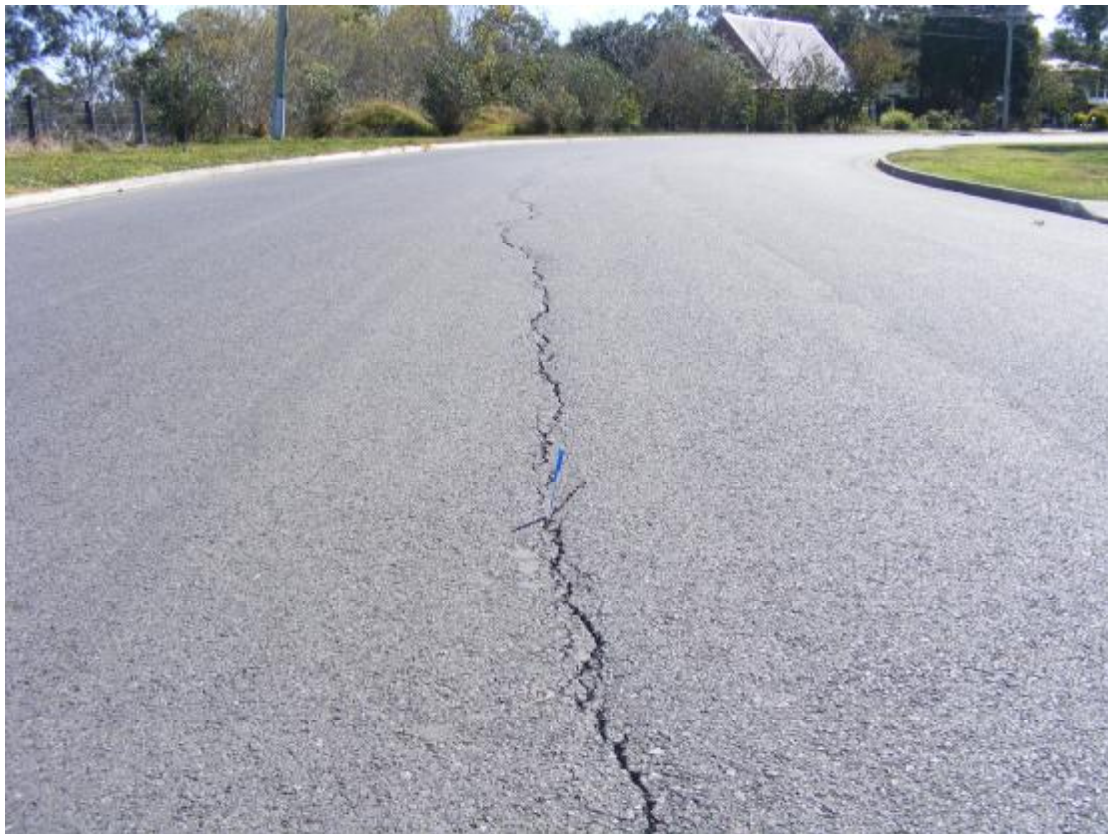
No significant deformation is occurring in either the pavement or the kerb and channel, so the conclusion can be drawn that the subgrade treatment is working, however the major problem in the street is the massive longitudinal crack in the very centre of the pavement, in some places, big enough to put a cup down, refer to figures 4.18 and 4.19

Figure 4.18: Suffield Drive section 1 longitudinal cracking

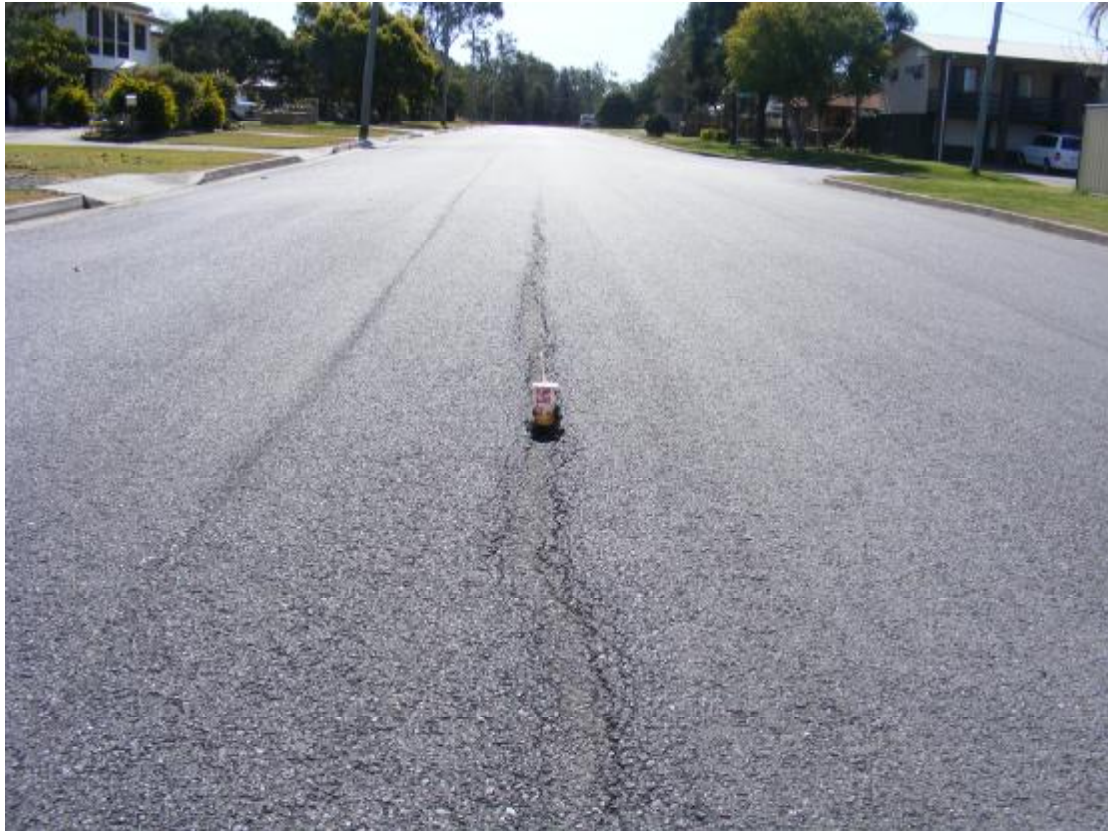
Figure 4.19: Suffield Drive section 1, cracking large enough for a coke cup

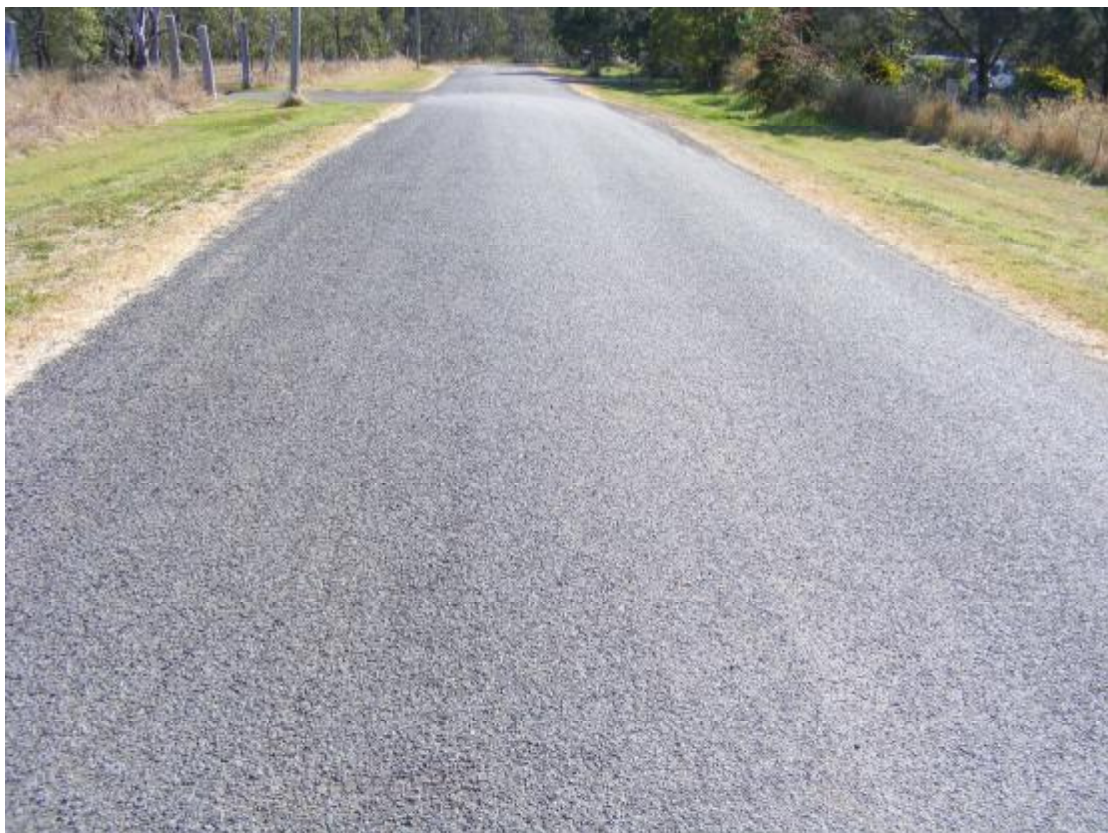
As seen in figures 4.20 and 4.21, the second section of road, built directly after the first section is in perfect condition despite being the same age and same subgrade conditions.

Figure 4.20: Suffield Drive section 2 perfect condition

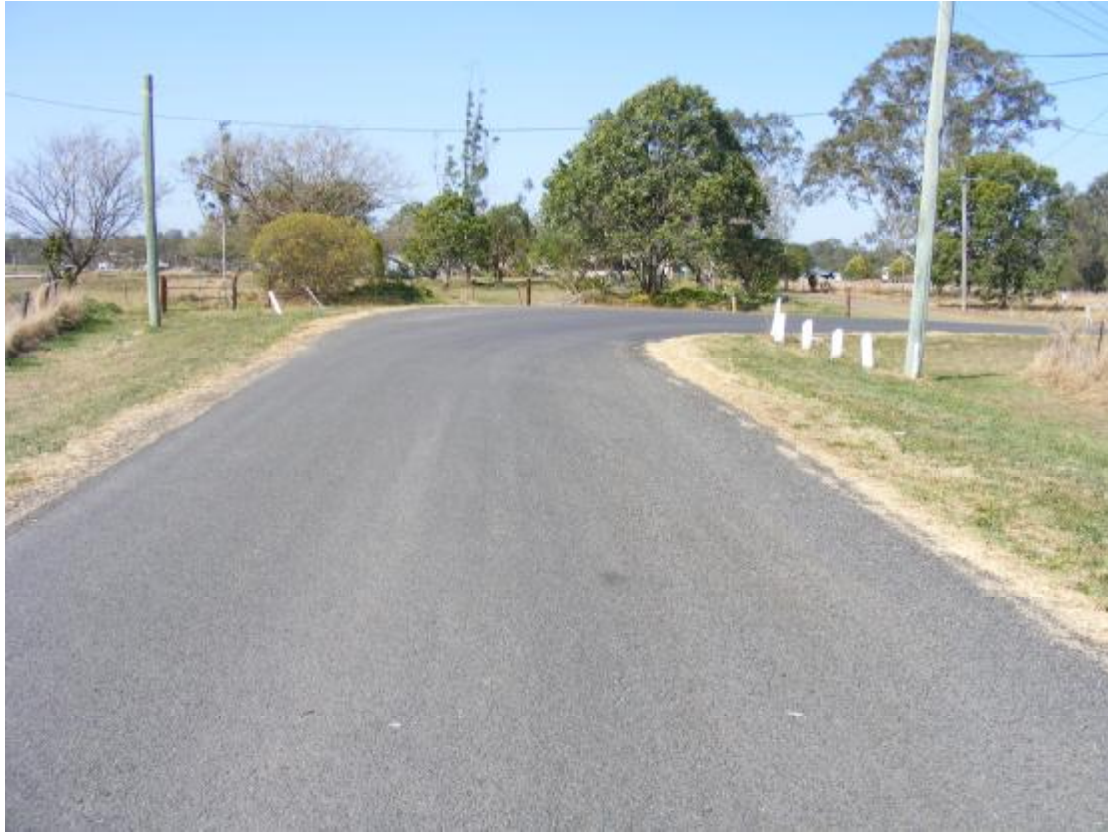
Figure 4.21: Suffield Drive section 2, good condition even on bends

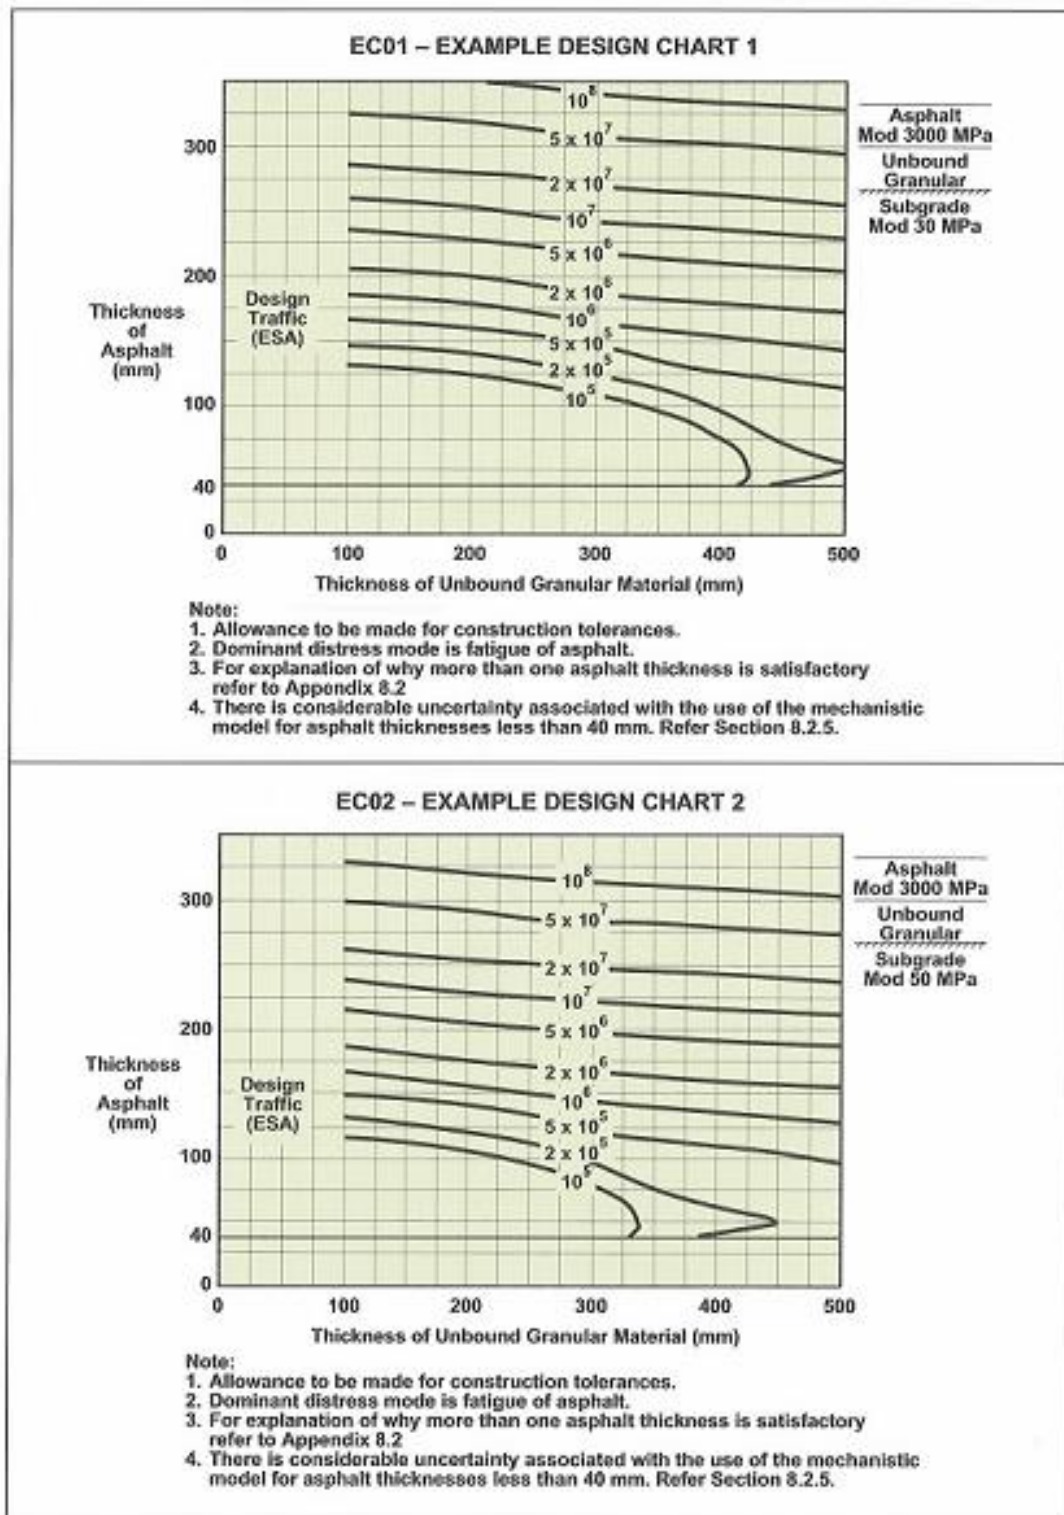
Figure 5.3: Austroads example design charts (Austroads 2004)

Examples of the design charts are shown in figures 5.2 and 5.3

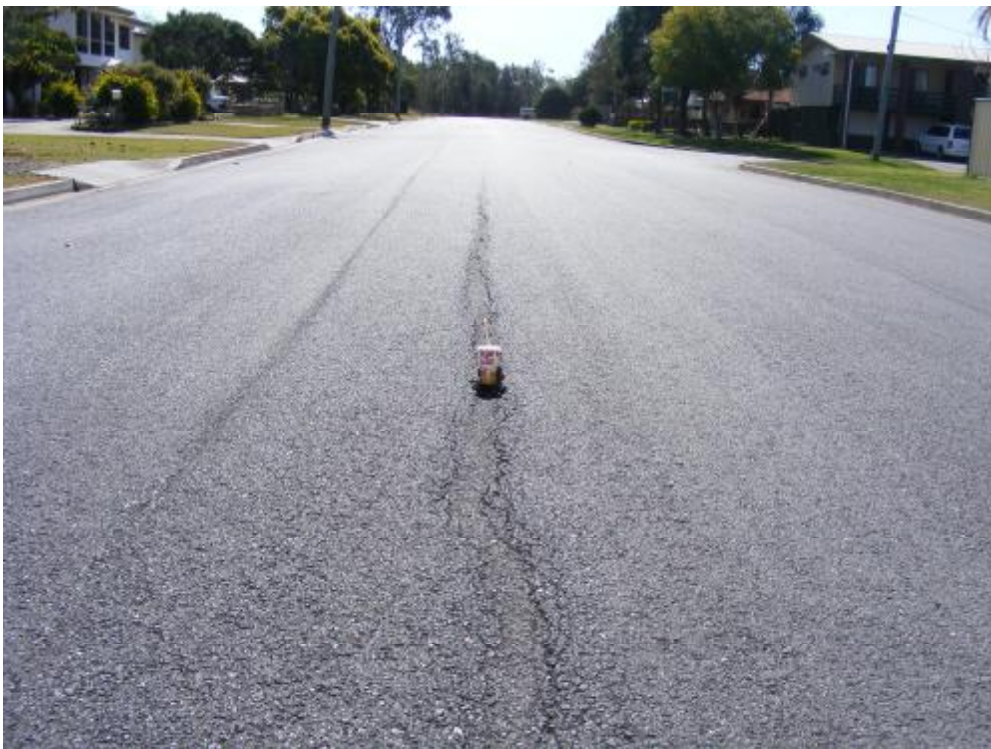
- Number of passes in a single day. According to the guide to best practice for the construction of stabilised pavements, Austroads (2003), any more than 3 passes side by side in a single day will lead to significant shrinkage which may separate the pavement in the middle of the road. As previously seen, the combination of a cold joint in the subgrade and 4 side by side passes on Suffield Drive Yamanto has lead to severe shrinkage in the middle of the road.

Figure 6.3: Severe pavement separation on Suffield Drive Yamanto
