**ALTERNATE PAVEMENT TYPES ON REACTIVE SOILS
IN THE IPSWICH COUNCIL AREA**

Jeffrey John Crone

Bachelor of Engineering (Civil)

Submitted: October, 2009

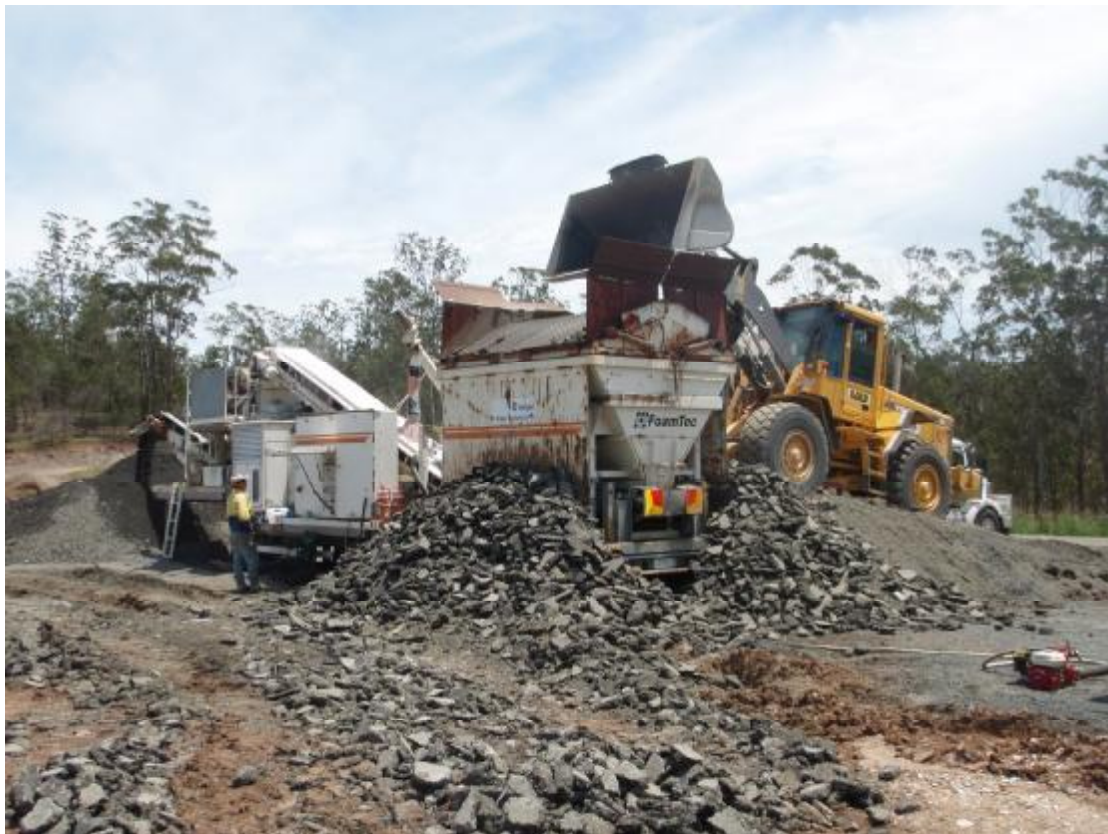
- Ex-situ mixing and replacing: mixing easier to control with load cells adding the correct additive, deficiencies in grading easily corrected with sieving and adding new material if required, visual inspection of subgrade making it possible to replace problem areas, however multiple handling and trucking of material to remote site significantly increases cost.

Figure 7.2: Foamed bitumen ex-situ plant producing mix

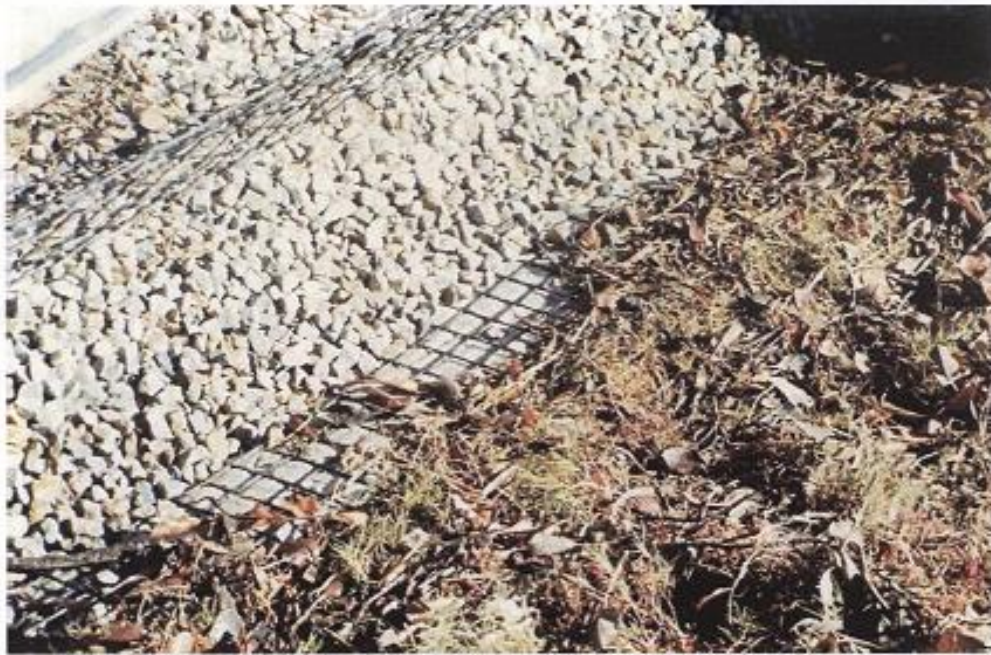
The success of geogrids dates back as far as 1996 in Australia. Geogrid was used successfully in the relocation of the 10 Terminal Regiment base to the banks of the Ross River in Townsville. The 1 kilometre by 11 meters wide access road had to be built across a tidal flood plain of mangrove mud and silty sands with a CBR less than 2. The insitu surface was not even capable of carrying construction traffic. The design used was a layer of geofabric laid directly over the natural ground, 2 layers of geogrid interlocked with a layer of 200mm thick 20mm aggregate and a 100mm layer of 20mm aggregate.

Figure 7.3: Granular platform over Tensar SS30 Geogrid (Schaeffer 2007)

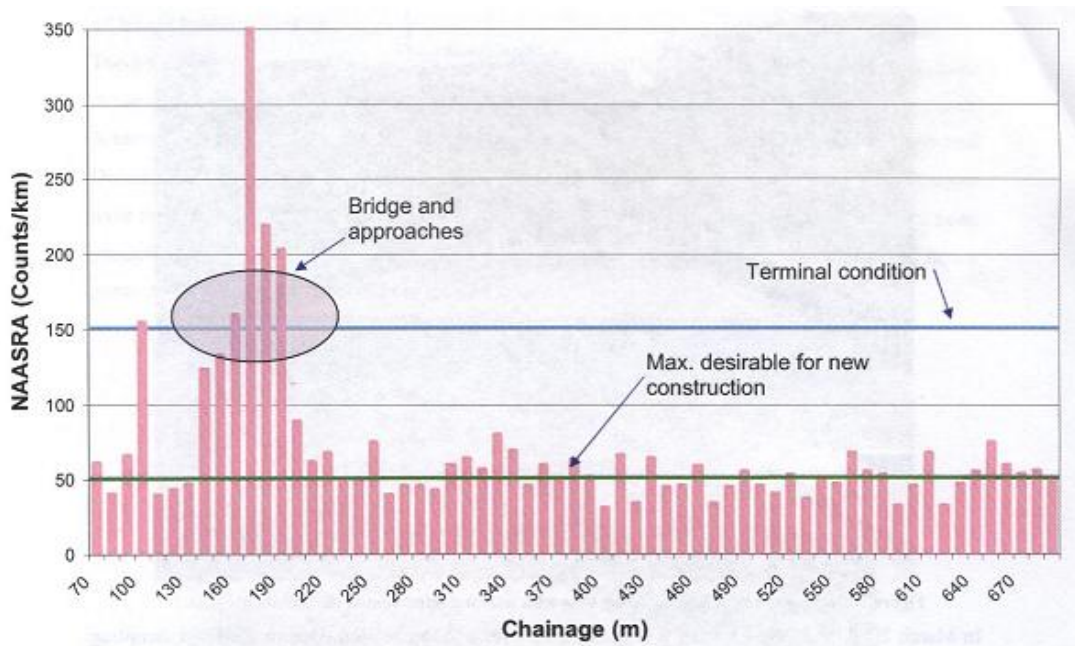
To date, the pavement has been inundated several times by king tides and carries significant loads such as Army trucks and transporters and is generally subject to constant heavy traffic. In March 2007 roughness tests were taken, and other than some minor sections around the bridge abutments, the test faired very well with roughness counts approximating that of new construction works despite being 13 years old.

Figure 7.4: Roughness count for the 10 terminal access road (Schaeffer 2007)

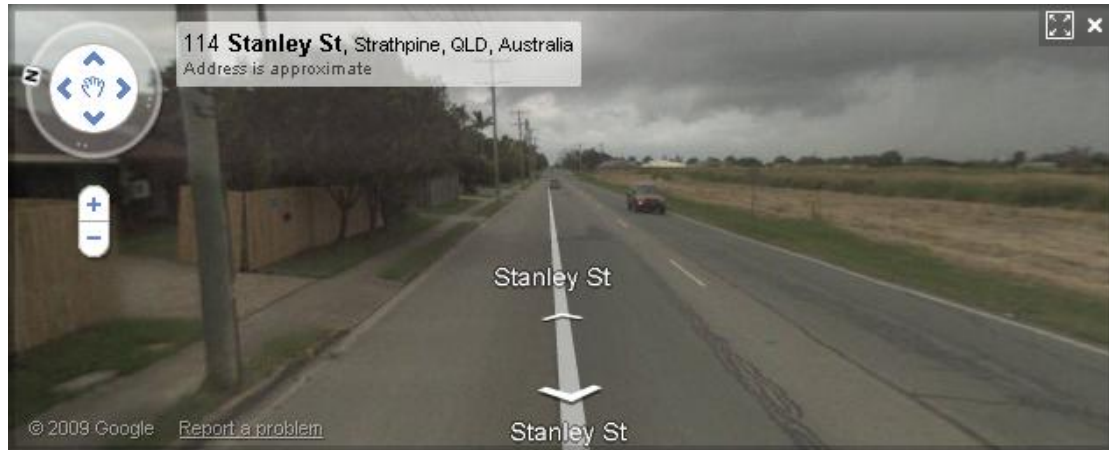
Figure 7.5: Stanley Street, Strathpine (Google 2009)

Stanley St is typical of the older streets in the area, over the years it has had kerb and channel added to one side by a developer, using a pavement type that was incompatible with the existing pavement, which has resulted in severe longitudinal cracking at the join between pavements allowing water ingress into the pavement and subgrade and the resulting multiple pavement failures. It had been rehabilitated at

some stage in the past with cement stabilisation, and under that the subgrade had a CBR rating of 2.

The designed solution to the problem consisted of replacement of the existing pavement and subgrade down 590mm to handle the existing and future designed traffic volumes. As it was a major through route an alternate method was chosen to minimise inconvenience to traffic.

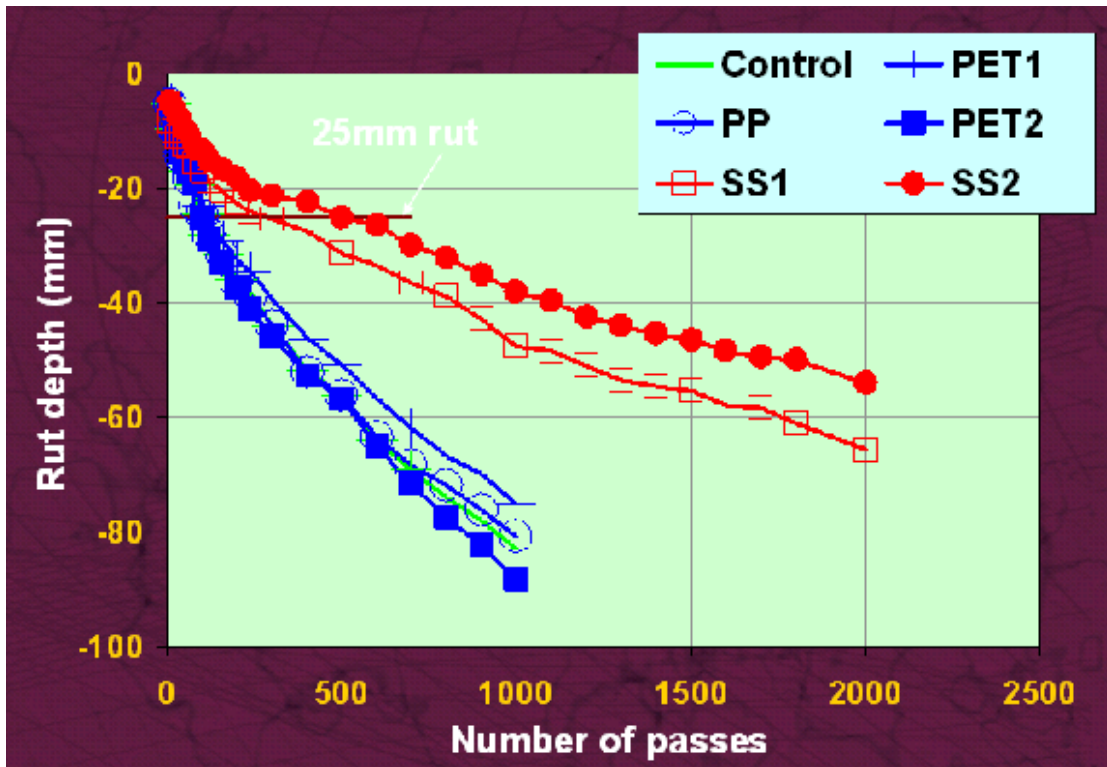
The history of the Tensar product dates back to 1992 where the US Army Corps of Engineers undertook a trafficking trial for light aircraft pavements. They performed multiple trials using a 13 tonne wheel load over pavements with several types of reinforcement including a control granular pavement. The results are shown in the graph below.

Figure 7.6: Results of USACE trafficking trials in 1992 (Geofabrics Australia 2009)

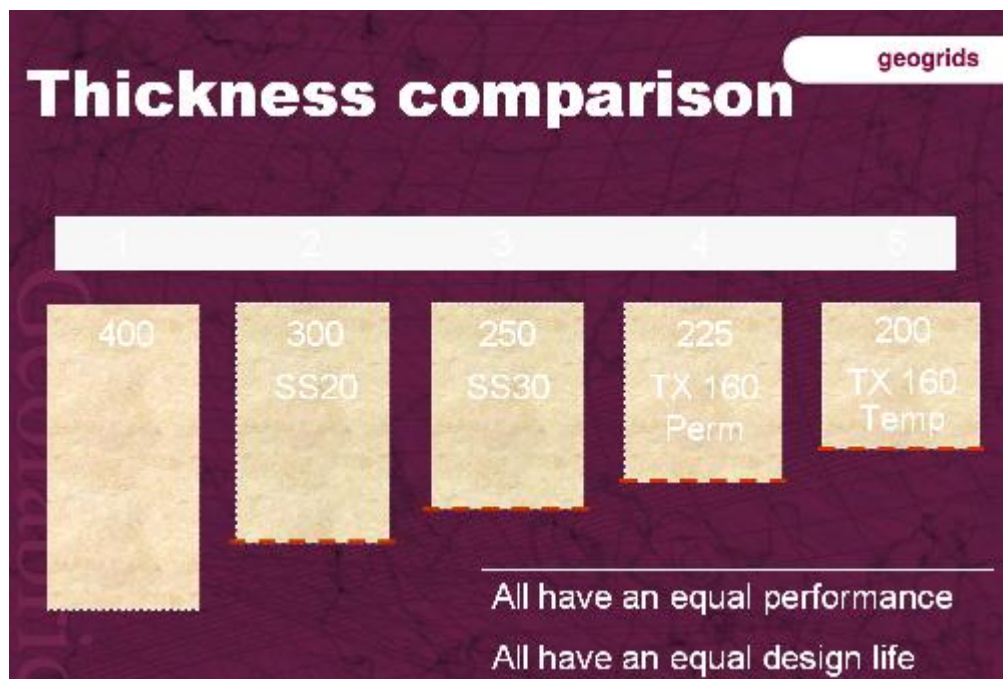
underground services, as well as saving the cost of extra excavation and pavement layers. A full cost analysis for this technology is undertaken in chapter 8.

Figure 7.8: Thickness comparison of Geogrids to gravel (Geofabrics Australia 2009)

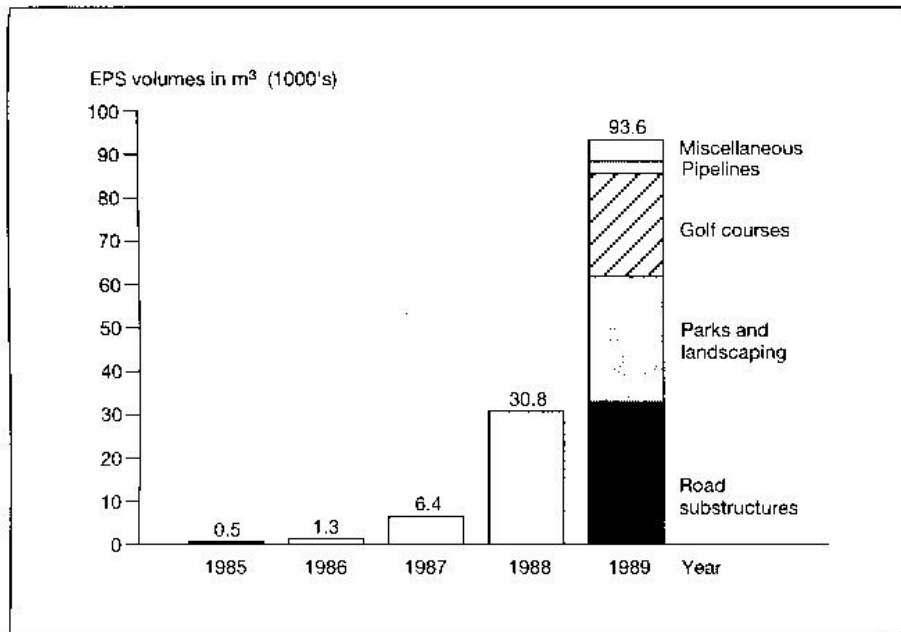
After the 1985 international road building conference in Oslo, various other countries looked favourably at the advantages of mass foam blocks, such as Holland, France, Germany, USA, Canada and Japan. Use of the block in Japan has seen enormous growth in the late 1980s, however to date no information exists on the use of the block in Australian conditions.

Figure 7.11: Use of foam blocks in Japanese earthworks projects (Styropor – Highway Construction/ Ground insulation.)

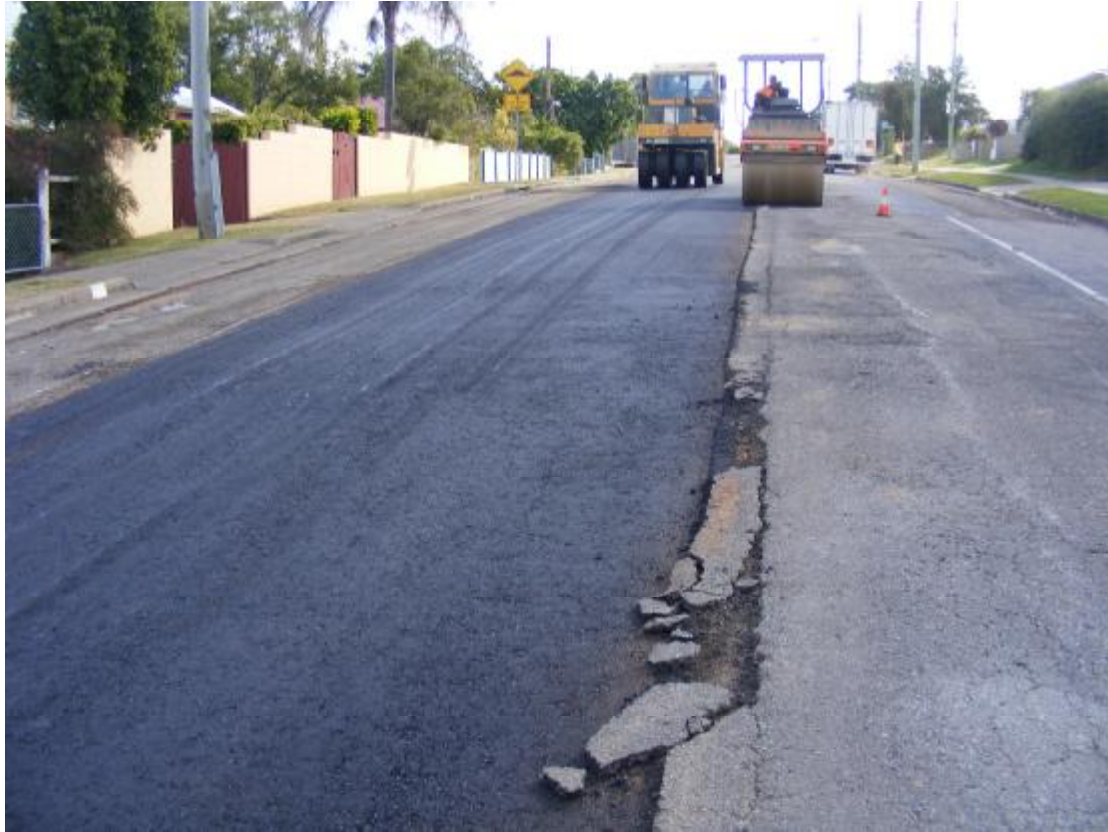
There is a general resistance within ICC to do full depth asphalt pavements despite their use on all the highways surrounding Ipswich. It is thought that this may be due to the difficulty in rehabilitating the pavement in the future. A recent job on Blackstone Road was as close as ICC has come to full depth asphalt. The pavement was experiencing cracking and rutting due to the volume of traffic using it. The solution was to profile the road down 200mm, replace the pavement with 150mm deep lift and 50mm asphalt wearing surface. However, as the pavement is still relying on underlying gravel layers, it cannot be considered a full depth asphalt pavement.

Figure 7.12: Blackstone Road Silkstone rehabilitation by deep lift asphalt

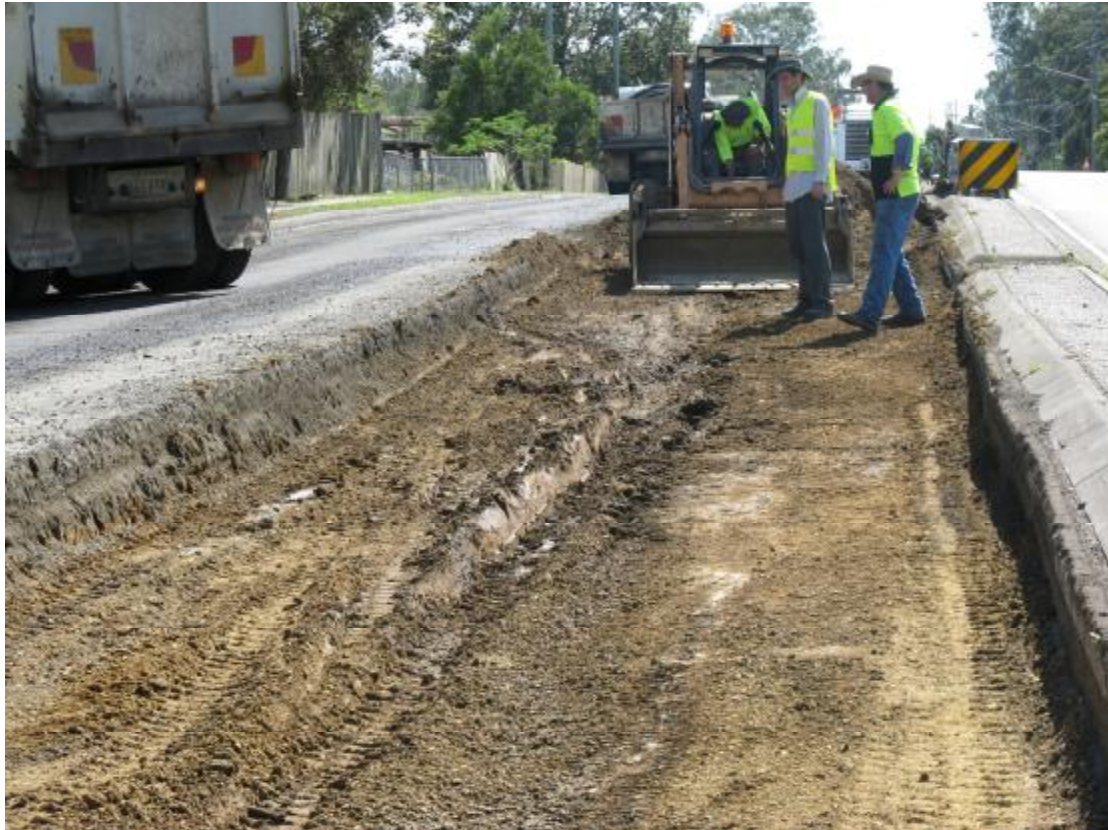
Actual costs for the pavement rehabilitation works were \$986,212, and the increase was due to a large soft area found in the subgrade after excavation of the base.

Figure 8.1: Soft subgrade on Redbank Plains Road

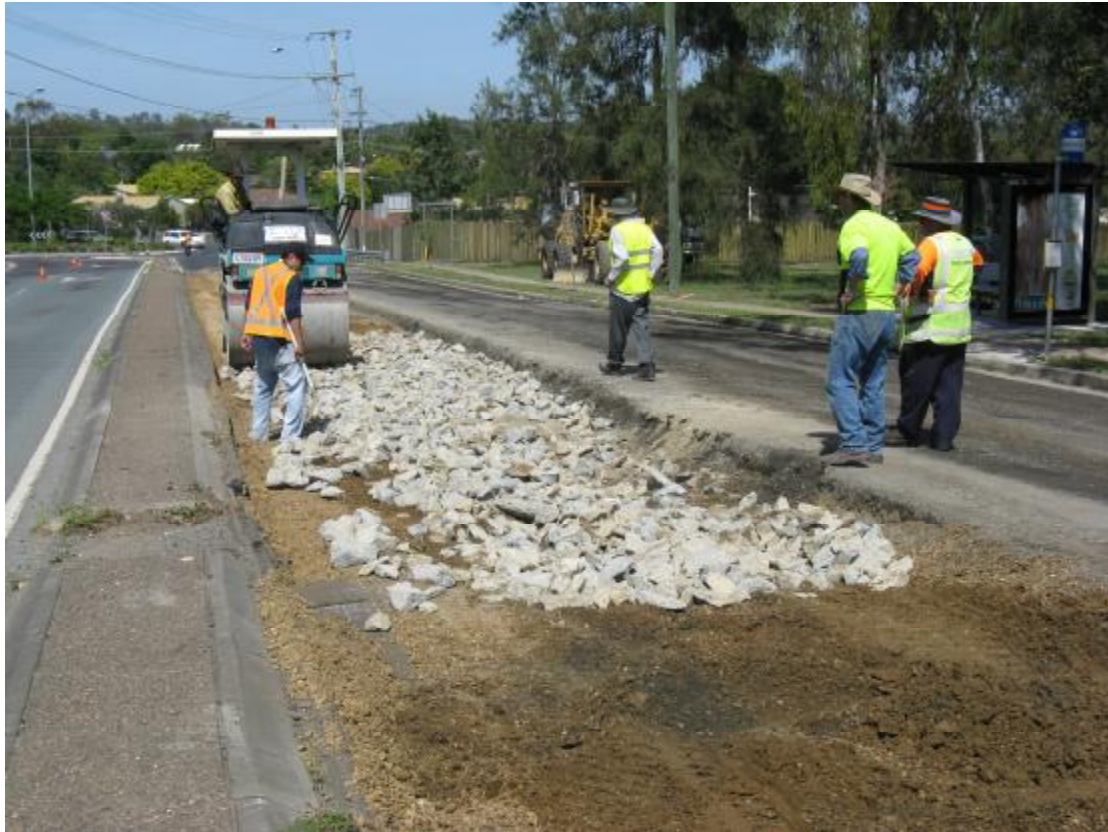
Figure 8.2. Rock stabilisation of soft subgrade

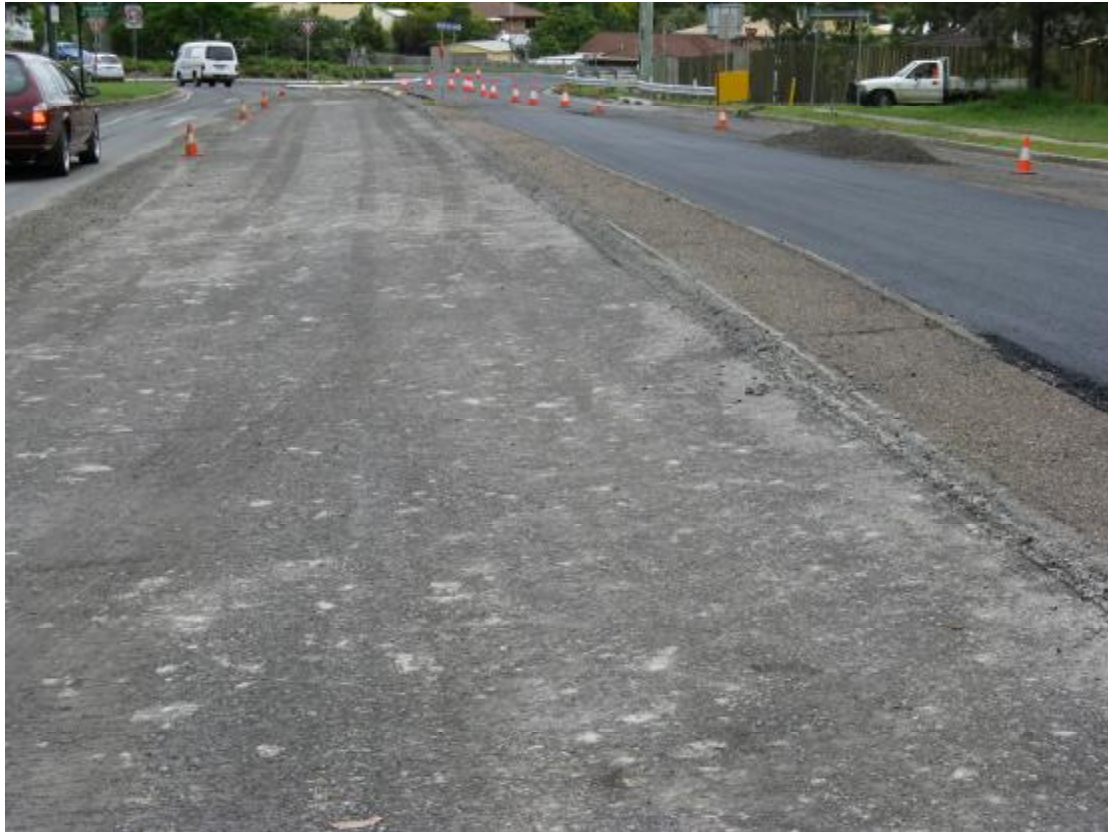
Figure 8.3: Foam bitumen treatment on Redbank Plains Road before wearing course
