University of Southern Queensland

**Re-Establishment of the State Border
between New South Wales and Victoria.**

Courses ENG 4111 and ENG4112 Research Project

Bachelor of Spatial Science: Surveying

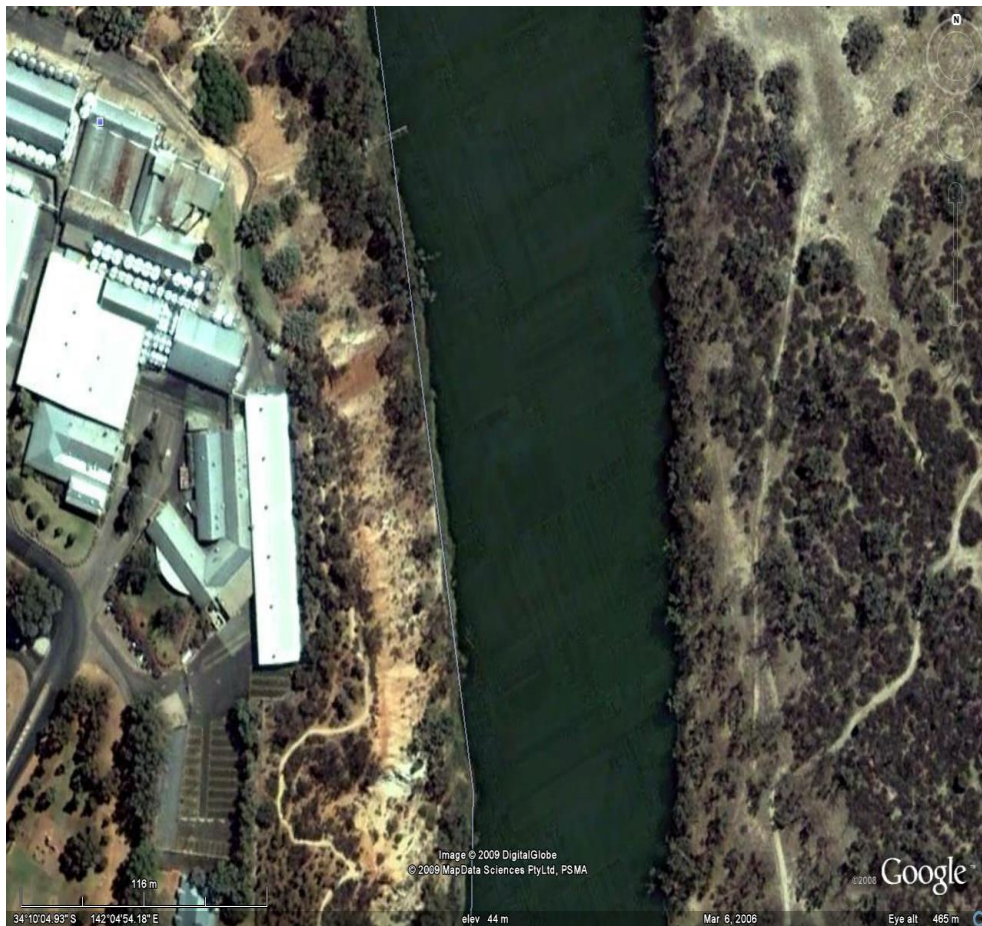
Figure 3.2 is an overhead picture of the first survey site. It shows the Winery, which has been constructed at the top of the seventeen metre high hill.

Site 1, (See figure 3.2 and figure 3.3), was chosen as the site itself remains very much untouched by human intervention and is still a very natural environment. The site has a very high natural bank, approximately 17 metres above the natural water level. The current conditions are believed to be very similar to that of 150 years ago, apart from some natural erosion.

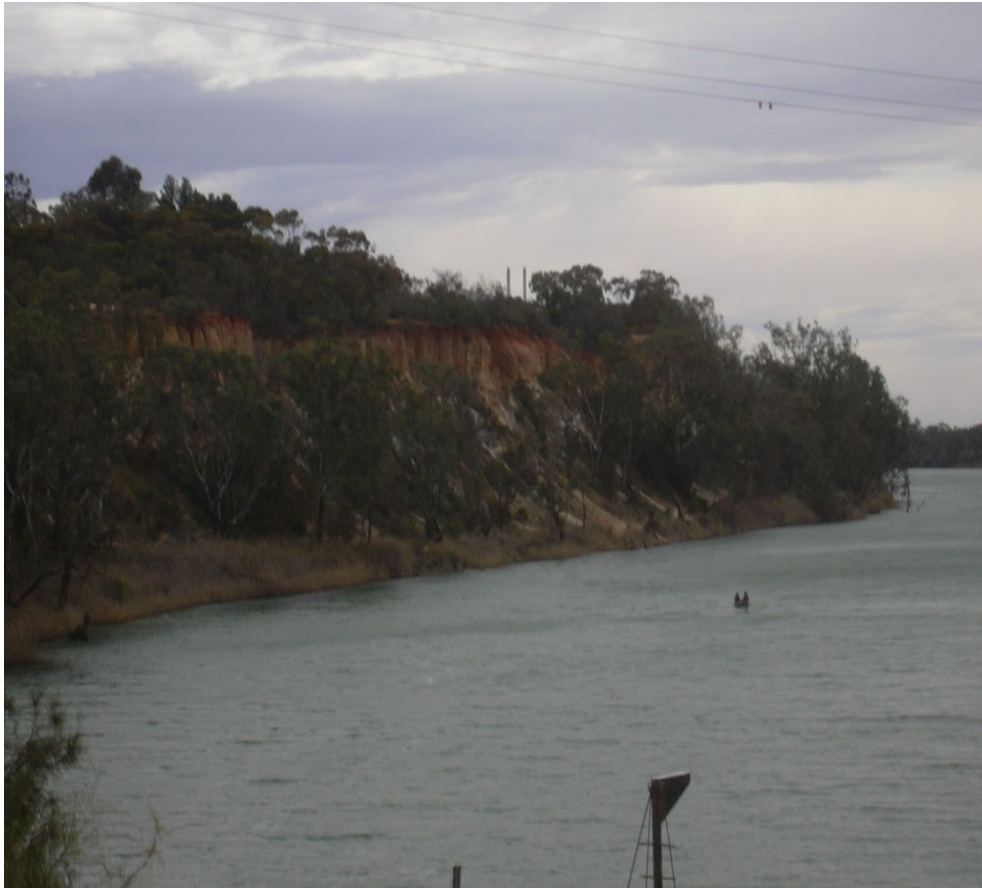
Figure 3.3 shows a side-on view of the bank in question. This gives a visual appreciation of the size of the bank that was surveyed.

Site 1 was the most difficult of the three chosen areas to survey. The main reason for this was the difficulty in accessing the very high bank. Four survey stations were required. One was placed in a very similar position to where the photo was taken for figure 3.3. This station located levels below the normal pool level. A boat and an extension prism pole were required for this as the natural land below the water dropped away rapidly. Levels were also located from the water level to the top of the high bank. Three stations were required at the top of the high bank, as level data was hard to locate due to this being heavily treed.

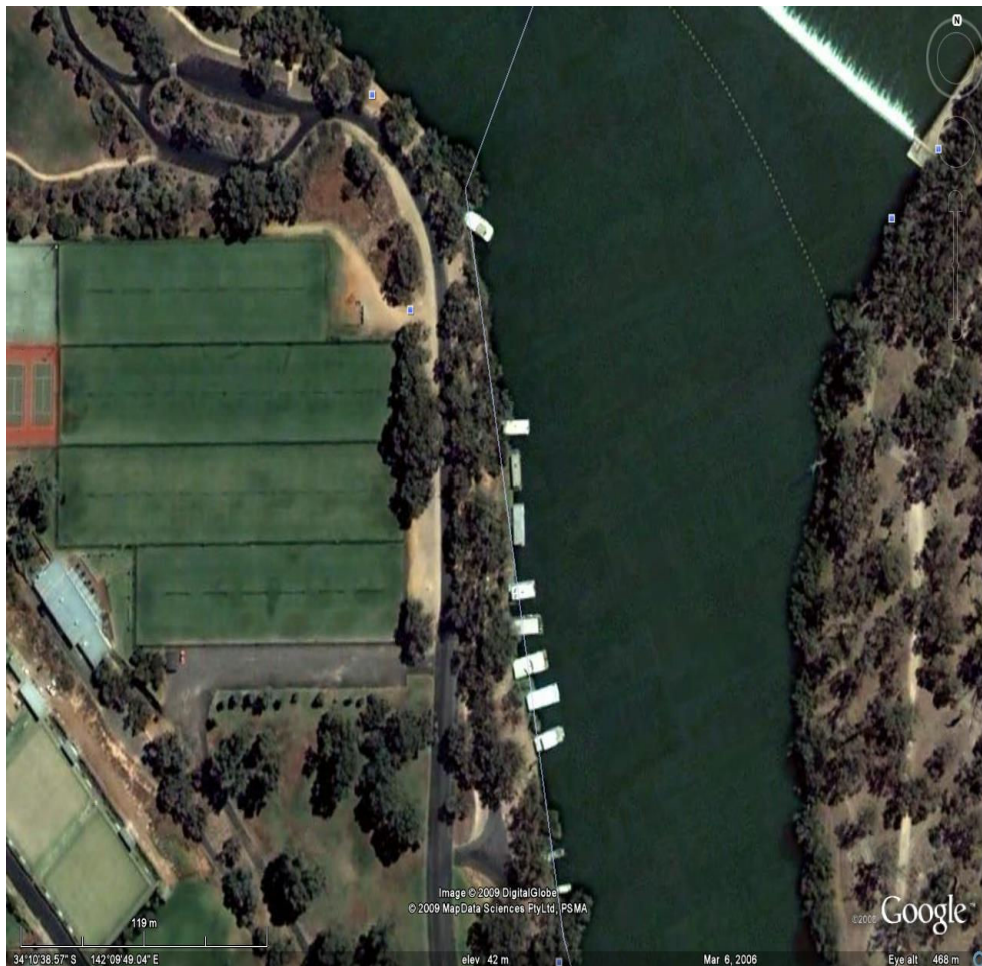
Figure 3.4, is an overhead picture of the second survey site. It shows the tennis courts adjacent to the survey area. House boats are also shown parked along the river bank.

Site 2, (See figure 3.4 and figure 3.5), was chosen as the site contains land that is both natural, in that the land in close to its condition of years gone by, and also contains land that has been changed over the years due to man-made intervention, which has seen it alter from its original condition.

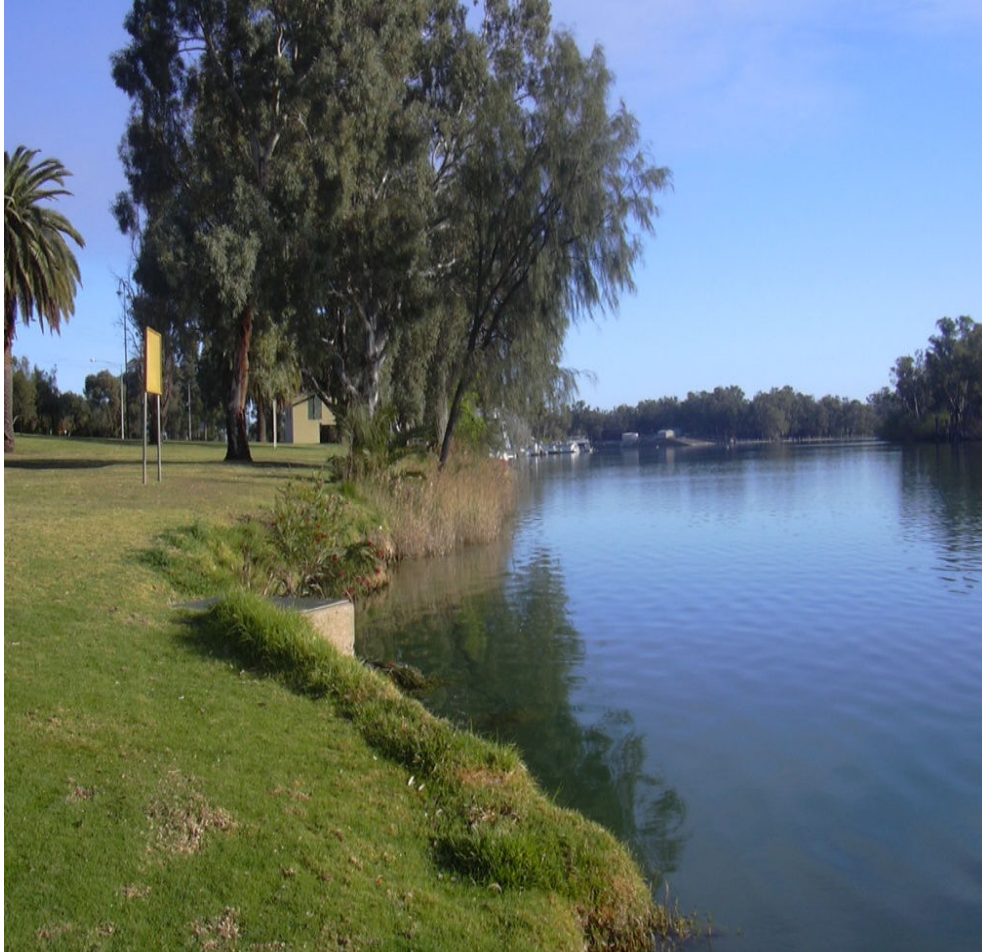
Figure 3.5, shows the bank that was surveyed for Site 2. The bank in the foreground has been altered by man-made constructions, while the bank further down stream remains largely unaltered.

Site 2 was the easiest of the three areas to survey. Just the two survey stations were required; one on the Victorian side of the river, and the other on the New South Wales side. This was because the survey data was much easier to locate from the opposite side of the river. The same method of surveying was used with a Total Station to locate the data from beyond the high bank down into the water. A boat and a five metre extension pole were also used to assist in locating levels under the water.

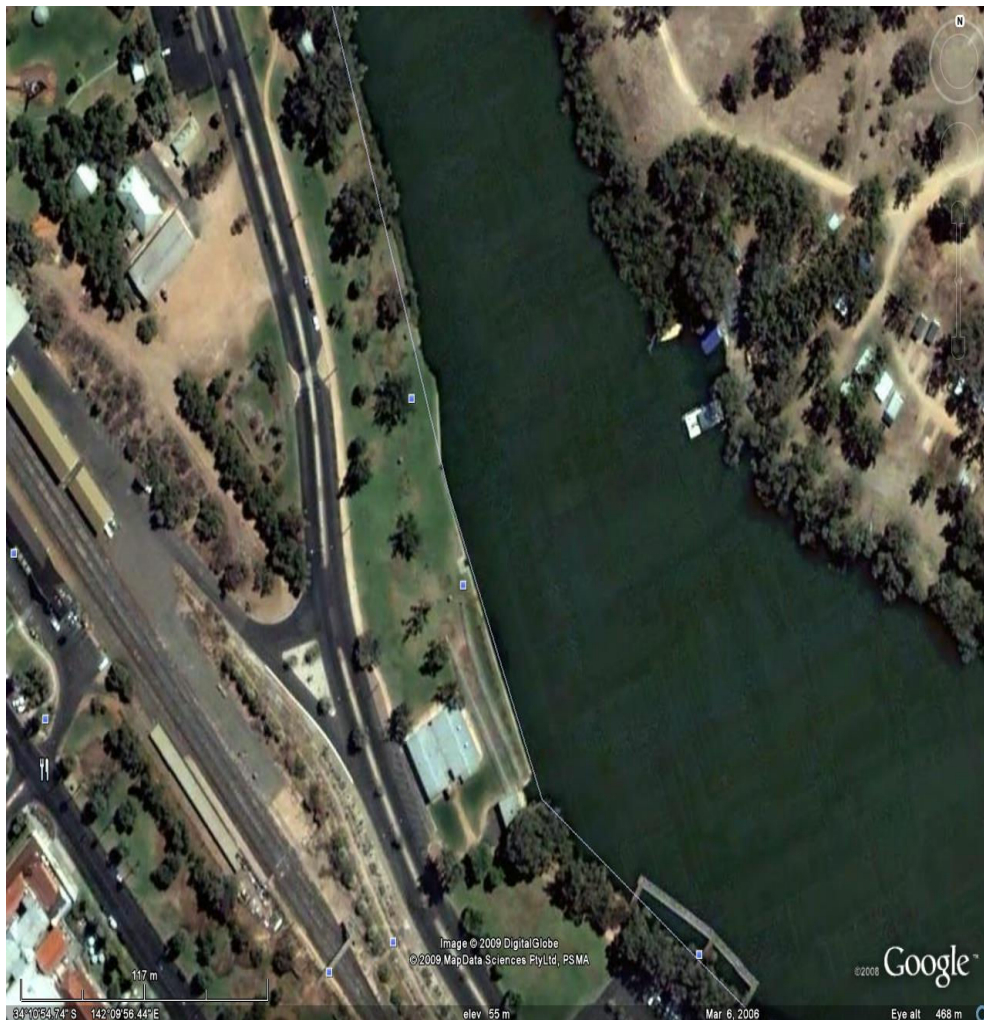
Figure 3.6, is an overhead picture of the third survey site. It shows the rowing club lawns and buildings adjacent to the survey area. The Mildura wharf is located at the upstream end of the surveyed area.

Site 3, (See figure 3.6 and figure 3.7), was chosen as the site contains land that has been affected by humans over the past 50 years. All land in this area has had changes to its natural appearance and therefore it is vastly different to how it would have been around 150 years ago.

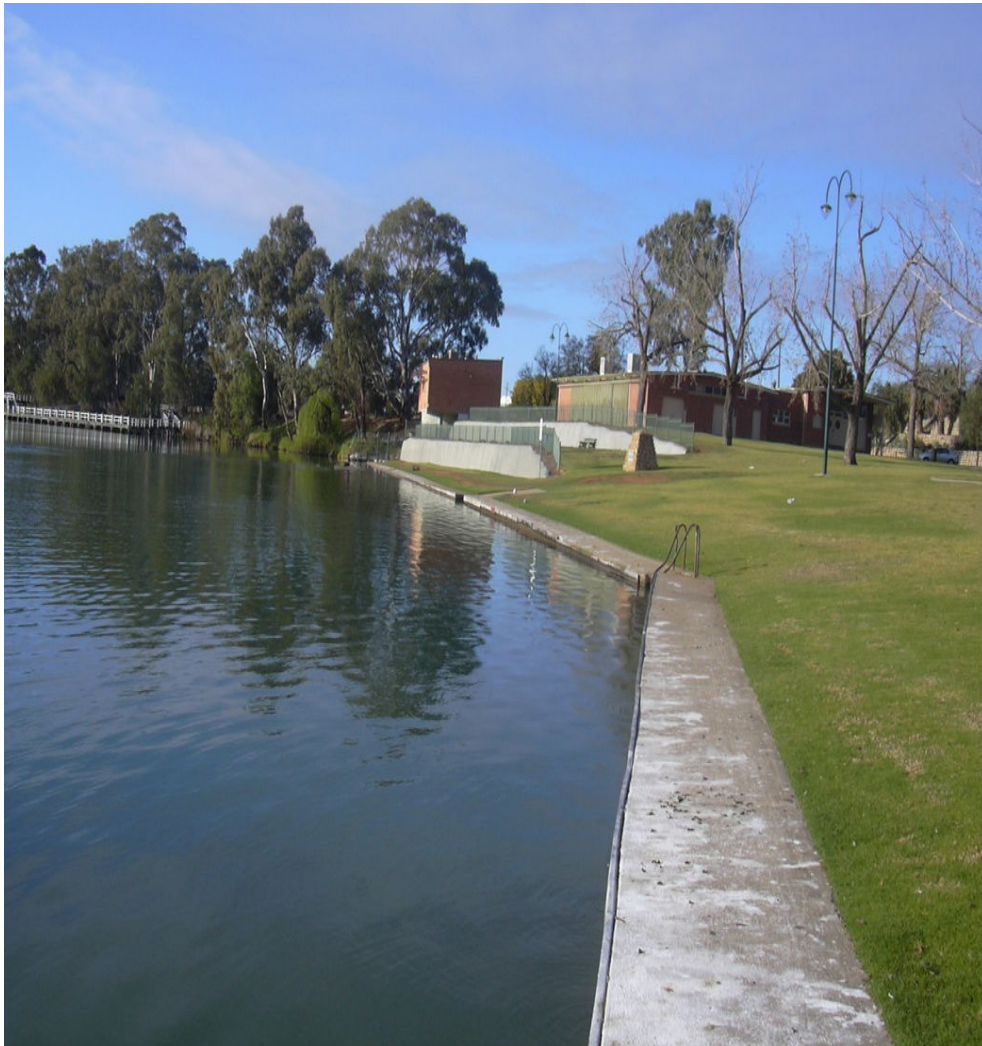
Figure 3.7, shows the bank which was surveyed for Site 3. As can be seen, the bank itself has been changed dramatically from its natural condition. Concrete retaining walls have been constructed and new buildings erected.

Site 3 was surveyed using the same methods as the other surveyed areas. Like the second site, two survey stations were used, one on either side of the river, with the level data being located with a Total Station and prism pole from beyond the high bank, down into the water. All data was located from the New South Wales side of the river to improve survey siting. Once again a boat and a five metre extension prism pole were used to locate the underwater levels.

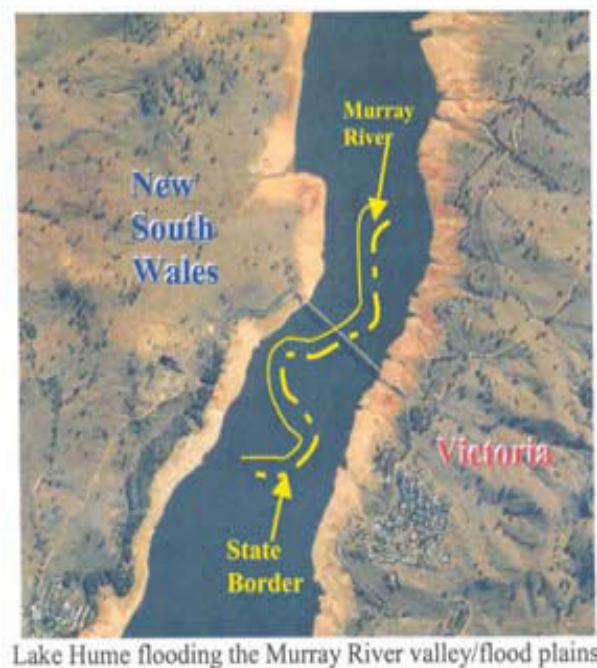
Figure 4.10, depicts the location of the river channel and the state border within the Lake Hume watercourse.

The bridge passes over the channel of the Murray River, which is now submerged under the lake. In this particular case, the surveyors were required to define the state border in the vicinity of the bridge. Normally this would have required the surveyors to survey levels across the entire lake in order to determine the original Murray River channel position. However, in this particular case the surveyors were able to take advantage of the lake being in drought. Therefore, the main channel that contained the average winter flow was now visible to the surveyors, making the re-establishment of the border a more practical process.

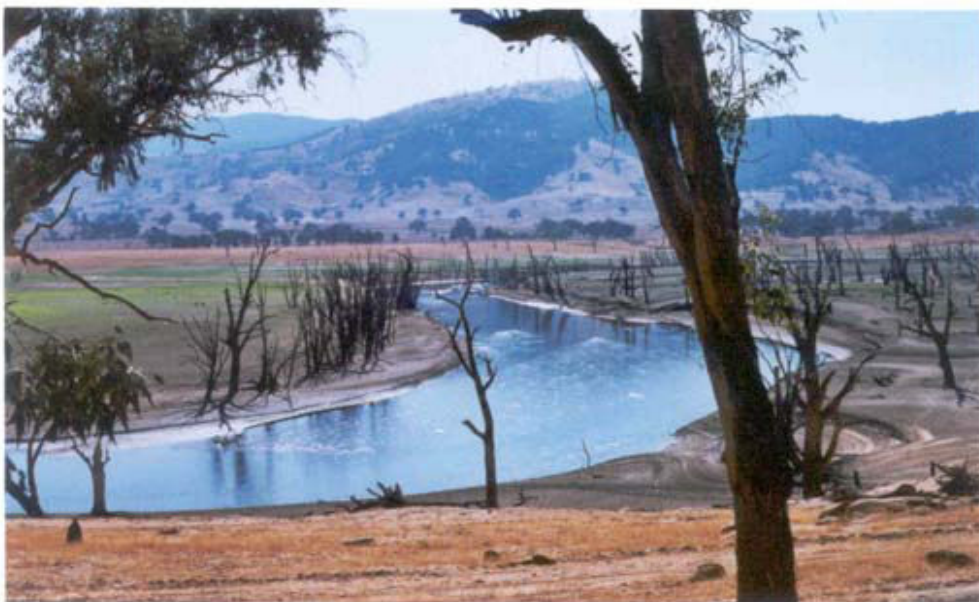
Figure 4.11 was taken during the drought in 2004 when much of Lake Hume receded back into the channel of the Murray, which clearly shows the location of the left bank (on the right side of the photo) and therefore, the position of the state border.

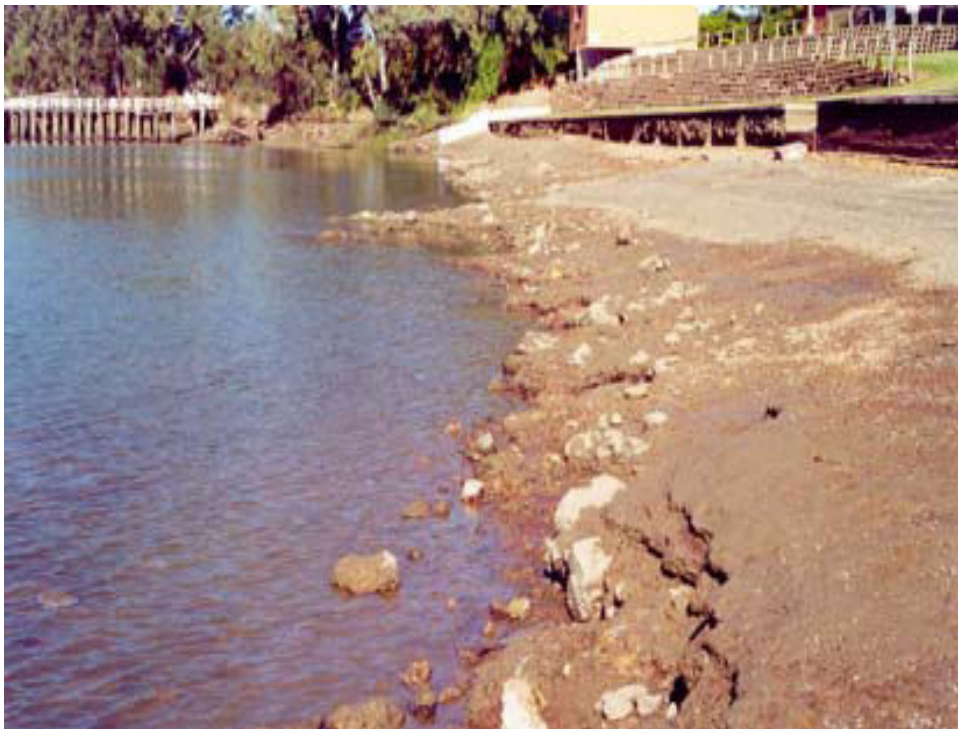
Figure 5.4

This picture of Site 3 was taken in 2001, when the loch and weir had been removed for maintenance. It shows the concrete retaining wall in the background that usually contains the normal pool level, and the top of the bank that contains the average winter level is now holding the current water flow.

The contours and cross sections of Site 3 show that although there has been much man made activity that has occurred on and around the banks of the river, most of this has taken place above the normal pool water level when the loch and weir are in place. The original channel of water flow or the ordinary winter level, is contained by the submerged high bank that has been located by this survey. It appears to be still very natural and untouched. It can be seen most evidently on Figures 5.4 and 5.5 on Pages 59 and 60.

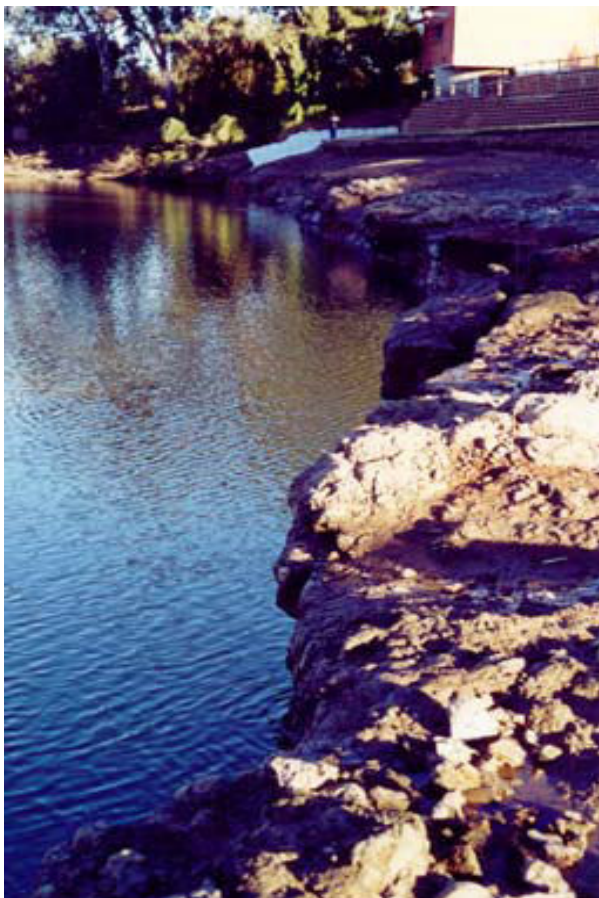
Figure 5.5

This figure of Site 3 was taken in relatively the same position as that in figure 5.4 except two days later. The water level has now receded well below the high bank that contains the natural flow.

Like the previous figure, it shows the concrete retaining wall in the background and the high bank that contains the average winter water flow is now very obvious.

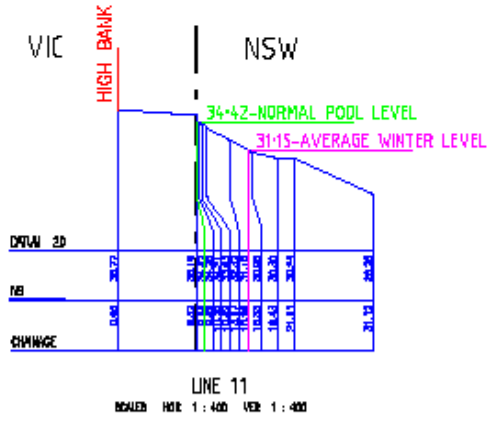
Appendix D (Cross sections of the chosen survey sites - Site 3)

(Cross section plans of Site 3 can be seen in the Appendices.)
