**EFFECTIVE ROAD PAVEMENT REHABILITATION FOR
LOCAL GOVERNMENT ROADS WITHIN THE
SUNSHINE COAST REGION**

A dissertation submitted by
Thomas Sanders

Bachelor of Engineering (Civil)

Submitted: October, 2014

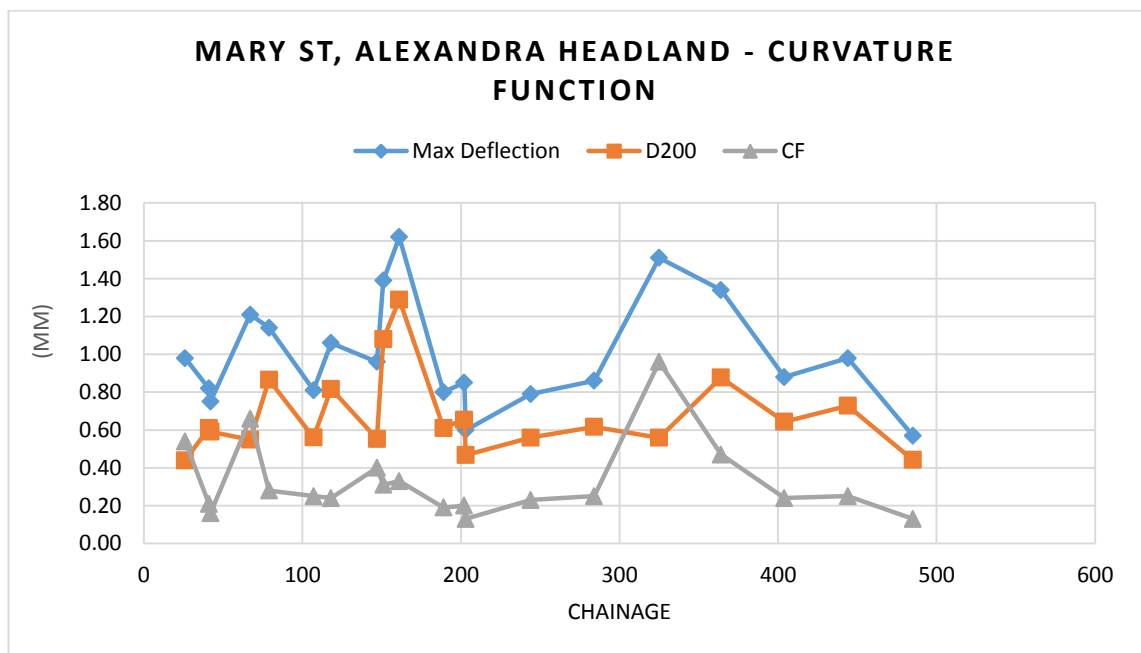
Mary Street, Alexandra Headland has an average relationship between CF values and maximum deflection of 31% for the length of the project, shown in Figure 30. Of particular interest are the five (5) locations where CF values exceeds 35% of the corresponding maximum deflection, ranging from 35% to 64%, demonstrated in Figure 30. Curvature function values at these locations range from 0.40mm to 0.96mm. Transport and Main Roads (2012) outlines pavements exhibiting CF values greater than 0.4mm may indicate a pavement that is lacking stiffness or a very thin pavement. Therefore, 25% of Mary Street is exhibiting characteristics of a pavement lacking stiffness.

Figure 30: Mary St, Alexandra Headland - Curvature Function

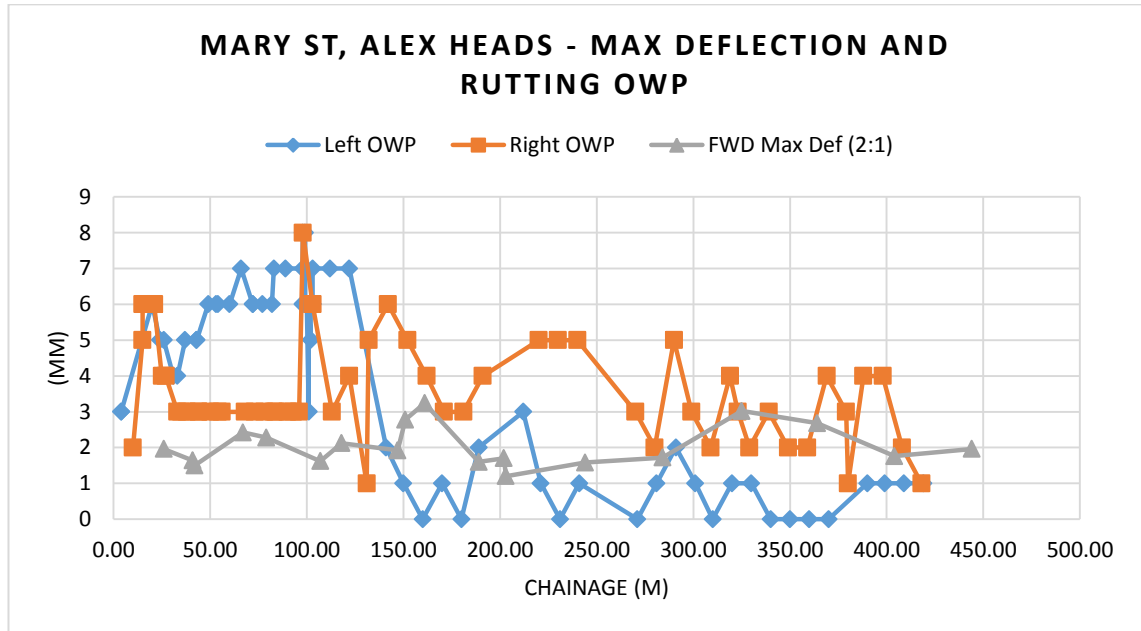
wheel path respectively. Chainage 150 to 170 in Figure 31 represents the only clear section of high correlation between the maximum deflection and rutting in the right outer wheel path.

Figure 31: Mary St, Alexandra Headland - Rutting and Maximum Deflection

Reporting requirements of severity and extent of outer wheel path rutting is outlined in Section 4.4.3. In accordance with this, Mary Street displays rutting with severity ranges of 0 – 5 mm and 5 – 10mm extending for 66% and 34% of the project respectively, shown in Figure 31. Austroads (2007) reports that structurally, rutting less than 10mm is not regarded as significant. As there is no evidence of shoving along Mary Street, the results characterise a pavement where the pavement layers are too thin to protect the subgrade. A reduction in pavement thickness was undertaken due to the inclusion of Tensar Grid and further work is required on the use of Tensar Grid pavement rehabilitation options to improve understanding of the product capabilities.

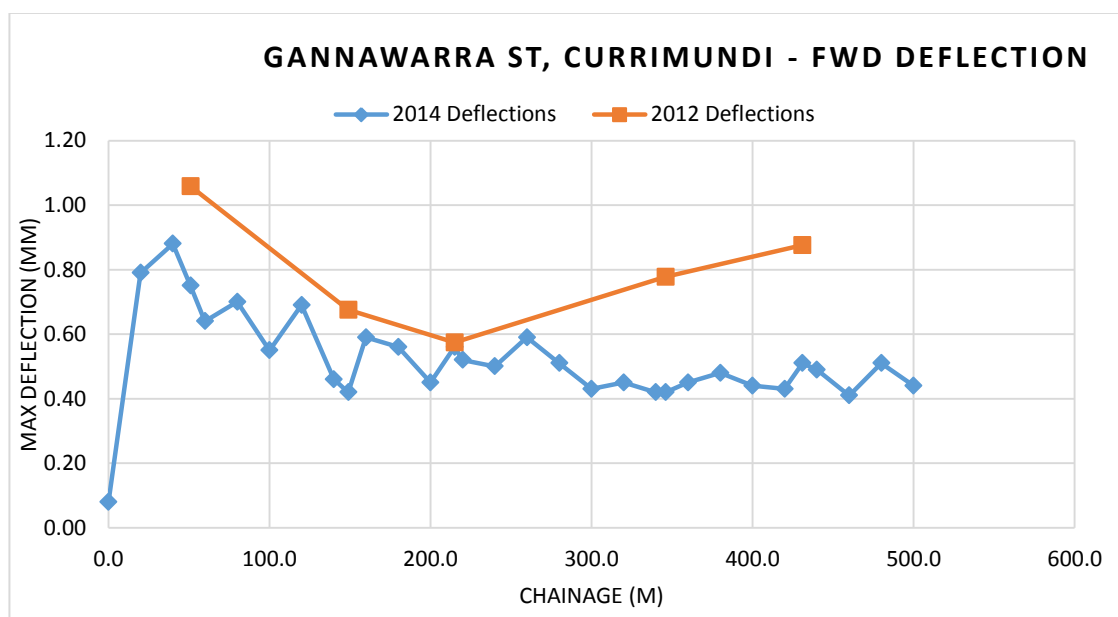
Figure 33 demonstrates marginal improvement in the maximum deflections from testing prior to pavement rehabilitation works in 2012 and post construction in 2014. Results demonstrate a uniform pavement structure. Average maximum deflection results for 2012 and 2014 were 0.79mm and 0.52mm respectively.

Figure 33: Gannawarra St, Currimundi - 2012 and 2014 Maximum Deflection

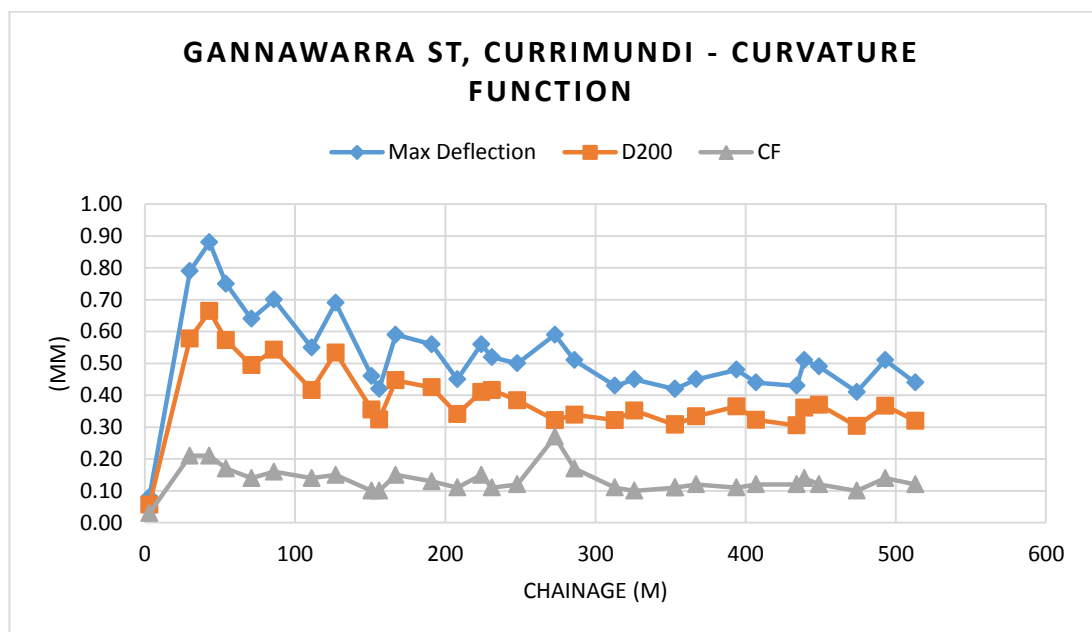
Gannawarra Street, Currimundi has an average relationship between CF values and maximum deflection of 26% for the length of the project, shown in Figure 34. TMR (2012) also suggests low values of CF (<0.2mm) indicate a stiff pavement and 90% of Gannawarra Street resulted in CF values below this with two (2) test locations marginally above at 0.21mm located at chainages 20m and 40m, resulting in values of 0.21mm.

Figure 34: Gannawarra St, Currimundi - Curvature Function

One (1) additional location returned a marginally high value of curvature in relation to maximum deflection, with a correlation of 46%. This locations returned a CF value of 0.27, marginally exceeding the ideal CF value of 0.2mm or less as outlined by TMR (2012).

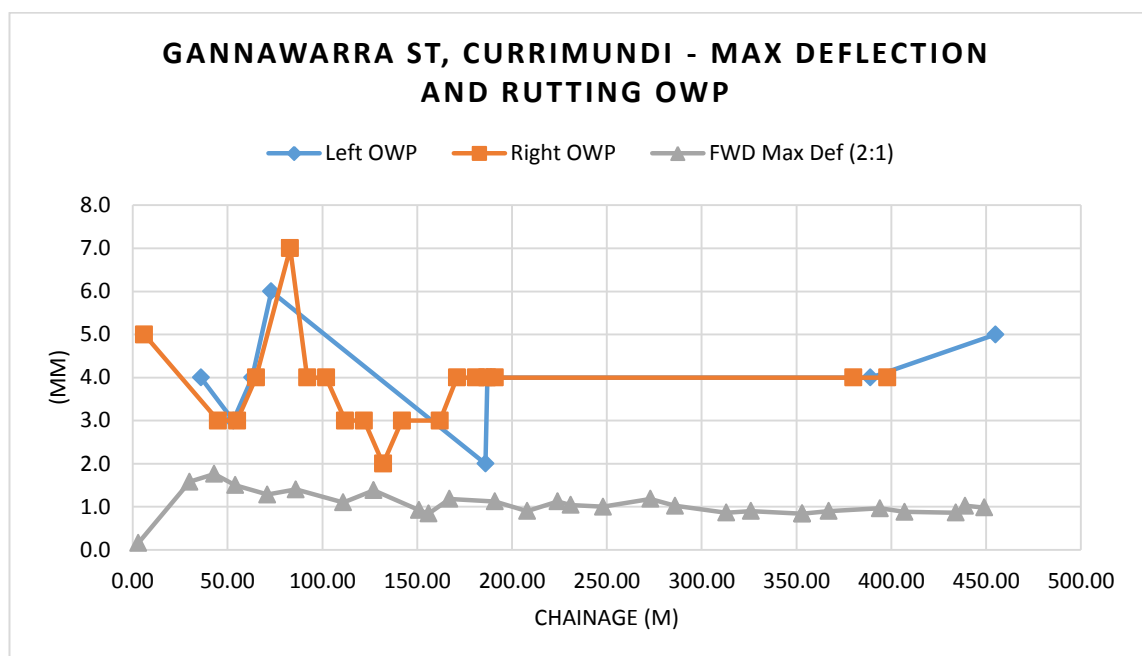
Figure 35 indicates an average rutting of 4.00mm and 3.78mm for the right and left outer wheel paths respectively. Chainage 70 to 85 represents a section of high rutting. As the rut depths measured at these locations do not correlate with pavement deflection and there is no shoving evident TMR (2012) suggests the likely cause is densification of the pavement layers under traffic early in the life of the pavement. This section is located at the intersection of Doondoon Street and experiences higher traffic loadings than the remainder of the project. This may also contribute to the high rutting measured by Radar Portal Services due to changes in cross-fall associated with keying in to the adjacent street.

Figure 35: Gannawarra St, Currimundi - Rutting and Maximum Deflection

Reporting requirements of severity and extent of outer wheel path rutting is outlined in Section 4.4.3. In accordance with this, Gannawarra Street displays rutting with severity ranges of 0–5mm and 5–10mm extending for 93% and 7% of the project respectively. Austroads (2007) reports that structurally, rutting less than 10mm is not regarded as significant. The above results indicate adequate pavement strength and depth, however, minor rutting may be due to densification of the pavement layers under early traffic.

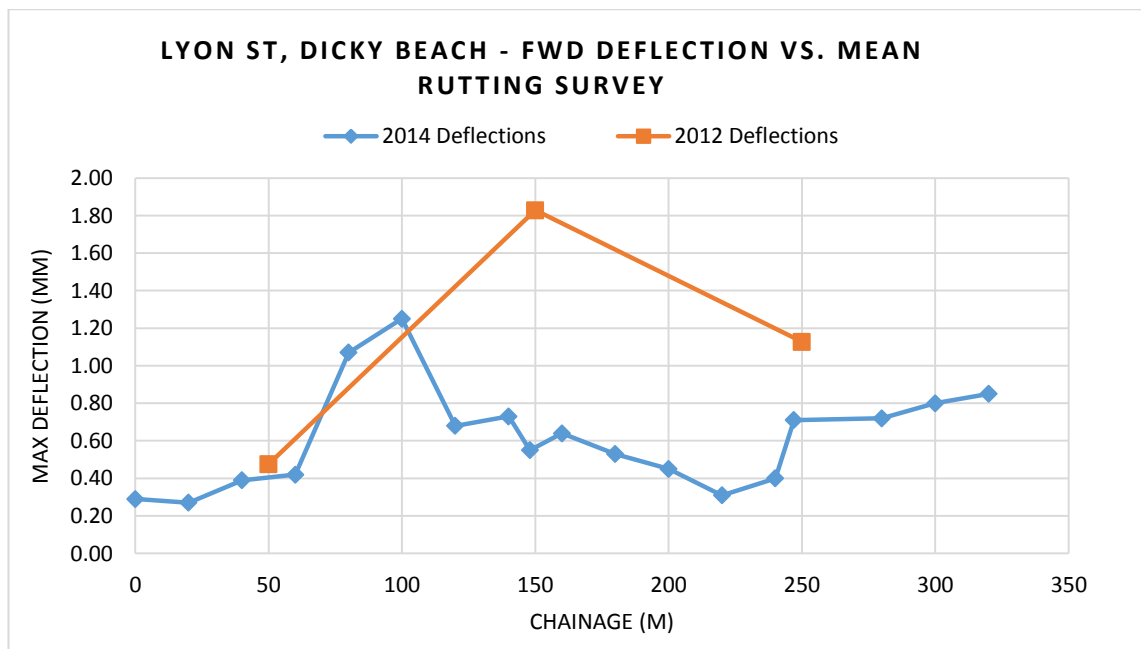
Figure 38 demonstrates a significant improvement in maximum deflection at two (2) of the three (3) locations tested in 2012. Test results within the first 75m are not relevant as this section was only resurfaced due to low 2012 maximum deflections and existing pavement conditions. Results from the remaining two (2) locations suggest a significant improvement in pavement strength. Extensive subsoil drainage works may have assisted in drying out the previously saturated subgrade. Average maximum deflection results improved from 1.14mm prior to pavement rehabilitation works in 2012 to 0.61mm post construction works in 2014.

Figure 38: Lyon St, Dicky Beach - 2012 and 2014 Maximum Deflection

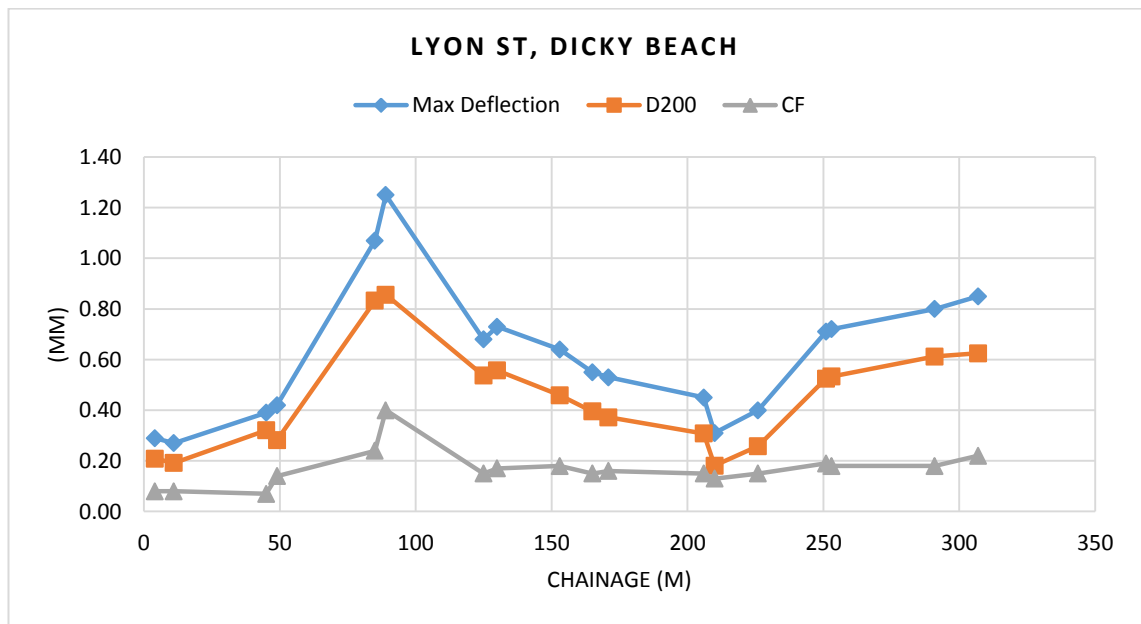
Lyon Street, Dicky Beach has an average relationship between CF values and maximum deflection of 28% for the length of the project, as demonstrated in Figure 39. Within the acceptable range for granular pavements of 25% to 35%, as outlined by Austroads (2009). Two (2) locations have a higher than desired relationship, returning values of 38% and 42%. These locations are however accompanied by CF values of 0.15mm and 0.13mm respectively which suggesting a stiff pavement and no further investigation is required.

Evaluating the project on CF values, 83% of Lyon Street returned results indicating high stiffness and strength in the pavement layers, with 17% between 0.2mm and 0.4mm. Below the suggested 0.4mm representing low strength and pavement stiffness as outlined by TMR (2012).

Figure 39: Lyon St, Dicky Beach - Curvature Function

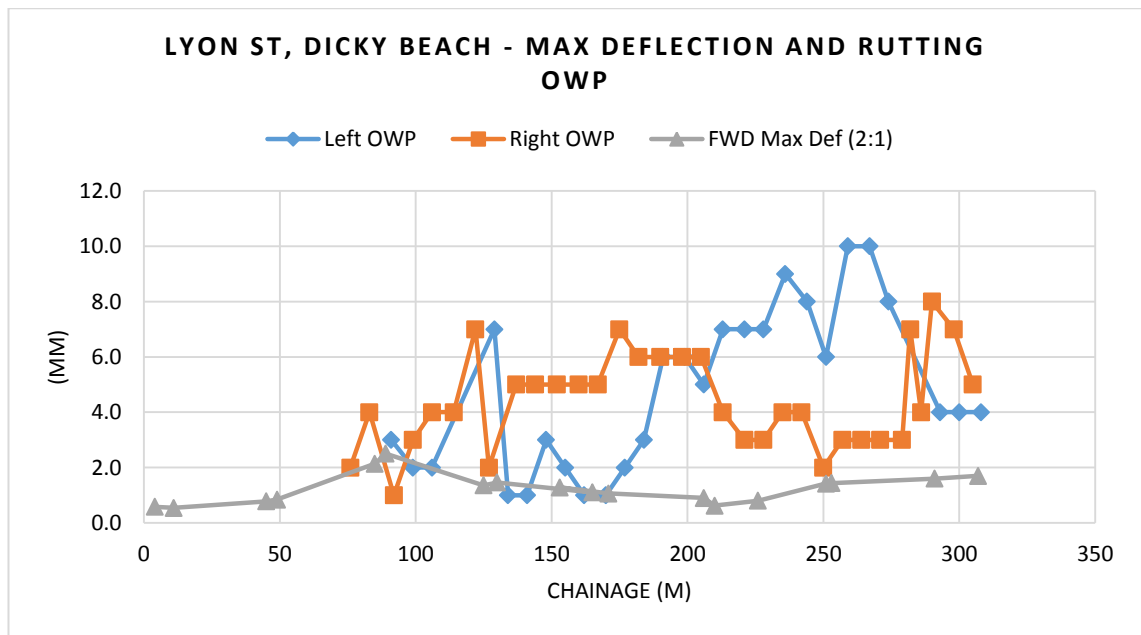
Results shown in Figure 40 indicate an average rutting of 4.78mm and 4.42mm for the right and left outer wheel paths respectively. Reporting requirements of severity and extent of outer wheel path rutting is outlined in Section 4.4.3. In accordance with this, Lyon Street displays rutting with severity ranges from 0-5mm, 5-10mm and 10-15mm extending for 65%, 32% and 3% respectively. As outlined, rutting less than 10mm is not considered structurally significant. Two (2) locations are exhibiting rutting in the high range between 10-15mm and may be susceptible to water ponding and a potential safety issue. Given the road hierarchy of Lyon Street, it is not considered a safety concern.

Figure 40: Lyon St, Dicky Beach - Rutting and Maximum Deflection

The results from testing indicate the use of 30/30 combi-grid has assisted in strengthening the subgrade and improving pavement strength, evident with the significant improvement in maximum deflection and low CF values. The severity of rutting in a few locations is of concern and could be due to a number of factors including moisture ingress, quality of materials and work methods used. During construction significant rainfall was experienced and may have contributed to isolated areas of higher than desirable moisture content within the pavement.

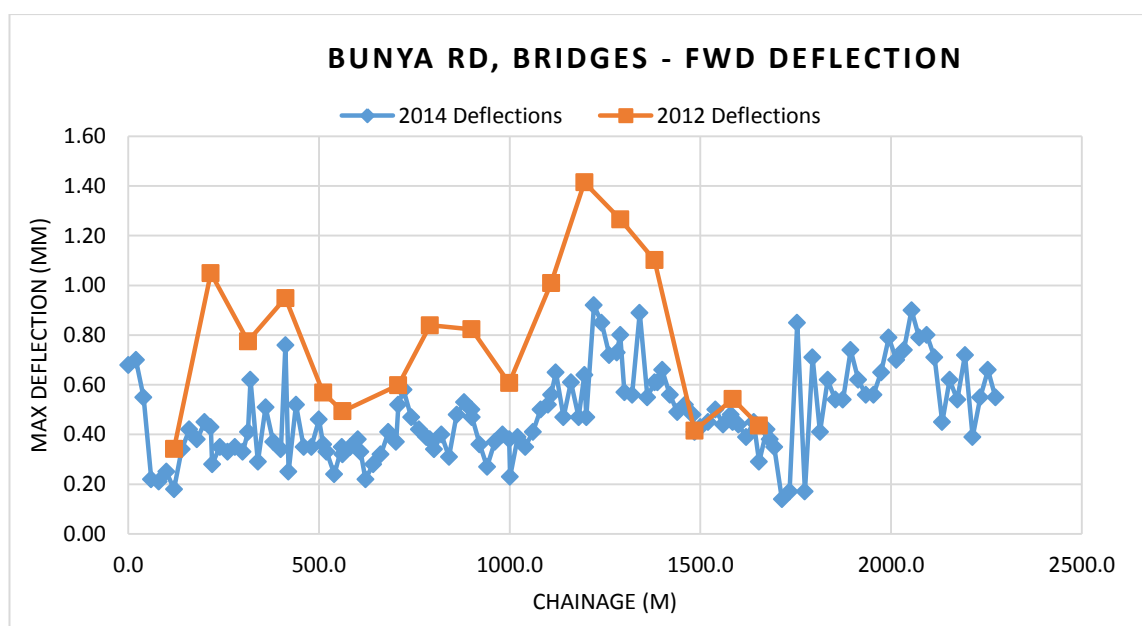
Figure 43 outlines the improvement in maximum deflections from testing conducted prior to pavement rehabilitation works in 2012 and post construction in 2014. Results suggest areas of significant improvement and sections of no improvement. Average maximum deflection results were 0.78mm and 0.48mm for 2012 and 2014 testing respectively, an improvement of approximately 40%.

Figure 43: Bunya Rd, Bridges - 2012 and 2014 Maximum Deflections

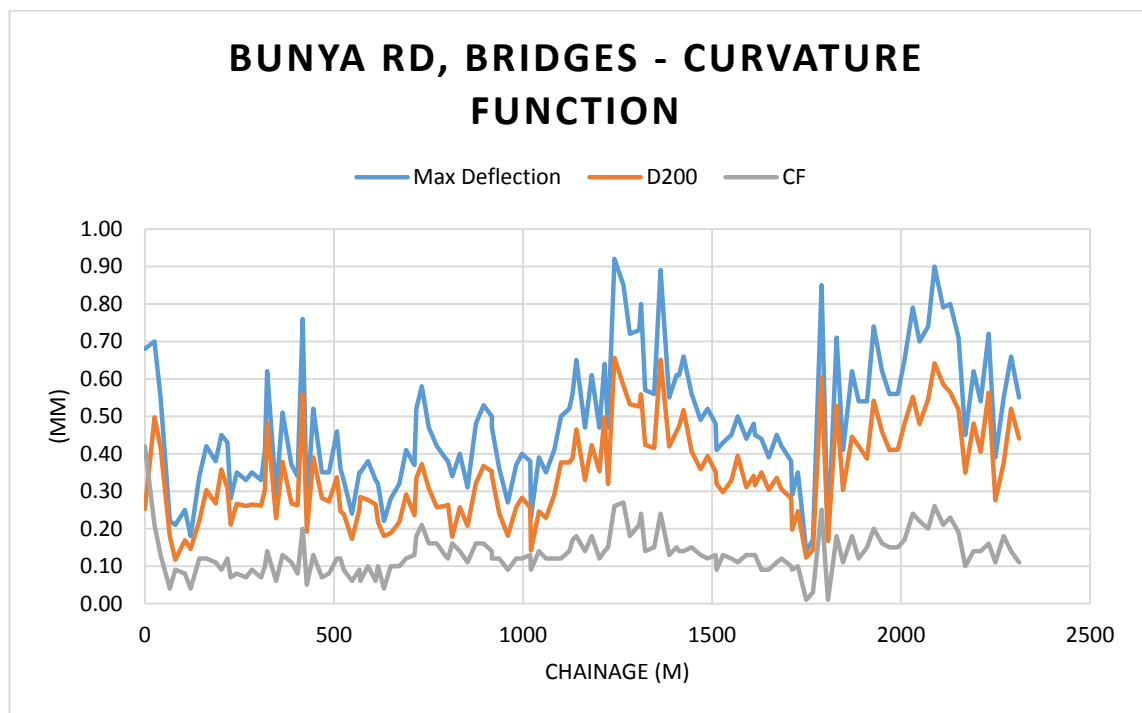
Evaluating for severity of CF values results in 89% of the project with a CF value between 0.0–0.2mm, representing a stiff, sound pavement. 10% of the project returned values between 0.2 and 0.4mm which is acceptable, shown in Figure 44. One (1)

location is exhibiting concerning characteristics, with a CF value greater than 0.4mm, indicating a pavement lacking stiffness. Further analysis determined this testing was undertaken on the preceding road section to where the pavement rehabilitation works commenced. Therefore, this test location is excluded from further discussion.

Figure 44: Bunya Rd, Bridges - Curvature Function

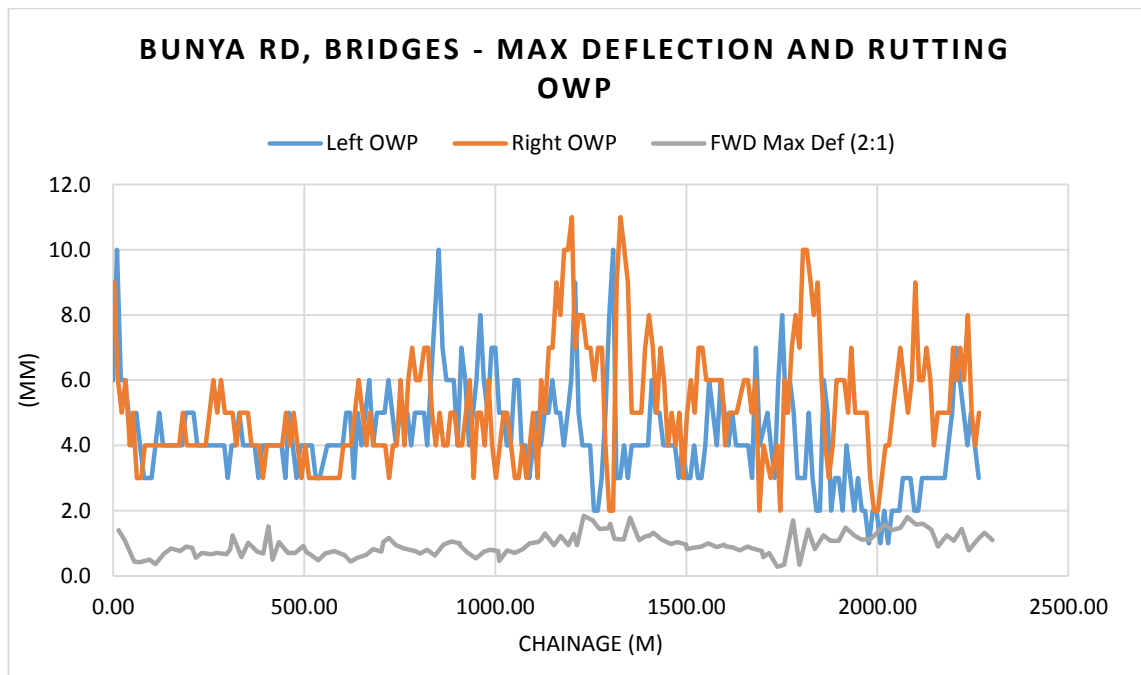
Results shown in Figure 45 indicate an average rutting of 4.30mm and 5.17mm for the right and left outer wheel paths respectively. Between CH1300 and CH1350 results indicate high rutting in both directions. This section is located between two large agricultural property driveways and based on a further site inspection on 10 October 2014, it was evident results may have been effected by foreign material located on the road due to the use of these driveways. Therefore, these results have been excluded from further discussion.

Figure 45: Bunya Rd, Bridges - Rutting and Maximum Deflection

Austroads (2007) reporting requirements outline, Bunya Road displays rutting with severity ranges of 0-5mm, 5-10mm and 10-15mm extending for 75%, 24% and 1% of the project respectively. As rutting less than 10mm is not regarded as significant, only five (5) locations represent areas of concern. Overall the results indicate adequate pavement strength and depth. Significant rainfall and inundation of sections of this project during construction may have contributed to isolated areas of high rutting and weak pavement strength. Between Ch1850.0 and CH1920.0 experienced several periods of inundation during these events, accounting for three (3) locations with high severity rutting.

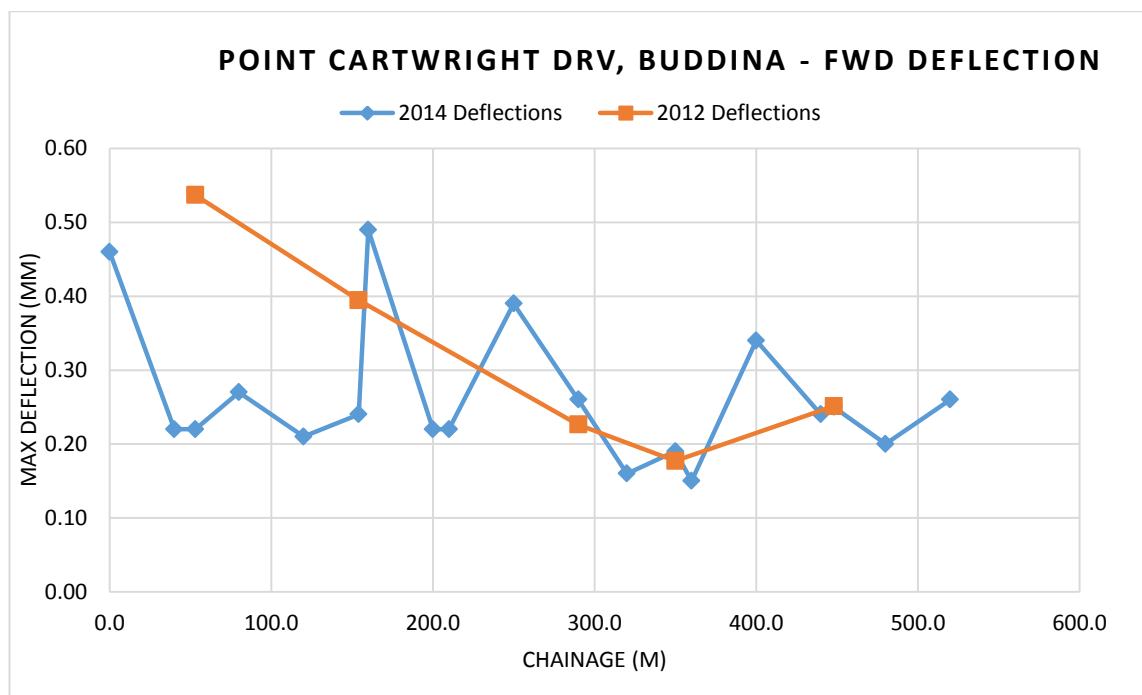
Figure 47 demonstrates inconsistent results for maximum deflections from testing prior to the pavement rehabilitation in 2012 and post construction in 2014. Maximum deflections are well within Sunshine Coast Council's acceptable range with an average maximum deflection of 0.26mm. An improvement from 0.32mm tested in 2012. This indicates the resulting failure of the road was due to the existing pavement reaching the end of its useful life on a sound subgrade.

Point Cartwright Drive is a trunk collector experiencing high traffic volumes. This area is also experiencing a lot of development associated with the adjoining shopping centres and redevelopment of housing blocks within the area. Results from maximum deflection, and confirmed with geotechnical testing suggest adequate subgrade strength and rehabilitation of the pavement layers was required.

Figure 47: Point Cartwright Drv, Buddina - 2012 and 2014 Maximum Deflection

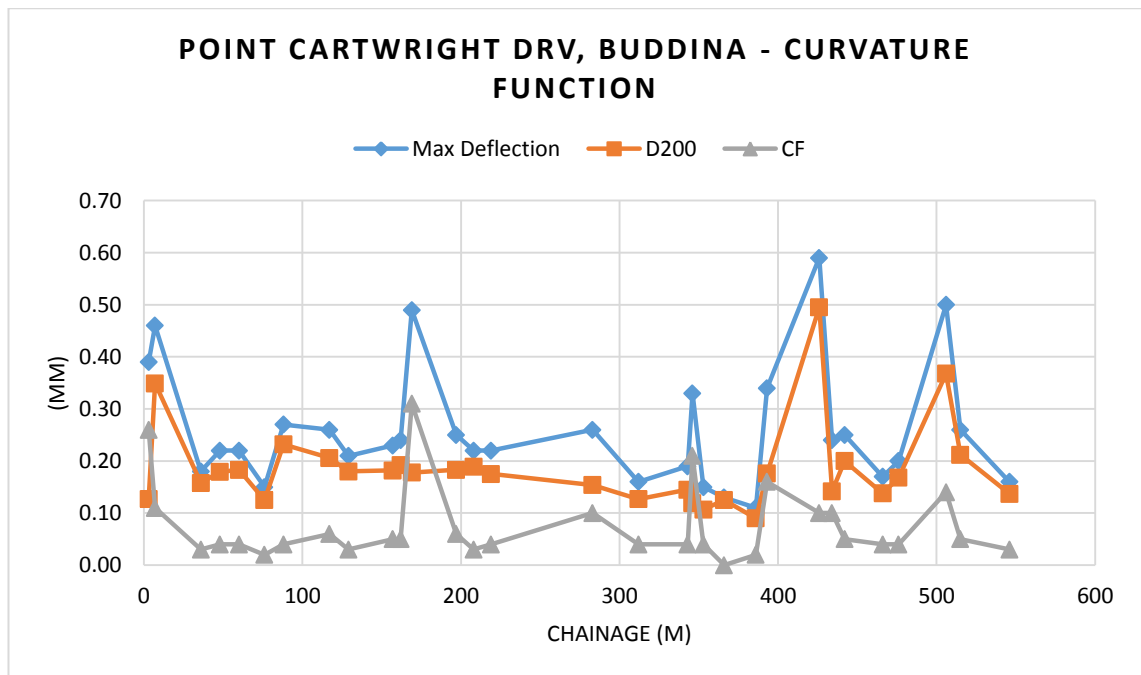
Deflection testing has a much more limited application to rigid pavements (Austroads, 2009). Notwithstanding, Point Cartwright Drive, Buddina has an average relationship between CF values and maximum deflection of 26% with six (6) locations which returned high results ranging between 38% and 64%.

Further investigation into the construction processes used is required to identify areas of pavement joins and if these results are related to paving patterns or failures due to underground infrastructure, common in areas of ageing infrastructure and sandy sub grade materials.

Figure 48: Point Cartwright Drv, Buddina - Curvature Function

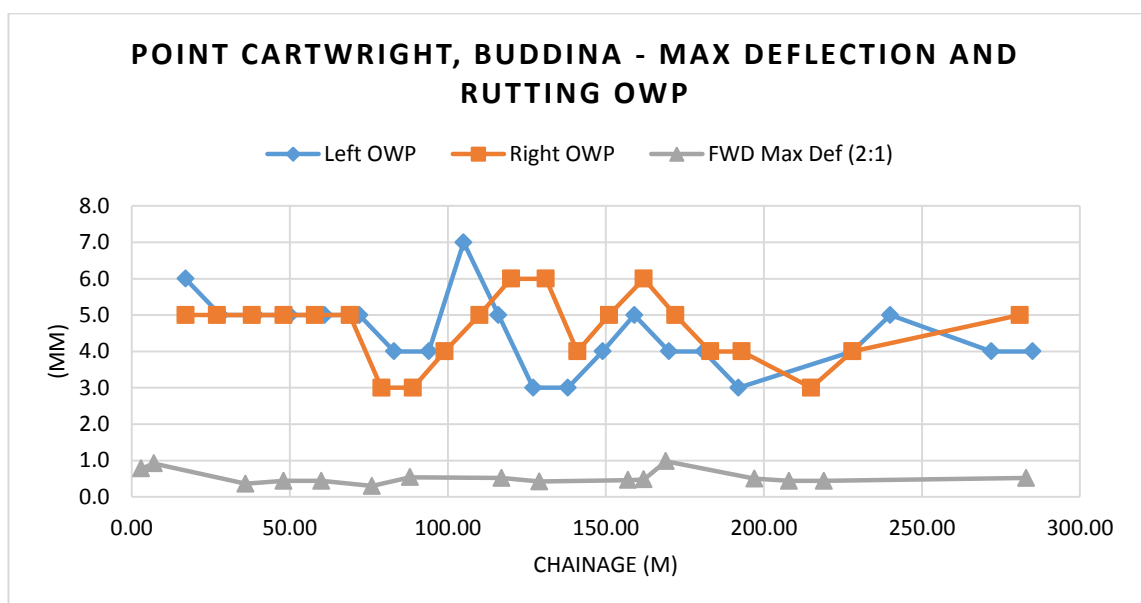
Figure 49: Point Cartwright Drv, Buddina - Rutting and Maximum Deflection

Figure 49 indicates no correlation between rutting and maximum deflection. Indicating rutting may be a result of early trafficking. Results indicate an average of 4.48mm and 4.62mm rutting for the right and left outer wheel paths respectively. Reporting the severity and extent of outer wheel rutting in accordance with Section 4.3.3 results in severity ranges of 0-5mm and 5-10mm with 88% and 12% of the project respectively. Indicating no areas of structural concern.

The results above demonstrate the lowest relationship between deflection measurements and rutting results. Consistently high rutting is evident within the first 75m, approaching a major Transport and Main Roads Queensland intersection. Previous experience in deep lift asphalt pavements suggests rutting may be a result of this pavement rehabilitation option due to early trafficking of the pavement and higher order roads and higher stress areas used i.e. roundabouts and major intersections. Sunshine Coast Council has recently specified Polymer Modified asphalts be used on all roundabouts and major intersections to alleviate this problem.

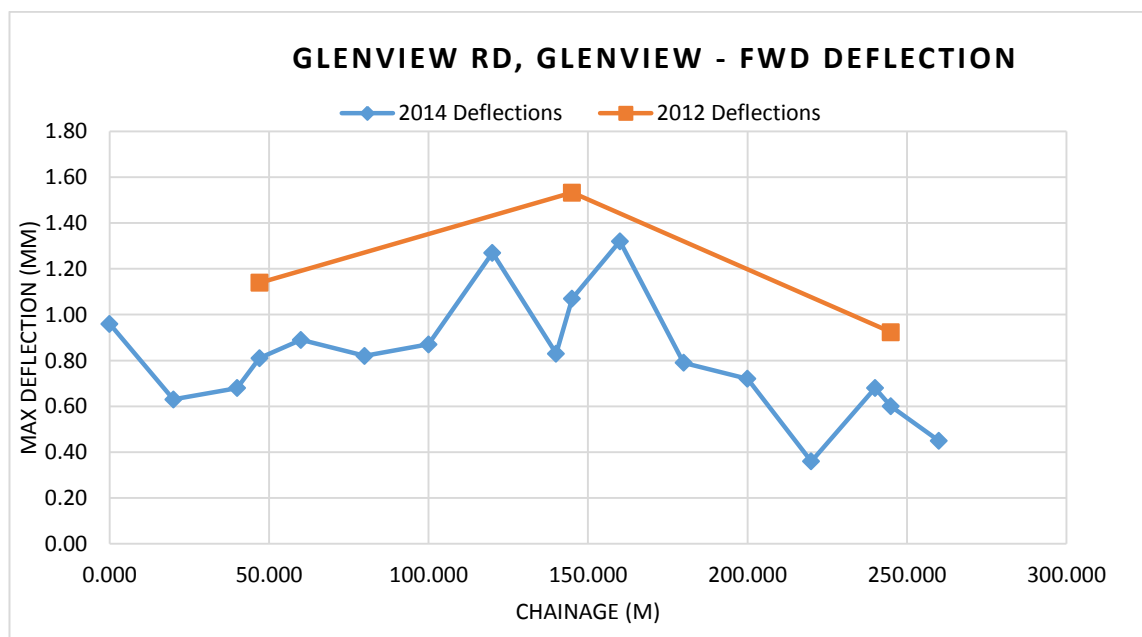
Figure 52: Glenview Rd, Glenview - 2012 and 2014 Maximum Deflections

Figure 52 demonstrates an improvement in average maximum deflections from prior to pavement rehabilitation works in 2012 and post construction works in 2014 from 1.20mm to 0.81mm. Notwithstanding, several test locations exhibit higher than desirable maximum deflections. Maximum deflections of 1.27mm and 1.32mm at CH120 and CH160 respectively are areas of concern, resulting in deflections above Sunshine Coast Council intervention level for resurfacing.

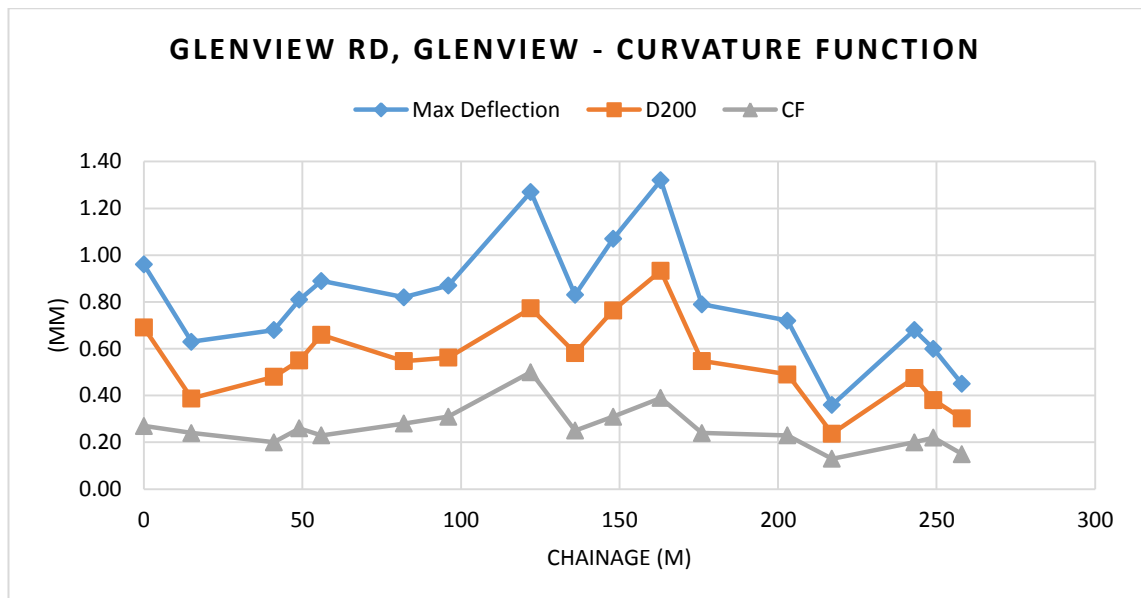
Figure 53: Glenview Rd, Glenview - Curvature Function

Austrroads (2009) suggests high CF values may indicate low stiffness in the upper pavement layers. Glenview Rd, Glenview has a slightly high relationship between CF values and maximum deflection of 32% for the length of the project, outlined in Figure 53. In accordance with Austrroads (2009) guidelines for granular pavements where the CF values are likely to be 25% to 35% of the maximum deflection.

The average CF value for this section of pavement rehabilitation is 0.26mm. within the lower range of values, suggesting a relatively stiff pavement. One (1) location at CH122.0 demonstrates a high CF value of 0.5. Further investigation and discussions with construction crews indicate an area of unsuitable subgrade at this approximate location which was treated at the time of construction. Results may indicate an adjoining section where subgrade replacement was not undertaken.

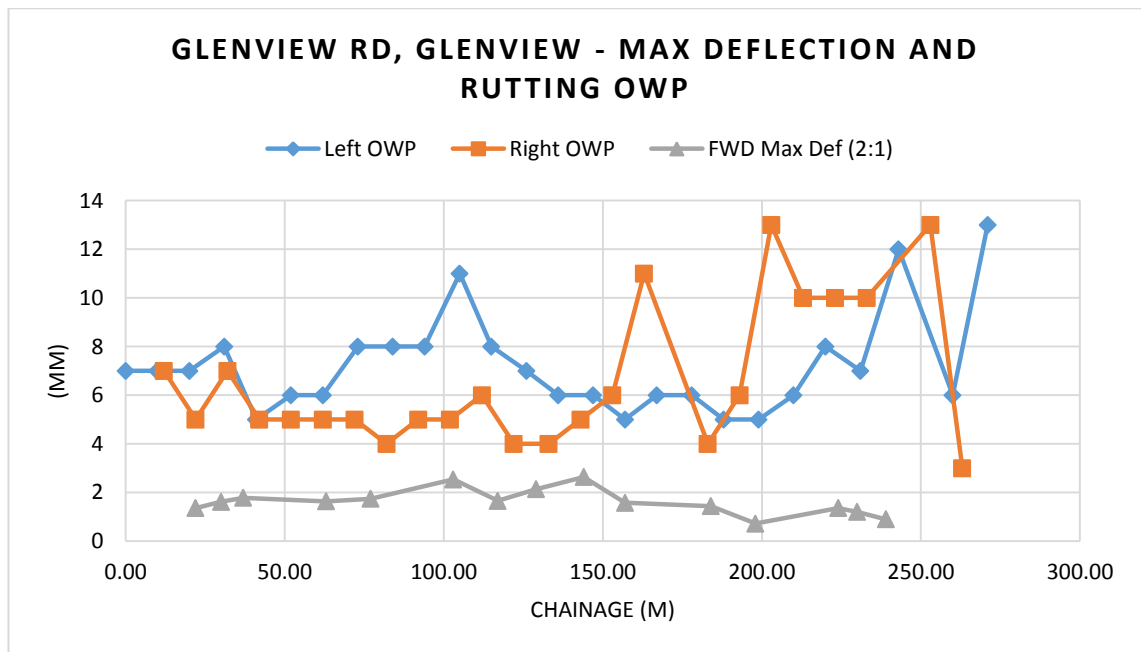
Figure 54: Glenview Rd, Glenview - Rutting and Maximum Deflection

Results indicate an average rutting of 7.19mm and 6.58mm for the right and left outer wheel paths respectively. The highest average rutting of all pavement rehabilitation projects tested as part of this research project. Figure 54 demonstrates that between CH100.0 and CH175.0 it can be seen that a small relationship between maximum deflection and rutting is evident. In this location TMR (2012) suggests the rutting may be caused due to insufficient pavement strength and deformation of the subgrade. Beyond CH200.0 there appears to be no relationship between pavement deflection and rutting and defects could be attributed to poor quality pavement materials, moisture ingress or early trafficking post construction.

Reporting requirements of severity and extent of outer wheel path rutting displays results for Glenview Road, Glenview in several categories of severity. This section demonstrated 34%, 48% and 18% of 0-5mm, 5-10mm and 10-15mm rutting severity. As there is no evidence of shoving along Glenview Road, the results characterise a pavement where the pavement layers are too thin to protect the subgrade.

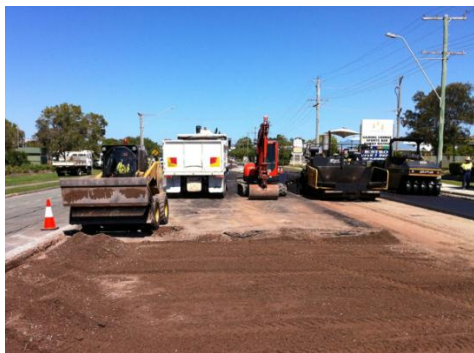
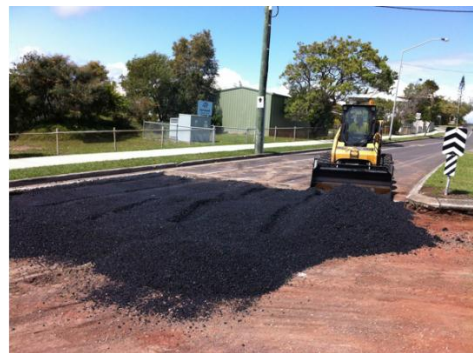
Figure 56: Buderim St, Currimundi - Construction Photos of Unsuitable Subgrade Locations

The project was not constructed exactly as outlined in the above pavement configurations. Sub base layers were combined and placed in one layer for the roundabout section to provide a sufficient platform to compact the base layer on. In the roundabout section the sub base layer was placed via the use of bobcats to limit traffic and construction loads on the subgrade.

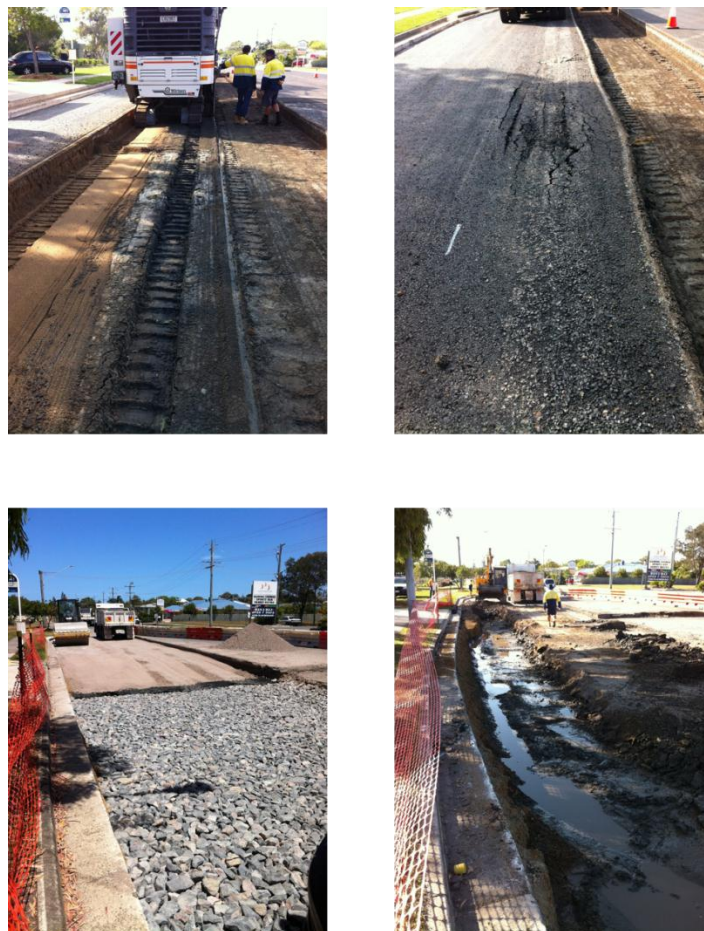
Figure 57: Buderim St, Currimundi - Construction Photos Subgrade Replacement

During this project several construction problems were encountered due to unsuitable subgrade locations. Additional geotechnical testing was undertaken at these locations and the relevant CBR results were in accordance with previous laboratory results. Notwithstanding, it appeared the collapsible soils present onsite had reached the point of saturation where there was a complete loss of shear strength, in some locations groundwater created ponding within the box. These locations were drained with additional subsoil drains and a working platform was constructed using rock and geofabrics. Some of the problems encountered are evident in Figure 57.

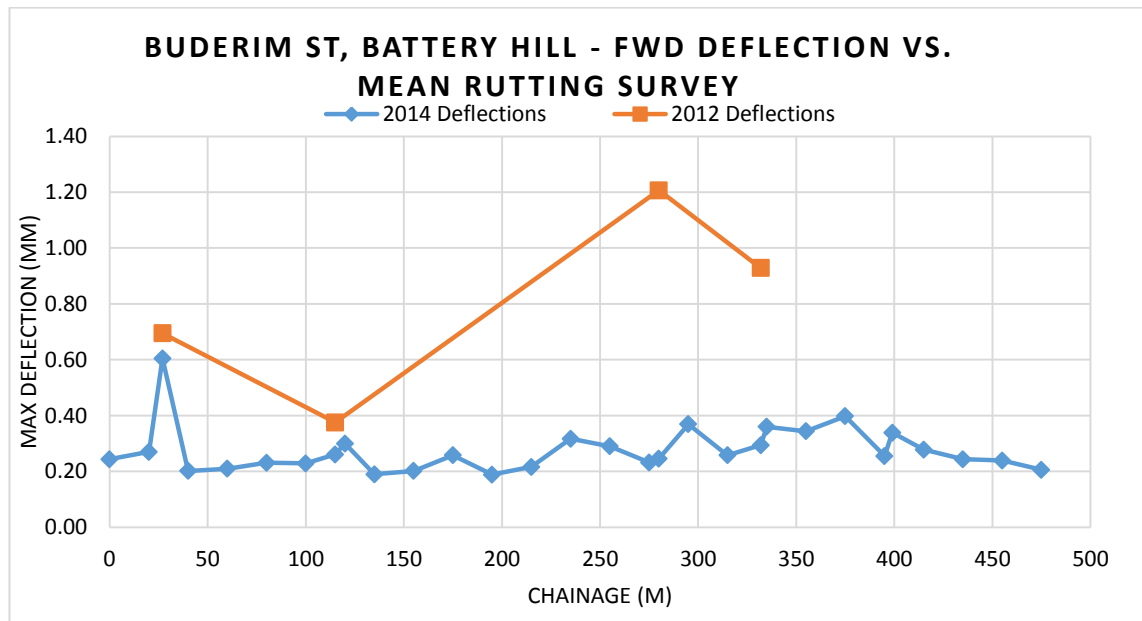
Figure 58: Buderim St, Currimundi - 2012 and 2014 Maximum Deflections

Figure 58 below demonstrates significant improvement in maximum deflections from testing prior to the pavement rehabilitation in 2012 and post construction in 2014. Maximum deflections are well within Sunshine Coast Council's acceptable range with an average maximum deflection of 0.28mm. An improvement from 0.80mm tested in 2012.

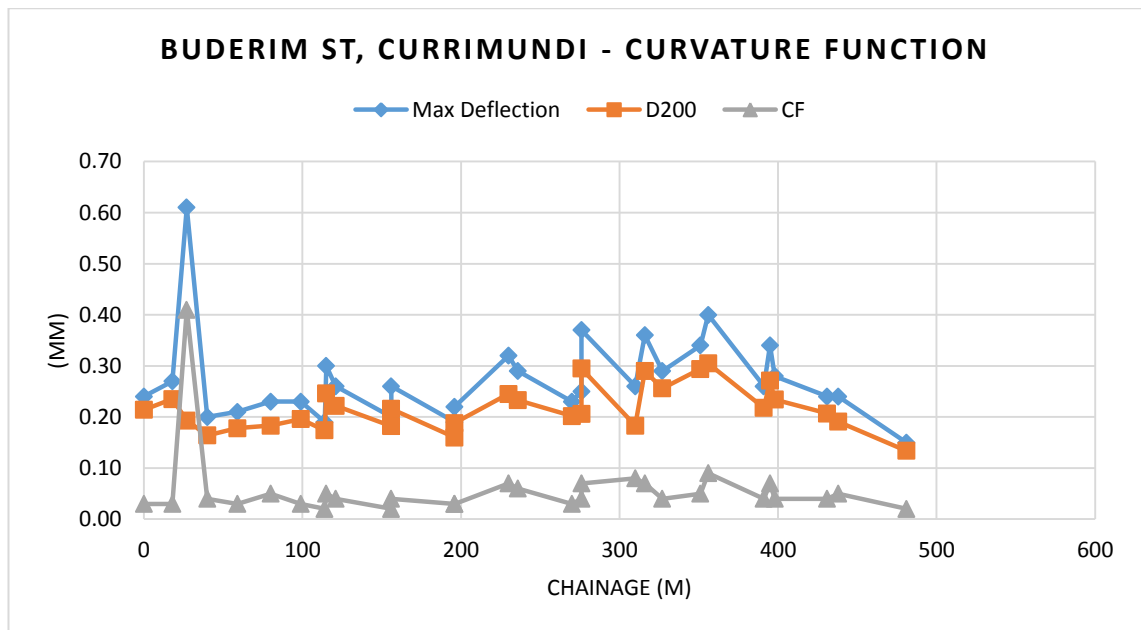
Figure 59: Buderim St, Currimundi - Curvature Function

Deflection testing has a much more limited application to rigid pavements (Austroads, 2009). Notwithstanding, Buderim Street, Currimundi has an average relationship between CF values and maximum deflection of 18% with one (1) location which returned a high result ranging of 67%, shown in Figure 59. This test location was situated approximately at the join of the section of subgrade failure outlined in Section 5.7.2 above, where significant subgrade improvement was required due to groundwater and water logged clay subgrade.

Further investigation into the construction processes used is required to identify areas of pavement joins and if these results are related to paving patterns or failures due to underground infrastructure, common in areas of ageing infrastructure and sandy subgrade materials.

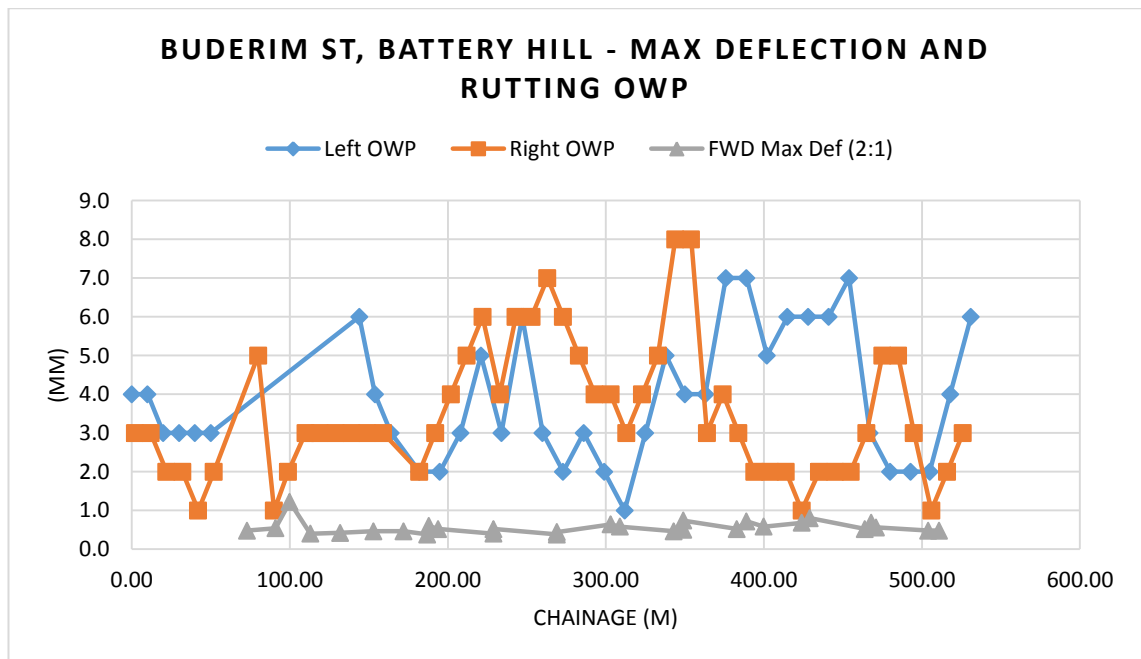
Figure 60: Buderim St, Currimundi - Rutting and Maximum Deflection

Figure 60 indicates no correlation between rutting and maximum deflection. Indicating rutting may be a result of early trafficking. Results indicate an average of 3.89mm and 3.48mm rutting for the right and left outer wheel paths respectively.

Reporting the severity and extent of outer wheel rutting in accordance with Section 4.3.3 results in severity ranges of 0-5mm and 5-10mm with 68% and 32% of the project respectively. Indicating no areas of structural concern.

The results above demonstrate the lowest relationship between deflection measurements and rutting results in conjunction with Point Cartwright Drive, Buddina

Previous experience in deep lift asphalt pavements suggests rutting may be a result of this pavement rehabilitation option due to early trafficking of the pavement and higher order roads and higher stress areas used i.e. roundabouts and major intersections. Sunshine Coast Council has recently specified Polymer Modified asphalts be used on all roundabouts and major intersections to alleviate this problem.

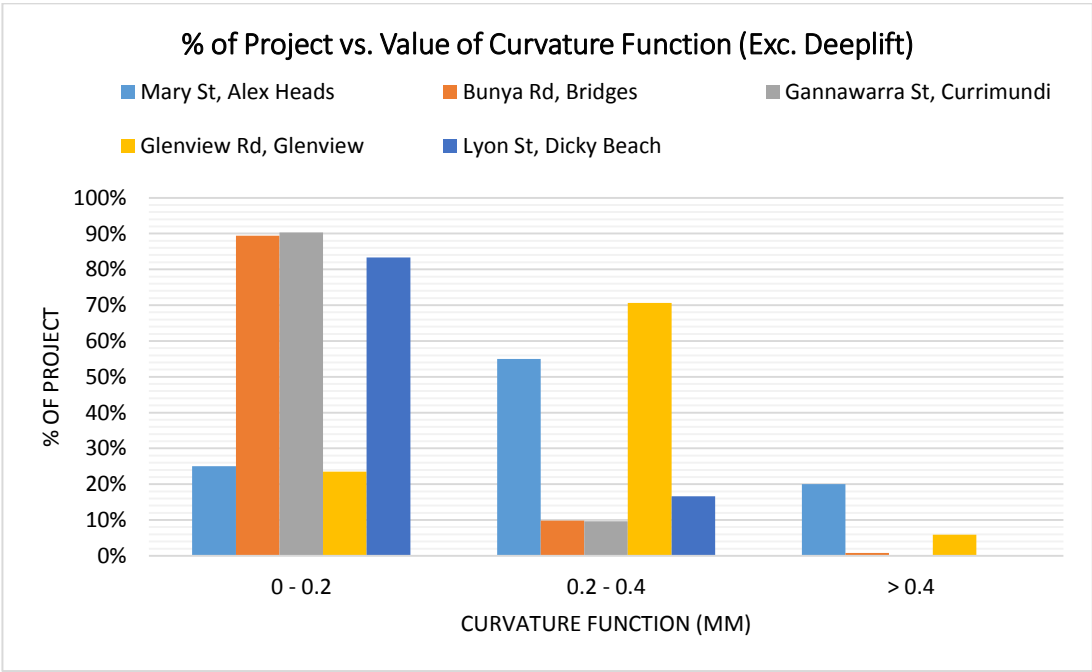
Figure 61: Curvature Functions of Various Pavement Rehabilitation Treatments

Figure 61 outlines the results of testing for average curvature function per project. Results are shown in three (3) categories of severity with results below 0.2mm representing stiff pavements and pavements with CF values greater than 0.4 representing pavements lacking stiffness.

From the results Glenview Rd, Glenview a granular replacement pavement and Mary St, Alex Headlands a Tensar grid and pavement reconstruction project exhibit pavements with the highest values of CF, greater than the 0.4mm defined as high by TMR (2012).

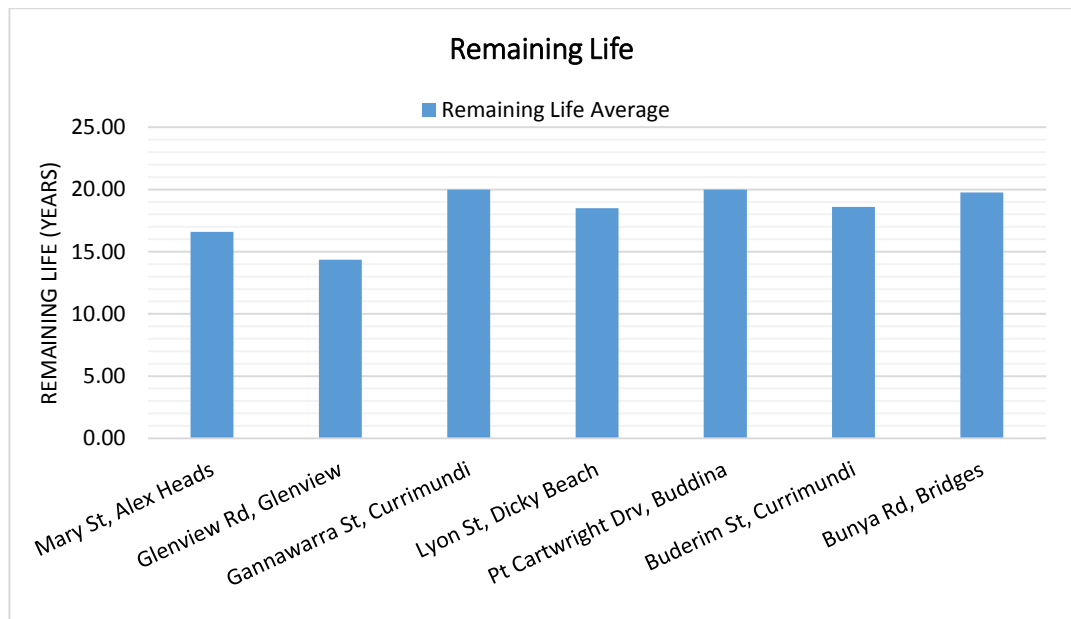
Figure 62: Remaining Life Comparison per Pavement Rehabilitation Option

When considering the results for calculated remaining life of each pavement once again Mary Street, Alexandra Headland and Glenview Rd, Glenview demonstrate the lowest values of seventeen (17) and fourteen (14) years respectively. Lyon St, Dicky Beach also appears slightly lower than expected at eighteen and a half (18.5) years. Point Cartwright Drive, Buddina and Gannawarra Street, Currimundi achieving a remaining life of twenty (20) years.
