**EFFECTIVE ROAD PAVEMENT REHABILITATION FOR
LOCAL GOVERNMENT ROADS WITHIN THE
SUNSHINE COAST REGION**

A dissertation submitted by
Thomas Sanders

Bachelor of Engineering (Civil)

Submitted: October, 2014

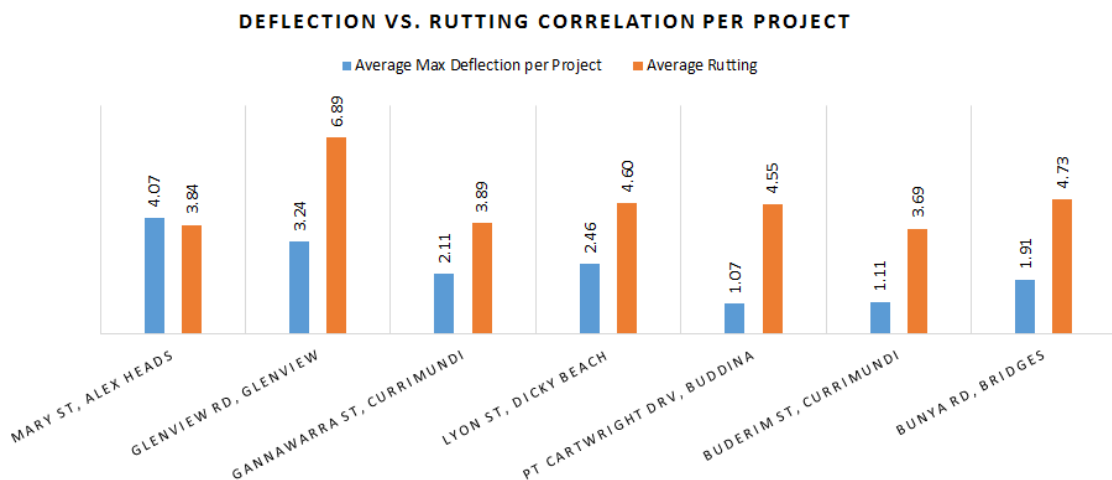
Figure 63: Relationship between Average Rutting Measured and Maximum Deflection Measured per Pavement Rehabilitation Option

The relationship between average rutting and average maximum deflection is shown in Figure 63. Glenview Road, Glenview and the two (2) asphalt deep lift pavement rehabilitations show the lowest correlation between rutting and maximum deflection. Confirming earlier results suggesting deep lift pavements are susceptible to rutting despite low deflections.

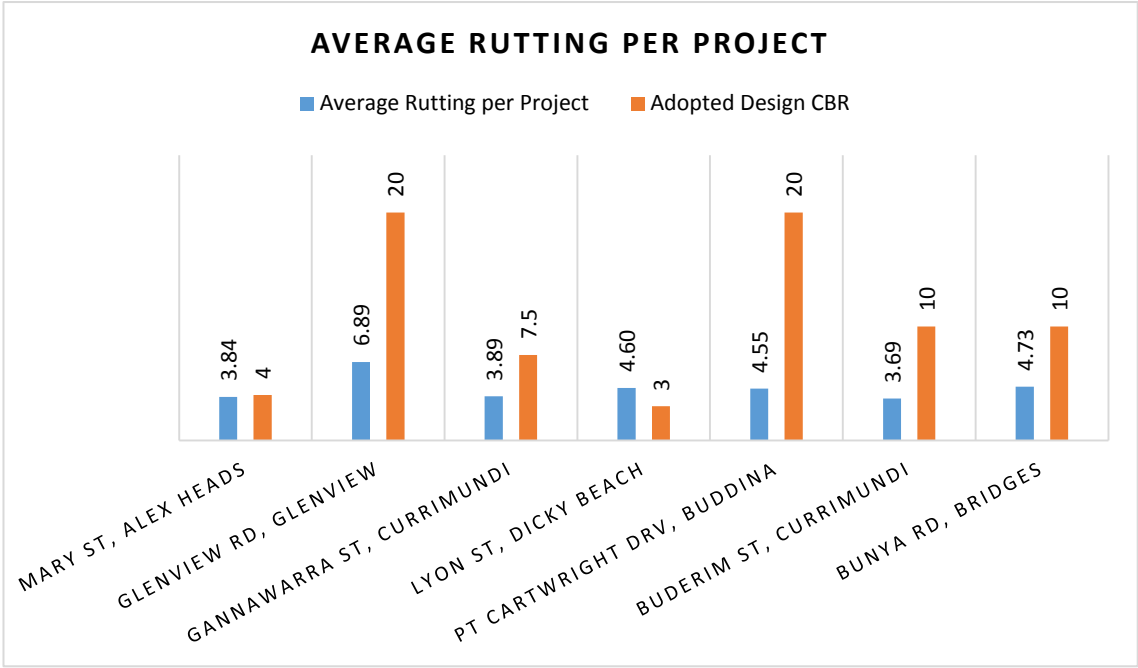
Figure 64: Relationship between Average Rutting Measured and Subgrade CBR Values

The relationship between the average rutting per project and adopted design CBR strength is shown in Figure 64. Glenview Road, Glenview and Point Cartwright Drive, Buddina experience high rutting averages despite adopted design CBR's of 20%. Mary Street, Alexandra Headland and Lyon Street, Dicky Beach display favourable rutting results in comparison to the low adopted CBR strengths. This confirms the use of geosynthetics can minimise rutting in pavements.

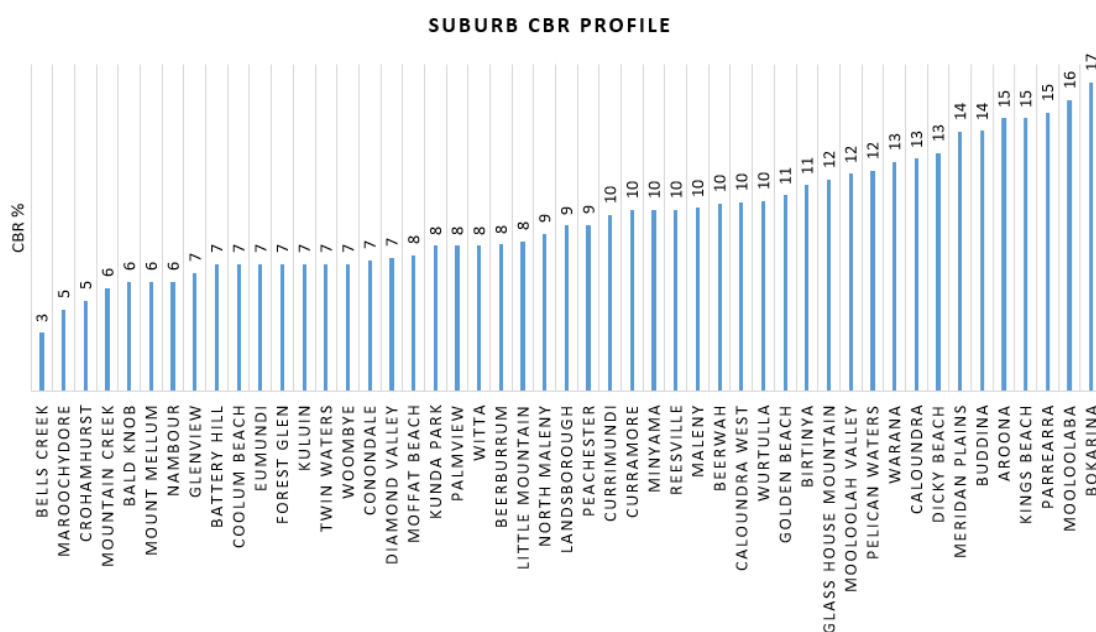
Figure 65: Subgrade CBR Suburb Profile

Initially, data extracted from the PMS was to establish a profile of subgrade CBR strength by suburb. This is shown in Figure 65 below. Only laboratory confirmed subgrade CBR values were included in this profile. While this provides a strong insight into local conditions, subgrade materials vary largely and need to be considered on a site specific basis.

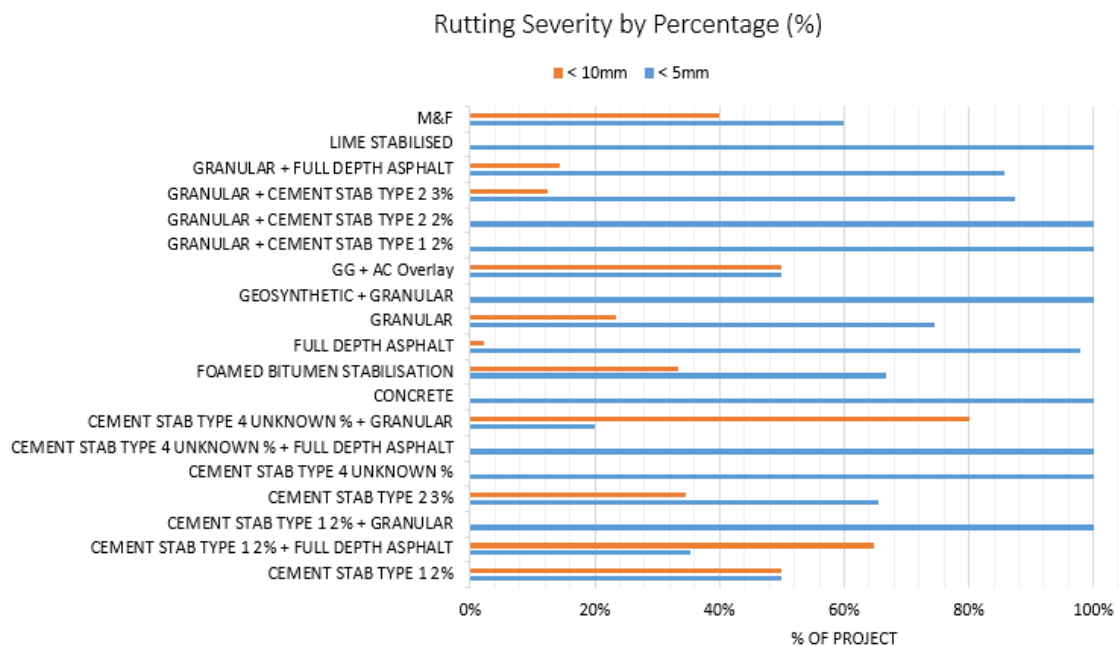
Figure 66: PMS Roads less than 10 Years - Rutting Severity by % and Pavement Rehabilitation Option

Through analysing Council's PMS system, treatments were categorised into nineteen (19) generic pavement types. Consisting of varying forms of in-situ stabilisation, ex-situ cement treated pavement materials, combinations of granular, stabilised material and structural asphalt, full depth asphalt and pavement incorporating geosynthetics. Figure 66 defines the severity of rutting evident by percentage of length of project pavement types in accordance with Austroads (2007) severity levels.

From Figure 66 it can be determined that the following treatment types exhibit high percentages of rutting severity greater than 10mm:

- Cement stabilised and granular (80%);
- Cement stabilised type 2 3% (35%);
- Cement stabilised type 1 2% and full depth asphalt (64%); and
- Cement stabilised type 1 2% (50%).

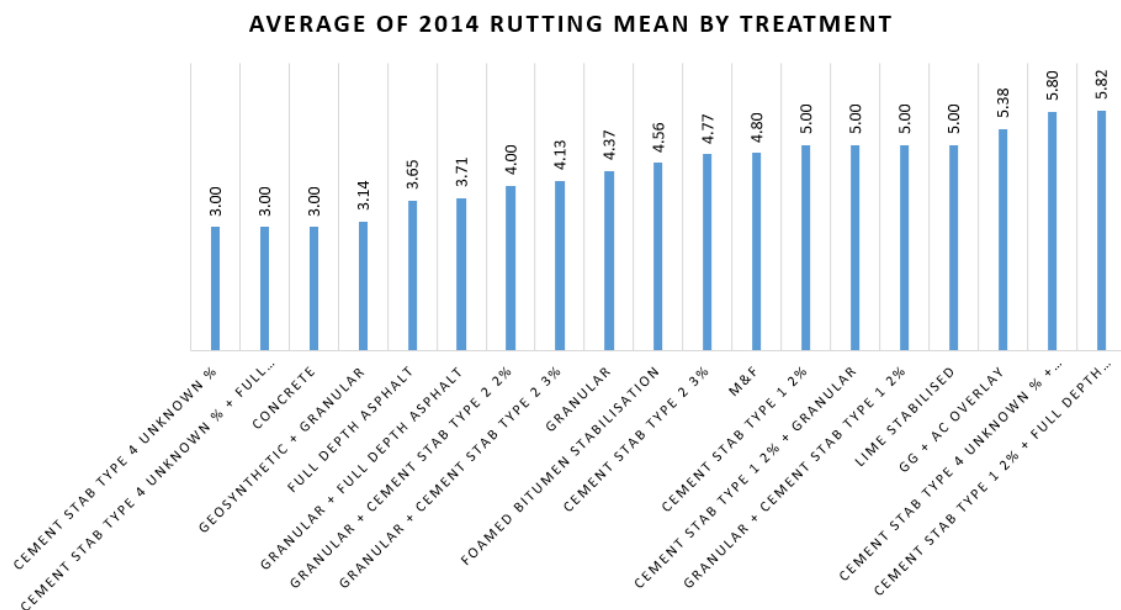
Figure 67: PMS Roads less than 10 Years - Average Rutting by Pavement Rehabilitation Option

Figure 67 displays the average rutting mean by treatment type. From this it can be clearly seen that combinations of cement stabilised and granular or deep lift asphalt experience high rutting averages, 5.80mm and 5.82mm respectively. The use of glass-grid and asphalt overlay also underperforms with a rutting mean of 5.38mm. Combinations where cement treated pavement materials are used as a base in comparison to a sub-base perform much better. Geosynthetics and granular pavements return a mean rutting of 3.14mm and is placed in the lower quartile. This may be due to the relatively young age of these pavements in comparison.

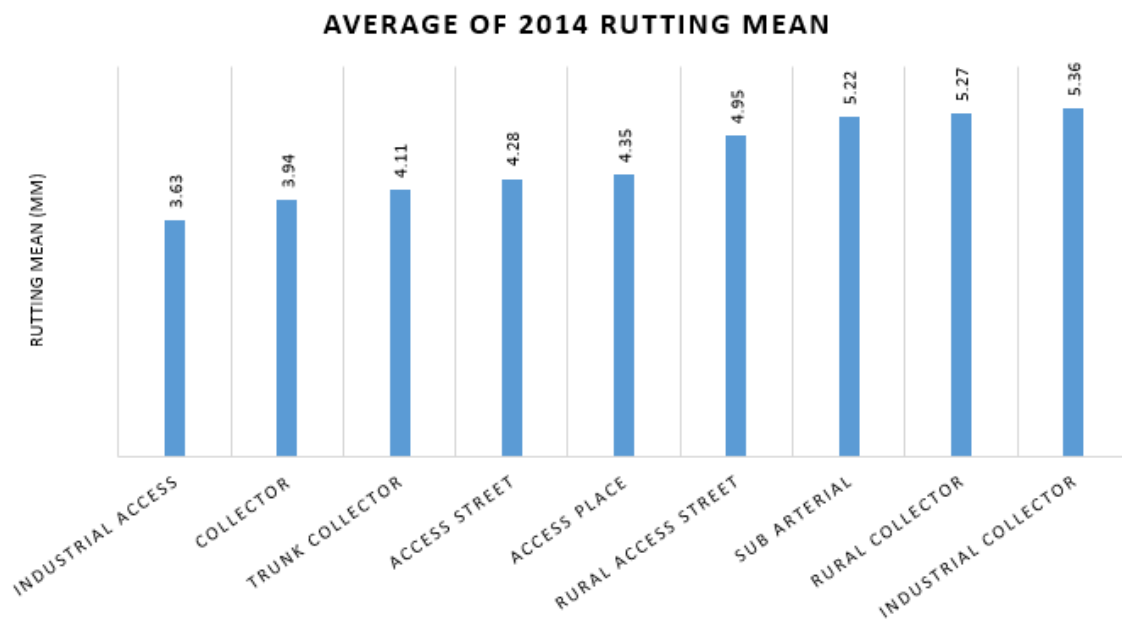
Figure 68: PMS Roads less than 10 Years - Average Rutting by Hierarchy

The hierarchy of the road also significantly increases the likelihood of higher severity rutting. Figure 68 determines the mean rutting values by hierarchy for roads within the Sunshine Coast, constructed or rehabilitated within the last 10 years. Sub-arterial, rural

collectors and industrial collectors return the highest rutting means of 5.22mm, 5.27mm and 5.36mm respectively. Collectors and trunk collectors returned mean rutting averages of 3.94mm and 4.11mm. Cameron Shields of the Sunshine Coast Council suggested this could be explained by Sunshine Coast Council's recent prioritisation of roads of regional significance including various collectors and trunk collectors, reducing the age of these roads in comparison to rural and industrial collectors.

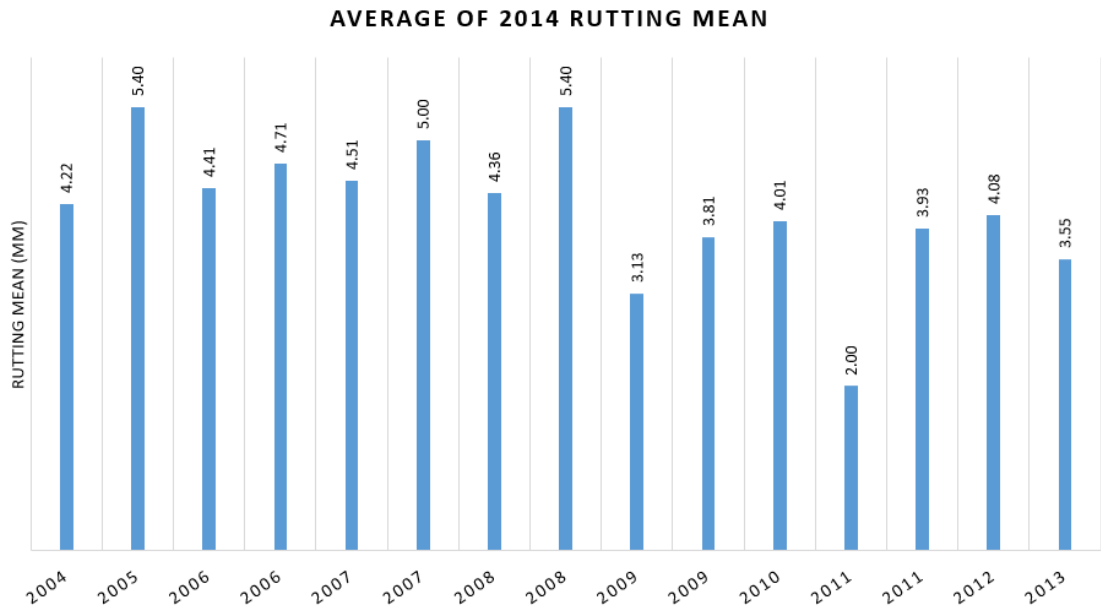
Figure 69: PMS Roads less than 10 Years - Average Rutting by Construction Year

Shown in Figure 69 below are the average rutting means for construction years, reported by Sunshine Coast Council's recent road condition survey. The general trend depicts an expected outcome of lower rutting means for projects constructed within the last 5 years, compared with those constructed between 2004 and 2008.

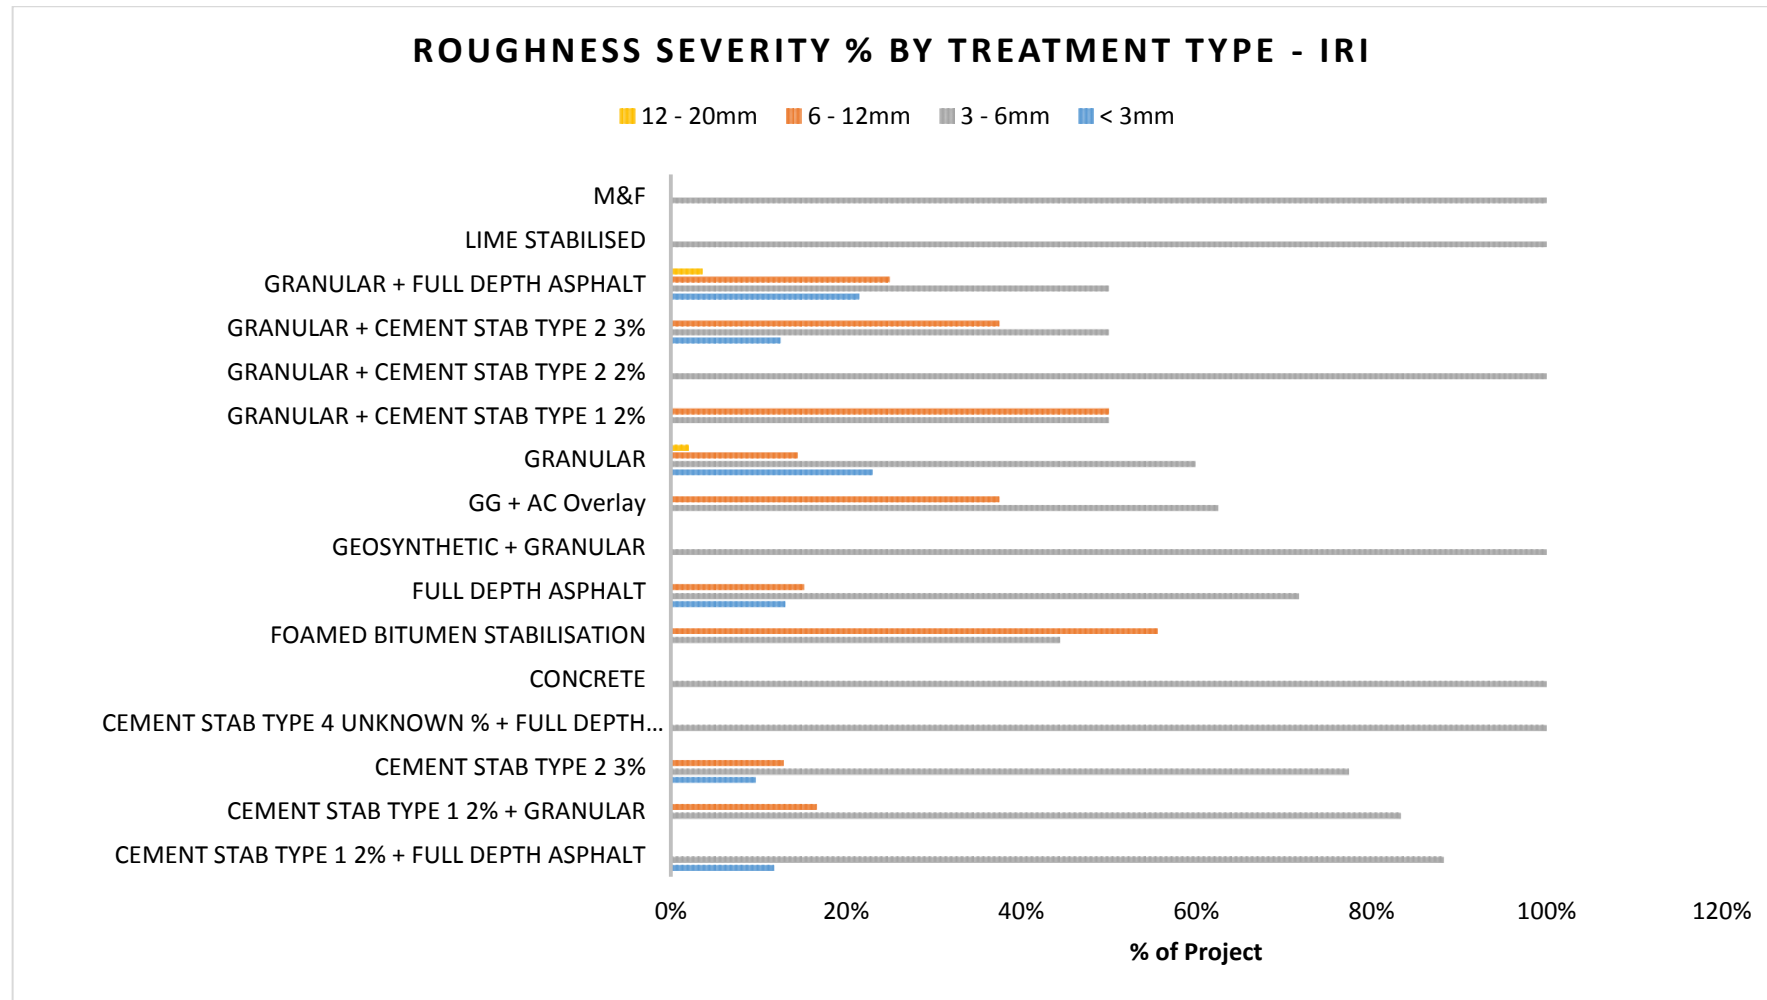
Figure 70: PMS Roads less than 10 Years - Rutting Severity (IRI) Intervention Levels by Pavement Rehabilitation Option

Therefore, Figures 70 and 71 display the results of the 2014 road condition survey in units of IRI and IRI3 respectively. IRI3 as previously outlined is a method applied by Council's contractor to achieve a more accurate roughness measurement for suburban roads. From these results the following treatment types experience high roughness measurements, with a small percentage of results within the Poor (12-20mm) severity level:

- Granular replacement pavements; and
- Granular and full depth asphalt.

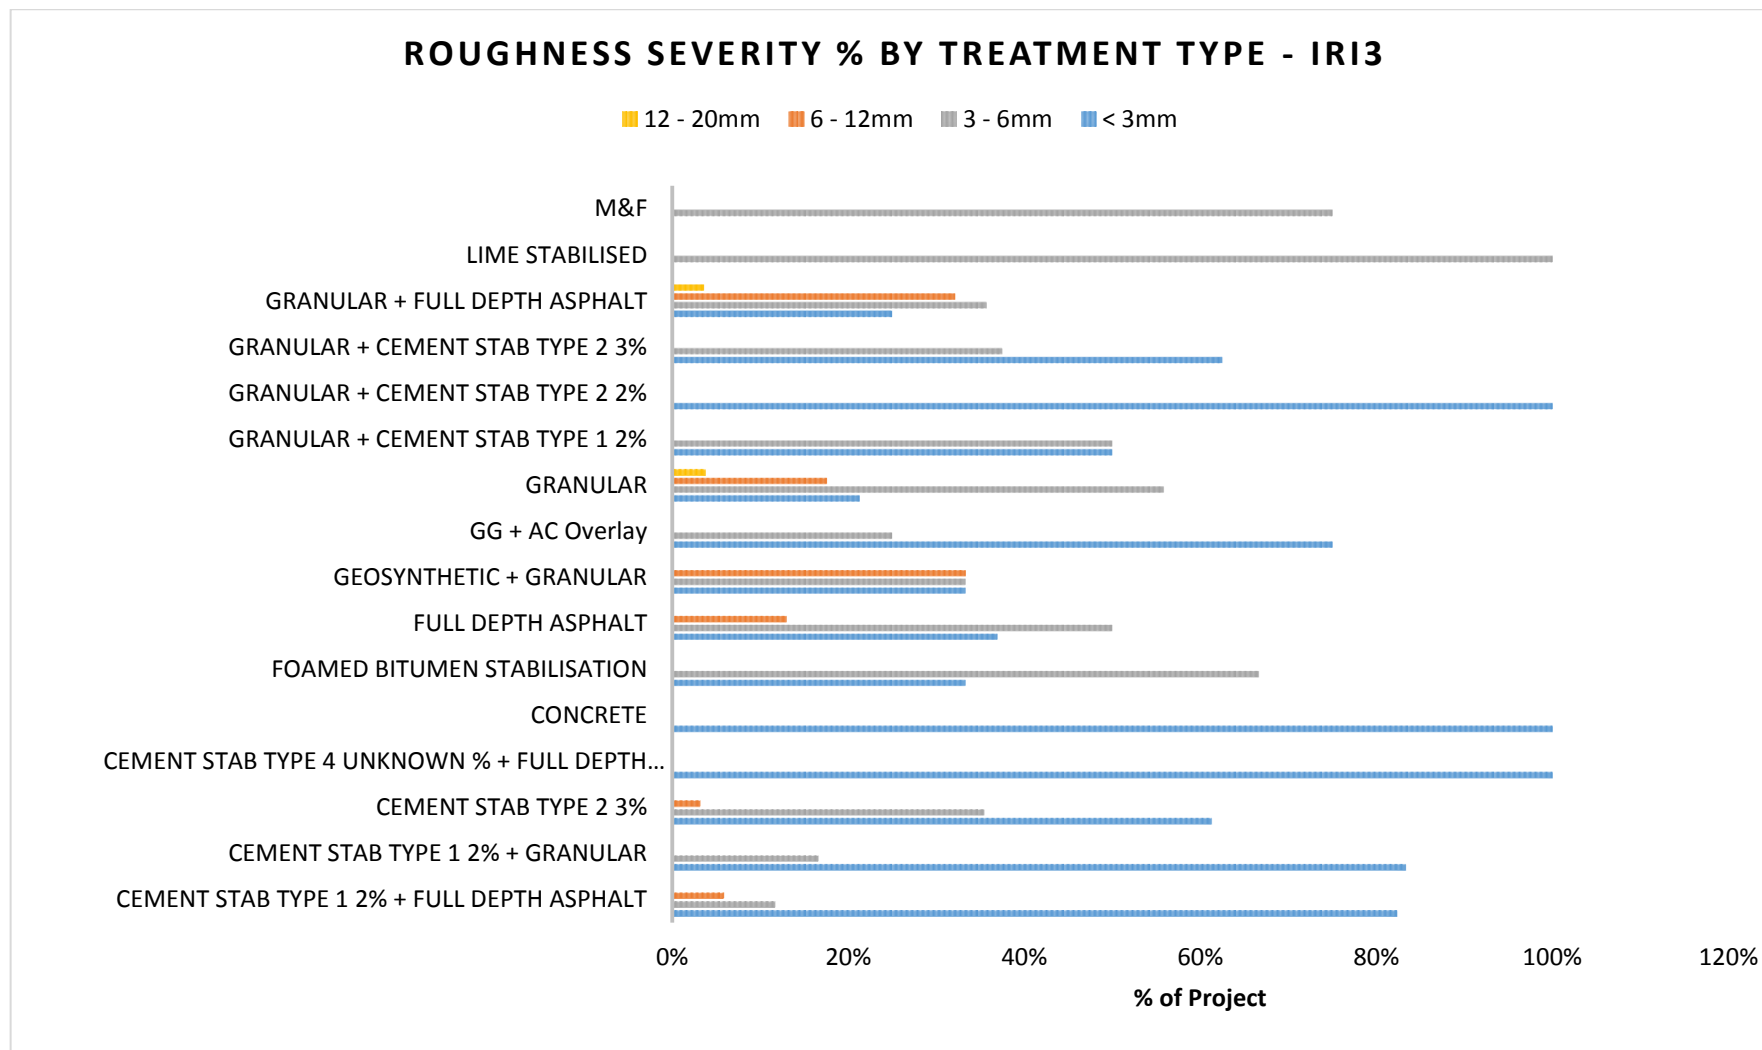
Figure 71: Rutting Severity (IRI3) Intervention Levels by Pavement Rehabilitation Option

This reduces to the following when considering the contractors methodology (IRI3):

- Granular and full depth asphalt;
- Full depth asphalt;
- Granular replacement pavements; and
- Geosynthetic and granular pavements.

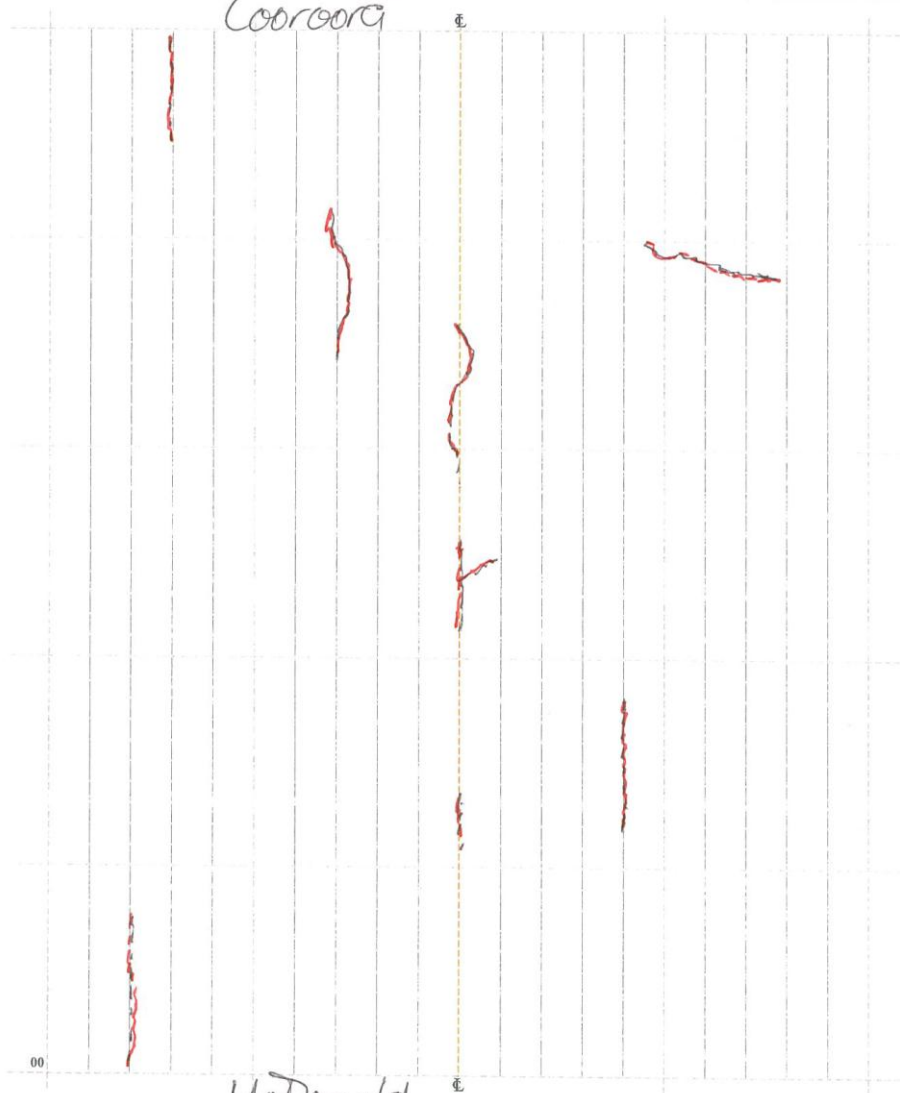
Block No: 103 Inspector: _____ Date: _____

CR Crocodile Cracking
CB Block Cracking
C Cracking 34m
CC Crescent (shear) Cracking 34m
