University of Southern Queensland

**Pacific Highway Glenugie: Case Study of the Use of Heavy Duty
Granular Pavement in Northern NSW**

Bachelor of Engineering (Honours)

Submitted: October, 2016

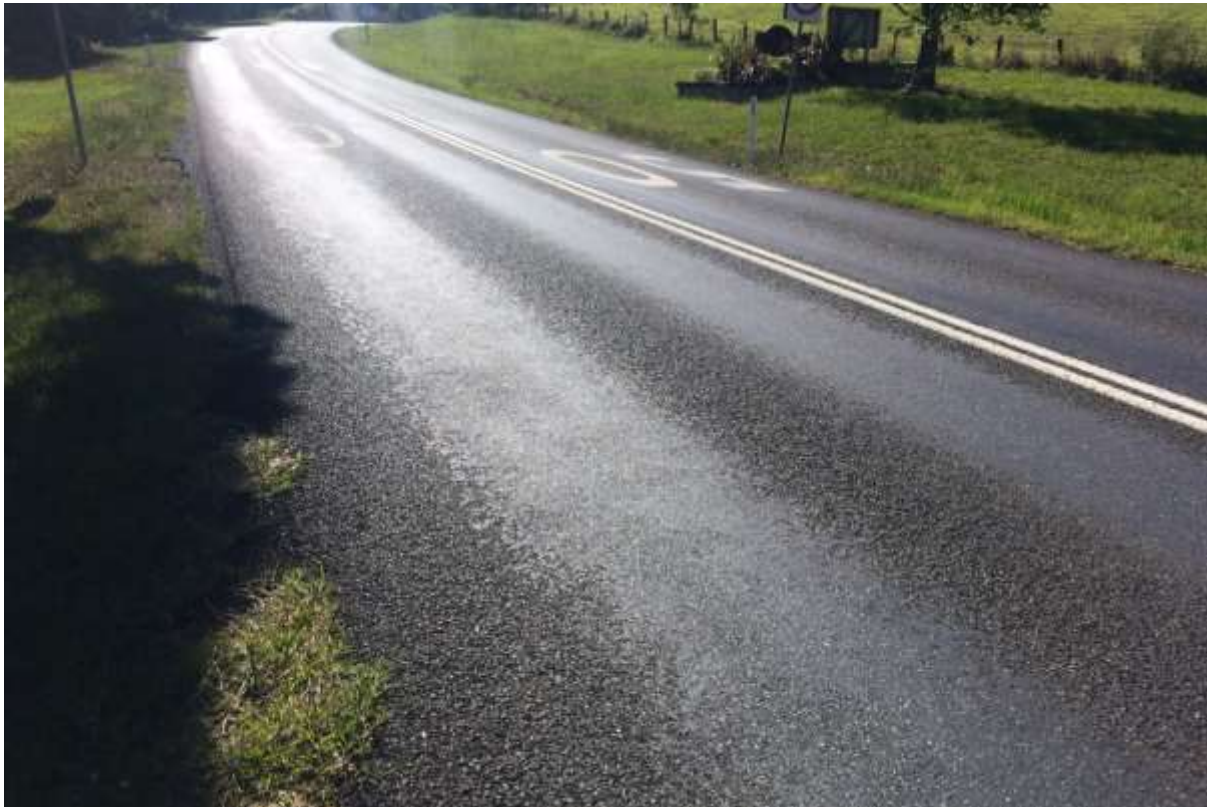
Flushing occurs as a combination of two things: surplus of bitumen and hot weather conditions. As the temperature of the seal increases, the excess binder rises to the surface producing a slick or smooth surface (Aktaş et al. 2013).

Figure 2.9: Example of flushing on local road with rutting also visible in the right lane.

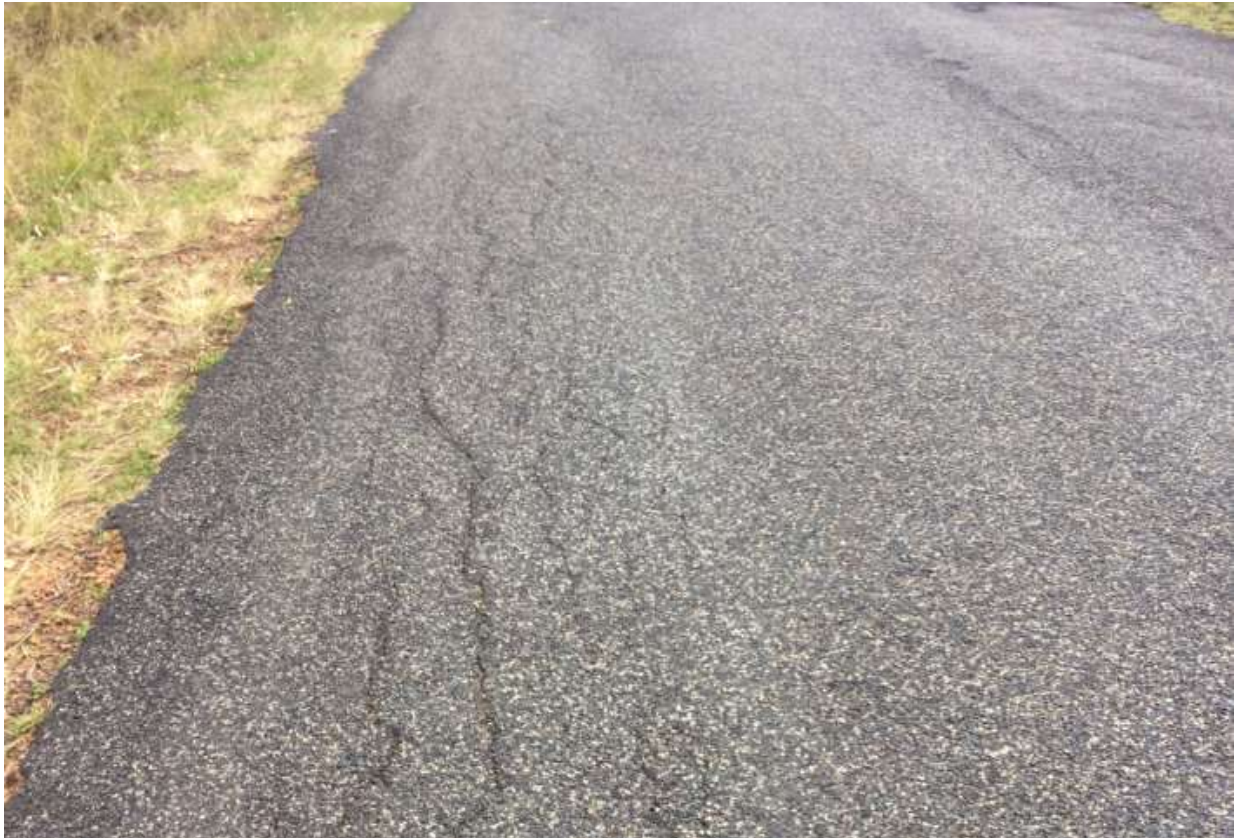
Figure 2.11: Example of distress cracking on local road.

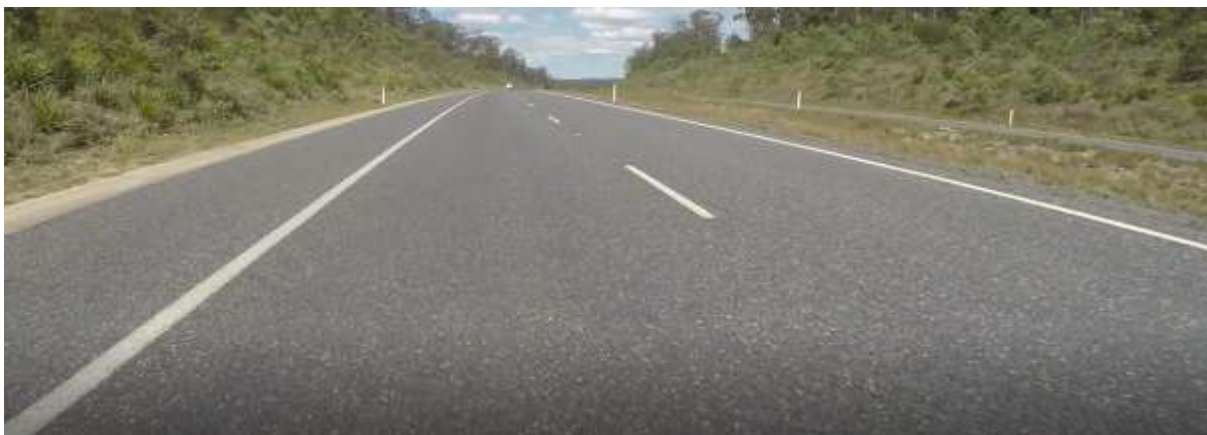
Figure 4.3: Image from the video used for the defect mapping of a section of road with no defects.

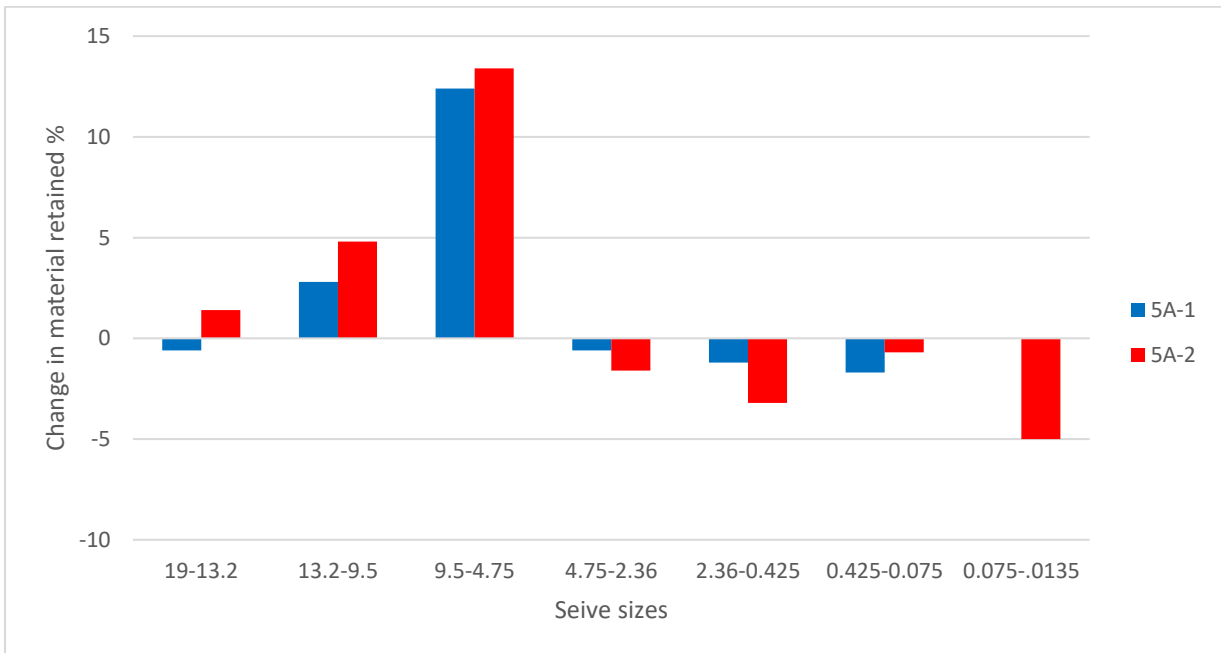
Figure 5.15: Change in material retain on the sieves for the base material at test pit 5

The figure above shows the result for both the shoulder material and material from the outer wheel path for the base layer at test pit 5. It can be seen that more material break down in the sample from the shoulder of the pavement. This would suggest that it is unlikely that traffic loading at is the cause of the break down base on these samples.

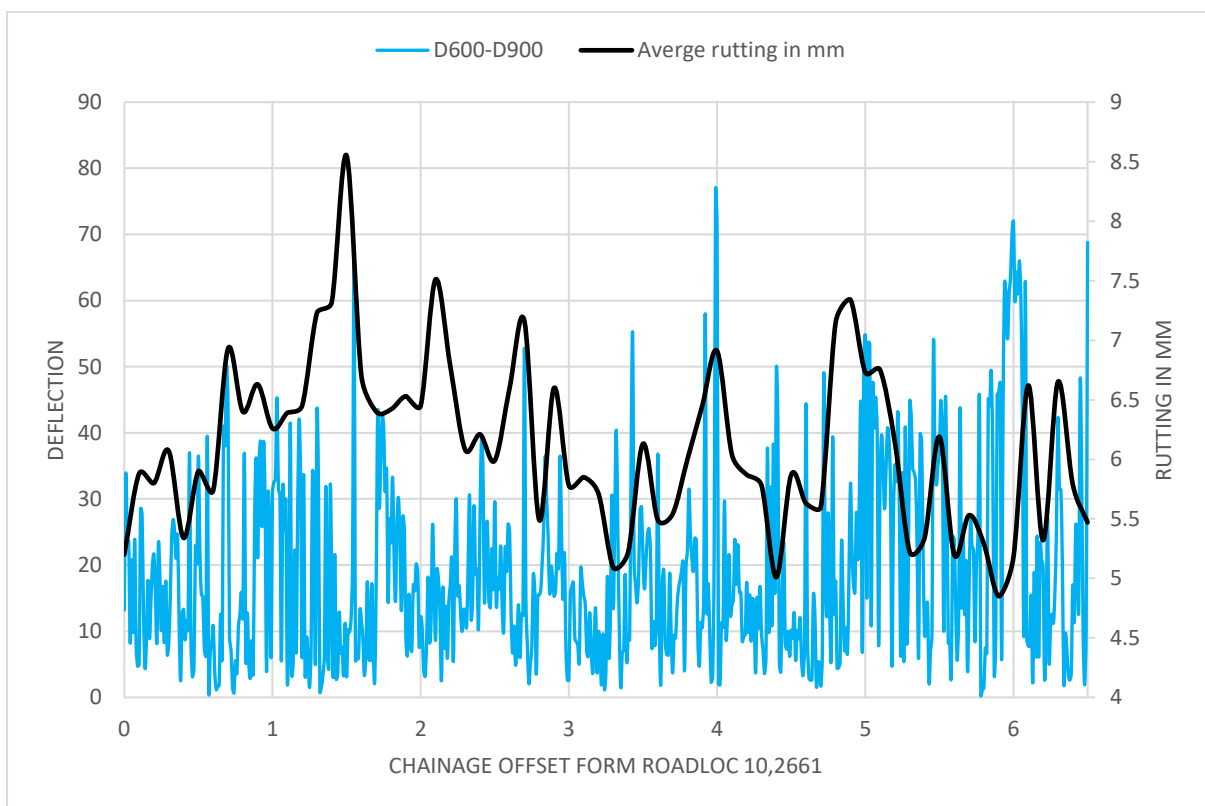
Figure 5.17: Lower Layer Index value vs rutting data

Similar to the Middle Layer Index it can be seen that the Lower Layer Index has no correlation with the rutting values as well. The two value act independent of each other with no pattern. At chainage 3, 4.8 to 5.2 and at 5.7 again no evidence of the weak or soft underlining material can be identified from the Lower Layer Index. The Lower Layer Index shows that the structural condition of the subgrade material is unlikely to have been a cause

of the high rutting or failures found in the outer southbound pavement. This is indicated by the lack of correlation between the lower Layer Index, the rutting values and failures in the pavement.
