Safety of electrical equipment in water-based amusement
rides from an engineering perspective

Kendra Gurrin

ENG4111 and 4112 Research Project

Bachelor of Engineering (Honours) (Power Engineering)

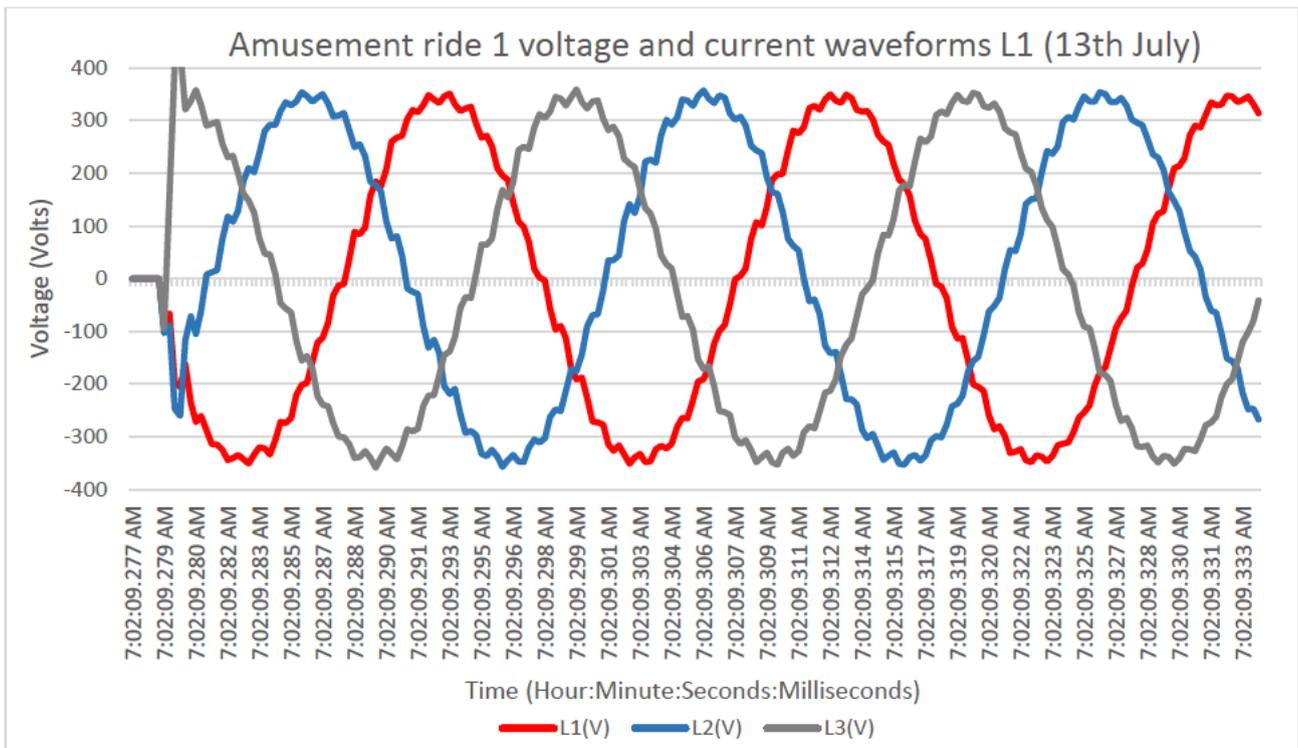
Figure 5.7 Water-based Amusement Ride 1 L1 voltage waveforms

The Institute of Electrical and Electronics Engineers (2014a) discusses transient waveforms in power quality analysis. Introducing a capacitor to a circuit can cause a switching current, resulting in a corresponding voltage transient. The waveforms are inspected, and voltage transients were present in Figure 5.7. The voltage transients are from the introduction of a capacitor. The capacitor draws current from the supply when the capacitive load is introduced to the circuit. They are resulting in the voltage transient's leading edge being negative. Introducing a capacitive load to an inductive power system with resonant frequencies can result in an oscillatory transient (The Institute of Electrical and Electronics Engineers 2014a).

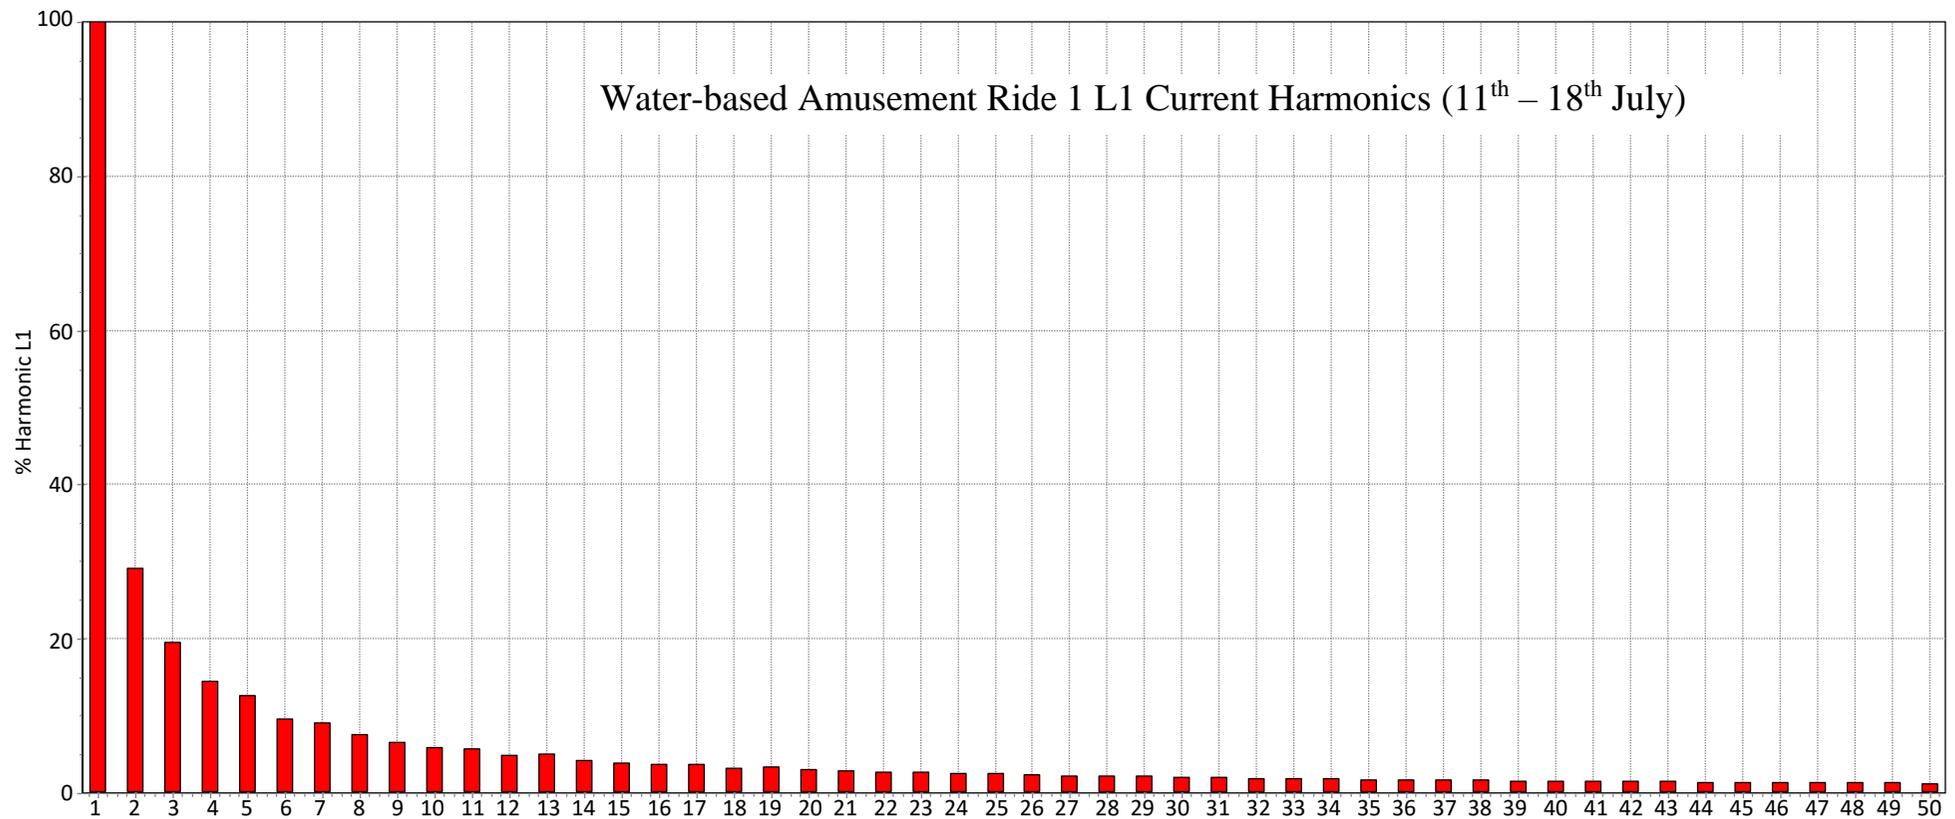
Figure 5.9 Water-based Amusement Ride 1 L1 current harmonics on the 11th until the 18th of July

The fundamental or first harmonic is 100%, and the current harmonics decrease as the frequency increases. The results for the current harmonics are very high, with the second harmonic at 29%. The water-based Amusement Ride 1 includes VSDs, which generate harmonic currents associated with the variable output frequency. The VSDs include line filters to reduce the harmonics, meaning the expected values should be less than is indicated. To analyse the results, there must be an understanding of the expected harmonic levels. Upon review, it was found that Standards Australia (2023a), identifies that harmonic current levels are evaluated during steady-state operation and, therefore, do not include transients. Harmonics and transients are different phenomena that are analysed differently. Transients are brief frequency changes lasting only microseconds, resulting from lightning or a switching event. In comparison, harmonics are present during steady-state operation. In the harmonic analysis, it was necessary to recognise that introducing transients could provide results that are not reflective of the actual harmonics in

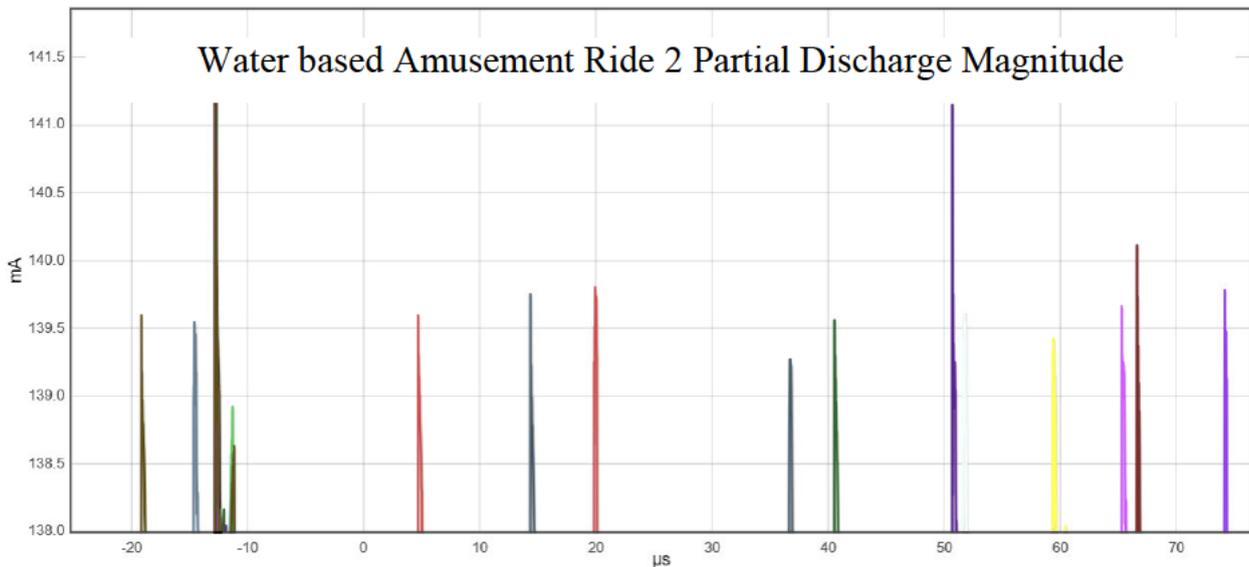
Figure 5.13 Water-based Amusement Ride 2 98th percentile of partial discharge

The partial discharge was completed for the three amusement rides. The 98th percentile for the partial discharge was used to obtain the pulse repetition rate. The pulse repetition rate and the magnitude were used to work out the severity of the partial discharge for comparison between the amusement rides, per the calculation in Figure 3.9. The partial discharge 98th percentile magnitude for Amusement Ride 2 is depicted in Figure 5.13. The partial discharge is in the 98th percentile over the testing period for short periods. The short periods indicate a low repetition rate, as per Figure 3.12 in section 3.1.2. The average severity identified was 0.48; the results were similar across all three amusement rides. The phase-resolved plot was also reviewed to analyse the partial discharge pattern.

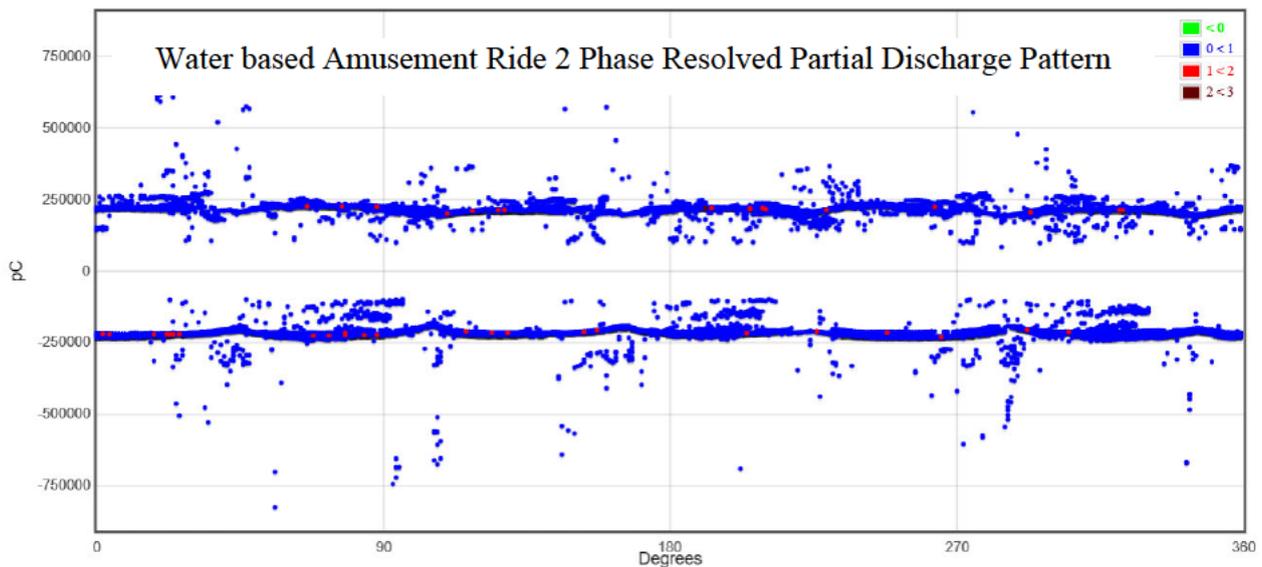
Figure 5.14 Water-based Amusement Ride 2 partial discharge phase plot

The phase-resolved plot for the water-based Amusement Ride 2 is illustrated in Figure 5.14. The plot is mainly flat without the recurring cycles that would be expected from a sine wave. The phase plot does not show partial discharge per pattern A in Figure 3.11 identified in section 3.1.2. The magnitude and phase plots for the partial discharge indicate noise rather than partial discharge from the research conducted. It was reasoned that the results did not indicate partial discharge; it represents noise. The results were similar across all three amusement rides.

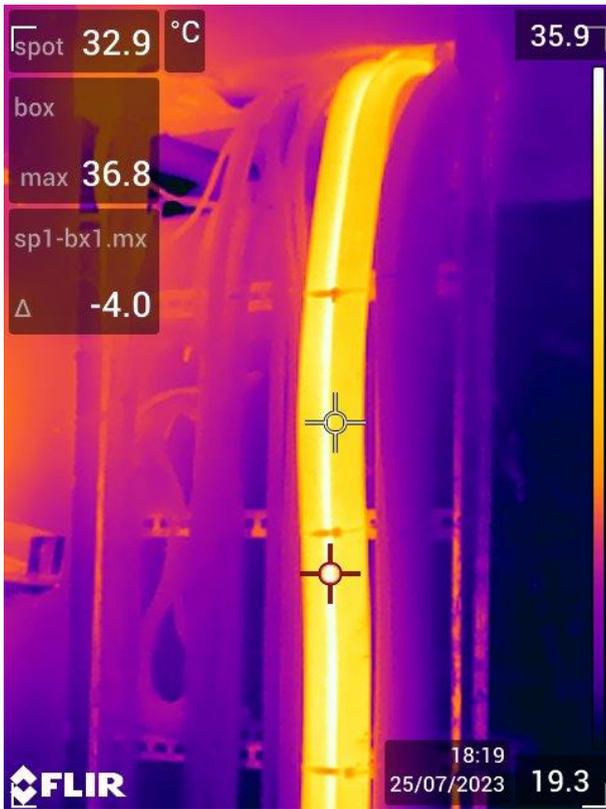
Figure 5.15 Water-based Amusement Ride 3 thermal image of pump 1 cables

There had to be an understanding of the theory of thermal imaging to review the results. The low emissivity of metallic surfaces was previously discussed in 4.1.3. The surface reflecting the background temperature was sighted in Figure 5.15 at the water-based amusement ride 3. The cables are encased within a shiny metallic sheath depicted in Figure 5.16. the background temperature of the background objects is being reflected; therefore, the thermal image is not indicative of the actual temperature rise. Reflection was considered carefully during the review of the testing results.
