**Locating Low Voltage Underground Power Cable Faults Using
Infrared Technology**

A dissertation submitted by
Gregory Mansell

in fulfillment of the requirements of
ENG4111 and ENG4112 Research Project

Bachelor of Engineering (Honours), Power Engineering

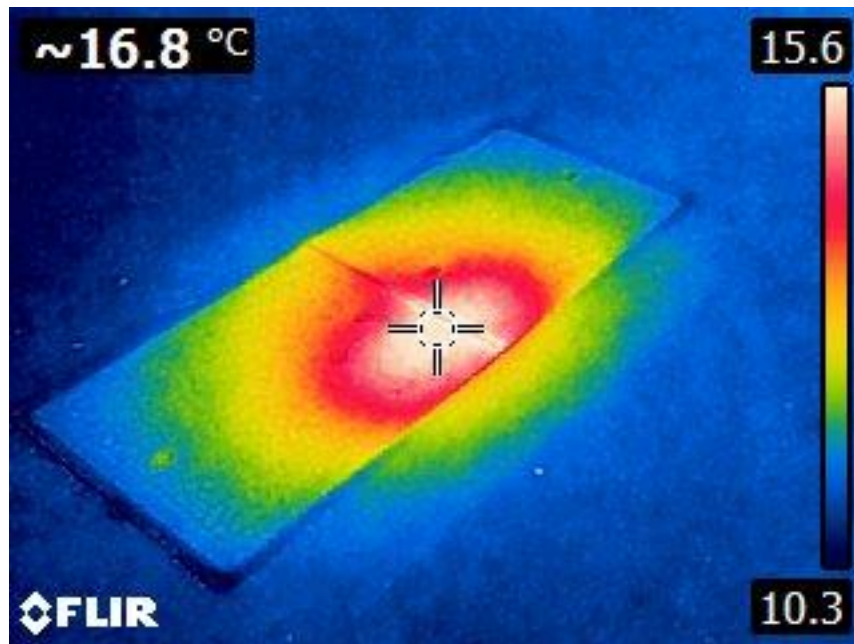
Figure 1 Surveying Area Above Fault for Heat Differential

These situations all utilise the camera's ability to have direct visibility of the apparatus to be surveyed, in order to capture the infrared radiation emitted from the target. This project differs in this approach, as the target will be buried, and the infrared measured will be radiated through the ground. Figure 1 below shows how the heat gradient is detected by the thermal camera. The bar on the right of the image shows the maximum and minimum temperatures. The white patch in the image indicates a temperature of 16.8°C. As the colours change down the spectrum the temperature drops to approximately 12°C. This colour gradient indicates a heat source under the ground and, in this situation, has conducted through the concrete to the surface.

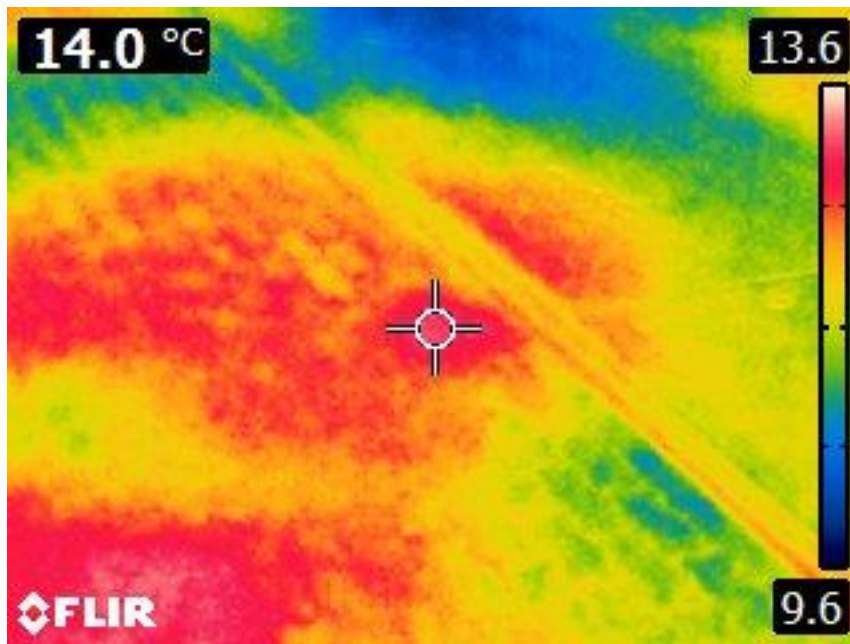
Figure 26 Thermal Image of the Fault Location at Site 5

This fault was pinpointed on the property boundary between the concrete footpath and the customer's tiled area. It had been raining during the day but the ground had started to dry up. Having the ground wet would have made a successful thermal survey nearly impossible since the water would have removed any heat from the ground.

Figure 26 shows the thermal image of the fault location at Site 5. The drain running through the centre of the image is affecting the conduction of the heat. Since the ground was still damp from the earlier rain the thermal survey was much harder to detect. In this instance the hot spot was much larger than normally expected. This may have been due to the tiles allowing heat to conduct through the gaps and spreading out much further than under a continuous piece of concrete. This effect can be seen on the right side of the image where the hot spot is more condensed. The lower right portion of the image also shows the temperature difference between the tiles and the gaps around the tiles.

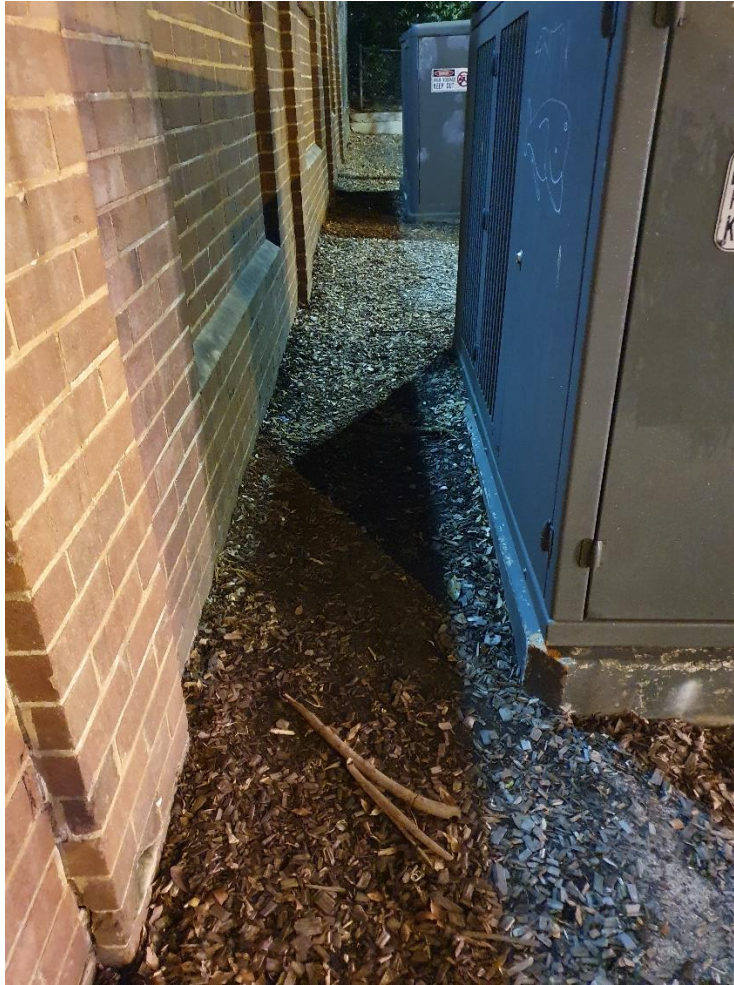
Figure 31 Location of Site 13

S1231 is located against an east facing brick wall that was exposed to the sunlight during the day, as seen in Figure 31. The low voltage cables have been installed between the substation and the wall. Figure 30 shows the infrared image of the area. The fault can be seen between the wall and the substation in the dull yellow area. This does not stand out as much as the other successful sites due to the radiated infrared radiation from the substation and the wall. A survey was also completed on the adjacent substation in a similar location that also showed no signs of heat between the wall and the substation, ruling out any form of reflection in this situation, also shown in Figure 30 below.
