University Of Southern Queensland
Faculty of Engineering & Surveying

Investigation into the Performance of First Flush
Systems for Diesel Engine Based Pollution on Roof
Runoff

ENG4112 Research Project

Submitted: October 2008

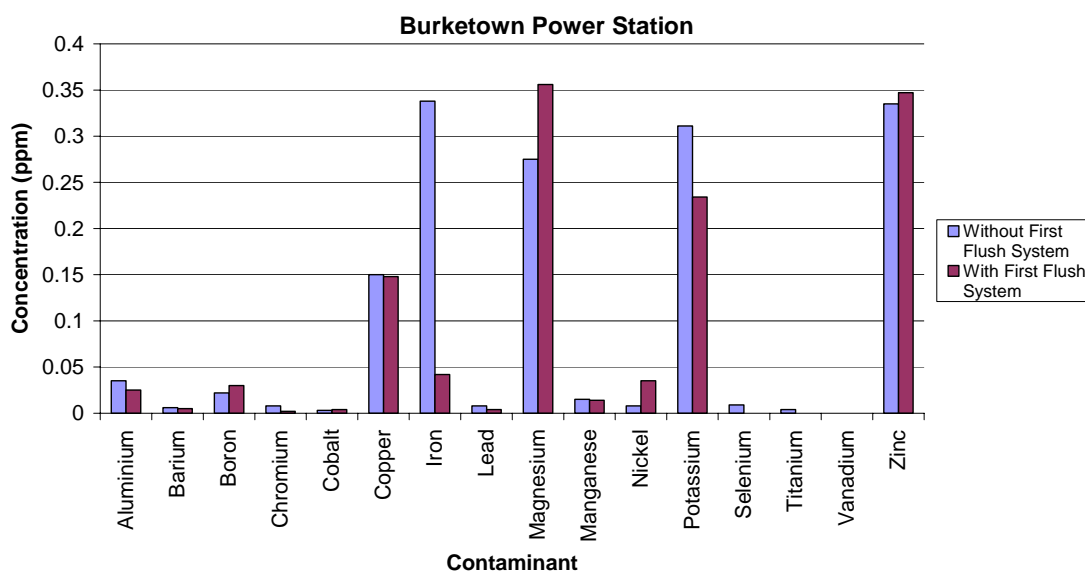
Figure 5.1 Concentrations of Metal Contaminants At Burketown Power Station

Burketown did not receive a recordable rain event in the period of time between when the initial sample and secondary sample were taken. The last recorded rain event at Burketown was nearly 8 weeks prior to taking the initial sample and was recorded to be 65.2mm. The first flush device was installed on 19/07/08. As mentioned earlier, the tank at this site has been disconnected from all downstream plumbing, and the tank was not used during the period of this study. This means that water did not enter or exit the tank during the period of this study and also that the first flush system would have had no effect. This site can be used to show the effects of detention time. Levels of boron, cobalt and magnesium increased around 25% after the period, levels of nickel increased nearly 80% whilst levels of iron decreased 80% as shown in Figure 5.1. The exact reasons for this are not fully understood but will be investigated further. It is possible that the tank simply was not stirred sufficiently prior to taking the first sample. The sample from this site was the only sample which had detectable levels of

Because of the long duration between rainfall events, the roof would be expected to have a high level on contaminant build up. It is possible that dew falling during the night is responsible for washing additional contaminants into the tank prior to the installation of the first flush. However, this area is quite dry during the winter months and very little, if any dew generally falls during the night. Unfortunately, the Bureau of Meteorology does not readily provide data on dew.

If the first flush system had been installed immediately after taking the first water sample, then dew would not have impacted this study since the volume would not be sufficient to fill the diversion chamber. This applies to all sites.

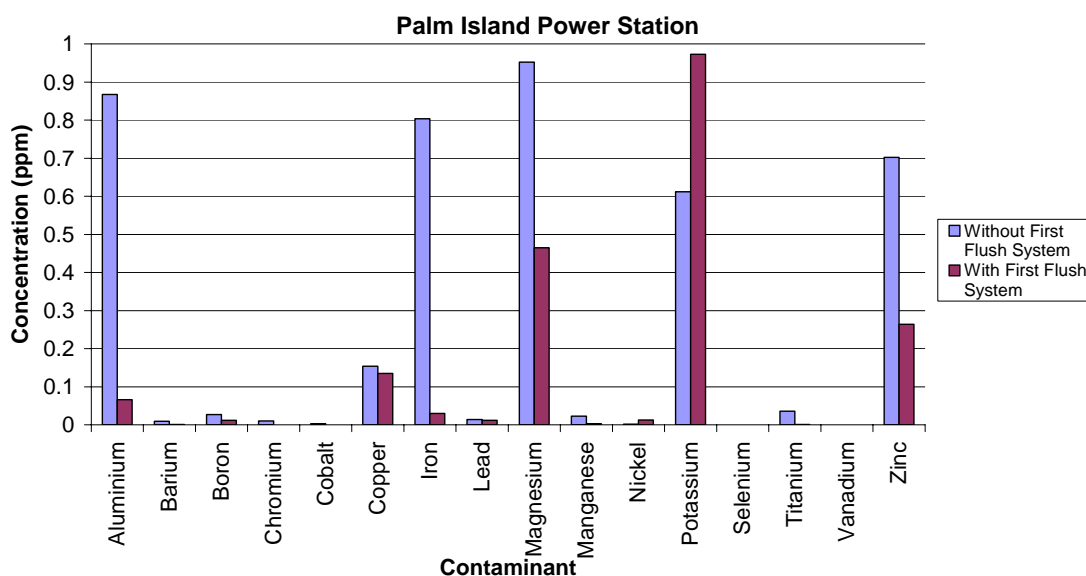
Figure 5.2 Concentrations of Metal Contaminants At Palm Island Power Station

The installation of the first flush system at Palm Island power station generally decreased the contaminant concentrations as shown in Figure 5.2, with the exception of potassium. The power station attendant had reported a slight rainfall event just prior to taking the sample. The BOM data states that 0.6mm fell during the day. The sample was taken early in the morning, so the actual rainfall just prior to taking the sample may be less.

If lower concentrations of metal contaminants were in fact present at the time of the second test, then the effects of the first flush device may be very minimal, if any.

This site was expected to have elevated concentrations of zinc in comparison to other sites because of the close proximity to the coast and accelerated corrosion rate. This was not the case.

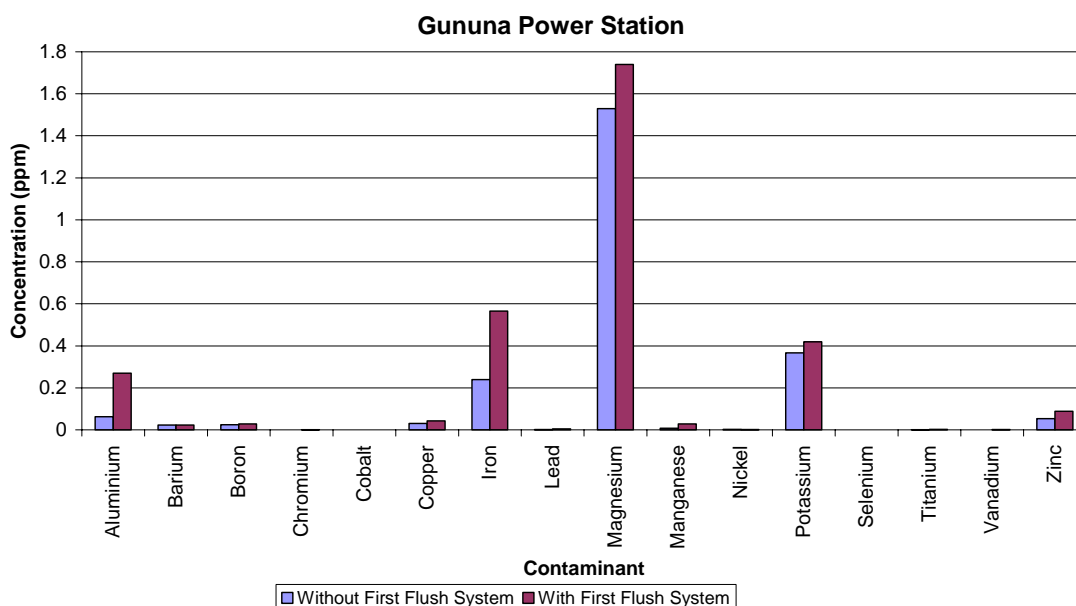
Figure 5.3 Concentrations of Metal Contaminants At Gununa Power Station

Since there were only slight rainfalls during this period the stored volume would have significantly decreased, however the metal contaminants generally settle to the bottom of the tank below the outlet level. As such, volume of metal contaminants would not have decreased to the same extent as water volumes. This theory explains the increased

concentrations in the tank but further testing would need to be undertaken before this could be considered conclusive.

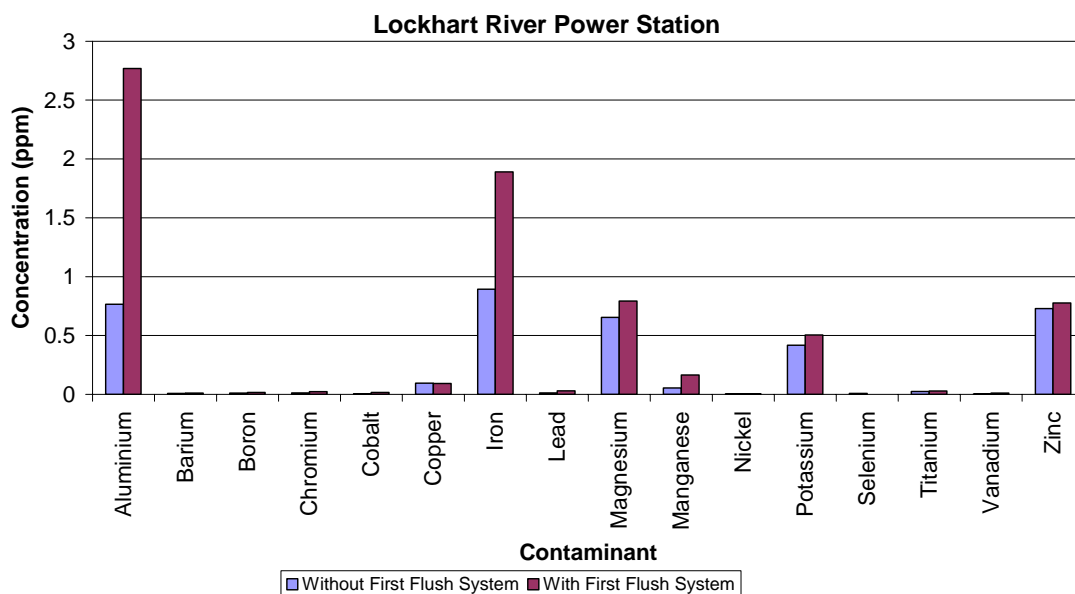
Figure 5.4 Concentrations of Metal Contaminants At Lockhart River Power Station

Concentrations of both metal and PAH contaminants increased significantly at Lockhart River as indicated in Figure 5.4. During the period between the initial sample and secondary samples being taken, only 66mm of rain fell. Given that the roof area is 58m², this equates to 3,828L. This does not represent the full amount that would have entered the rainwater tank since the first flush devices would have diverted a certain quantity of this. The exact quantity is difficult to predict and depends on rainfall intensity. At the time of the installation of the first flush device, the tank was full. The tank at this site is used often for washdown and irrigation purposes which consume large amounts of water. It is generally not used for domestic purposes.

The increase in contaminant concentrations can be explained by prevailing winds blowing strongly from the exhaust stacks towards the collecting roof, dispersing contaminants on the rooftop. Also, the level of water in the tank at the time of taking the second sample was quite low (as noted by the Power Station Attendant). As explained in the Gununa Power Station results, a decreased water level corresponds to increased contaminant concentrations.

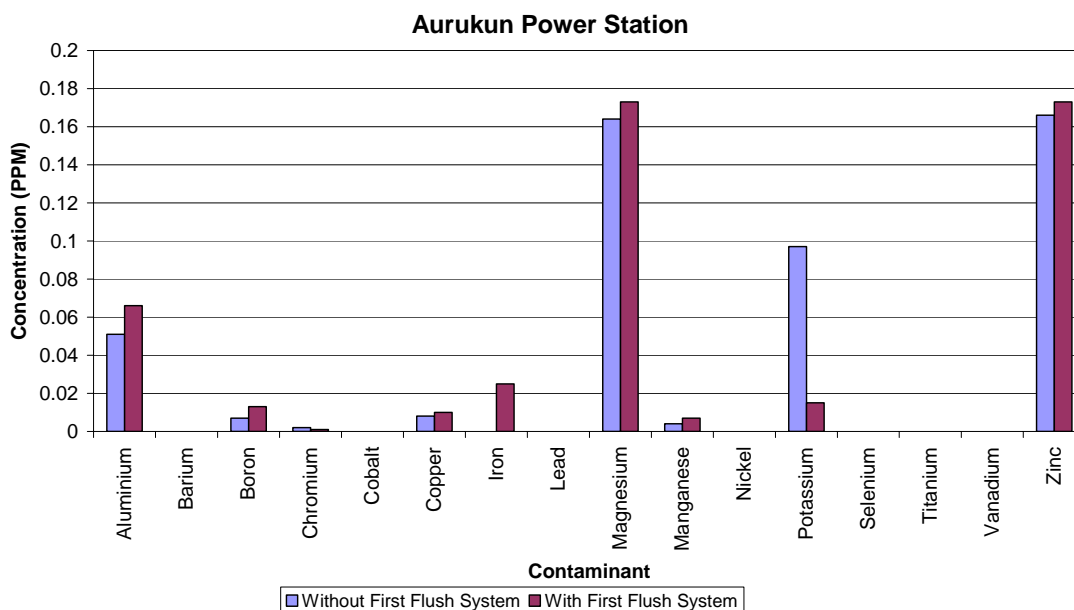
Figure 5.5 Concentrations of Metal Contaminants At Aurukun Power Station

When the samples were taken at Aurukun, the attendant did not stir the tank prior to taken the samples. This resulted in significantly lower metal concentrations and also in several metals not being detected at all as indicated in Figure 5.5. The results from this site are indicative of the water which is normally being provided to the outlets, but does not account for any mixing which may occur during heavy rainfall or other actions which may stir the tank.

At Aurukun, the failure to comply with ADWG was caused by biological contaminants, not metal contaminants which were the usual cause for failure.

The prevailing winds prior to the second sample were in the East South East direction.

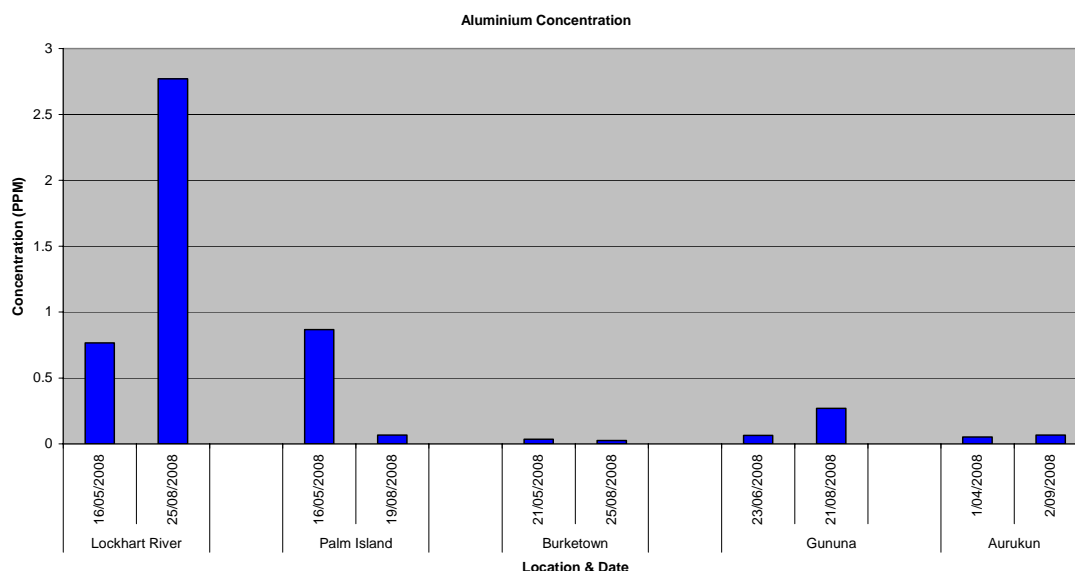
Figure 5.6 Aluminium Concentrations at Each Site

Aluminium concentrations at all sites are shown in Figure 5.6. The high concentrations of aluminium at both Lockhart River and Gununa are most likely caused by the aluminium roof sheeting at these sites. The other sites do not have aluminium roof sheeting. Aluminium bauxite in the Aurukun area may have elevated concentration at this site. It should be noted that bauxite mines exist in the area. Since Burketown and Palm Island do not have any aluminium rainwater goods, the aluminium concentration at these sites is believed to be the background level of pollution emitted by the diesel gensets, however many other origins are possible. The ADWG suggest that aluminium may be present in water through natural leaching from soil and rock. This may explain the concentrations of aluminium at Aurukun.

Since the guideline is based on factors which do not apply to this study, it would be possible to state that the results are not of concern. However, the levels of aluminium encountered during the study exceed the guidelines by several times that amount. Since overexposure to aluminium can lead to gastrointestinal irritation, nausea and possibly lung damage, it would be prudent and advisable to adopt the 0.2mg/L limit as set out in ADWG and WHO *Guidelines for Drinking-Water Quality*.

Dwivedi, Agarwal & Sharma (2006) reported aluminium to be present in particulate emissions from diesel-fuelled compression ignition transport engines at concentrations between 0.9 to 2.2mg/g when using mineral diesel. To some extent this study explains the level of aluminium concentrations, the exact degree of which is unknown. Aluminium was also noted in several of the available oil test results in concentrations similar to that found by *Dwivedi, Agarwal & Sharma (2006)*.

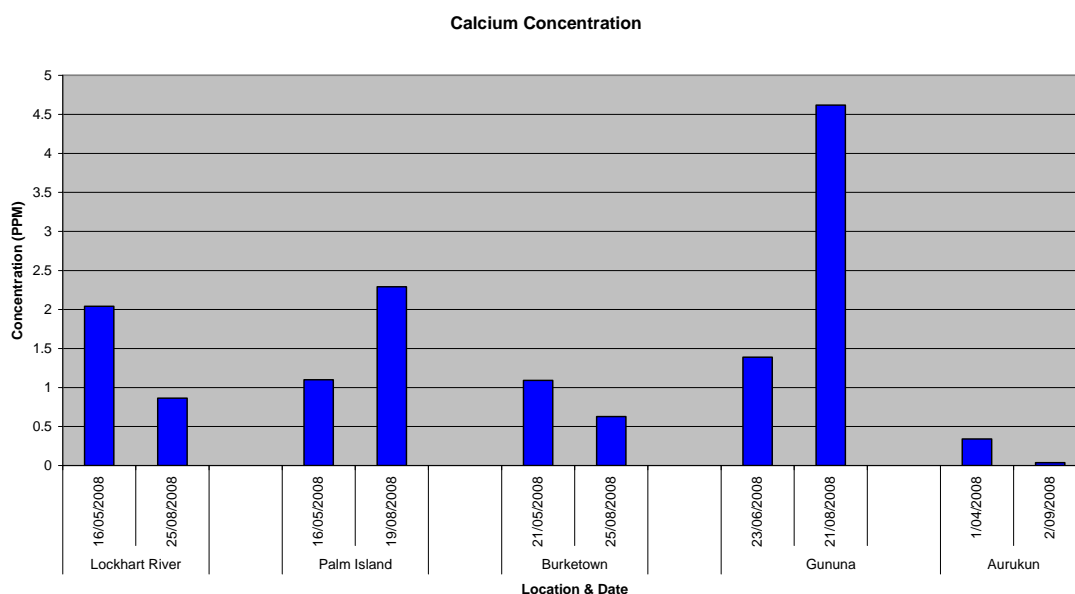
Figure 5.7 Calcium Concentrations at Each Site

Calcium concentrations at all sites are within the aesthetic guidelines. Calcium concentrations at all sites are indicated in diagram 5.7. The reason for the particularly high concentration of calcium at Gununa Power Station is not known. No calcium build up was visible at the time of inspection. The level of calcium encountered is not hazardous to human health.

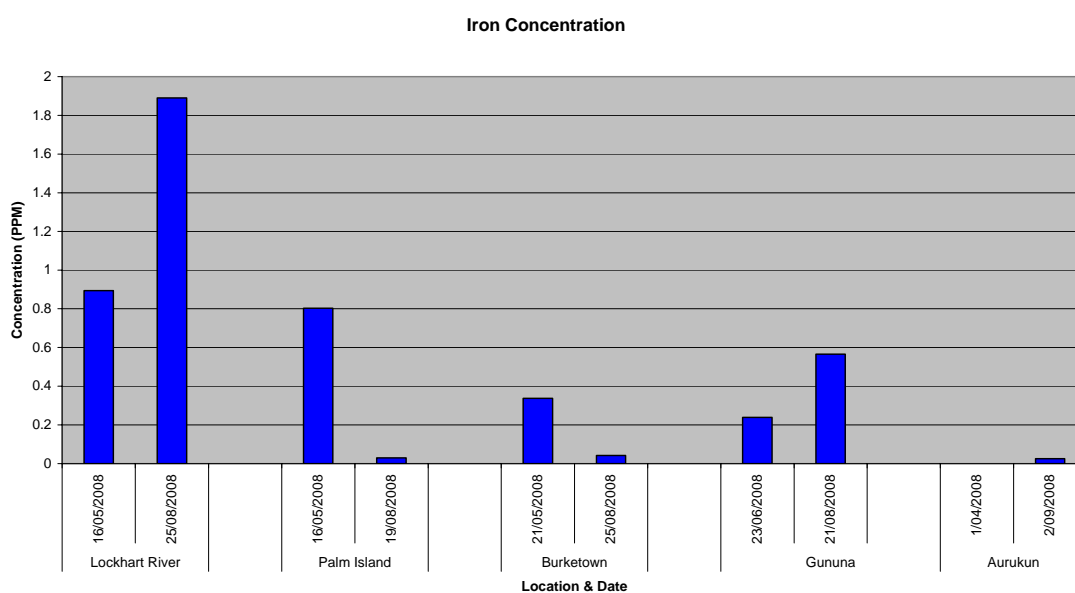
Figure 5.8 Iron Concentrations at Each Site

The guideline of 0.3mg/L for iron is based on aesthetic considerations. Concentrations above this level may produce an objectionable taste. As shown in Figure 5.8, the highest concentration was well in excess of this, at 1.89mg/L. The human body's

minimum daily requirement of iron is around 7mg, however this requirement varies with age and sex. High levels of iron are not harmful to the human body and excess quantities are passed through urine. In summation, the levels of iron encountered in the study do not pose health risks, although may lead to objectionable tasting water.

Iron is present in abundance in both diesel and lubricating oils. Previous studies have noted iron in diesel particulate. The most obvious source of iron contained in the samples is from the roof sheeting and emissions from the diesel.

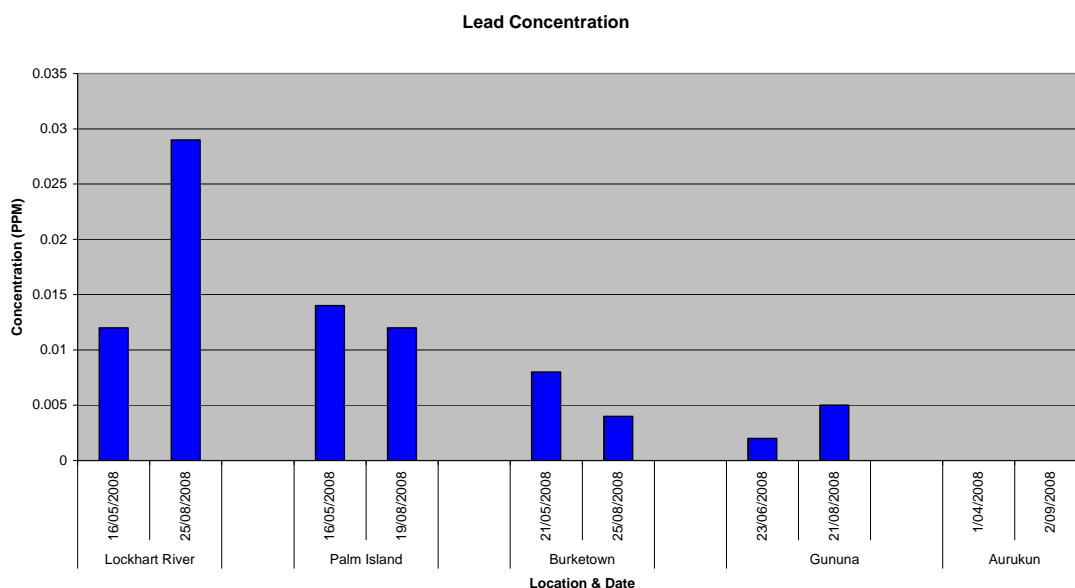
Figure 5.9 Lead Concentrations at Each Site

The highest concentration of lead encountered was 0.029mg/L. This is far in excess of the limit, 0.01mg/L. High levels of lead were detected in nearly all samples, with four samples above the ADWG health based limit. This would lead to significant health problems if employees were drinking this water for any considerable period of time including lead poisoning and other associated problems with the central nervous system

Lead may also be contained in some lower quality PVC. All pipes and plumbing used at these sites are high quality food grade fitting and pipes.
