University of Southern Queensland
Faculty of Engineering and Surveying

**Asset Management for Tamworth Regional
Council's Sewer Network**

Bachelor of Engineering (Environmental)

October 2010

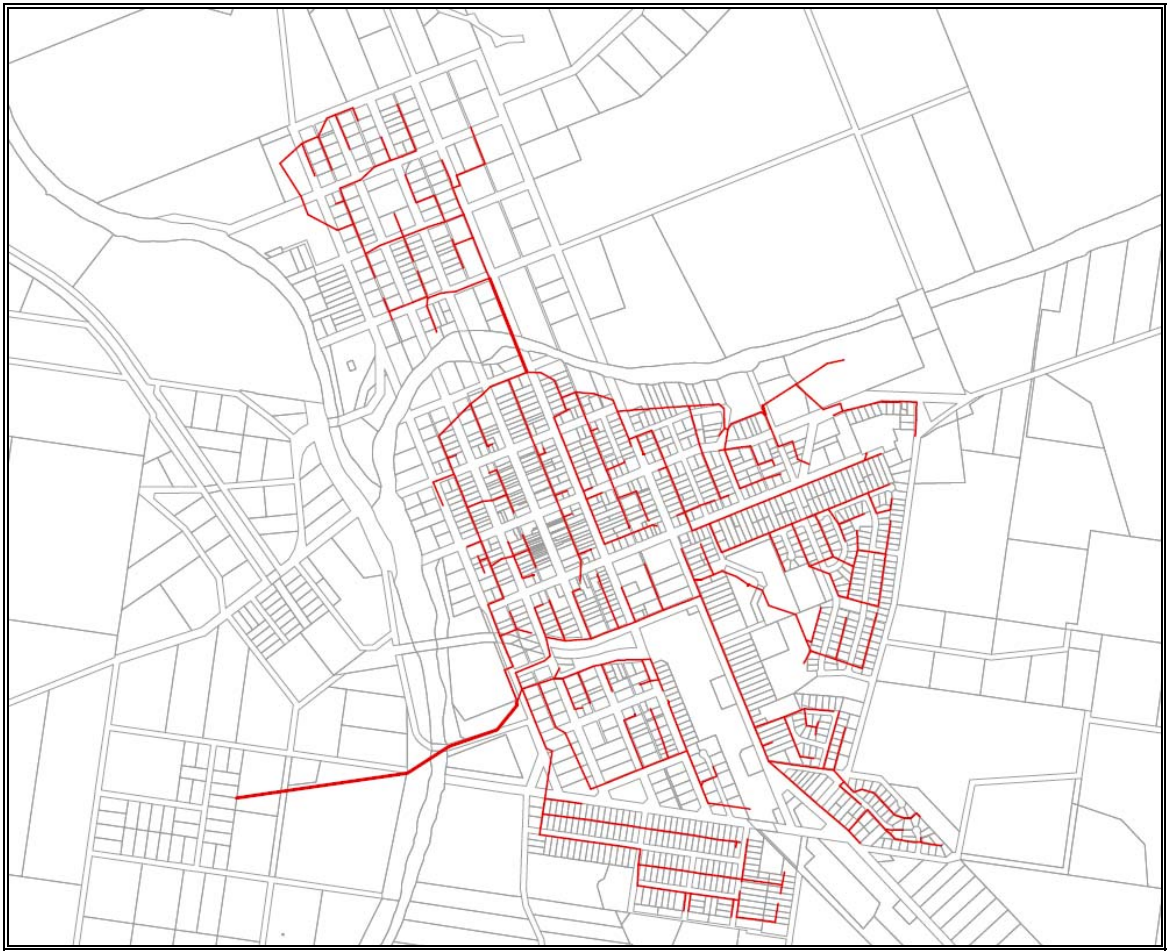
The original sewer network for Manilla was completed in 1948. A major augmentation was undertaken north of the Manilla River and completed in 2000. The system services approximately 2,000 people and consists primarily of a gravity sewer network with a deep carrier main, approximately six metres deep. This carrier main connects to the main pump station which delivers wastewater to the treatment facility. The sewer network consists primarily of vitrified clay and concrete pipes in older areas and polyvinyl chloride (PVC) in the newer augmented areas. A schematic layout of the Manilla sewer network is provided as Figure 1-7.

Figure 1-7 Sewer Layout of Manilla

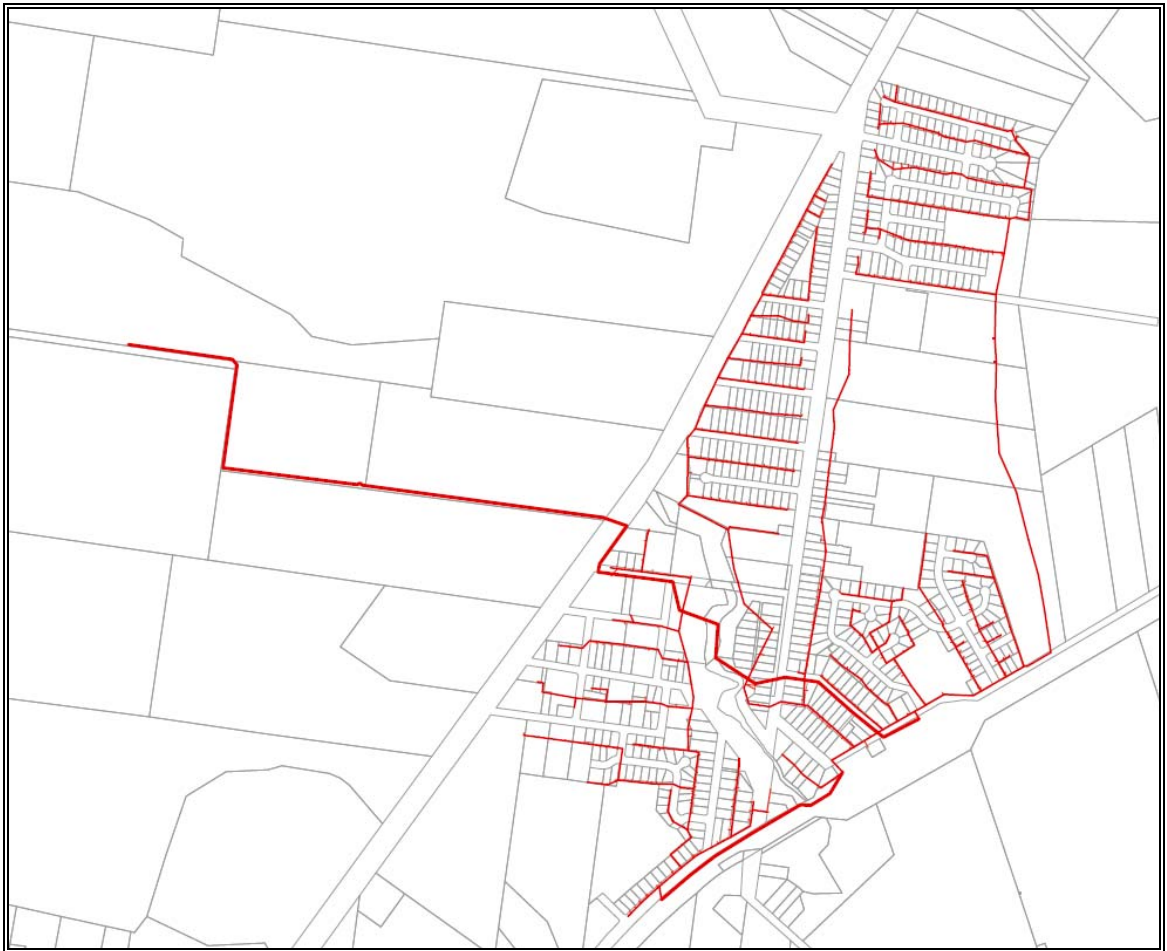
Kootingal is a relatively new sewer network with construction being completed in 1990. The system services a population of approximately 1,500 people and is entirely constructed of polyvinyl chloride pipes. A schematic layout of the Kootingal sewer network is provided as Figure 1-9.

Figure 1-9 Sewer Layout of Kootingal

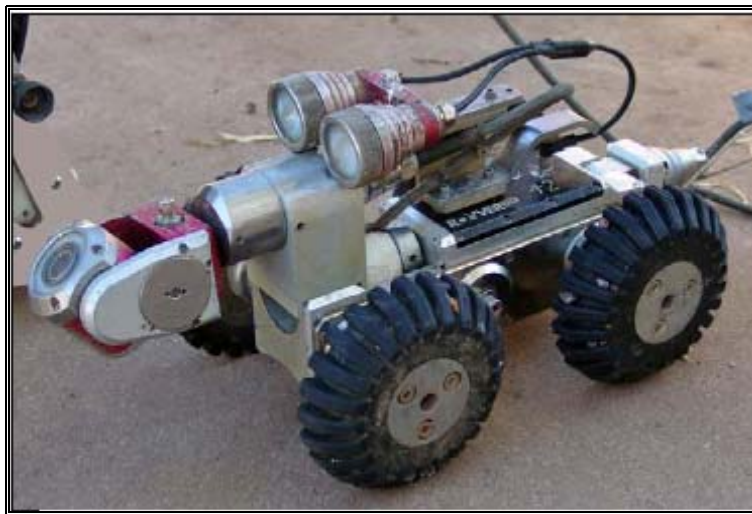
With regard to the current sewer pipe inspection technology, all commercial robots are completely tele-operated, usually via a tether cable and human operator (Amir et al 2006). Current pipe camera equipment provides high quality visual data to allow condition assessment. Despite this, sewer inspection robots have poor mobility function to pass any kind of pipe-bends such as curves and junctions so that those robots are only capable to move into the straight pipes (Amir et al 2006). A typical tractor type camera used for sewer inspection is detailed in Figure 2-5.

Figure 2-5 Sewer inspection tractor

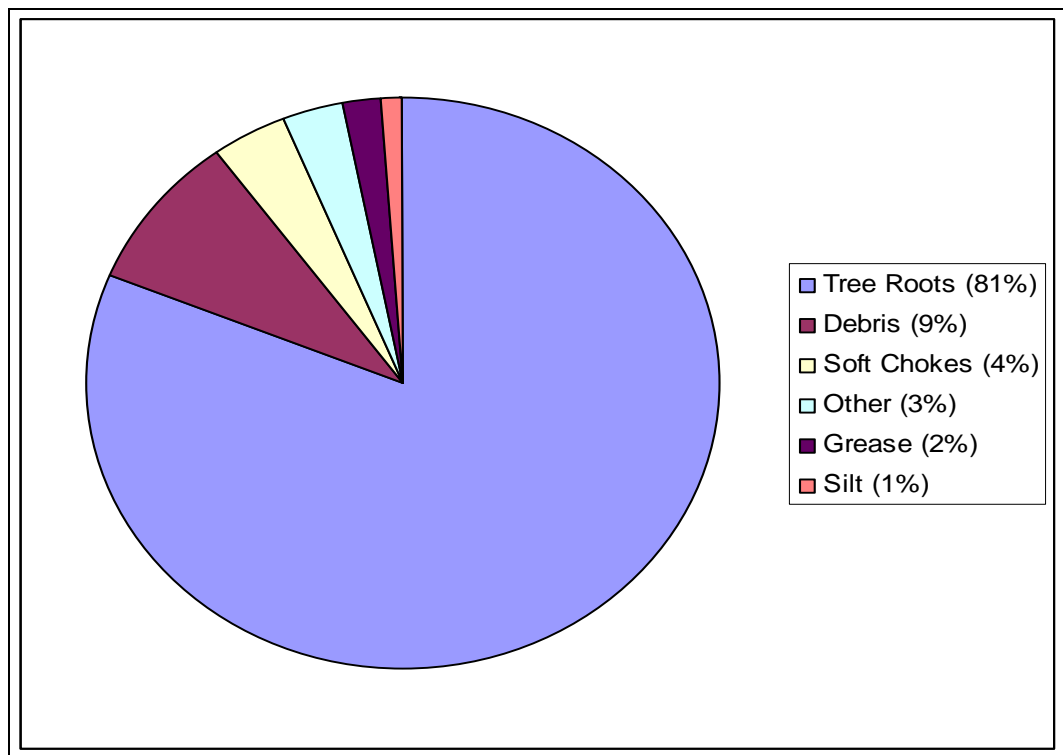
such as tree roots. Sewer blockages caused by tree roots is a common problem and can have a major impact on service standards and escalate public health risks. According to the ESC 75% of Yarra Valley Water's sewer blockages were caused by tree root infiltration (McCoy 2009). According to Sydney Water, the chokes in the Sydney region can be attributed to intrusions by tree roots (81%), debris (9%), soft choke (4%), other (3%), grease (2%), silt (1%) and broken pipe being the lowest contributor (less than 1%) (Samsung et al 2009). This is shown graphically in Figure 2-6.

Figure 2-6 Causes of sewer choke in Sydney Water areas (Samsung et al 2009)

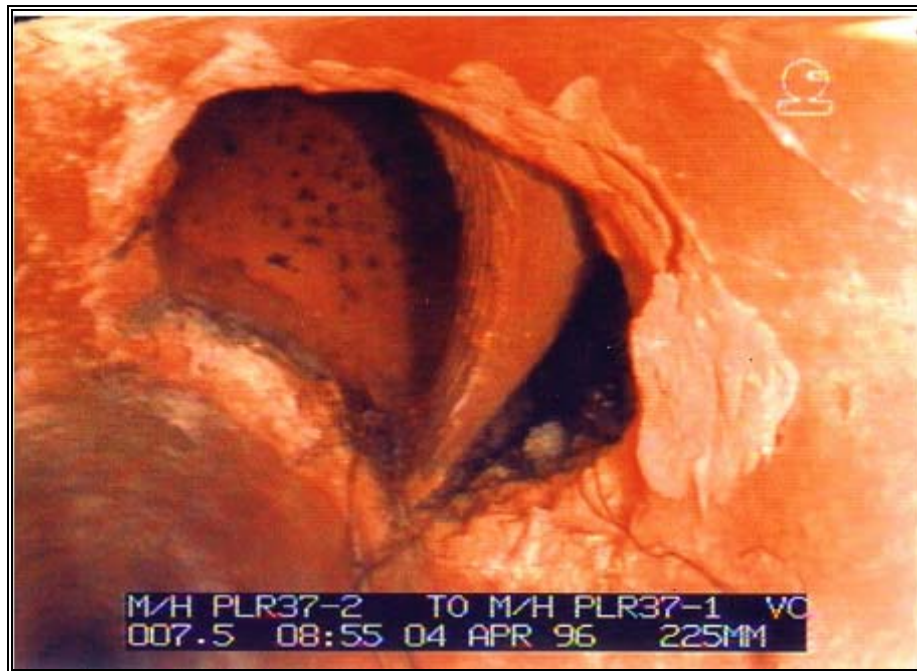
Figure 2-9 Example of poorly constructed lateral connection (WSAA 2005)

Poor design and construction can lead to sewer asset problems. Examples include poorly connected laterals to the sewer main which inevitable causes blockages (WSAA 2006). Poor designs can also lead to sewer network failures through not allowing enough grade for self cleansing velocity to be reached and material is deposited within mains (NSW Public Works 1987).

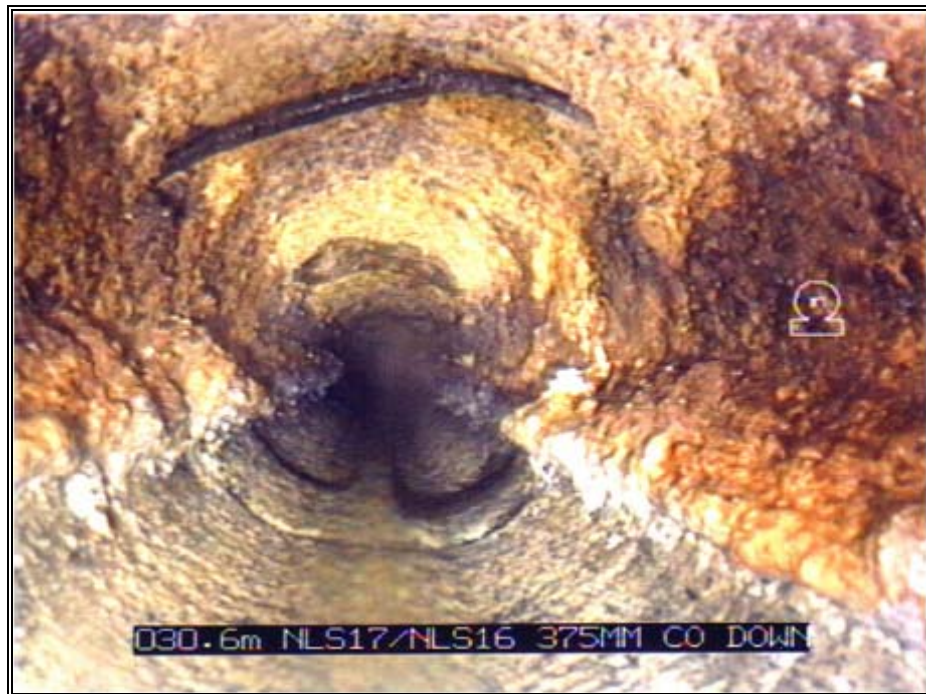
Figure 2-11 Example of concrete corrosion in a sewer main (WSAA 2005)

Corrosion generally occurs to assets constructed of concrete, asbestos cement or iron products. Corrosion can occur where low pH water is received to sewer from an industrial source but more readily occurs due to the formation of hydrogen sulfide gas within the network. The corrosion is caused by a combination of complex chemical and biological processes ultimately leading to the formation of sulphuric acid. The cost of remediation or replacement of corroded sewer systems is very high for large systems, in the order of several hundreds to several thousands of dollars per metre depending on pipe diameter and depth (University of Queensland 2010)

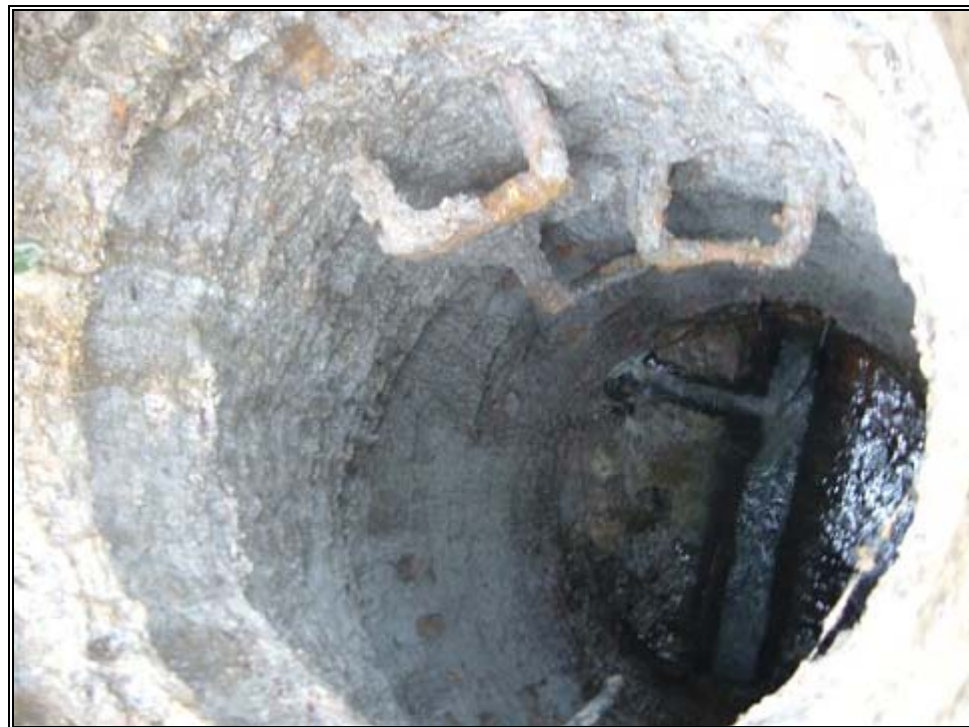
Figure 2-12 Example of concrete corrosion in a sewer maintenance hole

Maintenance holes are a major component of sewer network systems and are generally constructed from concrete, although some plastic products are now available. Corrosion of maintenance holes is common when subjected to high concentrations of hydrogen sulfide, particularly when poorly constructed with incorrect cement type.

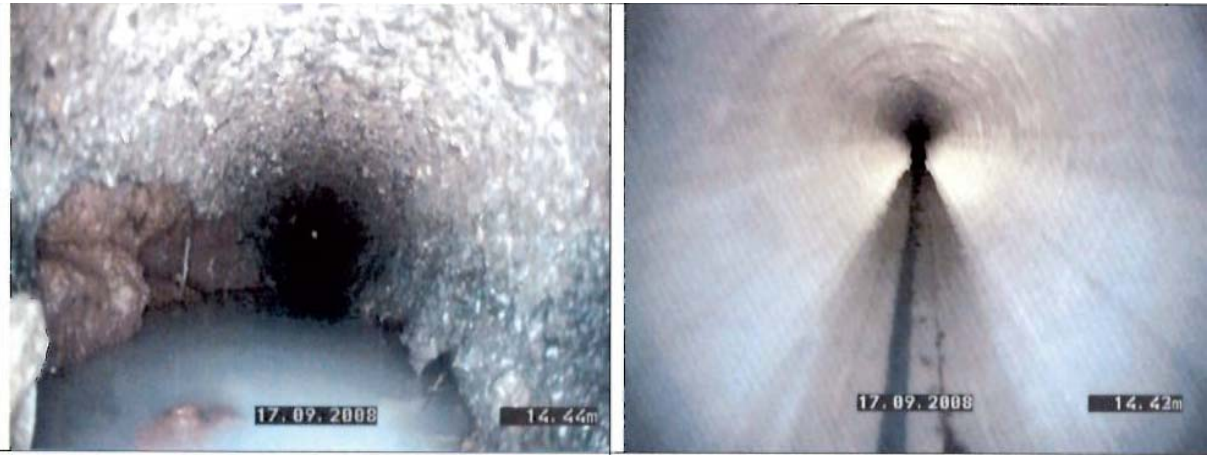
A pre-rehabilitated and post rehabilitated photograph of a cured in placed relined sewer main is provided as Figure 2-15.

Figure 2-15 Example of sewer main pre and post cured in place relining (Insituform Pacific 2008)

- The liner is winched through the manhole in smaller diameter sewer mains or inverted through the main.
- The liner is inflated either with air or water.
- Heat is applied to harden the resin and enable the liner to remain in its final form.
- The ends of the liner are cut and made smooth and to restore services

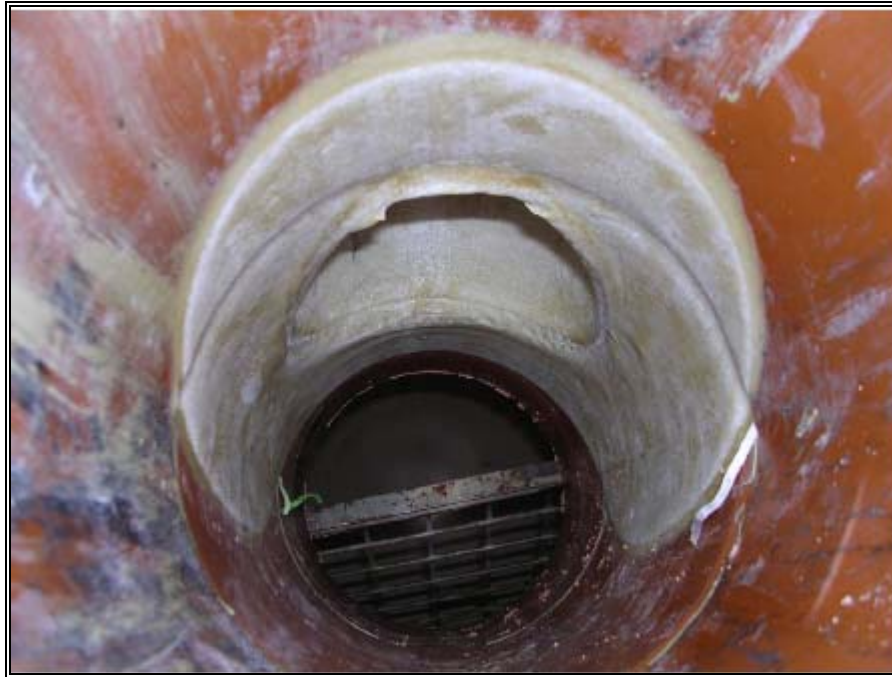
Relining can be used in conjunction with lateral sealing. In this process a seal is installed from inside the previously lined pipe into a lateral connection. This seal can prevent the ingress of groundwater as the system becomes entirely sealed. An example of lateral sealing is provided in Figure 2-17.

Figure 2-17 Example of sewer lateral connection lining (WSAA 2005)

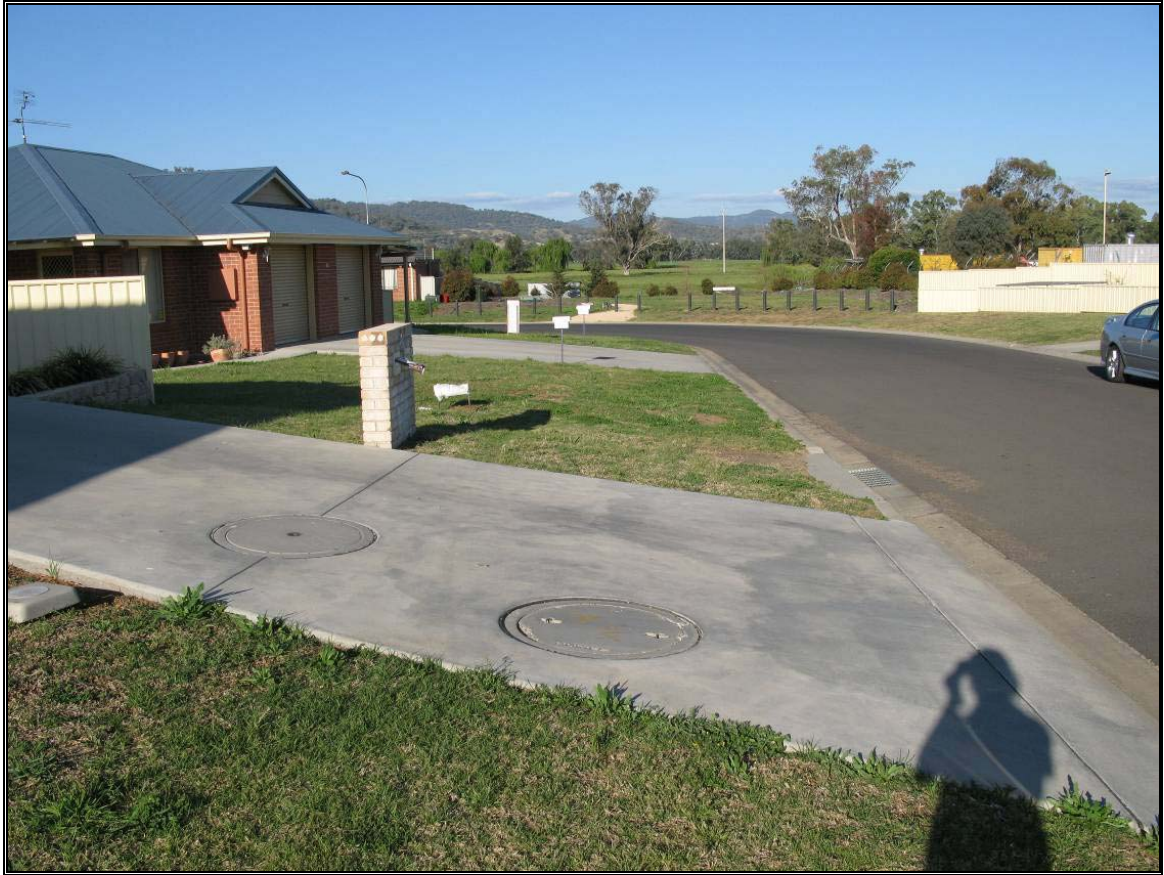
Despite the risk associated with the network a number of sites were identified as having potential risks. An example detailed in the report identifies sewer manholes Mh8186 and Mh1374, identified as being of concern to operators, are located in a residential driveway off Karwin Street in South Tamworth, as shown in Figure 4-1.

Figure 4-1 Manholes Mh8186 and Mh1374 Karwin Street, South Tamworth

During a site investigation residents confirmed recent overflows from these manholes. Multiple overflows were also reported by a resident from a house branch inspection opening in a property directly opposite. Public exposure to surcharges in Karwin Street from manholes Mh8186 and Mh1374 is possible and is associated with wet weather events to be discussed in subsection 4.2.2.

One particular example outlined by the study is the sewer overflow occurrences at manholes Mh8186 and Mh1374 located in Karwin Street, Tamworth. Prior to the

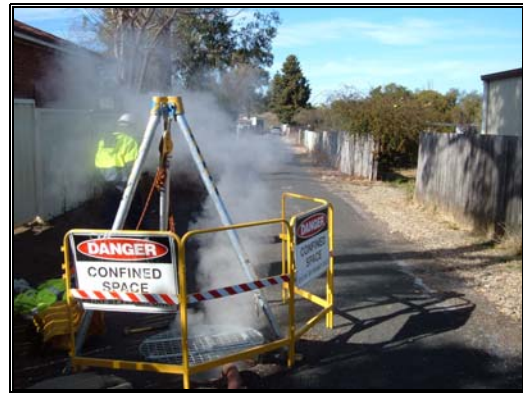
Council undertakes a significant amount of proactive sewer asset renewal by various techniques. Council commenced asset rehabilitation programs in the late 1980's using primarily contracts to complete these works. Council has completed approximately 20 contracts for sewer relining and sewer pipe bursting renewing a total of 70 kilometres of sewer assets. Further to this Council has also completed numerous sewer main reconstruction (sewer main replaced in its given location) and sewer main realignment. Details of asset renewals are provided in Appendix C. The photographs provided below detail two different methods of sewer relining previously used by Tamworth Regional Council.

Figure 4-5 Sewer relining Ribloc (TRC 2010) Figure 4-6 Sewer relining cured in place (TRC 2010)
